To: Safe Roads / NZ Transport Agency
Attn: Liv Theunissen
Date: 21 August 2018
Re: ATP installation issues near SH6 Kingston / SH83 Otematata

Quality Assurance Statement	
<i>This document has been prepared for the benefit of New Zealand Transport Agency and Safe Roads Alliance. No liability is accepted by ViaStrada Ltd, or any of its employees or sub-consultants with respect to its use by any other person.</i>	Prepared by: Glen Koorey
	Reviewed by: Axel Wilke
	Project Number: 1090-14
	Project Name: ATP markings cycling review
	Version: 1

1. Background

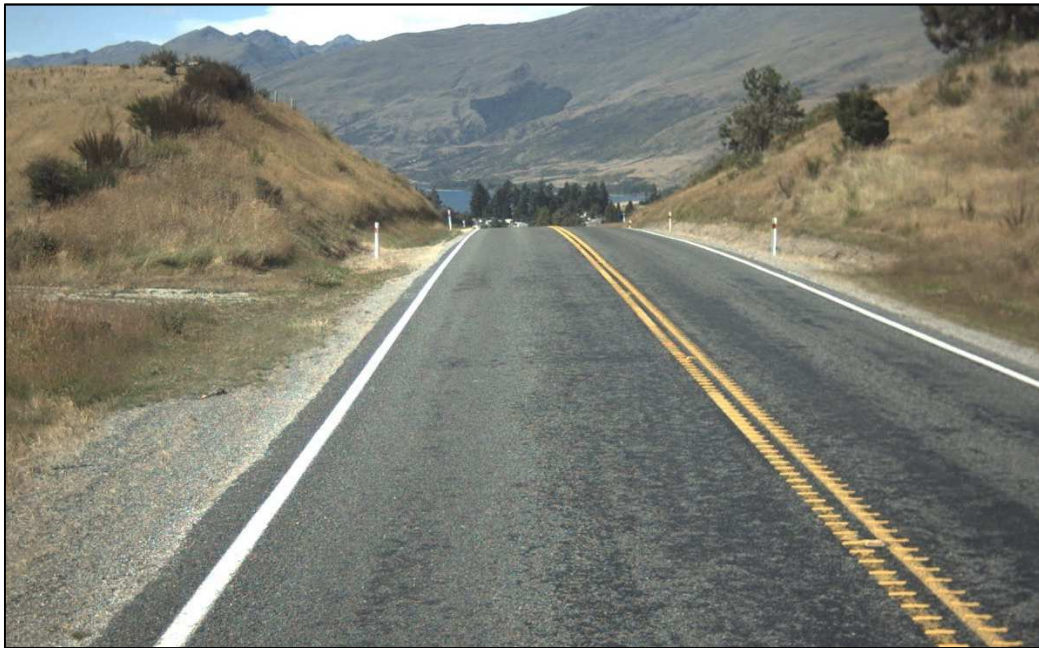
The figure below shows the crest at RP 12.70 (decreasing direction), prior to ATP installation (no photo available post-installation). The decreasing direction shoulders outside the edgeline are relatively narrow, typically 300 mm or less; for this reason, ATP has probably been installed outside the edgeline. However, the crest curves have very limited sight distance, which typically warrants not installing ATP over the crest until sight distance improves again. There are also notable downhill gradients (e.g. 12.7-12.4) where riders can pick up speed and care needs to be taken if riders were in close proximity to the ATP. However, again the limited shoulder would preclude riders from being placed inside the ATP here.

- a) **Remove ATP** from crest areas with limited sight distance (i.e. Incr direction: 12.18-12.32, 12.48-12.70. Decr direction: 12.80-12.62, 12.42-12.20). While this removes the restriction for anyone cycling, it doesn't address the lack of shoulder space and hence overall cycle safety.

- b) Provide additional **seal widening**, particularly where sight distance is limited or there is serious edge-break (i.e. Incr direction: 12.08-12.74. Decr direction: 12.80-12.10). There appears to be sufficient space to ensure at least (say) 600 mm consistently of clear sealed shoulder (i.e. clear of the ATP) with negligible earthworks, which would greatly improve cycling safety. However, there is a notable cost implication for such work.

- c) **Relocate shoulder ATP** to the edgeline, to maximise the available shoulder space for cycling. This option is only useful on its own if there is sufficient clear shoulder width available (i.e. at least 400-500 mm outside the ATP; more on the downhill sections); for most of this section that doesn't appear to be the case (unless it was placed inside the edgeline), which would therefore still require some seal widening. There is also a reasonable cost to remove and reinstall the ATP.

Recommended treatment: *b) seal widening at indicated locations*

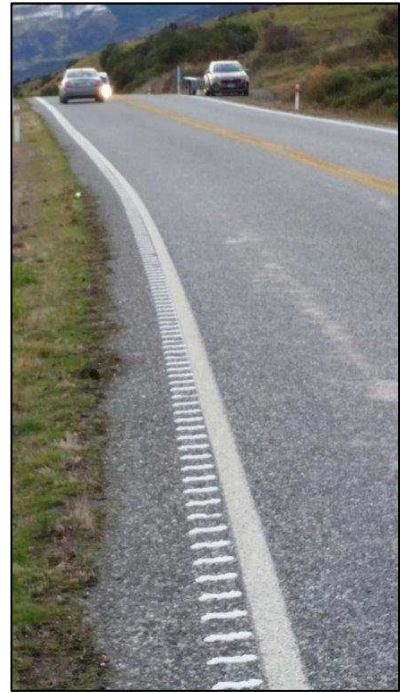
While there appears to be a reasonable shoulder width through this section (at least 500 mm, wider through the horizontal curve), the available clear width is narrowed by installation of ATP outside the edgeline (see photo). Coupled with the limited sight distance through the horizontal and vertical curves, this creates problems for any riders who are compelled to ride in the traffic lane instead.

- a) **Remove ATP** from sections with limited sight distance (i.e. Incr direction: 8.99-9.27. Decr direction: 9.35-8.95). For this section, that should provide sufficient remaining shoulder space and thus improving cycle safety.

- b) Provide additional **seal widening**, particularly where sight distance is limited or there is serious edgebreak (i.e. Incr direction: 8.98-9.17. Decr direction: 9.39-8.98). There generally appears to be sufficient space to ensure at least (say) 600mm consistently of clear sealed shoulder with minimal earthworks; more work may be required on the inside of the horizontal curve. However, there is a notable cost implication for such work.

- c) **Relocate shoulder ATP** to the edgeline, to maximise the available shoulder space for cycling. This option on its own would generally provide sufficient clear shoulder width available through this section (i.e. at least 400-500 mm outside the ATP); there may be a few isolated patches that would still require some seal widening to achieve this. There is also a reasonable cost to remove and reinstall the ATP.

Recommended treatment: a) remove ATP at indicated locations

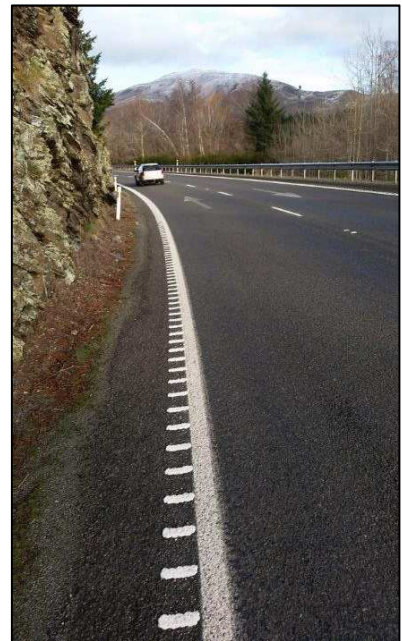
The increasing direction shoulders in the vicinity are reasonably narrow at 300-400 mm typically. The shoulder ATP has been placed outside the edgeline (see photo), requiring cyclists to ride in the traffic lane. This is problematic due to the poor forward sight distance around the corner (down to 80 m), because of the bank and vegetation, and it is notable that a WU6 “cyclists” warning sign has been installed just prior to the curve. By contrast, the decreasing direction shoulder (adjacent to the guardrail) is generous and appears to pose no problems with ATP installed.

- a) **Remove ATP** from narrow section with limited sight distance (i.e. Incr direction: 6.85-7.09). Although this provides some shoulder space for cyclists to use, it is still somewhat narrow in parts with limited sight distance, minimising the improvement to cycle safety.

- b) Provide additional **seal widening**, particularly where sight distance is limited (i.e. Incr direction: 6.87-7.09). There generally appears to be sufficient space to ensure at least (say) 600 mm consistently of clear sealed shoulder with minimal earthworks; that width may not be fully achievable in front of part of the closest rockface and ATP may still need to be removed there (~6.93-6.98), especially as additional drainage work such as kerbing may also be required there. There is also a notable cost implication for such work.

- c) **Relocate shoulder ATP** to the edgeline, to maximise the available shoulder space for cycling. This option is only useful if there is sufficient clear shoulder width available (i.e. at least 400-500 mm outside the ATP); for most of this section that doesn't appear to be the case, which would therefore still require some seal widening (unless it was placed inside the edgeline). There is also a reasonable cost to remove and reinstall the ATP.

Recommended treatment: *b) seal widening with localised ATP removal around rock outcrop*

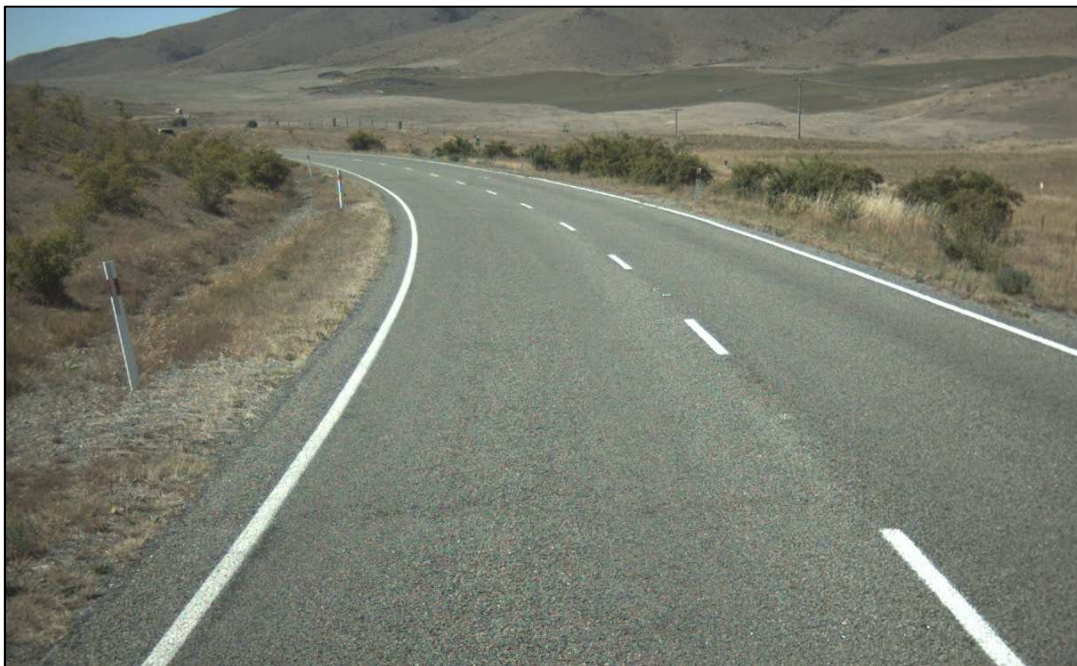
Although no photos are available post-installation, given the available shoulder width presumably the ATP has been placed just outside the edgeline, to encourage riders to ride inside it. The original desktop review only specified a few gaps in the ATP installation, mostly where there was shoulder widening or narrowing at side roads, curves and bridge approaches, as well as specific geometric restrictions at RP 85/7.51-7.23 and 85/6.85-6.65. On further review, it may also be appropriate to remove ATP on some partly obscured left-hand bends (see photo below), and to extend the excluded sections around the Otematata saddle.

- a) **Remove ATP** from narrow sections with limited sight distance; suggested sections are the partly obscured left-hand bends at RP 85/9.90-9.62 and RP 85/8.49-8.27 and around the

Otematata saddle between RP 85/7.60-6.85. Although this provides some shoulder space for cyclists to use, it is still somewhat narrow in parts with limited sight distance, minimising the improvement to cycle safety.

- b) Provide additional **seal widening**, particularly where sight distance is limited (i.e. locations noted above). There generally appears to be sufficient space to ensure at least (say) 600mm consistently of clear sealed shoulder with minimal earthworks. However, there is a notable cost implication for such work, especially given the length of highway being investigated.
- c) **Relocate shoulder ATP** to the edgeline, to maximise the available shoulder space for cycling. This option is only useful if there is sufficient clear shoulder width available (i.e. at least 400-500 mm outside the ATP); for most of this section that doesn't appear to be the case, which would therefore still require some seal widening (unless it was placed inside the edgeline). There is also a considerable cost to remove and reinstall the ATP over this length.

Recommended treatment: a) remove ATP at indicated locations

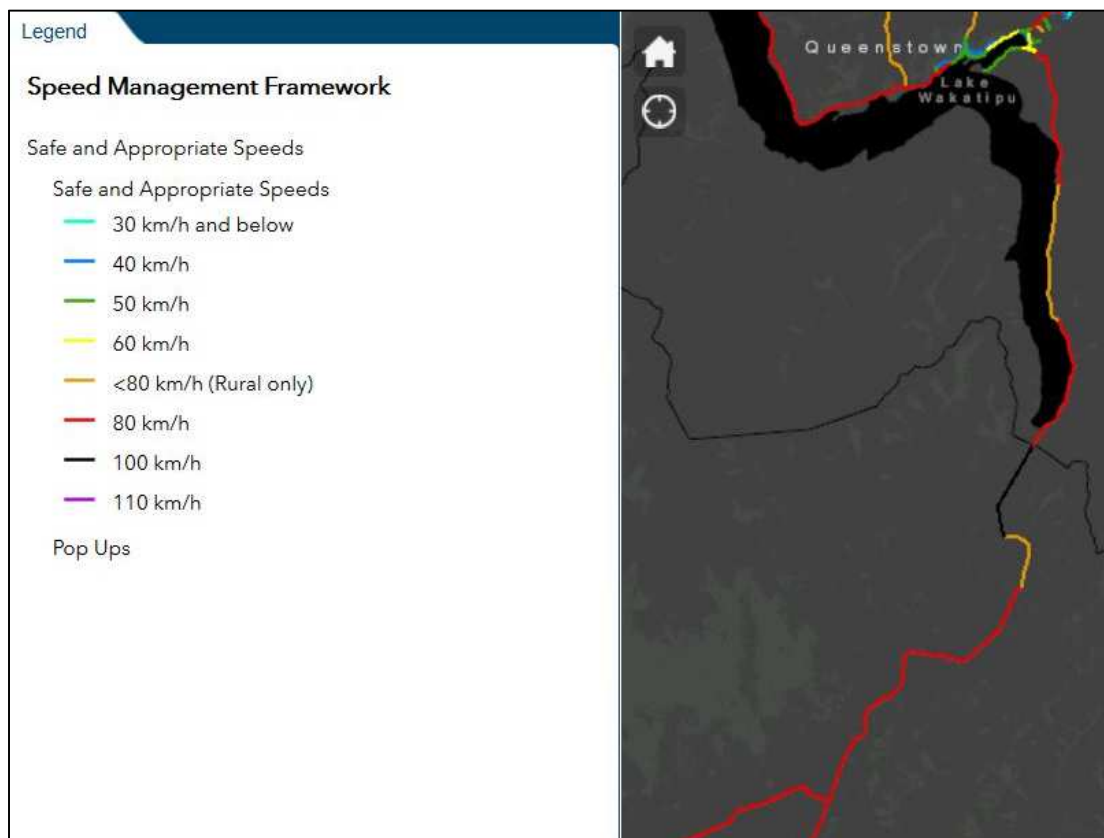
In all cases but site 3 (and for much of the highway networks treated recently with ATP as part of the Safety BOOST programme), **reducing the speed limit** to 80 km/h would be very effective to reduce the likelihood and severity of cycle crashes with motor vehicles. The calculated “safe & appropriate speed” for the roads investigated in this report (from NZTA Risk Assessment maps) is 80 km/h or less (e.g. see extract below).

Recommended treatment: lower speed limits to 80 km/h on sections of concern
