Ilam Road Cycle Facility

Design, Performance and Safety Review

Prepared for Christchurch City Council
December 2013/4

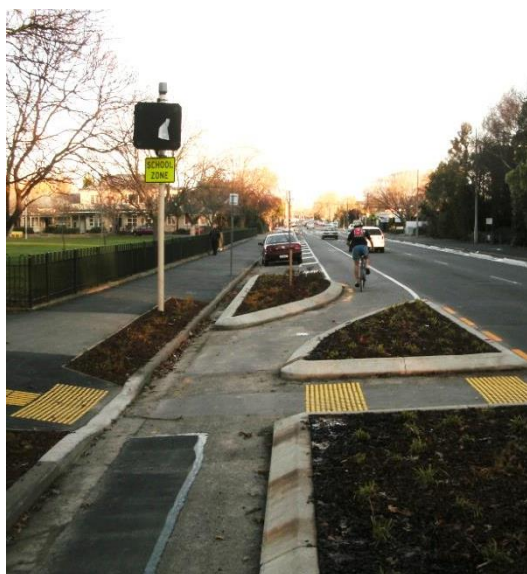
Photo 1: Chicane in southbound cycleway north of Ilam School results in a relatively tight alignment when biking at high speed.

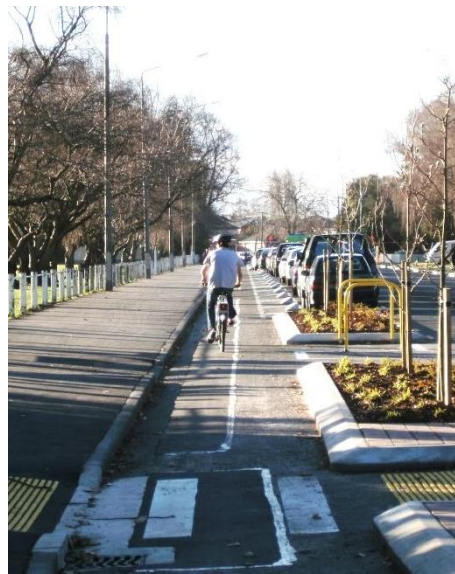
Similarly, it is not clear what was the thinking behind the cycleway widths provided (other than fitting within the available kerb lines). We understand that 1.8m was a target width, although this has not always been achieved (e.g. south of University Drive) and it is not clear whether this is actually an appropriate target for the conditions (e.g. should overtaking between cyclists be provided for?).

Photo 2: This cycleway width is ambiguous about whether it is designed for overtaking by other riders.

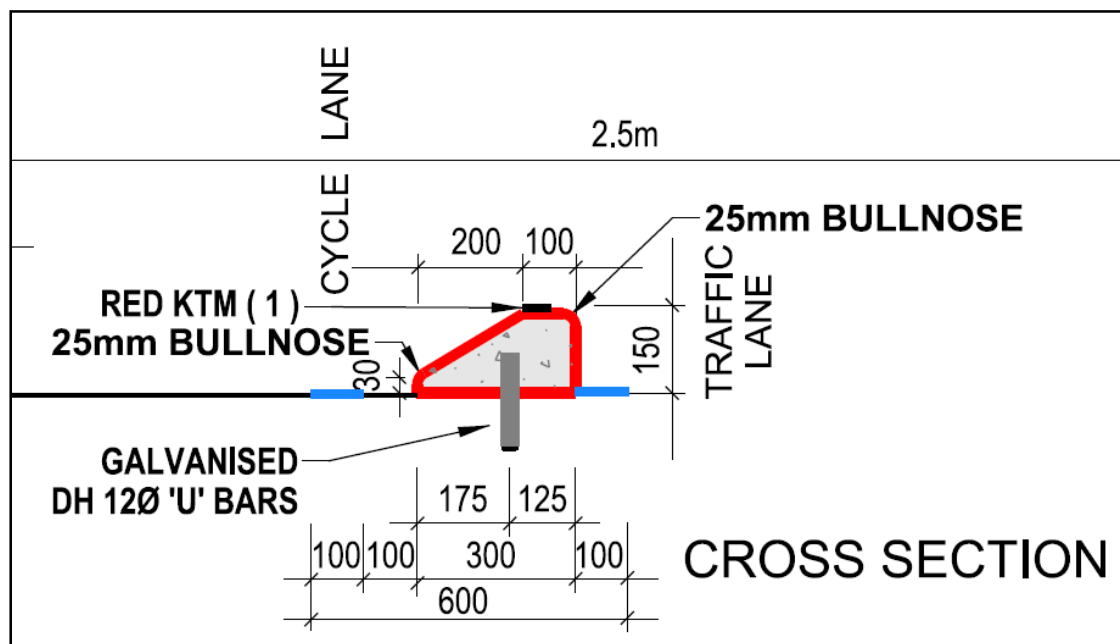
Figure 1: Cross-Section Details of Cycleway Kerb Separators

The Ilam Road design uses a separator between the cycleway and traffic/parking lanes consisting of an angled kerb block profile (the angled side facing the cycleway). Figure 1 shows the cross-section detail for these separators. This has caused considerable concern and discussion by road users and local stakeholders. The relatively low profile and grey colouring has made it relatively unobtrusive and thus prone to be hit by many motor vehicles.

The SAT's understanding was that the selection of the kerb profile template was a somewhat pragmatic decision making use of an existing standard design for mountable kerbs surrounding traffic islands (CCC 2010). Some discussion had been undertaken with supplier RTL about other separator design options, but it was felt that these were too limited. It is notable that vertical "flexi-posts" used in trials elsewhere around the city (Koorey *et al* 2013) were not considered suitable for in this situation. It is also significant that details about the design for these separators were not presented as part of the public consultation process for the Ilam Road project.

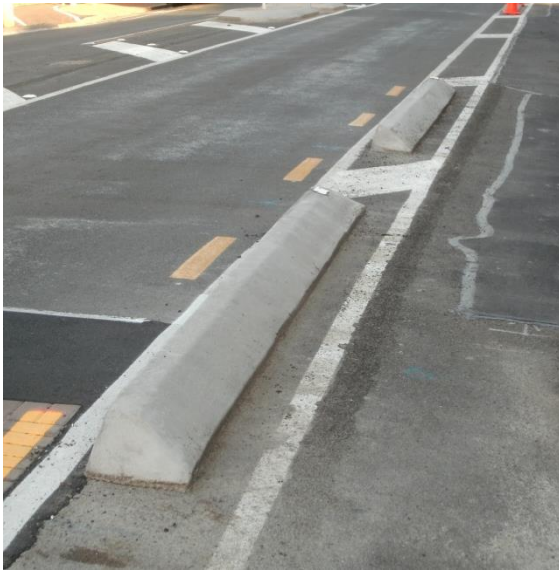
A key issue (identified elsewhere in this report too) was the non-mountable nature of the separators for motor vehicles. Whilst this clearly helped to discourage encroachment into the cycleways, it resulted in significant damage to both vehicle and separator when there was a collision (of which it was evident there were many to date). This goes against the principles of a "forgiving" road environment for all road users, as well as contributing to a high separator maintenance cost.

Photo 3: Concrete kerbs used as separators along Ilam Road.

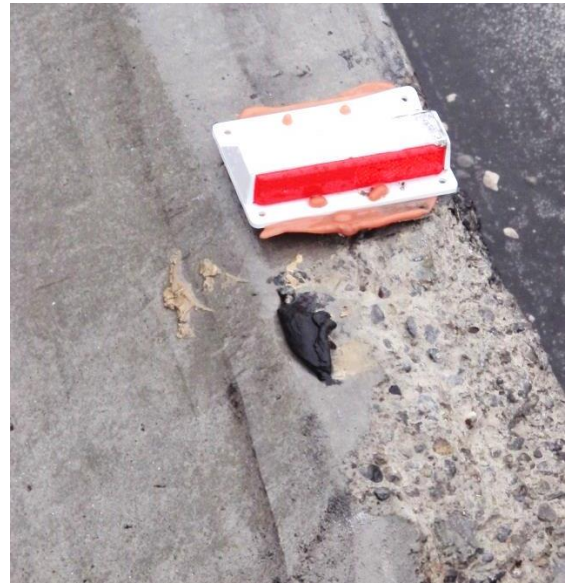
Photo 4: Typical damage experienced by separator kerbs due to vehicle collisions.

As discussed in Section 4.3, the new cycleway separators have experienced regular damage since their introduction. It is suspected that the relative inconspicuity of the separators has contributed to this (in conjunction with the unfamiliarity of road users to the new facilities). This appears to be due to:

The physical damage to both separators and vehicles has caused considerable concern from stakeholders. Given the desire to obtain widespread support for these facilities from the general public, the design of these separators does not appear to have helped.

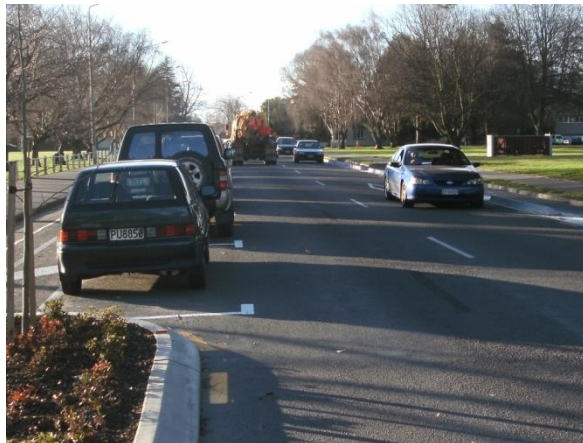
- A slowing of traffic, even in the absence of other traffic (see further discussion in Section 5.1).
- In relation to the adjacent on-street car parking, the tight cross-section also causes potential problems when opening driver-side doors (see Photo 5).
- Traffic waiting to turn into the side roads or enter an adjacent carpark may block traffic behind, causing delays.
- A motor vehicle undertaking a u-turn to enter/leave a car-park may have trouble doing so within the space available (made more difficult by the relative inconspicuity of the concrete separators, as discussed in Section 5.2).

Photo 5: Car parking immediately next to narrow traffic lanes

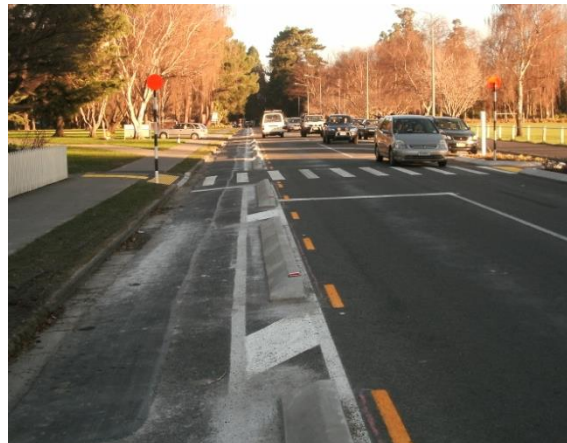
Photo 6: Existing kerb lines have been retained while fitting in cycleways

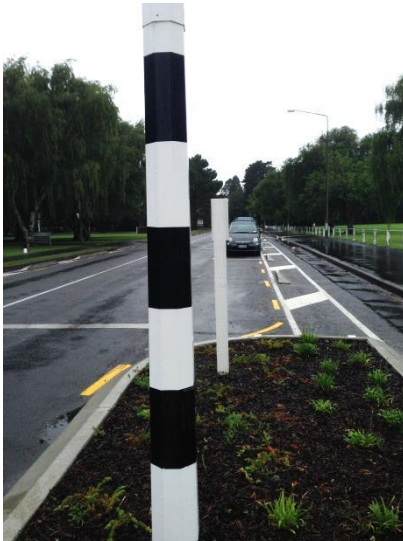
1. Pedestrian sight line blocked by shuttering effect created by lamp post and hazard marker post (refer to Photo 7 and Photo 8)
2. Sight lines blocked or restricted due to new planting (adjacent trees etc) Refer Photo 9)

Photo 7: Pedestrian Sight line reduced by shuttering effect created by pedestrian lighting pole and post.

In both of these respects, an assessment at the time of installation (even during design) would have resulted in the identification of the issue, and would have allowed the corrective action to have been undertaken immediately.

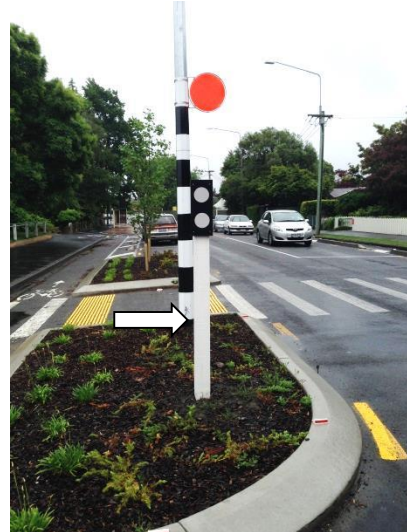
Photo 8: Hazard marker could have been mounted lower (refer to arrow), eliminating sight line obstruction.

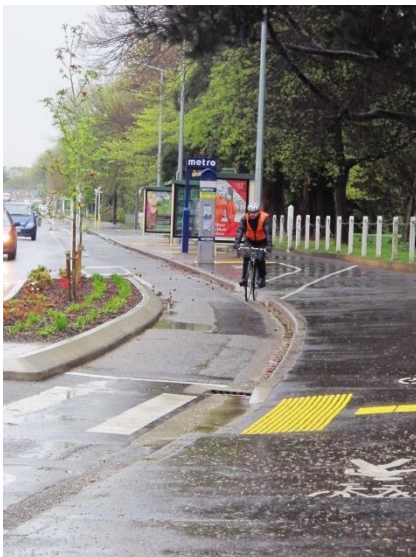
Photo 9: Pedestrian Sight line reduced by shuttering effect created by pedestrian lighting pole and post.

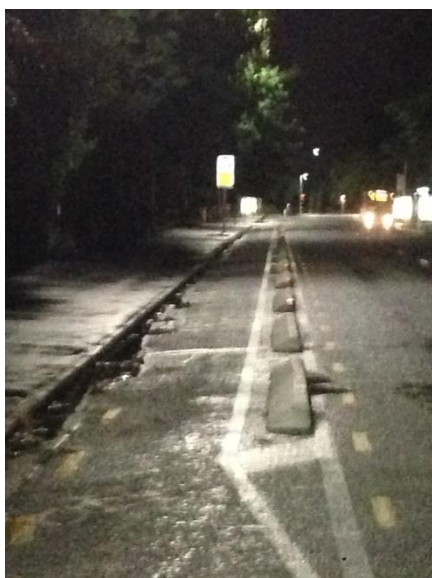
It was noted that the lighting along the route generally comprised of upgraded LED lighting heads on high outreach arms from the back of the footpath. In a number of locations the effectiveness of the overhead lighting was restricted due to adjacent trees and vegetation, resulting in locations of darkness. In some locations the areas of darkness on the facility also corresponded to areas of dense vegetation or poor lighting from the adjacent land use. Examples include behind the bus stops adjacent to the Ilam Homestead and the foot path alongside Rutherford and Rochester Halls on Ilam Road.

Photo 11: Large areas of darkness alongside extensive vegetation that form a personal security risk and result in poor illumination of the shared use off road cycle facility.

It is essential that all constructors have a good knowledge of the principles of CPTED, and that they identify site specific issues such as shading and at risk areas during construction, and that these issues are identified to the design team for immediate corrective action.

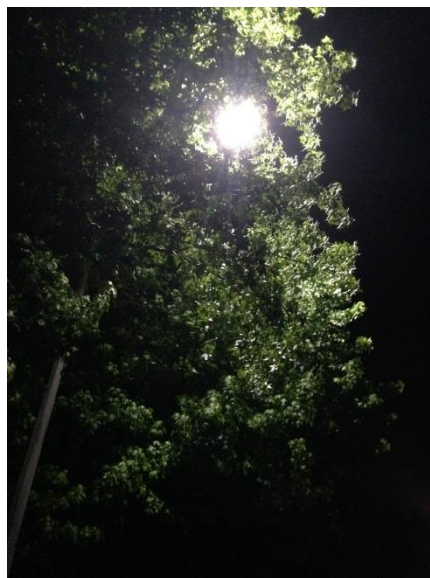
Photo 12: Example of new lighting heads installed in a tree canopy resulting in poor lighting of the cycle facility.

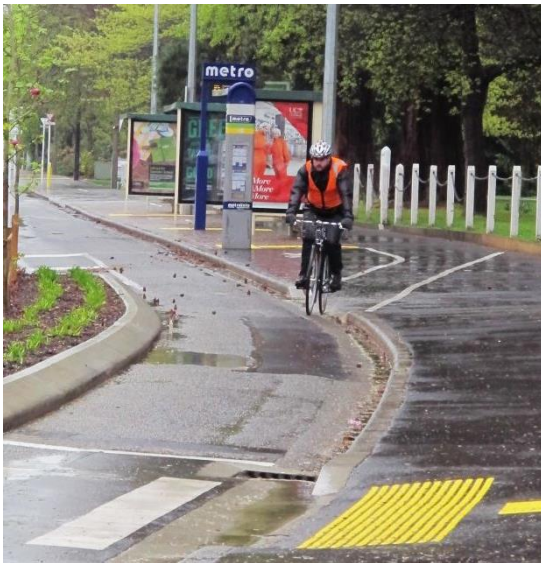
The applied design incorporates features that transfer cyclists from on road to off road and back. This places a strong need for adequately marked and formed shared facilities. This transition and shared facility use places the cyclist and pedestrian at conflict in locations.

Photo 13: Photo of Cycle use of off – road facility (opposite University Drive). Note obstruction to inter-visibility caused by advertising and bus shelters.

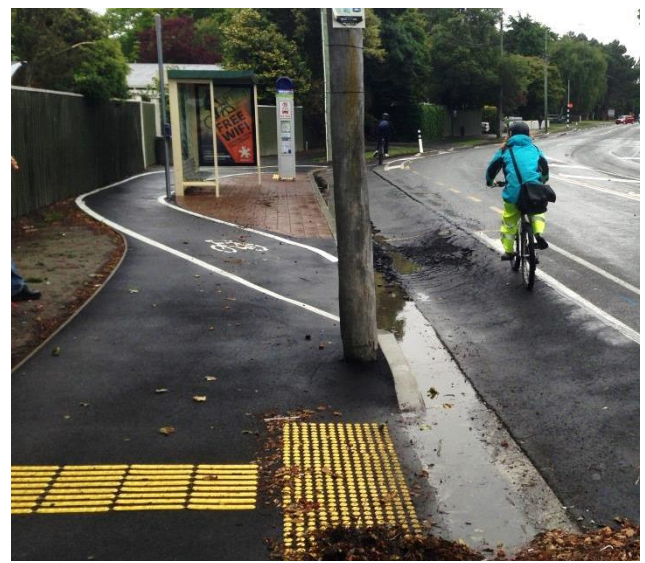
Photo 14: Photo of Cycle use of off – road facility (South of Montana Ave). Note obstruction to inter-visibility caused by advertising and bus shelters.

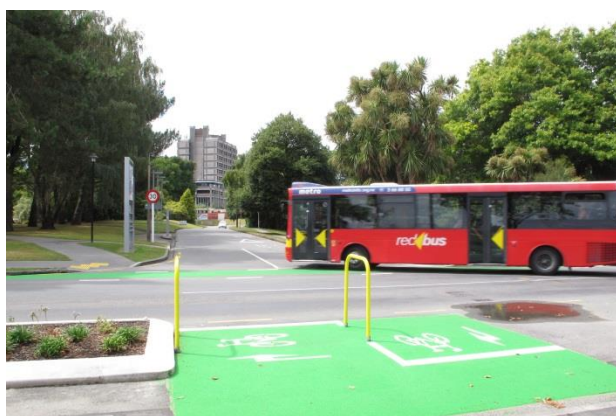
There are a number of bus routes that run along Ilam Road, with certain bus routes turning into and out of the University. It was observed that exiting buses generally had difficulty remaining in their own lane upon exit, and resulted in the front of the bus traversing into the opposing traffic lane. The use of tag axle buses compounds this issue due to the wider sweep path.

Photo 15: Photo of Bus use at University Drive.

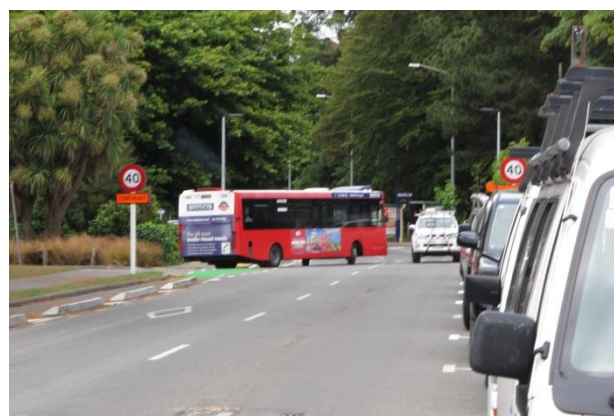
Photo 16: Example of bus crossing over the centre line

In general, most buses that access the University are single axle buses. The utilisation of a tag (twin) axle bus at the intersections may cause a significant safety concern with vehicles crossing into the opposing traffic lane.

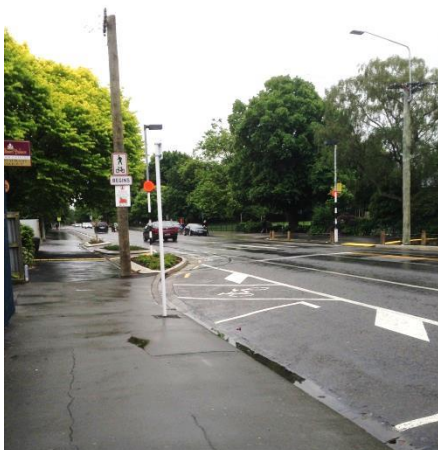
The pedestrian crossing in the vicinity of the Ilam Primary School has two parking spaces installed to the south, outside the dairy. Refer to Photo 17 and Photo 18.

Photo 17: On street parking in close proximity to Ilam School pedestrian crossing. Note limited space ahead of parking for on-road to off-road transition.

In practical terms this southern car park is problematic for use – vehicles attempting to occupy it are required to commence a reversing movement from within the lane and the on-street cycle facility. This could be hazardous during peak times where school children are arriving at school, and during peak traffic times. The complexity of the location in close proximity to the pedestrian crossing adds a further level of risk to the situation.

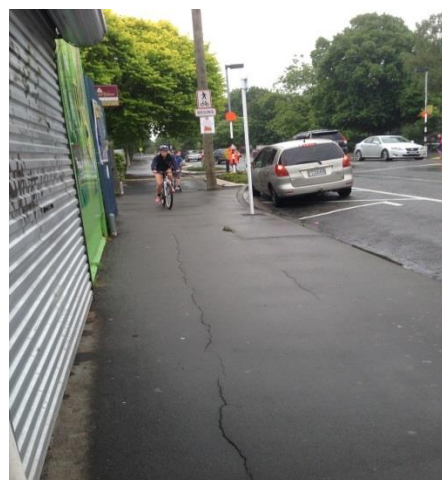
Photo 18: Difficulty in accessing car parks has led to poor parking discipline.

It was observed that these parking spaces are difficult to access, with the southernmost car park only able to be used with a reverse in movement due to the square end at the kerb island. This results in many people not using the car park, and parking over the cycle facility transition. (Refer to Photo 18)

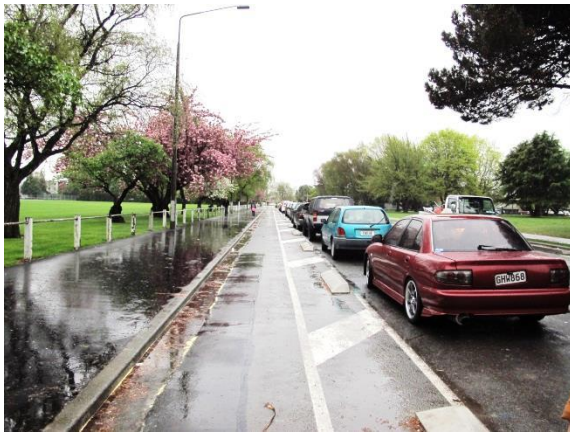
Vehicles occupying the parallel parking spaces along the new facility typically undertake a reverse in movement to occupy the parking space. Refer to Photo 19 and Photo 20.

Photo 19: On street parking alongside the cycle facility. Note poor parking discipline with drivers trying to avoid separators.

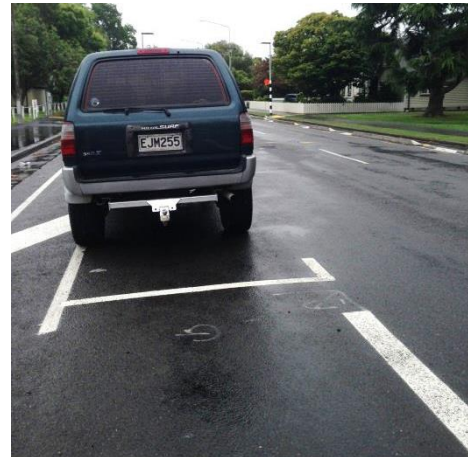
Photo 20: Parking in close proximity to cycle crossing facilities can lead to poor sight lines.

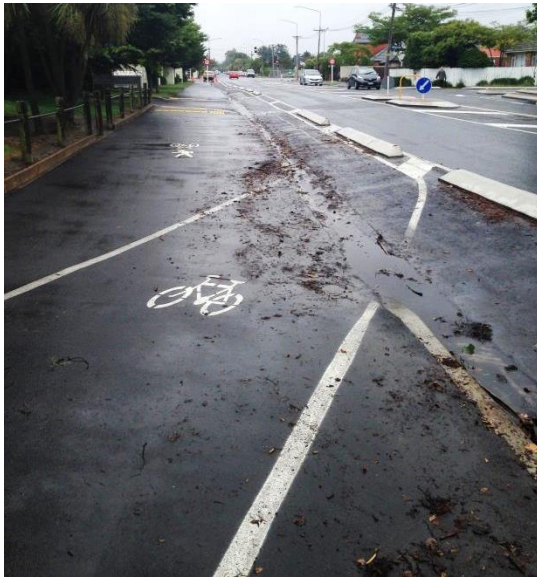
1. The lip of the drainage channel is high enough, and at a shallow angle and could cause a cyclist to lose control (Refer to Photo 21)
2. The drainage channel is flat in longitudinal profile and causes ponding within the transition (Refer to Photo 22)

In the instance of 1) above, it was observed on site (during wet conditions) that there was a reluctance for the cyclist to traverse through the channel when there was deep free water in the channel. In this instance, cyclists were staying on the footpath and looking for a secondary area that was free of (or less) water. This adds to the conflict on the footpath, away from the designated shared facilities

Photo 21: On street parking alongside the cycle facility. Note poor parking discipline with drivers trying to avoid separators.

On road / off road transitions should be designed to eliminate elements that would cause safety issues for the cyclist. The location of these transitions should be carefully considered to minimise conflicts with other road users at locations such as intersections and accessways.

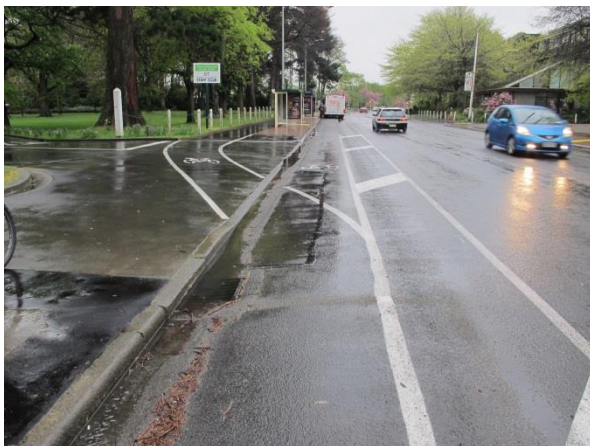
Photo 23: Example of transition in conflict zone at intersection.

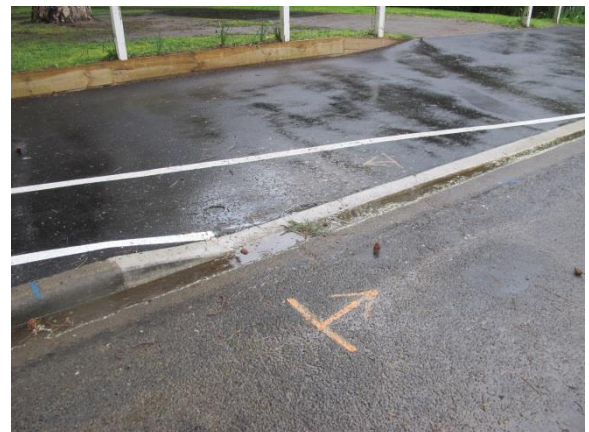
Photo 24: An acute angle of approach and lip on channel can cause a cyclist to lose control

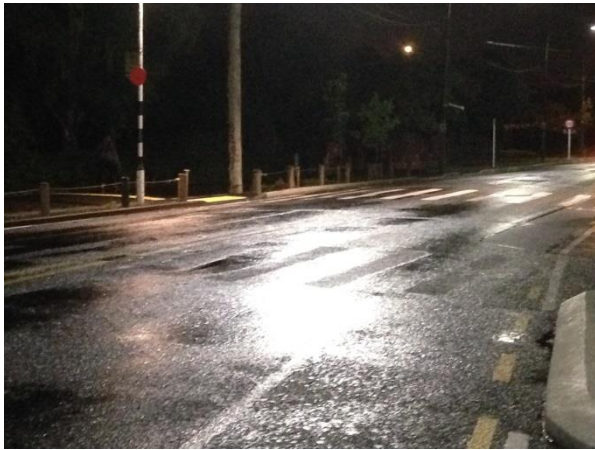
During the site inspections in the wet, and at night in the wet, it was observed that the removal of the markings was "clean" to the edge of the old markings. This means that the markings only were removed, and under dark / wet conditions they hold their original form and shape.

Photo 25: Pedestrian Crossing at Roundtree Road intersection. Note old pavement markings showing through on road surface as a result of following exactly old edges.

A best practice for the removal of old markings should be detailed that requires the operator to feather out the edges of the old markings so that sharp edge lines are not created, eliminating the risk of confusion.

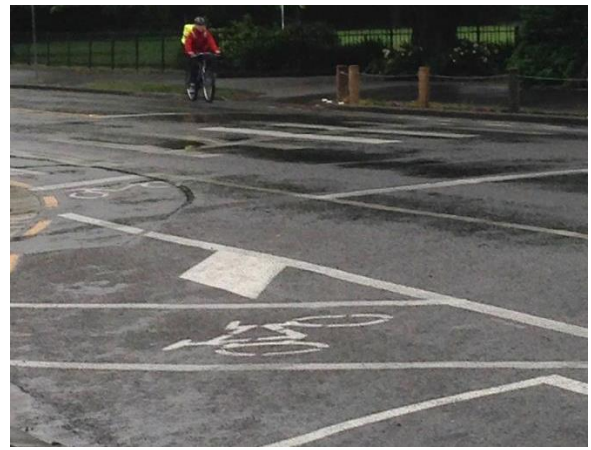
Photo 26: Transition from on-road to off-road (Ilam Road Pedestrian Crossing @ Roundtree). Confusion with multiple markings showing and cross over in from of parking space.

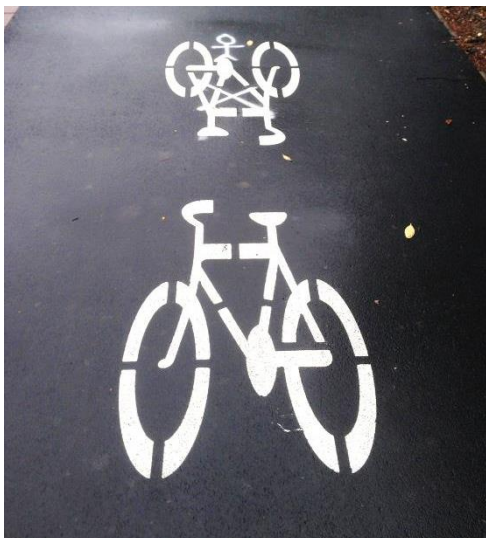
1. Cycle / cycle markings on a shared path (marked for removal) – should be cycle / pedestrian
2. Narrow cycle box at intersections (vehicles park over, facility too narrow to accommodate cycle movement into the box),
3. Give Way symbols missing from cycle facilities (Montana Avenue).

Photo 27: Incorrect cycle markings requiring removal and replacement of pedestrian symbol on shared facility. .

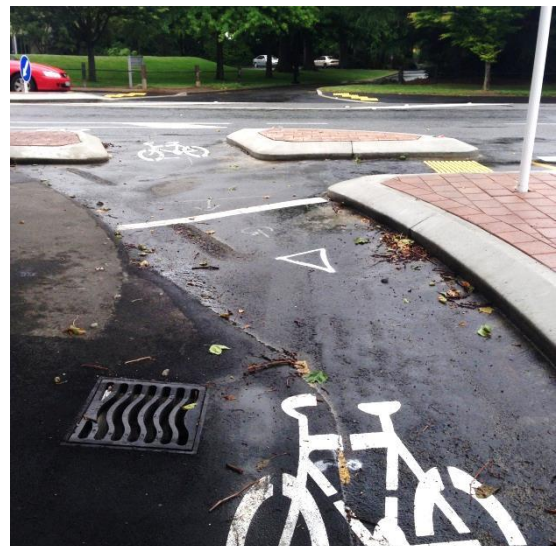
Photo 28: Give Way symbol required for cycle path on Montana Ave junction. Note temporary white triangle marking. Area of high conflict between pedestrians and cyclists.

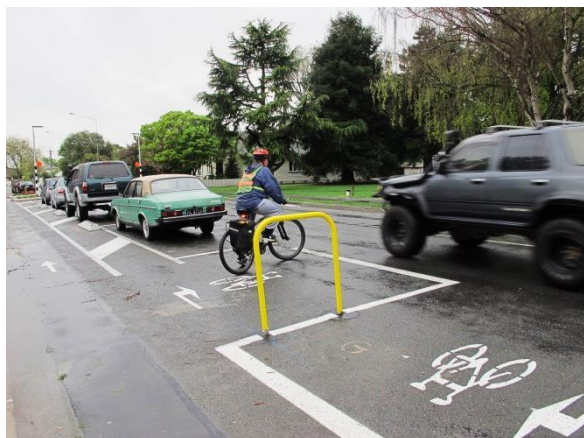
It is noted that many of the longitudinal seal joints are located in the cycle lane (Refer to Photo 29 below). This joint is often associated with a change in road profile. At locations along the route it was noted that there were isolated areas of joint failure, and the use of bitumen crack sealing has created areas with a slick road surface.

Photo 29: Seal joint is within the trafficable cycle lane. Displacement to the median would eliminate seal joint in a demand area.

Future designs should incorporate the formation of the construction joint into the central median. This should be a key review element during design and / or construction and will eliminate a potential safety issue for cyclists (especially in the wet).

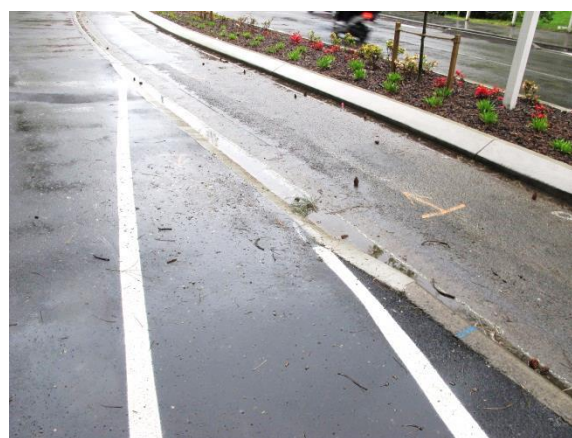
Photo 30: Transition to on-road facility. Note mixture of surface types and joints within cycle path

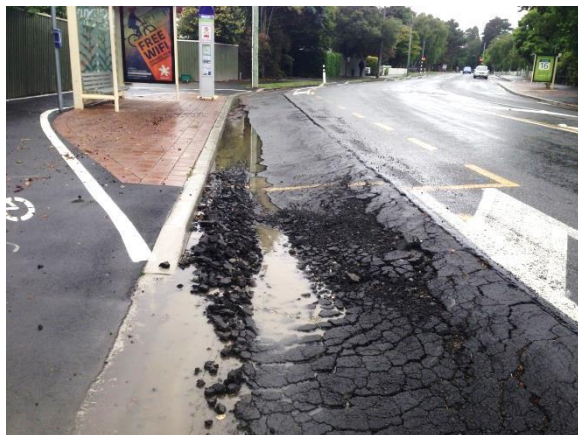
The bus stop in the vicinity of the curve south of Montana Avenue has been reconstructed with what appears to be new footpaths, kerb and channel and pavement. During the site inspection it was noted that the pavement in this location has suffered rapid failure, and is unsafe for use. This area of pavement failure is within the cycle lane and in the location of the bus stop. Refer to Photo 31 and Photo 32.

A review of the cross section of the road at this location reveals that the side slope of the shoulder is excessive, and may be a contributing factor to the pavement failure. In this instance, the axle load of buses would be towards the left wheel set, and would create high lateral shear.

It was observed that cyclists travelling along this section would undertake a rapid “pop-out” movement, into the traffic lane. Drivers approaching from behind would not be prepared for this movement, and could be slow to react to the cyclist. The issue is complicated with the location of the central pedestrian refuge immediately north of the bus stop and area of pavement failure. There is an extreme risk of rear end collisions with the cyclist.

Photo 31: Large areas of pavement failure at Bus stop on Ilam Road near Montana Ave. Note steep slope of shoulder and sharp edge of joint. High risk to cyclists in this location.

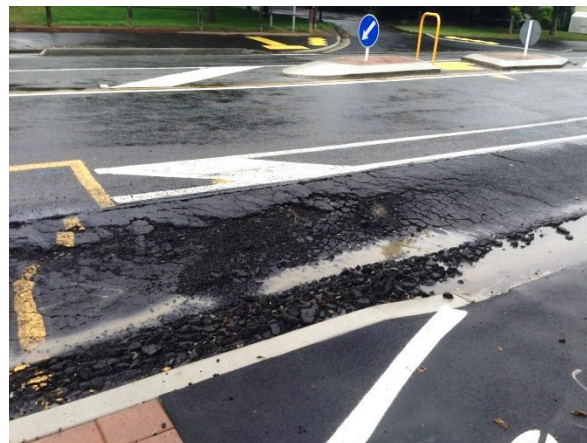
Photo 32: Large areas of pavement failure at Bus stop on Ilam Road near Montana Ave. Failure is within cycle path and is not traversable by cyclists.

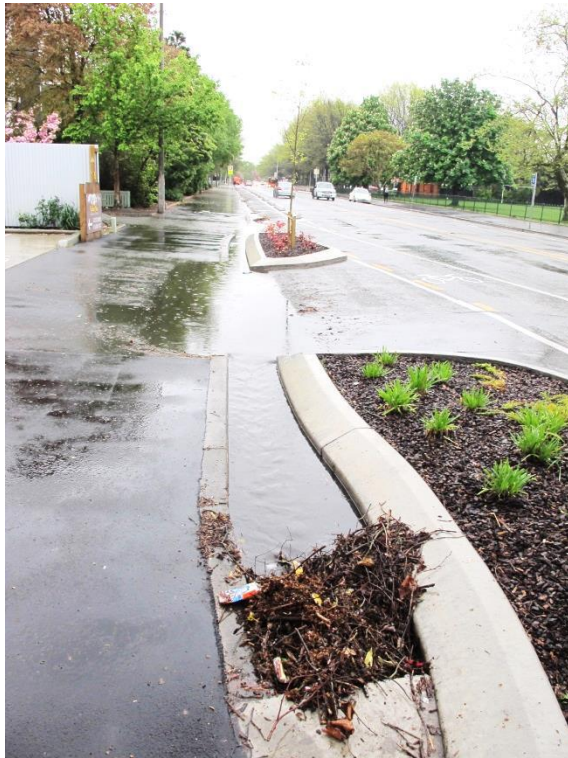
In all the site inspections, undertaken weeks apart, there was observed many issues with respect to the cleanliness and debris within the cycleway. Much of the debris was vegetation and rubbish. Refer to Photo 33 and Photo 34.

Photo 33: Drainage facilities prone to blockage due to adjacent vegetation. Regular cleaning of the sumps and drainage paths is required to prevent flooding of facility.

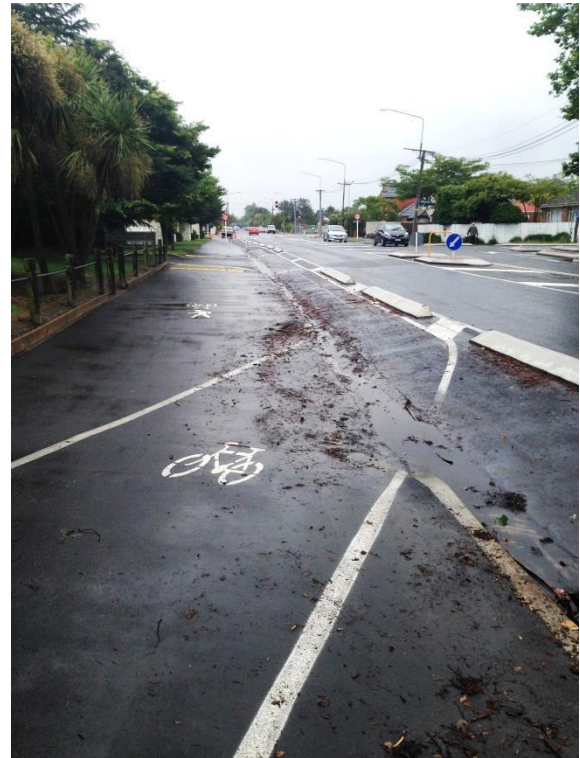
Photo 34: Debris within the cycle path that can lead to loss of control for cyclist due to slippery / greasy surface. Note lack of space for a vehicle within the cycle path. Standard street cleaners will not be suitable for the design of the facility.

All of the observed cleaning issues revolved around the ability of maintenance operations to maintain the new facilities to the desired standards. Failure to clean the facilities will deter cyclists from using the cycle paths and result in them occupying the traffic lane, contrary to the desire to provide a separated facility.
