# Dunedin Cycle Lane Marking Trial

Report prepared for  
**NZ Transport Agency**

**ViaStrada Ltd**  
**July 2014**

This report documents a formal New Zealand Transport Agency trial carried out on Dunedin's Cumberland Street (State Highway 1) in the block between Hanover and Frederick Streets. Non-standard road markings for cycle lanes were tested for their effectiveness.

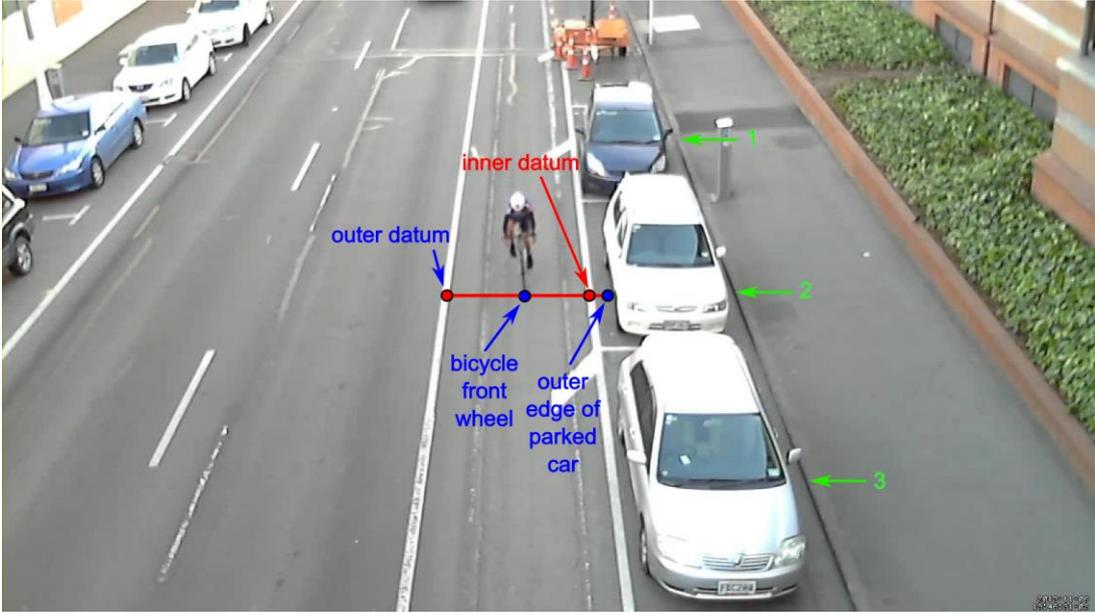
(The photo on the cover page details the method used to analyse cyclist tracking positions.)

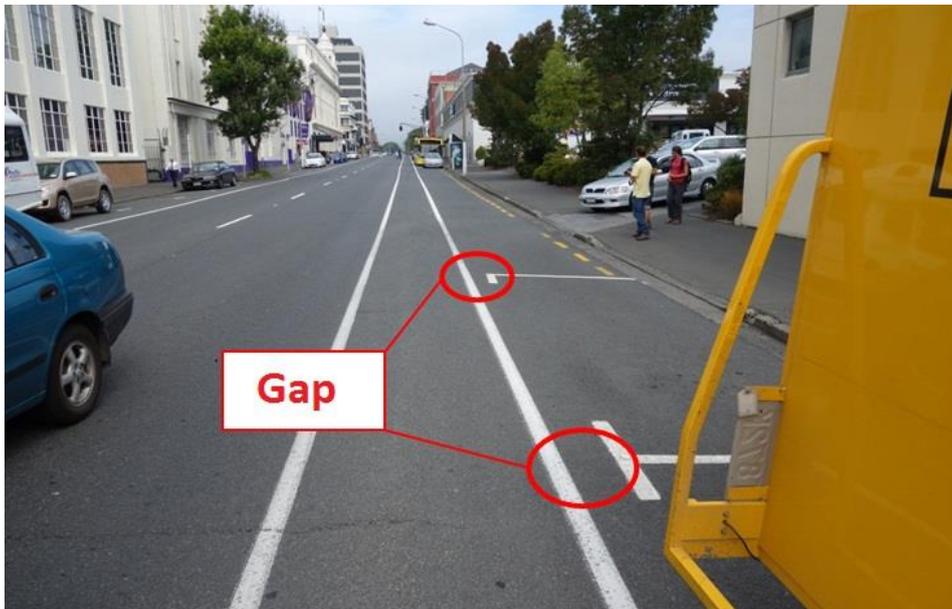
**Figure 2: Existing layout with parking, and inner and outer edgelines forming cycle lane**

On the left hand side of the 1.2 m to 1.5 m cycle lane, a narrow 0.6 m gap is created by the inner (left) edgeline and the parking ticks. Of specific concern with this layout is the proximity between parked vehicles and cyclists, as opening car doors leave little or no space for cyclists to avoid crashing into the door or entering the adjacent vehicle lanes.

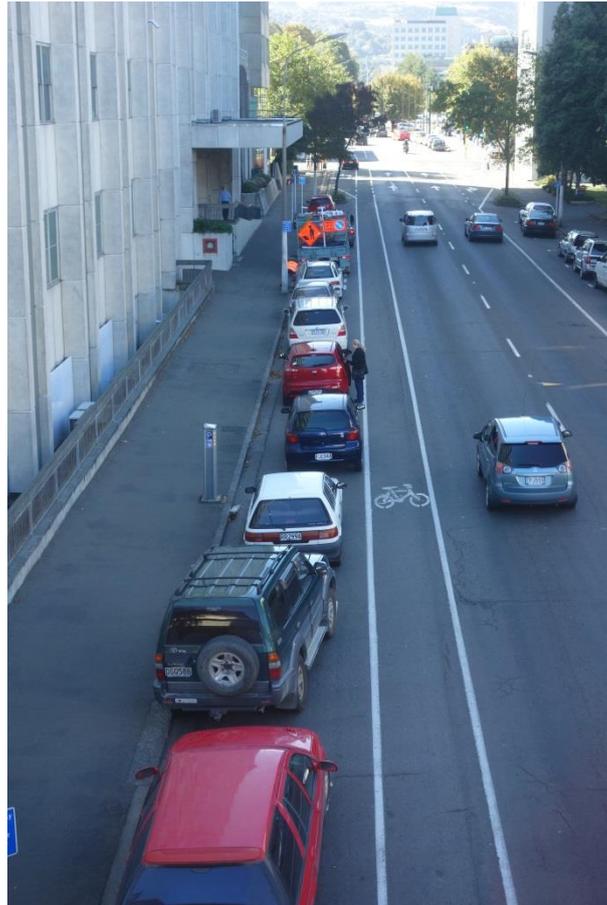
Furthermore, we measured parking discipline as the offset from kerb to the inside (i.e. left) rear tyre side wall,<sup>1</sup> but vehicles have different widths, and we thus measured the width of a sufficiently large sample size to get a statistically significant vehicle width distribution. Lastly, it needs to be noted that vehicles did not necessarily park perfectly parallel to the kerb. All these issues are demonstrated in Figure 3.

Figure 3: Different parking disciplines and vehicle sizes will influence cyclist tracking

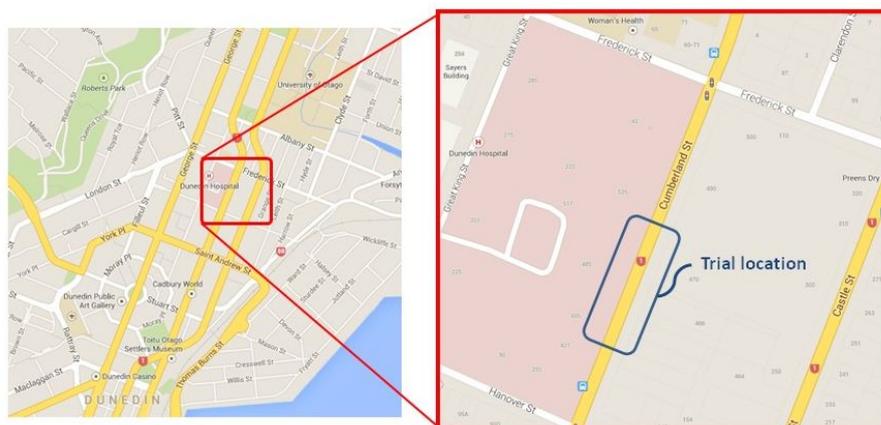
The marking trial was located on the northbound section of the SH1 pair through central Dunedin. The survey site, as illustrated in Figure 4 was located on Cumberland Street between Hanover and Frederick Streets outside the hospital. The site has two lanes of traffic in the northbound direction and the speed limit is 50 km/h. The Average Annual Daily Traffic (AADT) and percentage of heavy vehicles for the two one-way pair streets, north and south of the trial location are detailed in Table 1.

Figure 4: Trial location

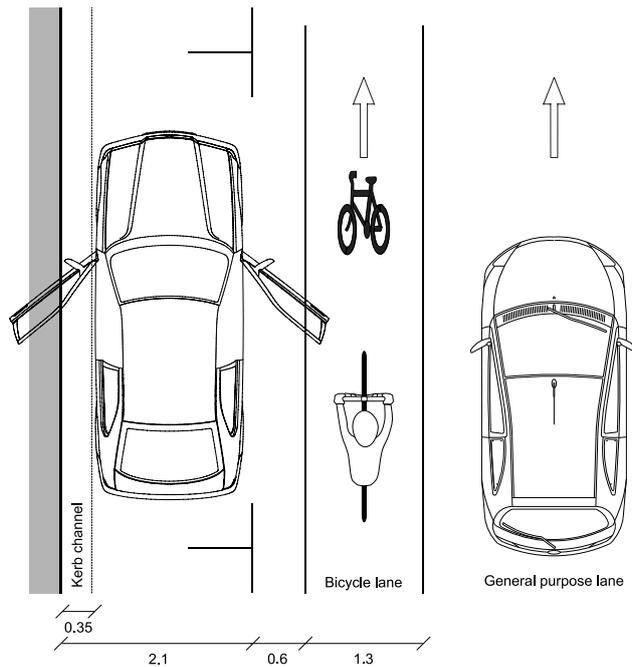
**Stage 1** represented the existing road marking layout before the trial began (Figure 5),

Figure 5: Stage 1 markings prior to the trial commencing

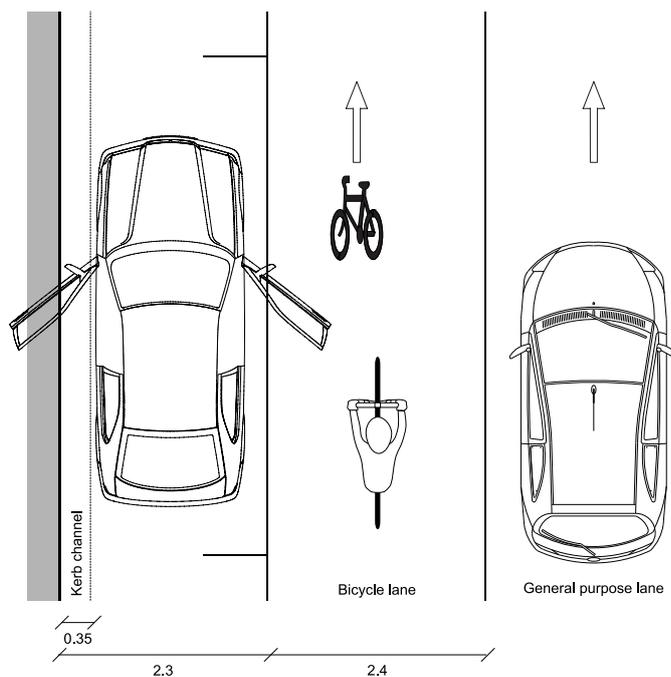
**Stage 2** represented the changed cross section (Figure 6), and

Figure 6: Stage 2 markings with widened cycle lane<sup>3</sup>

The cross section shown in Figure 6 was implemented in this or a modified form along the entire SH1 one-way pair in Dunedin between Stuart and Duke Streets (3.6 km in total). The traffic lanes were narrowed, and the buffer between the right traffic lane and parking on the right hand side of the streets also reduced in width. In effect, the parking – cycle lane part of the carriageway was given an additional 0.7 m with the treatments. Note that the heads of the parking ticks were removed and the parking lines extended to a newly-placed edgeline. This change resulted in the left parking bays to increase in width by 0.2 m (Figure 7). The changed layout was achieved as part of reseals in some sections, and through water blasting in the remainder of the network. The water blasting technique is less effective, as traces of the original markings can still be seen (see Figure 7). The section where the video observations were carried out had the old markings removed through water blasting.

<sup>3</sup> Note that Figure 6 represents the layout that was implemented at zones 1 and 2; as discussed further down, the other sites were somewhat different.

Figure 6 represents the markings that were installed at zones 1 and 2, the zones used for the video surveying. However what was actually intended for the sections that were not resealed, the existing parking ticks be left and the inner cycle lane edgeline be moved closer to the heads of the ticks. None of the other long-term parking zones used in the parking survey, i.e. zones 5,6 and 8, were resealed and thus they were marked differently to zones 1 and 2, as illustrated in Figure 9 and Figure 10. Figure 9 shows the section of the northbound section of the SH1 pair just south of Union Street; this area was zone 5 in the parking discipline survey. Figure 10 shows Castle Street south of Frederick Street; this area was zone 8 in the parking discipline survey.

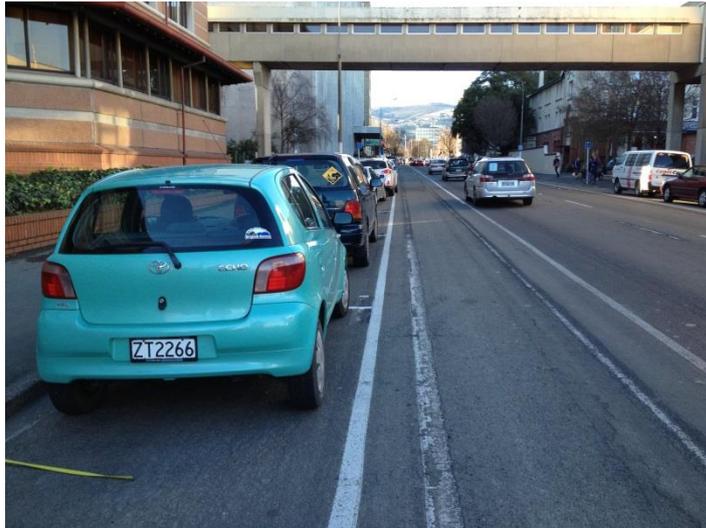
**Figure 7: Removal of parking ticks in zones 1 and 2**

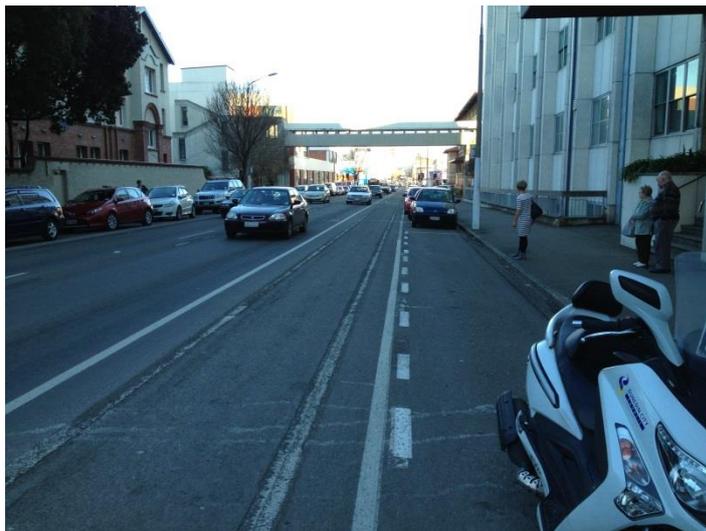
At the P5 time-restricted sites, individual car parks are not marked, but the whole parking area is demarcated with a continuity line, which was retained. This includes zone 3 which is directly downstream from the trial site (see Figure 12 for zone numbers) as illustrated in Figure 8.

**Figure 8: Continuity line demarcating the P5 parking area was retained**

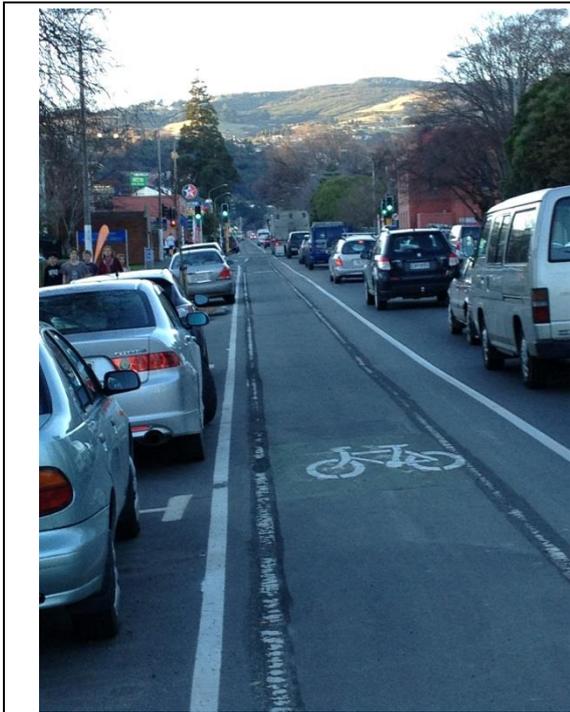
Figure 9: Stage 2 cross section in zone 5

The markings that had been specified for the research were as per Figure 9 and Figure 10. What was implemented in zones 1 and 2 was not as specified, but is as shown in Figure 6. The difference in layout is subtle, but it resulted in significantly different parking behaviour. Figures 8 and 9 show a layout where the existing parking ticks remained and the edgeline (i.e. the left hand side of the cycle lane) moved closer towards the kerbs. Drivers perceived that space for parking was more confined, and parking discipline improved, i.e. they parked closer to the kerb. In the layout shown in Figure 6, the edgeline was placed at the same offset from the kerb, but the parking ticks were removed, and the parking lines extended to the relocated edgeline. Drivers perceived that space for parking was less confined, and parking discipline declined, i.e. they parked further away from the kerb. Table 5 below summarises the situation.

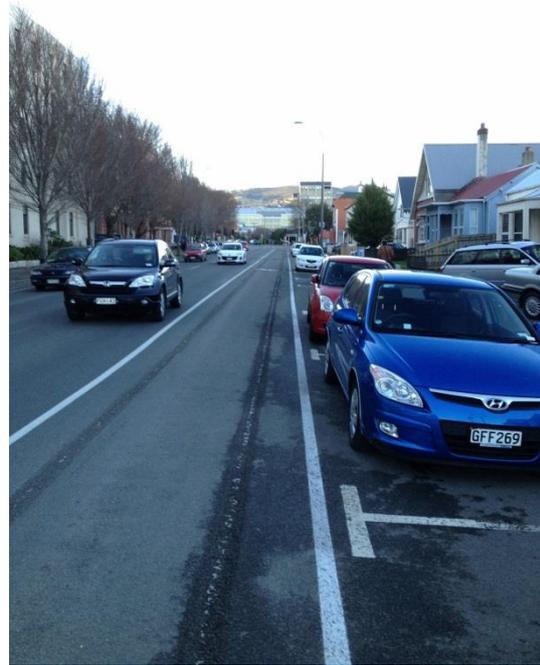
Figure 10: Stage 2 cross section in zone 8

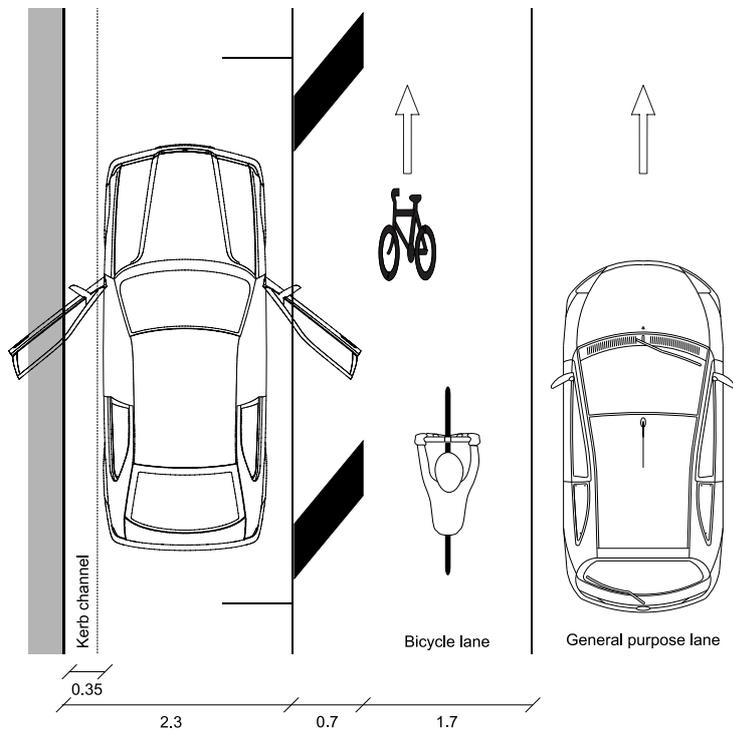
In **Stage 3**, chevron markings were added to the car door opening zone of the cycle lane as shown in Figure 11. This was only implemented in the block where the video measurements were taken (i.e. zones 1 and 2 as shown in Figure 12).

Figure 11: Stage 3 markings with buffers in the cycle lane

**Stage 3** saw chevron markings added to the cycle lane in those sections where the video surveys were taken (Figure 11).

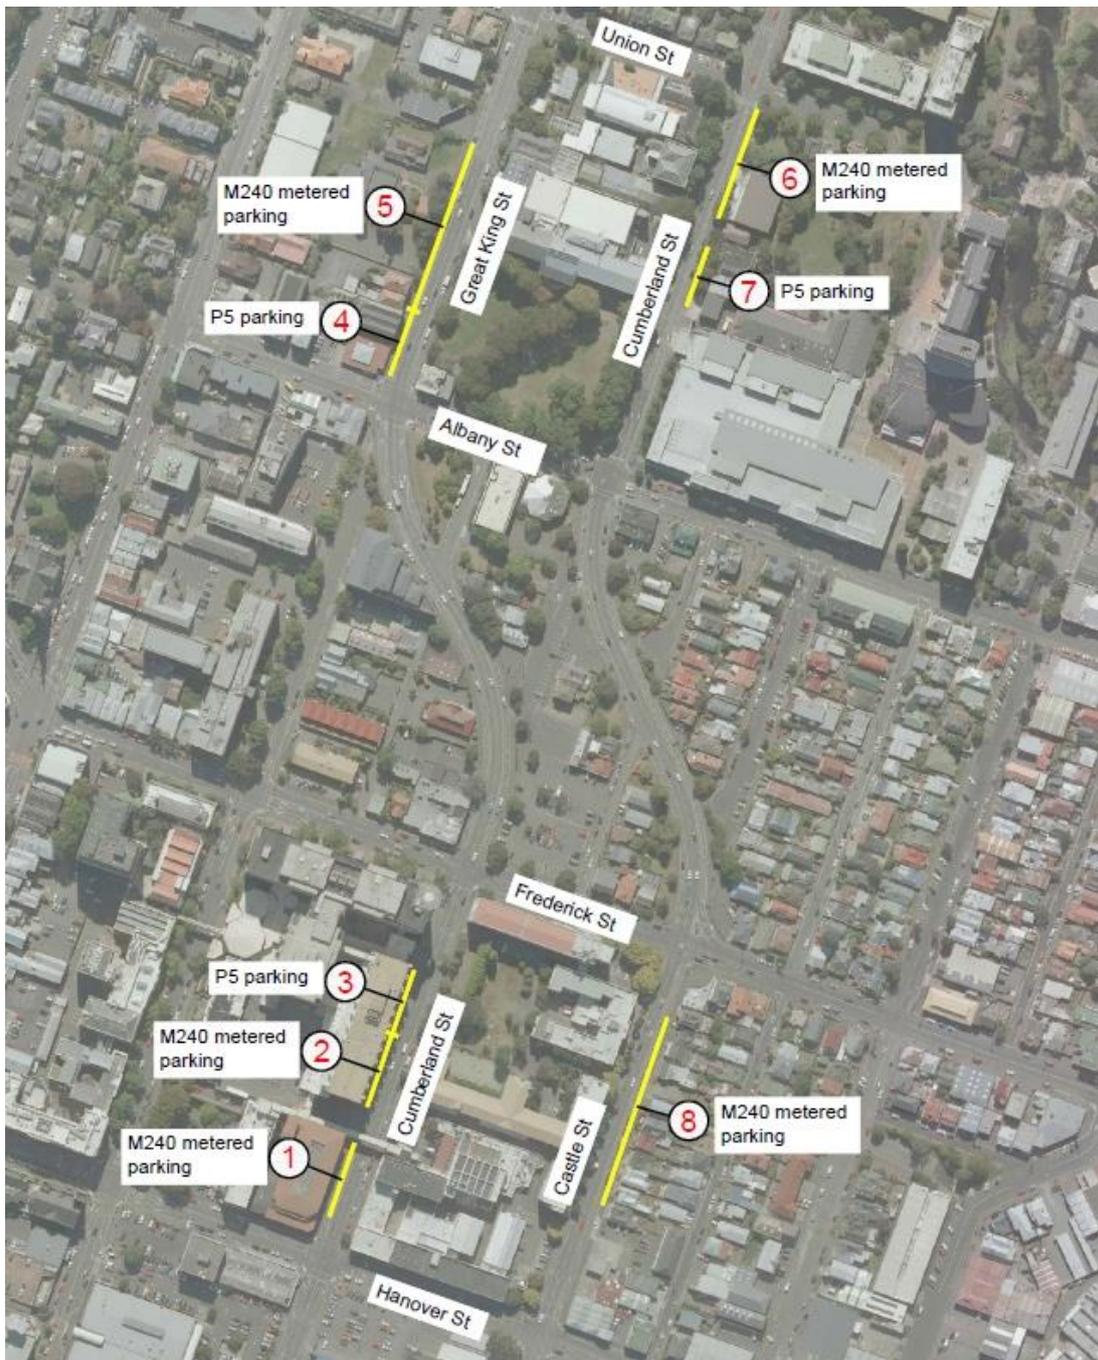
Parking discipline has been manually measured using a tape measure throughout the period between April and December 2013 in the eight zones identified in Figure 12. The northbound SH1 hospital bridge from which the video tracking survey was undertaken (see sections 4 and 4.2; Figure 22) is located between zones 1 and 2.

**Figure 12: Parking discipline data collection zones**

In zones 1 to 5, the one-way traffic moves in a northbound direction, and in zones 6 to 8, it moves in a southbound direction. As cycle tracking was measured from the over bridge, zone 1 is referred to as “upstream”, and zone 2 as “downstream”.

The marking trial is supplemented by measuring parking discipline, as it was anticipated that the changed road markings may result in drivers parking further out from the kerb. Parking discipline was measured in various locations, and this is further explained in section 3.1 and shown in Figure 12.

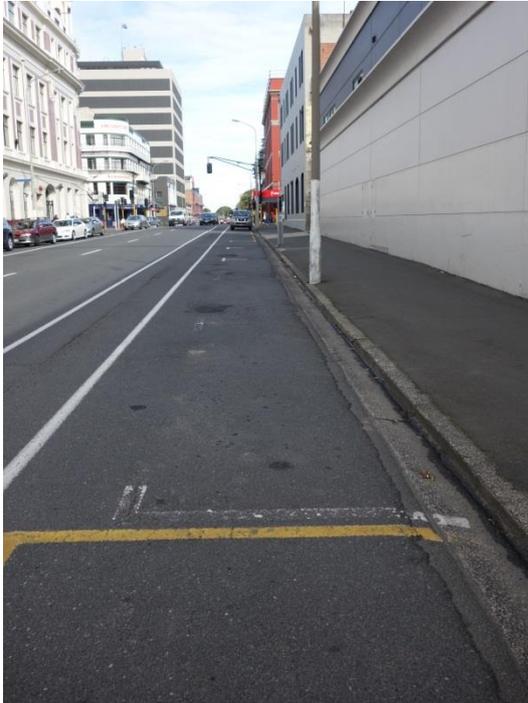
The eight zones had different characteristics. They differed in parking management, and there was either free short term parking (P5) or paid long term metered parking (M240). They also differed in the physical nature of the transition from carriageway to channel; in some zones, the transition was nearly flush (Figure 14), while in other areas, successive pavement overlays had created a distinct lip (Figure 13). This aspect was not measured, but visually assessed and categorised as ‘flat’ or ‘lip’.

Figure 13: Lip at carriageway / channel boundary due to successive overlays

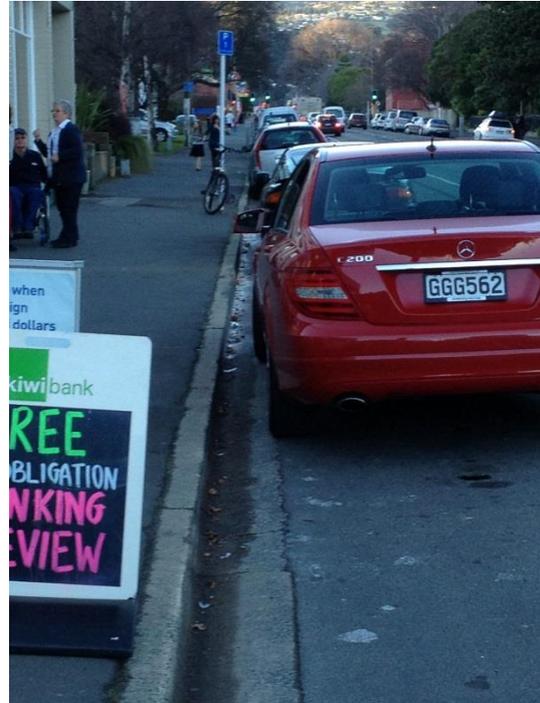
Figure 14: Flush transition from carriageway to channel

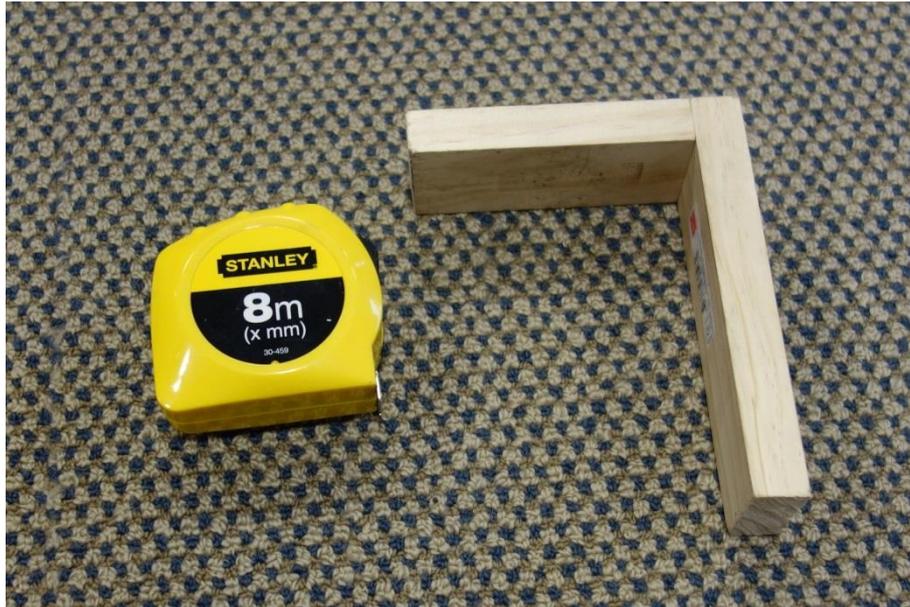
**Figure 15: Survey equipment used for measuring parking discipline**

The wooden angle was placed on top of the kerb, and the distance to the side wall of the tyre was measured from a datum marked on this tool to the nearest centimetre. The datum coincided with the back of the timber that touched the kerb face. Appendix D shows an example survey form, and as it can be seen, time of survey, zone number, number plate of the surveyed vehicle, and offset from the kerb were recorded along with notes where required. The data were transferred into a spreadsheet. Many cars remained in place between repeat surveys, and since number plates were recorded, it enabled the analyst to check the quality of the data collected, as offset measurements ought to have been the same in those cases. Very few inconsistencies were found, and it was thus concluded that all surveyors collected data of good quality.

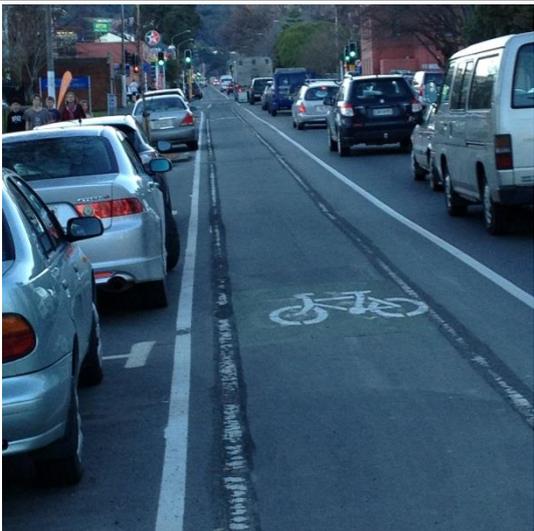
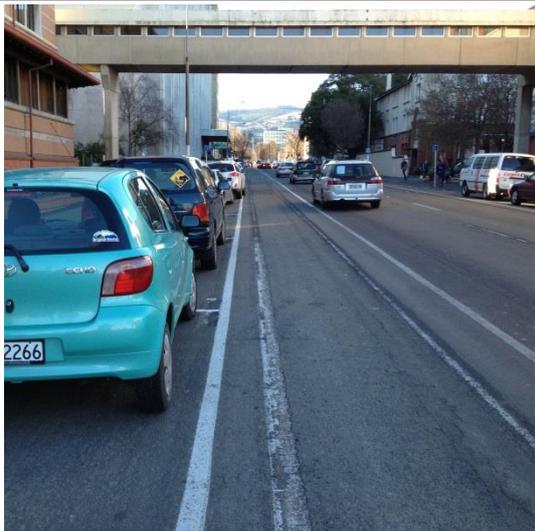
**Table 5: Two types of stage 2 road markings**

Stage 2 markings for P240 areas as specified	Alternative Stage 2 markings for P240 areas
Implemented in zones 5, 6, and 8	Implemented in zones 1 and 2
Parking ticks kept	Parking ticks removed and parking lines extended to edgeline
Improved parking discipline	Declined parking discipline

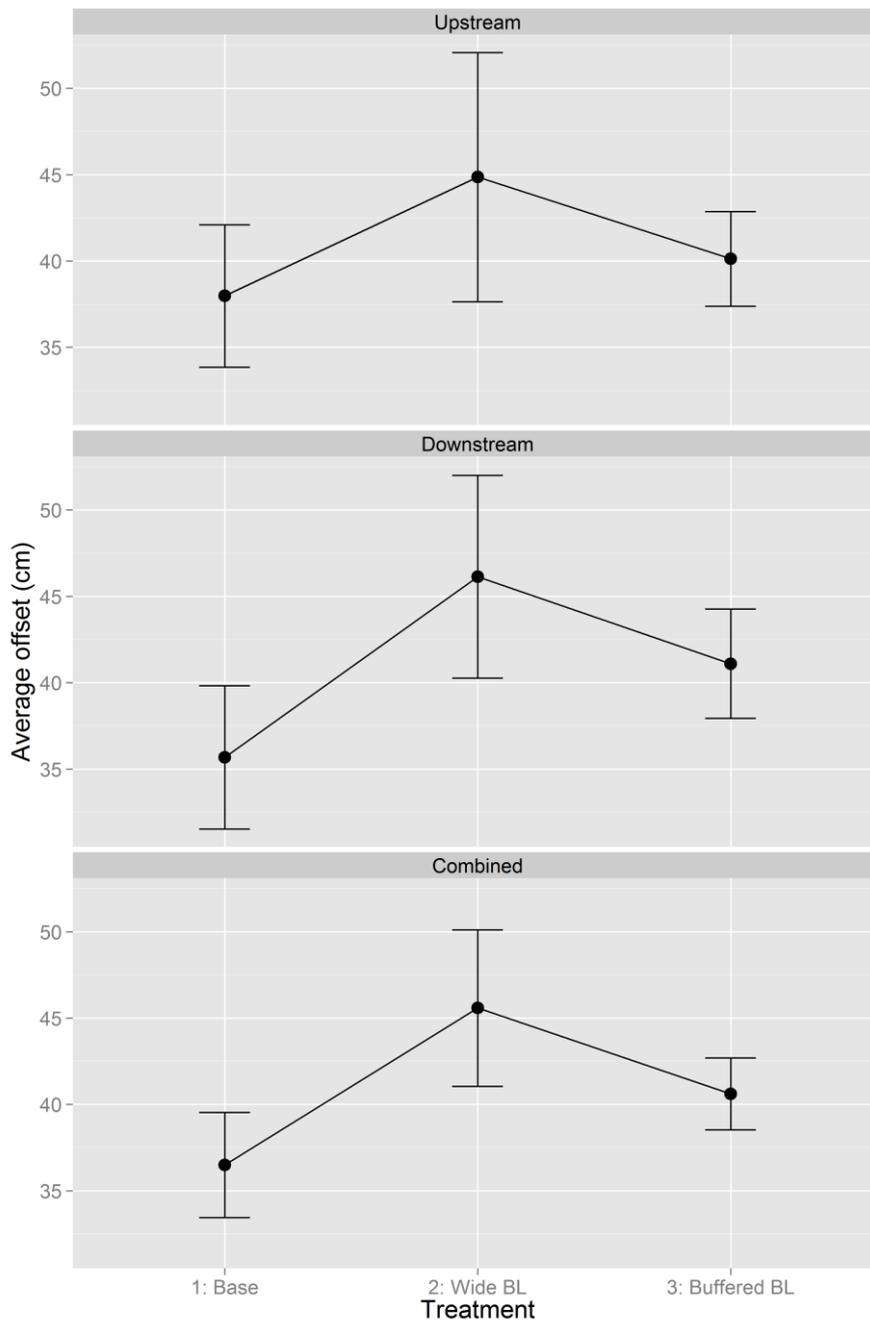
What is shown as 'Upstream' in Figure 16 refers to zone 1, and 'Downstream' refers to zone 2. 'Combined' refers to the data for both zones 1 and 2 evaluated together.

If the difference between two samples is statistically significant, the respective confidence intervals will not overlap. The confidence intervals for the parking offset from kerb for the three stages are represented on Figure 16 by the span of the vertical lines. Thus, for the upstream site, none of the changes produced a statistically significant difference. For the downstream site the confidence intervals for stage 1 and stage 2 do not overlap so the lane widening produced a statistically significant increase in vehicle offset from the kerb, however there was no statistically significant change brought about by the buffer marking introduced in stage 3. The combined data show the same trends as for the downstream site, i.e. a statistical difference between stage 1 and stage 2.

**Figure 16: Average parking offsets from the kerb and 95% confidence intervals**

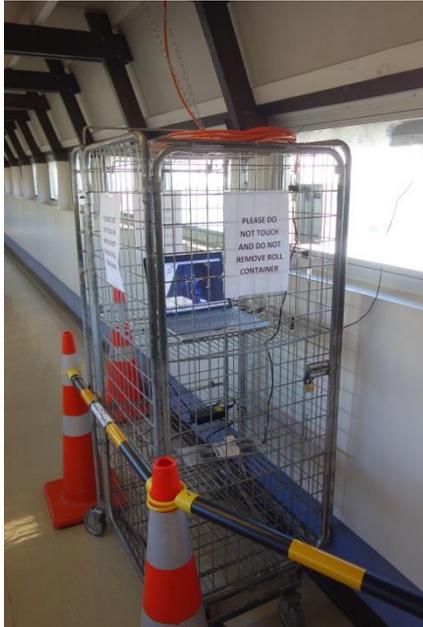
The methodology utilised digital a video camera positioned above the roadway on an enclosed pedestrian overpass that links the hospital buildings on either side of the survey site. The survey recording hardware was in a locked cage so that it could not be tampered with (Figure 18), and the camera was fixed to the outside of the building (Figure 17) and alternated between the two sites (upstream and downstream) meaning that the datasets for the two sites do not contain any data from the same period.

Figure 17: Camera setup

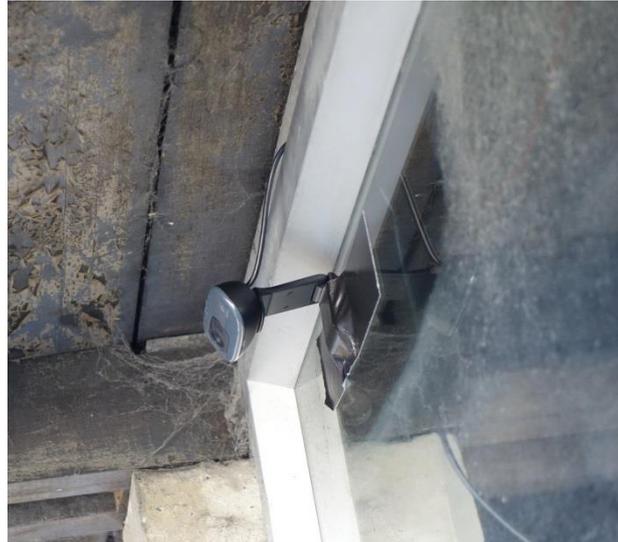
Figure 18: Survey hardware in locked cage

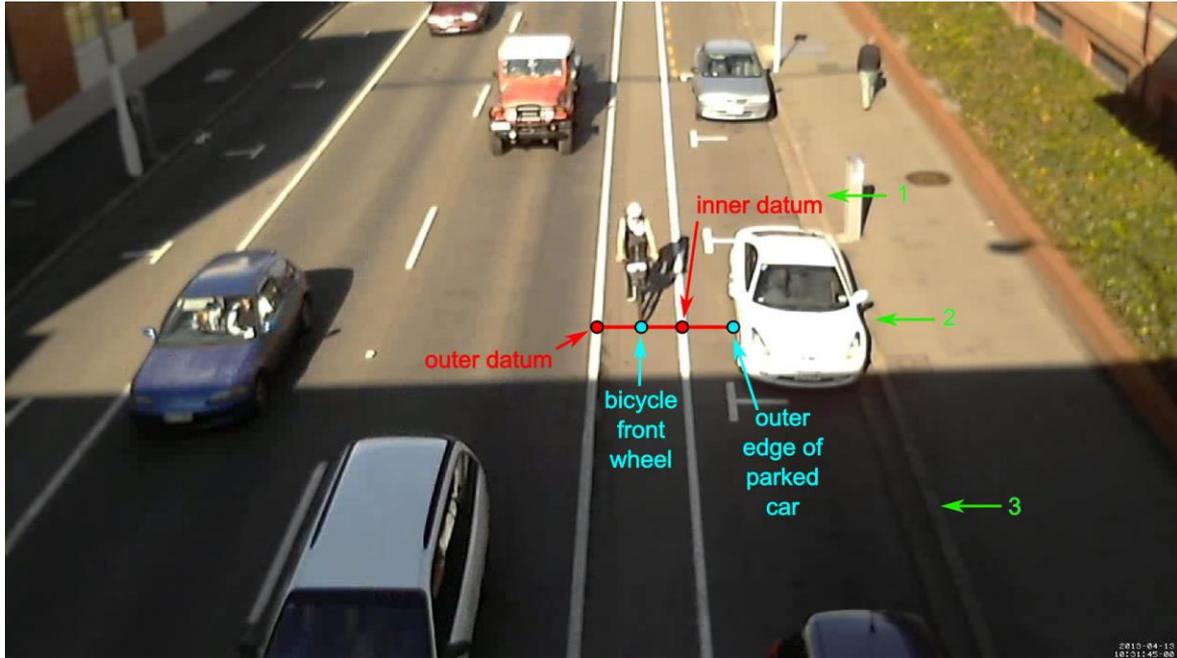
Example screenshots are provided in Figure 19, Figure 20 and Figure 21 for each of the three trial stages at the upstream (zone 1) location. The lateral tracking of the cyclist could be reasonably confidently recorded using this method to within a few centimetres. The position of parked cars was somewhat more difficult to measure with accuracy; however, neither measurement is likely to be subject to significant bias. Appendix B discusses the repeatability of the method in further detail.

Figure 19: Sample screenshot before treatment

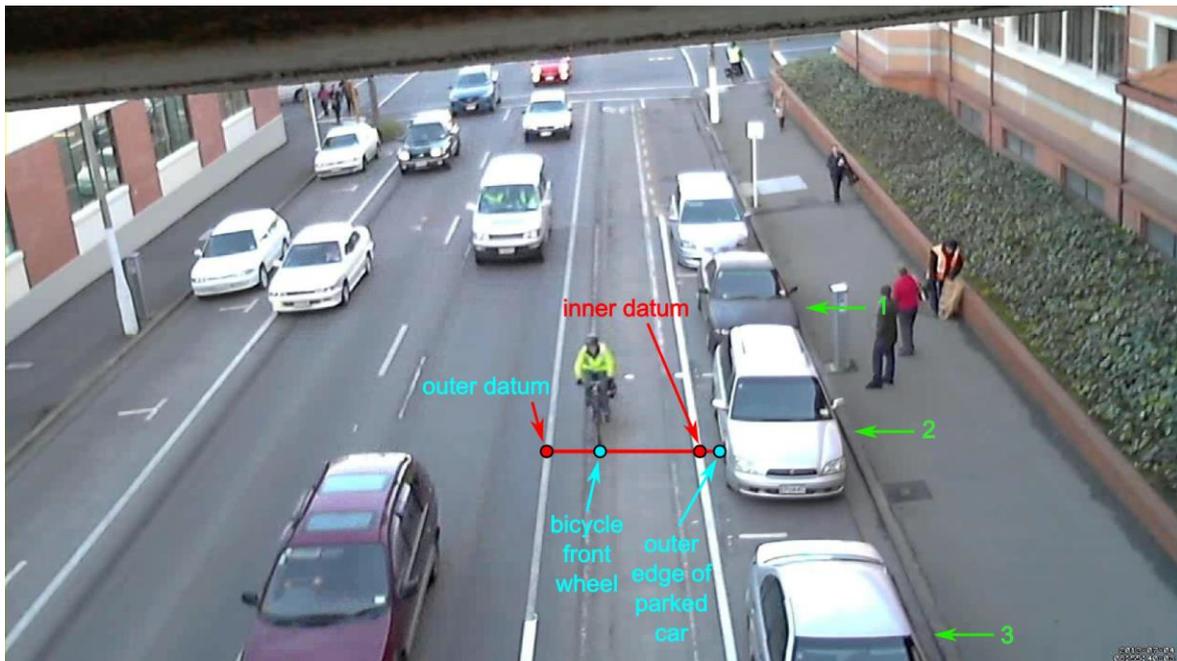
Figure 20: Sample screenshot with wide cycle lane

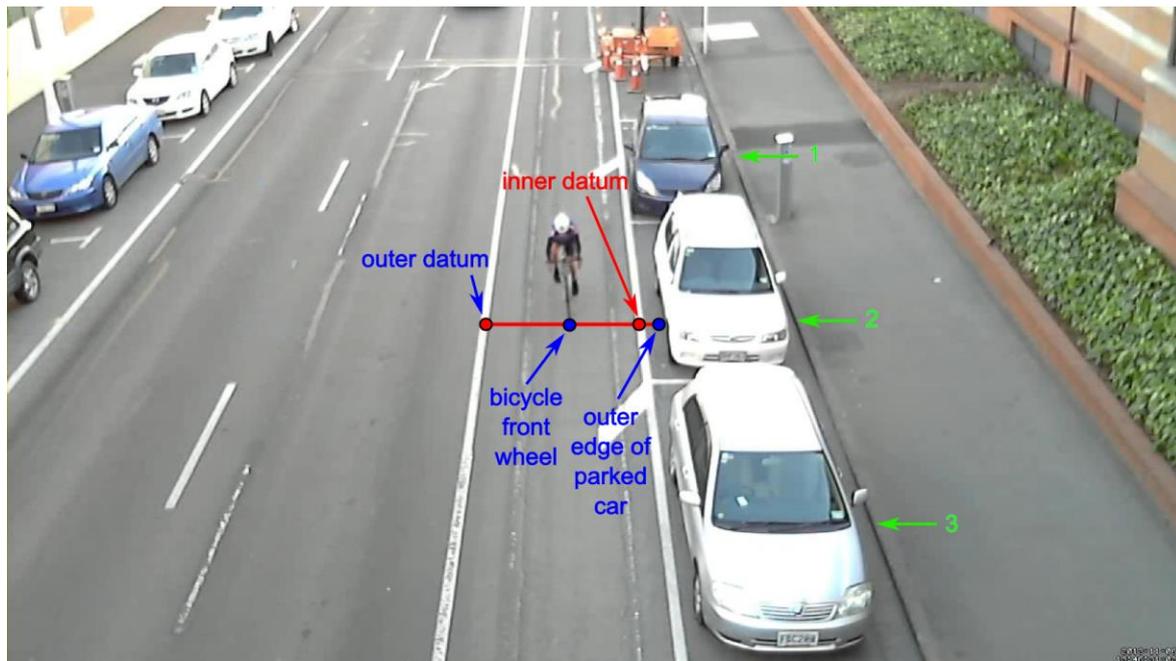
**Figure 21: Sample screenshot with wide cycle lane and buffer**

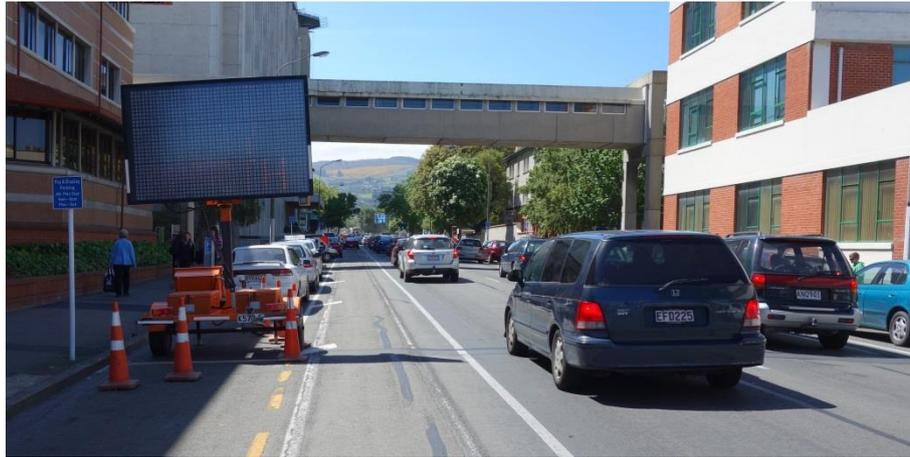
- During Stage 3 (i.e. wide cycle lane with buffer), a large variable message sign (VMS) was present at the upstream end of the observed area during the observations (Figure 22). This may have had some influence on cyclist lateral tracking, at least at the upstream position. If it did have any impact it most probably would have been to encourage cyclists to travel farther out than they otherwise may have done.

Figure 22: Temporary sign present during stage 3 surveys

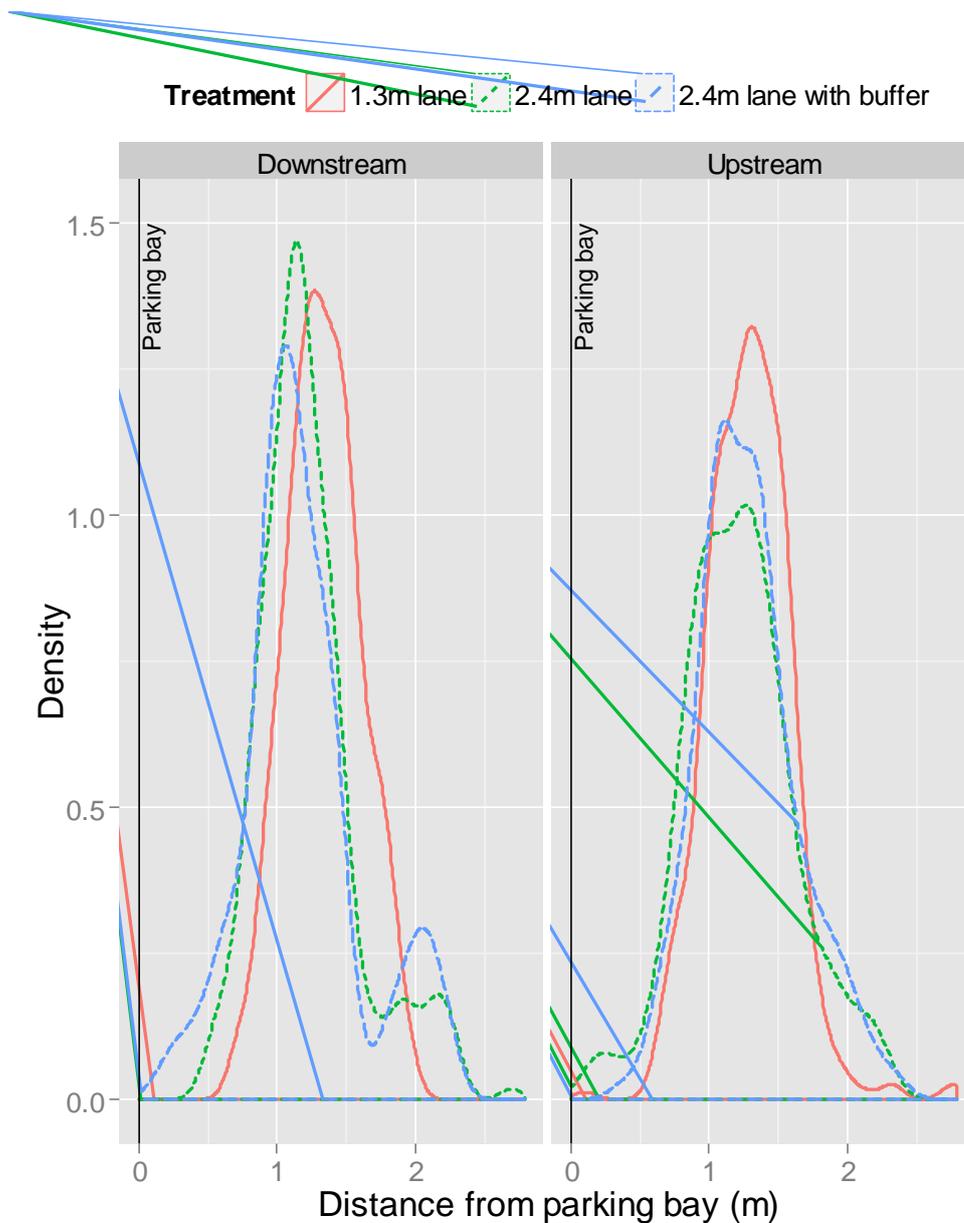
- Widening the cycle lane increased the lateral offset of cyclists from the inner edgeline in the range of 0.45 to 0.54 m.
- However, this was not sufficient to compensate for the loss of the 0.6 m buffer between the parking ticks and inner edgeline before treatment. The result is that the average cyclist cycles 0.01 to 0.16 m closer to the parking zone after treatment.
- The buffer does not seem to have a significant effect on cyclist lateral tracking positions.
- The proportion of cyclists travelling within the dooring zone has significantly increased after widening the cycle lane in most cases, roughly doubling from 10% to 20-25%. The effect of the buffer is inconsistent; it appears to have reduced markedly the proportion riding within the dooring zone at the upstream site but has had no effect at the downstream site (compared to the 2.4 m lane without buffer).

Figure 23: Cyclist lateral tracking by site and treatment

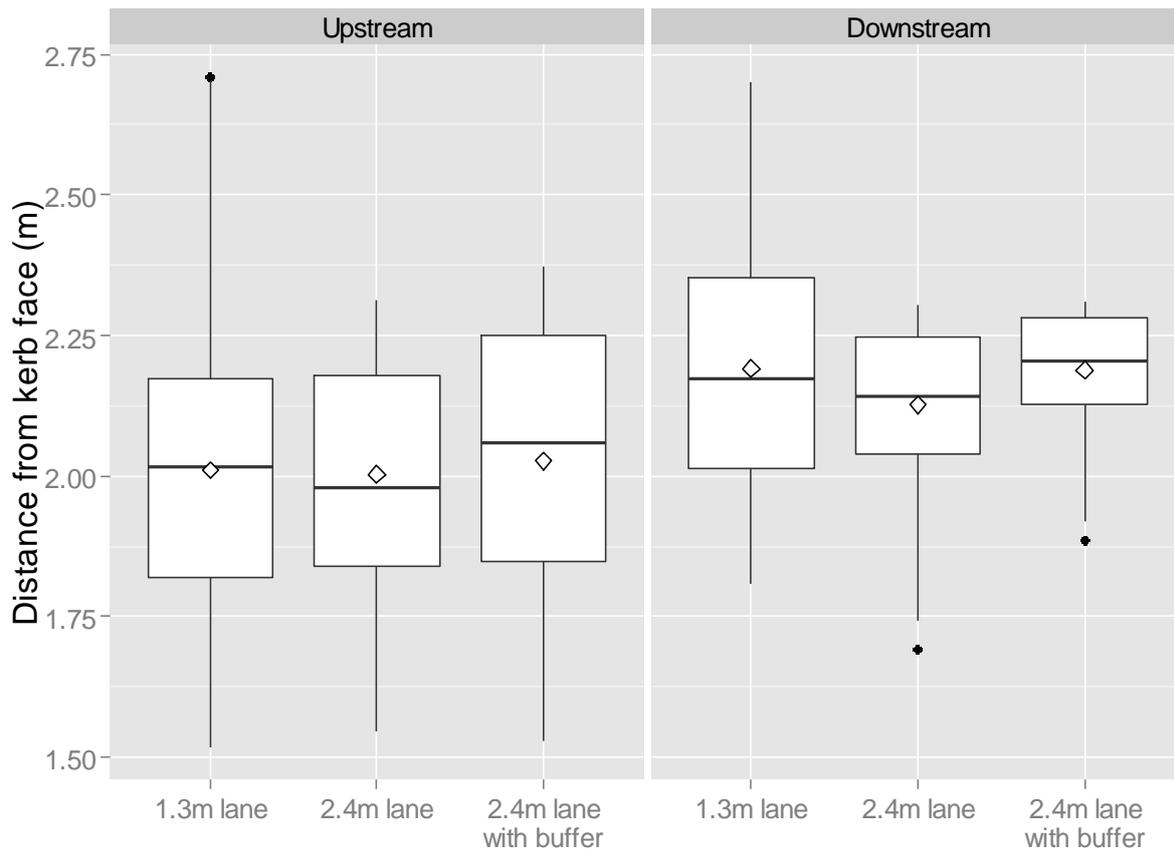
Figure 24 is a box-and-whiskers plot showing the parking data obtained from the video survey, and illustrates the insignificant changes in mean and median parking offsets but the significant reduction in parking offset variability at the downstream site after treatment.

**Figure 24: Lateral parking positions by site and treatment from video survey<sup>10</sup>**

In descriptive statistics, a box-and-whiskers plot is a convenient way of graphically depicting groups of numerical data through their quartiles.

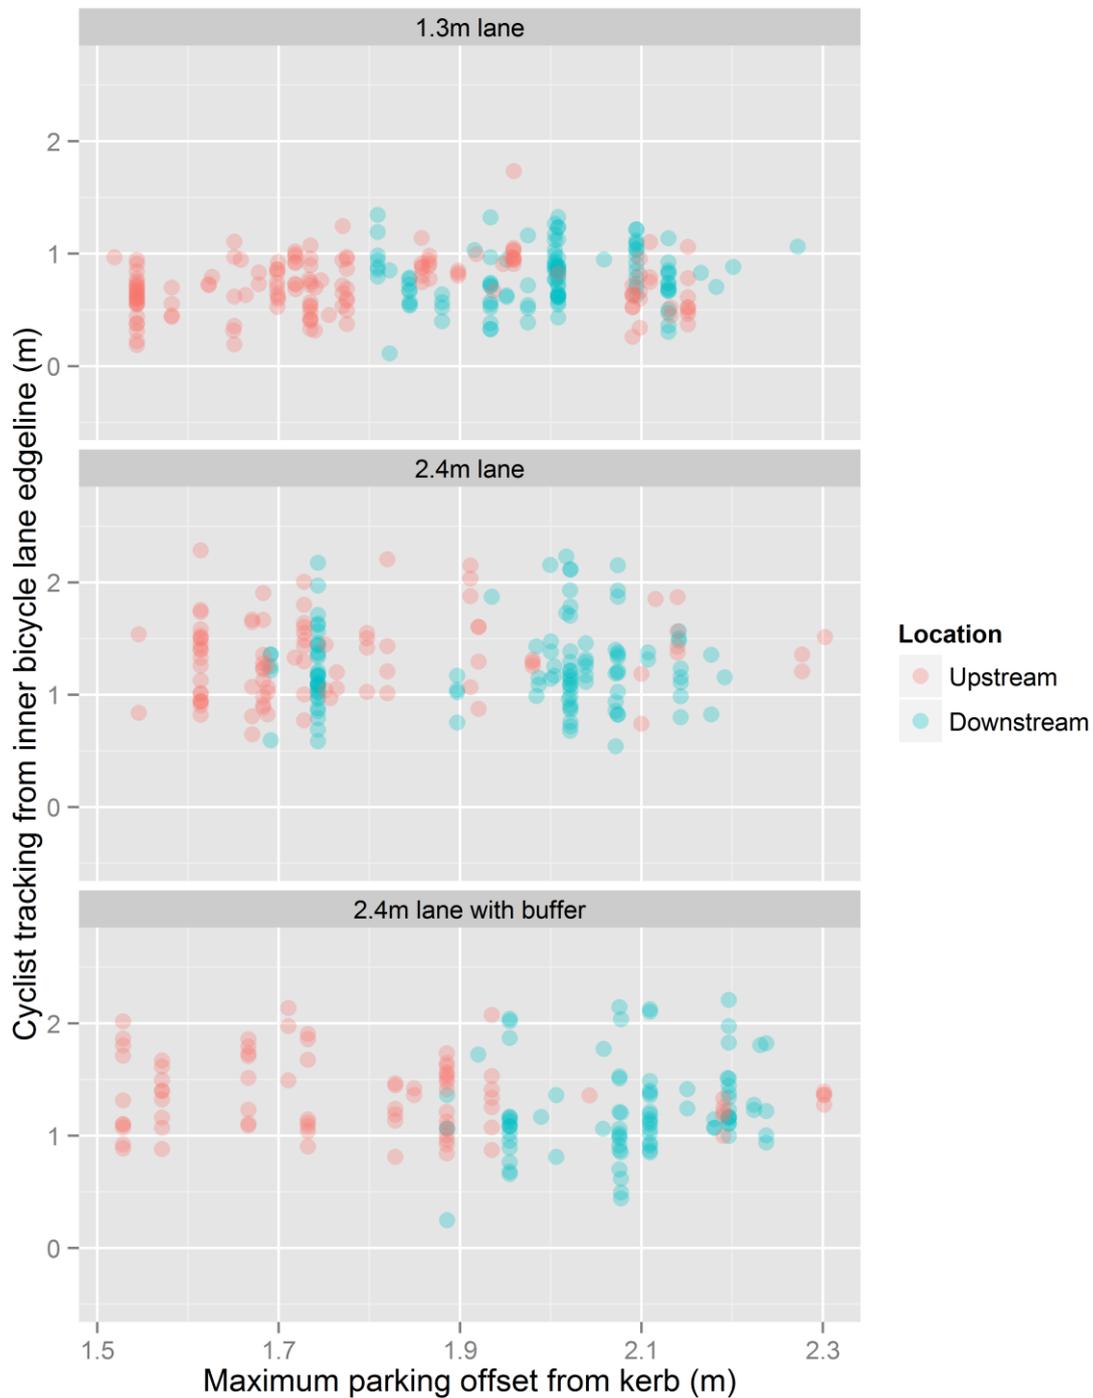
this figure the maximum car position of the three bays at each location is presented. Similar results are obtained if only the parked vehicle directly adjacent to the datum is considered.

Figure 25: Lateral parking positions and cyclist tracking by site and treatment from video survey

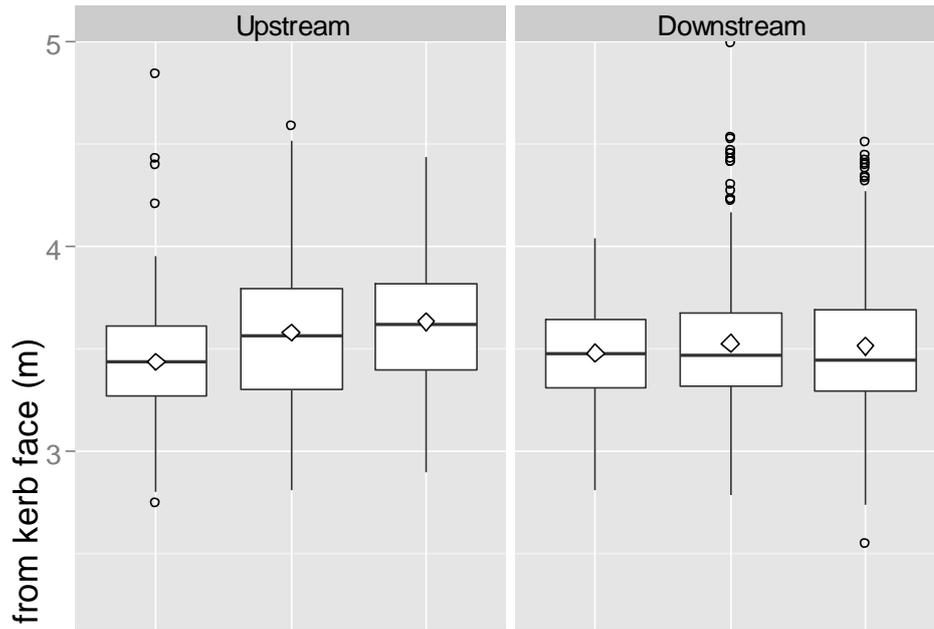
Figure 26: Cyclist lateral tracking

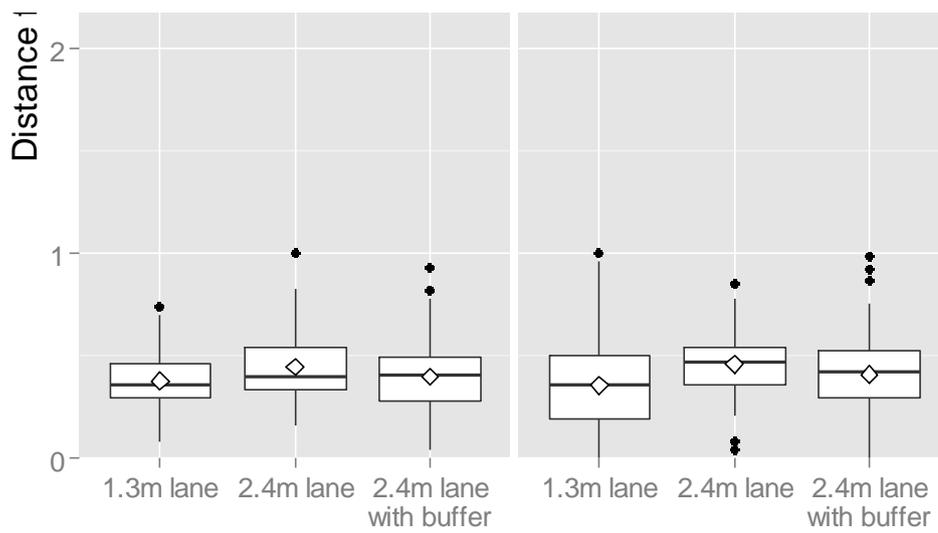
Figure 27: Parking offset from manual surveys

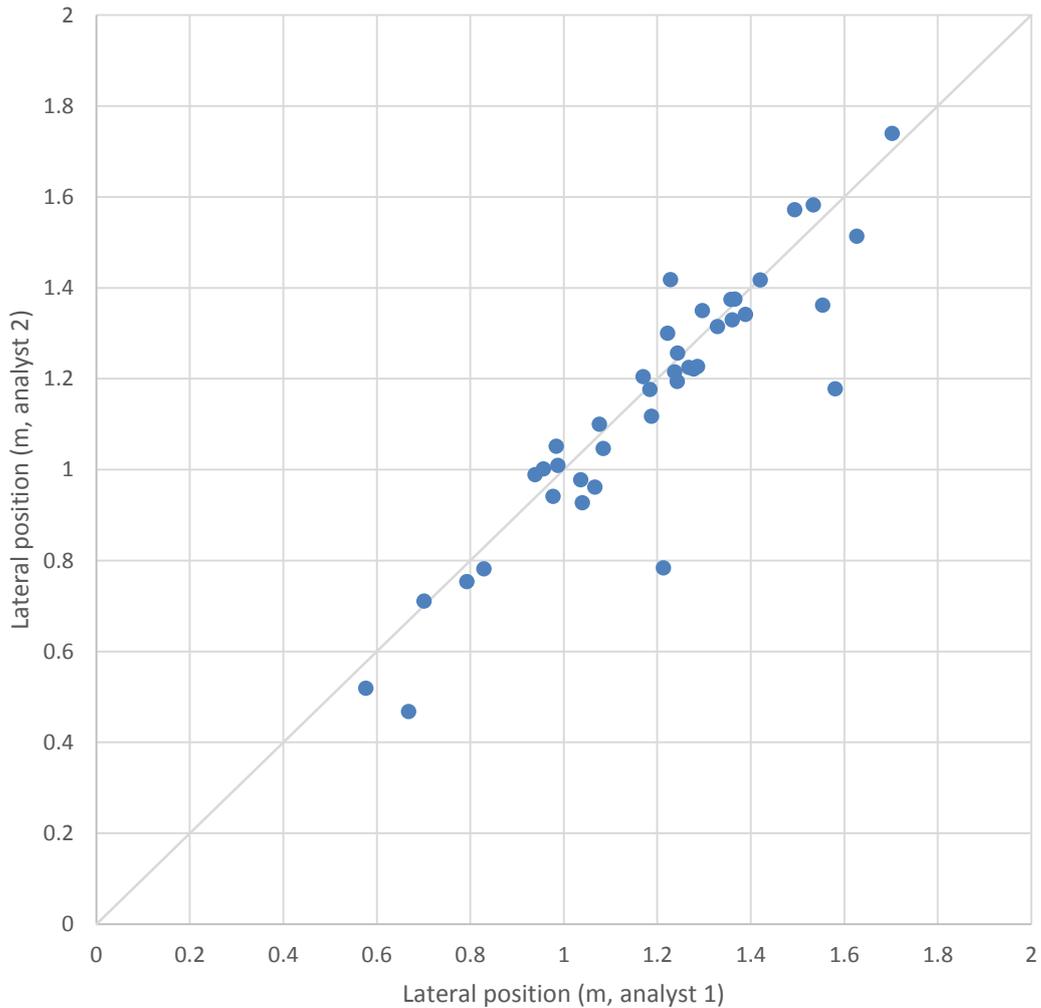
The accuracy of the video-based lateral tracking method has been tested for repeatability using independent analysts (i.e. the technical staff member charged with extracting the data from the video survey) on a sample of records. A sample of 40 records was examined independently by two analysts and the data compared. The differences in the average tracking position from this sample was statistically insignificant ( $M=0.04$  m,  $p=0.08$ ) and at the individual level most records closely aligned (Figure 24). This analysis suggests the method is reliable, at least insofar as it is not subject to undue variation between analysts.

Figure 28: Repeatability of measured lateral tracking positions
