# Post Implementation Review

## (SH1) Te Rapa Road–Eagle Way Signalised Intersection

Hamilton City Council

August 2016

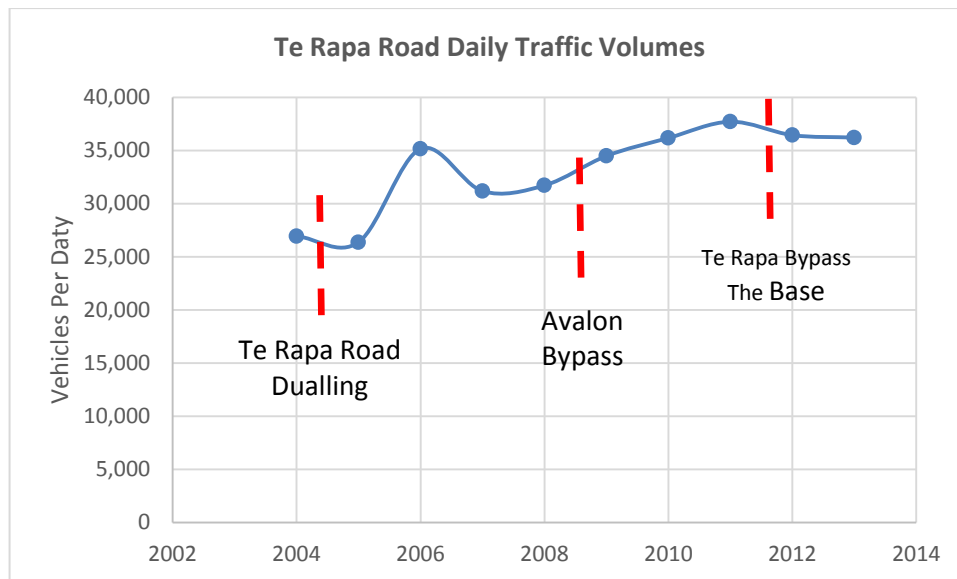
**Figure 3: Traffic volumes**

The effects of the Te Rapa Bypass, as reported in the ITA, were expected to reduce through traffic by 50% and this was expected to lead to a significant reduction in the volume of traffic on Te Rapa Road. However, this is not evident from the recorded Te Rapa Road traffic volumes, which are virtually unchanged over the period 2010–2013, as shown below (Figure 3).

The lack of change in volumes following the opening of the Te Rapa Bypass is probably due to the introduction of additional Base traffic and traffic rerouting from other roads in the Hamilton urban network. The interpretation is that The Base largely absorbed the capacity on Te Rapa Road made available by the Te Rapa Bypass.

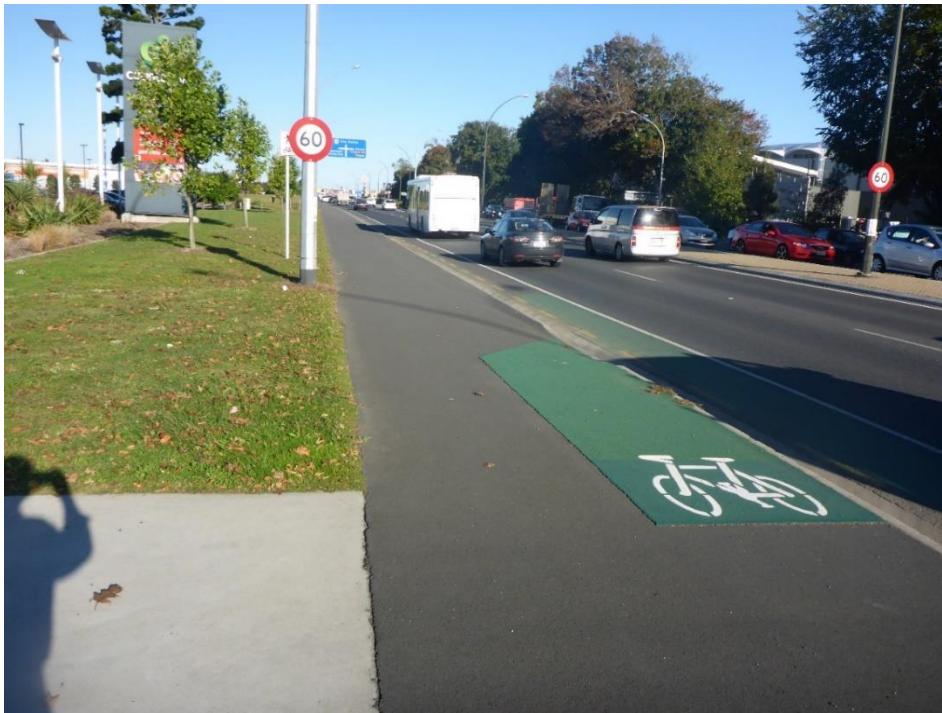
- Te Rapa Road looking south from Eagle Way intersection, showing shared and separate cycle lanes and 60 km/hr limit.

- **Northbound cyclists on Te Rapa Road are reluctant to use the dedicated lanes provided.** This is common to all such facilities associated with long merges, or in this case diverges either side of the Eagle Way intersection. The northbound cycle lanes operate best for cyclists entering the base car parks. For all other northbound movements, cyclists either need to use the left-hand side and then cross the left turning traffic stream, or alternatively remain on the Te Rapa Road straight ahead lane with diverging and through traffic passing either side of them.

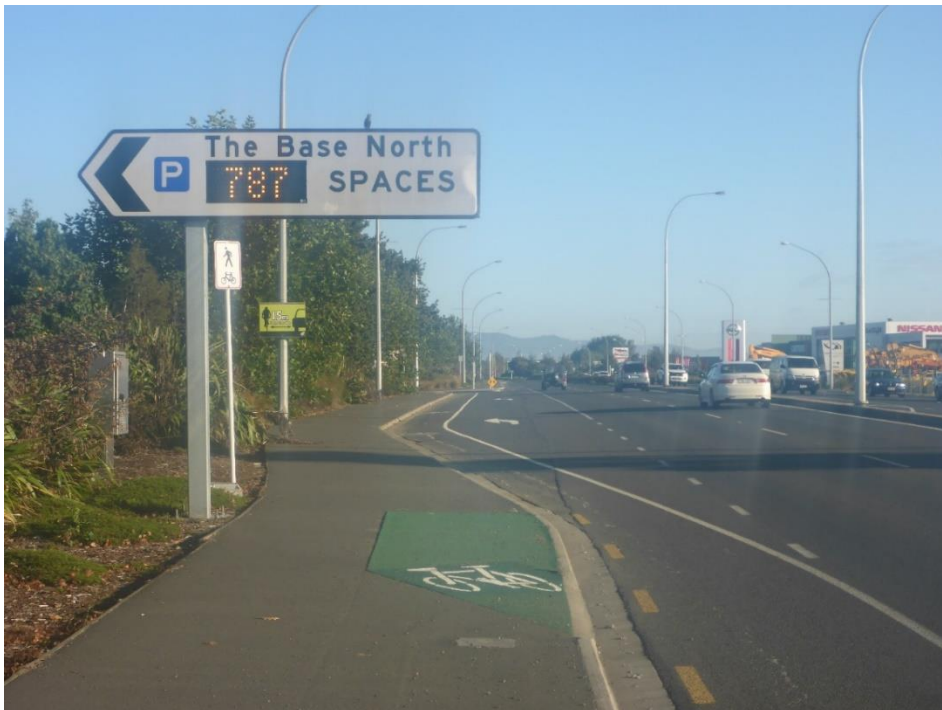
- Left slip to northern car park on Te Rapa Road, north of the Eagle Way intersection.

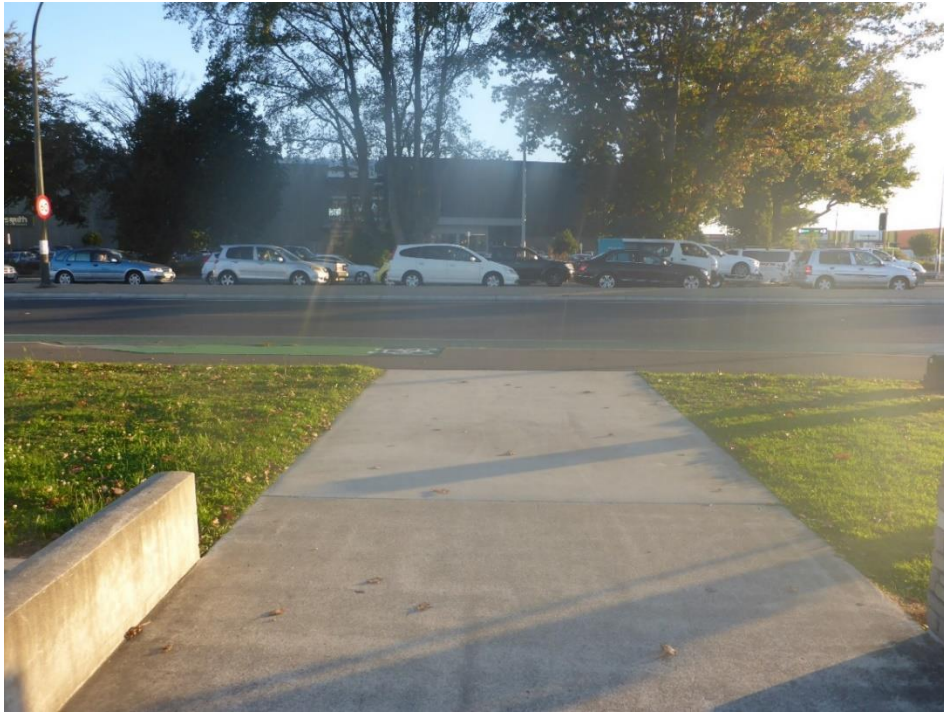
- Informal crossing activity immediately to the south of the intersection on Te Rapa Road where the alignment of paths on either side of the road acts to direct pedestrians to cross the road at an inappropriate, and what appears to be unsafe, point.
- Northbound cycle lanes on Te Rapa Road, parallel to the car park diverges on either side of the intersection, were not observed to be used by through cyclists who preferred to ride close to the through lane instead.

- **Alignment of east-west footpath between retail areas, contributing to informal crossing movements of Te Rapa Road south of Eagle Way intersection**

- **There is a mismatch between crossing facilities at the intersection and the footpath alignment between the Te Rapa Road retail areas (immediately to the south of the Eagle Way intersection).** This alignment may have been more appropriate for pedestrian movements at a roundabout but does not lead pedestrians to a safe crossing point for a signalised design. Potentially unsafe and informal pedestrian crossing movements were observed to occur here on site visits, in particular, children running over the road between queuing vehicles.

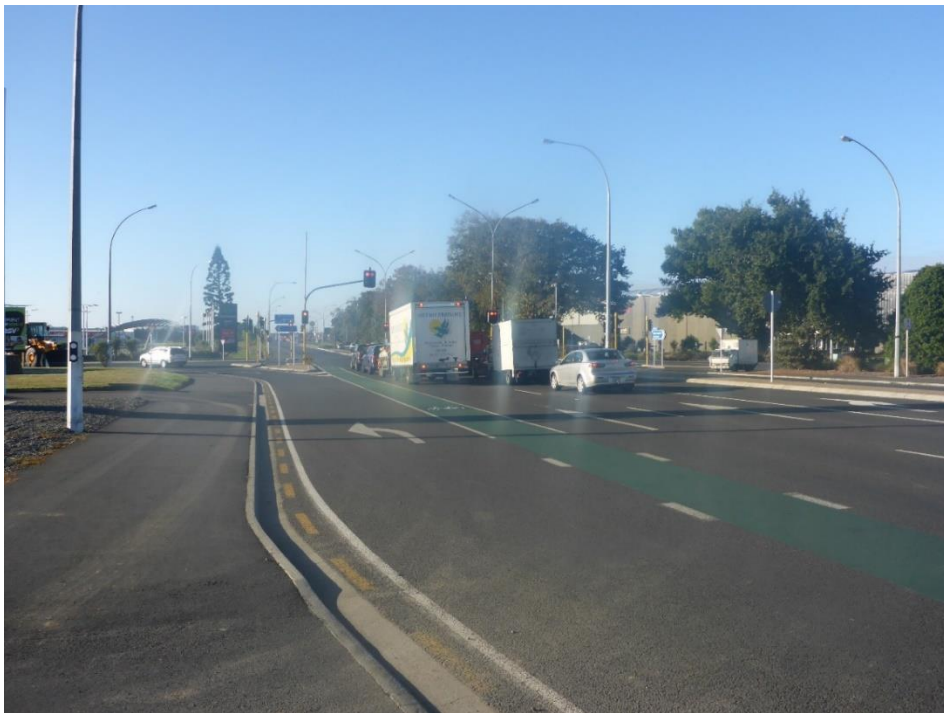
- **Northern Te Rapa Road approach to Eagle Way intersection, showing left turn slip lane and straight ahead cycle lane**

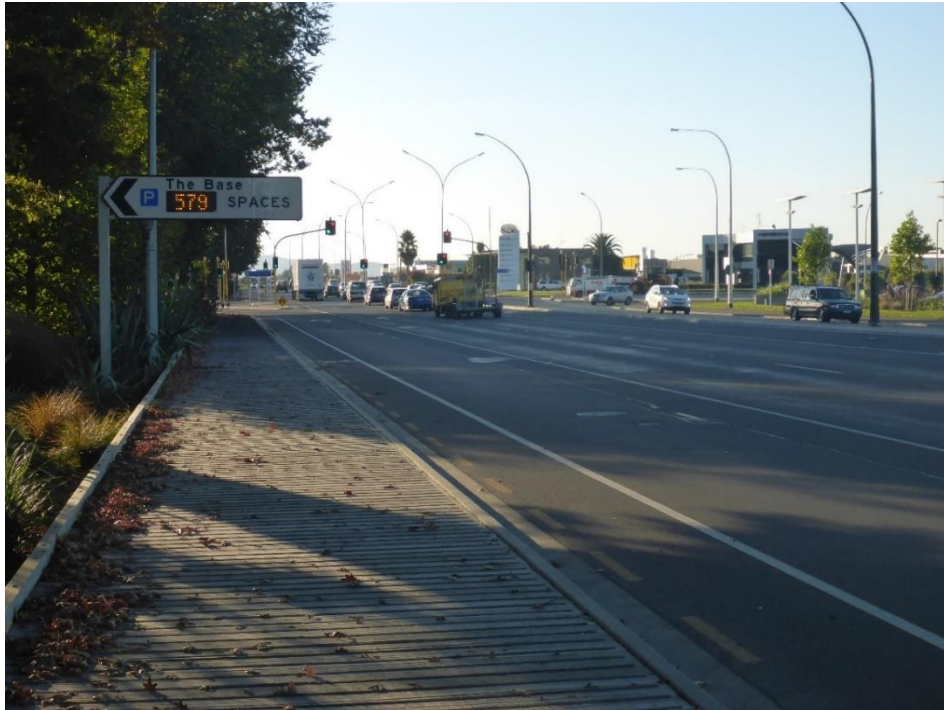
- **Information on car parking availability is automated and integrated with the operation of Te Rapa Road.** The automatic detection of individual parking space availability and the linkage to real time electronic signage advising approaching drivers represents good practice. This assists in reducing potential wasted travel, minimises uncertainty and increases the efficiency of the adjacent road network.

- Northbound Te Rapa Road left slip and approach to Eagle Way intersection, showing advance parking signage, footpath and cycle lane.
