Post Implementation Review

Ohingaiti–Makohine Realignment

Manawatu/Whanganui Highways and Network Operations

November 2016

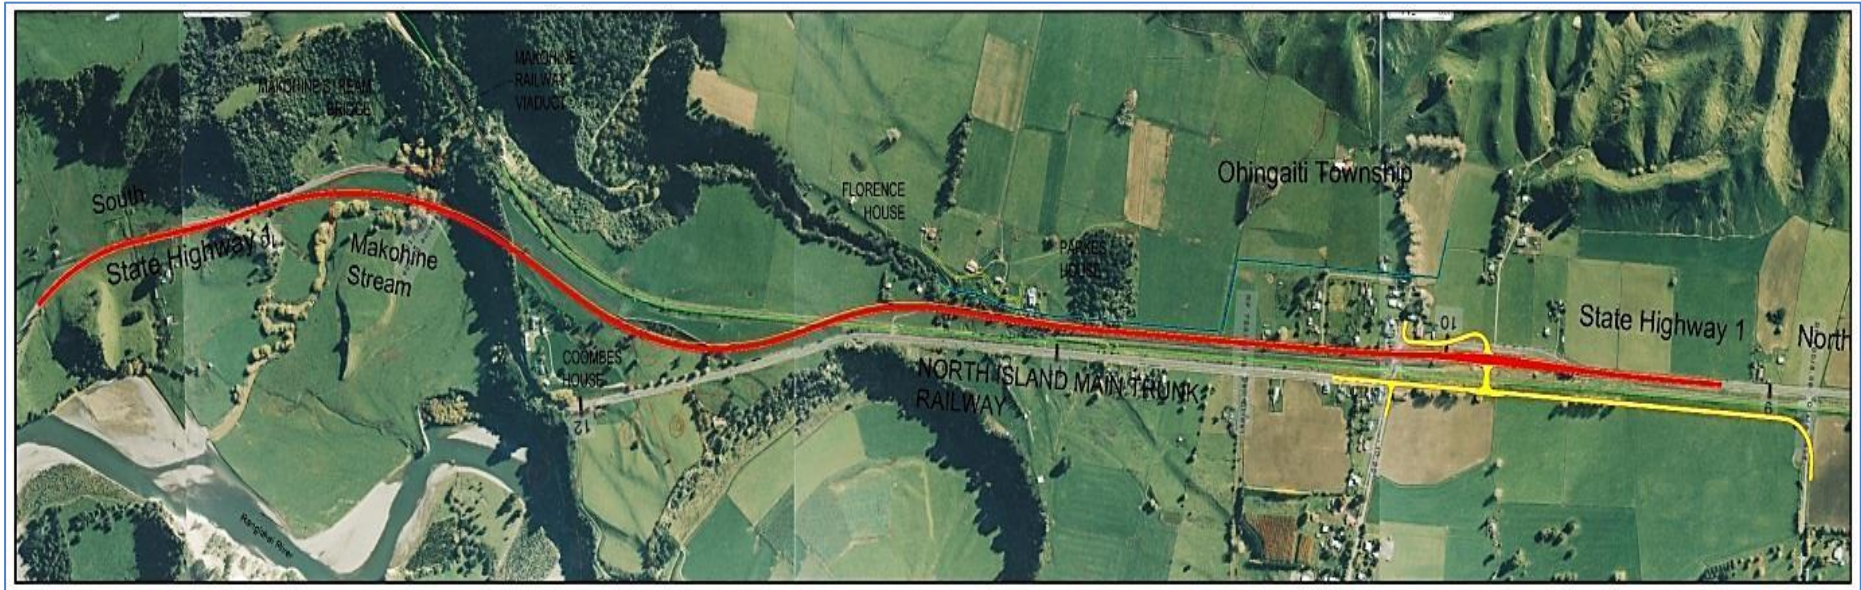
Figure 1: Ohingaiti–Makohine proposed alignment plan

The project involved realignment of a section of State Highway 1 (SH1), located 30 km south of Taihape. The works included 4km of new road including a rail tunnel, a northbound passing lane, and a new bridge near the Makohine viaduct. Figure 1 on page 3 shows the proposed alignment plan.

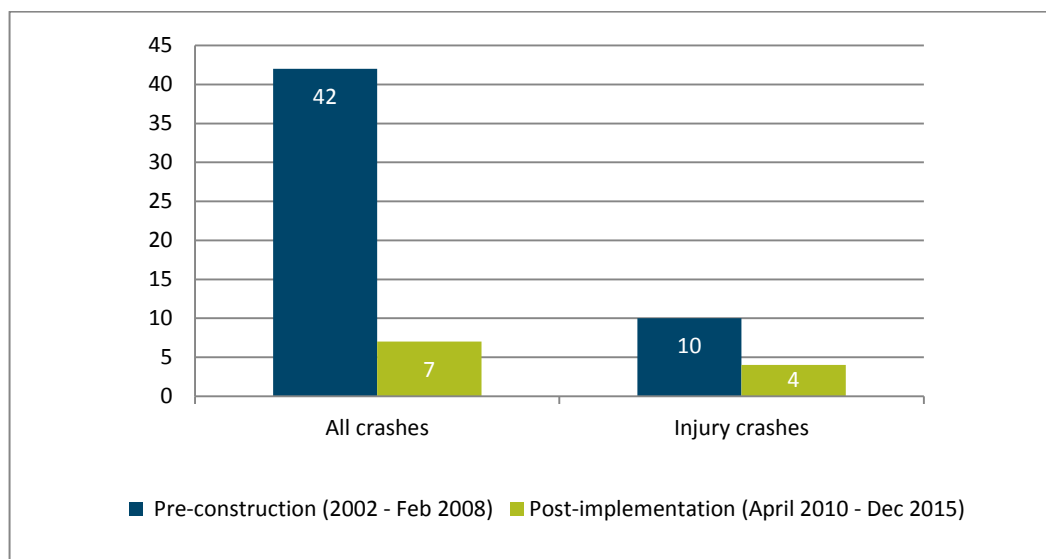
Figure 2: Comparison of recorded crashes Ohingaiti–Makohine before and after realignment

Overall, the project has been highly successful with improving safety. Crashes have fallen from 42 recorded between 2002 and the start of construction of the project in early 2008 to only seven crashes recorded between project completion in early 2010 and the end of 2015 (figure 2). Between these same periods, injury crashes more than halved from 10 to four.

The reduction in crashes at Ohingaiti–Makohine is statistically significant. This means it can be concluded with a high level of confidence that the fall in the crash rate can be attributed to the safety improvements made by the project and not merely the result of random fluctuations in the incidence of crashes. This review also tested whether the observed reduction in crashes along the realignment might have been affected by wider safety trends by testing it against crash rates over all open roads in Rangitikei District. The crash reduction at Ohingaiti–Makohine was still statistically significant with this trend adjustment.

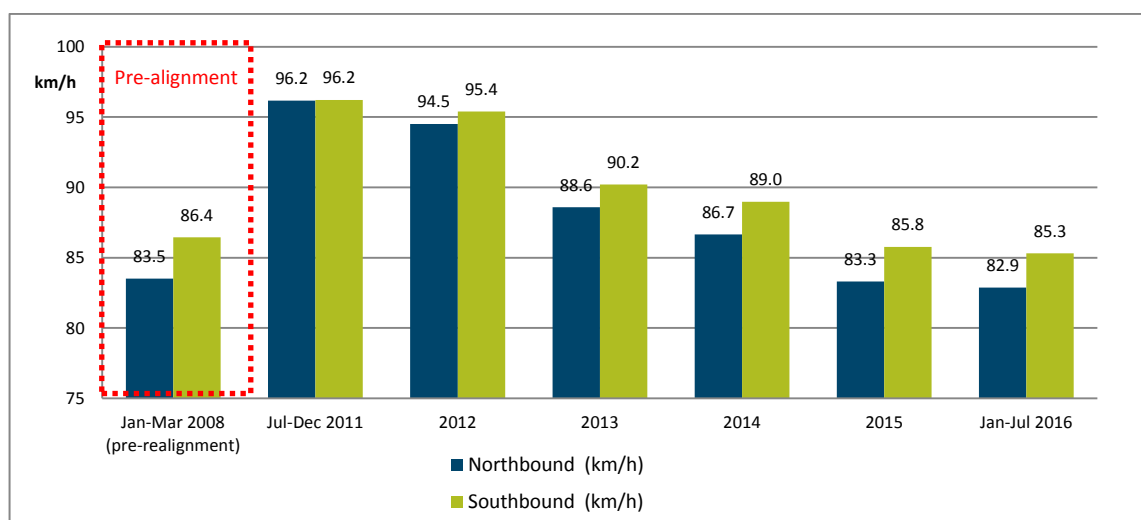
Figure 3: Comparison of average vehicle speeds on State Highway 1 Ohingaiti–Makohine before and after realignment

Average speeds on State Highway 1 at Makohine–Ohingaiti initially increased by around 10km/h or more as a result of the alignment, as shown in figure 3. On the previous alignment, speeds of around 83–86 km/h were typical on average along the whole pre-alignment route. After the realignment average speeds increased to around 96km/h.

Average speeds recorded on SH1 at Makohine–Ohingaiti have trended downwards since around 2012, as evident in figure 1, to the extent that average speeds have returned to about the same as they were on the old highway alignment. This has eroded the travel time savings achieved by the realignment project to the extent that average travel times are now back to the same level or even slightly slower than that existed on the old alignment (Figure 2).

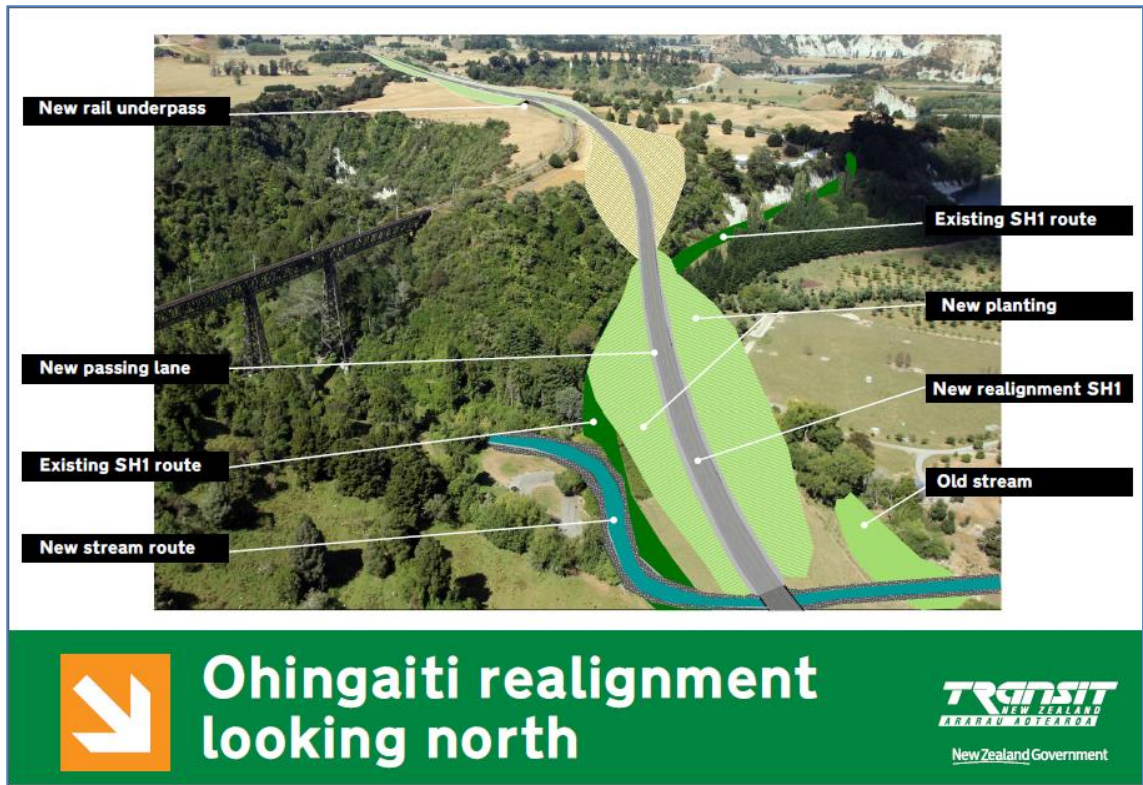
- Realignment project plan looking north (Transit NZ files)

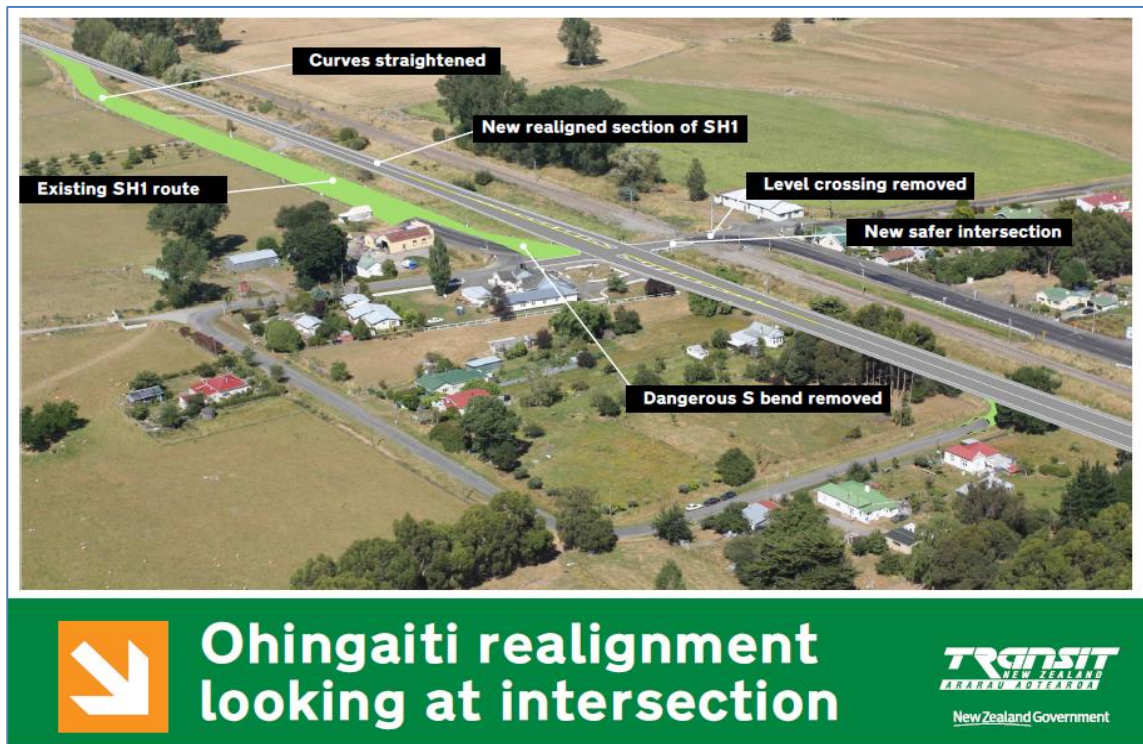
- Realignment project plan looking at intersection (Transit NZ files)
