# **Post Implementation Review**

# Kamo Bypass Stage 2

**Northland Highway & Network Operations**

January 2017

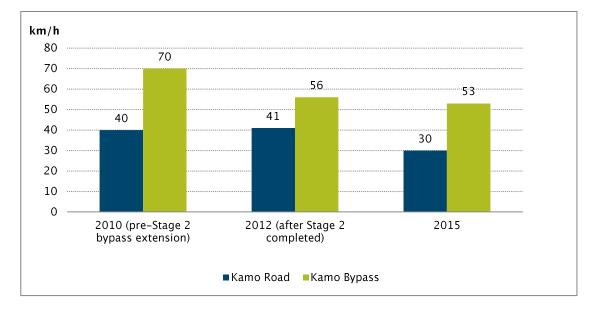
# Figure 3: Average speed comparisons – Kamo Bypass and Kamo Road before and after opening of Stage 2 of the bypass

The Kamo Bypass is a faster and more efficent northern route out of Whangarei than Kamo Road. However, since completion of Stage 2 of the bypass there has actually been a deterioration in average speeds along the bypass. This is apparent from Figure 3, which shows that in 2010, before Stage 2 was completed, there were average speeds of 70kmh along the bypass and its previous linked section of Kamo Road (which Stage 2 replaced). This compared with average speeds of 40kmh on Kamo Road. Since Stage 2 opened, average speeds have fallen significantly, from around 70kmh to an average speed of 56kmh in 2012, with some further deterioration apparent more recently in 2015, when there was an average speed of 53kmh.

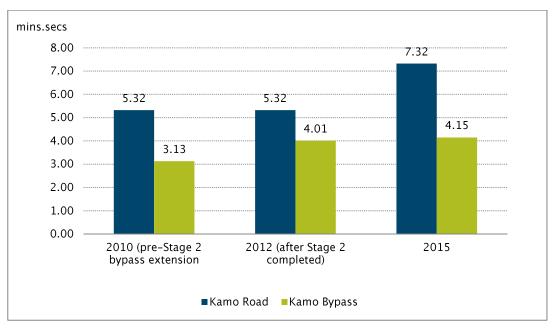
# Figure 4: Travel time comparisons – Kamo Bypass and Kamo Road before and after opening of Stage 2 of the bypass

The effect of these observed average speeds on travel times is summarised in Figure 4. Before completion of Stage 2 of the bypass, it took on average five and a half minutes to drive Kamo Road from just south of where the Stage 2 section of the bypass now begins to its intersection with the northern end of the bypass (Stage 1). These average travel times along Kamo Road were initially (in 2012) unaffected by the opening of the Stage 2 extension, but more recently (on average over 2015) have slowed by two minutes. It is unclear why this has occurred.

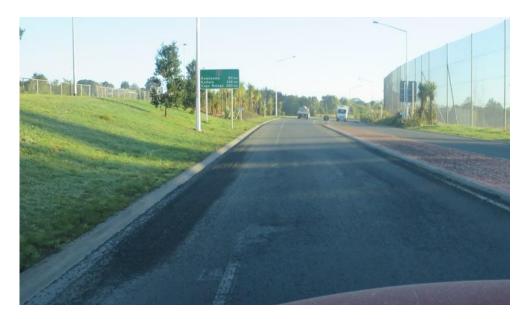
### Figure 7: Kamo Bypass pavement deterioration

Our field visit in August 2016 found the condition of the highway pavement on the bypass to be poor (see Figure 7). The Transport Agency first noted the road was showing signs of premature failure in early 2016. It commissioned an independent review in March 2016 to determine the liability with respect to the failures. The independent review concluded that the road had been constructed to Transport Agency specifications, and that even though the Open Grade Porous Asphalt (OGPA) had been in place for just over four years, it would expect the contractor would vigorously defend any action to recover funds.

It also found that based on the road curvature measured on this project, the OGPA life of between four and five years is within the predicted life expectations of this surfacing. Further enquiries as part of this post implementation review revealed that the pavement has deteriorated to a point where a full resurface of the bypass is now required. This will cost approximately \$1 million and is planned to be done over summer 2016/17.

HNO have worked with the National pavements specialists to try to identify the causes of the failure of the OGPA surfacing. Any liability under contracts has been very difficult to ascertain and pavement remediation has become a priority and is currently underway. An independent review has suggested that the service life of the OGPA surfacing may be shorter than anticipated. This will be given due consideration by the team at National office and will inform future pavement designs. The "Quality Right" initiative addresses the concerns that

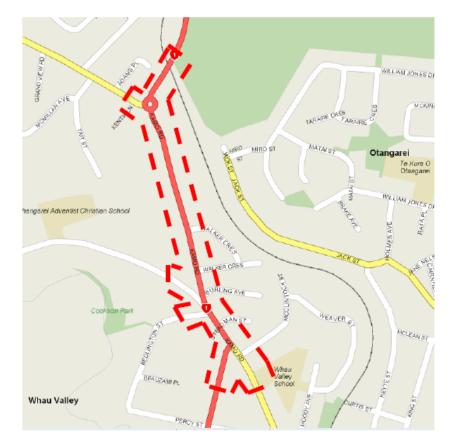
# Figure A1: Crash history analysis location as presented in the Scheme Assessment Report

- Crashes within an area extending from immediately south of the Kamo Road/Western Hills/Stage 2 Bypass intersection up Kamo Road to where it originally connected through a roundabout to the southern start of the Stage 1 bypass. (Figure A1 shows this crash area as presented in the project's SAR – before the Stage 2 bypass was constructed.)
- Crashes in Whangarei District were used as a control group to assess the potential effect of wider regional crash or reporting trends on the observed number of crashes on the studied section of Kamo Road.
- A post-project crash area along the Kamo Stage 2 bypass, starting from immediately south of the Kamo Road/Western Hills/Stage 2 Bypass intersection north along the bypass to approximately 200m north of its intersection with Puna Rere Drive.

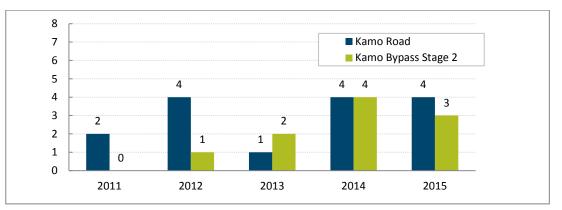
## Figure A3: Crashes on Kamo Stage 2 Bypass and original Kamo Road route

Figure A3 below compares crash numbers on Kamo Bypass Stage 2 after it opened (in September 2011) with the section of Kamo Road it replaced.<sup>6</sup> Crashes at the intersection of Western Hills Drive, Kamo Road and the start of the Stage 2 Bypass were deliberately excluded. This was to avoid double counting of crashes at this intersection being attributed to both routes. (Crashes at the intersection are discussed separately below.)

Overall, there were 10 crashes on the Stage 2 Bypass between when it opened and December 2015, compared with 15 crashes over the same period on the section of Kamo Road the bypass extension replaced. The overall incidence of crashes on both routes is low, with no serious or fatal crashes since project opening. Most (seven) of ten recorded crashes on Stage 2 of the bypass were at the signalised intersection with Puna Rere Drive. These have tended to mainly involve nose-to-tail crashes at the traffic signals.

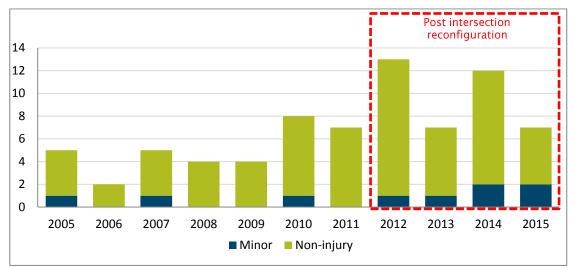
Figure A4: Crashes at the Western Hills Drive/Kamo Road/Kamo Bypass intersection (southern start of bypass), October 2011 to December 2015

The intersection of Western Hills Drive (SH1) and Kamo Road was reconstructed as part of the project to add the southern entrance of the Stage 2 bypass. There has been a significant increase in recorded crashes at the intersection since the intersection was reconfigured – see Figure A4. Predominantly these have been non-injury crashes, with no high severity (fatal or serious injury) crashes, and only a handful of minor injury crashes recorded. The majority of crash types (68%) have been rear end/obstructions, while nearly a quarter (24%) were attributed to crossing/turning crashes.

It is unclear whether the observed increase in crashes indicates any specific safety issues with the intersection's design, or whether it is simply reflective of the intersection now being higher capacity and substantially busier than previously:
