# Post Implementation Review

## East Taupo Arterial (Taupo Bypass)

Taupo District Council

2017

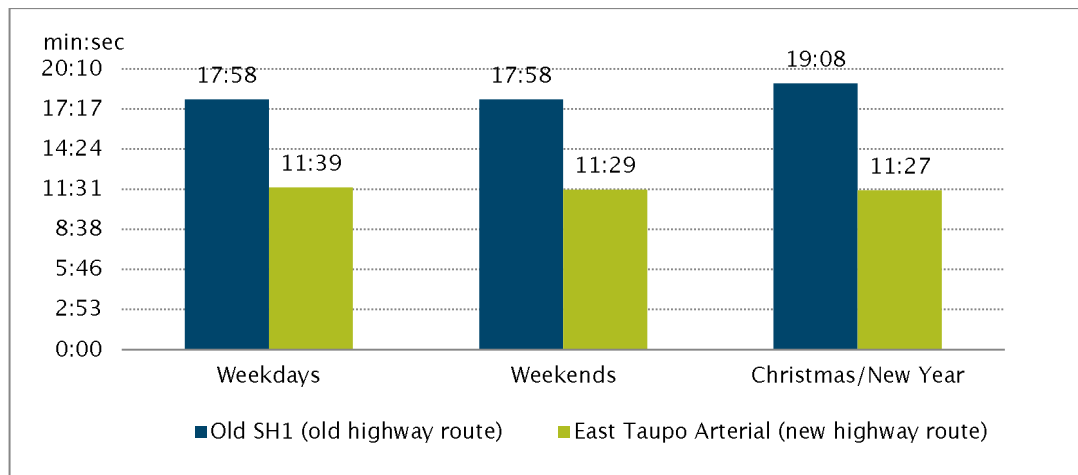
**Figure 2: Average northbound travel times for East Taupo Arterial bypass and old SH1 for northbound traffic, 2015**

The average travel times on the bypass compared to the old SH1 route are around 6–6.5 and 5.5 minutes less for northbound and southbound traffic respectively on weekdays and weekends.

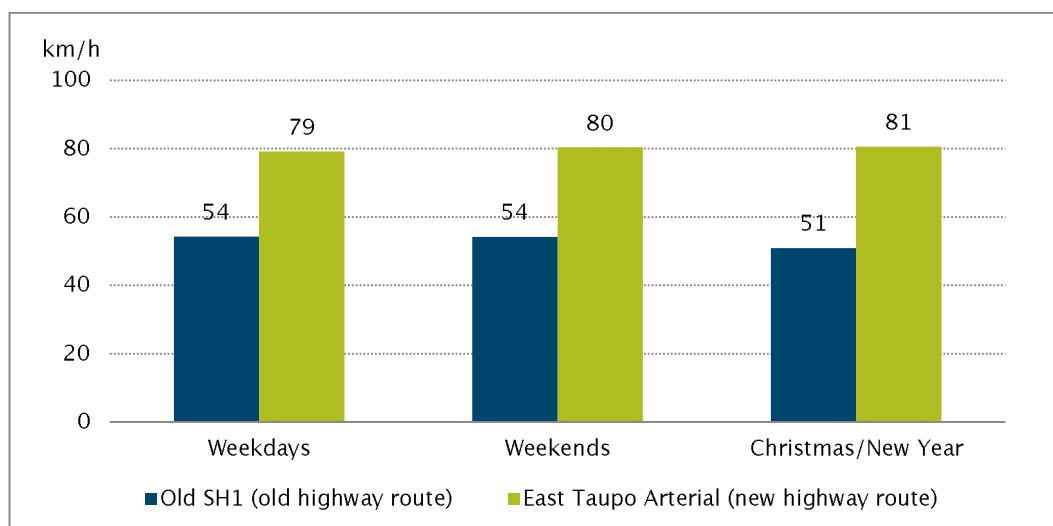
**Figure 4: Average speed comparison – East Taupo Arterial bypass and old SH1 for northbound traffic, 2015**

township. There is also periodic congestion and signalised intersections within the township which slows through-traffic. The effect of these factors are apparent in figure 4, which compares average speeds on the alternate routes.<sup>2</sup>

Speeds on the old SH1 route tend to average out at between 51–54 km/h overall, while bypass traffic averages speeds of around 80 km/hr.

<sup>2</sup> The average speeds shown in figure 4 are for northbound traffic. However, the results for southbound traffic were almost identical.

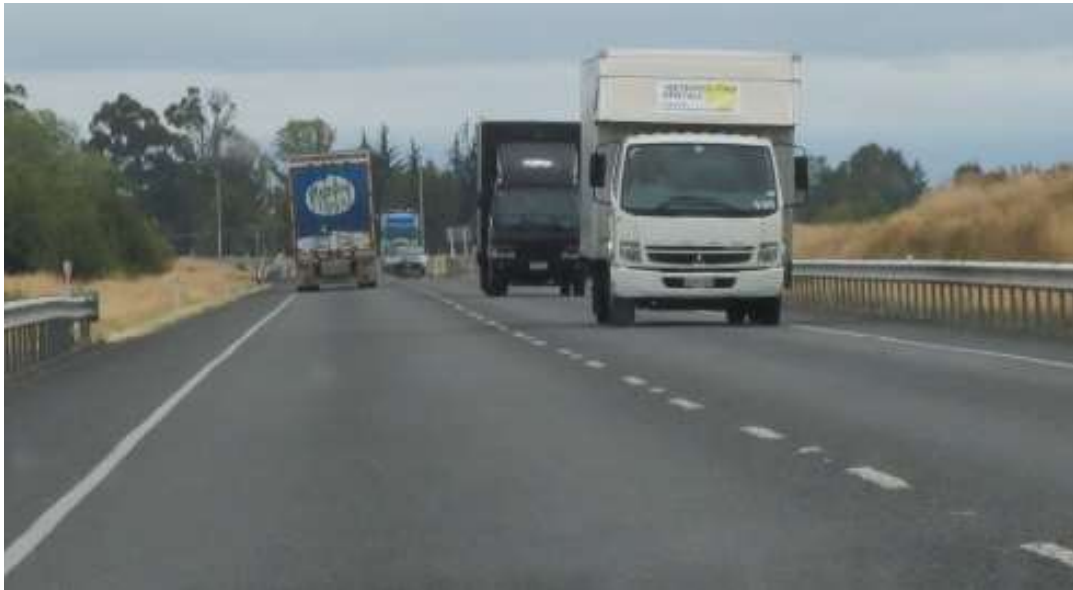
**Figure 6: Trucks heavily use the bypass, diverting them from Taupo township**

The bypass itself is heavily used by trucks, as evident in figure 6. Around 1,400 heavy vehicles used the bypass on a daily basis in 2015. More than one in five vehicles (22%) on the bypass are trucks or other heavy vehicles. This proportion is at the high end observed for state highways (where typically the proportion of heavy traffic to total traffic is around 4–11%).

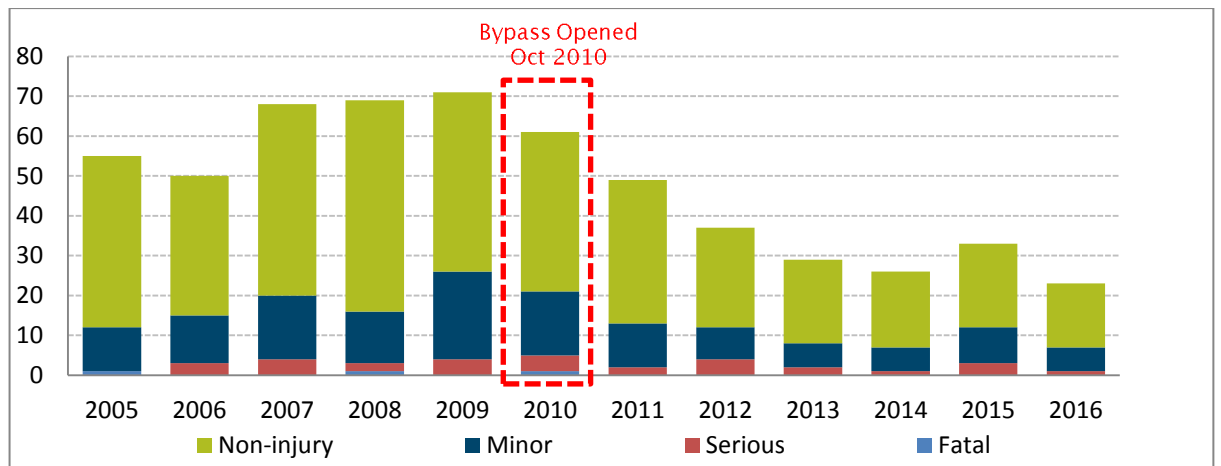
**Figure 7: Crashes on old SH1 route by severity 2005–16**

Safety has improved on the old SH1 route via the lake front and through the Taupo township. The crash rate on the old SH1 route has nearly halved from 62 crashes per year over the period January 2005 to October 2010 to 35 crashes per year recorded in the six years since the opening of the bypass in early October 2010. Figure 7 shows the trend of total crashes on the old SH1 route and how it has declined since the bypass was opened.

The reduction in crashes on the old SH1 route since the bypass opened is statistically significant. This means it can be concluded with sufficient confidence that the observed decline in crash incidence is a trend of improved safety and not merely the result of random fluctuations with crashes. It is difficult to 'go the next step' and explicitly attribute this safety improvement specifically to the effects of the bypass' introduction. Nevertheless, it is reasonable to conclude that the significant reduction in traffic volumes observed on the old SH1 route since the bypass opened will have helped contribute to the reduction in crashes.

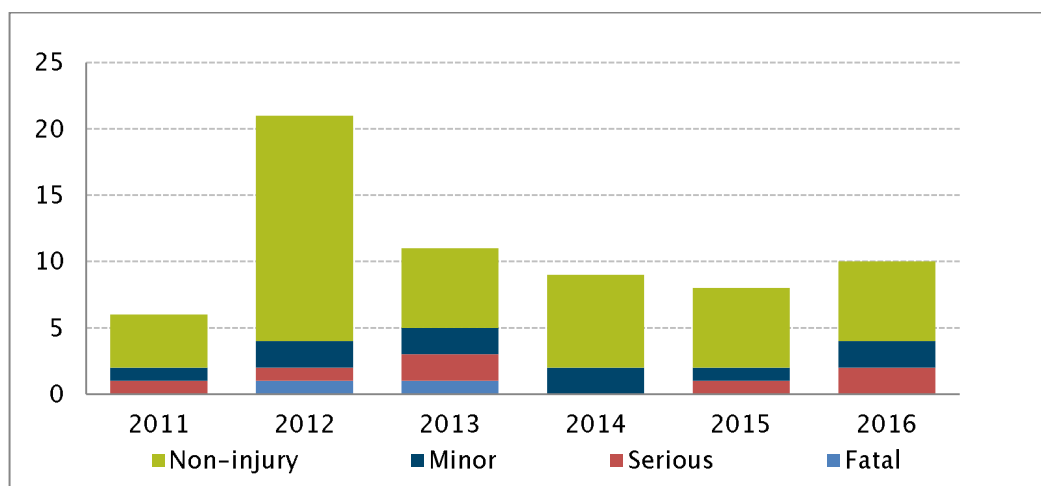
**Figure 8: Crashes on ETA Bypass by severity 2011–16**

There has been a relatively high crash rate on the Eastern Taupo Arterial since it opened. Figure 8 shows the trend in crashes by severity between 2011 and 2016. There were 65 crashes reported on the bypass over this period, including two fatal crashes and seven serious injury crashes.

It is apparent from figure 8 that there was an upward spike in non-injury crashes in 2012 which has not been repeated since. Analysis of the specifics for these non-injury crashes identified that driver-related factors dominated over environmental factors with their cause. Poor observation was identified as a crash factor in nearly two-thirds of the crashes. It should be noted, however, that it is problematic to draw clear conclusions from the incidence of non-injury crashes as their reporting is highly variable. The observed spike may also have been the result in the random fluctuation that tends to occur with crashes.
