Post Implementation Review

Urban Cycleways Programme

September 2018

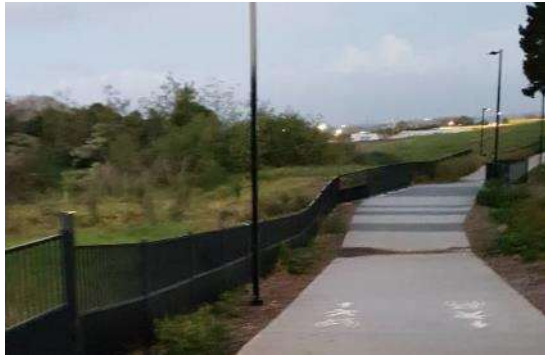
We encourage the consideration and inclusion of design features to support accessibility for all people, including those in wheelchairs. The incorporation of such facilities must however consider any adverse impacts such facilities may have on the primary target user group.

At the Meadowbank facility we considered the provision of accessible ramps (and associated level platforms) to be a poor design choice. Given the significant length and elevation differences of the shared path, few wheelchair users would likely utilise the path. Due to the inclusion of accessible ramp features we experienced sudden changes in weight when travelling downhill resulting in decreased comfort. To alleviate this discomfort we needed to reduce speed significantly or rise from our seats. Cyclists travelling at speed, not in the seated position and experiencing sudden weight changes will have less control over their bike and therefore be exposed to greater crash risk.

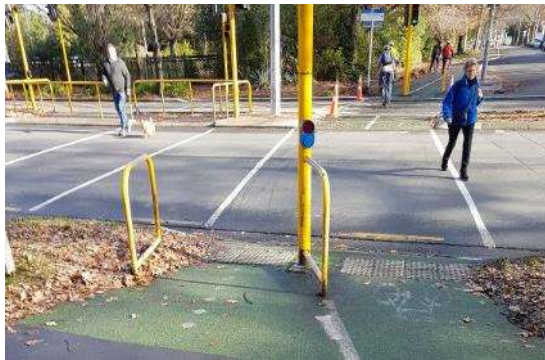
We visited a number of cycle facilities that required cyclists to cross signalised intersections and observed distinct differences in the level of service afforded to cyclists around the country. In Christchurch we noted the use of automated and advanced cyclist detection loops on intersection approaches. This enabled cyclists to 'call' for a green phase prior to arrival (reducing cyclist wait times at intersections) and without the need to push a call button. While such technology will undoubtedly add to a project's delivery cost, on well-utilised facilities it is likely to be cost-effective.

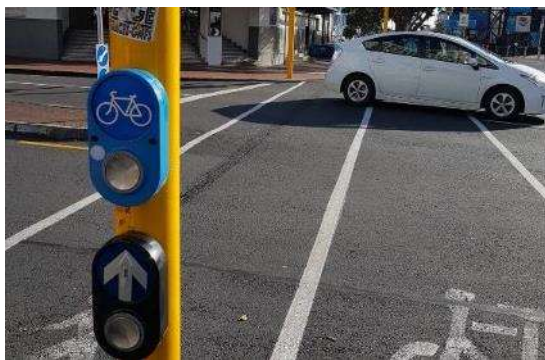
In Auckland and Christchurch we observed that crossing facilities generally differentiated between pedestrians and cyclists. This is considered good practice as the time required for cyclists to cross is less than that required by pedestrians. Distinguishing between pedestrian and cyclist users enables the correct amount of 'green time' to be provided and avoids unnecessary delay to other road users.

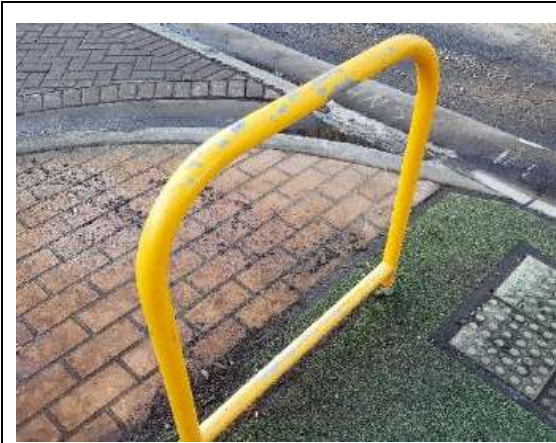
Hold rails improve levels of service for cyclists by enabling cyclists to remain seated on their bike while waiting to cross; this is particularly helpful to those cyclists using toe clips or cleats. Of the facilities visited, we found most had hold rails installed; and that the design of these varied around New Zealand. In Christchurch we noted wear on the horizontal foot rail, indicating that some cyclists likely have a preference for a foot rail. Consideration should be given to incorporating a foot rail into hold rail standards. It is possible that the bottom rail may also allow easier detection of the hold rail by visually impaired users utilising a cane.

Note: foot rails alone should not be provided as they may be hard to see.

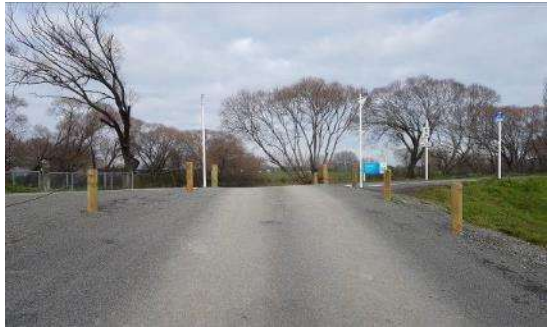
<p>Bollards pose an inherent and significant safety risk to cyclists due to their non-frangible nature, and because they can, in some instances, be hard to see. In consideration of the safe systems approach¹⁰, bollards (and staples¹¹) should only be used when alternative approaches to restricting vehicular access is not available, and where the safety hazard posed by a vehicle or to vehicle occupants¹² is greater than that of a permanent bollard.</p> <p>We observed a bollard layout on the Passchendaele Memorial walk/cycle path that restricted vehicular access to a shared path facility, while minimising collision risks to vulnerable road users. The layout achieved this by funnelling vehicles through a narrow single lane so that vehicles were not able to make a right angle turn onto the shared path facility. In taking this approach an opening in the line of bollards for the full width of the shared path was possible¹³.</p>

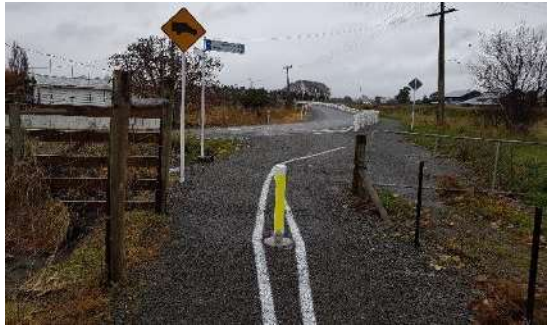
<p>We observed inconsistency in the way cyclists were alerted to bollard hazards. The use of sufficiently sized, spaced and conspicuous bollards in conjunction with the inclusion of white lines to provide cyclists advance warning is considered good practice (where bollards are required). Based on cyclist dimensions in Austroads, it is however suggested that white lines should indicate the safe trafficable area and therefore provide at least 375mm separation from hazards (or more when hazards are located on curves). We note in such instances, additional cycle facility width may be required.</p> <p>Based on cyclist dimensions we also recommend that all facility side furniture (such as fence posts and signs) be located at least 375mm from the edge of the cycling facility to ensure that they do not present an immediate safety hazard.</p>

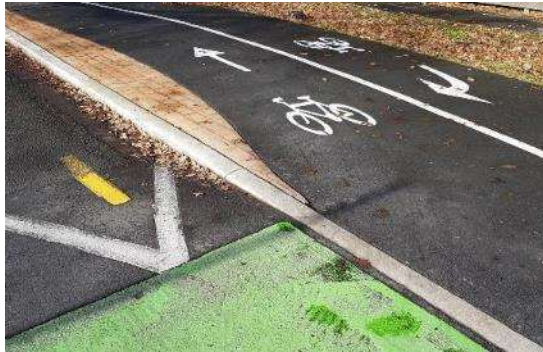
Wheels have a tendency to follow the contours of the surface they are on (commonly referred to as 'tramlining'). We noted a number of instances where surface levels (on or directly adjacent to cycle facilities) could expose inexperienced or unwary cyclists to a tramlining risk. Changes in surface level should be located at right angles to a cyclists' actual and expected travel desire line to mitigate such risks. Where this is not possible, we recommend site specific risk mitigation measures be implemented. For examples similar to that illustrated, such measures could include: realignment of the cycle facility, widening of the speed table to provide greater separation between cyclists and the kerb line, and/or the provision of a white line to indicate the safe trafficable area.

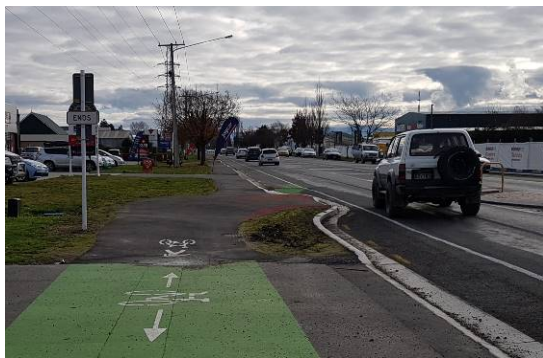
Cycle facilities were found to generally terminate in appropriate locations and with adequate advanced warning ensuring cyclists could make appropriate decisions as to how they might continue on their journey.

In two instances cycle facilities were found to terminate abruptly and/or in unsafe locations.

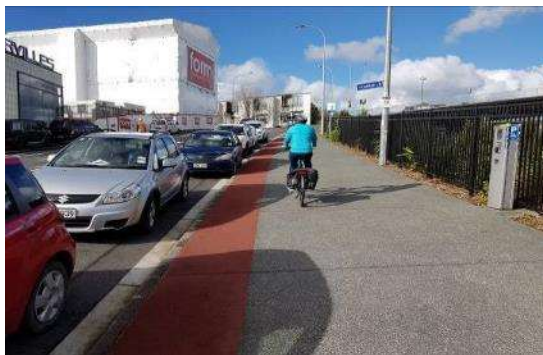
In a number of locations roadside parking was directly adjacent to cycling facilities. In such instances, there is a risk that a car door could open into the path of oncoming cyclist and result in a crash. To minimise this risk, we observed a number of instances where coloured and/or textured surfaces had been applied to encourage cyclists to shy away from the door opening zone. This was observed to be effective and is considered good practice. Similar to the treatment of bollards, an increase in cycle facility width may be required where such treatments are necessary.

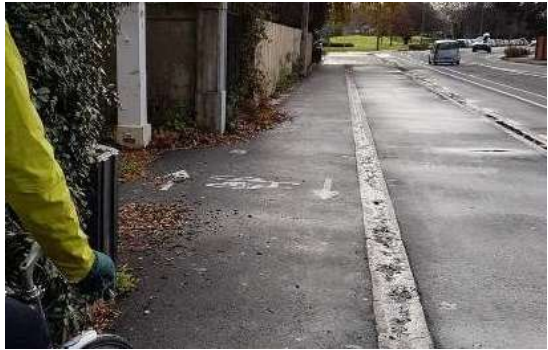
<p>Cycle logo markings were found to provide two functions. They were used to indicate cycle facilities, and they were used to raise awareness to other road users that cyclists may be present. In the illustrated example, cyclists may misunderstand the purpose of logos as indicating the correct riding position, rather than their intended purpose which was to warn vehicles. Such interpretation would put cyclists at greater risk of conflict with those leaving adjacent properties¹⁴. Care is required in the application of cycle logo markings in such circumstances and an alternative approach should be considered.</p>

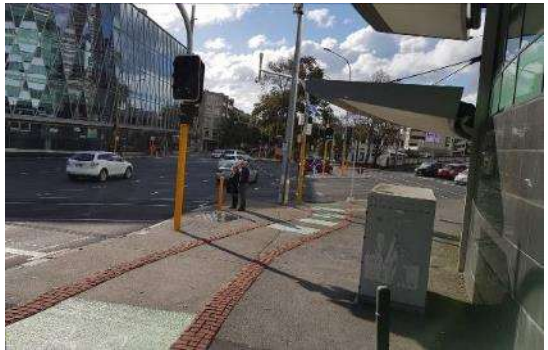
<p>Signalised intersections including cyclist phases were generally found to operate safely. In the illustrated example, however, a cyclist green phase allowed cyclists to come into direct conflict with pedestrians who were also on a green phase (crossing at right angles to the cycle facility). Greater consideration of phasing and the separation of cyclist and pedestrian flows is required where dedicated cycle lanes cross a pedestrian facility.</p>

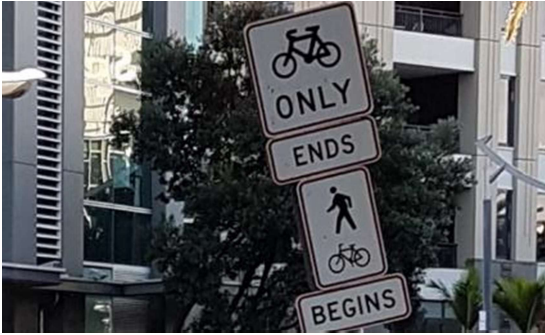
<p>Alternating between shared spaces and dedicated cycle lanes can be confusing.</p> <p>A number of cycle facilities alternated between shared spaces and dedicated cycle lanes. This resulted in a significant number of signs being used to indicate such changes. As new users to such facilities we found such alternating to be confusing, and we observed a significant majority of facility users ignoring them (while still exhibiting safe and courteous behaviour). We recommend greater effort into providing continuous facilities, or using design principles that negate the need for signs or markings to indicate and encourage the desired user behaviour.</p> <p>Additionally we note that the number of regulatory signs fixed to each pole must comply with Traffic Control Devices Manual requirements, if the intended conditions are to be enforceable.</p>

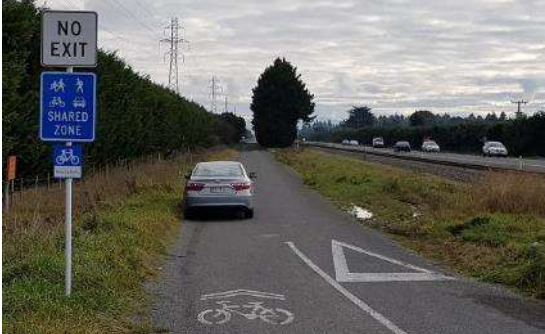
<p>Incorrect signage can result in cyclists deviating away from provided facility.</p> <p>Ensure signage provided is correct for all users. In the example illustrated the road was signed as a 'no exit' for all road users, however onward provision for cyclists and pedestrians was available. Failure to accurately reflect road conditions may result in cyclists and/or pedestrians unfamiliar with the area using alternative parallel routes which may provide a lower level of service, and/or encourage such users to disregard road signs at other locations.</p>

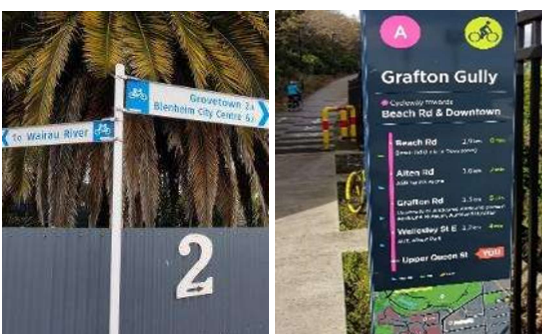
<p>Directional signage can be particularly helpful, especially for tourist routes.</p> <p>The provision of advanced directional signage (and maps) was observed on a number of routes. Directional signage is considered particularly useful for new cyclists, so would be particularly beneficial on routes that regularly attract new users (such as tourist routes). We noted one instance where intersection layout signage was used, which could be helpful in navigating complex intersections where the use of signage and markings may distract road/facility users. We note that New Zealand directional signage specifications is due out soon.</p>

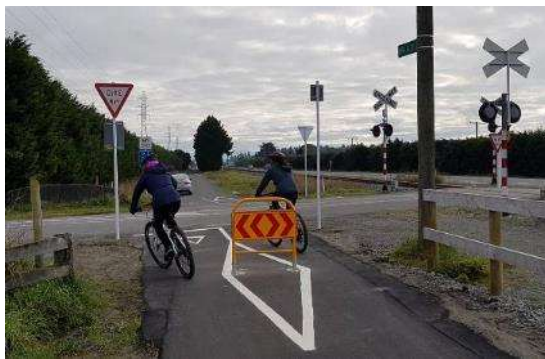
Designing intersections before construction improves build quality.

Ensure the design of intersection treatments is given thorough consideration prior to the construction phase so that the necessary path width can be provided without the need to provide patches. Patches reduce ride quality and may increase maintenance needs in future.

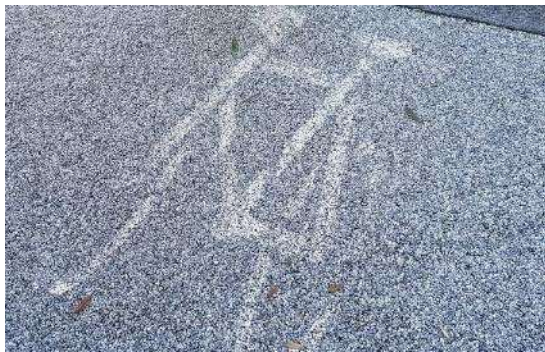
Road markings require sufficient contrast to be effective.

White cycle logo markings situated on light pavements were hard to see, particularly when faded. Consideration should be given to colour contrasting to maximise marking visibility.

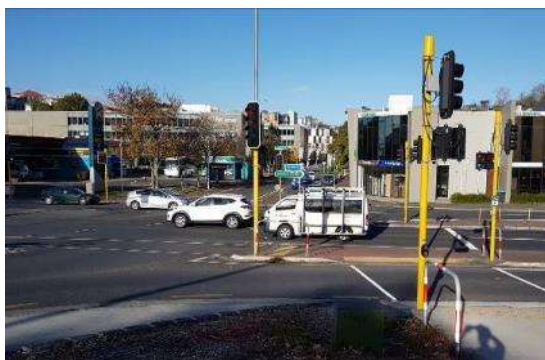
Minimise cyclist delay at signalised intersections to provide improved levels of service.

Where cyclists are required to cross two legs of an intersection in order to continue along a cycle facility, the green phases for cyclists on each leg should be coordinated so minimise delay and ensure cyclists only need to wait once.

Additionally, when cyclists call a cycle crossing phase, a green phase should be provided within the current signal phasing cycle (and have a wait time of no longer than 120 seconds). This reduces delay to cyclists, minimising the risk that cyclists cross an intersection during a red phase either due to frustration, or cyclists considering that there is an error/fault with the phase call button.

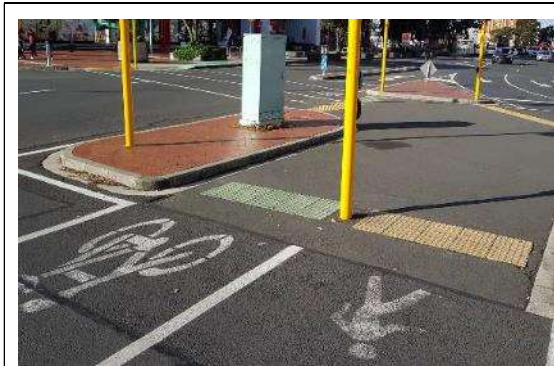
Avoid layouts that encourage pedestrian and cyclist conflict.

Where pedestrians and cyclists are segregated, care should be taken to avoid the 'flipping' of pedestrian and cyclist alignments. Flipping alignments introduces conflict as users are required to cross the path of one another. For example, in the situation illustrated, pedestrians and cyclists were required to swap sides within the traffic island (from left to right and vice versa) in order to comply with the indicated markings. In some instances this can result in high levels of non-compliance, and due to some users complying and others choosing not to comply, this can create conflict and frustration between pedestrian and cyclist users.

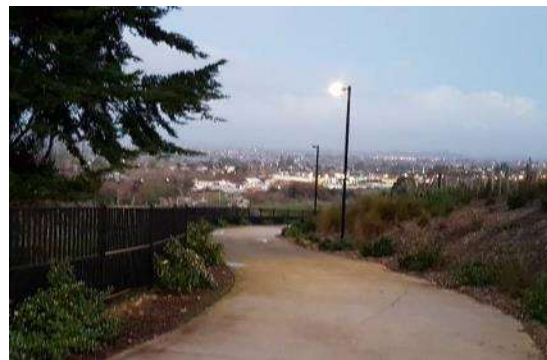
Forward visibility, operating speeds, and slippery surface risks require consideration.

Additional design consideration may be required on south facing slopes where the lack of sun, dampness and insufficient tracking create opportunities for moss/mould growth that can result in slippery surfaces. Such design considerations could include improved vegetation control/removal, increased maintenance activity (particularly during winter months when such build up is more likely) or surface considerations such as the use of unbound materials.

Prolonged and steep downhill sections can result in significant cyclist speeds. Consideration of forward visibility requirements is required, particularly given that many cyclists will take the straightest line available through bends. With the increasing prevalence of electric bicycles, there is an increasing likelihood of uphill cyclists also travelling quickly. The combined speed of cyclists approaching one another could therefore conceivably be in excess of 60km/hr. A crash at this speed would likely be very significant.

Adequate forward visibility will also reduce the probability of cyclists misinterpreting a cycle facility's alignment, and unintentionally leaving the facility. We noted one facility where this risk would be significant in low light conditions. At this facility a short extension was provided to give access to a raised viewing platform, which was positioned on the outside of a sharp downhill bend. Positioned on the outside of a bend, and constructed of the same construction materials meant that the viewing platform approach provided the first visual cue of the facility's possible, but incorrect, alignment. Combined with potentially high cycling speeds and limited forward visibility this poses a significant risk to cyclists unfamiliar with the facility (particularly in low light conditions).

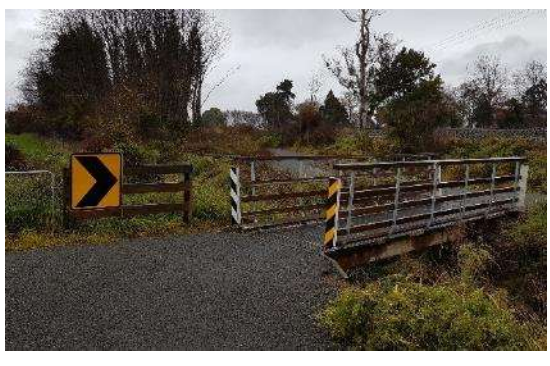
<p>Large, high quality delineation devices for night time cyclists can reduce safety risks.</p> <p>Providing reflective boards to help alert cyclists to hazards such as tight bends and bridge ends is good practice. Consideration could also be given to white edge lines to further assist cyclists avoid hazards at night. In cases where there is a drop off (such as to a water course) consideration should be given to the inclusion of white sighting boards.</p>

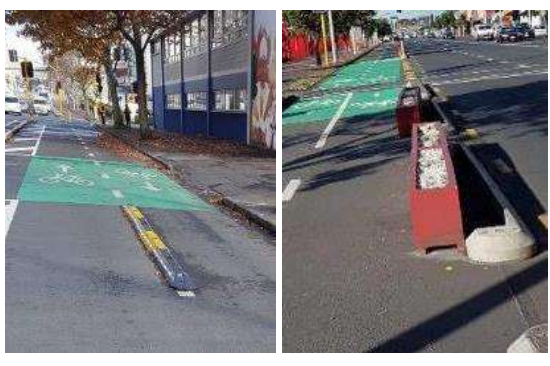
<p>Care is required to avoid the placement of furniture that can pose a risk to cyclists.</p> <p>Kerb blocks installed on cycle lanes to separate cyclists travelling in opposing directions pose an inherent safety risk due to the risk that they may be struck. This risk is particularly pronounced for cyclists who may be passing slower cyclists, and their view to such kerb blocks being obscured by the cyclist in front. The placement of safe hit posts on the kerb blocks will not alleviate this risk and create additional maintenance needs.</p> <p>Additionally design elements should not reduce the available facility width or pose a safety hazard to passing cyclists.</p>

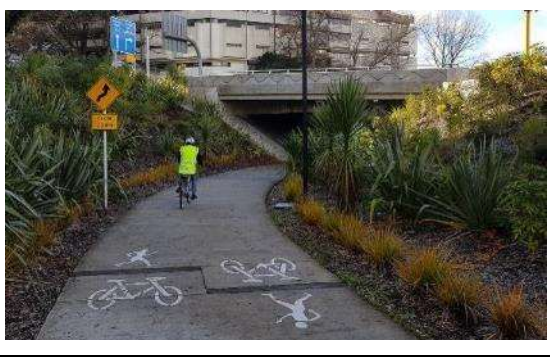
<p>Advanced warning signs good practice.</p> <p>Where the provision of adequate forward visibility is difficult²¹ and where the removal of hazards is not possible, the use of advanced warning signs is good practice.</p>

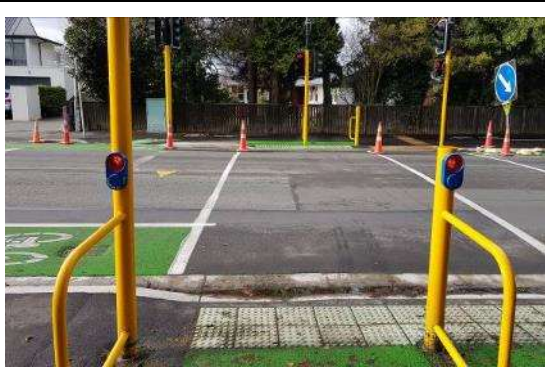
Design considerations for cycle hold rails.

To reduce cyclist effort to remain stationary while waiting to cross an intersection, it is helpful if the surface adjoining the cycle hold rails is level. Cycle hold rails should be sufficiently set back to ensure front wheels of bicycles are at least 300mm away from the road edge when waiting. Where cyclists need to make tight right angle turns, designers should consider whether the benefit provided by hold rails is greater than the hindrance posed by decreasing the space available (to make the right turn). Consideration is also required to ensure the hold rails do not impede the path of pedestrians.

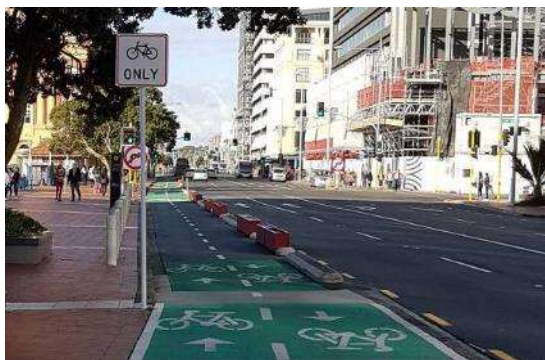
Adequate sign set back required to avoid risk of cyclist collision.

Care is needed to ensure signs and support poles are suitably set back from cycling facilities to mitigate the risk of cyclists striking them.

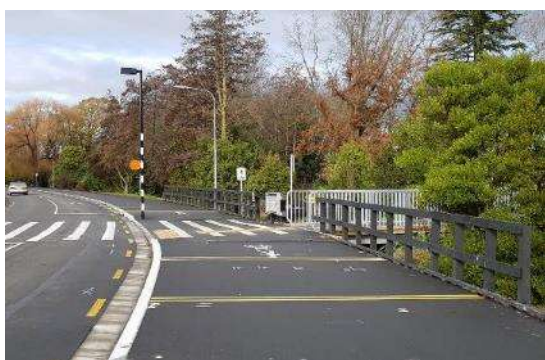
Ensure cycle facility markings meet cyclist expectations.

Caution is required when providing zebra crossings in shared facilities as they may not be expected. To maximise legibility and familiarly to cyclist users the zebra crossing arrangement should follow standard design layouts which include orange globes on both sides of the crossing, an advanced diamond pavement marking and a give way limit line.
