Post Implementation Review

Gisborne CBD Cycleway

Stage one: Sponge Bay to Wainui

Tairawhiti Roads

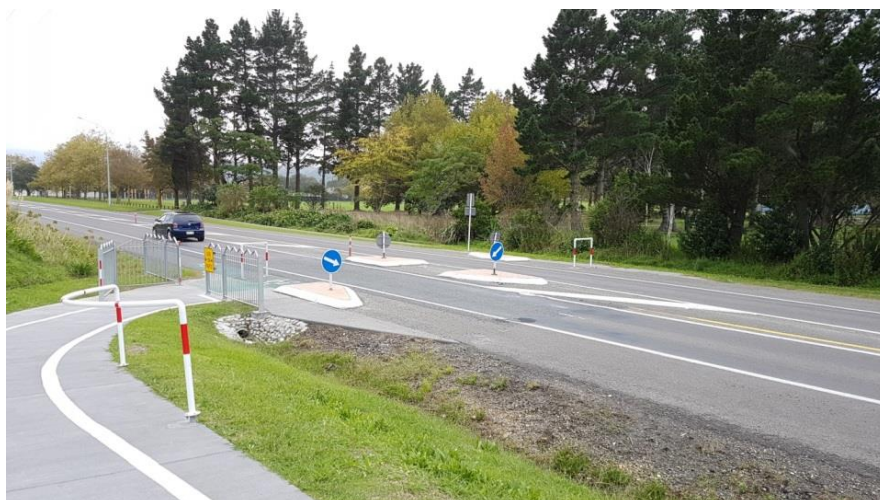
Figure 2: Termination of shared path at 70 kph zone.

The shared path terminates in a 70 k/m zone. Terminating the shared path approximately 1km west where there is a 50km/hr posted speed limit would provide a safer walking and cycling environment – see Figure 2 below. While it is acknowledged that this extension forms part of Phase 2 of the project, it was not clear why this could not have proceeded as part of Phase 1 particularly when approval for it was provided on 12 June 2014.

Greater scrutiny of where shared paths terminate is required to ensure that their attractiveness to new users is maximised. At the western end of the facility for example, cyclists are required to ride in a 70km/hr road environment in order to connect to the new facility. This requirement is likely to have deterred many 'interested but concerned' cyclists, who typically contribute significantly to new user numbers. While subsequent phases of the programme will resolve this shortcoming, economically, the project may have benefited from deferral.

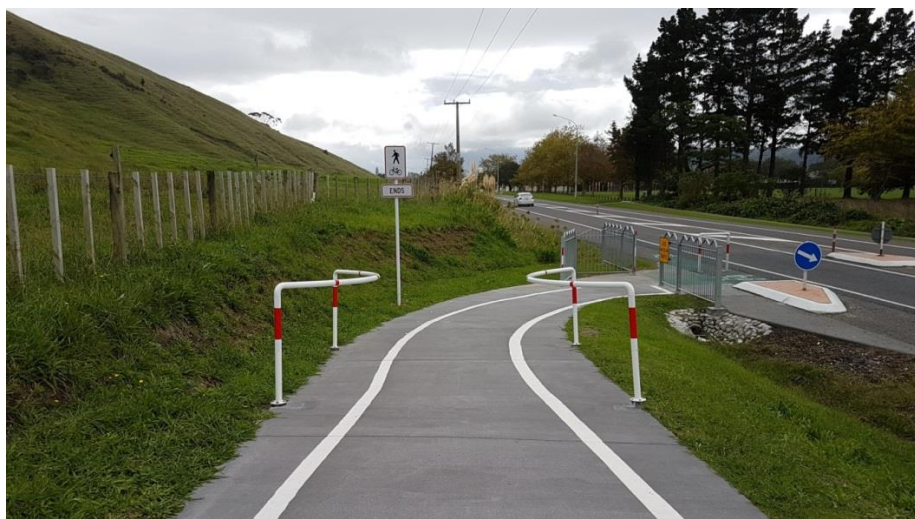
Figure 3: The metal width restrictors

The ongoing use of ‘width restrictors’ (figure 3), which presumably are intended to slow cyclists down on the approach to intersections and heavily used accessways, should be evaluated. The width restrictors are considered by the review team to adversely impact on safety as they will likely be inconspicuous during low light conditions despite the presence of reflectorised strips on the horizontal faces of some of the restrictors. Their inconspicuous nature arises due to the small surface area facing the direction of travel, which in conjunction with the generally poor lighting used by cyclists travelling during low light conditions, would make them hard to see.

It is recommended that Tairawhiti Roads undertakes a review of the potential risks posed by the 'width restrictors' on the Gisborne to Wainui shared path.

This review should include consideration of the risk posed to shared path user strike due to the combination of their form/height and visibility during low-light conditions. It should then undertake the necessary actions to ensure that the level of safety afforded to shared path users is acceptable.

It is recommended that the NZ Transport Agency develops national policy guidance/design standards regarding use of 'width restrictors' on cycleways.

This should be based on a detailed review of their existing use on shared paths and cycleways, and assessment of risks they pose to cyclists due to their design and visibility during low-light conditions.

The provision of width restrictors on facilities used by cyclists should be supported with evidence of their need, and height of any horizontal components carefully considered. The decision to include width restrictors should offset the anticipated benefit from the potential risk posed to cyclist strike. The height of horizontal components should be positioned to ensure they do not pose a risk to cyclists.

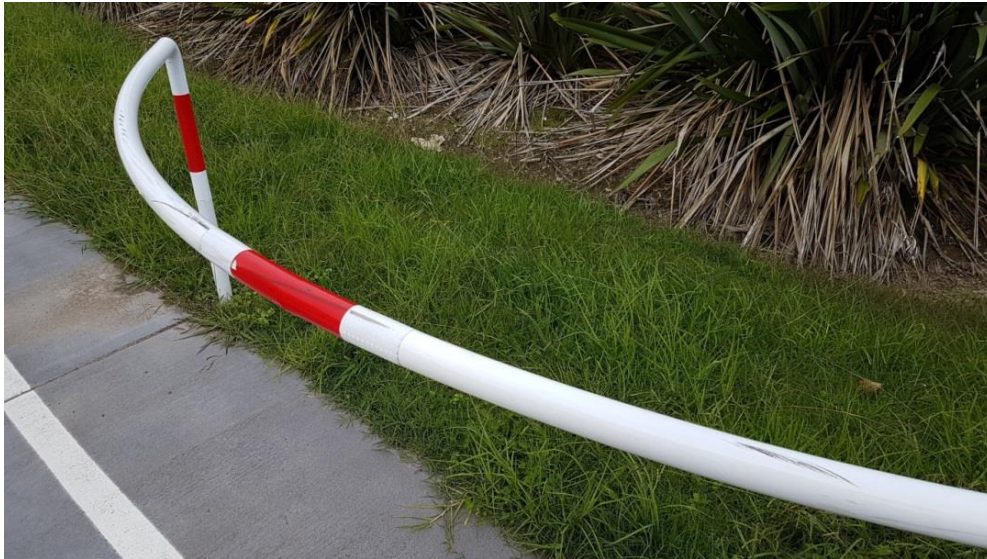
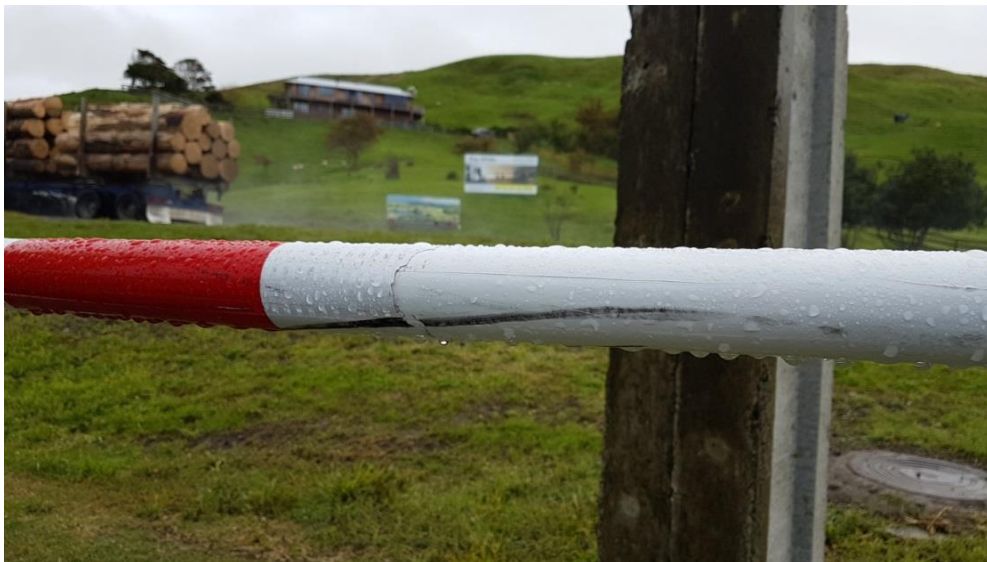
The horizontal components associated with the width restrictors showed evidence of being struck (figures 4 and 5). The horizontal components were found to be positioned at a height where they could conflict with adult cyclist handlebars, and upper body parts (including the face/head) of younger shared path users which could result in significant injury.

Figure 4: Width restrictor evidence of being struck

Figure 5: Width restrictor evidence of being struck

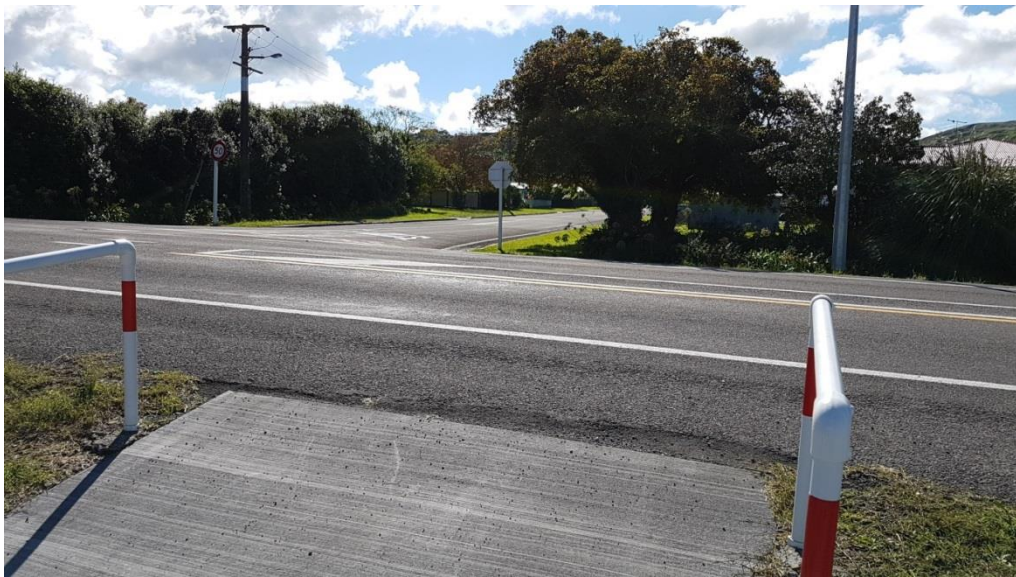
Figure 6: Lateral shared path connections at Murdoch Road

Lateral shared path connections, such as that at Murdoch Road (Figure 6) could place vulnerable road users in direct conflict with traffic due to the absence on onward pedestrian and cycle facilities.

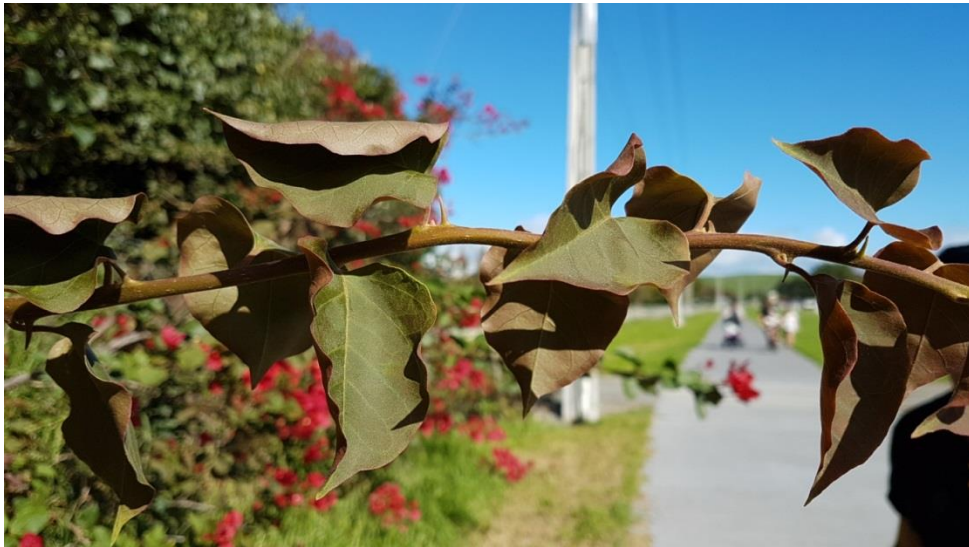
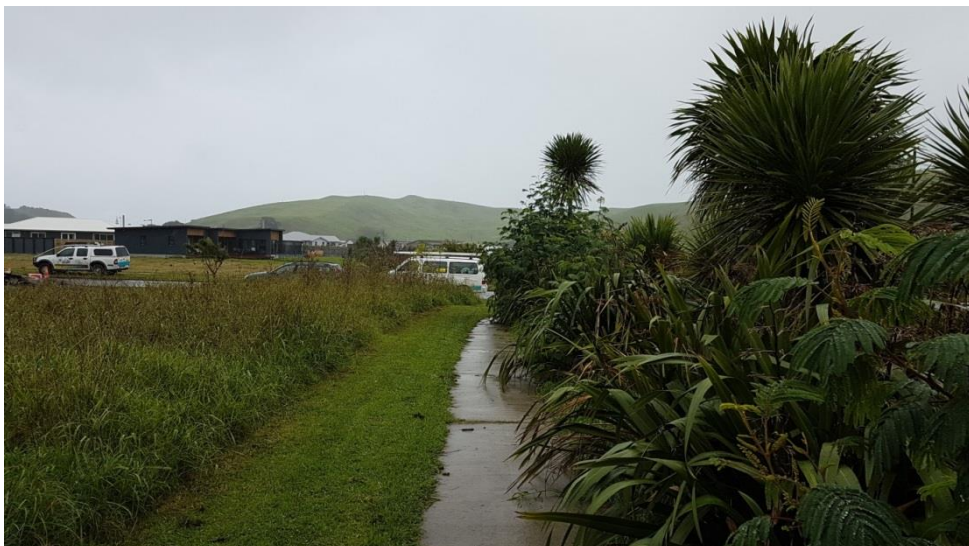
Regular maintenance activities need to be done to ensure that vegetation does not encroach on the shared path and impede users. Examples of encroaching vegetation were observed during the site visit, particularly 150m southwest of Oneroa Road where there is a thorny hedge (see Figures 7 and 8).

Figure 7: Encroaching vegetation on cycleway

Figure 8: Encroaching vegetation on access way

It is recommended that Tairawhiti Roads undertakes regular maintenance activity on the cycleway including vegetation control.

This will ensure that vegetation does not encroach on the shared path and impede users.

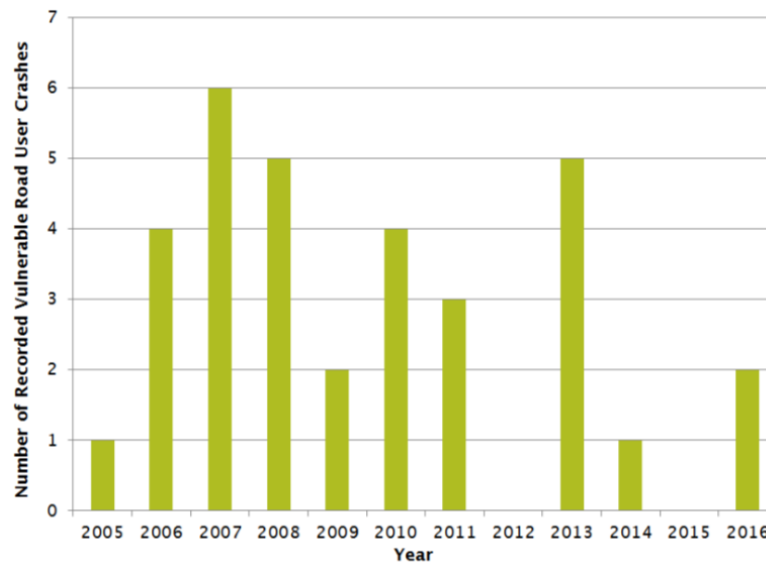
Figure 9: Number of recorded crashes within the greater project area

It is reasonable to expect that the shared path has increased the presence of vulnerable road users at adjacent locations on the wider road network. A review of crash records from the wider road network, as depicted in Figure 9, does not provide any evidence to suggest a notable change in either vulnerable road user crash frequency or severity trends.

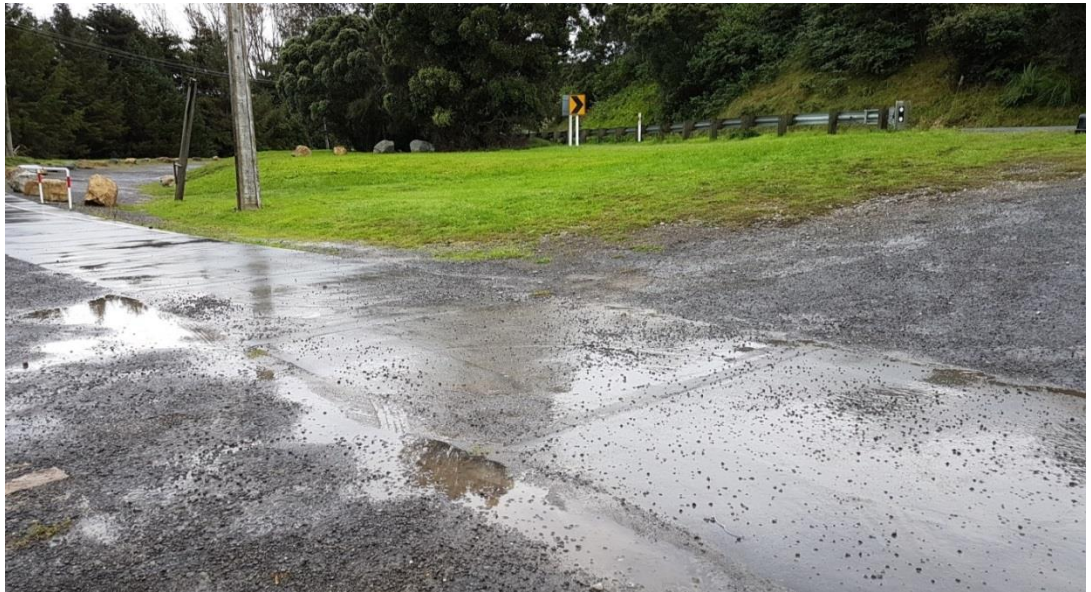
Figure 11: Significant chip loss on Wainui Road

- Significant chip loss had occurred on Wainui Road due to the vehicle stresses induced by the steep gradient of the access way serving this property. Loose gravel had migrated onto the shared path and could pose a hazard for shared path users (figure 11)

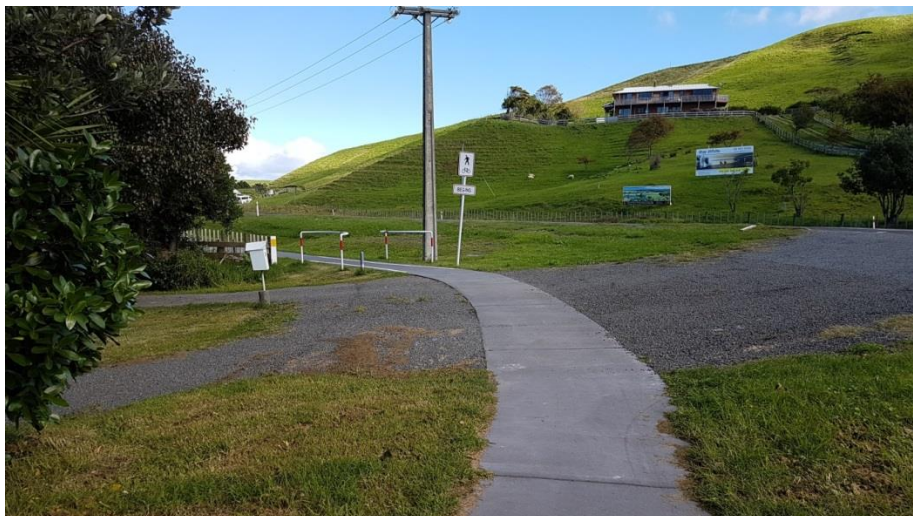
Figure 12 : Section of shared path below minimum widths

- A short section of the constructed shared path near Oneroa Road (figure 12) does not meet the recommended 3m minimum desirable width. Should the shared path be extended in future as planned this will necessitate the removal of a short, but recently formed, section of pathway.

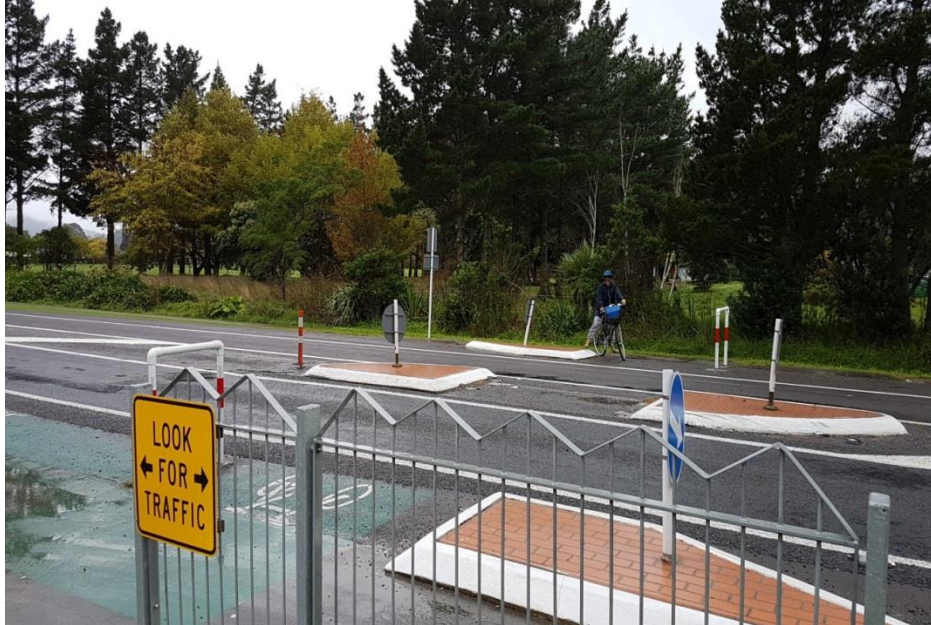
Figure 13: Steel safety railings

- The steel safety railings installed opposite Heath Johnston Park were identified as a safety hazard by the project team prior to the shared path opening (figure 13). To address this risk, the vertical elements of the rails were either capped with a horizontal top rail, or bent outwards. Where vertical rails were bent outwards fractures were apparent in the steel, which without suitable treatment will not likely endure and may require premature replacement.

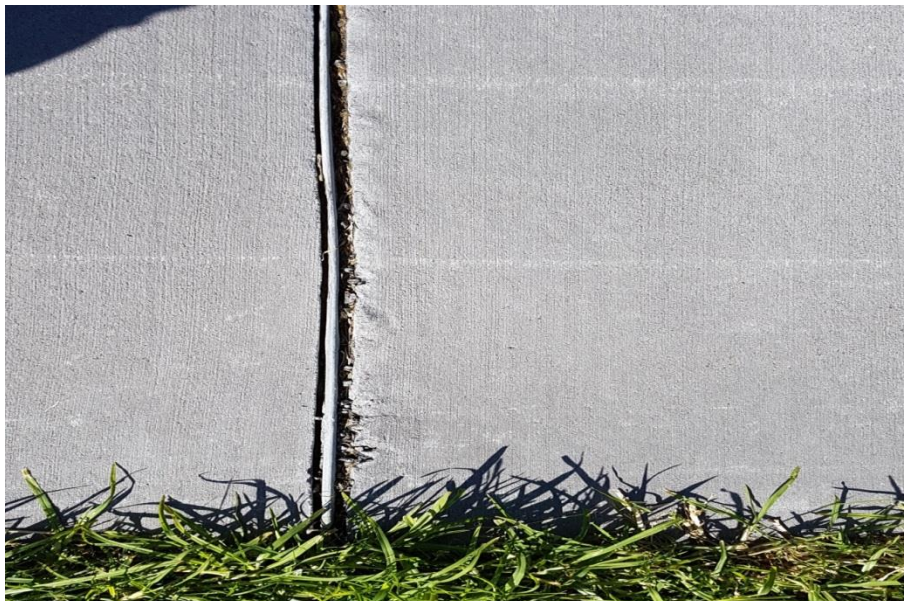
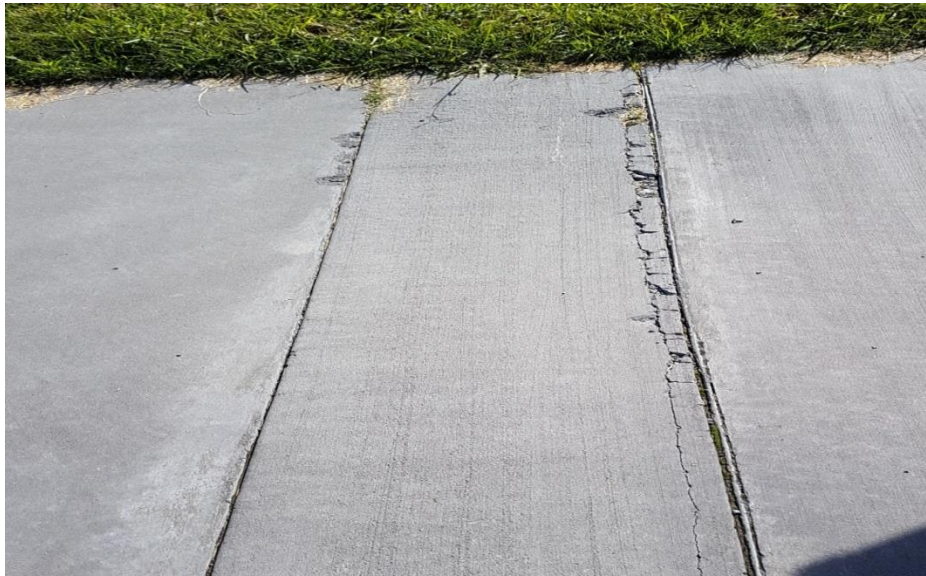
- Steel strips were observed to have been installed in a number of the shared path's concrete shrinkage control joints. The review team were unable to establish the purpose of the steel strips, but observed a correlation to their presence and surface defects in adjoining concrete slabs.

Figure 14: Surface defects at path joins with steel strips

Figure 15: Surface defects at path joins with steel strips

The inclusion of steel strips in concrete shrinkage control joints can result in surface defects. During the course of the audit it was not possible to ascertain why the steel strips were used, but if possible, it would be desirable to avoid their inclusion in future projects.
