Warkworth to Wellsford

Ecology Assessment

July 2019

Document title: Ara Tūhono Project, Warkworth to Wellsford Section; Ecology Assessment

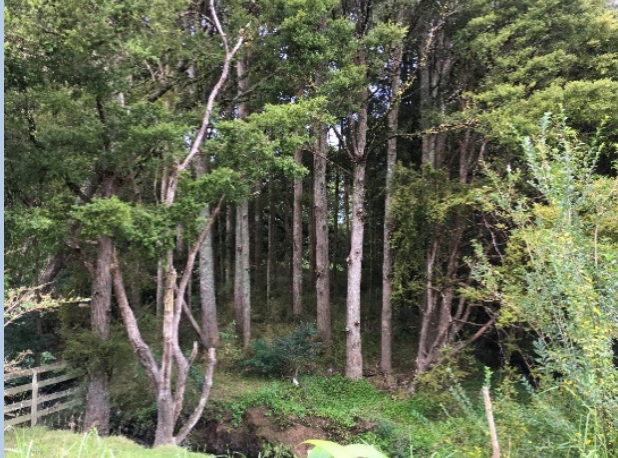
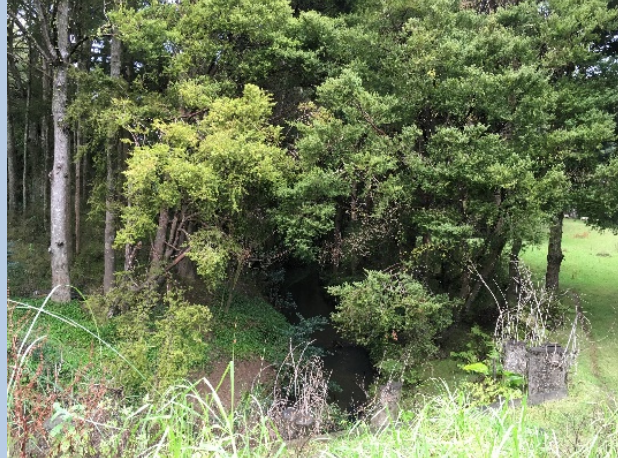
Site ID	WN_T_Mahu_02
Size (ha)	4.5
Ecosystem type and vegetation description	<p>Kauri, podocarp, broadleaved forest (WF11)</p> <p>Totara canopy interspersed with kahikatea and rimu. Canopy height is approximately 15 m and the DBH of the canopy trees ranges between approximately 40 – 60 cm. While kauri is noted as a component of ecosystem type WF11 (Singers et al., 2017), no kauri was observed during the site walkover.</p> <p>Subcanopy vegetation comprises māhoe, pūriri, ponga and kānuka. There is a dense, even-aged understorey of thin-leaved <i>Coprosma</i>, twiggy <i>Coprosma</i>, hangehange, red mapou, karamu and lancewood, with some tree privet and Chinese privet around the margin. Ground cover comprises a dense layer of various moss species as well as ferns, grasses and sedges. The ground cover species include leather-leaf fern, thread fern, basket grass, hook sedge and forest sedge. There is abundant growth of the epiphytic white rata.</p>

Habitat quality	Good. The remnant appears to have been recently fenced (within the last 10 years) and is recovering well from stock damage. Consequently, there is a very dense, even-aged, understorey comprising of broadleaved trees and shrubs, which likely persisted in the seedbank while the understorey was browsed.
Ecological Value	Moderate
Rationale	<ul style="list-style-type: none"> • The site rates as moderate for ‘diversity and pattern’ and ‘ecological context’. • Diverse vegetation assemblage but impacts of previous grazing evident. • Comparable size to nearby SEA sites.

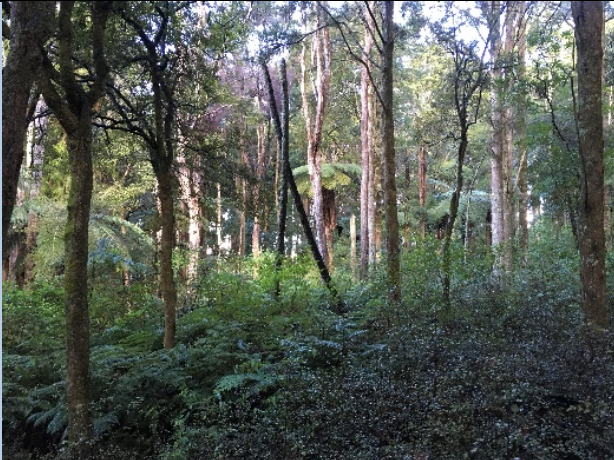
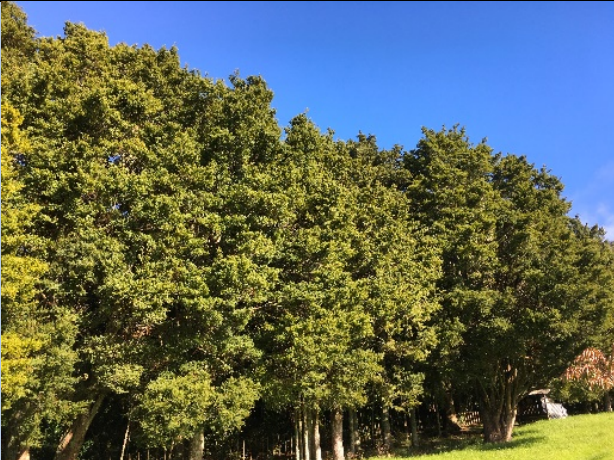
Site ID	WN_T_Koura_01 ^b	
Size (ha)	5.5	
Ecosystem type and vegetation description	<p>WN_T_Koura_01a - Kahikatea, pukatea forest (WF8) WN_T_Koura_01b - Exotic forest (EF.1) WN_T_Koura_01c - Kā nuka scrub/forest (VS2)</p> <p>This site forms the headwaters of WN_W_Koura_01. Approximately 0.6 ha of the site is kahikatea-pukatea forest, surrounded by a mosaic of forest types including plantation pine, exotic forest of wilding conifers and acacia trees, and regenerating kā nuka forest interspersed with totara and kahikatea (part of which is covenanted).</p>	
Habitat quality	<p>Good</p> <p>Although parts of the site are dominated by exotic species, the remnant kahikatea-pukatea forest patch appears intact and there is no evidence of degradation by stock.</p> <p>The mosaic of forest types provides a diversity of habitats and the large exotic species potentially provide cavities for native fauna.</p> <p>A key part of this site's value and function is its connectivity to other wetland remnants across the valley floor.</p>

Ecological value	<p>Kahikatea, pukatea forest (WF8) - High Kā nuka scrub/forest (VS2)- Moderate Exotic forest (EF.1) - Low</p>

Rationale	<ul style="list-style-type: none"> The kahikatea, pukatea forest meets the rarity/distinctiveness criterion, as this forest type is a LENZ IV category with less than 20% indigenous cover remaining (refer to Section 2.6 and Appendix A). The surrounding vegetation rates moderate for ecological context as it buffers the kahikatea, pukatea forest and the covenanted wetland (WN_W_Koura_01) downstream. The small size of the kahikatea, pukatea forest remnant (0.6 ha) means it does not rate highly for other significance criteria such as representativeness and diversity and pattern. However, the forest remnant has good connectivity to a variety of indigenous ecosystem types that sit within the same valley. 	
Site photos

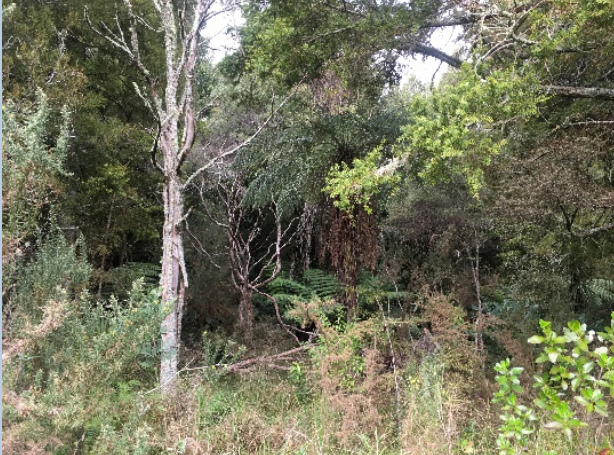
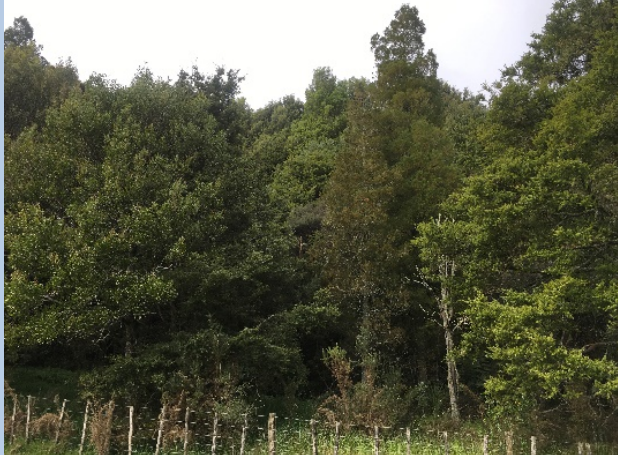
Site ID	WN_T_Koura_02	
Size (ha)	28.3	
Ecosystem type and vegetation description	<p>Kā nuka scrub/forest (VS2) Broadleaved species scrub/forest (VS5)</p> <p>Regenerating kā nuka forest grading into young treefern-dominated scrub on the upper slopes. Totara is a frequent canopy component, interspersed with young kahikatea, mā nuka, mamaku, ponga, and mature remnant pine trees. The site borders two wetland complexes, which include raupō reedland and kahikatea, pukatea forest.</p>

Habitat quality	<p>Good. A relatively large, intact example of a regenerating forest complex with community sequence from wetland through fernland on upper slopes. Some stock access evident around margins.</p> <p>Gorse dominant along old farm tracks, but has been recently controlled.</p>

Ecological value	Moderate
Rationale	<p>The site rates as moderate for diversity and pattern and high for ecological context:</p> <ul style="list-style-type: none"> • The site is part of an ecosystem sequence from raupo reedland through kahikatea-pukatea forest to the regenerating forest on the upper slopes. • As part of this complex, the forest provides a buffer the wetland (WN_W_Koura_02) which has been assessed as having Very High ecological value. • Notwithstanding this, regenerating kā nuka forest is one of the few indigenous ecosystem types in Auckland that has been classified as Least Concern based on IUCN criteria (Singers et al., 2017).
Site photos

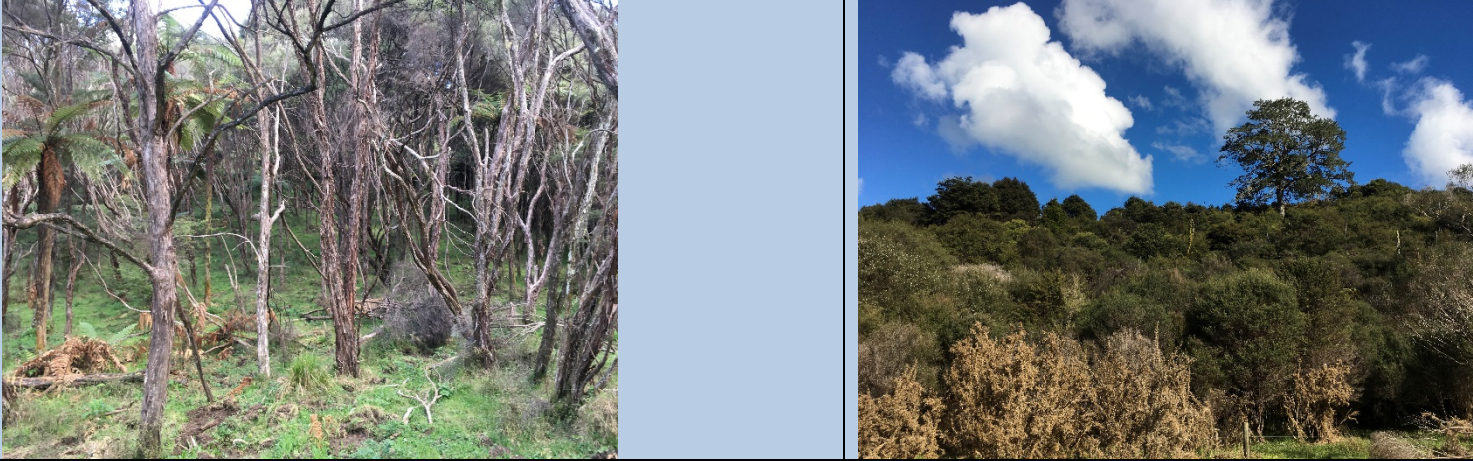
Site ID	WN_W_Koura_01
Size (ha)	1.1
Ecosystem type and vegetation description	<p>Exotic wetland (EW) Machaerina sedgeland (WL11)</p> <p>A covenanted wetland largely vegetated in exotic pasture grasses, buttercup, Mercer grass and exotic water pepper. Native wetland species (<i>Machaerina teretifolia</i>, sharp spike sedge, Edgar’s rush, leafless rush, harakeke, swamp sedge and giant umbrella sedge) are locally abundant towards the centre of the wetland. Occasional mā nuka and juvenile kahikatea are present on the wetland margin.</p>

Habitat quality	Moderate. The wetland is largely exotic. However, the assemblage of naturally occurring native wetland species indicates suitable wetland hydrological conditions. Stock are excluded.
Ecological value	Moderate
Rationale	<ul style="list-style-type: none"> • The site rates as moderate for rarity/distinctiveness, as the feature includes a component of naturally occurring native vegetation and indigenous wetlands are a LENZ IV “threatened environment” category where less than 20% indigenous vegetation remains. • However, the majority of the site is dominated by exotic vegetation. • The intact wetland hydrology and remnant indigenous wetland vegetation community indicates good restoration potential, and restoration is likely because this is a requirement of the regulatory incentive provisions under which the site was covenanted.
Site photos

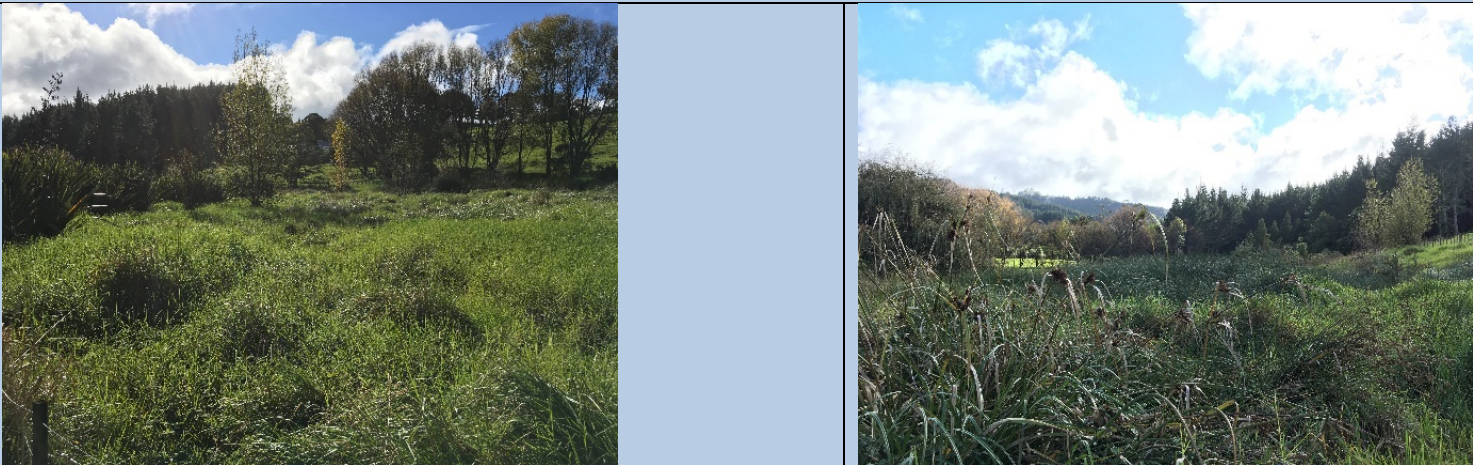
Site ID	WN_W_Koura_02
Size (ha)	0.8
Ecosystem type and vegetation description	Raupo reedland (WL19) Raupo wetland and regenerating kahikatea forest with regenerating forest and scrub surrounding upper reaches. A stand (23 stems, 8.2 cm – 40.8 cm diameter) of regionally uncommon swamp maire is present on the wetland margin.

Habitat quality	Good. Remnant wetland with intact regeneration sequence occurring in the headwaters. Stock access evident and weeds present on the margin. Lower reaches of the wetland truncated by a deep drainage ditch.

Ecological value	Very High	
Rationale	<ul style="list-style-type: none"> • Rates high for rarity/distinctiveness as the site supports regionally uncommon swamp maire and banded rail (At Risk – Declining, recorded October 2017). • Meets diversity and pattern criterion due to connectivity over multiple environmental gradients from freshwater wetland to regenerating forest in the upper slopes. • The site comprises raupo reedland and kahikatea, pukatea forest, which are identified as Endangered and Critically Endangered respectively in Singers et al (2017). • Indigenous wetlands comprise a LENZ IV “threatened environment” category where less than 20% indigenous vegetation remains. 	
Site photos

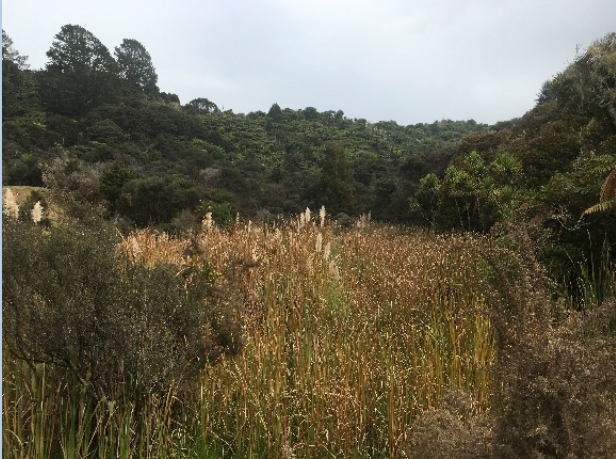
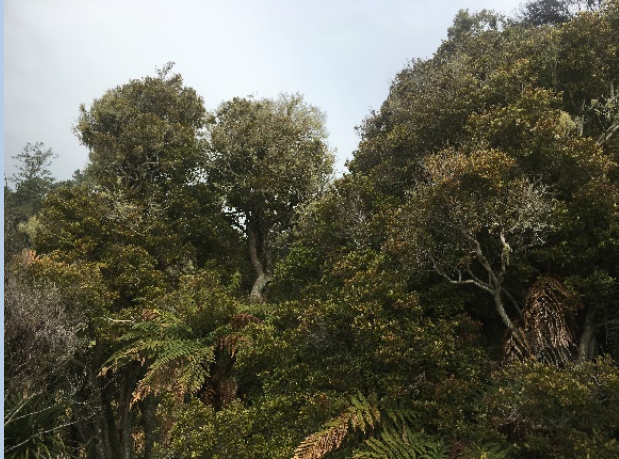
Site ID	WN_W_Koura_03	
Size (ha)	1.1	
Ecosystem type and vegetation description	<p>Raupo reedland (degraded example) (WL19)</p> <p>Wetland dominated almost entirely by <i>Isolepis prolifera</i>, a native species tolerant of grazing and disturbance, and common in nutrient rich wetlands. Mānuka, mamaku, cabbage tree, Edgar’s rush, and raupō are also sparsely present. The wetland is truncated and culverted by farm track.</p>

Habitat quality	Poor. Full stock access, hydrological modification and limited species diversity.

Ecological value	Moderate
Rationale	<ul style="list-style-type: none"> • Meets rarity/distinctiveness criterion as indigenous wetlands are a LENZ IV “threatened environment” category where less than 20% indigenous vegetation remains. • Nevertheless, this feature is a degraded example of a raupo reedland ecosystem that is degraded by stock access (the feature is unfenced) and modified drainage.
Site photos

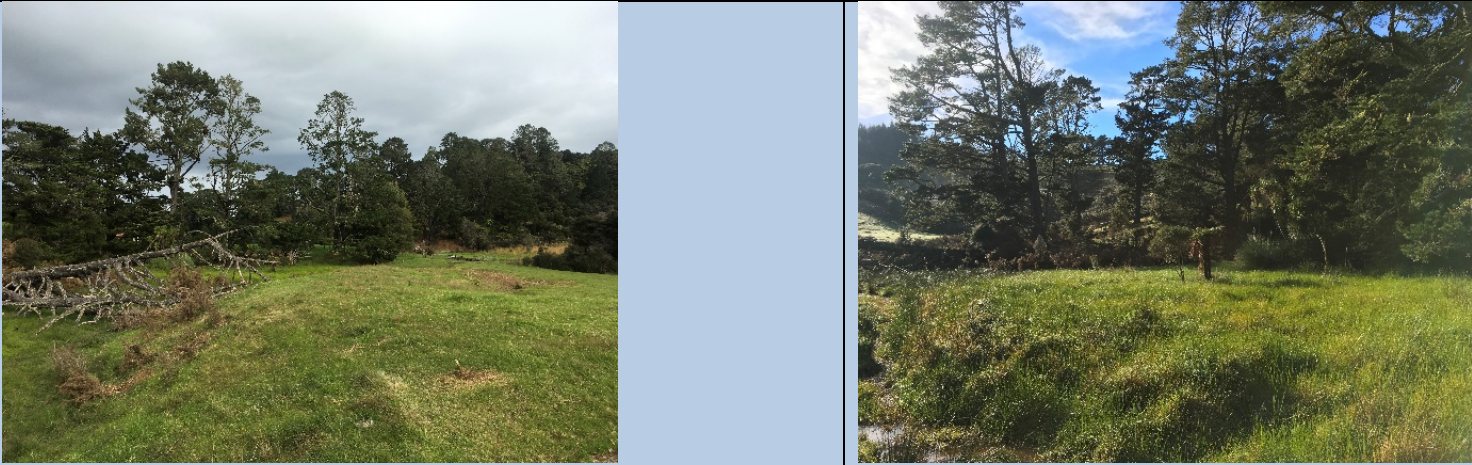
Site ID	WN_W_Koura_04
Size (ha)	0.8
Ecosystem type and vegetation description	<p>Exotic wetland (EW)</p> <p>Sits within the same valley system as wetlands WN_W_Koura_02 and WN_W_Koura_03. Like WN_W_Koura_03, it is modified by livestock grazing. Vegetation comprises marsh clubrush, swamp millet, giant rush and abundant exotic soft rush. Sparse patches of regenerating secondary scrub (mānuka, juvenile totara and kahikatea) are present around the wetland margin, interspersed with gorse that has recently been sprayed and scrubbed. Upstream the wetland grades into a 1 ha patch of “kauri, podocarp, broadleaved forest” (WF11) dominated by kahikatea and totara, with pūriri, taraire and pukatea. This remnant is outside of the proposed designation boundary.</p>

Habitat quality	Poor. Full stock access, hydrological modification and limited species diversity. With the exception of stock-related pugging, minimal hydrological modification.

Ecological value	Moderate
Rationale	<ul style="list-style-type: none"> The wetland meets rarity/distinctiveness criterion as indigenous wetlands are a LENZ IV “threatened environment” category where less than 20% indigenous vegetation remains. However, the feature is a mosaic of patches dominated by both exotic and indigenous wetland species. Both the plant community assemblage and the hydrological functionality of the wetland are degraded by stock.
Site photos

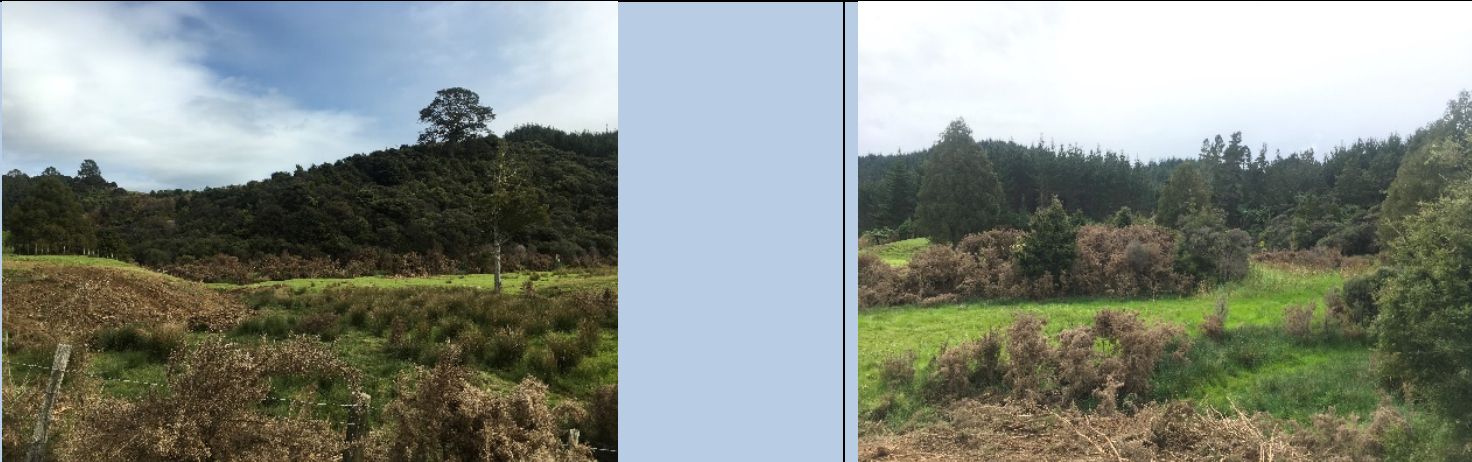
Site ID	WN_W_Koura_05
Size (ha)	0.6
Ecosystem type and vegetation description	<p>Raupo reedland (WL19)</p> <p>Sits within the same valley system as wetlands WN_W_Koura_02, WN_W_Koura_03 and WN_W_Koura_04. The feature comprises a branched raupō wetland surrounded by pines within the southern boundary of the Matariki Forest. The wetland is truncated by a drain at the southern boundary of the forest, beyond which it becomes grazed pastureland. Part of the smaller western branch of the wetland grades into WN_T_Koura_02. The remainder of the wetland remnant is surrounded by a thin strip of native riparian scrub (mā hoe, pate, mamaku, red mapou and cabbage trees, interspersed with juvenile totara and kahikatea) surrounded by plantation pines.</p>

Habitat quality	Good. Stock excluded. The upstream reach of the larger eastern branch has been modified (bisected by a forestry road and a mountain bike track).
Ecological value	High

Rationale	<ul style="list-style-type: none"> • Meets rarity/distinctiveness criterion as indigenous wetlands are a LENZ IV “threatened environment” category where less than 20% indigenous vegetation remains. • Stock have been excluded from the wetland remnant. • Drains a sub catchment afforested in plantation pines. 			
Site photos

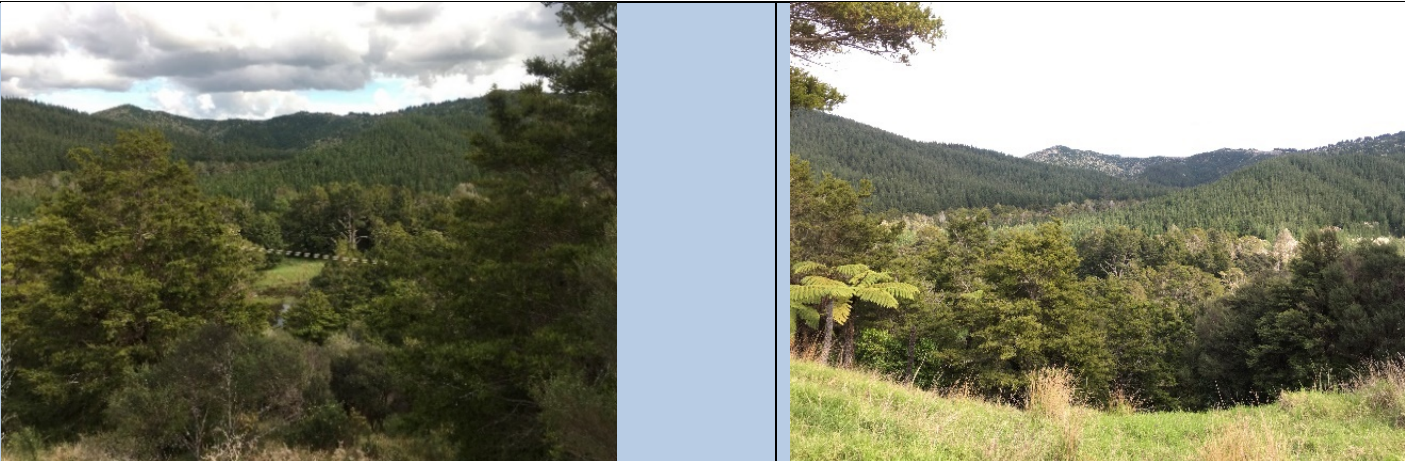
Site ID	HN_T_Hōteo_02 (SEA_T_683)
Size (ha)	11.0
Habitat type (bold) and dominant species	<p>Taraire forest</p> <p>Old growth taraire dominates the canopy along with pū riri, tī toki and pukatea. Scattered emergent trees include tō tara kahikatea and rewarewa. The regionally rare shrub kaikō mako was also recorded here.</p> <p>Riparian margin comprised largely of kā nuka, mā hoe, totara, crack willow, ribbonwood and nī kau. <i>Tradescantia</i> and rank grass dominates the groundcover along the stream margin in places where the canopy is sparse.</p> <p>The At Risk – Naturally Uncommon fern mokimoki was noted during the 2010 botanical assessments undertaken in 2011 (Bioresearches 2011).</p> <p>DOC plant records show that the At Risk – Naturally Uncommon orchid <i>Danhatchia australis</i>, which is commonly associated with taraire forest, has been identified in close proximity to the site on multiple occasions.</p>

Habitat quality	<p>Good</p> <p>Comparatively large patch of mature forest with high species diversity. The understory is largely intact although weeds are invading the margins. The stream banks are heavily scoured and lack stabilising vegetation.</p> <p>Bioresearches (2011) identified multiple <i>Amborhytida dunniiae</i> within the taraire forest comprising site HN_T_Hōteo_02. This is the location of the proposed Hōteo Viaduct (Bridge number 11).</p>

Ecological value	Very High	
Rationale	<ul style="list-style-type: none"> The site is listed as SEA_T_683 in the AUP(OP) on the basis of Threat Status and Rarity' and 'Diversity' criteria. The site rates highly for all ecological significance criteria (except 'representativeness') due to its age, natural diversity and connectivity to other important ecological sites such as the Hōteu River and Sunnybrook Scenic Reserve to the south. 	
Site photos

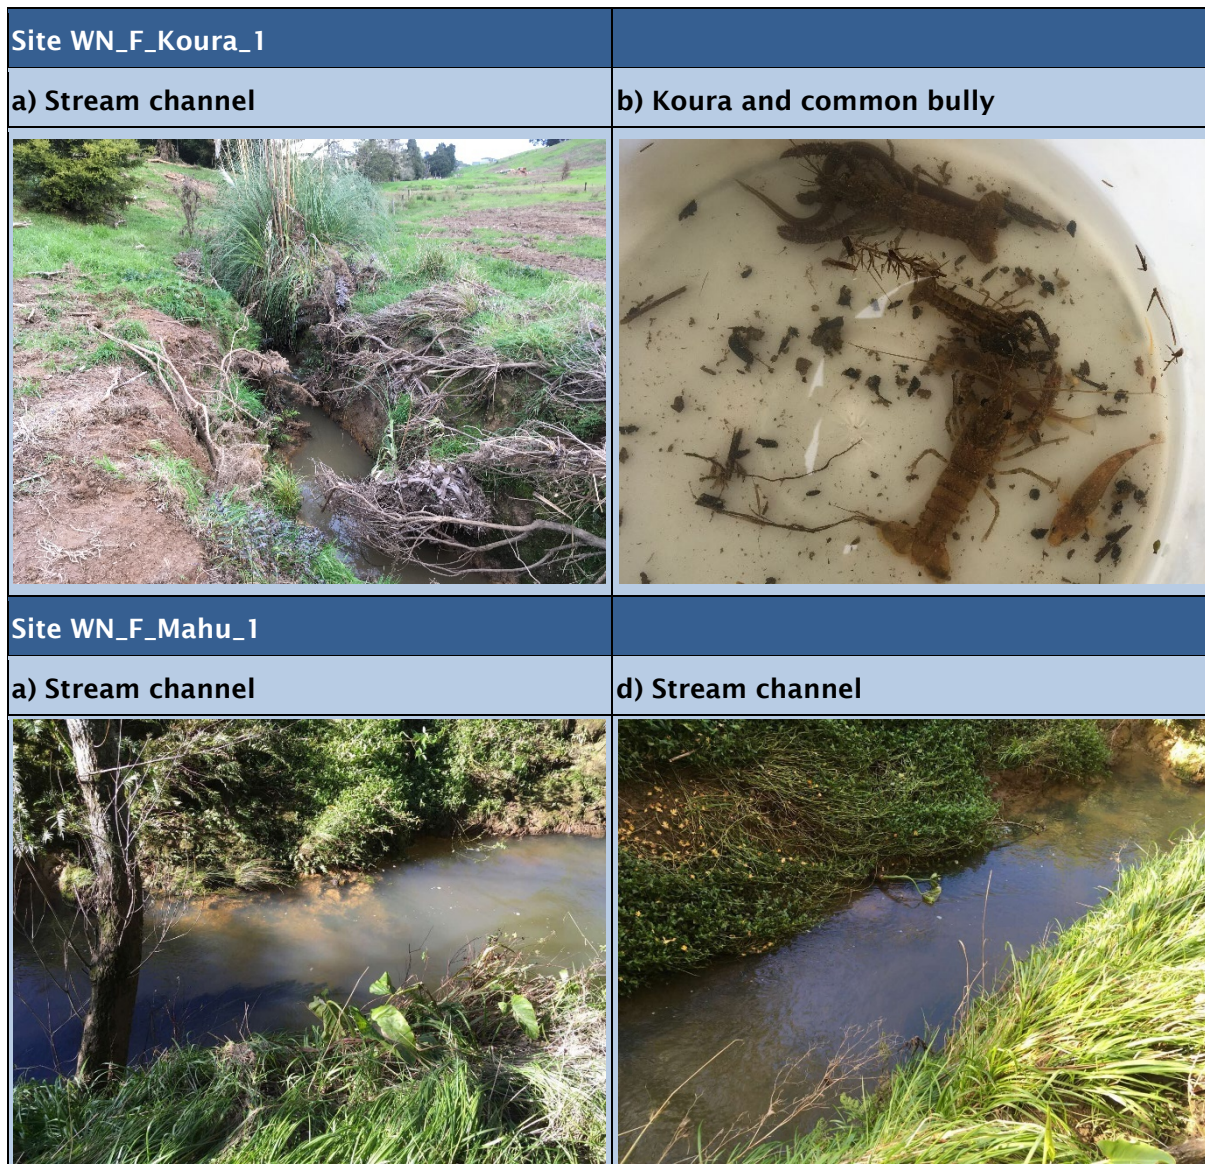
Figure 2 – Photo of survey sites within the Warkworth North Section.
