AHB Alliance
**Historic Coatings – Additional
Monitoring and Investigations
Summary Report**

November 2018

This report presents the findings of the Historic Coatings Further Investigations project (OoS133). This is the third phase of the Historic Coatings Study, which has also included the Historic Coatings Pilot Study (AHBA, March 2016), Historic Coatings Characterisation Study (AHBA, October 2018).

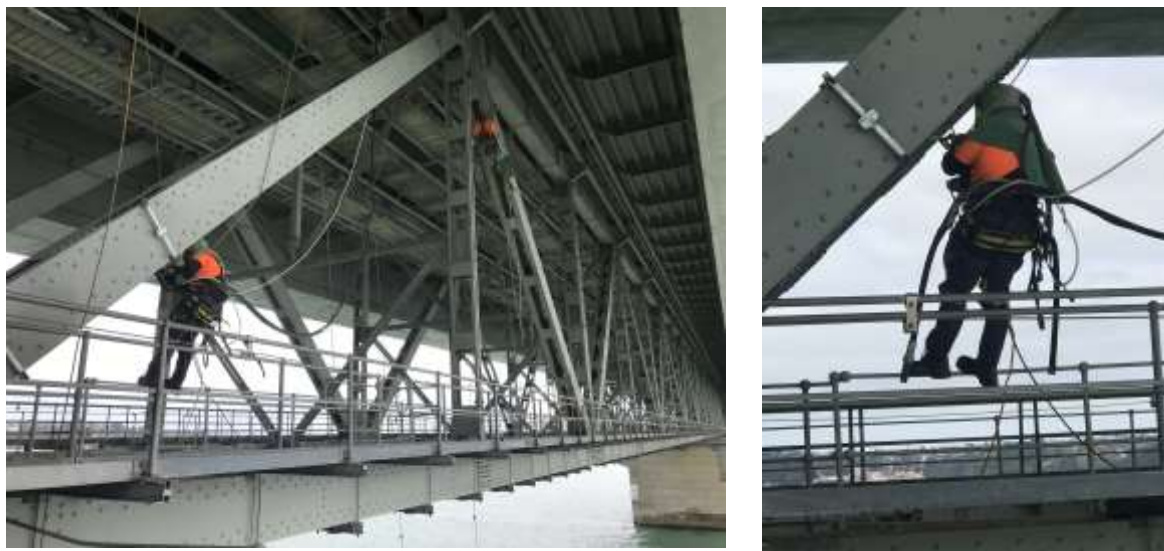
Figure 1: Location of works on the Auckland Harbour Bridge during DAB at Span 5.

On the day of sampling, dry abrasive blasting (DAB) took place at Span 5 on two diagonals either side of Post 5.3. The DAB carried out on the day of sampling was spot blasting of rusty surfaces the length of the diagonal including inside the structure where needed.

The pot was loaded from the upper platform and the two abrasive operators dropped into the work position on the diagonals. The complete length of each diagonal was blasted. There was restricted access from the blasting area to the pot filling area. Eighteen 15kg bags of garnet were used for the blasting on the day of testing. Spot blasting took place over 4 hours.

Fig 1.1 and 1.2 Abrasive Blaster operators spot blasting on diagonals on each side of post 5.3 on eastern side of bridge

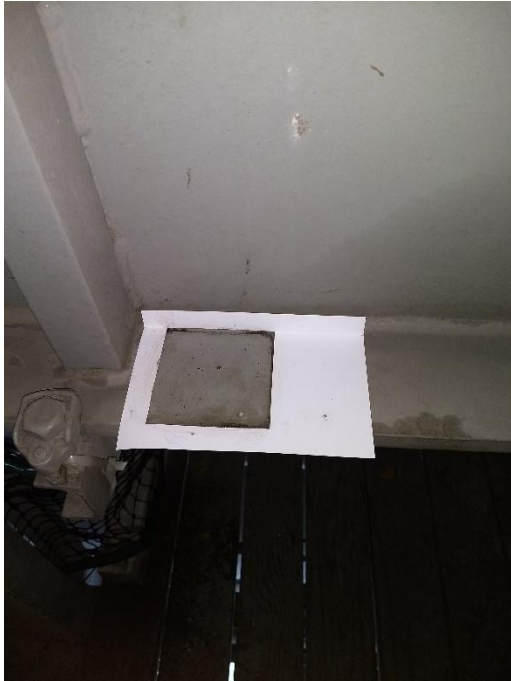
Southern smoko hut

Levels of total chromium and lead detected in the bungy pod were significantly lower than the results from the other areas. The dust in the southern smoko hut had the highest concentrations of lead and total chromium.

The other areas tested (smoko huts and central walkway) contained lead in dust at levels that exceeded the adopted guidelines, and total chromium at much higher levels than those found in the bungy pod. This indicates that dust is building up in these areas following abrasive blasting.

Due to the potential health hazard of the sampled compounds good hygiene practices should be reinforced to ensure that dust concentrations are kept to a minimum on surfaces in work and break areas. A reduction in dust concentrations on surfaces will in turn decrease the risk of exposure via ingestion or inhalation.

Exceedances have been observed for Lead as outlined in Section 4. Due to the potential health hazard of this compound good hygiene practices should be reinforced to ensure that dust concentrations are kept to a minimum on surfaces in work and break areas. A reduction in dust concentrations on surfaces will in turn decrease the risk of exposure via ingestion or inhalation.
