AHB Alliance
Historic Coatings Study
Pilot
June 2016

AUCKLAND HARBOUR BRIDGE ALLIANCE DRY ABRASIVE BLASTING EMISSIONS

AIR MATTERS REPORT 16026

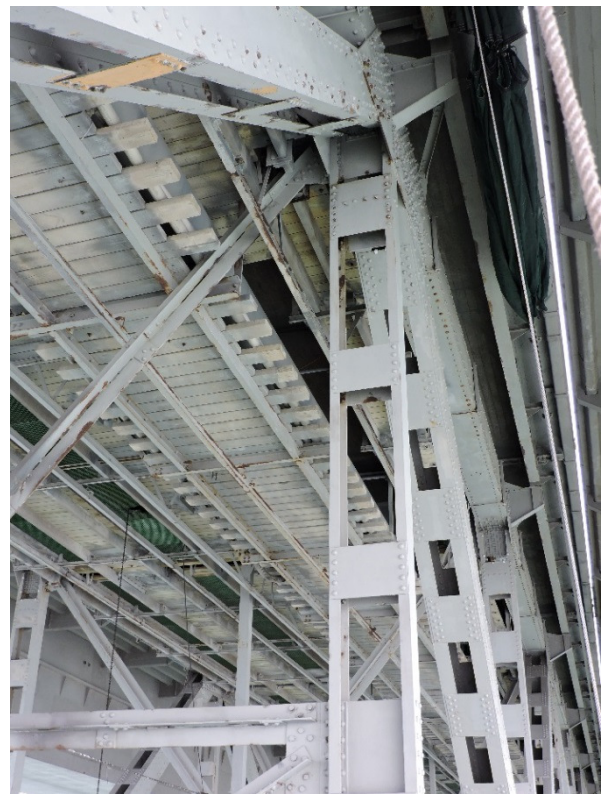
Photo 1: Sampling site

The pilot site post was in average condition, with some rust and general dirt. It was considered to be generally representative of elements that might be scheduled to have this type of maintenance carried out.

The pilot site was selected as Post 10 located in Span 7.

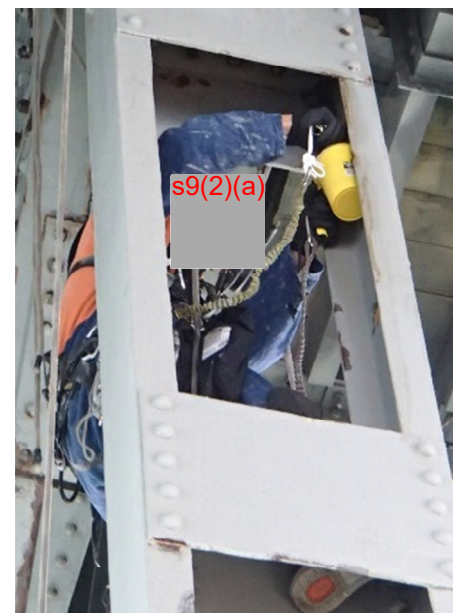
Photo 2: Paint sampling

Eight paint samples in total were collected. Four samples were collected prior to water blasting (labelled Sample A) and four samples were collected directly next to the first four samples after water blasting had finished (labelled Sample B). Each sample was collected from an area of approximately 10cm², which was scraped back to bare steel using a linbide scraper; the samples were collected in a zip-lock bag for analysis. Due to access difficulties, the paint samples were collected by the maintenance crew enlisted to undertake the abrasive blasting.

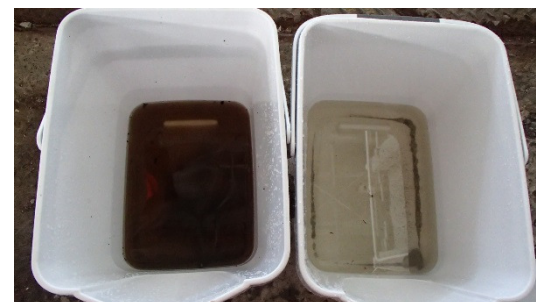
Photo 3: Initial Sample (IS) on the left, End Sample (ES) on the right

IS: Dark, no odour, very murky. ES: clear, no odour, some sediment + paint flake.
See sediments

All metals decreased in concentration in the end sample compared with the initial sample, with the exception of hexavalent chromium which was not found in the Initial Sample, but was present in the End Sample at 0.033 ppm (parts per million). The contaminants that were found at the highest concentrations in the washwater were zinc, chromium, lead, and copper.

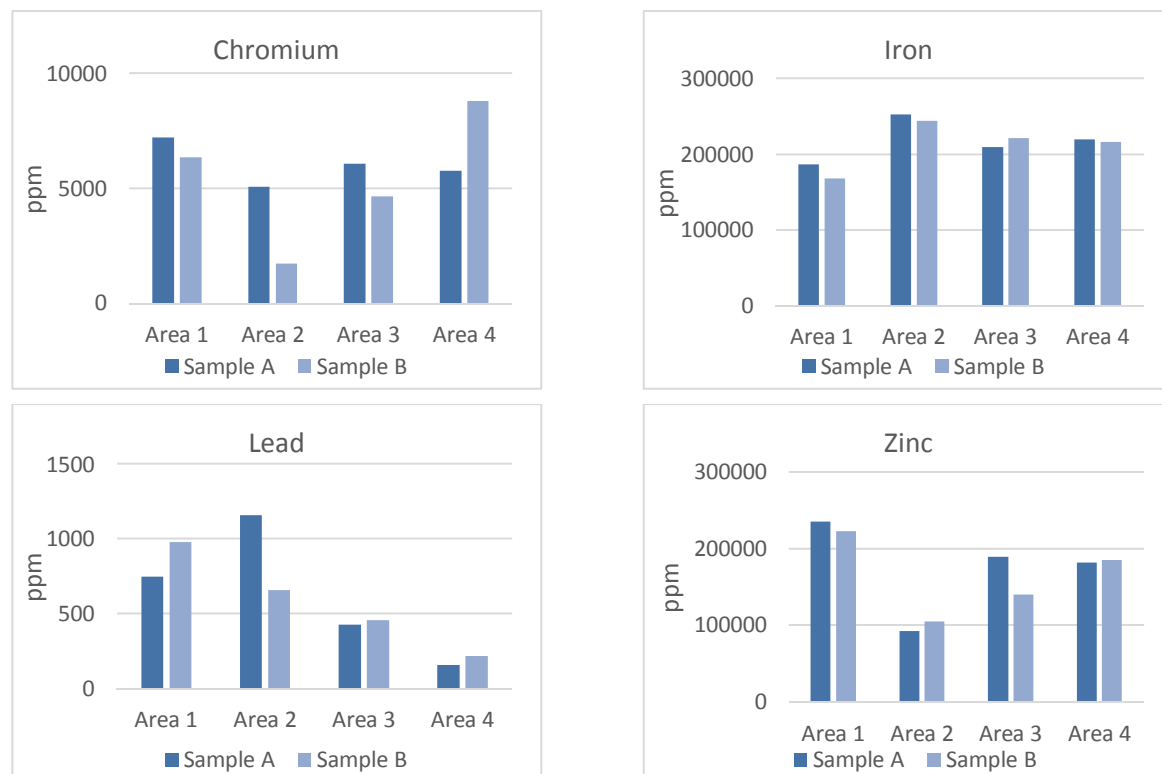
Charts 1a-d: Paint Sample results for key elements

The results for Sample A and Sample B were generally similar for each area. There did not appear to be a relationship between the level of an element detected and whether or not the area has been waterblasted prior to sample collection. Level of iron was relatively consistent across the samples (coefficient of variation (CoV) 13%), the level of lead varied much more significantly (CoV 59%), and variation of chromium and zinc was in between (CoV 36% and 31% respectively).

Presence of lead appeared to be relatively variable across the post. This may be due to previous maintenance works having removed or reduced lead-containing paints in some areas, or due to varying lead contamination in non-lead-based paints that have been used for touch-ups over the years. A consequence of this is that when lead testing is carried out prior to abrasive blasting (to confirm no lead-based paint layer >5000ppm), the sampling density may need to be reviewed, to ensure that the area to be blasted has been characterised sufficiently.

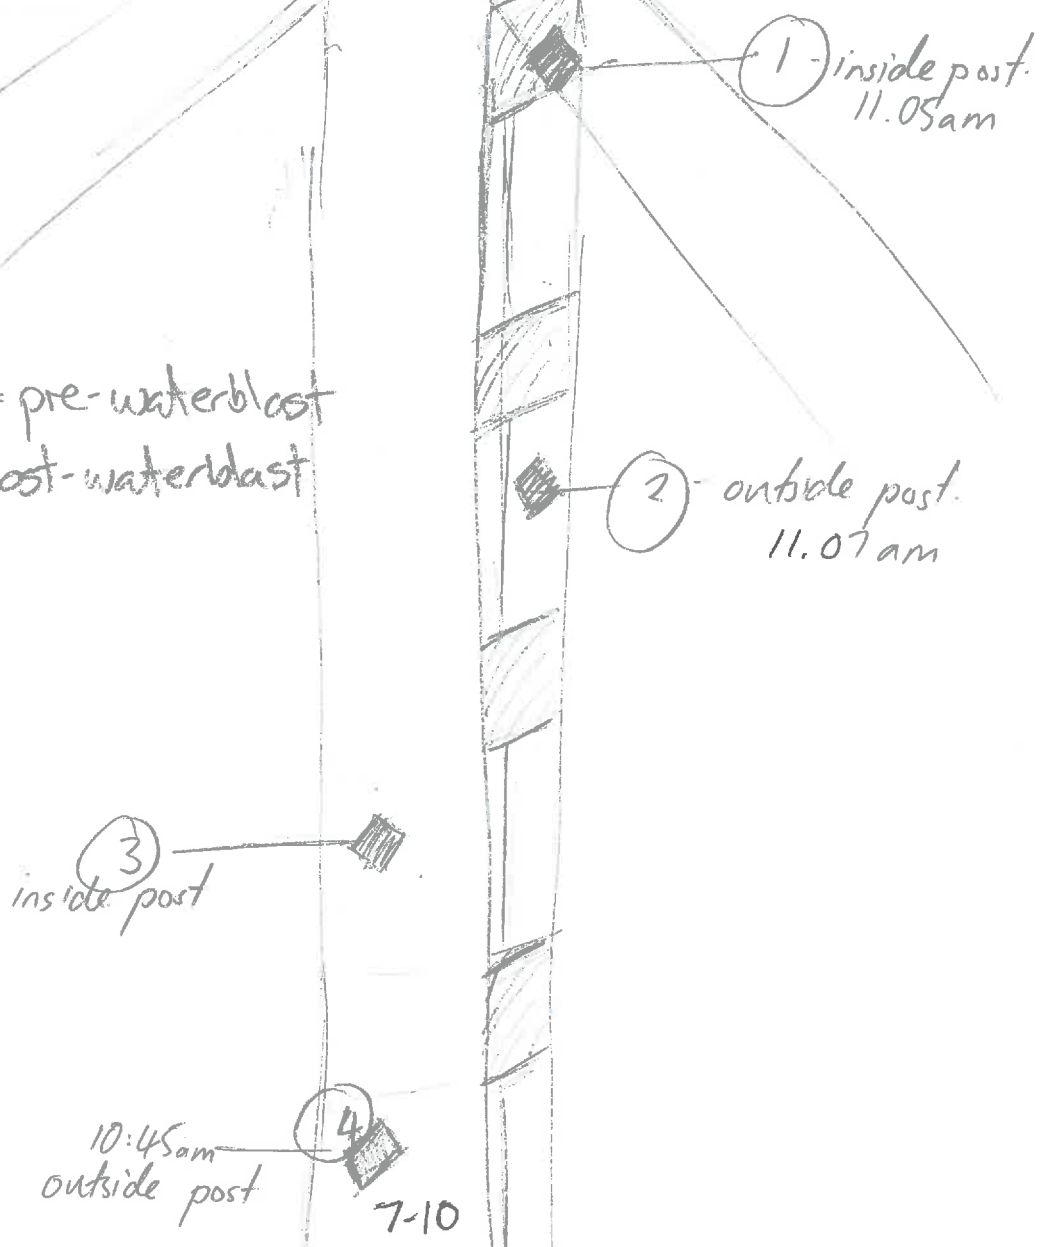
Sample locations
- paint scrapings

Sample A = pre-waterblast
Sample B = post-waterblast

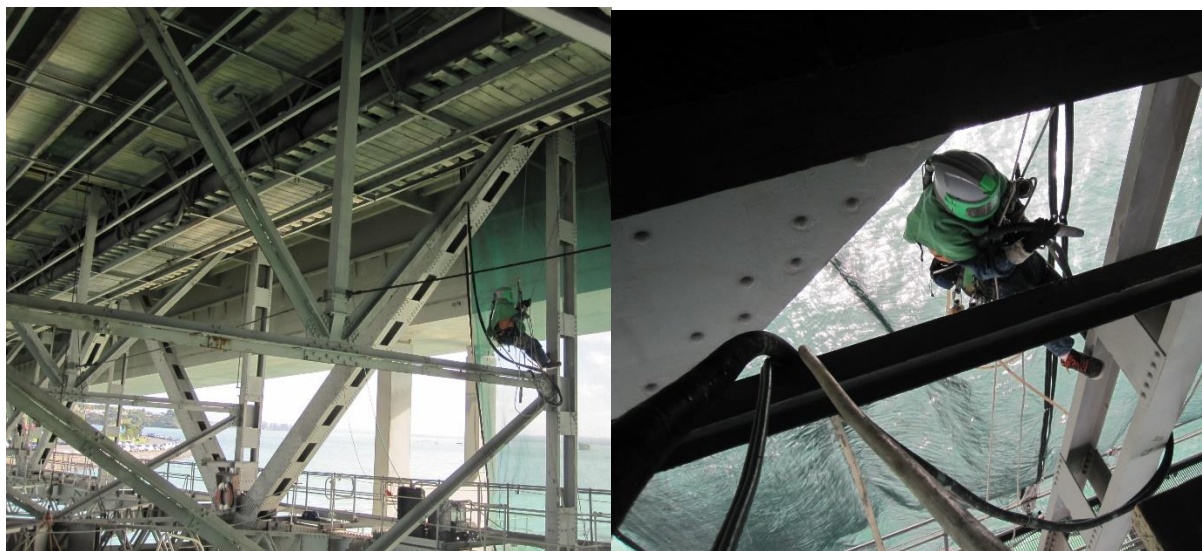
Fig 1.1 and 1.2 Abrasive Blaster operator spot blasting on vertical steel structure

The pot was loaded from the upper platform and the abrasive operator dropped into the work position on the diagonal. There was restricted access from the blasting area to the pot filling area. Two 20kg bags of garnet were used for the blasting on the day of testing. Spot blasting took place over 2.75 hours.

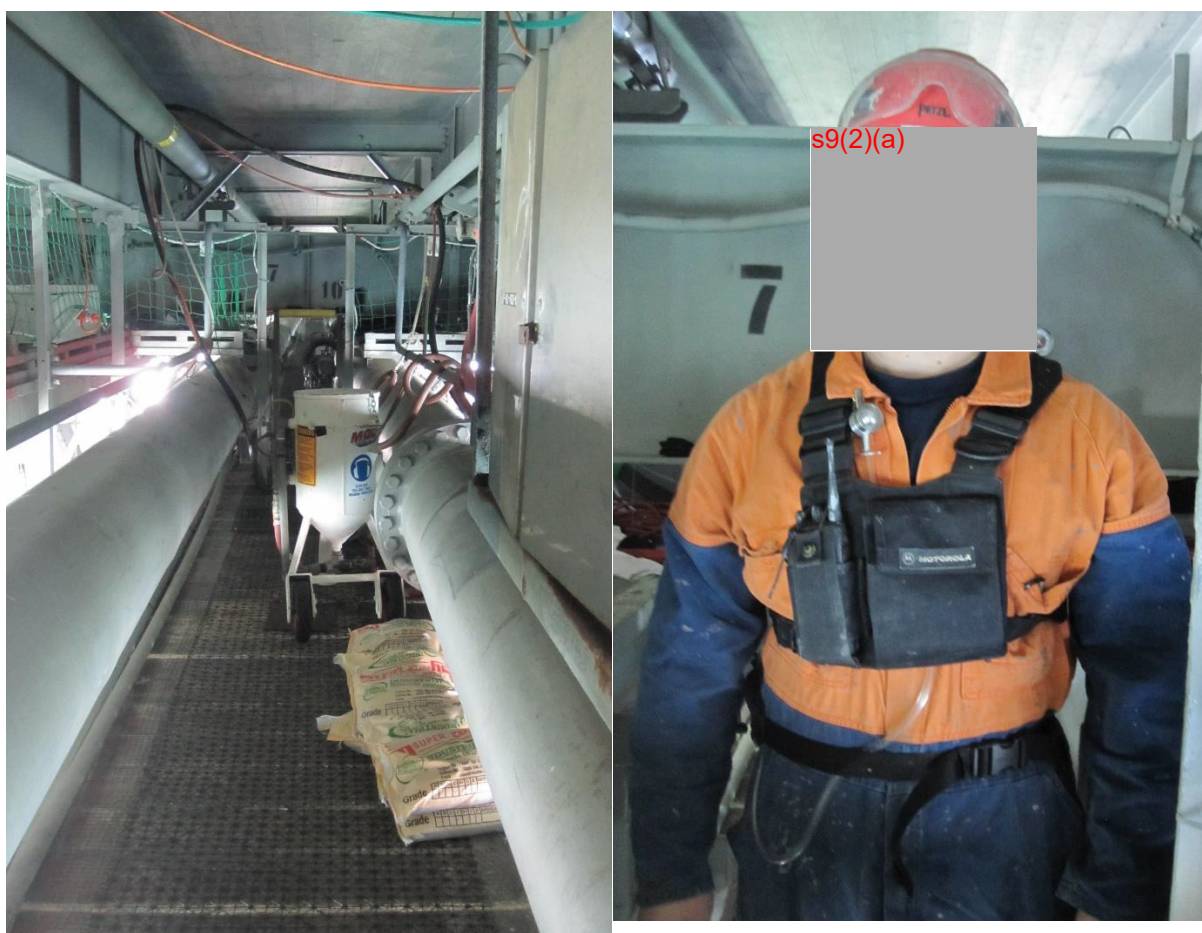
Fig 1.3: Location of the blasting pot and garnet on the upper walkway (location 7.10)

Fig 1.4: Pot person on upper platform wearing dust/metal sampler

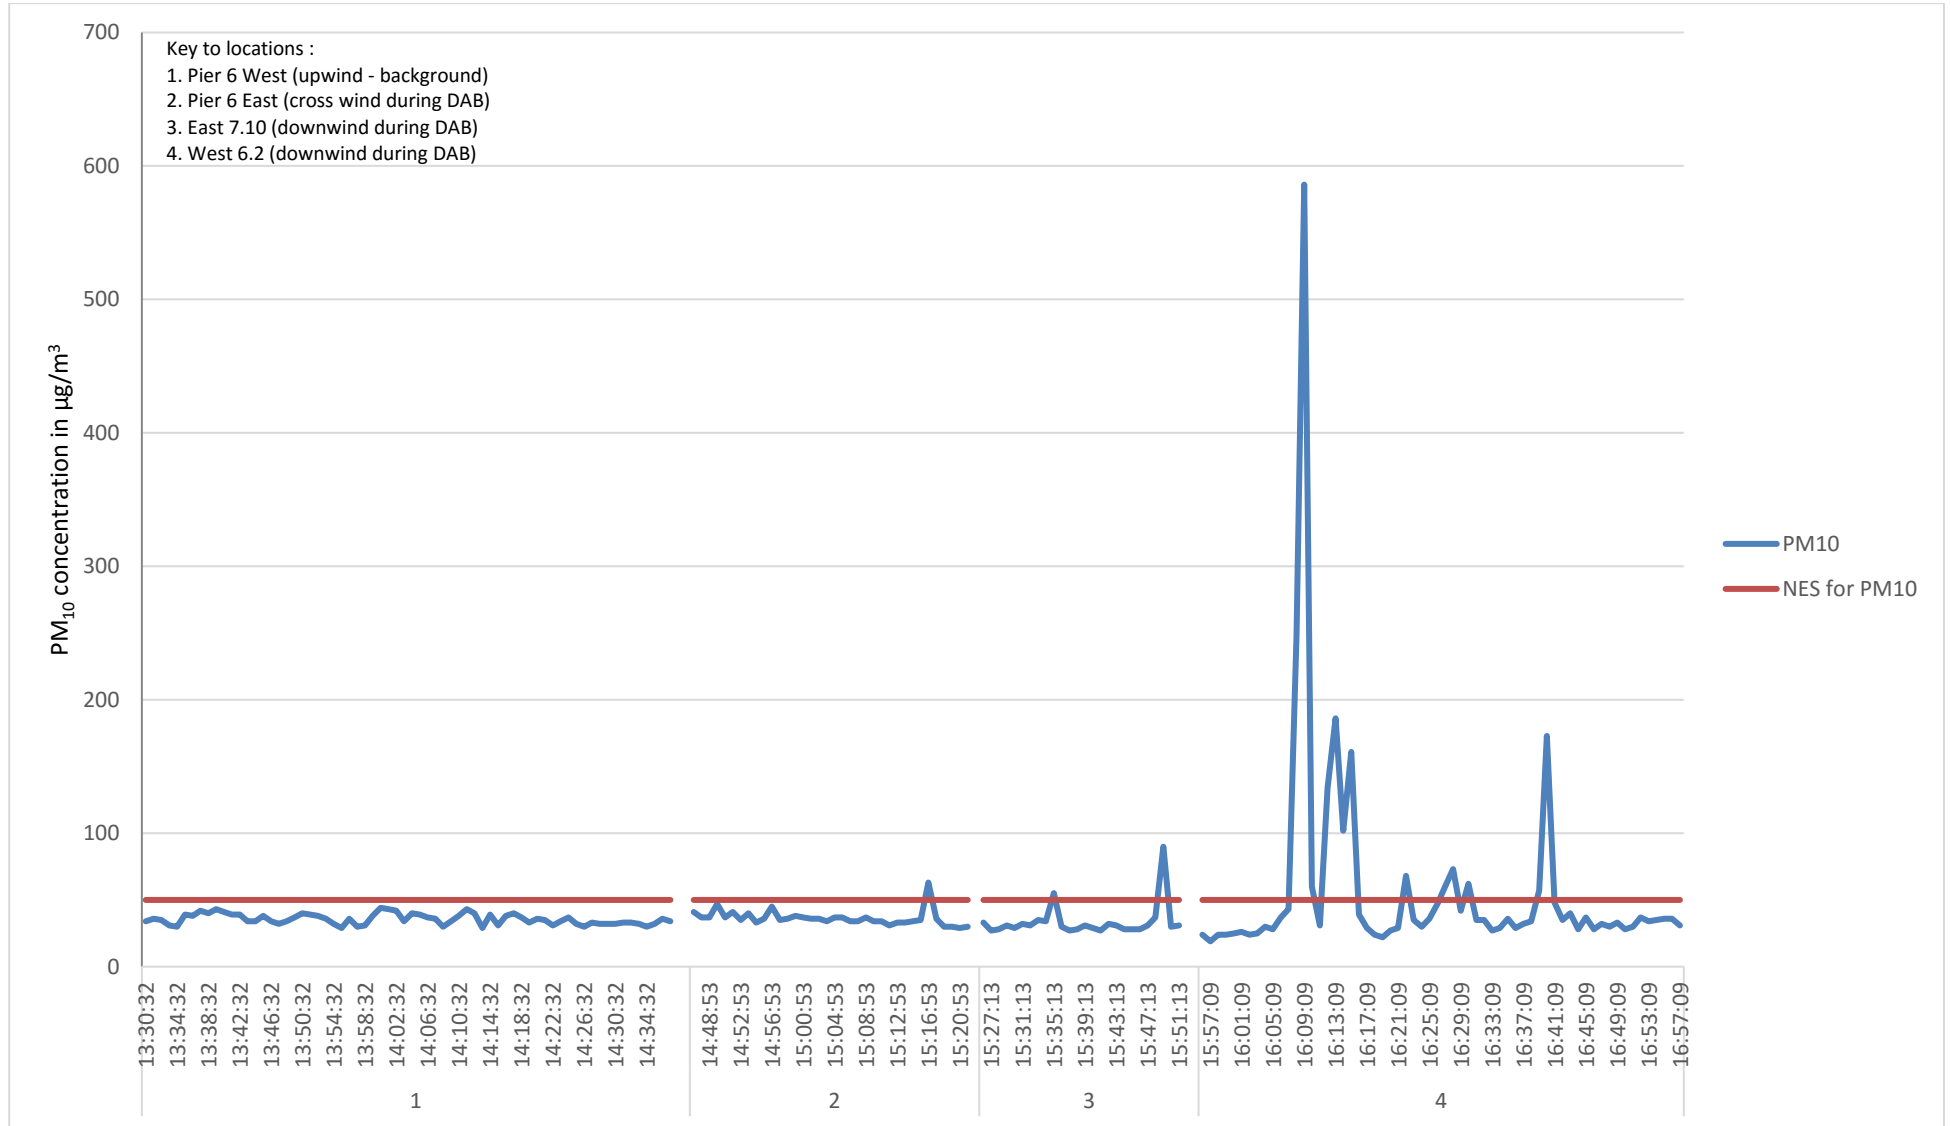
Chart 1: PM₁₀ concentrations (1 minute average) at various locations during dry abrasive blasting compared against the 24 hr NES for PM₁₀

Real-time samples for PM₁₀ indicated that the level was above the environmental standard of 50µm/m³ when the monitor was within 15 metres of the blasting. This is a 24 hour average and as the actual blasting is short term, would not have exceeded the standard on this day of work.
