Northern Corridor Improvements

Assessment of Archaeological Effects

Project No: 250310
Document Ref:
NCI-3PRE-2ENV-RPT-0019
Revision: 3

2 December 2016

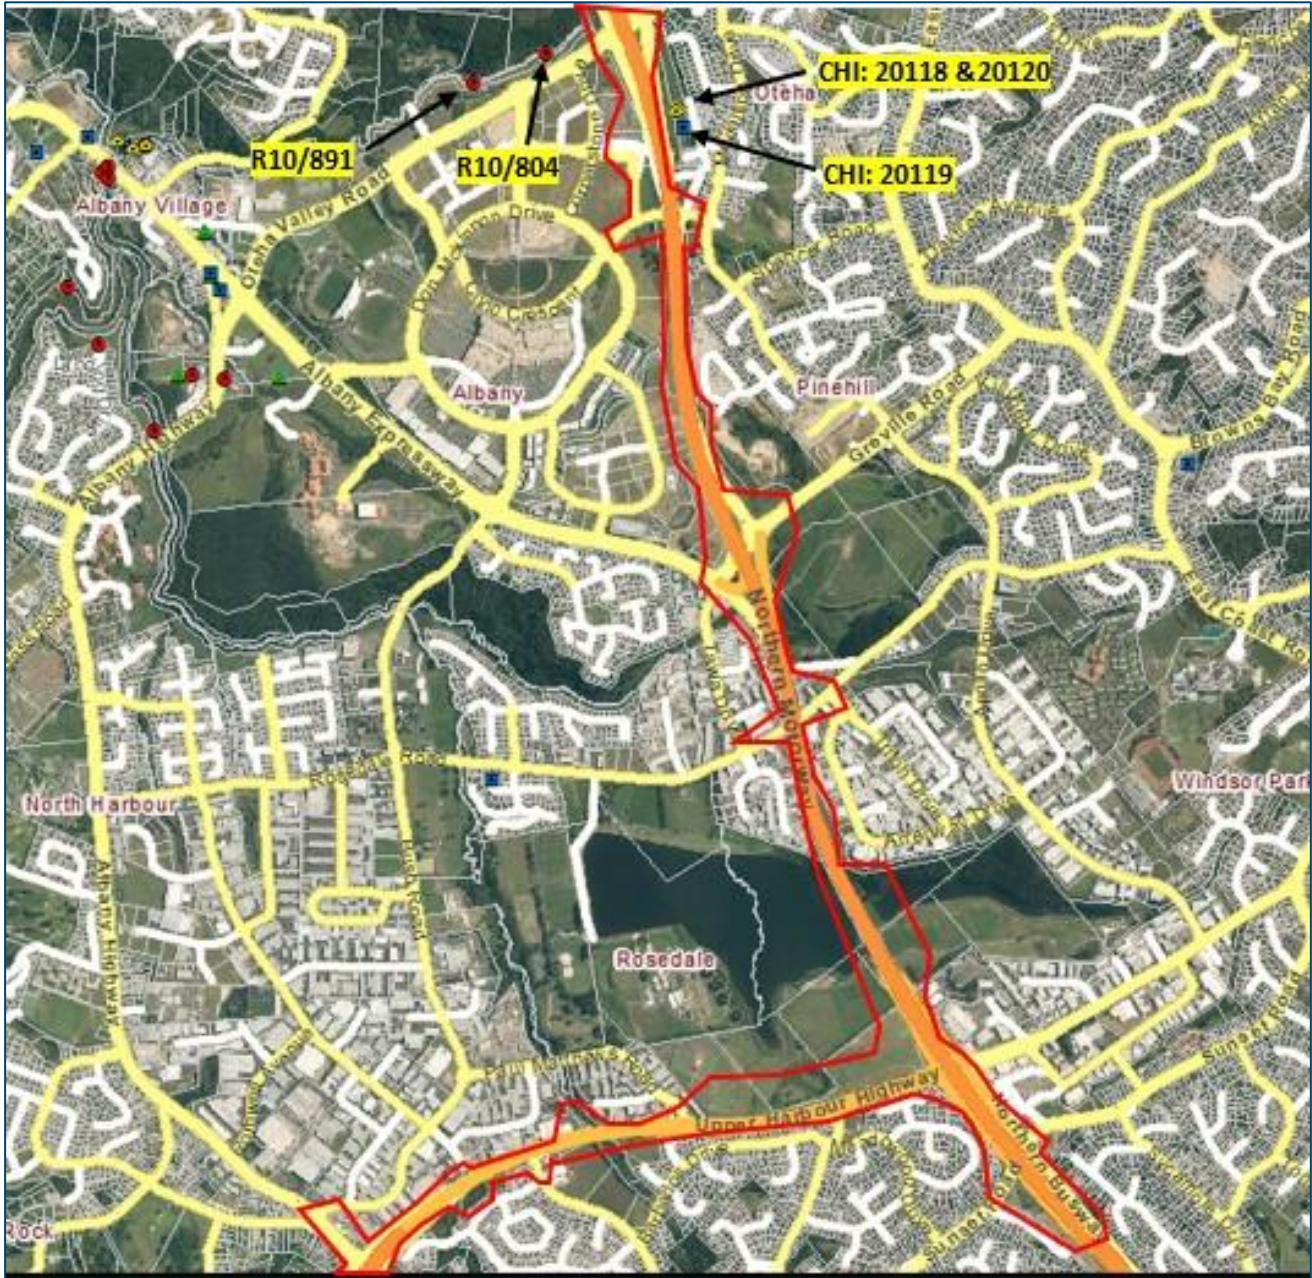
Figure 2 Locations of historic heritage sites in the general area of the Project

Note - Shows the majority of historic heritage sites are in close proximity to waterways. Sites within 500m of the assessment area (outlined in red) have been labelled.

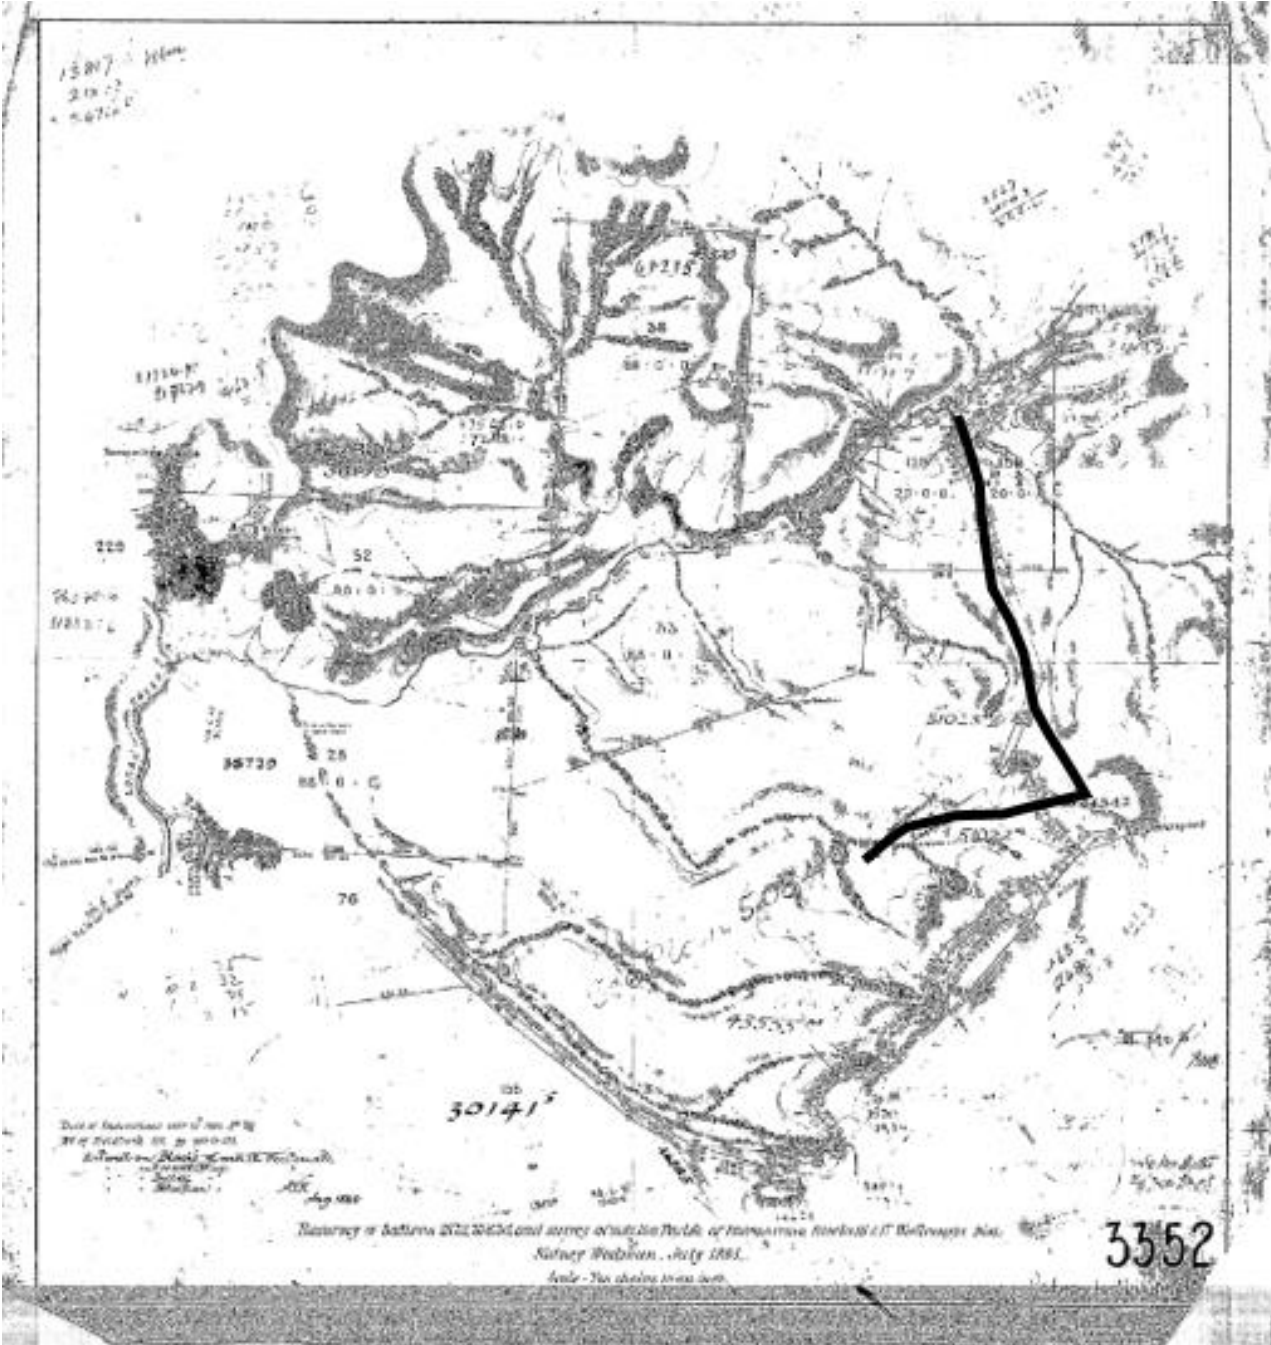
Figure 4 AK SO 3352 I from 1884

Note - Approximate location of the Project motorway sections marked in black

The Project area reflects the developmental history of the district in general. This can be seen in a plan from 1884 (**Figure 4**) showing the upper reaches of Lucas Creek to the north and open country with small waterways which had changed to agricultural properties by 1913 as shown in a plan of that date (**Figure 5**). The area continued to be rural in nature until relatively recently, with little development apart from the construction of the wastewater treatment facilities at Rosedale in the late 1950s and more recently motorway construction in the late 1990s.

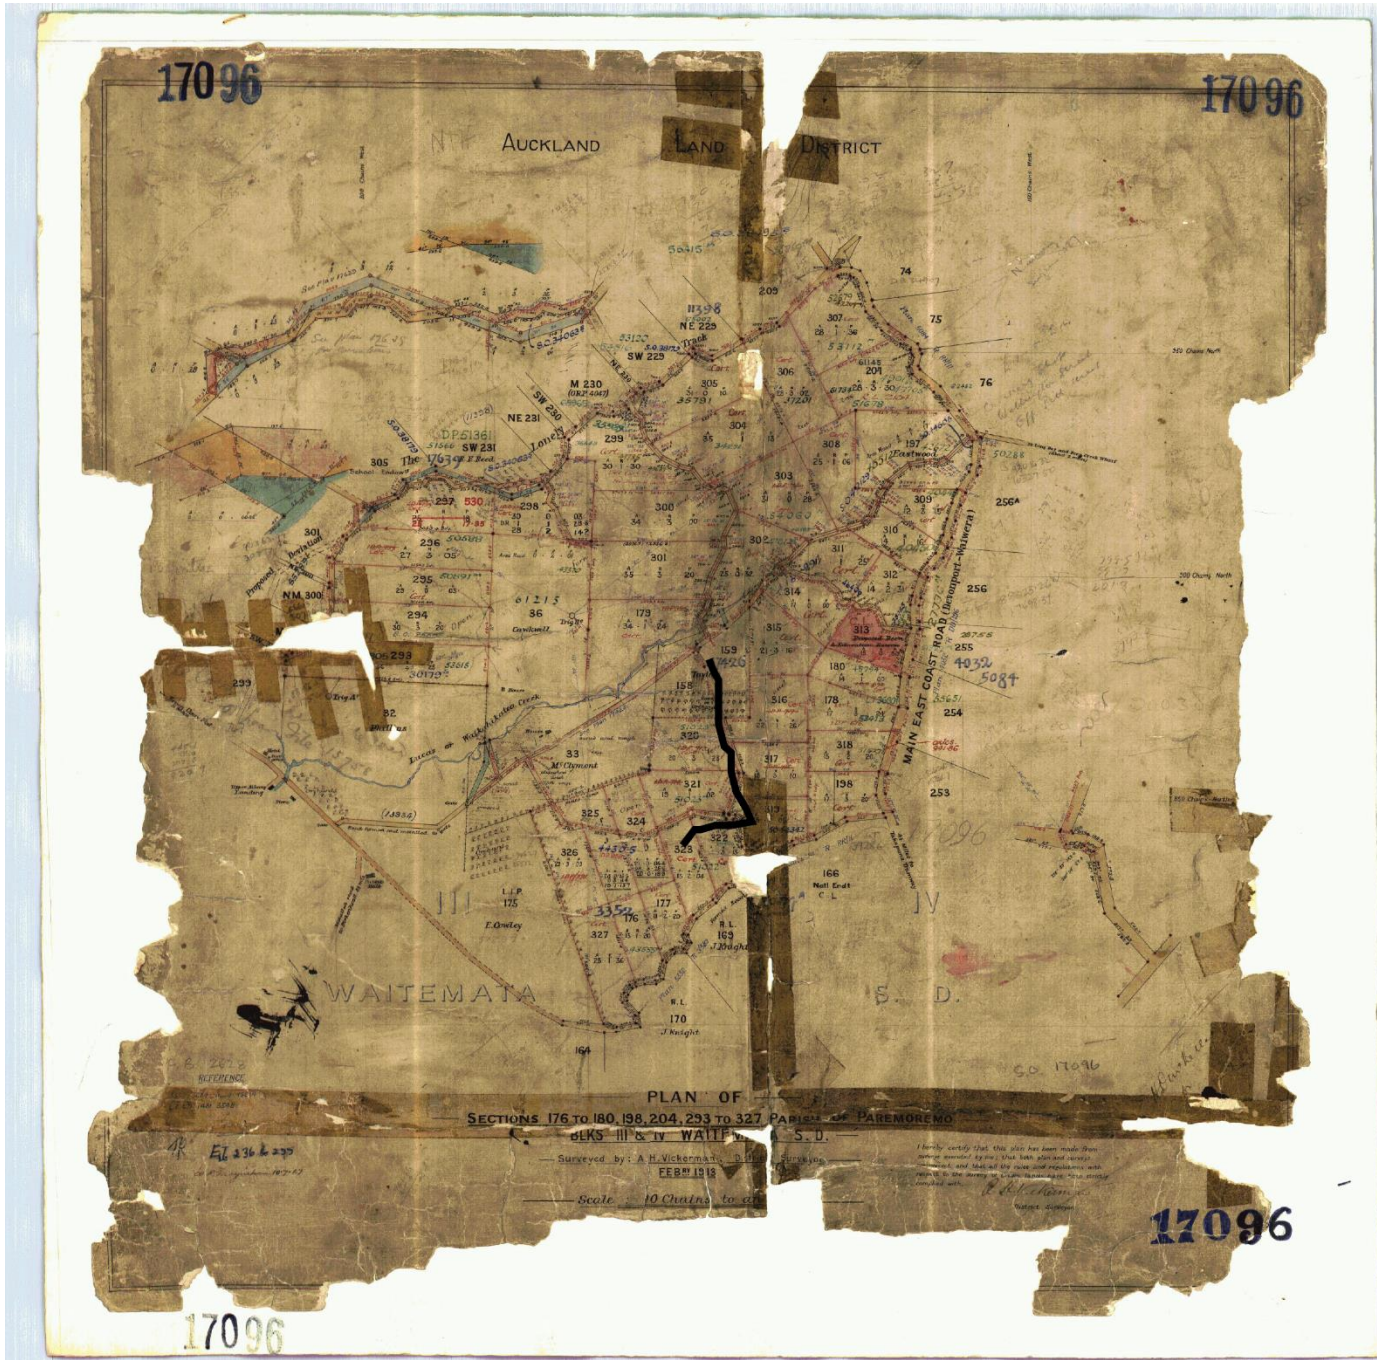
Figure 5 AKC SO 17096 I from 1913 with the division of lots showing orchards, cropping and pasture usage

Note - Approximate location of the Project motorway sections marked in black

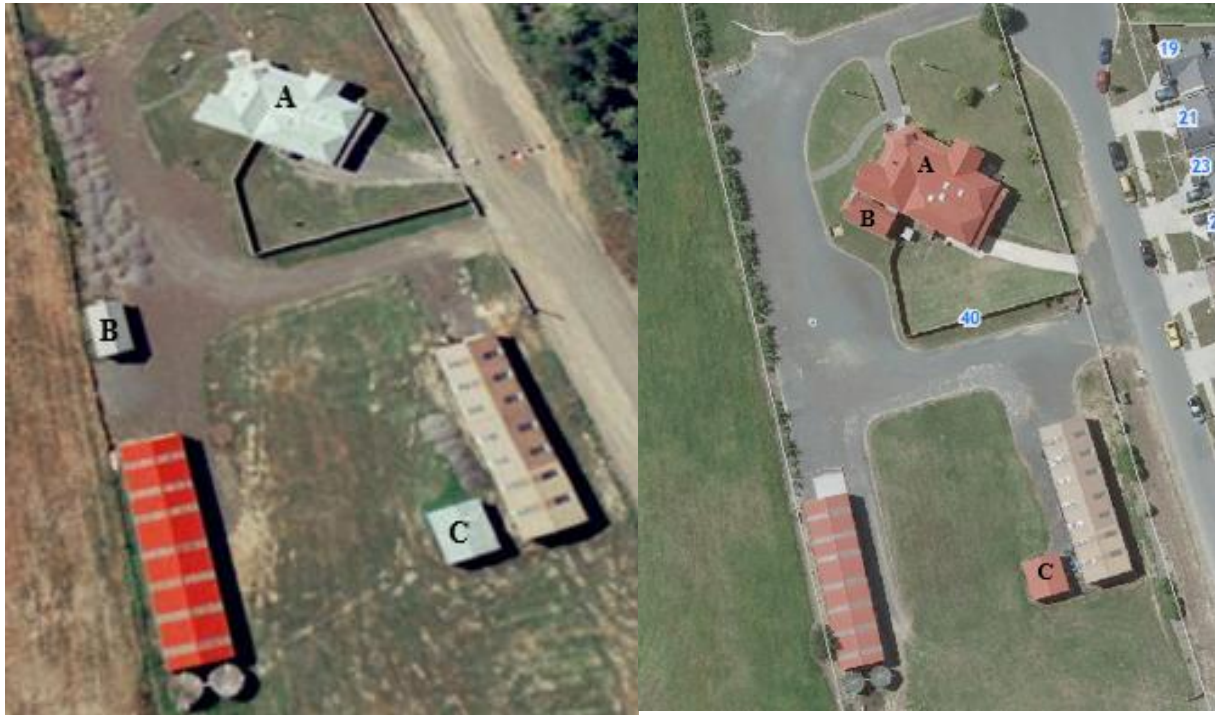
Figure 12 Aerial photographs of the three historic buildings at 40 Masons Road from 2000 (left) and 2010 (right)

Note - A: Historic Villa, B: Takapuna Jailhouse (Former) and C: Takapuna Police Station (Former).

The buildings at Masons Road were still in place in 1997, as can be seen in the aerial photograph in **Figure 11** which also shows buildings located at 157 Oteha Valley Road. By 2000, however, the house and farm buildings were gone and had been replaced by the vintage car club's three historic buildings that are still located on the site (**Figure 12**).

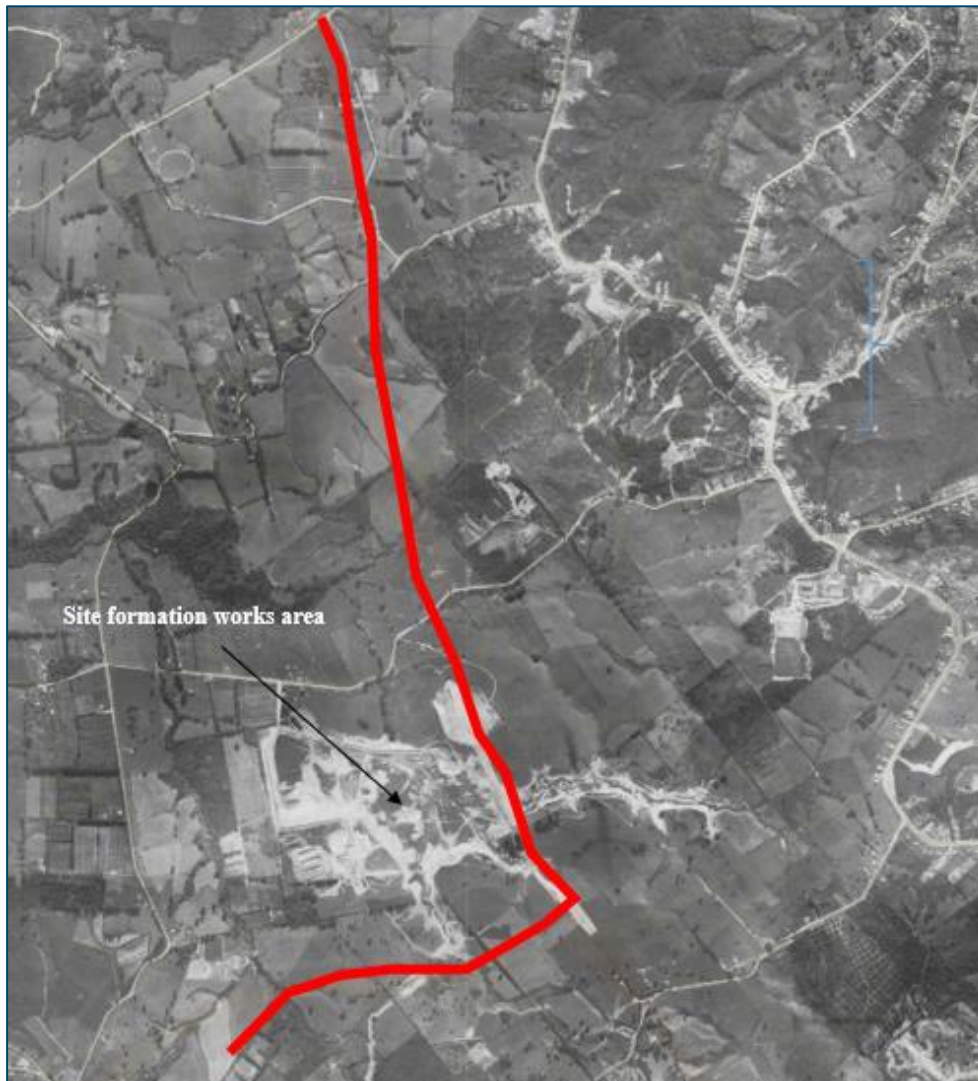
Figure 14 Aerial photograph from 1959 showing formation works for the Rosedale Wastewater Treatment Plant

Note - Approximate location of the Project motorway sections marked in red

There are two major existing impacts in the Project area, namely the motorways themselves (SH1 and SH18) and the RWWTP and treatment ponds, which opened in 1962 (construction works in 1959 can be seen in **Figure 14**). As noted earlier in this report, the Project area was predominantly rural in nature prior to motorway construction. The improved transportation corridors and the associated expansion transformed the previously agricultural landscape into one characterised by residential developments, community facilities and commercial/light industrial sites (the aerial photograph in **Figure 15** from 2000 shows built-up areas as well as site formation for projects ongoing at that time). Thus, it can generally be stated that previous developments have caused major impacts to the landscape that would have most likely destroyed any archaeological deposits or features that may have been present in many parts of the Project area.

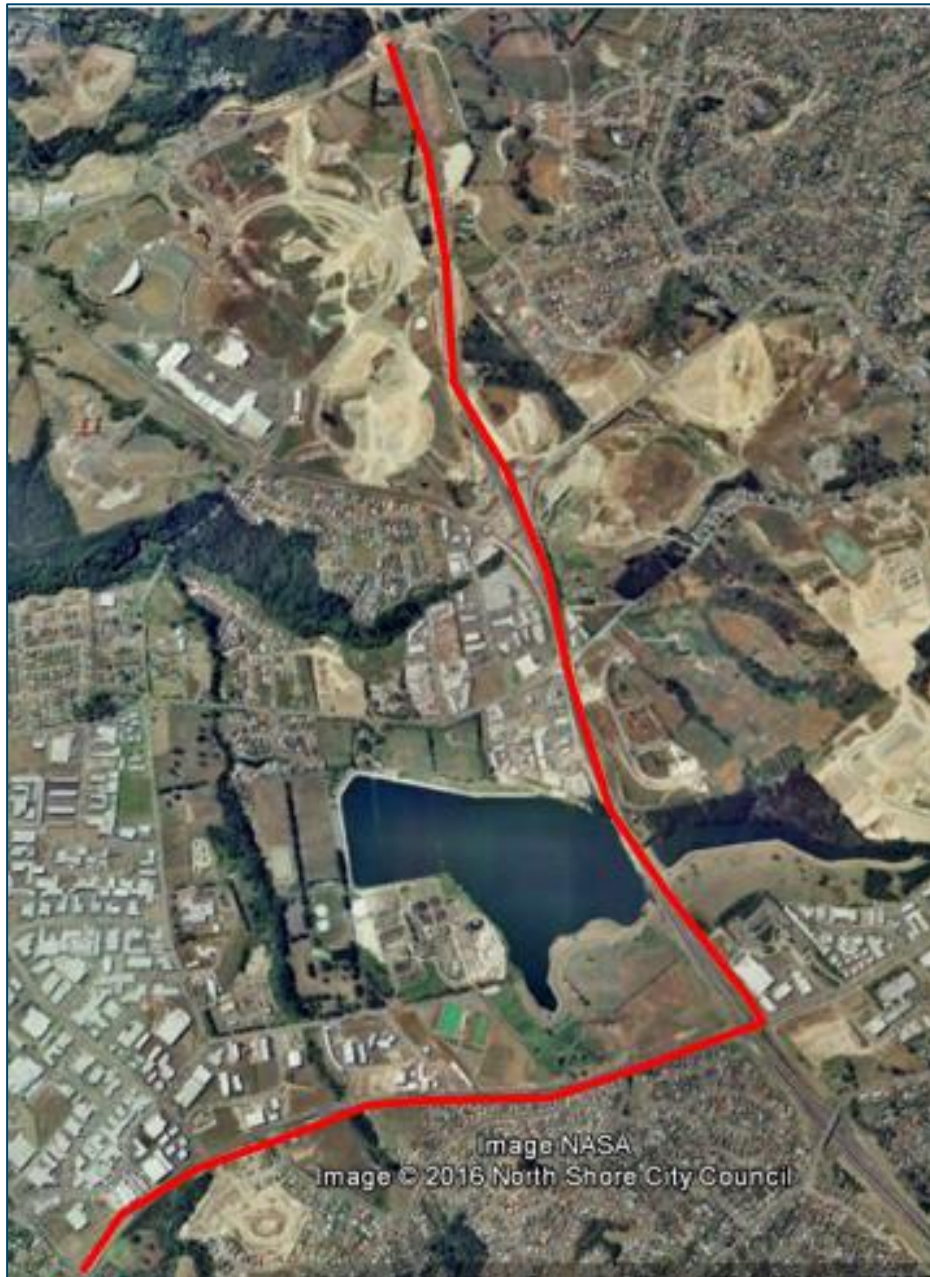
Figure 15 Aerial photograph from 2000 showing completed and ongoing development

Note - Approximate location of the Project motorway sections marked in red

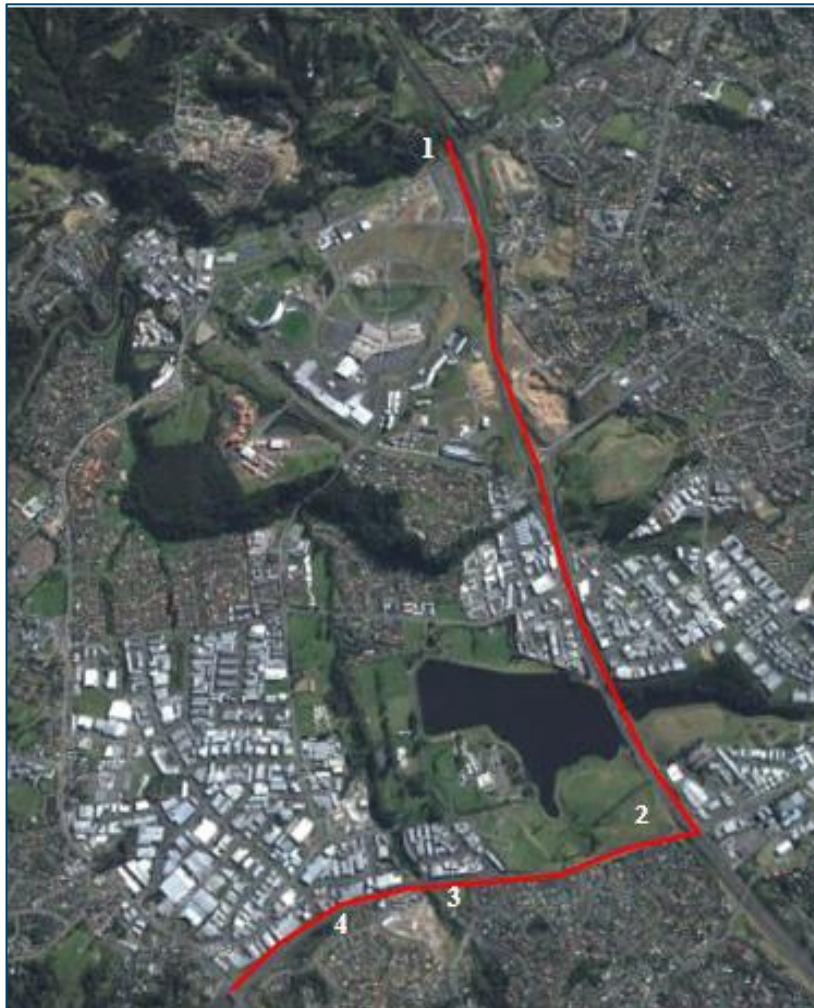
Figure 16 Aerial photograph from 2015 of Project area

Legend	
1:	Northern tip of the assessment area near Lucas Creek
2:	Eastern part of the Constellation Reserve
3:	The Rook Reserve
4:	The Bluebird Reserve

Note - Approximate location of the Project motorway sections marked in red

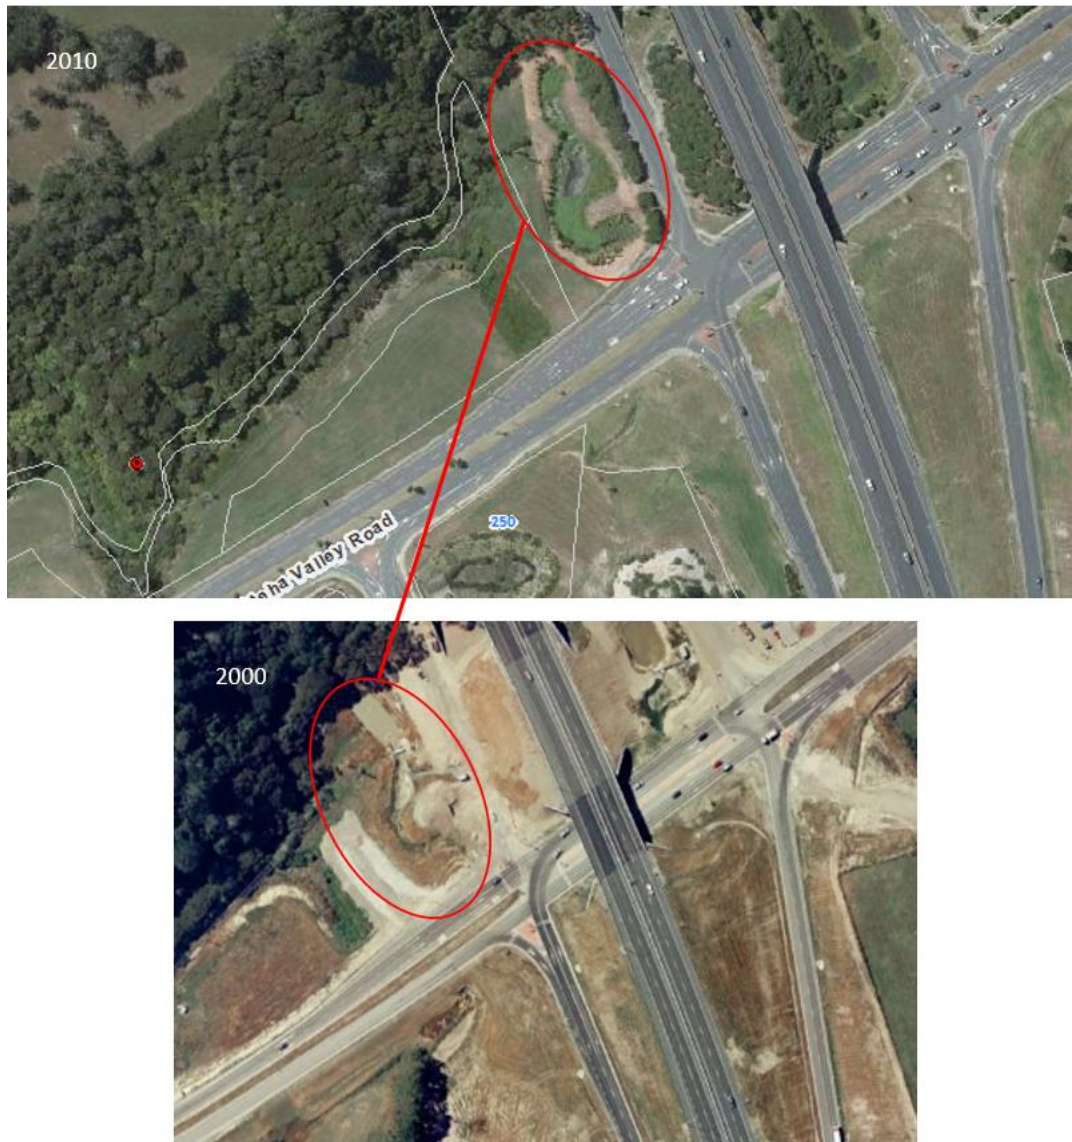
Figure 18 Aerial photographs of potential archaeological interest at Oteha Valley Road near Lucas Creek

Note – Area 1 indicated in red in the upper aerial photograph. Bottom left: aerial photograph from 2000 showing previous impacts to Area 1

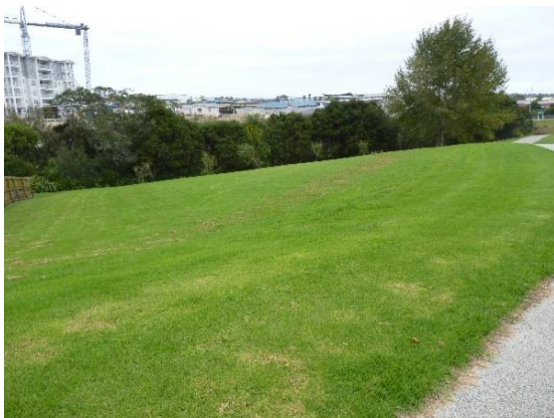
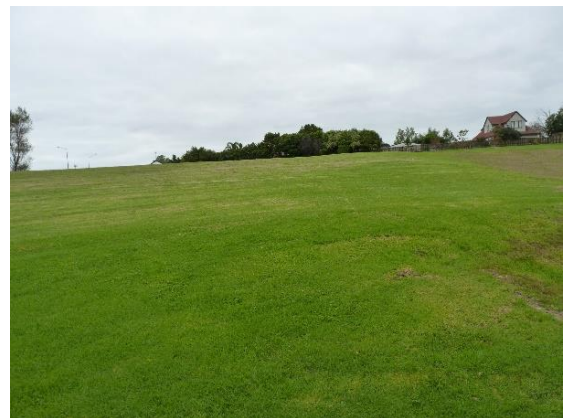
Figure 25 Views of Rook Reserve: western side looking north and the hill slope on the eastern side of the reserve (looking east)

The Rook Reserve (**Figure 25** and **Figure 26**) is located on a hill slope extending into a wooded gully with a footpath constructed along the western side and leading down into the gully itself. There are also modified areas along the footpath that have been levelled and covered in concrete for installation of exercise equipment. A wetland is proposed to be located within the reserve. The site was grass covered with a few trees present. No evidence of archaeological features or deposits were identified during the site visit.

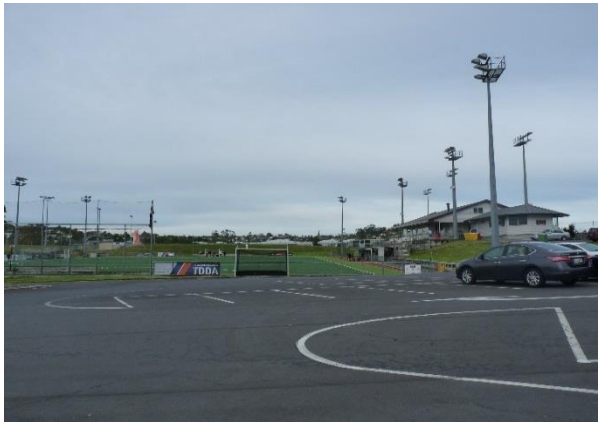
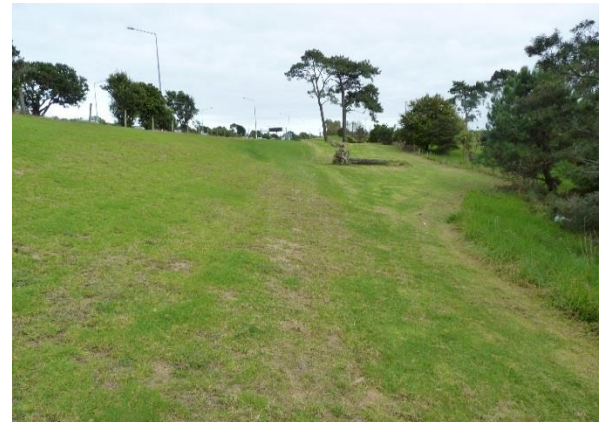
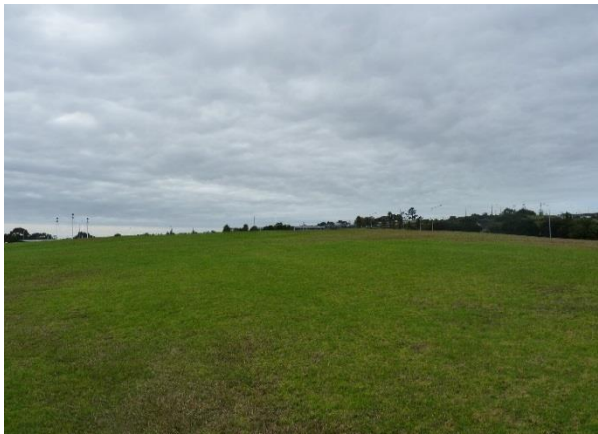
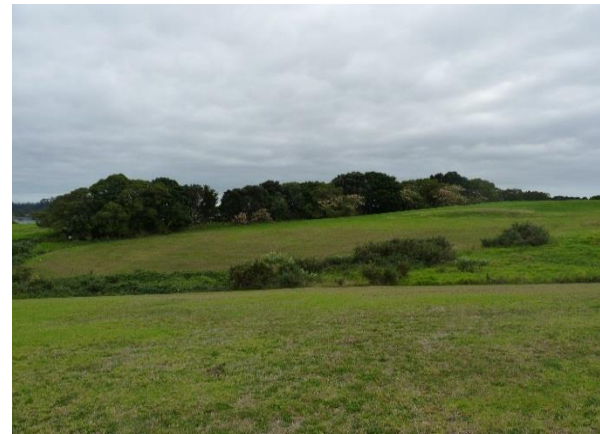
Figure 27 Views of Constellation Reserve: sports grounds; the section linking the east and west parts of the reserve (looking west); eastern part of the reserve (looking east); the eastern part of reserve with a stand of trees at its northern border (looking northeast)

As noted earlier, the western part of the reserve has been developed for use as sporting grounds (**Figure 27**). The eastern section is grass covered and set on hilly terrain rising to the northeast. In the north it is separated from the wastewater plant grounds by a stand of mature trees (**Figure 27**). The reserve is bordered on the south by the Upper Harbour Highway and the eastern and western parts of the reserve are joined together by a strip of steeply sloped land running between the highway and an above ground section of a concrete pipeline. No evidence of archaeological features or deposits were identified during the site visit.
