Northern Corridor Improvements

Assessment of Freshwater Ecological Effects

Project No: 250310
Document Ref:
NCI-3PRE-2ENV-RPT-0024
Revision: 1

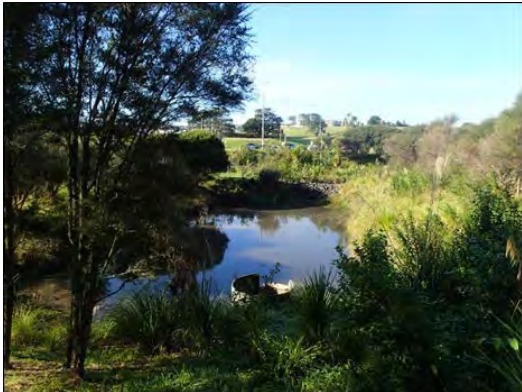
Figure 6 SWP 1 (A1 39) Oteha East

Two existing stormwater ponds are located within the Project area north of Oteha Valley Road. The stormwater ponds are east (SWP 1, A1 Pond 29) and west (SWP 2, A1 Pond 30) of the northern motorway. Both stormwater ponds are divided into two, with a central bund and are surrounded by a narrow band of native and exotic shrubs, dominated by flax (*Phormium tenax*), cabbage trees (*Cordyline australis*) and long grasses. SWP 1 (Figure 7). The stormwater ponds are both Alpur ponds, which primarily collect water from the motorway system and discharge to Lucas Creek.

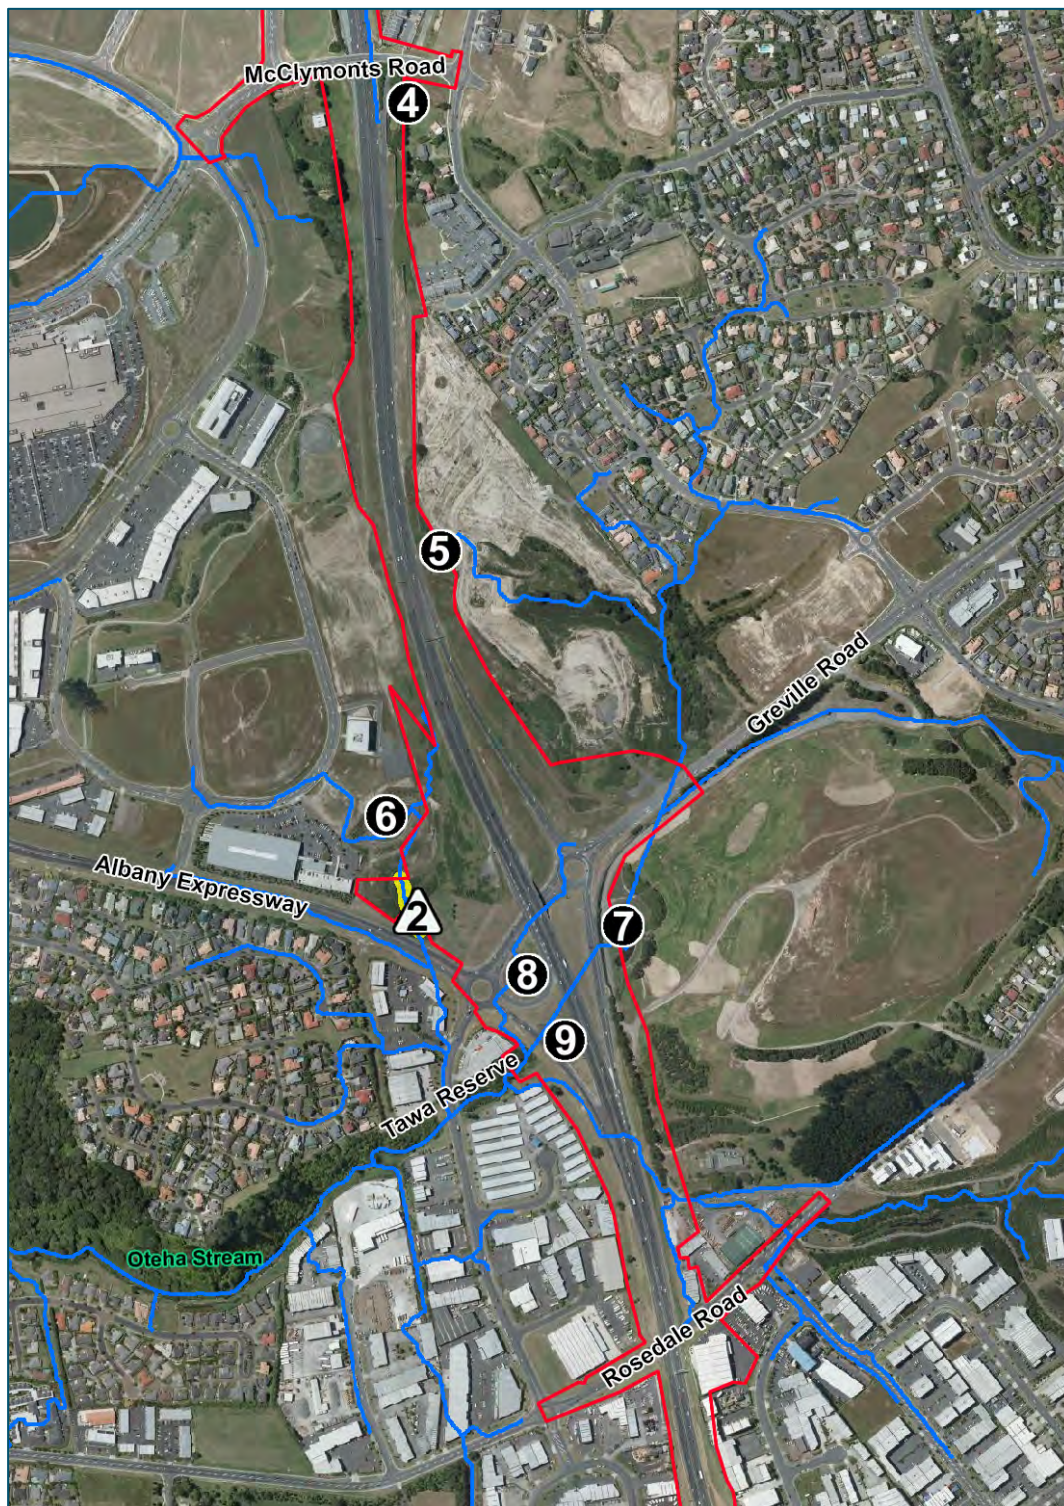
Figure 10 Freshwater Habitats – McClymonts Road to Rosedale Road - SEV (Δ) and Stormwater Pond Locations (●)

Figure 10 provides an overview of the freshwater habitat located between McClymonts Road and Rosedale Road within the Project area.

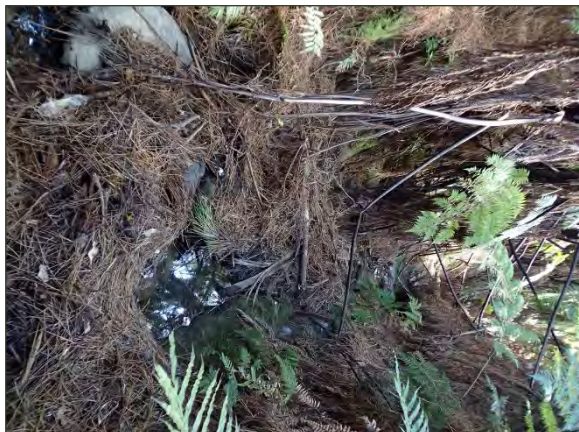
Figure 11 Oteha Stream Tributary

Note: Steep banks

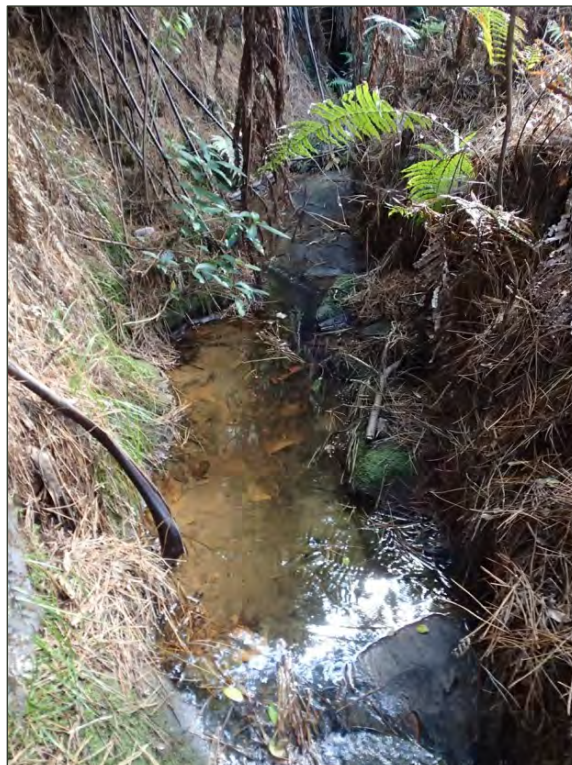
Figure 12 Oteha Stream Tributary

Note: Pools and riffles

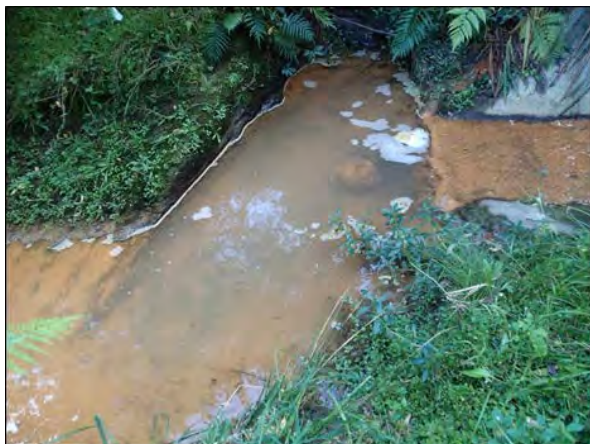
Figure 13 Upper Oteha Stream

Note: Culvert apron on right and discharge pool

Upper Oteha Stream, within Tawa Reserve, forms a stabilised steep sided watercourse. The short area of the watercourse within the Project area includes several culverts, culvert apron, the scour pool and stream immediately below the pool. Potential adverse effects of works in the watercourse and on the banks in the vicinity of the creek include bank failure, sedimentation and loss of a small section of low quality aquatic habitat.

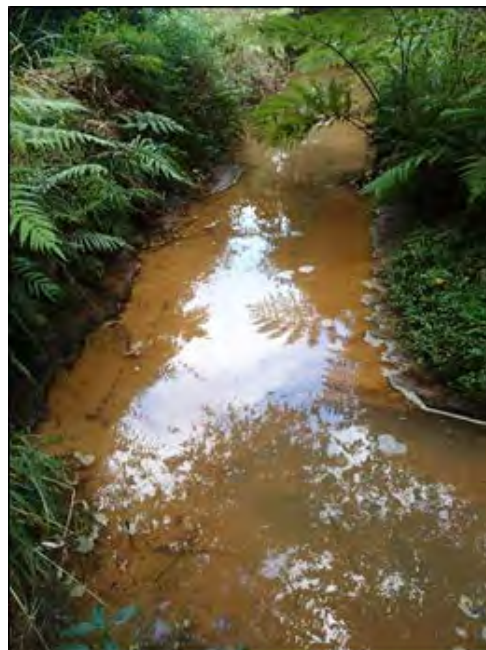
Figure 14 Upper Oteha Stream

Note: Iron floc

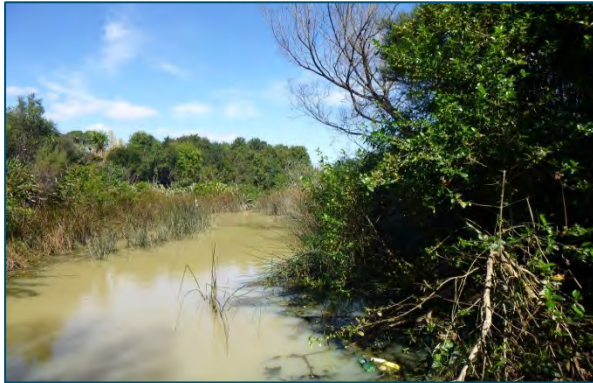
Figure 15 SWP 4 (A1 32) McClymonts Road

This pond was one of two stormwater ponds that were investigated later in the year (in September) once the Project stormwater maps were made available. The temperature of the pond in September was 12°C, within the range of “excellent” which is considered to be suitable for most stream life (Biggs *et al.*, 2002) and conductivity was low (125 µS/cm), indicative of low enrichment. Dissolved oxygen concentration and saturation were low, at 6.1mg/L and 56% respectively, a level where moderate stress would be caused to aquatic organisms (Davis-Colley *et al.*, 2014) and at a level where the nets and traps were required to be placed in a position to ensure an air pocket was available for fish.

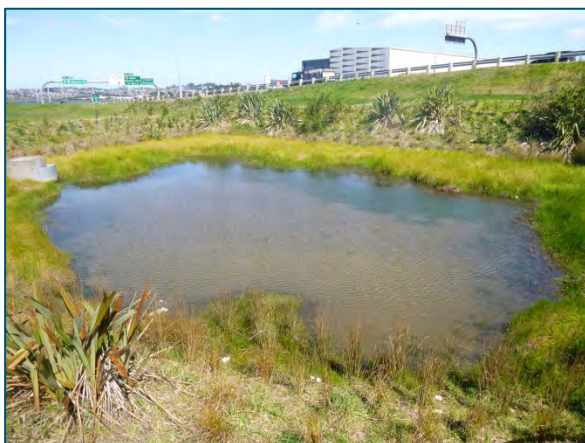
Figure 16 SWP 5 (A1 33) Colliston Rise

A small, shallow stormwater pond is present within the Project area, adjacent to the SH1 southbound lane, north of Greville Road and accessible from Colliston Rise (SWP 5). The pond is approximately 20m long by 16m wide and on average 0.15m deep. The pond was bounded by pasture grasses, with the occasional amenity plant (dominated by flax) and there was no shading on the water (Figure 16). The water was clear. The water was too shallow for the deployment of fyke nets. Two Gee minnow traps were placed in the pond overnight. No fish were caught.

This pond was one of two ponds that were investigated later in the year (September 2016) after the Project stormwater maps were made available. The temperature of the pond was 13.6°C, within the range of “excellent” which is considered to be suitable for most stream life (Biggs *et al.*, 2002) and conductivity was low (86 µS/cm), indicative of low enrichment. Dissolved oxygen concentration and saturation were excellent, at 9.95mg/L and 95% respectively, a level where no stress would be caused to aquatic organisms (Davis-Colley *et al.*, 2014).

The aquatic ecological values of the stormwater pond were low.

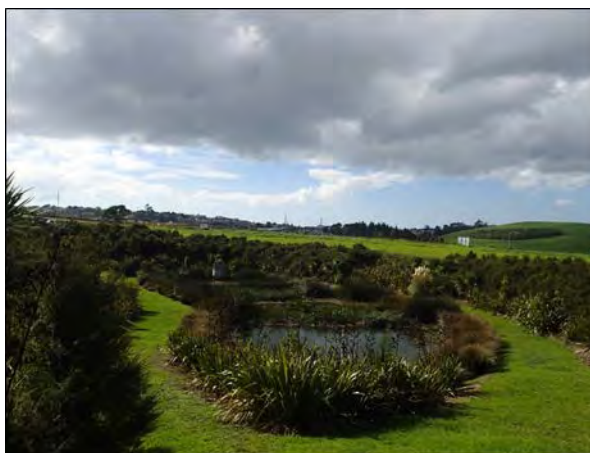
Figure 17 SWP 6, 35 Corinthian Drive

A large stormwater pond is present adjacent to the Project area, accessible from 35 Corinthian Drive (CD), draining via culverts to an upper tributary of Oteha Stream. This stormwater pond is an Auckland Council asset and serves part of the urban catchment.

The water temperature of the pond was 17.7°C, indicative of autumn conditions and within the temperature range of "good", which is considered to be suitable for most invertebrates (Biggs *et al.*, 2002). Conductivity was low (114 µS/cm), indicative of low enrichment. Dissolved oxygen concentration and saturation were very high, at 11.91 mg/L and 126% respectively, a level where supersaturation was occurring and a level potentially dangerous to fish and invertebrates¹. The supersaturation of the pond was likely a result of photosynthetic aquatic oxygen producers such as macrophytes and algae (**Figure 18**), and is known to occur on occasions in stagnant waters, such as stormwater ponds.

The aquatic ecological values of the stormwater pond were low.

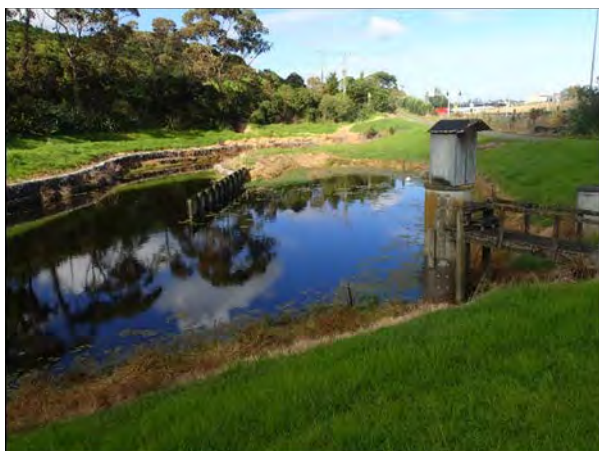
Figure 19 SWP 7 Rosedale Closed Landfill

A large stormwater pond, approximately 86m by 30m, is located in the Rosedale Closed Landfill adjacent to Greville Road and the Greville Road on-ramp southbound (**Figure 19**). The stormwater pond is unshaded, surrounded by short grasses, and discharges to a culvert under the motorway that drains to Oteha Stream.

Two fyke nets and six Gee minnow traps were placed the pond overnight to determine the presence of native fish. Two introduced green and golden bell frogs (*Litoria aurea*) were caught in the nets but no fish were caught. The water temperature of the pond was 18.4°C, indicative of autumn conditions and within the temperature range of 'good', which is considered to be suitable for most invertebrates and periphyton (Biggs *et al.*, 2002). Conductivity was high (444 µS/cm), indicative of enrichment and dissolved oxygen concentration and saturation were very poor, 4.03 mg/L and 43% respectively, at a level where significant persistent stress would be cause to aquatic organisms living in the pond.

The aquatic ecological values of the stormwater pond were very low.

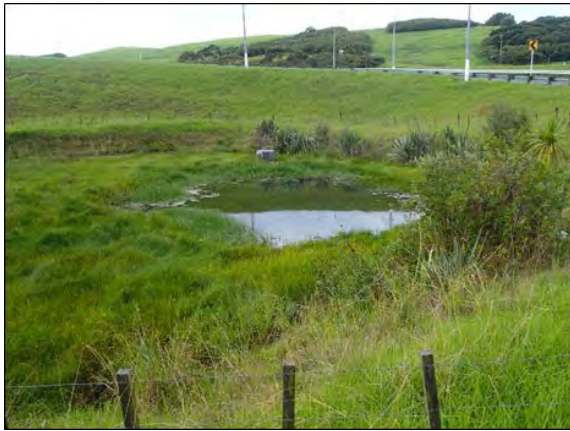
Figure 20 SWP 8 (A1 34) Greville Road northern on-ramp

Two Alpurā stormwater ponds are present in the Greville Road, Tawa Drive, Albany Expressway, SH1 intersection (Alpurā A1 Ponds 34 and 35). A stormwater pond is located within the round-a-bout formed by the Greville Road on-ramp north (**Figure 20**) and a second stormwater pond is located immediately south of the on-ramp north (**Figure 21**). Both stormwater ponds contained wetland plants (*Carex* species, *Baumea articulata*) are mostly unshaded, surrounded by grasses with occasional patches of amenity plants (flax, cabbage tree, manuka). Both stormwater ponds drain to Oteha Stream via a 3000mm diameter culvert.

The northern pond, bounded by the on-ramp round-a-bout, measured approximately 24m by 37m while the southern pond measured approximately 51m by 10m. One fyke net and two Gee minnow traps were placed in each pond overnight. No fish were caught in the nets and traps and no fish were observed in these ponds.

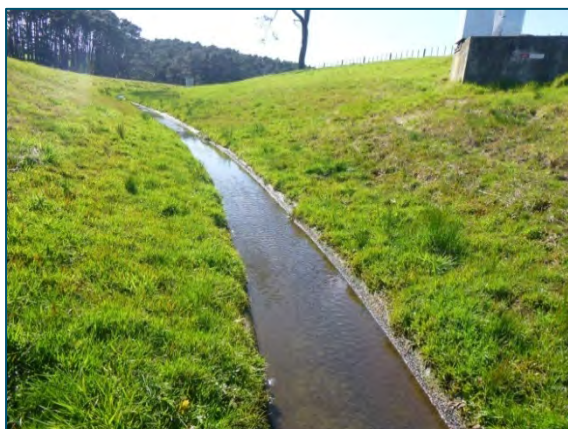
Figure 24 Stormwater Drain South of Pond 2

The stormwater system east of the motorway and south of RWWTP Pond 2 was constrained to a narrow, open concrete lined channel (**Figure 24**) draining generally east to west adjacent to the southern banks of Pond 2, then draining via culverts (**Figure 25**) and open drains north and west to Oteha Stream. The concrete channel was uniform, 0.8m wide and 0.2 - 0.3m deep. The riparian vegetation was limited to short pasture grass and there was no effective shading on the drain and no quality habitat for aquatic fauna.

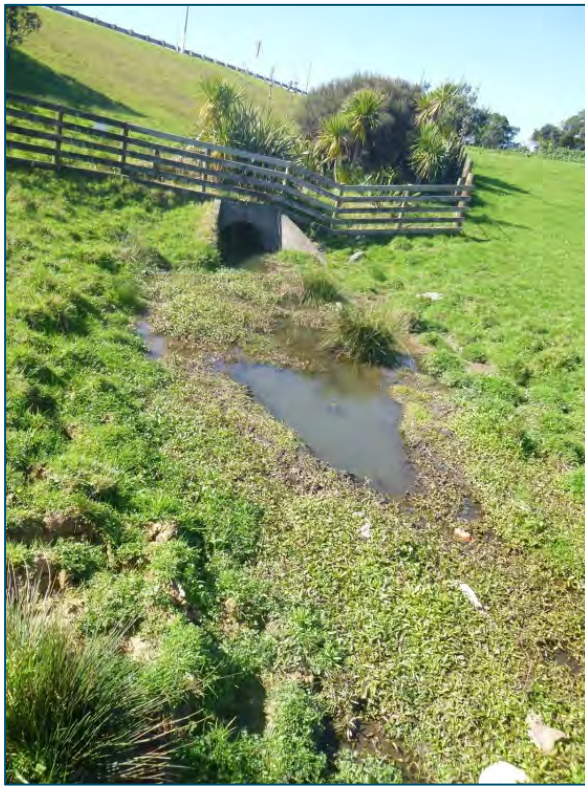
Figure 28 Upper watercourse draining SWP 10

SWP 10 (ARC Refuse Pond) near the corner of Constellation Drive and SH1 off-ramp drains via a culvert under SH1 to the centre of the RWWTP site (Figure 27, Figure 28). The outlet of the culvert discharge forms a watercourse running south to north for approximately 60m to drain to the open stormwater drain adjacent to the Pond 1 southern road (Figure 29). Stock have access to the watercourse and the banks and stream bottom have been pugged, forming a broken boggy area about 3m wide. The water depth in the central area was approximately 0.06m within pools. Rushes (*Juncus* species), water pepper (*Persicaria hydropiper*) and buttercup (*Ranunculus* species) were present throughout the wetted area (Figure 29). The riparian vegetation was limited to short pasture grass. Mosquito fish were abundant in the pools.

On this basis, native fish recovery and relocation is recommended for the works within this location. The works area should be isolated, the water flow temporarily diverted and work should be staged to allow the upper watercourse to de-water naturally, allowing fish to move into the lower channel prior to any major stream works. Native fish recovery and relocation should then be carried out at the site to ensure any stranded native fish are relocated.

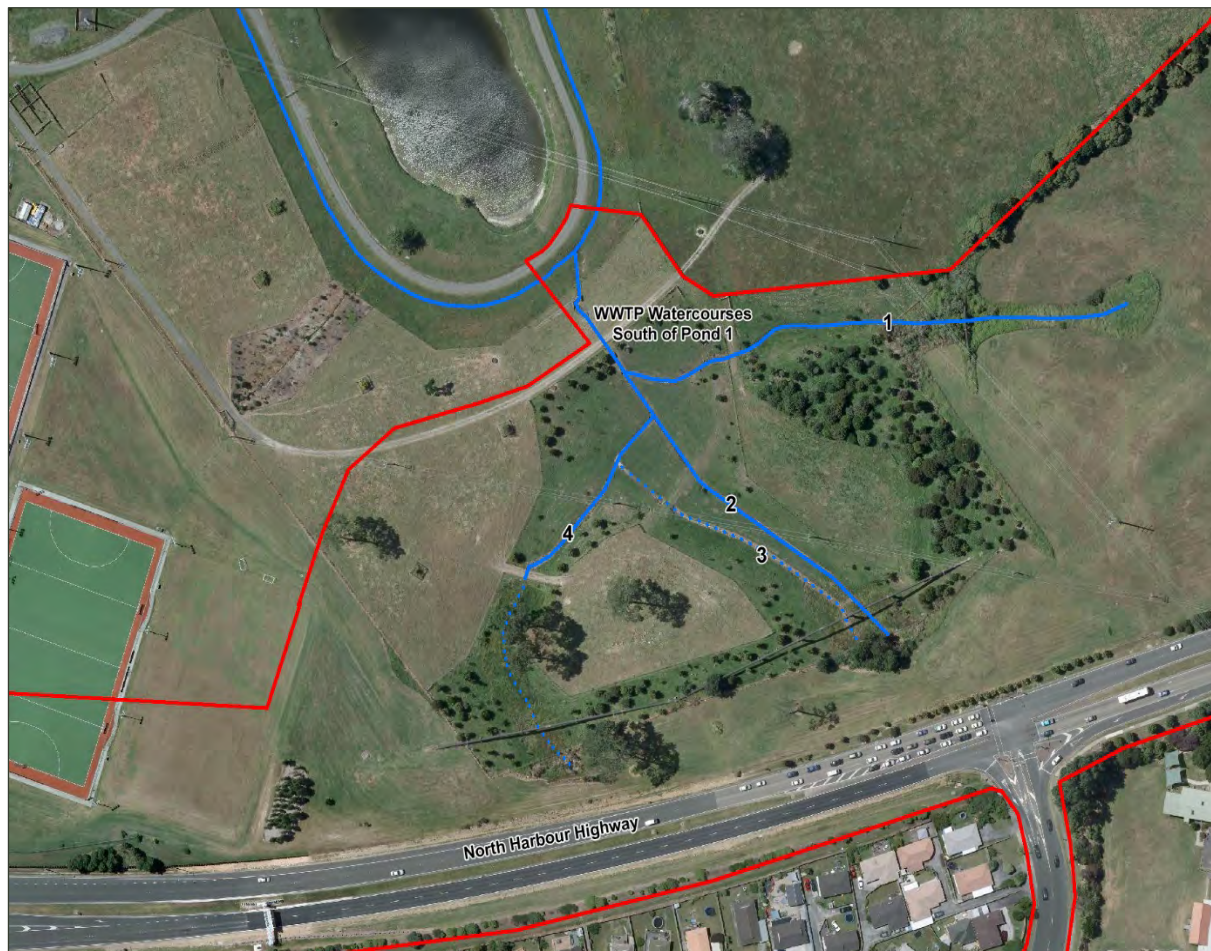
Figure 30 Freshwater Habitats RWWTP Watercourses South of Pond 1

Within the RWWTP site, immediately north of UHH in line with Caribbean Drive, an area of modified watercourses and stormwater drains is present (**Figure 27** and **Figure 30**).

The RWWTP watercourses south of Pond 1 are highly degraded, open and exposed, and the main watercourses are diverted concrete lined stormwater drains. Given the watercourses are to be converted into a new wetland with wetland plants, a variety of depths and habitat types, there will be an increase in biodiversity and an increase in aquatic ecological values. Additional riparian planting around the wetland, specifically on the northern side, is recommended as the riparian planting will increase the shading and substrate to the wetland, increase water temperature control and provide bankside shelter and habitat to birds utilising the wetland.

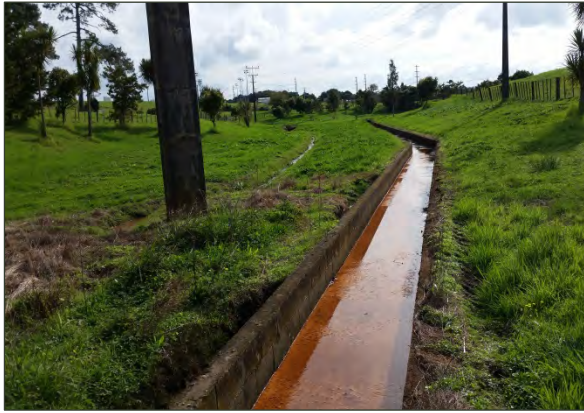
Figure 31 RWTP stormwater drain from Caribbean Drive

Stormwater from Caribbean Drive and the urban areas south of UHH drain north under the Highway via a 1350mm diameter culvert to the RWWTP site. The watercourse has been confined to a concrete lined open drain (Watercourse 2, **Figure 30**), 1m wide with 0.4m concrete block sides. This open drain was lined with iron floc and contained a continuous flow less than 0.01m deep (**Figure 31**). This watercourse is a modified element of a natural drainage system that existing prior to land modification (email from Matt Byrne, Auckland Council to Aurecon, 24 November 2016).

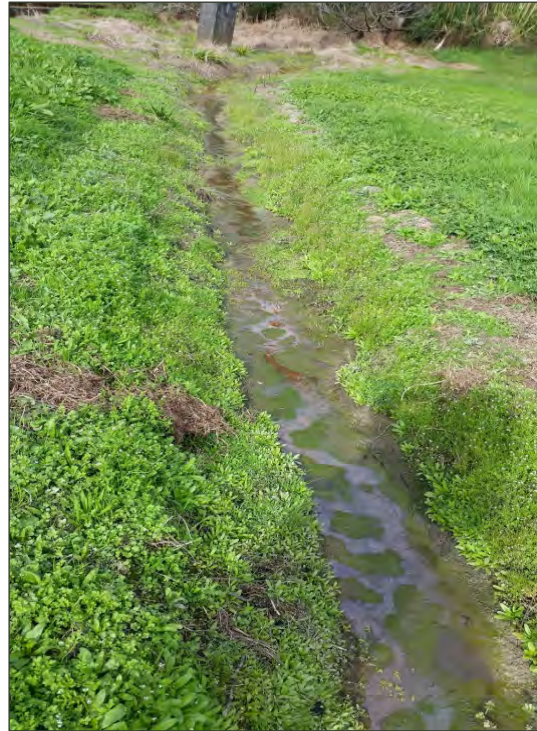
Figure 32 RWWTP Drain parallel to the Stormwater Drain in Figure 3

Immediately south-west of the stormwater drain, an anaerobic ditch was present, generally adjacent to the stormwater drain (Watercourse 3, **Figure 30**). The ditch varied between 0.2 and 0.5m wide, was anaerobic, with mud, slime, iron floc and maintained elongated very shallow pool areas, but no flow (**Figure 32**). The ditch was bisected by a culvert, forming a deeper header pool, approximately 0.5m deep, before widening and joining a similar ditch from the west (Watercourse 4, **Figure 30**) and draining east via a very incised ditch to the stormwater drain. A shortfin eel, approximately 480mm long, was present near the junction with the stormwater drain and mosquito fish were present throughout. The drains were unshaded with the riparian vegetation limited to short grasses.

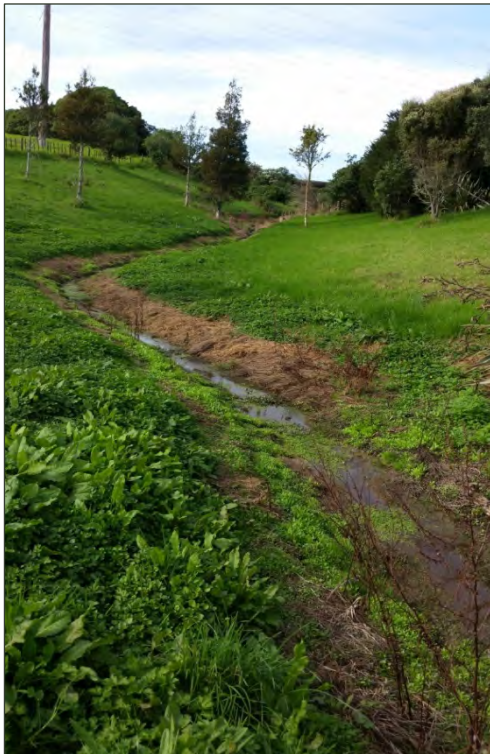
Figure 33 RWWTP Effluent Trial Area

A watercourse draining the central area east to west to the stormwater drain (Watercourse 1, **Figure 30**) was not investigated further than the fenceline, as the area was a treated effluent irrigation trial (Site 1 Field A) (**Figure 33** and **Figure 34**). The hydrology of this watercourse was not determined but is likely to be largely determined by the operation of RWWTP. The riparian vegetation of this watercourse comprised short grasses with amenity planting in the upper reaches (**Figure 33**).

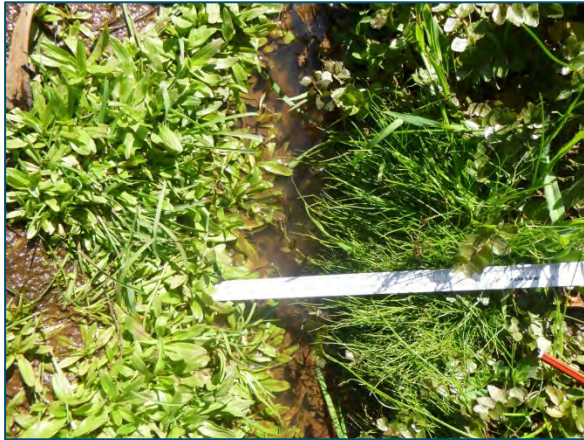
Figure 35 Narrow watercourse West of Drains

West of the Caribbean Drive stormwater drain, during winter, water seeped out from under Upper Harbour drive to a narrow drainage channel which flowed north and north-east to a culvert under the farm access track, to join with the stormwater system draining Caribbean Drive (Watercourse 4, **Figure 30**). The drainage channel was not a natural watercourse and appeared to have been formed. In September the watercourse averaged 0.15m wide (**Figure 35**), widening to 2m immediately in front of the culvert. At this time (early spring) there was no flow in the watercourse and the culvert was completely dry. The watercourse did not meet the criteria under the Auckland Unitary Plan, Operative in Part (AUP) for an intermittent stream. The banks were firm and contoured, clear of shrubs and the riparian vegetation was dominantly pasture grass with buttercup and occasional amenity trees (**Figure 36**).

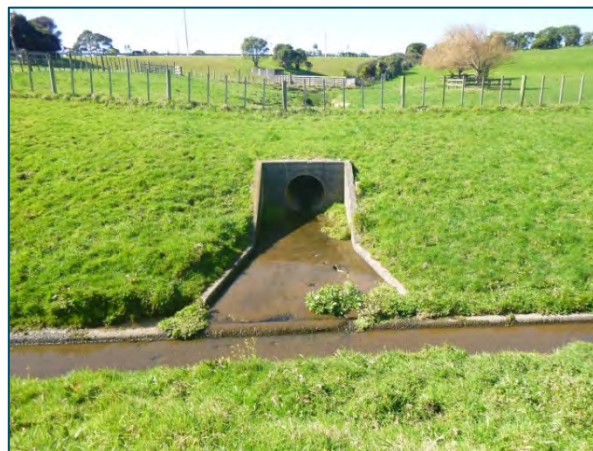
Figure 38 Stormwater Drainage System adjacent to Pond 1

The stormwater from this site was constrained to an open concrete lined channel draining generally west to east adjacent to the southern banks of Pond 1, then draining via culverts under SH1 (to drain north and west to Oteha Stream). The riparian vegetation comprised short pasture grass. There was no effective shading on the drain and no quality habitat for aquatic fauna (**Figure 37** and **Figure 38**).

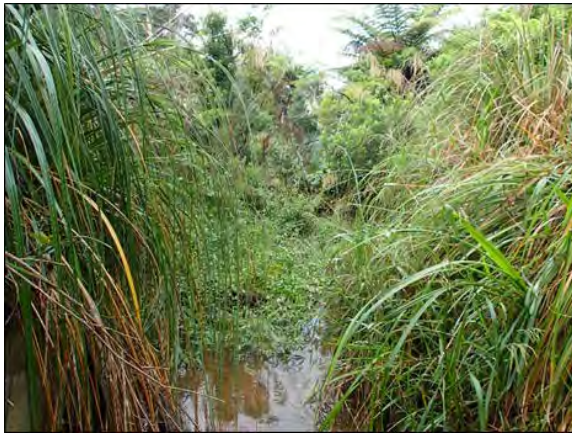
Figure 39 Alexandra Stream South, Rook Reserve – Downstream

The substrate was dominated by silt with a good mix of gravel, cobble, bedrock and wood providing harder substrate. Aquatic macrophytes were present in low abundance throughout the SEV reach. The macrophytes included willow weed (*Persicaria maculosa*), starwort (*Callitriche stagnalis*), water celery (*Apium prostratum*), water purslane (*Ludwigia palustris*), watercress (*Nasturtium officinale*), curly pond weed (*Potamogeton crispus*) and swamp lilly (*Ottelia ovalifolia*). The riparian vegetation in Rook Reserve adjacent to Alexandra Creek comprised a mix of native restoration planting and exotic weeds (refer the Assessment of Terrestrial Ecological Effects).

Crans bully and shortfin eel were the only native fish recorded from the southern Alexandra Creek SEV reach. These species were common in the SEV reach, with 24 eels (size range 220 – 800mm) and ten bullies (ranging from 34mm to 67mm long) recorded. No koura or other larger invertebrates were found the creek, but the exotic mosquito fish was present. The Fish IBI score was 22, indicative of 'poor' species diversity in comparison to other Auckland streams, given the altitude and distance from the sea (Joy & Henderson, 2004).

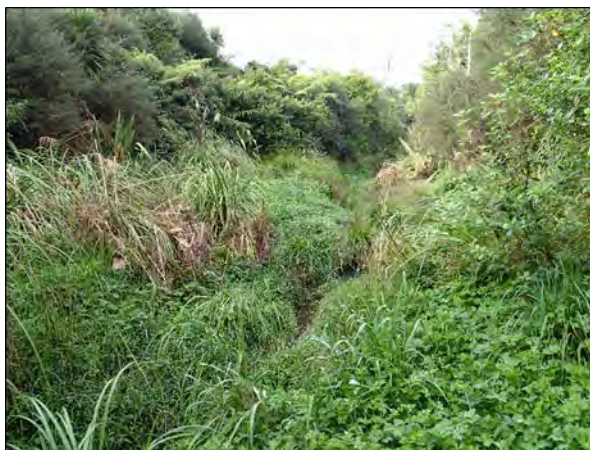
Figure 41 Alexandra Stream, Omega Reserve – Downstream

Alexandra Stream within the Project area forms thickly vegetated watercourse with the potential for moderate to high volume flows, evident from flood debris on the bank and the size of the catchment (approximately 173ha).

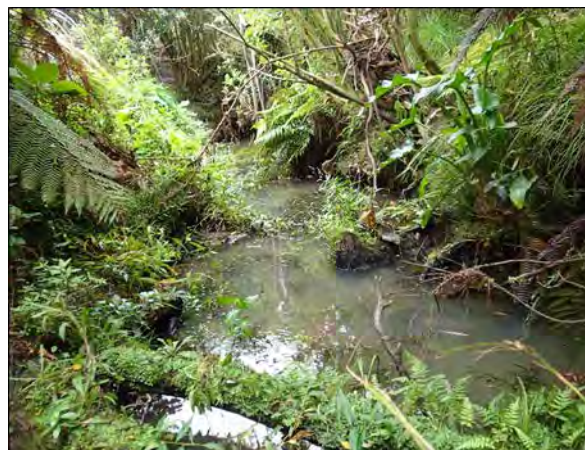
Figure 42 Alexandra Stream, Omega Reserve – Upstream

Alexandra Stream, north of the UHH, lies within Omega Reserve. The Project area includes just over 200m of the stream north of the Upper Harbour Highway to Paul Matthews Road. Alexandra Stream was flowing at the time of the assessment and a SEV was carried out over a 200m reach of the stream. A SEV was carried out on 5 May 2016.
