# Ground Contamination – Preliminary Site Investigation

December 2017

Mt Messenger Alliance

Technical Report 12

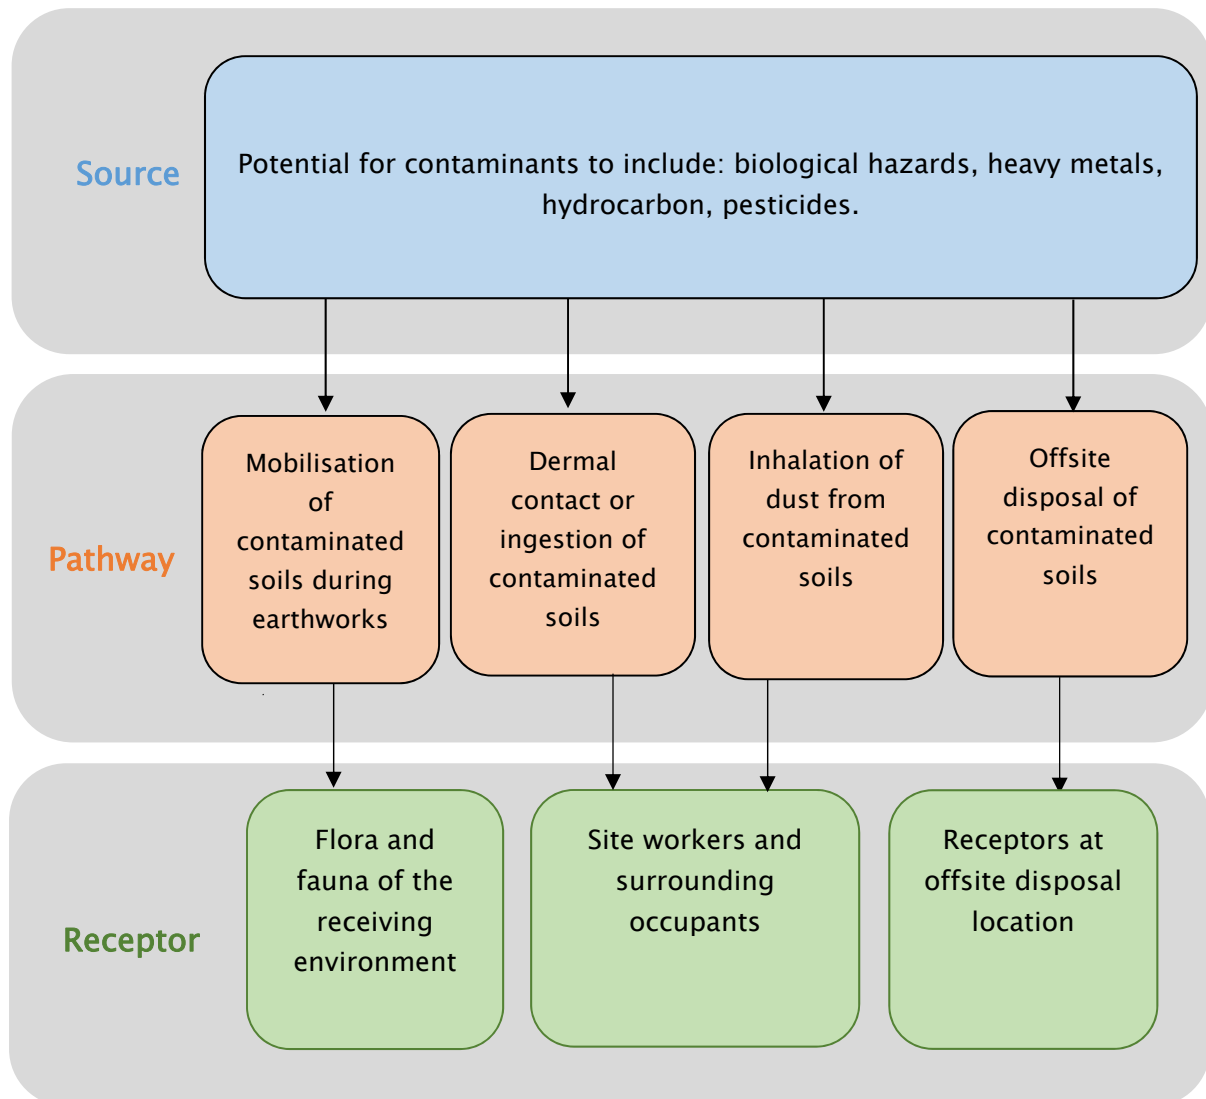
Figure 5.1: Preliminary conceptual site model.

The preliminary conceptual site model shows that there is potential for contaminants associated with fly tipping activities and disposal of waste to land to pose a risk to human or environmental receptors during the works. However, a large portion of the proposed alignment has not been subject to the potential contaminating activities and the potential for such activities to have occurred is isolated to the northern and southern extents of the proposed alignment as shown in Figure 2 (Appendix A:).

The potential risks to human health and the environment are expected to be able to be managed during works through the implementation of appropriate controls so that the effects from contaminated land will be less than minor. Such controls are to be informed by soil sampling and testing (referred to as a detailed site investigations (DSI) in the NES Soil and the MfE Contaminated Land Management Guidelines No 1: Reporting on Contaminated Sites in New Zealand (updated 2011)) and set out in a Contaminated Land Management Plan (CLMP) (refer Volume 5 of the AEE). The CLMP details management, monitoring and reporting requirements with respect to contaminated land for the Project.

The impacts of the identified potentially contaminating activities along the proposed alignment are likely to be isolated to near surface soils. These soils are likely to be removed during construction activity (mainly for geotechnical reasons). As such, it is highly unlikely for any contamination to be at a sufficient level to pose a risk to human health and the environment to remain on site on completion of the construction works.

Even if contaminated soil is retained (likely to be at the boundaries of the proposed alignment), these can be managed by capping (or other methods), to ensure that risks to human health and the environment will be less than minor. This will be provided for in the CLMP.

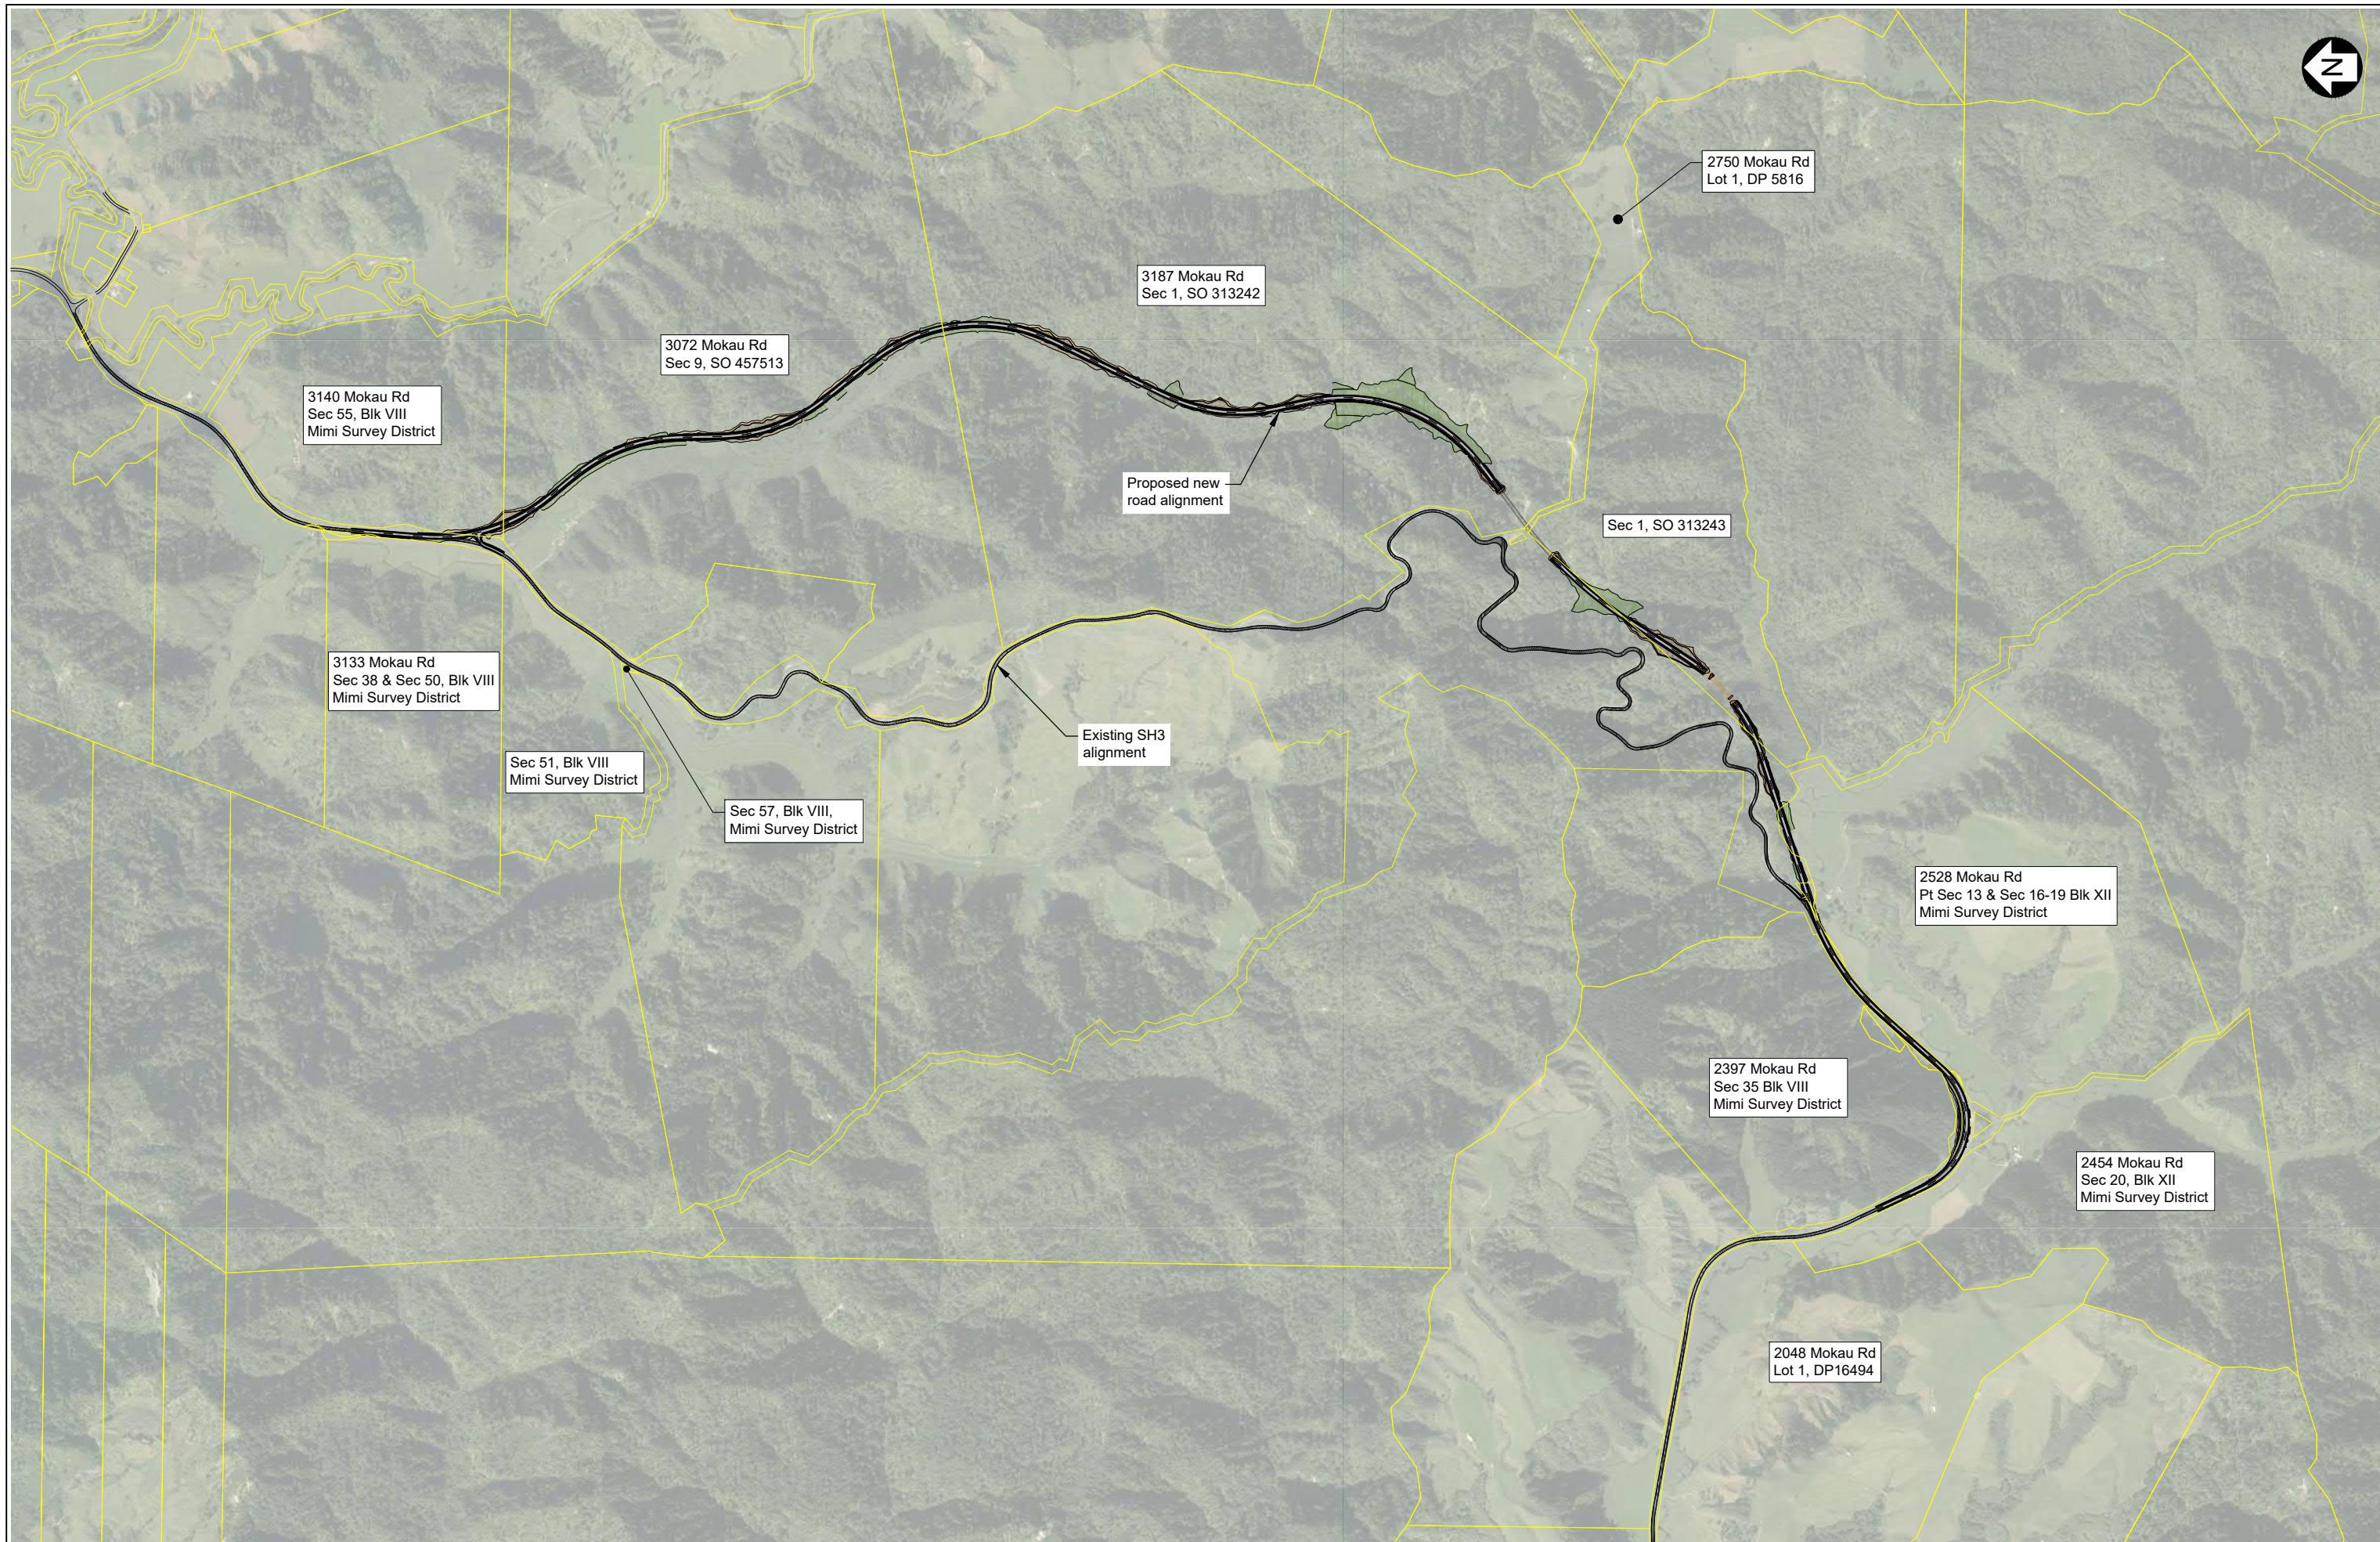
*Figure 1 – Overview Site Plan*

The proposed alignment intersects a number of rural zoned properties. The details of these properties are provided in Table 2.1 below and shown on Figure 1 (Appendix A:).
