Assessment of Ecological Effects – Freshwater Ecology

December 2017

River Lake Limited

Technical Report 7b

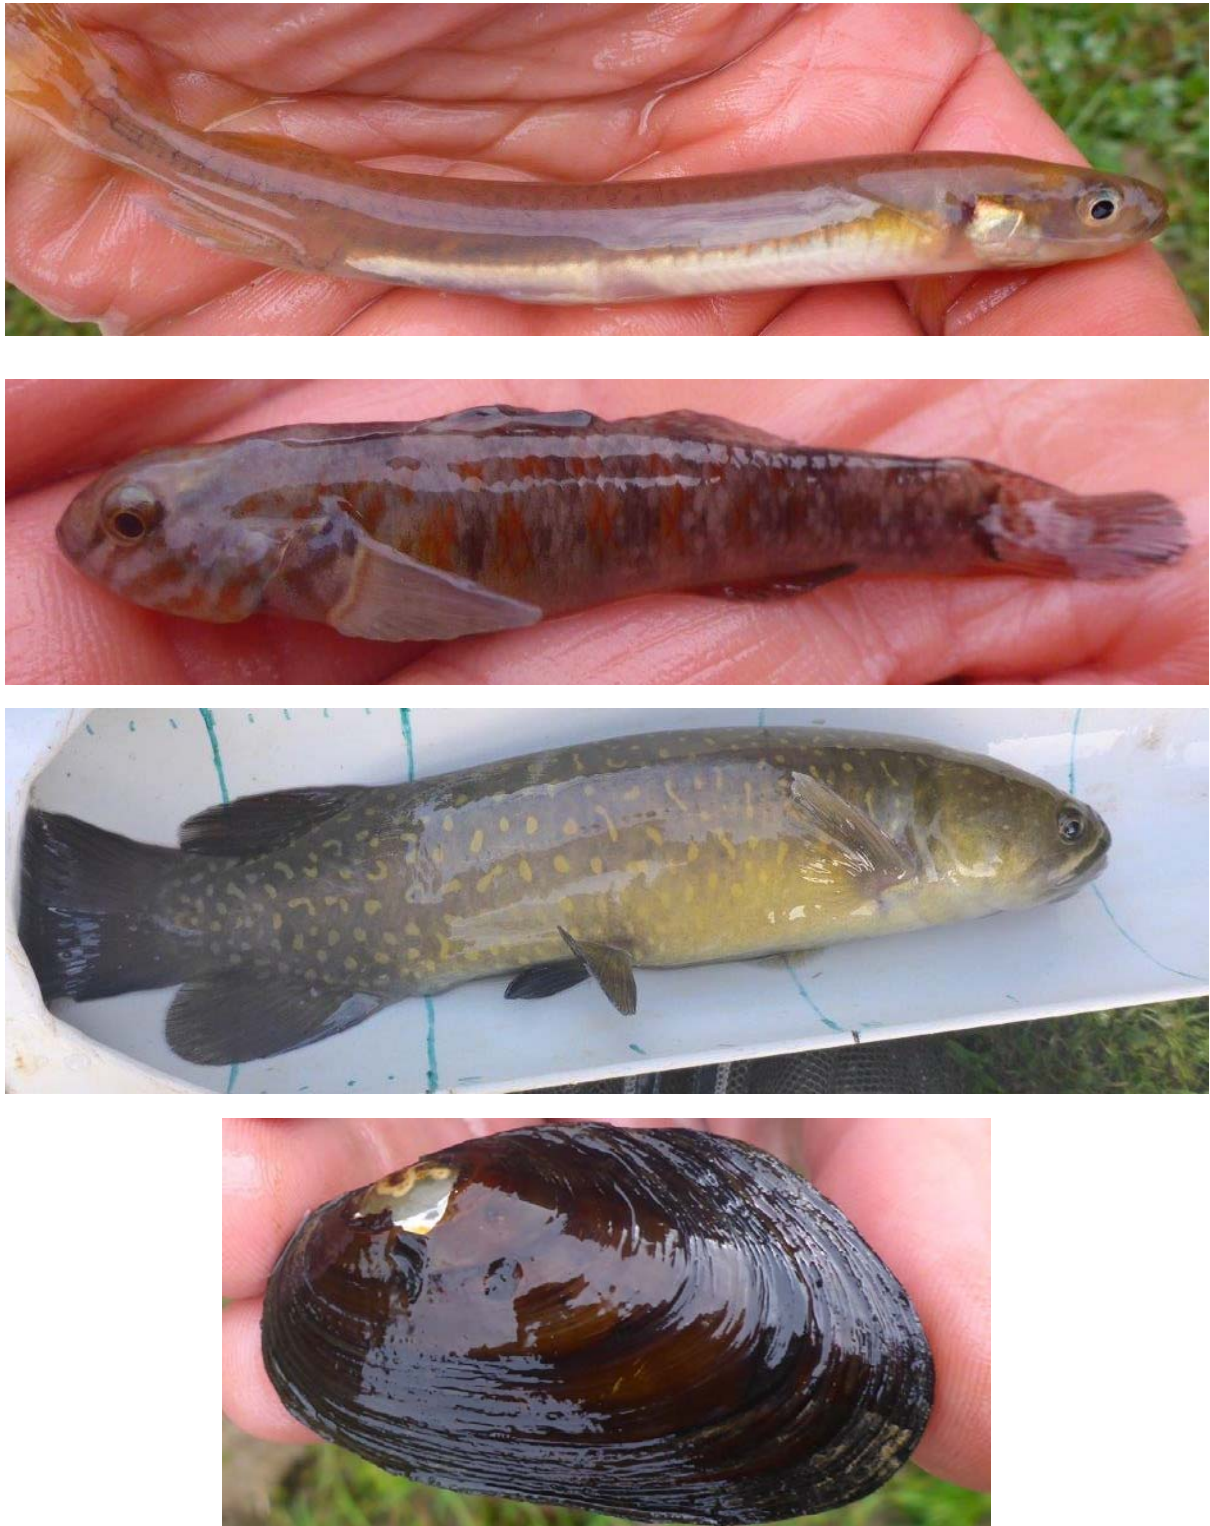
Figure 3.1 – Some typical fish and bivalves in Mangapepeke Stream and Mimi River. From top to bottom: adult inanga (site E1), redfin bully (site E1), giant kōkopu (site E7), kākahi (site E1).

Fish surveys of streams around Mt Messenger during early June and August 2017 found longfin eel, inanga, common bully, giant kōkopu, banded kōkopu, redfin bully, kōura and Paratya shrimp. Kākahi were also found in both streams (Figure 3.1). The lower gradient streams tended to be dominated by large longfin eel, adult inanga and redfin bully, while the steeper sites tended to have banded kōkopu, redfin bully and kōura – all have good climbing ability (Table 3.5). Longfin eel, giant kōkopu, redfin bully and inanga all have a threat status of ‘At-Risk declining’ (Goodman et al. 2014). Kākahi are in decline around the

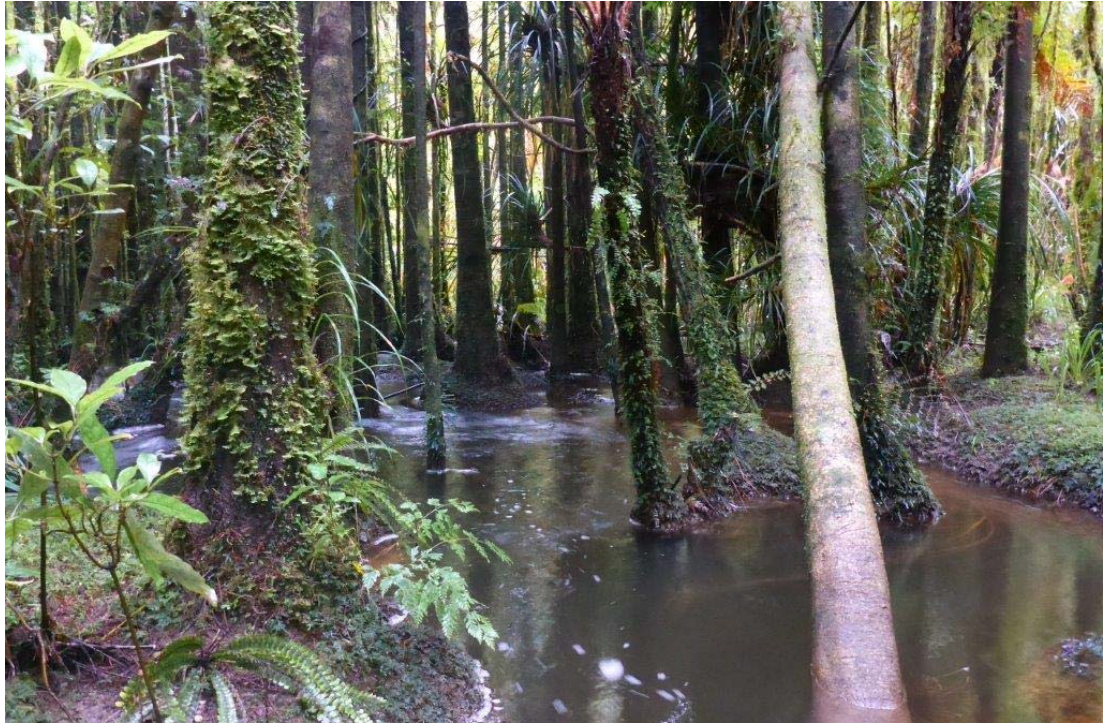
Figure 4.1 – Mimi River tributary flowing through the kahikatea swamp forest (site Ea25).

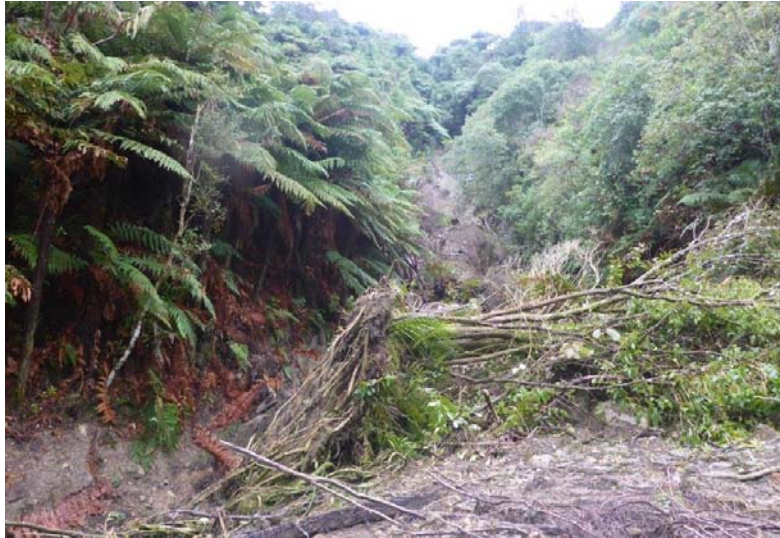
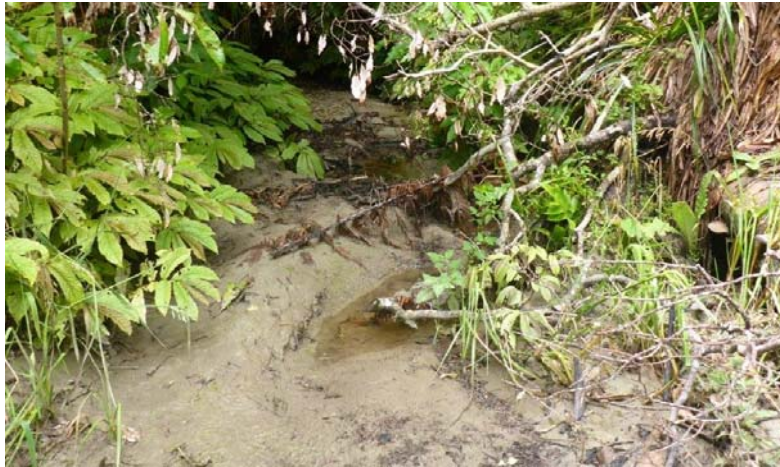
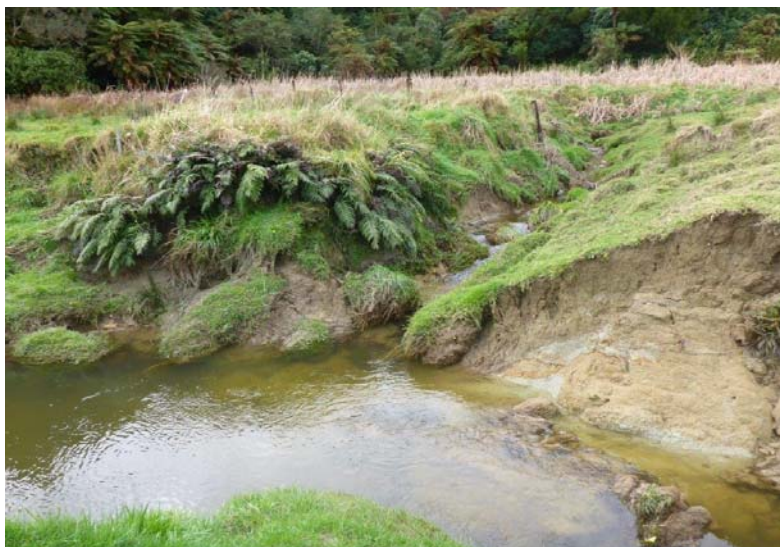
Figure 4.2 – Some sources of sediment to streams around Mt Messenger. Top: a landslide in a tributary downstream of the Project's route (38.898097°, 174.576161°). Middle: sedimentation in a forested headwater of Mangapepeke Stream west branch (site N7, Hamill)

The reason for the relatively high sediment cover in streams is the papa mudstone geology. This is a soft rock and the gravel and cobbles are readily crushed to silt by hand. Small slips were common even in bush catchments and stream bank erosion is common in areas of pasture. High sediment loads appear to be a natural feature of these streams, but in the absence of mitigation measures land disturbance can easily cause accelerated erosion and sedimentation (see Figure 4.2).

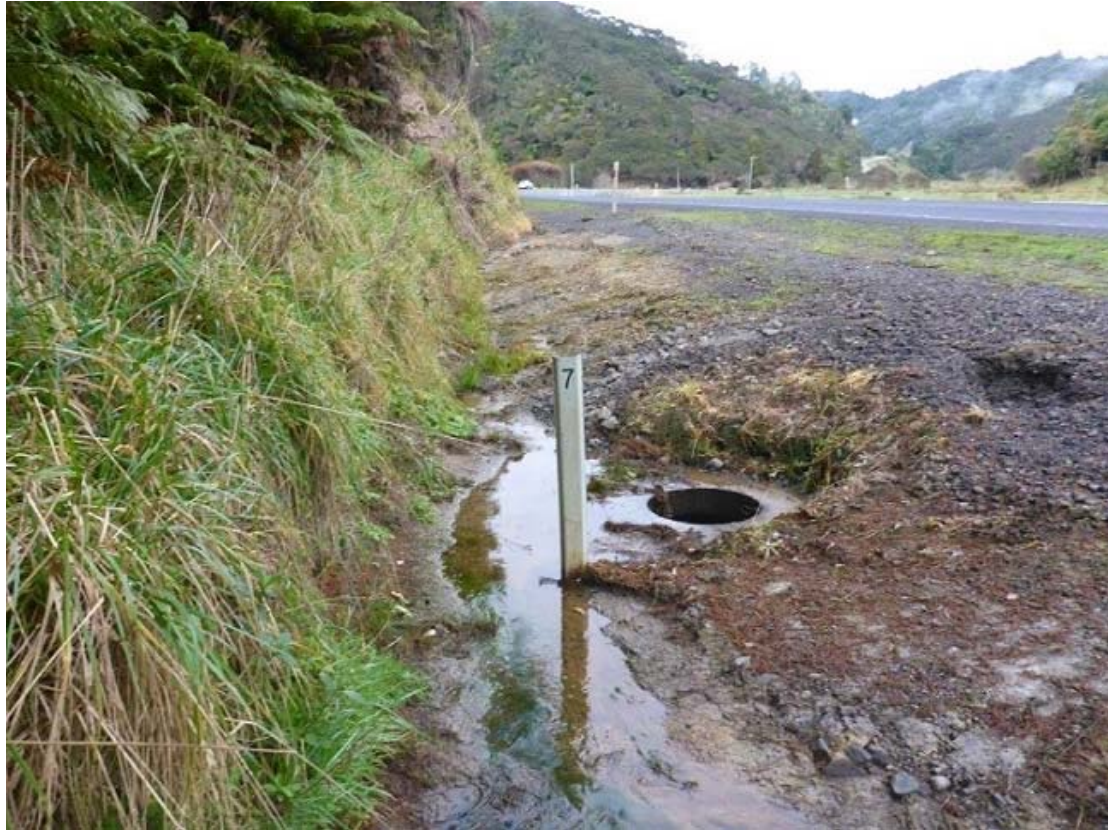
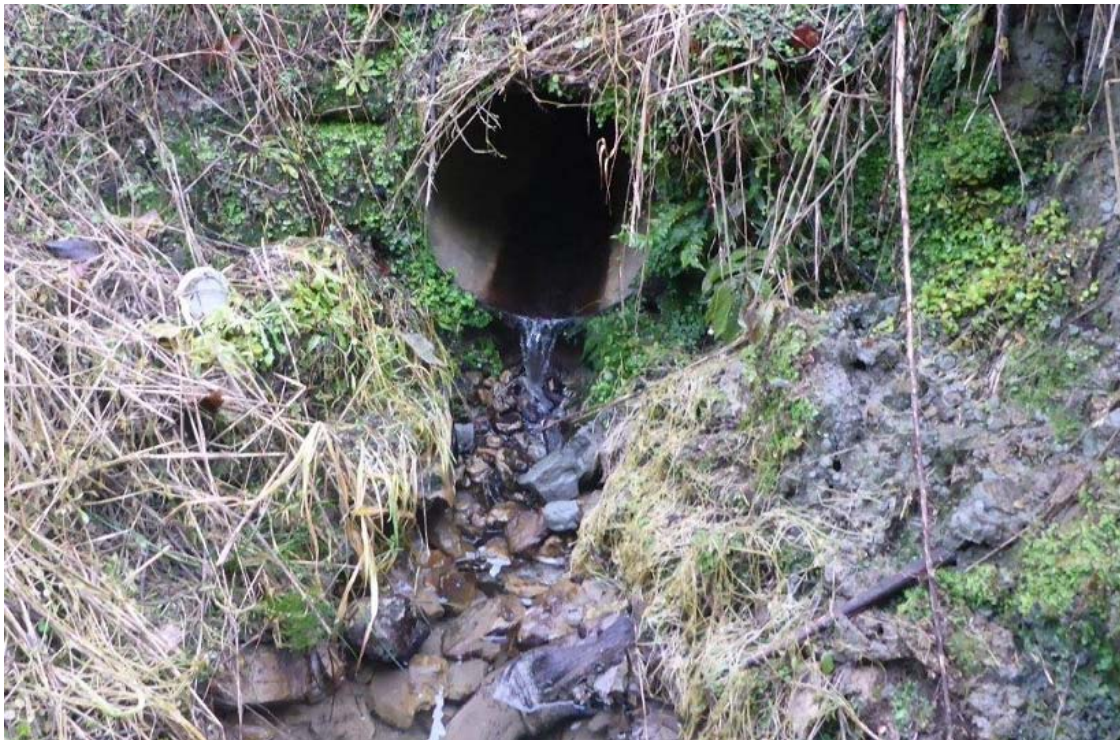
Figure 4.4 – Fish barriers on small intermittent streams from the current SH3. Site Ea1/Ea2 (top) site Ea21 (bottom) (1 August 2017). Limited fish habitat upstream of these barriers reduces their overall effect on fish populations.

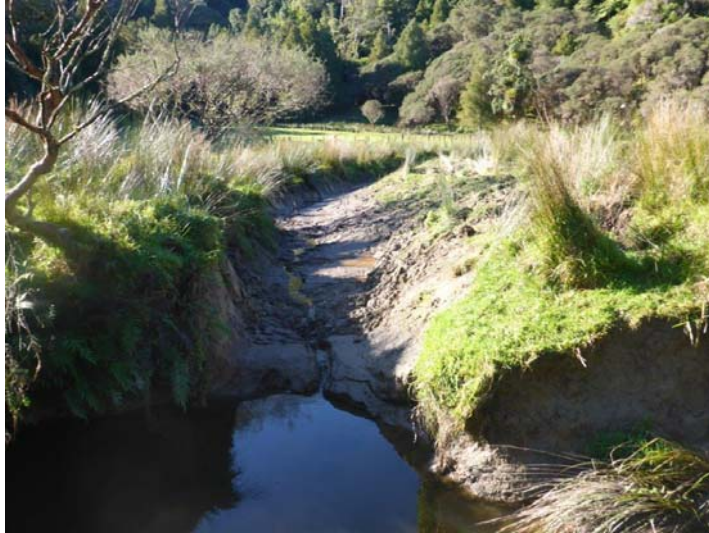
Figure D 3 – Site Ea3, tributary to Mangapepeke Stream entering at site E1. Recent drain clearance.

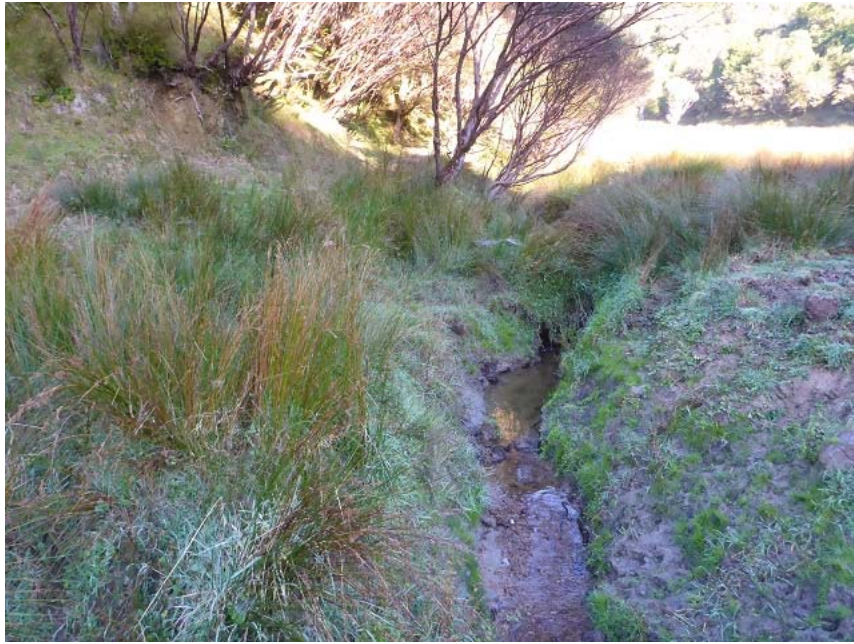
Figure D 6 – Site ETL5 Tributary to Mangapepeke Stream being crossed by access the access track, June 2017.

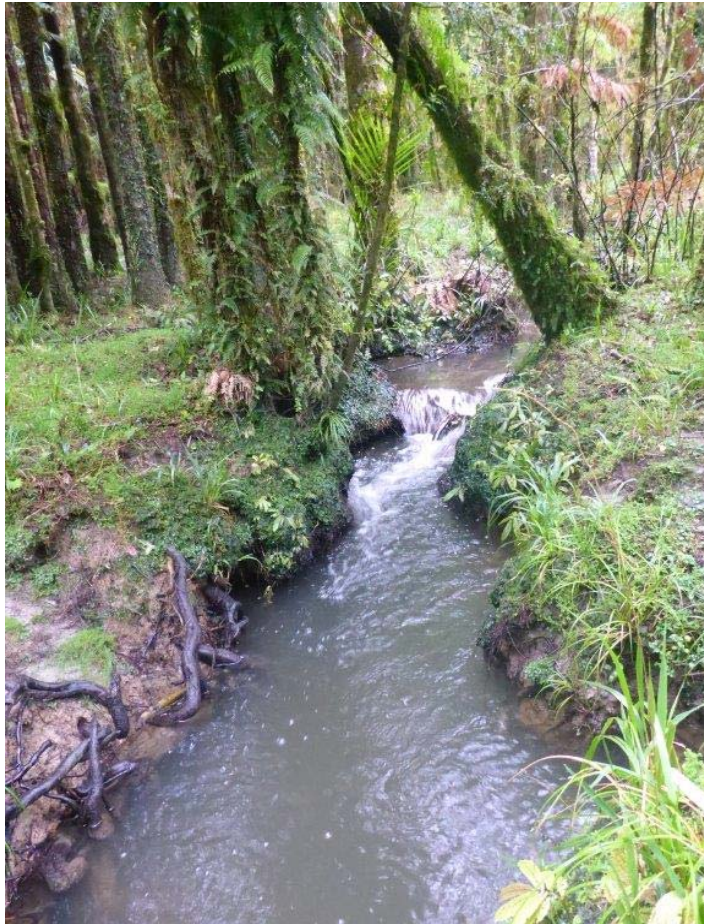
Figure D 8 – Mangapepeke Stream upstream of site Ea10 tributary, August 2017. Degraded kahikatea swamp forest.

A remnant of degraded kahikatea swamp forest is present on the true right of the Mangapepeke valley near site Ea10. The forest condition has been degraded by stock grazing, nevertheless the stream through this small section has maintained much of its complex original complex morphology, ie relatively narrow and deep with tree roots stabilising the stream banks and forming pools, undercuts and small cascades. The streams in the valley have high potential to be enhanced by excluding stock, and riparian planting.

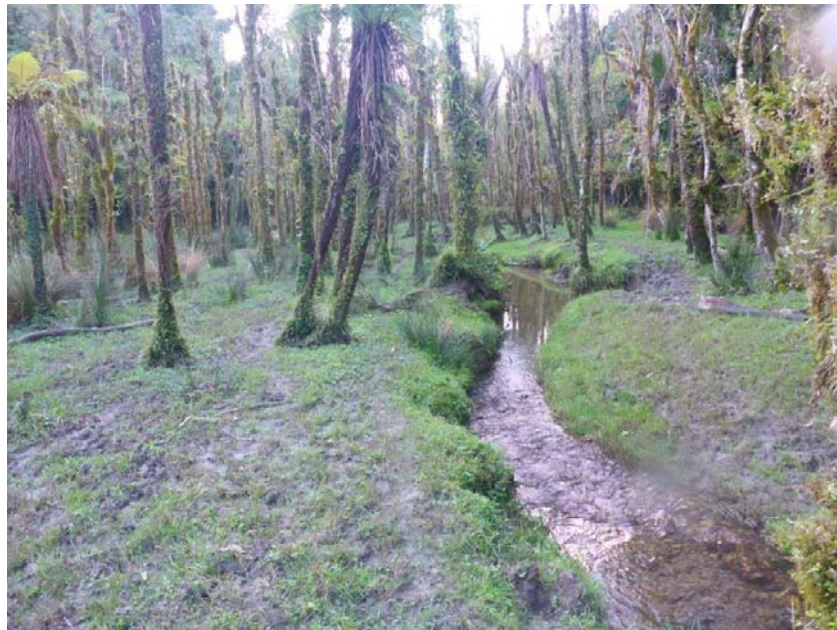
Figure D 13 – Site E4 Mangapepeke Stream. Sediment deposition on stream bank from a recent flood, 7 June 2017.

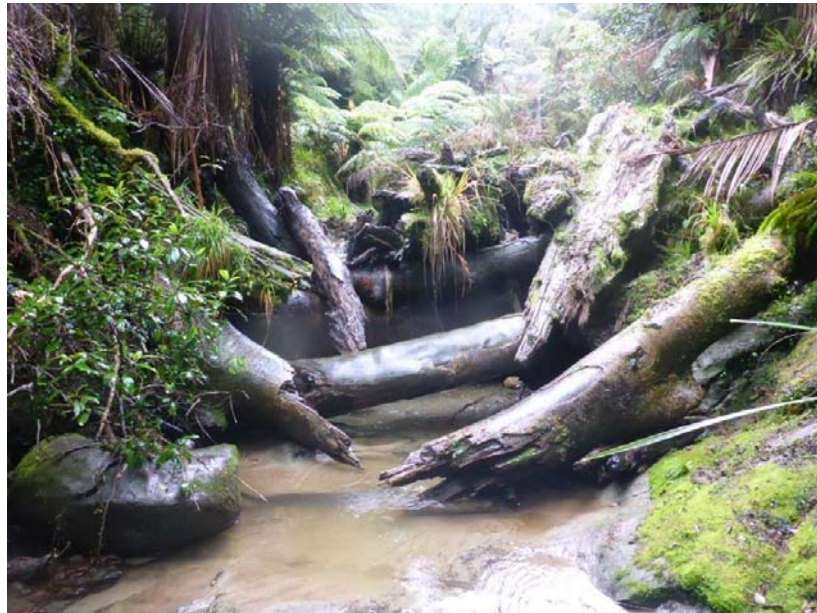
Figure D 17 – Log jam in Mangapepeke Stream upstream of site E5 waterfall.

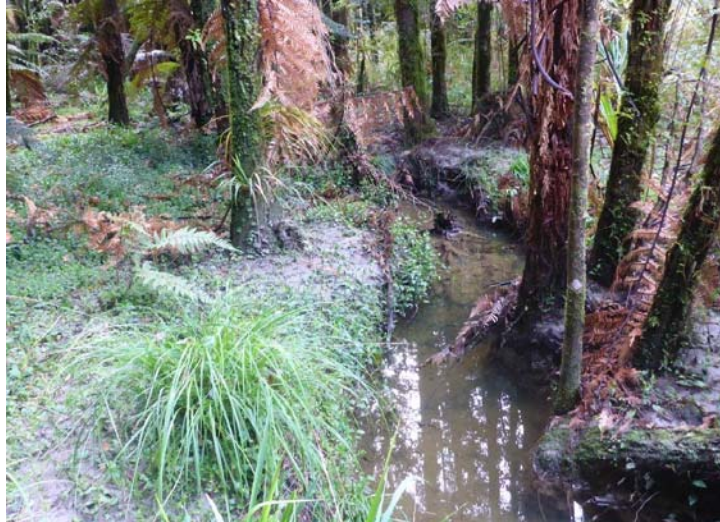
Figure D 25 – Site Ea20, Mimi River tributary. Kahikatea forest section being bridged.

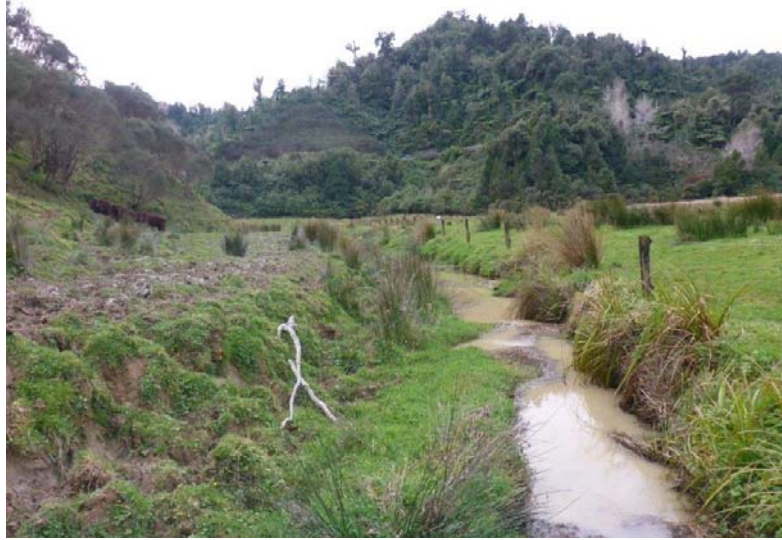
Figure D 31 – Site Ea28, Mimi River tributary facing downstream. Water turbid due to runoff from cattle pugging.

Bank slumping and cattle near the streams had an observable impact on fine sediment within runs on the stream bed. In some cases, pugging by cattle caused complete smothering of the bed of smaller streams/drains (eg site Ea28).

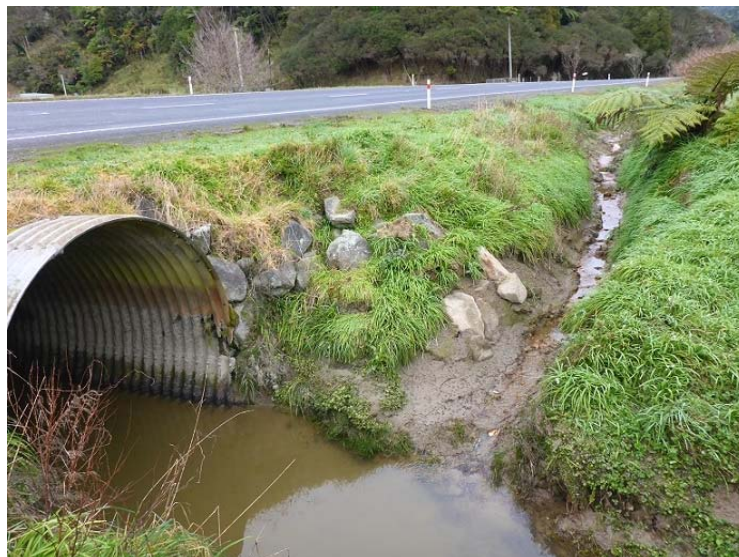
Figure D 32 – Mangapepeke Stream culvert under the current SH3 north of Mt Messenger, August 2017. This site is not affected by the Project.
