Western Ring Route – Waterview Connection

Assessment of Archaeological Effects

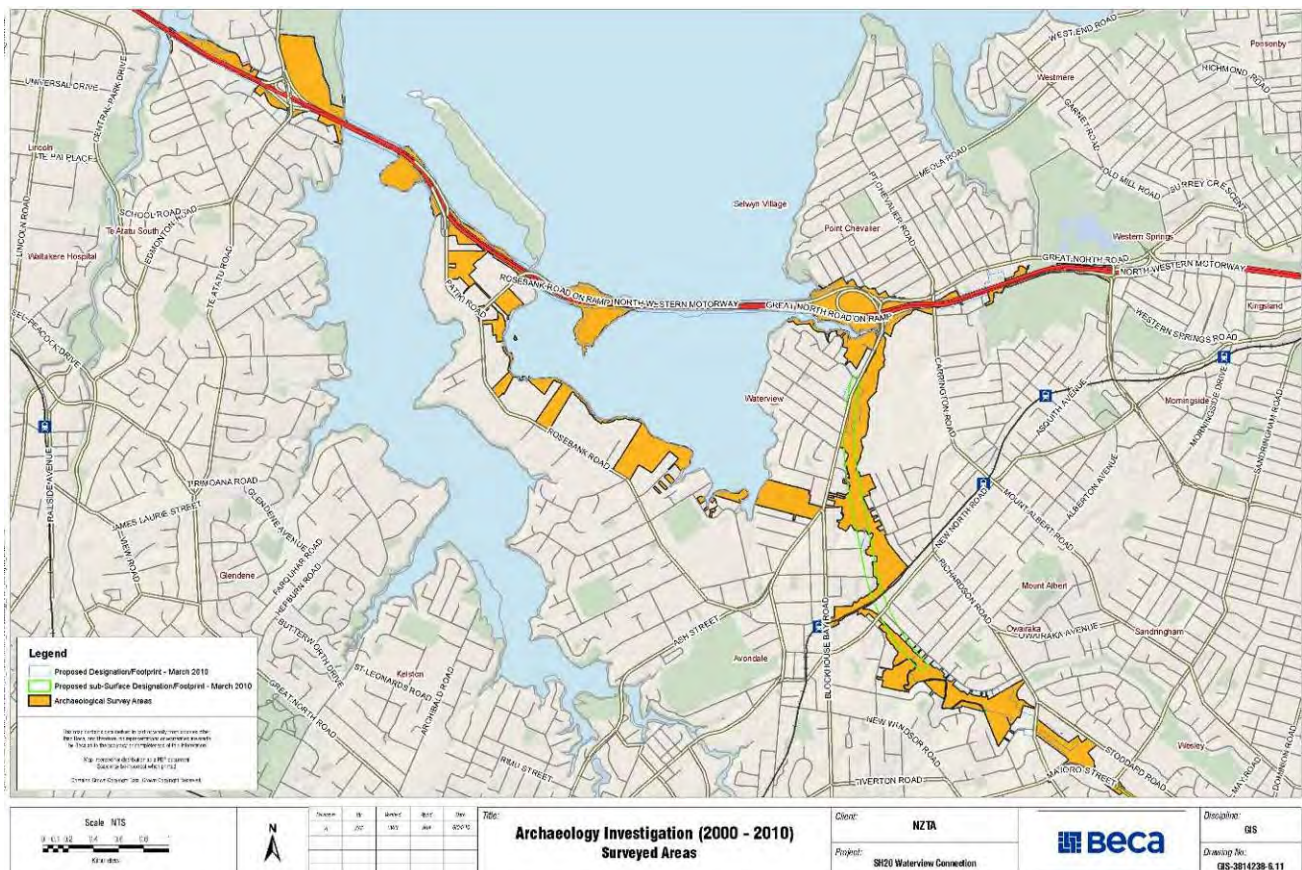
Figure 4.1: Areas surveyed for archaeological sites by Biosearches between 2000 and 2010

A literature search and field surveys were undertaken to identify potential and recorded archaeological sites and historic structures in the project area. The initial surveys and assessments of effects on archaeological values were carried out by Brent Druskovich of Biosearches between 2000 and 2010, and a final archaeological survey report was prepared by Druskovich in 2010 (**Appendix A**). **Figure 4.1** shows the areas surveyed at various stages of the project.

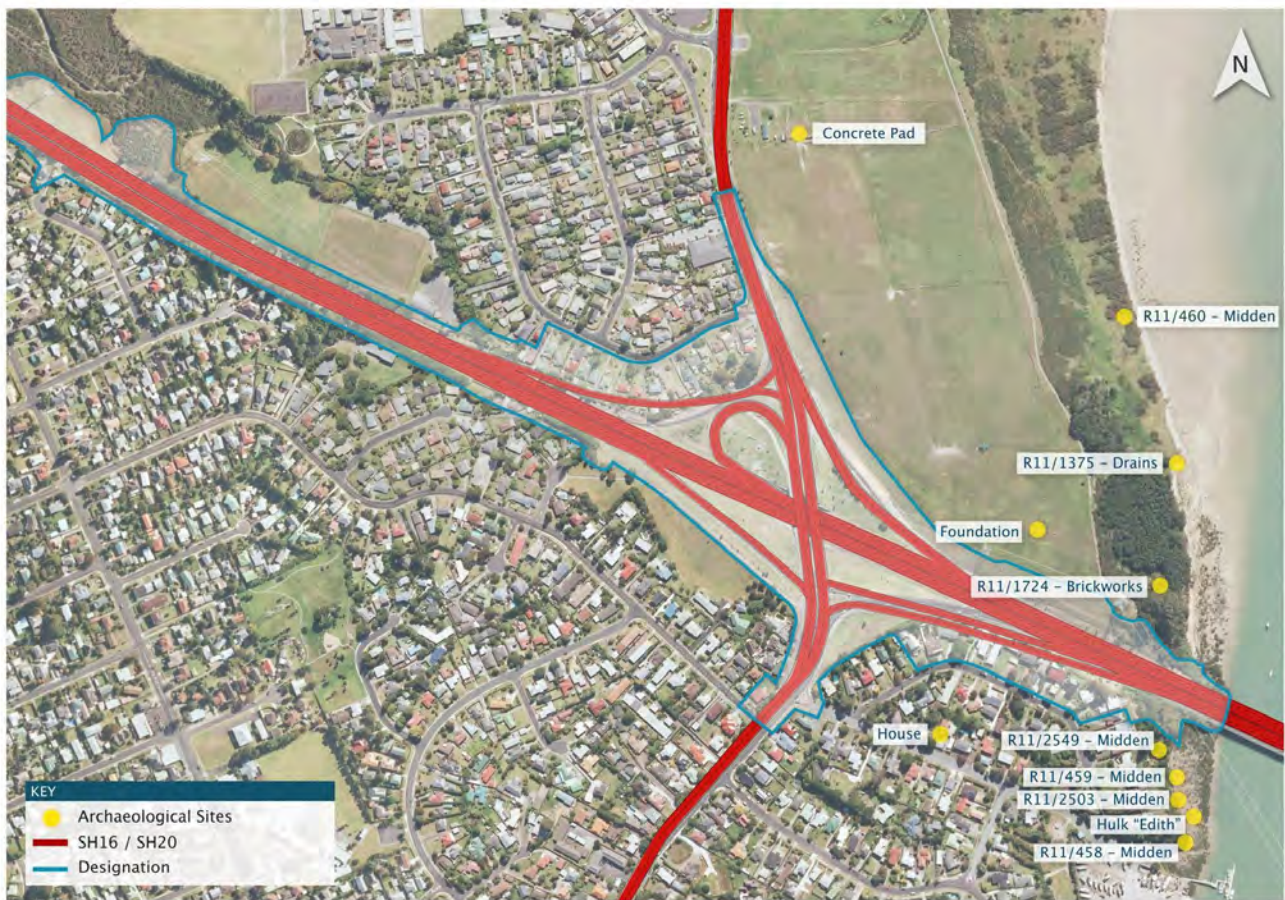
Figure 6.1: Locations of recorded archaeological and other historic sites in Sector 1 in relation to the construction footprint

On the northern side of the motorway are some concrete foundations that are thought to have been part of a former cowshed and windmill, and some brick foundations of unknown date and origin, which Druskovich notes are in the vicinity of a former homestead visible in 1940s aerial photographs. Neither of these have been recorded as archaeological sites, but the concrete foundation is identified in Waitakere City Council's Harbourview-Orangihina Open Space Management Plan (2003) as a site of potential historical interest. Both these sites are within the Harbourview Orangihina Park. A construction yard is located in the park, but would occupy only part of the area to the north of the brick foundation and to the south of the concrete foundation.

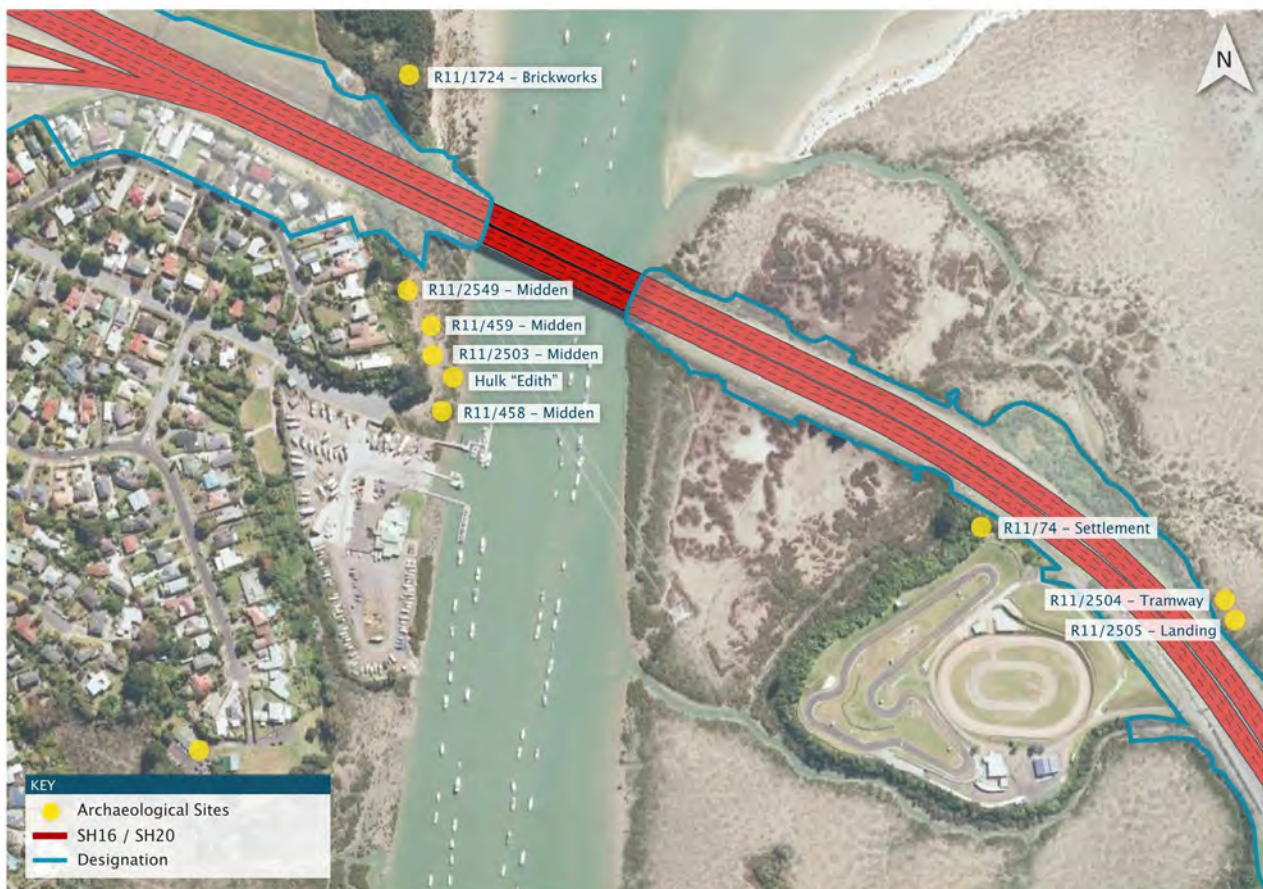
Figure 6.3: Recorded archaeological sites in the vicinity of Sector 2 in relation to the construction footprint

This sector of the route crosses the Whau River and is entirely on reclaimed causeway or bridge. No archaeological sites are present in this sector. However, in the CMA Druskovich noted eroding material from site R11/459 at the western end (Sector 1) and from site R11/74 at the eastern end (Sector 3) (see **Figure 6.3**). A hulk, or abandoned boat (the *Edith*), formerly located on the western side of Sector 2 was recorded in this area by the ARC, but the record notes that it had rotted away by 1993, and Druskovich found no remains that are likely to relate to the hulk.

Site	Description	Condition	Relationship to Construction Footprint
ARC CHI 202	Hulk (<i>Edith</i>) built at Omaha in 1905, converted to a barge and register closed in 1925. Abandoned on west bank of Whau River	Rotted away bar a few rusty spikes reported in 1993. Nothing visible today	South of construction footprint

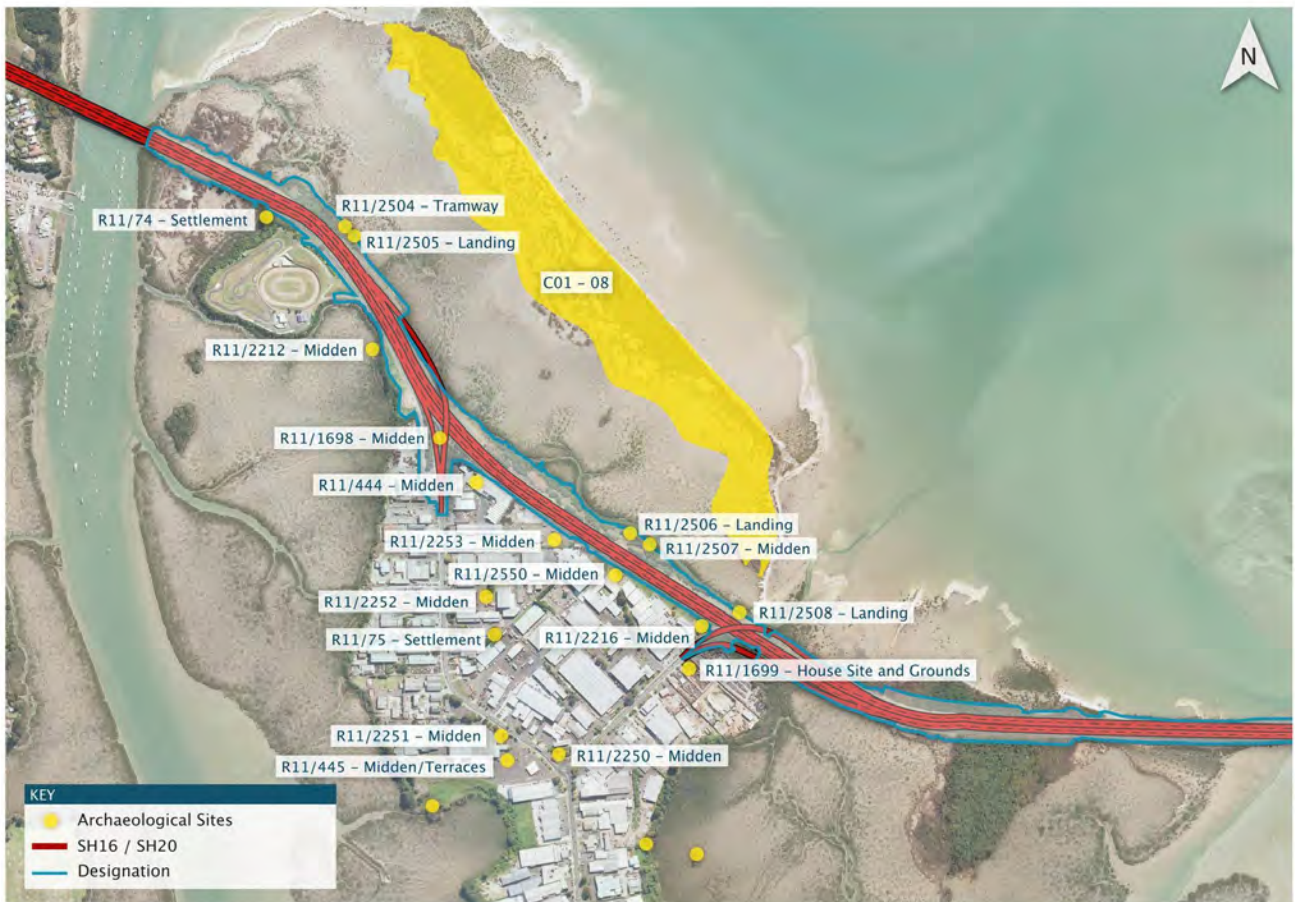
Figure 6.8: Locations of recorded archaeological sites in Sector 3 in relation to the construction footprint

At the northern end of the Rosebank Peninsula, a number of sites have been recorded within the construction footprint or immediately adjacent to it (see **Figure 6.8**, **Table 4**). Several of the recorded sites have already been damaged or destroyed by past activities including motorway construction and urban development. Much of the western end of Rosebank Peninsula between the current motorway and Waitemata Harbour has been modified substantially and the area was used as a works depot when the original motorway and bridge to Te Atatu was constructed. No archaeological sites would be expected within this area or generally within c.5m of the existing motorway. The earlier work on the ramps at Patiki and Rosebank Roads has also already modified the

Druskovich (Bioresarches 2010) also recorded six new sites, five of which are on the northern side of SH16: R11/2504 (Tramway); R11/2205 (Landing); R11/2506 (Landing); R11/2507 (Midden); and R11/2508 (Landing). These sites are located either within the construction footprint or immediately adjacent to it. Druskovich noted that the majority of this area is covered in dense invasive weeds (especially blackberry and pampas), which restricted visibility and field survey.

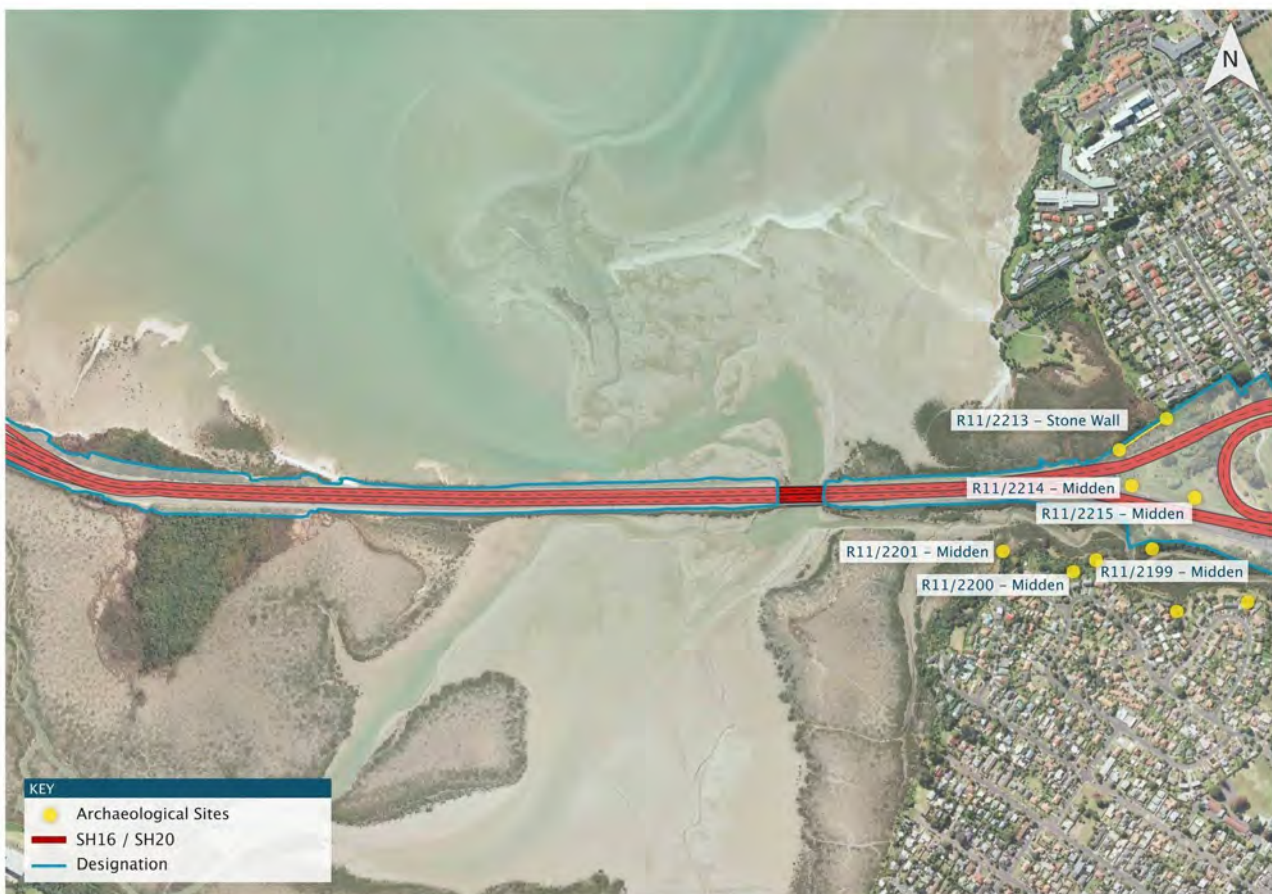
Figure 6.9: Locations of recorded archaeological sites in Sector 4 in relation to the construction footprint

Three midden sites (R11/2199, 2200, and 2201) are recorded at the eastern end of Sector 4, to the south of the Waterview Inlet (Figure 6.9, Table 5) and are therefore not in the vicinity of any proposed works.

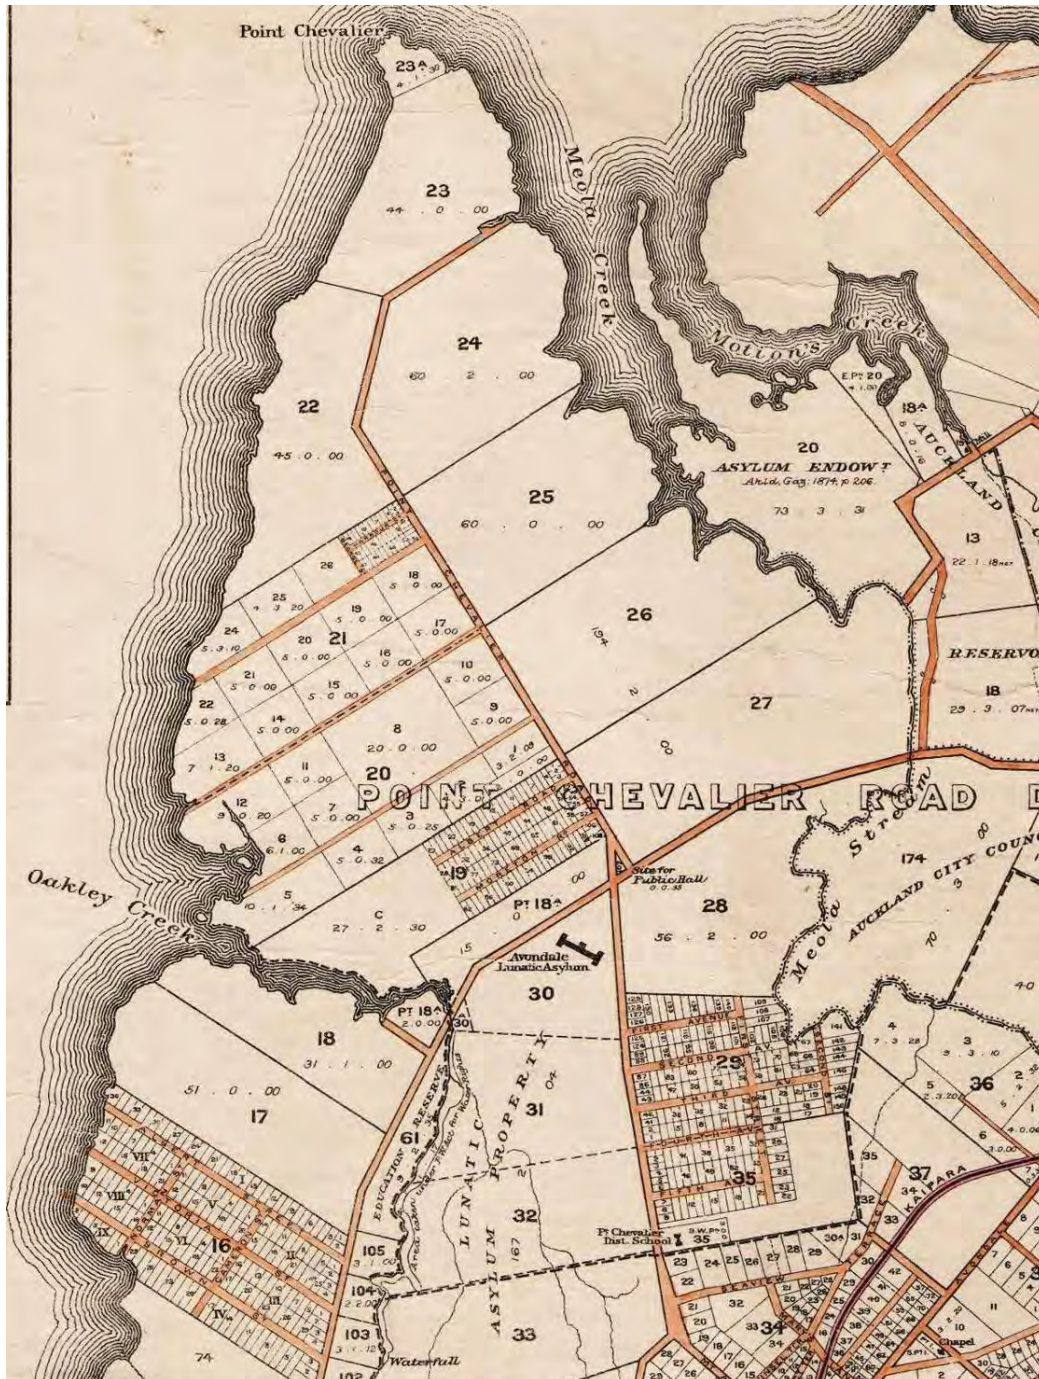
Figure 6.11: 1891 plan (Eden Roll 46) showing the original allotments in the Waterview/Pt Chevalier area (Auckland Public Library NZ Maps 4785). Pt 18A south of the Oakley Creek/Waterview Inlet was the site of the flour mill.

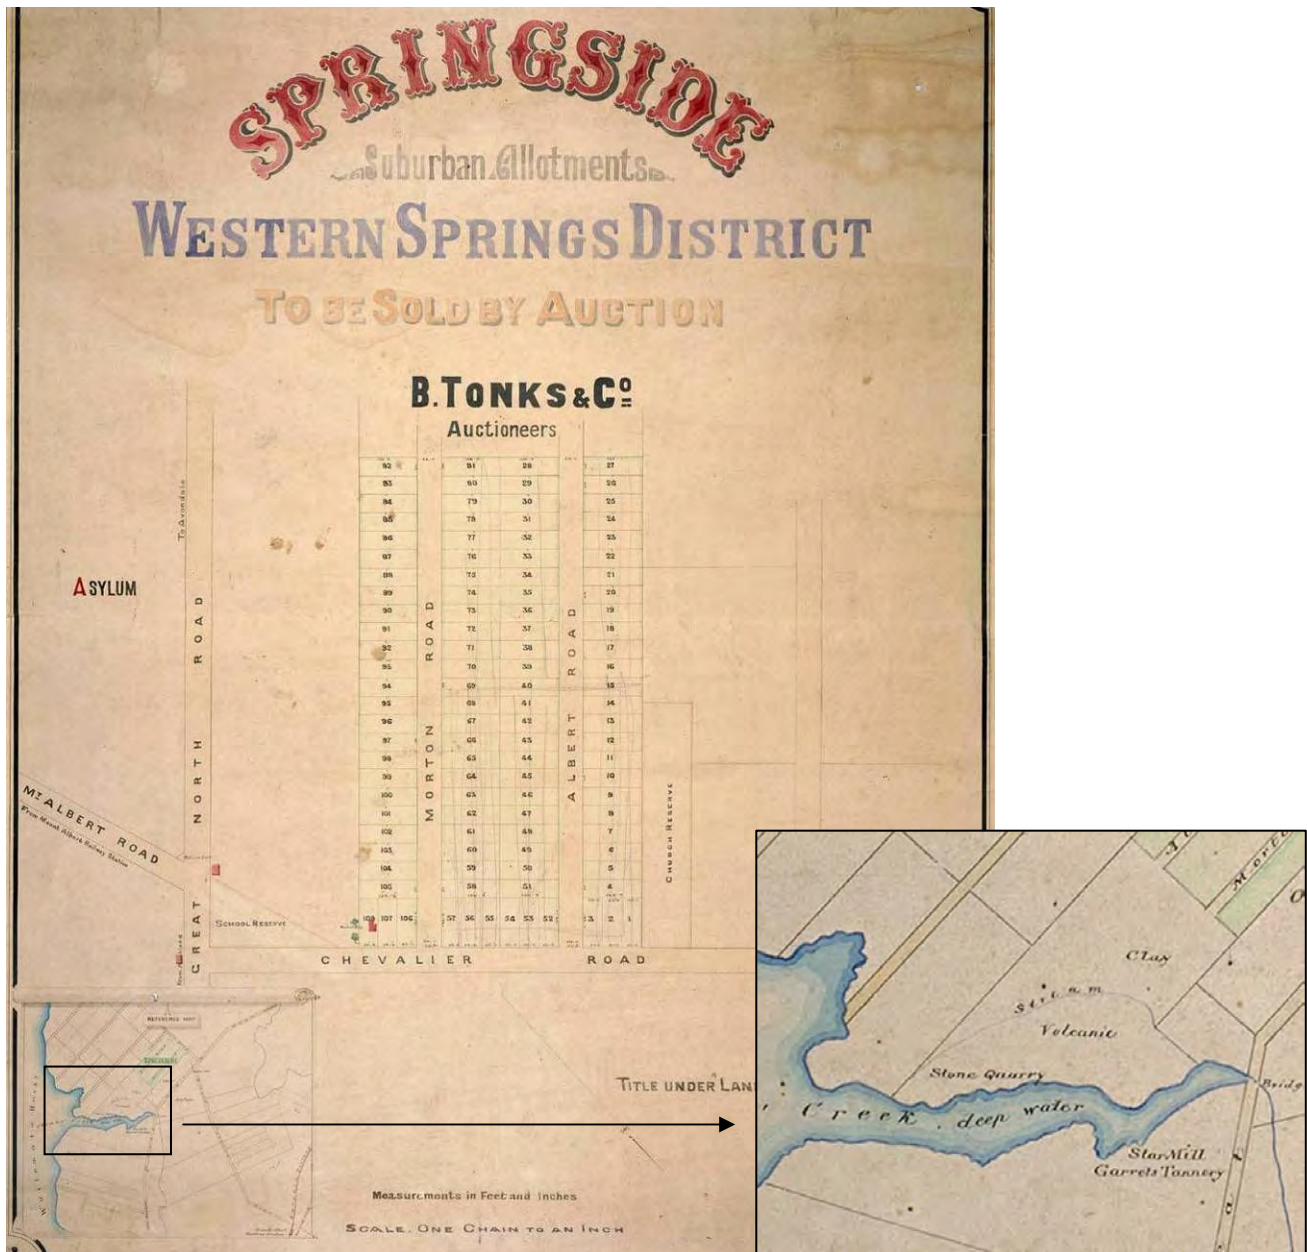
Figure 6.14: Auckland Public Library NZ Map 2695 'Springside Suburban Allotments Western Springs District To be Sold by Auction' (1882), with enlargement of inset plan. The Star Mill/Garrett Brother's Tannery site is shown south of Oakley Creek and a Stone Quarry to the north on the unsubdivided part of allotment 19. Note also the stream to the north of the Stone Quarry

The 1880s Springside subdivision plan shows a quarry on the northern side of Oakley Creek on Mattsons property (**Figure 6.14**). This local quarry would almost certainly have been the source of the basalt used for the foundations and retaining walls of the flour mill in 1859, and for the bridgehead and other structures on the northern side of the creek probably during the tannery period. In 1879 there is a record of stone being quarried 'close to Oakley Creek, for the purpose of getting out stone for the new wing of the Asylum' (Truttman n.d. (c), citing Walker 1961), which may also refer to quarrying on the Mattson property. In 1912, the Birkenhead Borough Council acquired some of Mattson's Flat for quarrying purposes, but the quarry was apparently operated inefficiently, and production appears to have been on a relatively small scale until the 1920s, when the Waitemata County Council quarry was established (Truttman n.d (c); McCurdy and Mason 2006: 11). Operation of the quarry in the later periods would have destroyed some of the archaeological evidence relating to earlier periods of occupation (pre-European) and use (the tannery operation and the 19th century quarry).

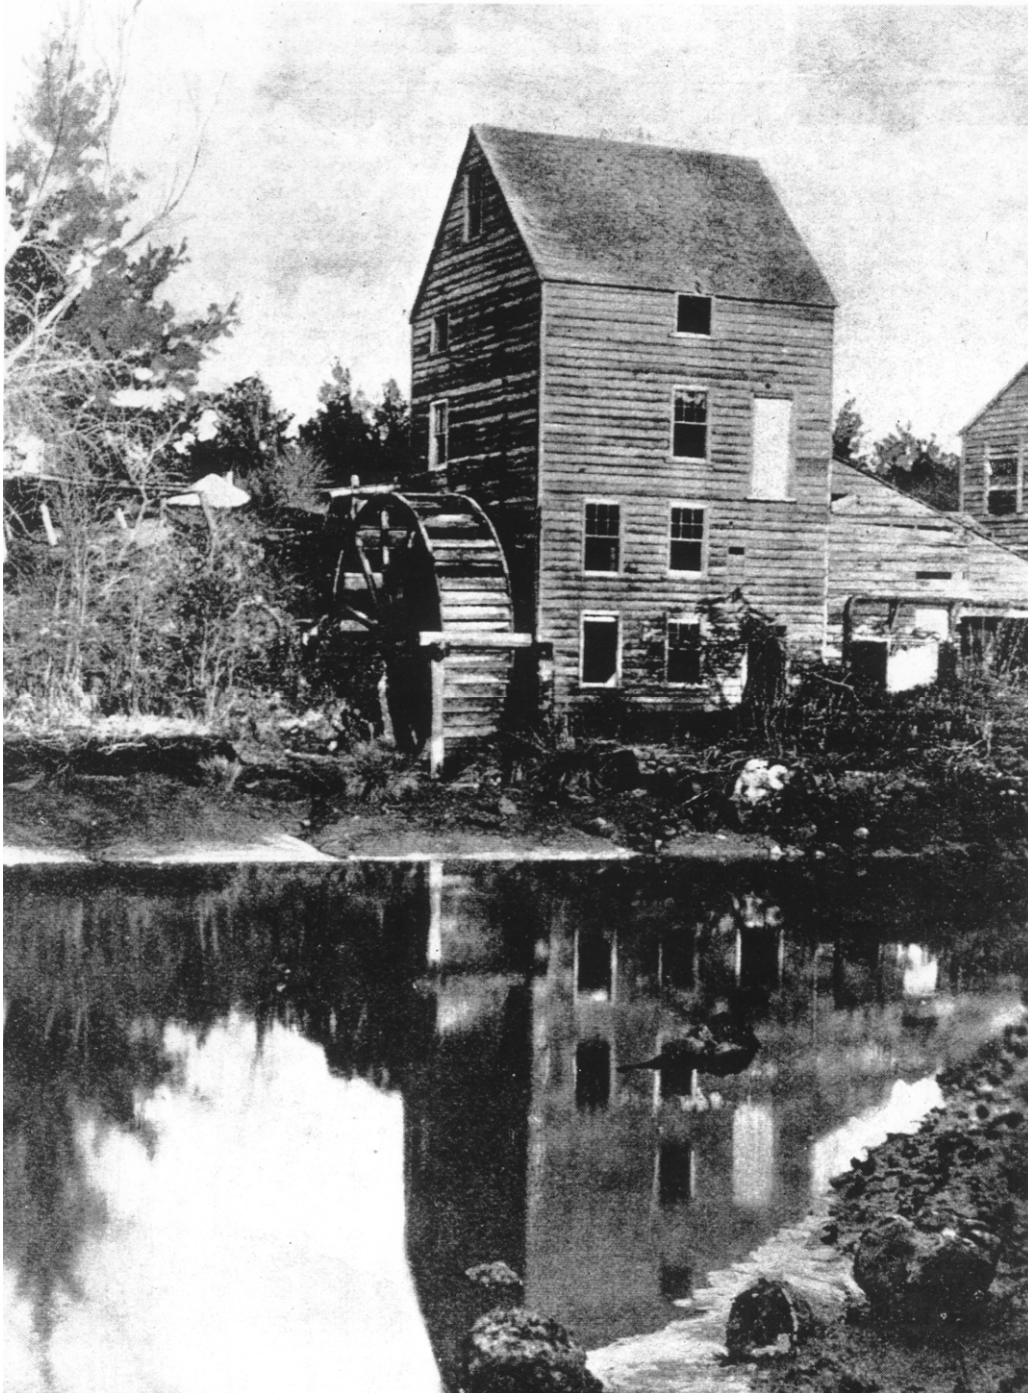
Figure 6.15: The Waterview mill, originally Thomas's Mill or the Star Mills and later part of the Garrett Brothers Tannery (site R11/2191). This view dates to 1898, about 8 years after the tannery closed (from the *New Zealand Graphic and Ladies Journal*, 10/9/1898 p.332, Auckland Public Library A1683)

The full layout of the tannery operation is not known, but two photographs show the mill and some of the buildings some years after it closed (**Figure 6.15** shows the mill/tannery in 1898, and **Figure 6.16** in 1909). The photographs show a five storey mill house and the high breast shot (i.e. backshot) mill wheel which date from 1873, when the earlier flour mill was rebuilt after the fire. The lean-to building to the right is likely to be the tannery boiler house, as this is the location of a remnant boiler on the site today (see Section 6.5.1.2). The boiler would have provided steam power for the Vickers pumping engine (referred to in the *Herald* article, 24/4/1879) and other machinery. Beyond the lean-to, two other buildings are visible in **Figure 6.16**, raised some way off the ground. It has been suggested that these are drying sheds (e.g. Truttman 2007: 14), though storage sheds for bark are also a possibility as the bark would presumably have been kept close to the mill and was needed in large quantities. There are low earthen foundation walls on the northern side of the creek for buildings which might also have served this purpose.

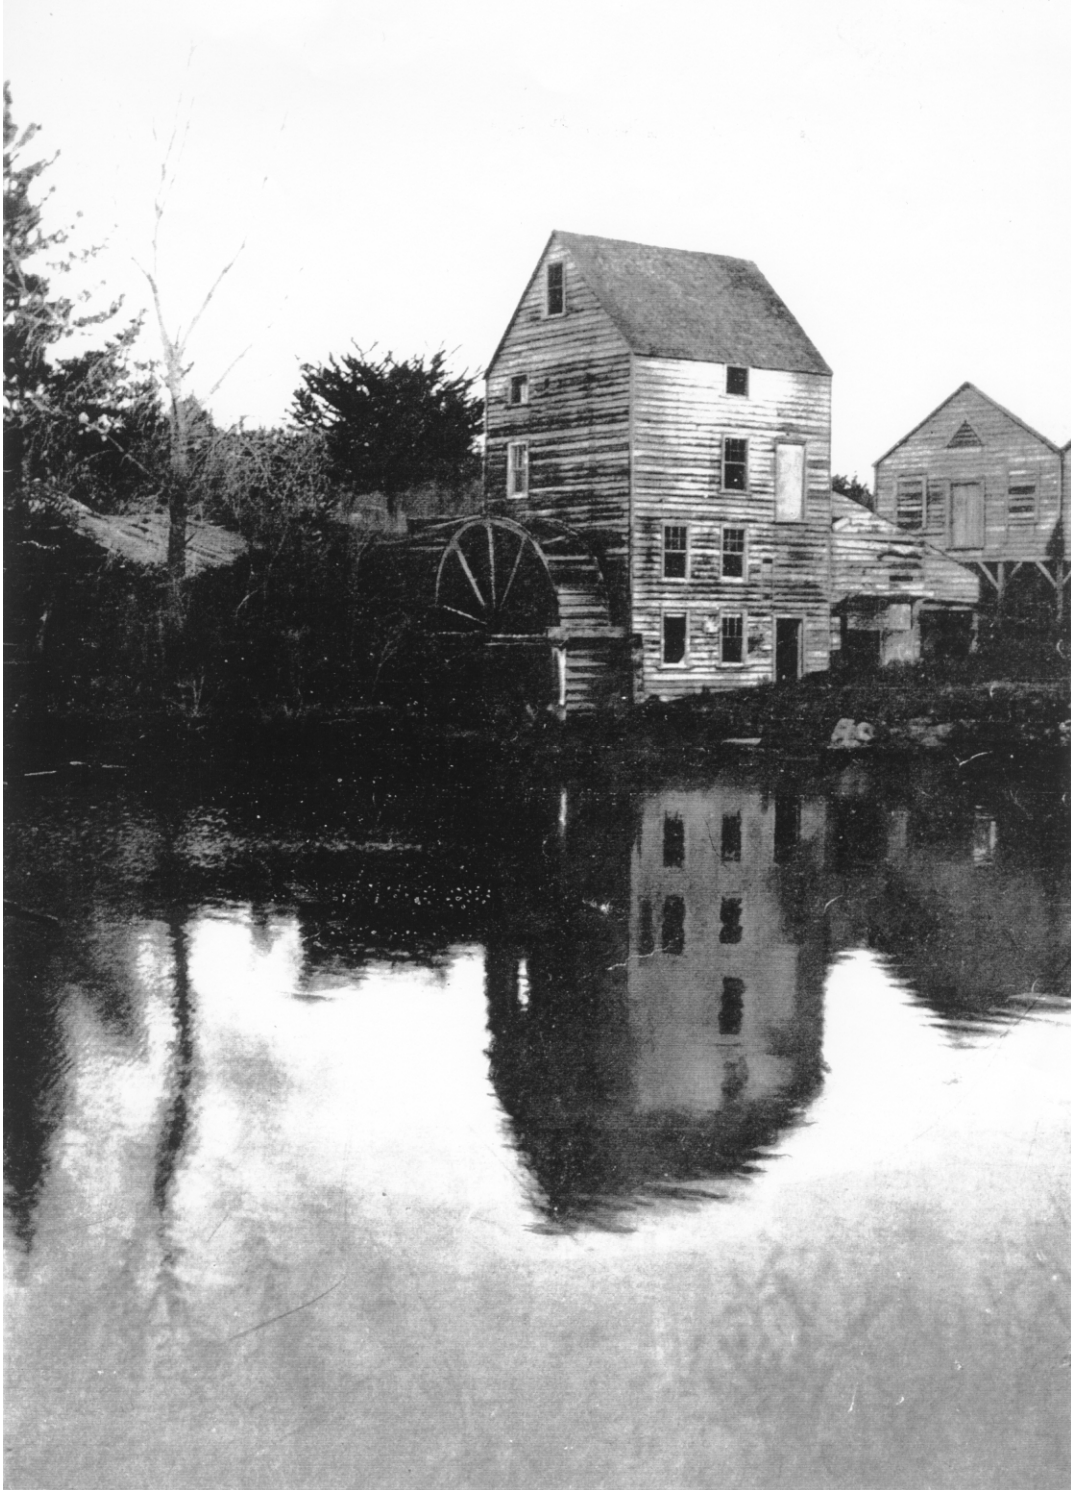
Figure 6.16: The mill in 1909 photographed by Samuel Frith (from the *Weekly Graphic and New Zealand Mail*, 11/8/1909, p.17, Auckland Public Library A1730)

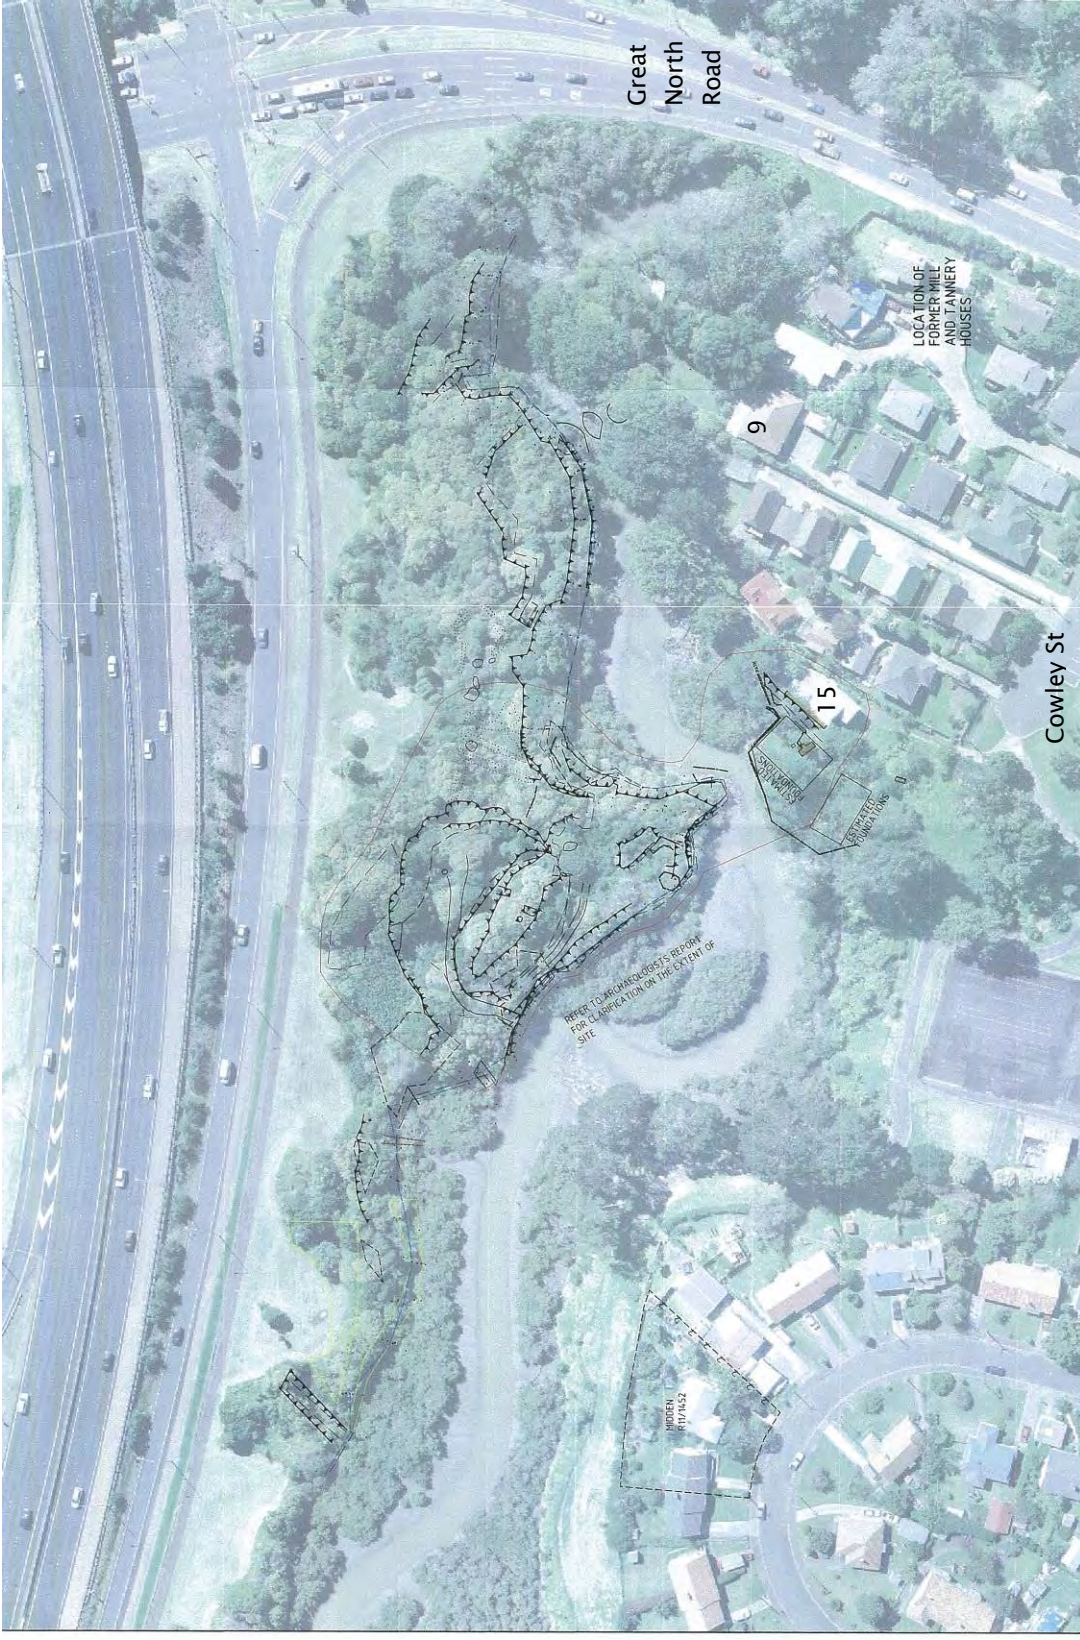
Figure 6.18: Plan of the Waterview Inlet Heritage Area containing Site R11/2191 (mill/tannery/quarry), R11/2203 (Maori settlement), R11/2202 (midden/karaka trees) and R11/2459 (midden). (Plan compiled by Thorne Archaeology, Biosearches and Beca). Nos. 15 and 9 Cowley Street are marked. See enlarged sections in Figure 6.19 – Figure 6.22

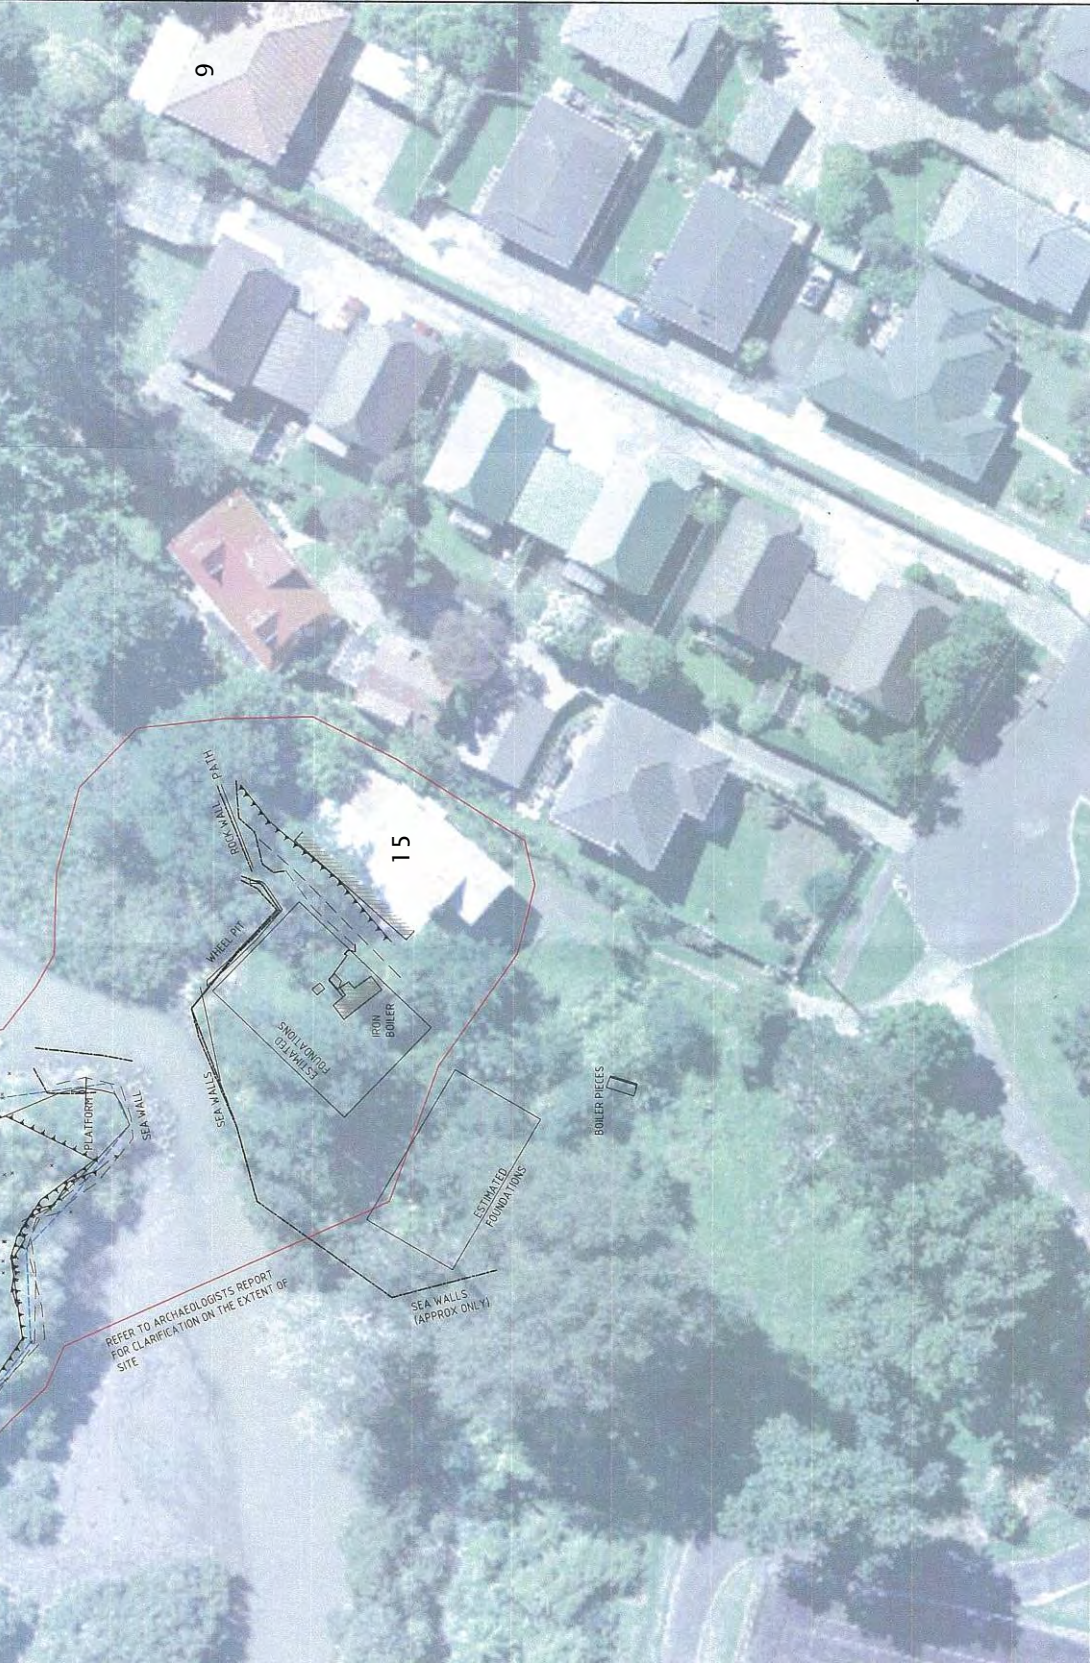
Figure 6.19: Detail showing the mill site south of Oakley Creek (rock walls, wheel pit, boiler and boiler pieces) and the northern bridgehead surrounded by collapsed rock. Nos. 15 and 9 Cowley Street indicated

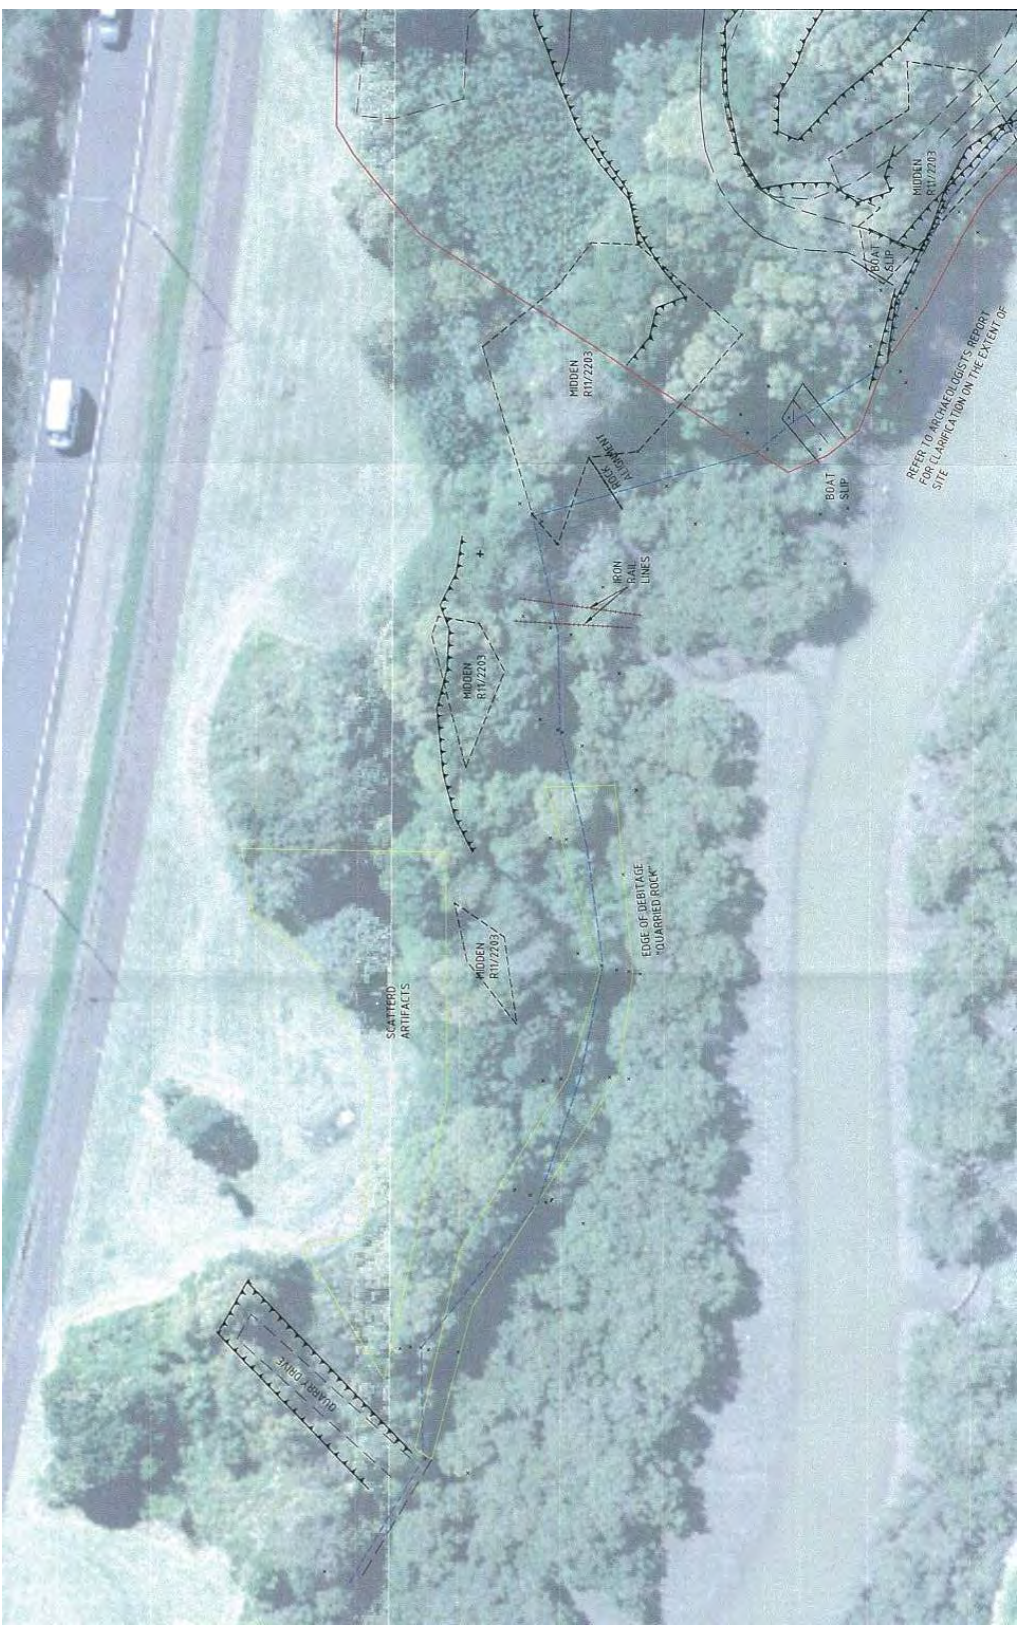
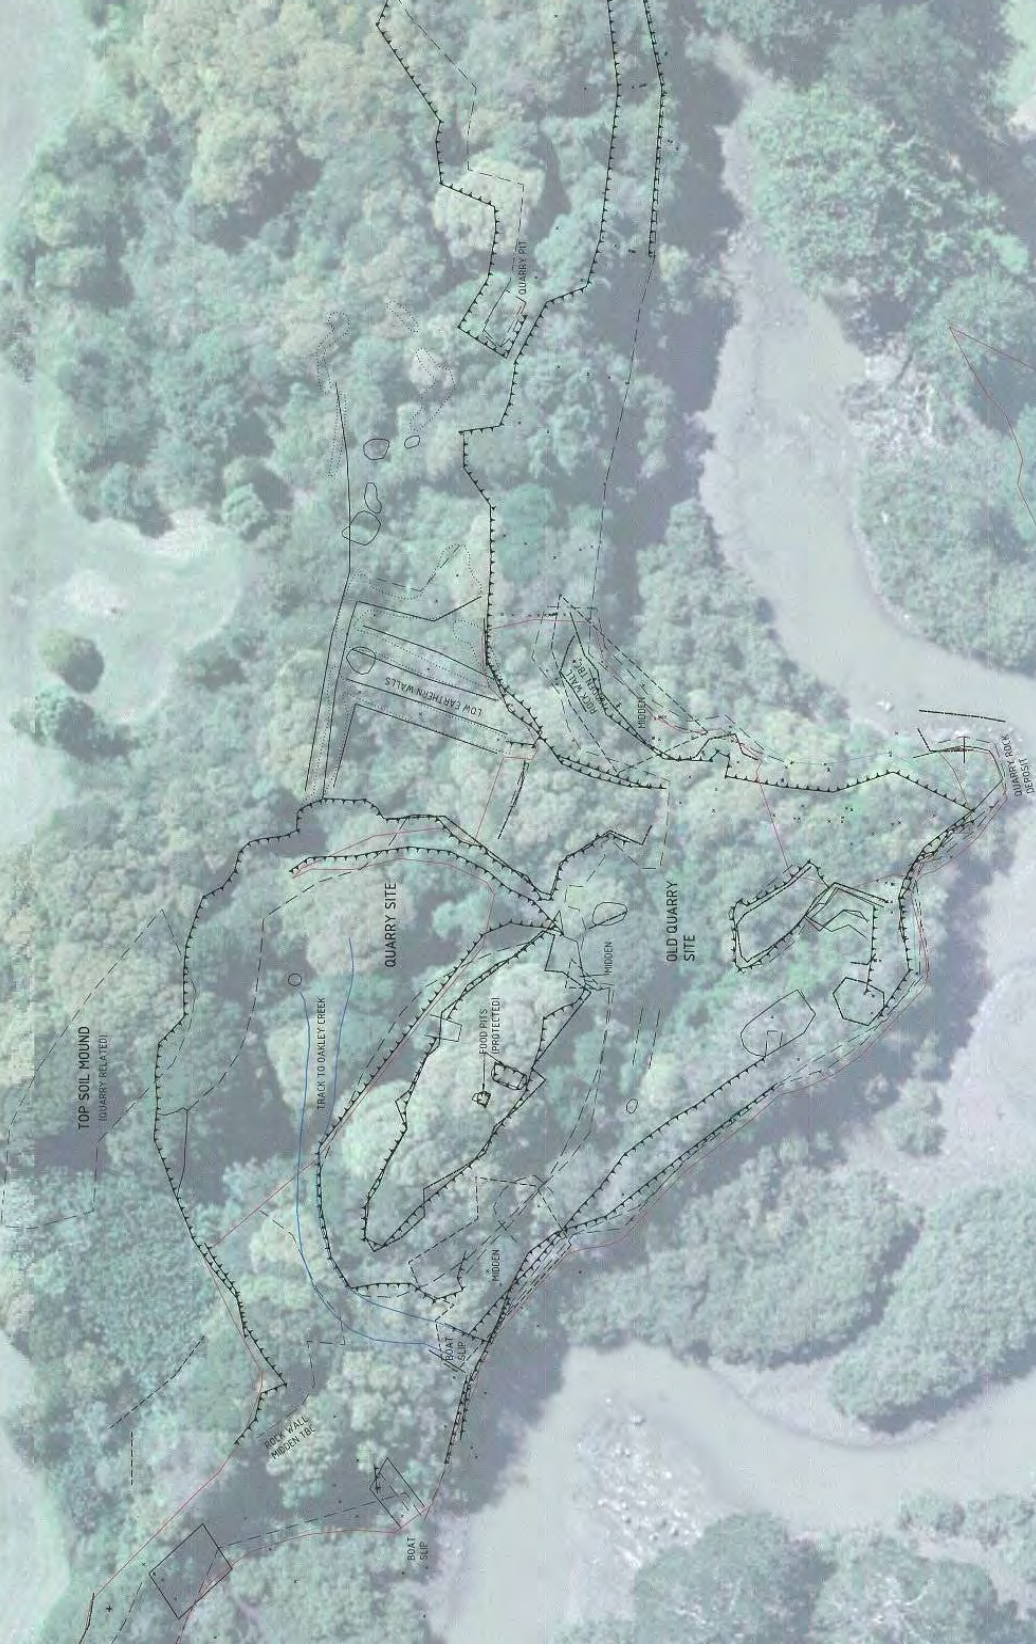
Figure 6.20: Detail showing the western part of the Waterview Inlet Heritage Area north of Oakley Creek (areas of midden, quarried rock, rock walls and alignment, boat slips and a tentatively identified 'quarry drive')

The remains of a former Maori settlement (R11/2203) and two possibly associated midden sites (R11/2202 and R11/2459) have been recorded in the same general location as the tannery and quarry site (R11/2191), on the northern side of the Creek (**Figure 6.18** and **Figure 6.20–Figure 6.22, Figure 6.29**).

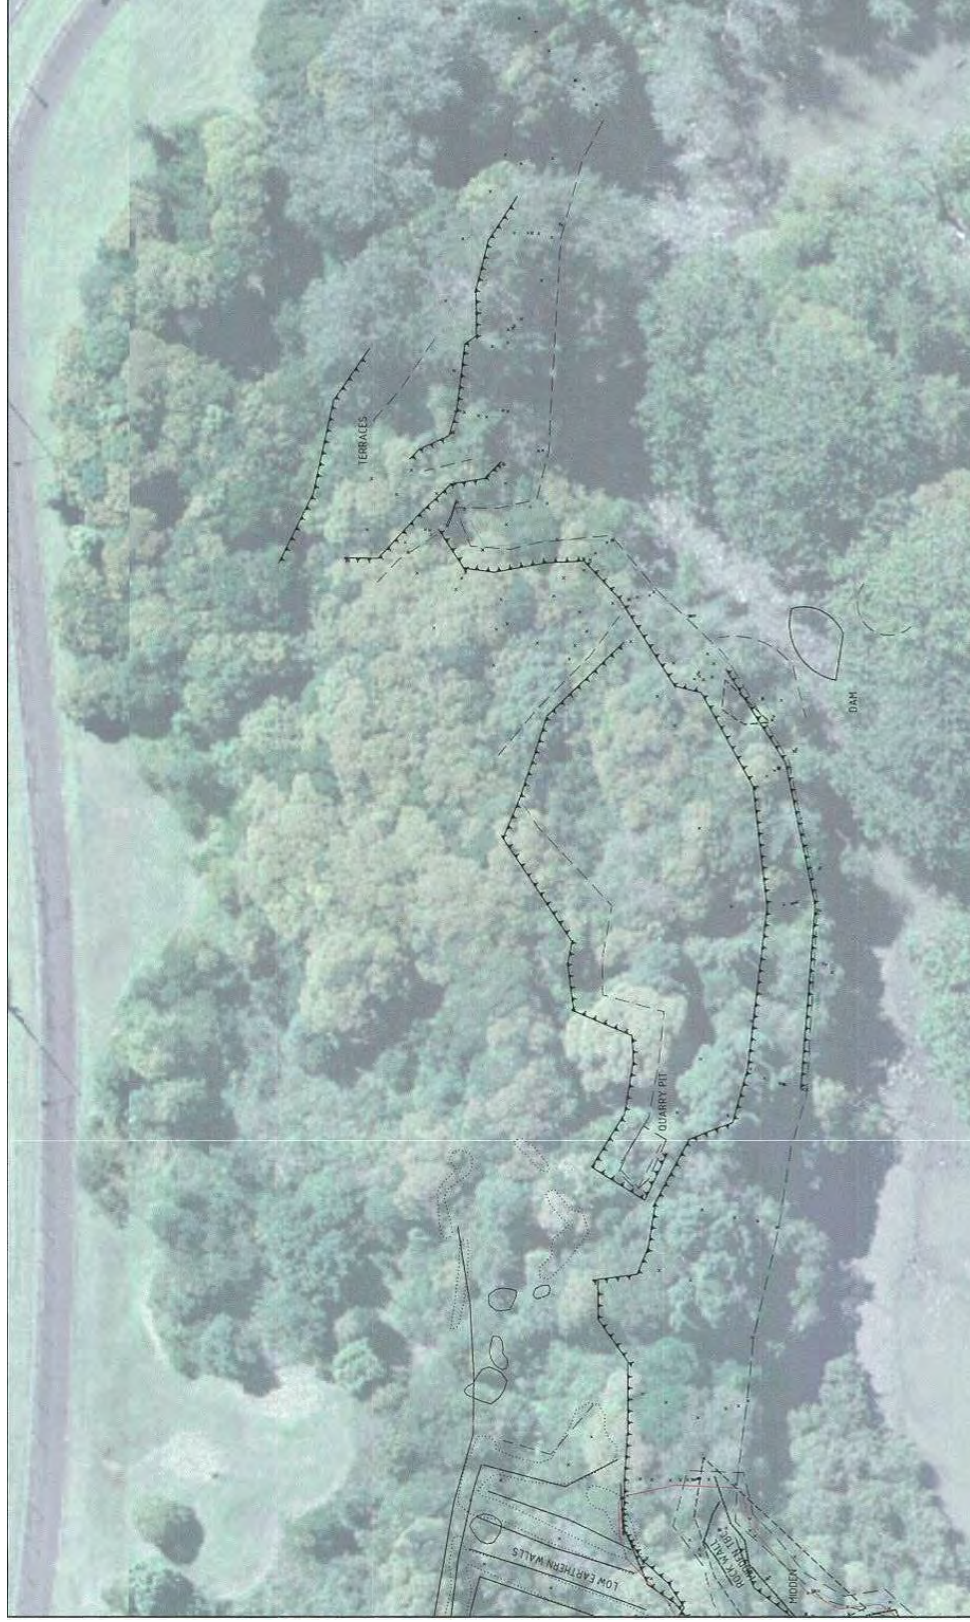
Figure 6.22: Detail showing eastern part of the Waterview Inlet Heritage Area north of Oakley Creek (low earthen walls, midden, rock wall, and old quarry features including areas of benching and terracing, mounds and a pit)
