Western Ring Route – Waterview Connection

Assessment of Archaeological Effects

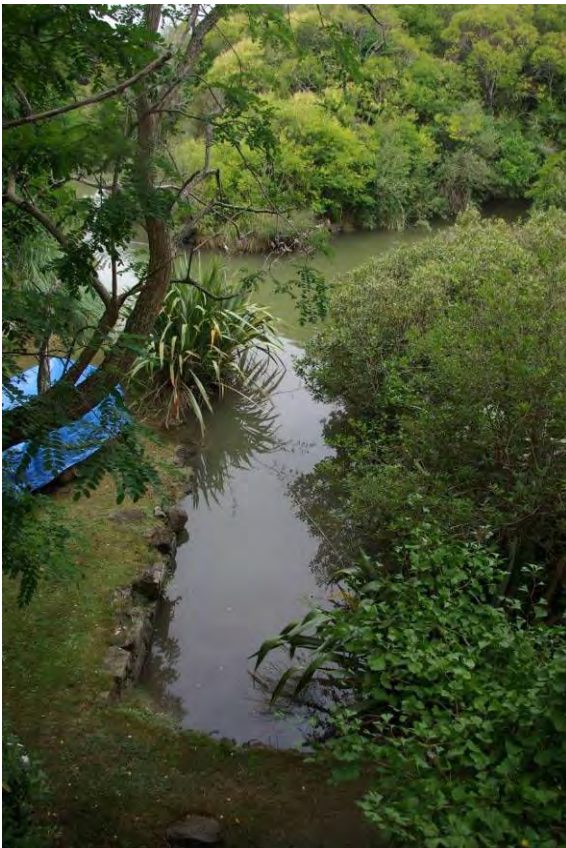
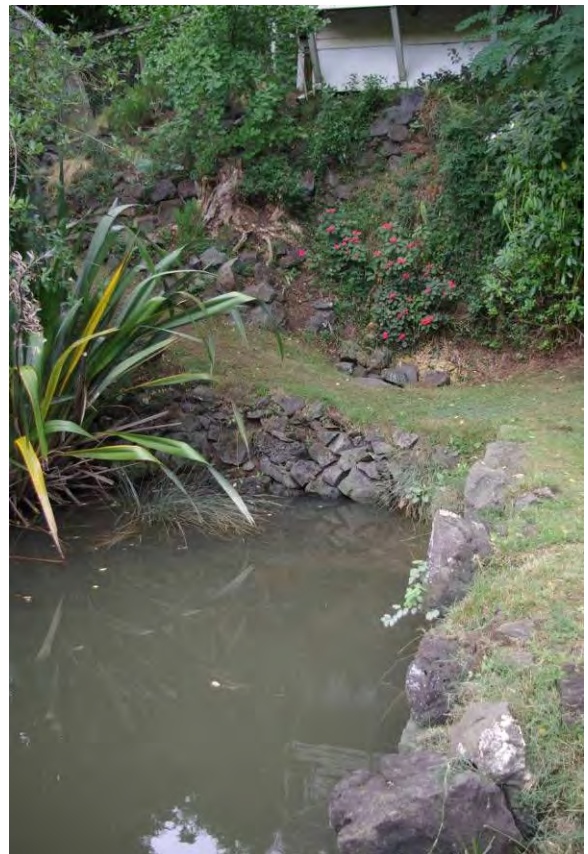
Figure 6.23: The inlet formed by the construction of a basalt lined wheel pit for the original mill; views to the north (left) and to the south (right)

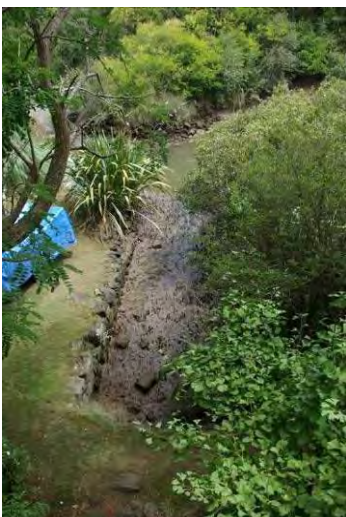
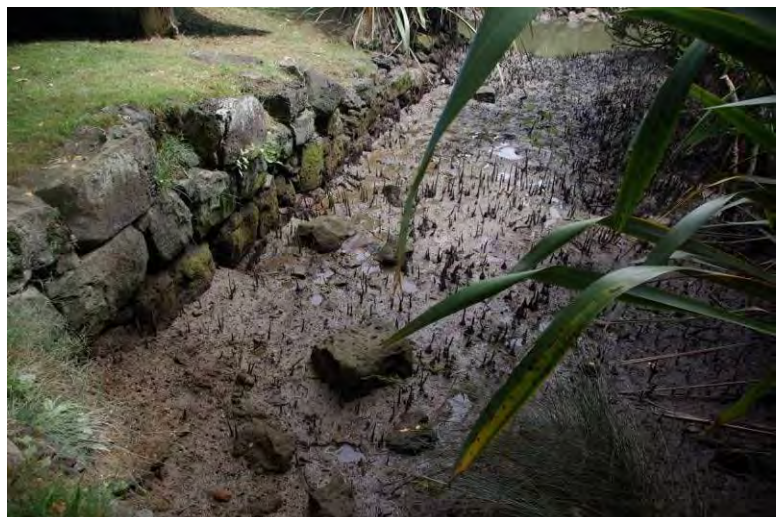
Figure 6.24: View of wheel pit at low tide showing stonework. The vegetated bridge abutment across the creek can be seen in the background of the general view on the left

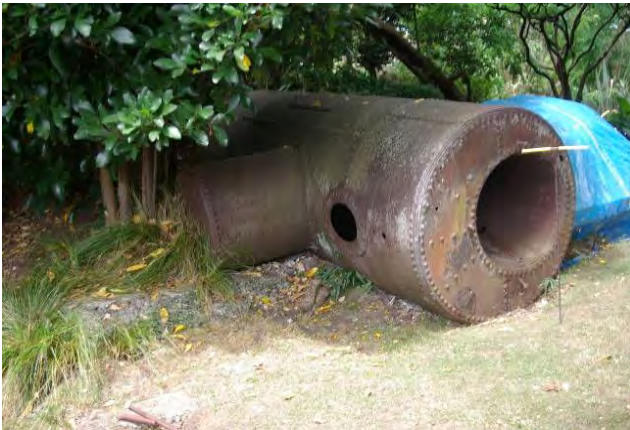
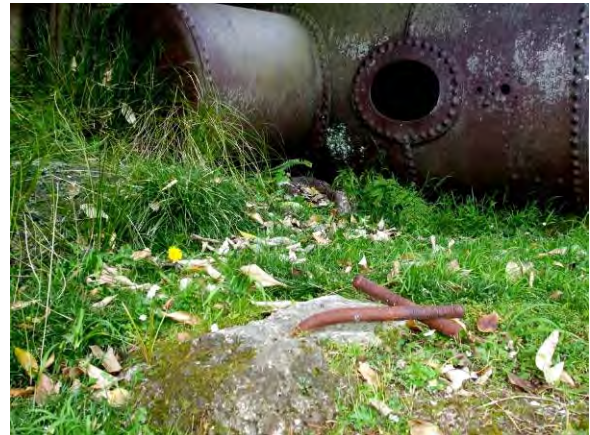
Figure 6.25: Remains of the Cornish boiler and concrete foundations (photo on right courtesy of Robyn Mason and Peter McCurdy)

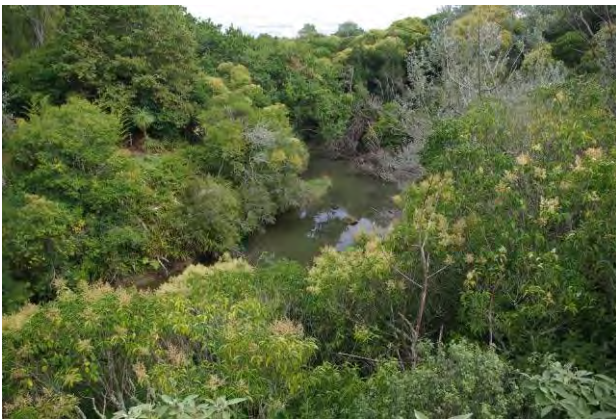
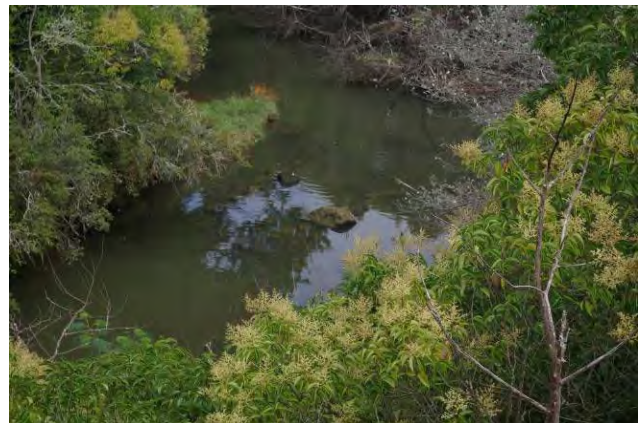
Figure 6.26. Views of the creek from the current cycleway bridge over Great North Road, looking west (right: close-up showing a deposit of cut basalt in the creek)

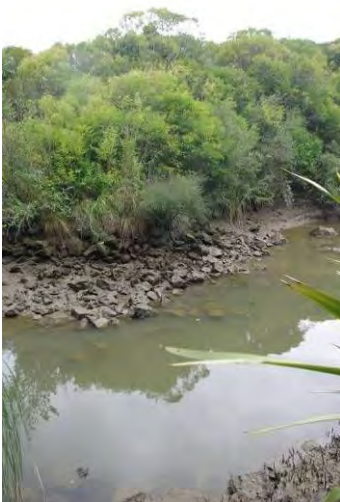
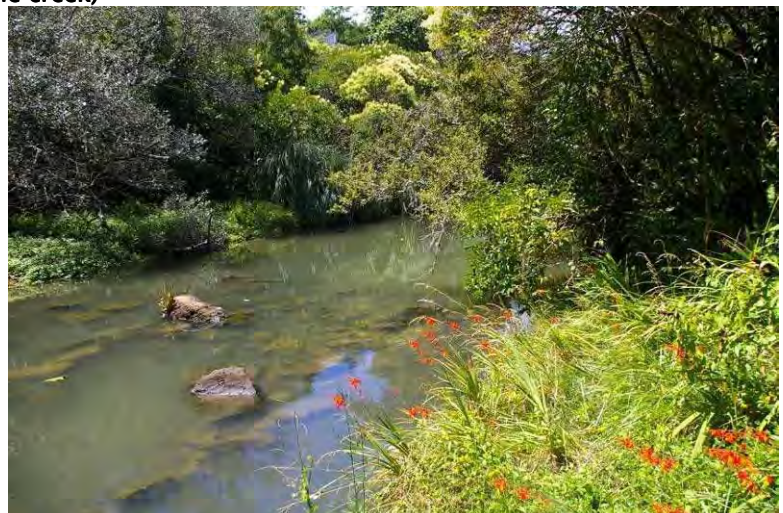
Figure 6.27: Low tide, showing the heavily vegetated northern bridge abutment (left) and cut basalt boulders some 50m upstream (right)

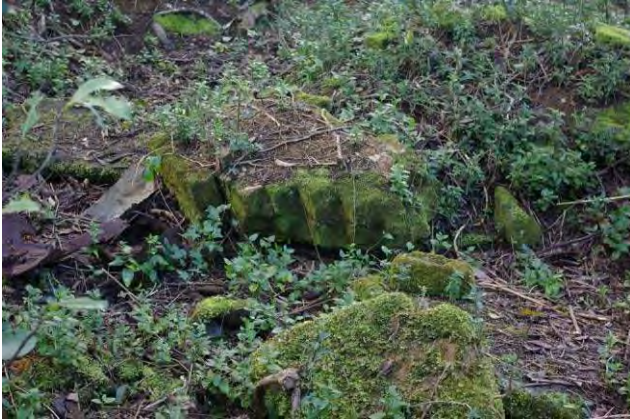
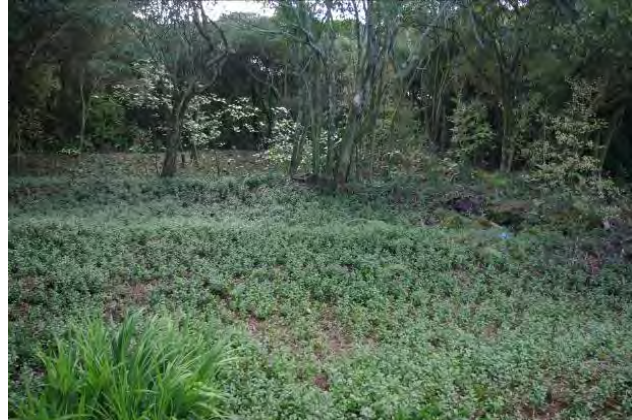
Figure 6.28: Brick and iron debris on the northern side of the creek (left) next to low earthen walls (right)

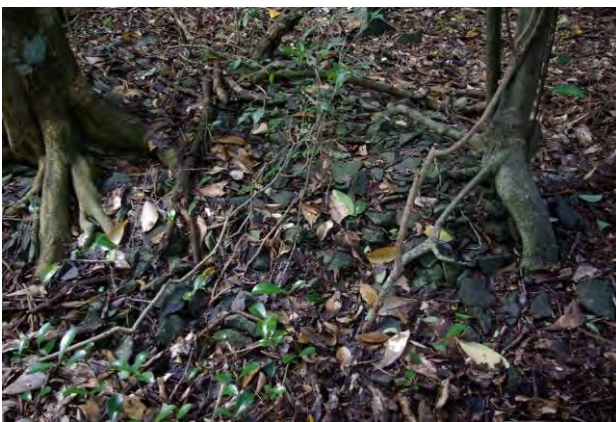
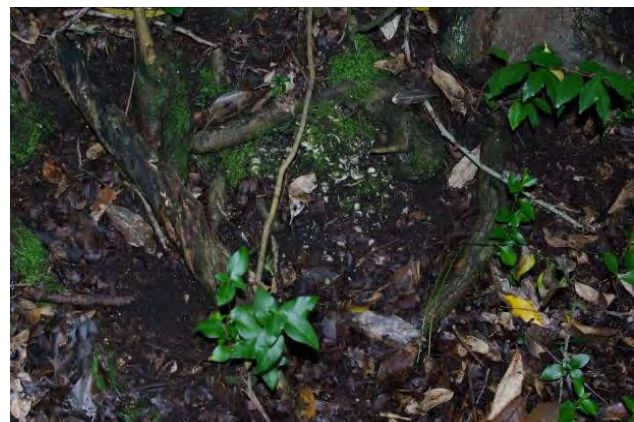
Figure 6.29: Northern side of creek: close-up of stone mason's flaking floor near quarry (left) and midden eroding below the pits in site R11/2203 (see also Figure 6.21)

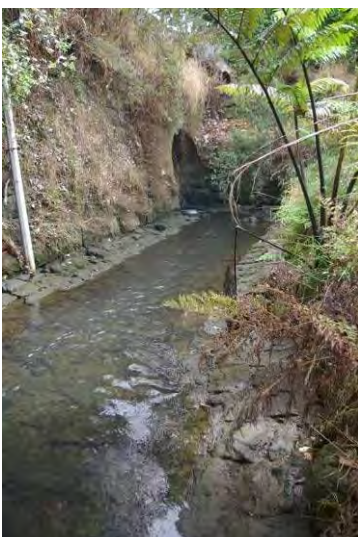
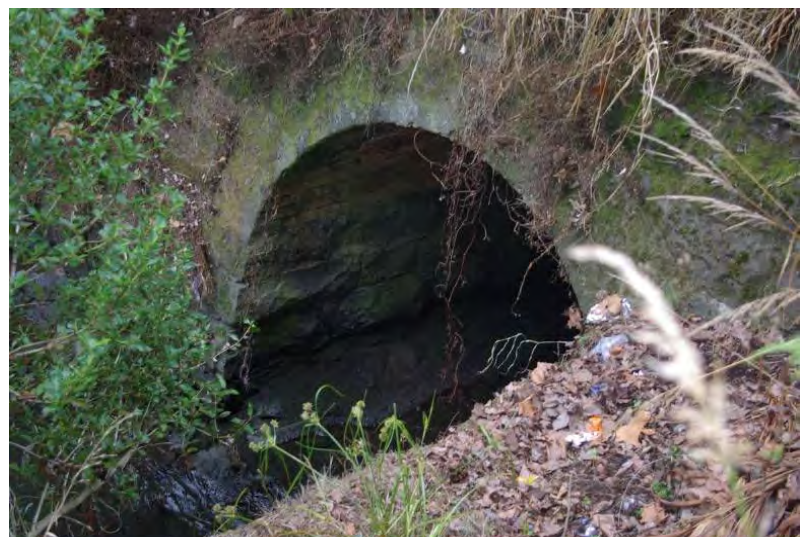
Figure 6.30: View of the old dam site (in the foreground in the view on the left) and the basalt and brick bridge culvert through which Oakley Creek flows beneath Great North Road, from the east

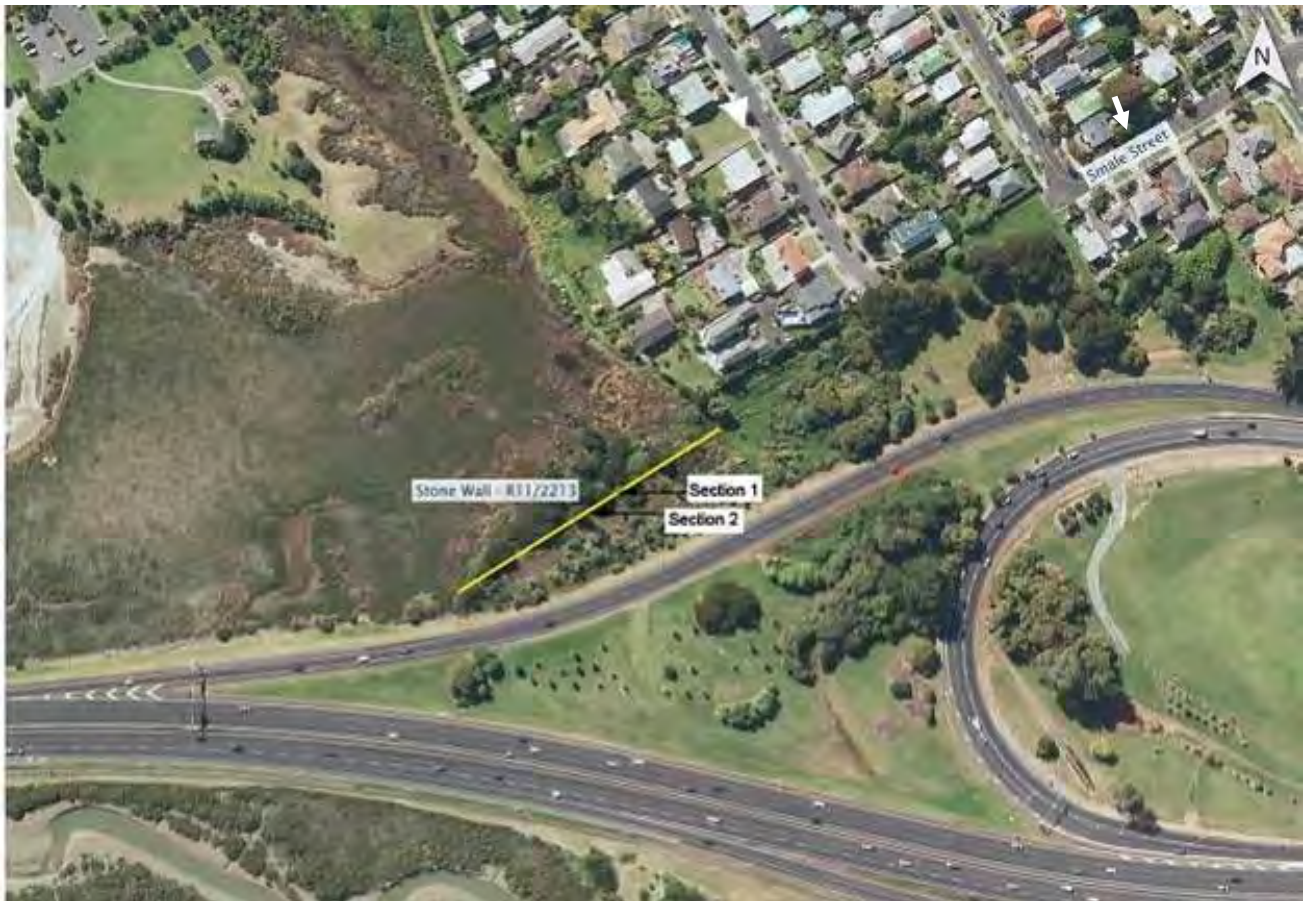
Figure 6.35: Location of stone wall R11/2213, and wall sections surveyed in detail

Two sections of the wall were examined in detail (**Figure 6.35**). A description of the construction type and condition of the wall based on this examination is provided in **Appendix C**. Section 1 was found to be in moderate condition with some evidence of rebuilding (**Figure 6.38**). Section 2 was in very good condition with little evidence of repair (**Figure 6.39**).

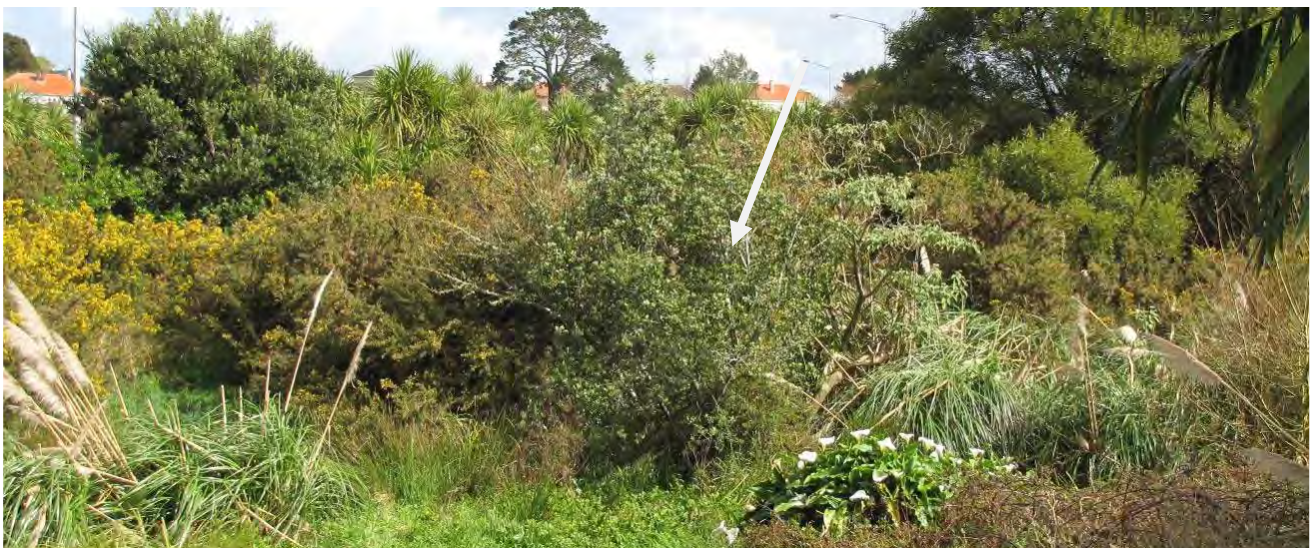
Figure 6.36: View of the location of the eastern end of stone wall R11/2213 (arrowed), and vegetation growth

The wall today is a 130m long dry stone wall on a small island of dry land within a mangrove swamp and small drainage channel that empties into the Waitemata Harbour, some of the area being very overgrown (**Figure 6.36, Figure 6.37**). The wall is typically between 1m and 1.2m high, c.1.2m wide at base and 0.6m wide at top. However at the western end the wall narrows and reduces in height and extends for c.4–5m into the mangroves and mudflats (this section being c.0.8m wide and c.0.4m high).

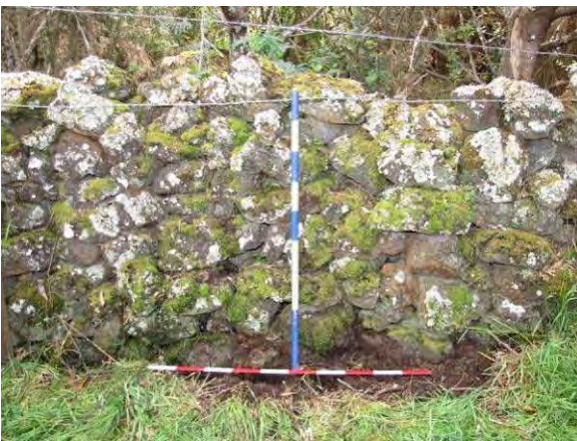
Figure 6.38: R11/2213 stone wall Section 1

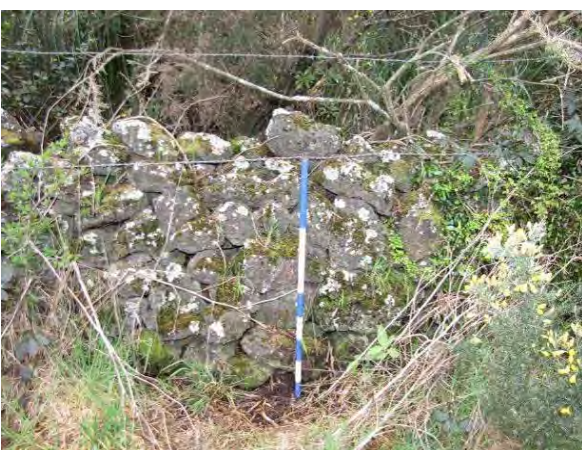
Figure 6.39: R11/2213 Section 2

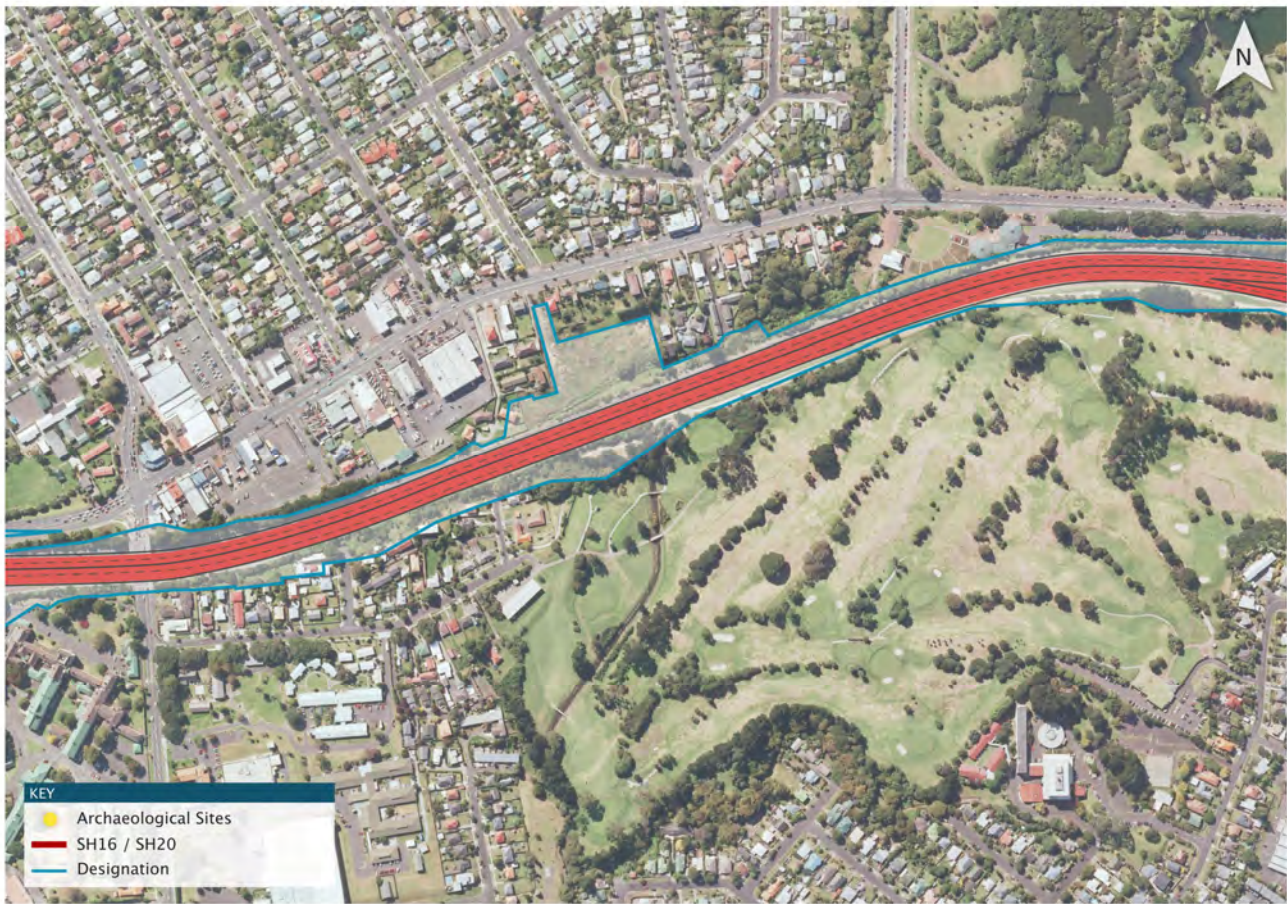
Figure 6.40: Sector 6 construction footprint

There are no known archaeological sites within Sector 6 (Figure 6.40). Review of historic plans by Druskovich (Bioresearches 2010) indicated that this area was largely farmland prior to 1900. Earthworks have been carried out over most of the construction footprint.
