Settlement - Building Damage Categories
[L = 10m, H = 3m]

Client: New Zealand Transport Agency

Project: SH20 Waterview Connection Combined Surface Tunnel

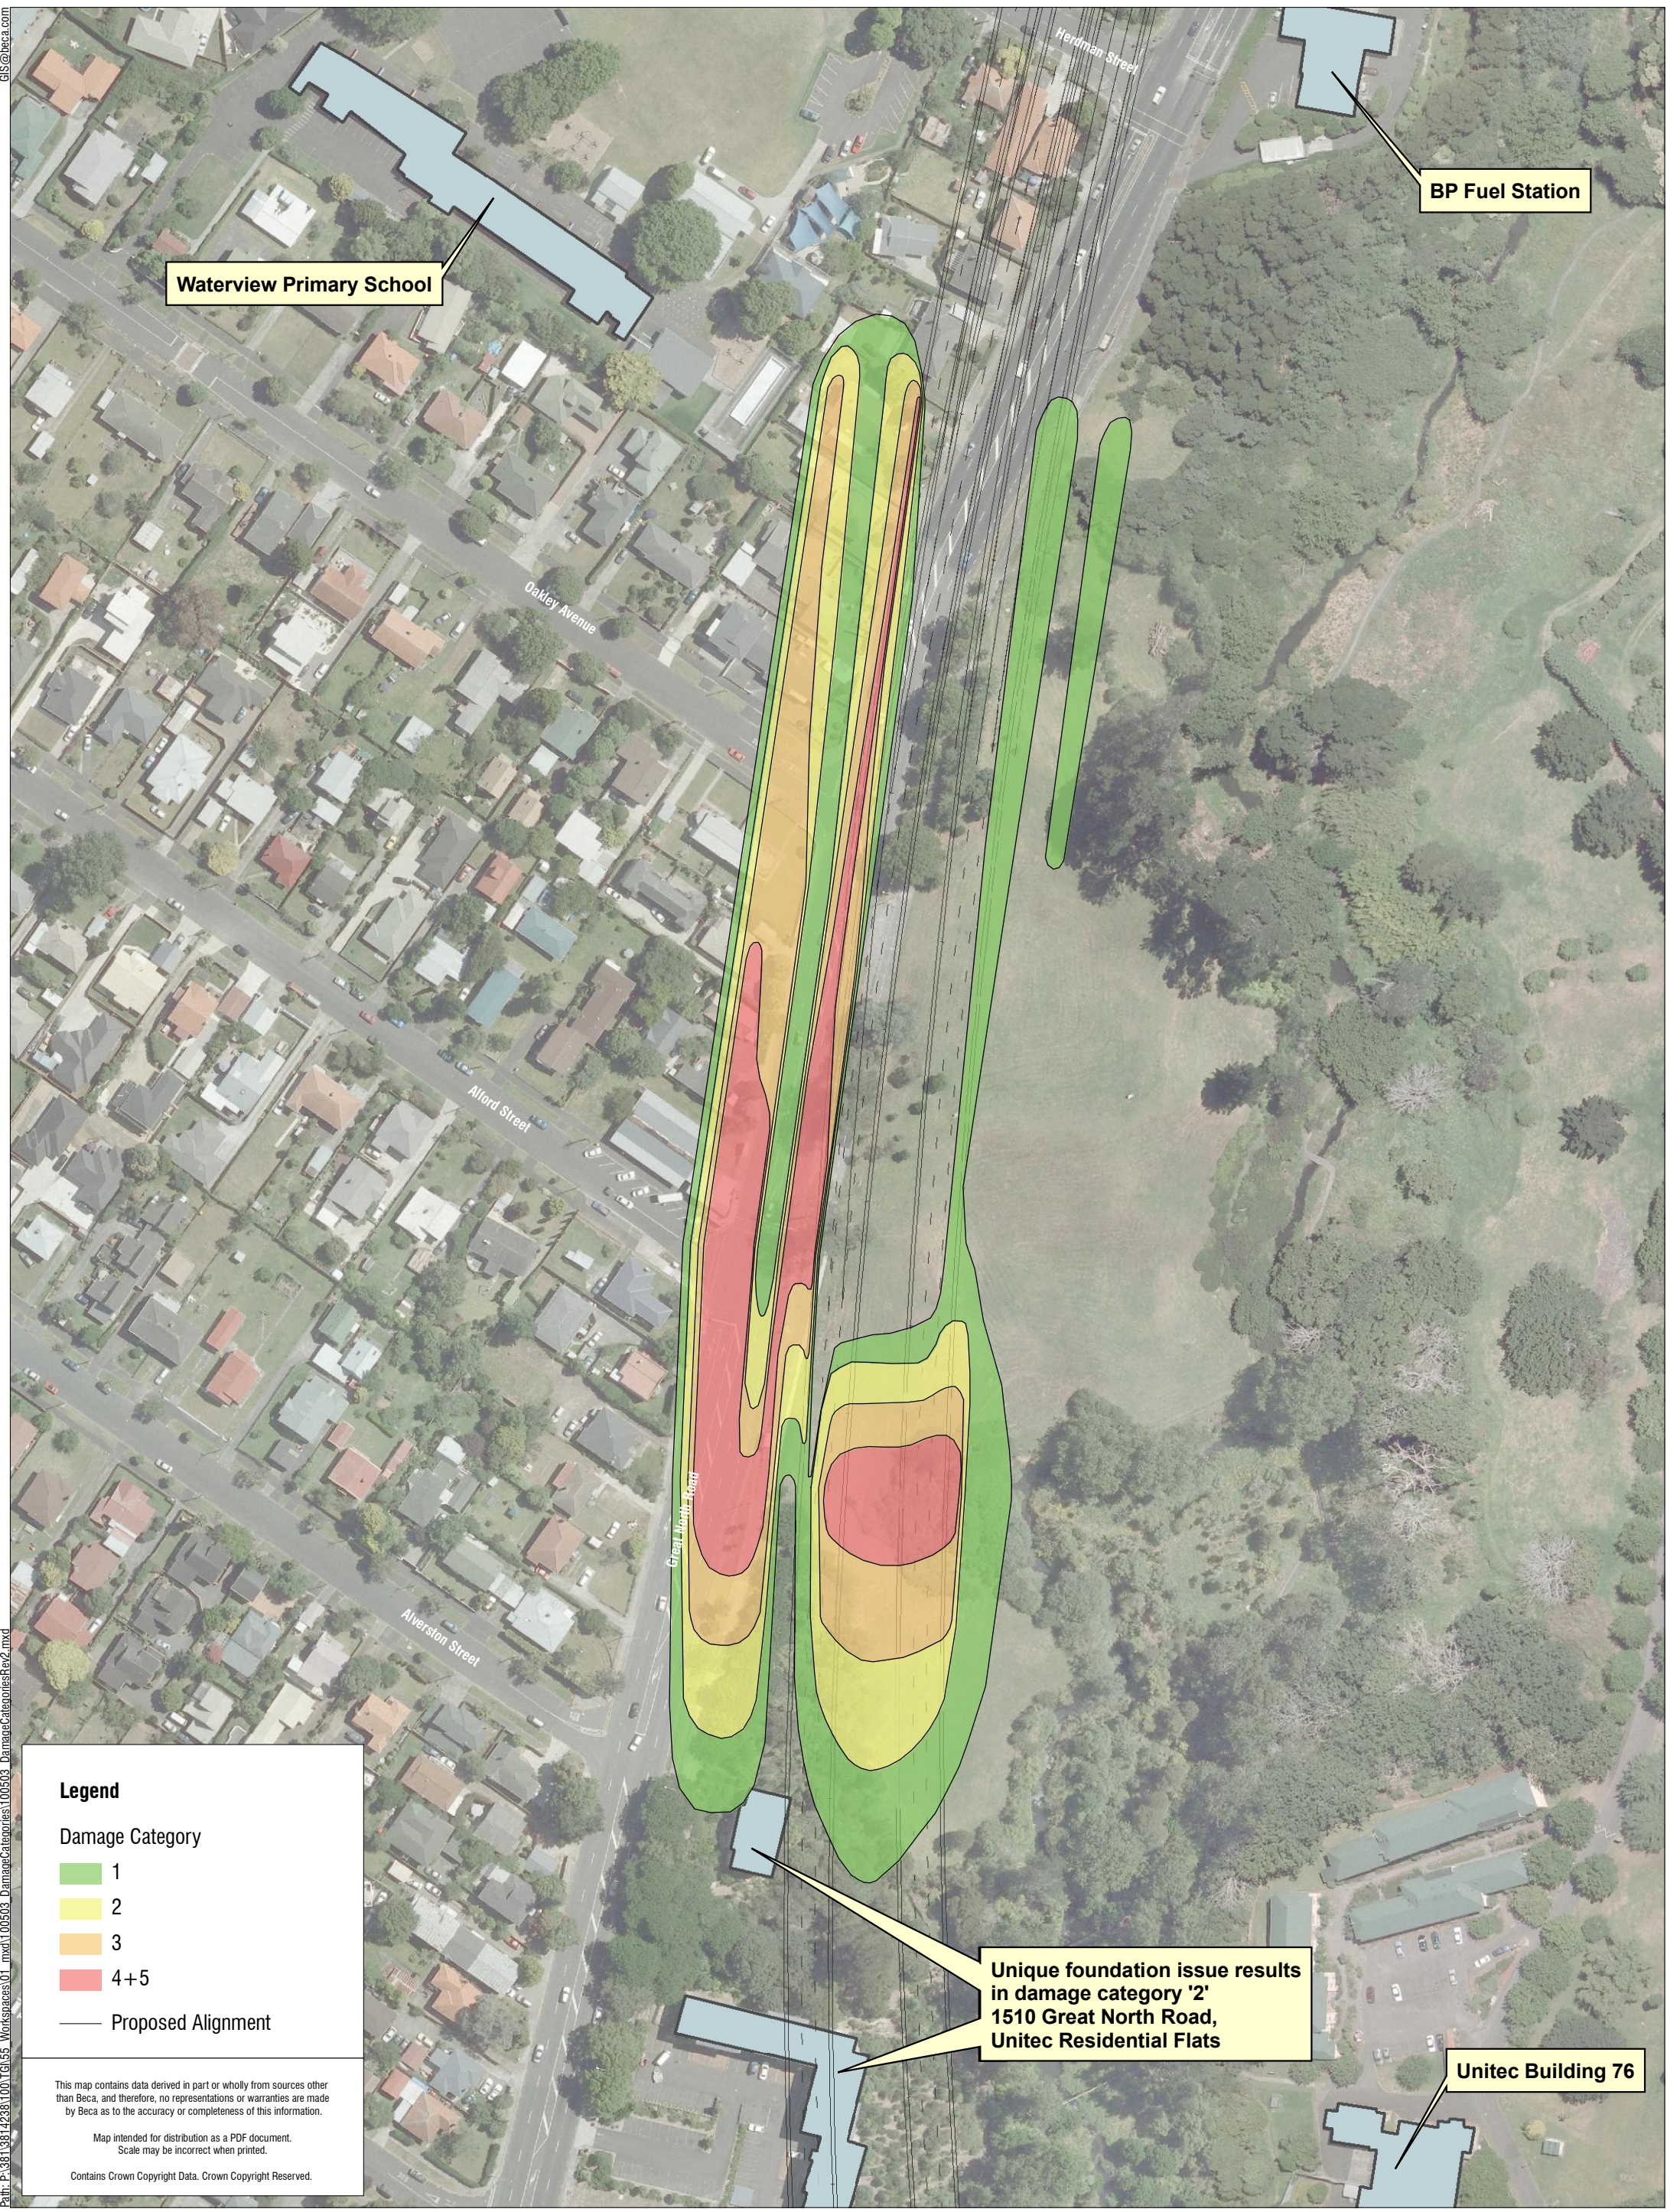
Figure: G - 2

Unique foundation issue results in damage category '2' 1510 Great North Road, Unitec Residential Flats

Settlement - Building Damage Categories
[L = 10m, H = 3m]

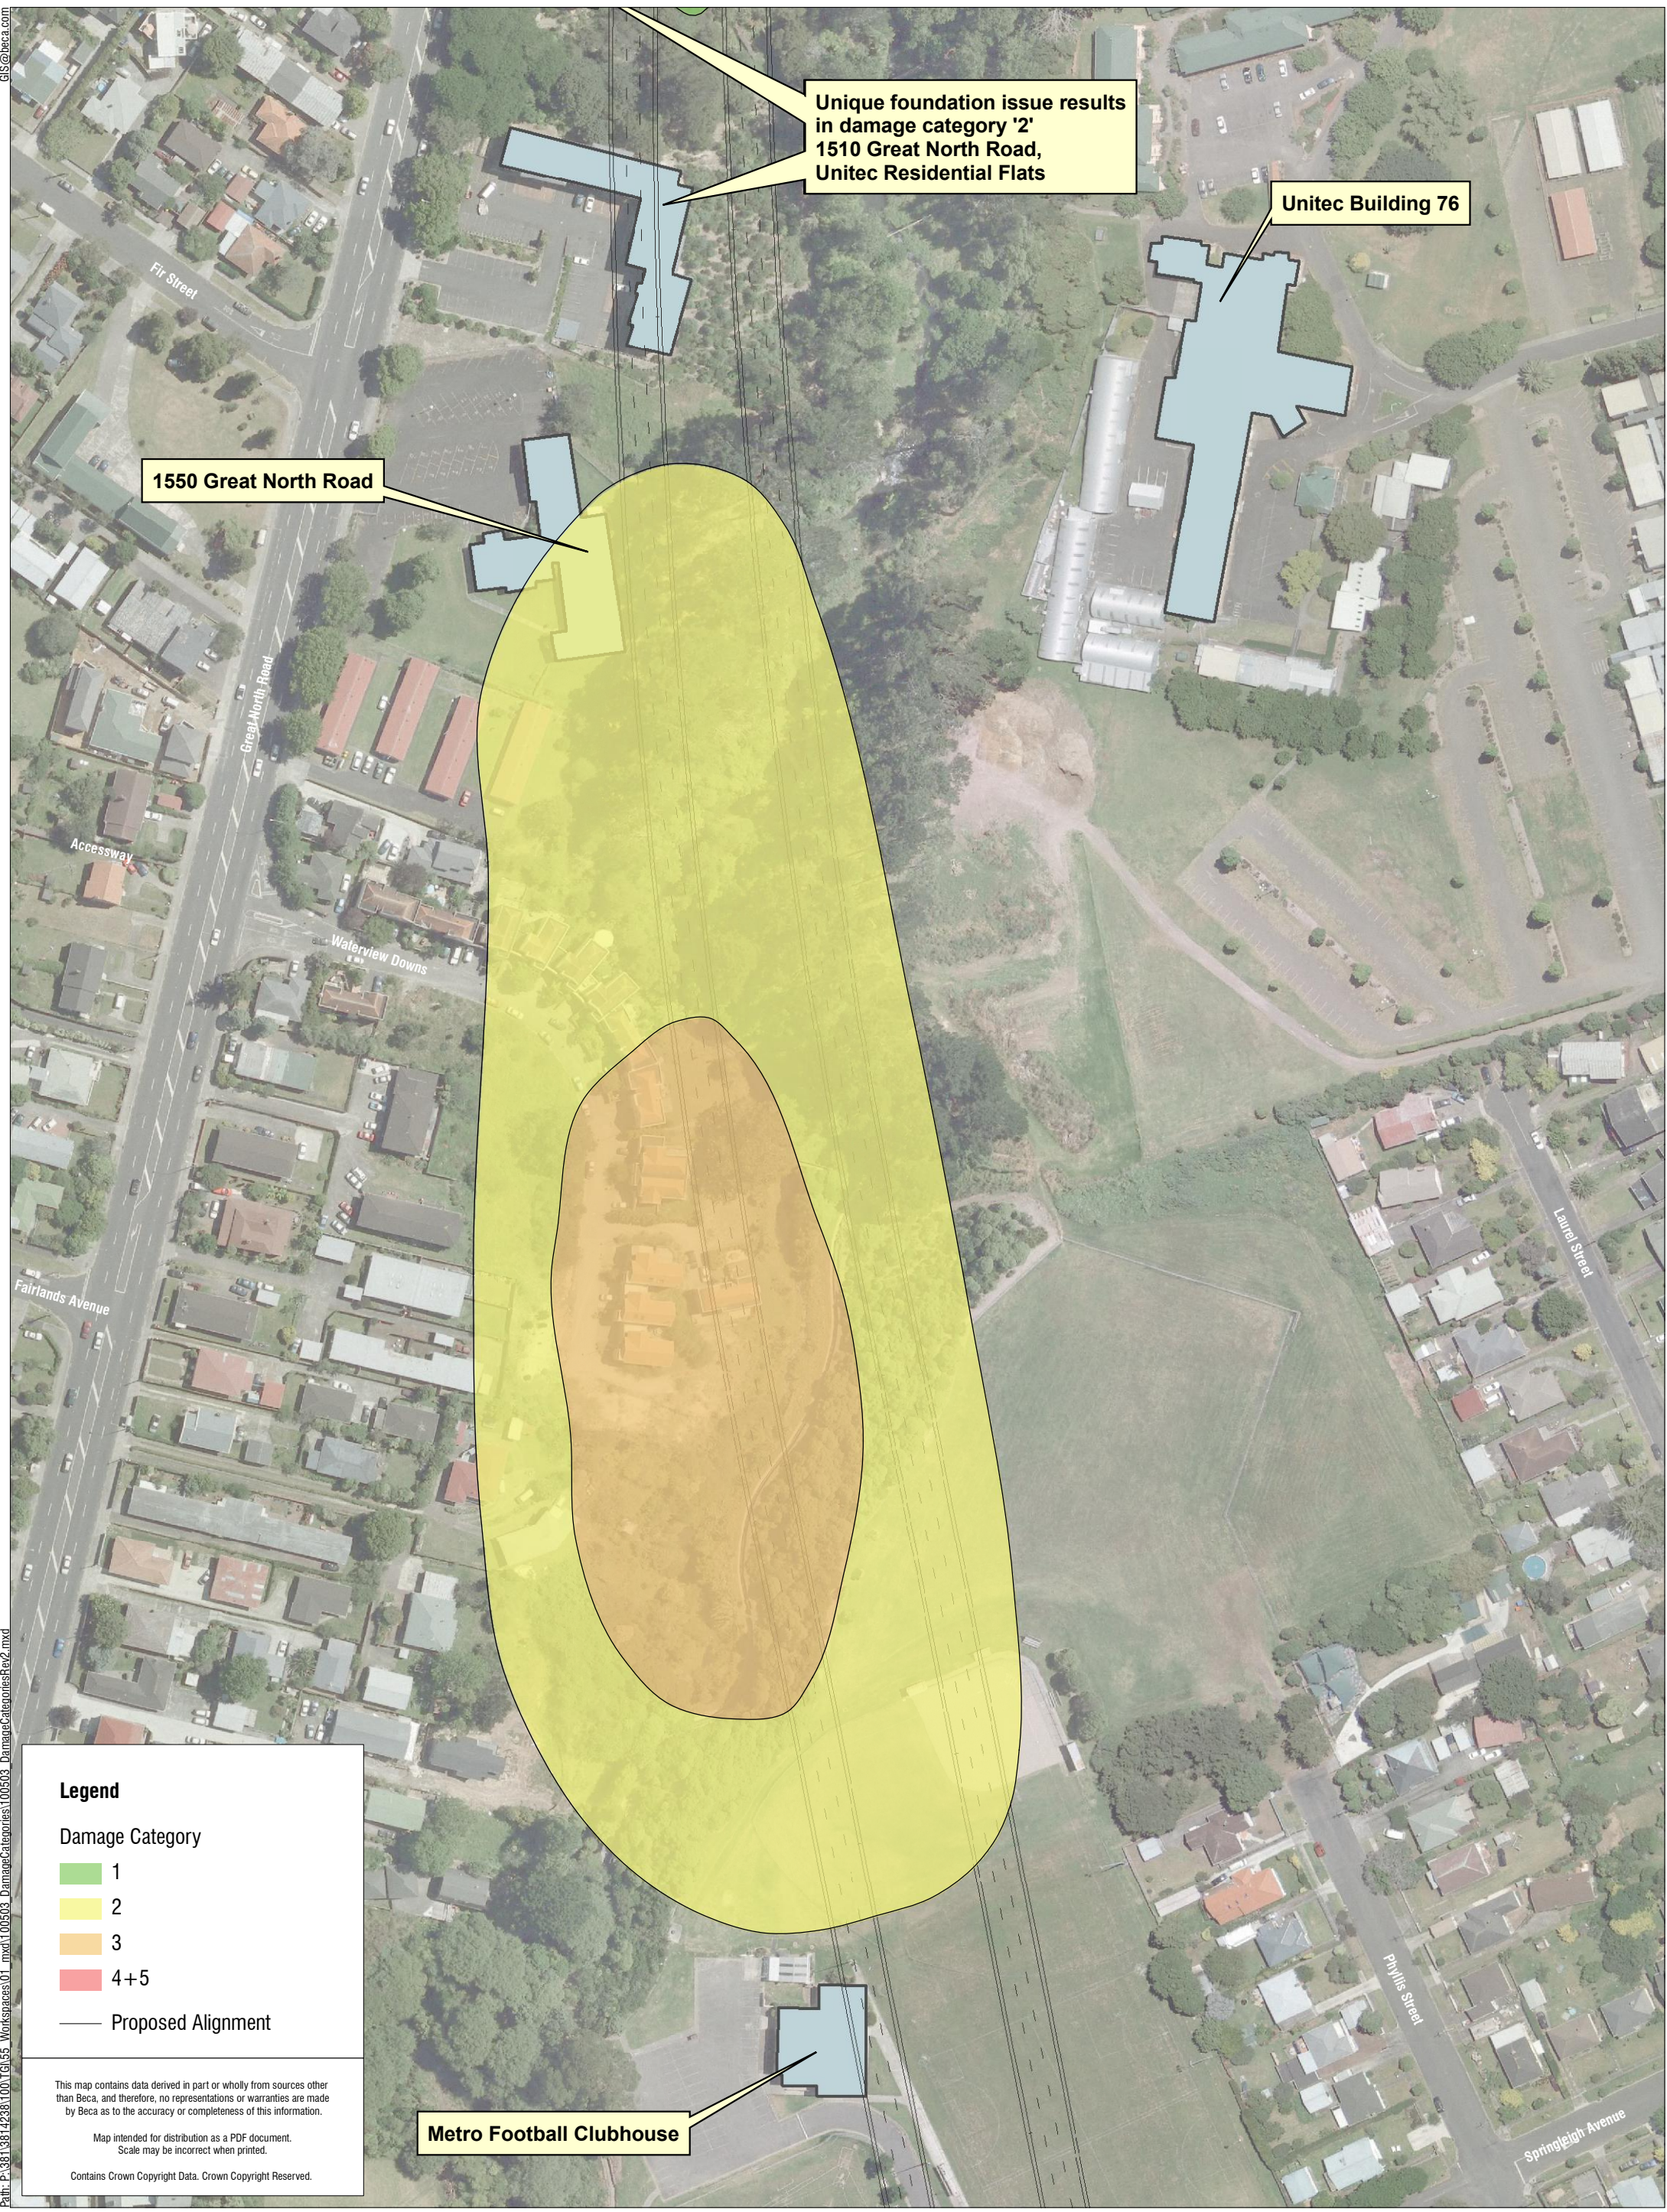
Figure: G - 3

Unique foundation issue results in damage category '2' 1510 Great North Road, Unitec Residential Flats

Settlement - Building Damage Categories
[L = 10m, H = 3m]

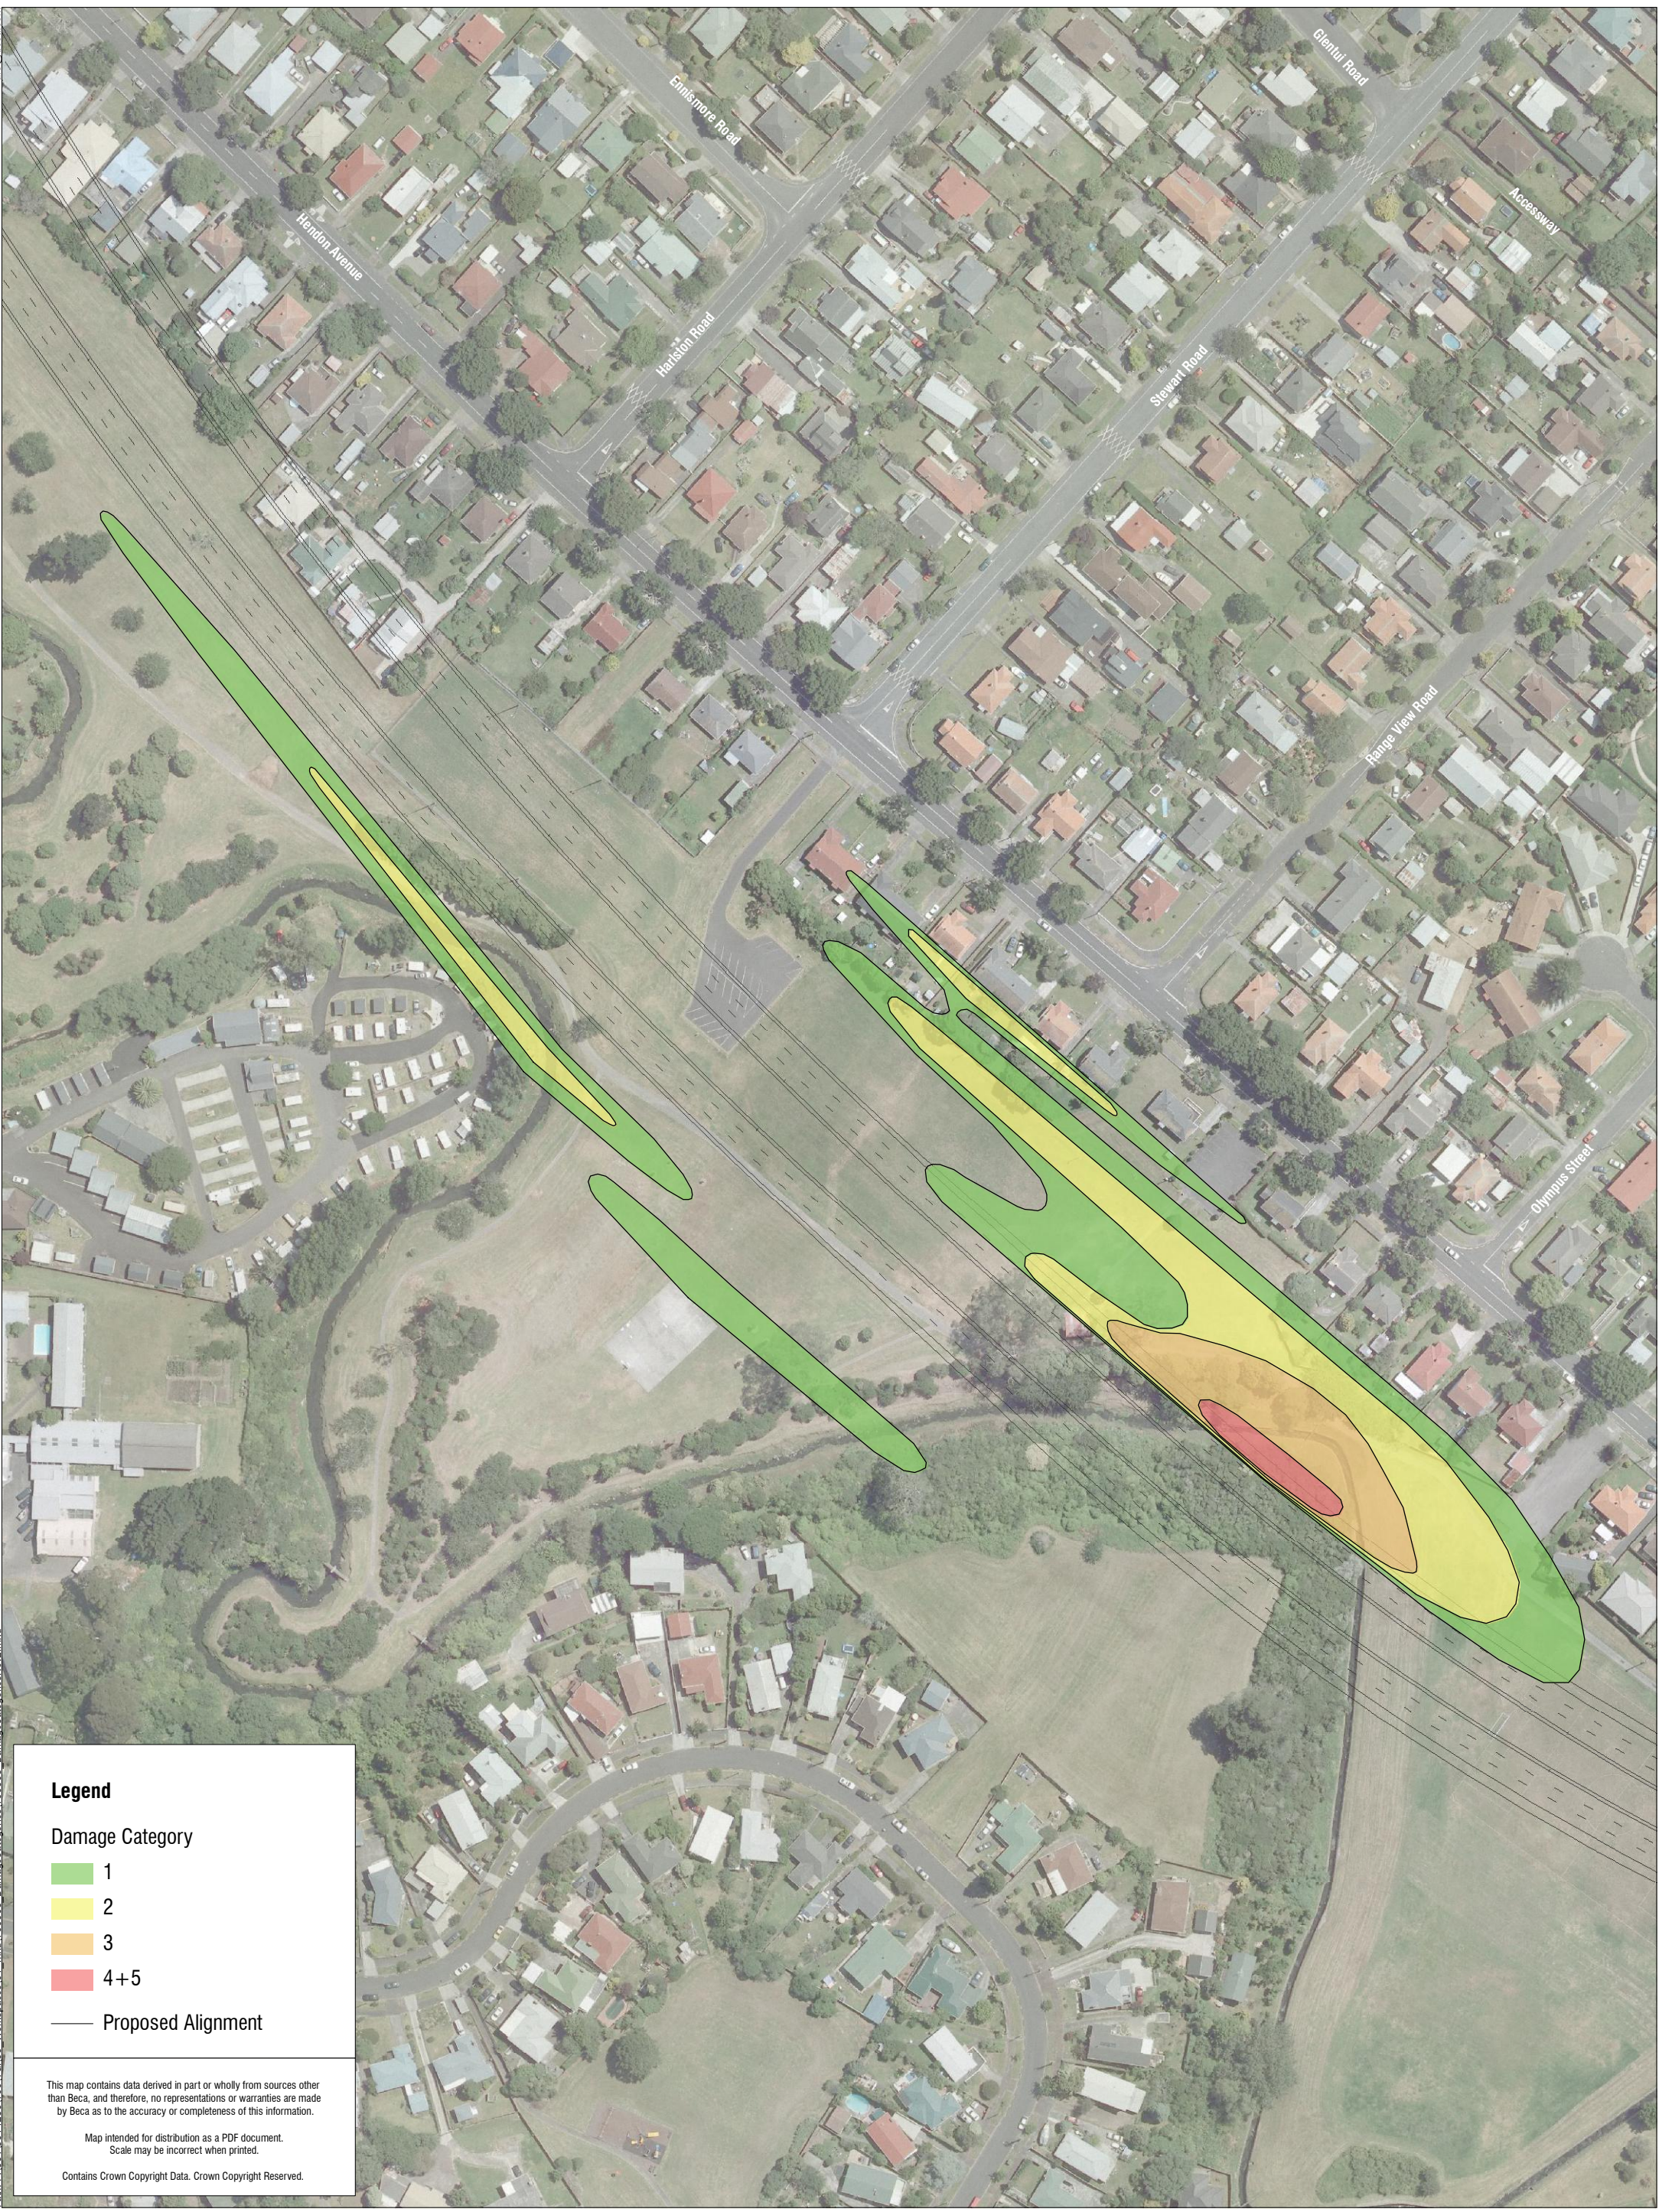
Figure: G - 4

**Settlement - Building
Damage Categories**
[L = 10m, H = 3m]
