Matakohe Bridges replacement project

The Matakohe Bridges realignment project is progressing well through the colder, wetter winter months.

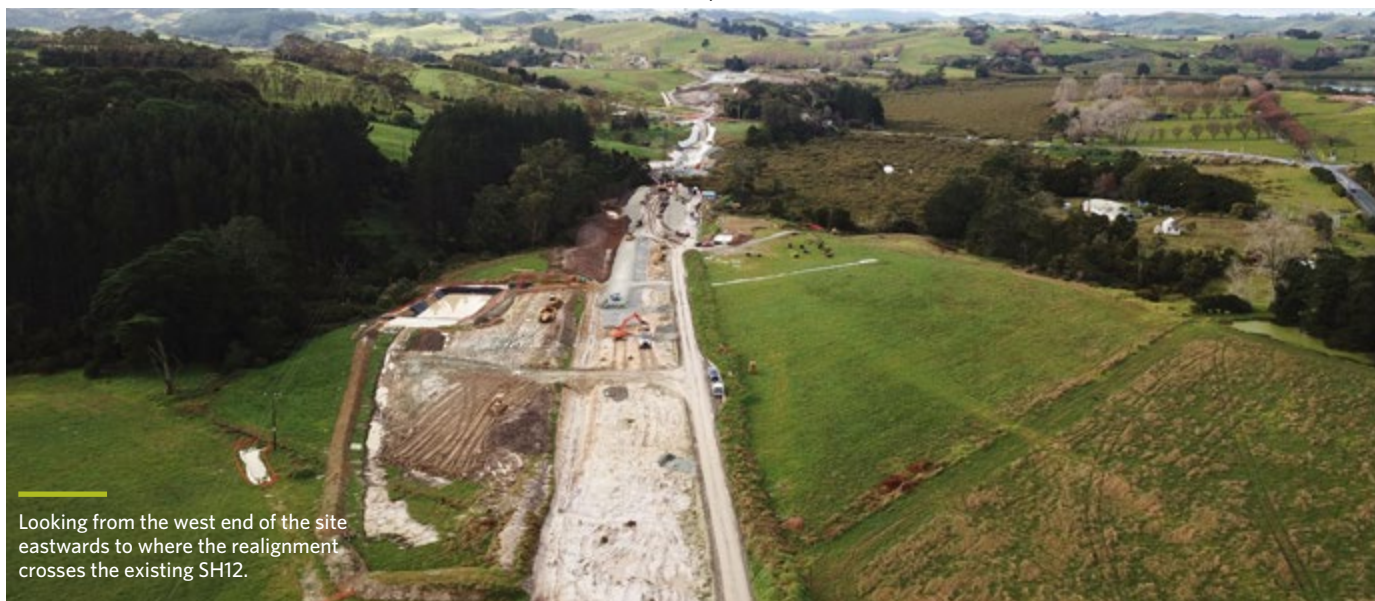
Looking from the west end of the site eastwards to where the realignment crosses the existing SH12.

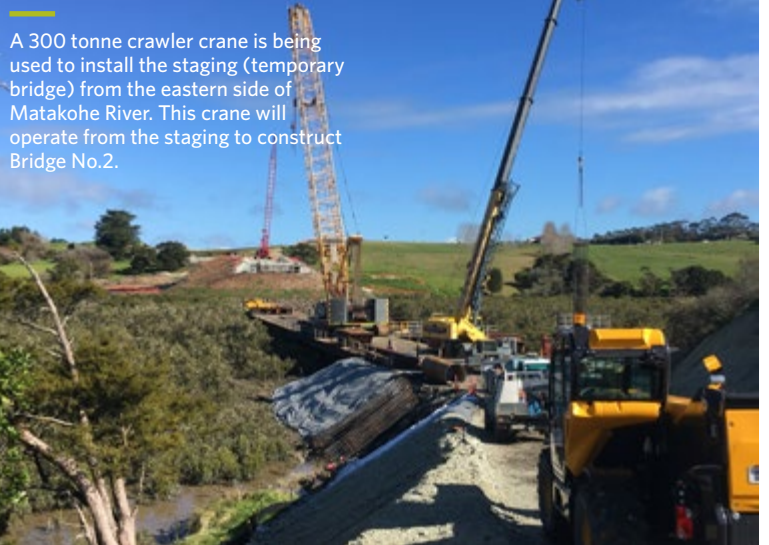
A 300 tonne crawler crane is being used to install the staging (temporary bridge) from the eastern side of Matakohe River. This crane will operate from the staging to construct Bridge No.2.

The large 300 tonne crane located at the eastern side of Matakohe River is now constructing the staging (temporary bridge) which will soon be used for access to construct the new bridge.

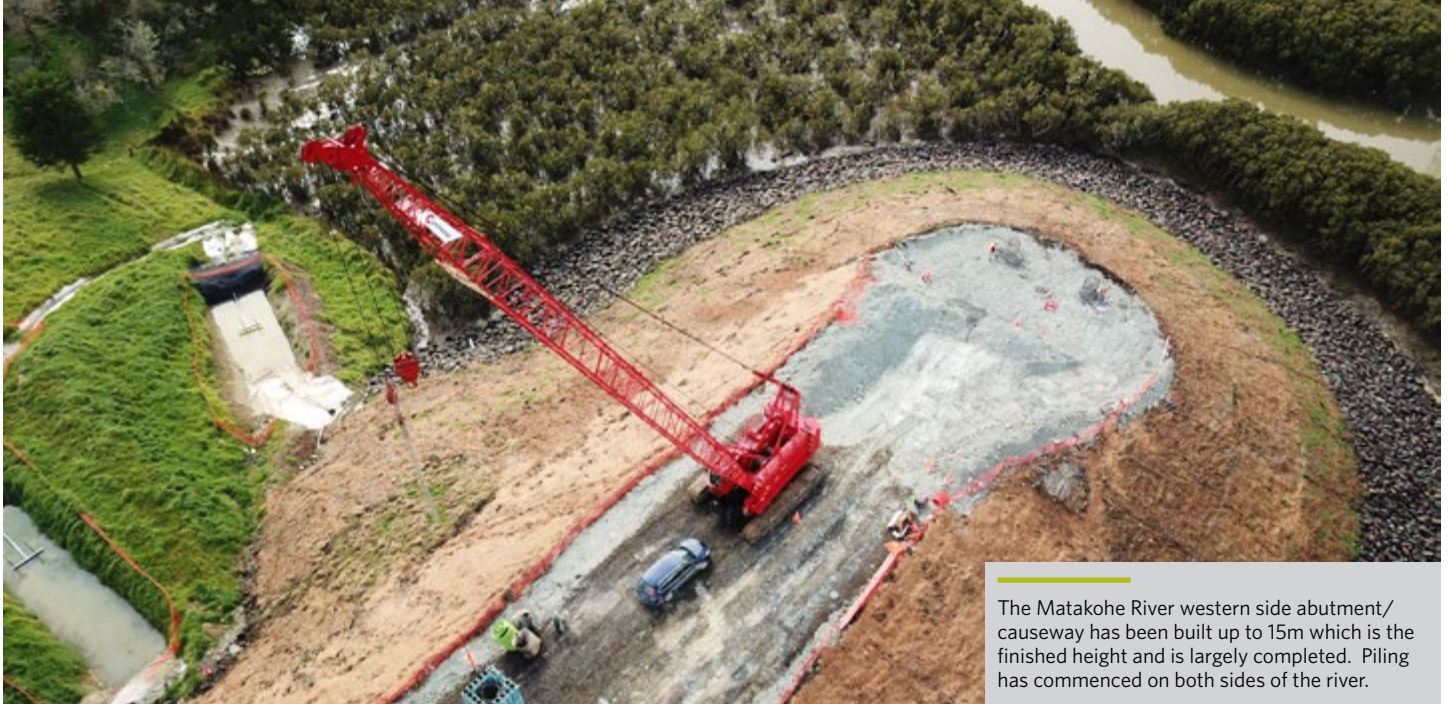
The Matakohe River western side abutment/causeway has been built up to 15m which is the finished height and is largely completed. Piling has commenced on both sides of the river.

The Matakohe River western side abutment/causeway has been built up to 15m which is the finished height and is largely completed.

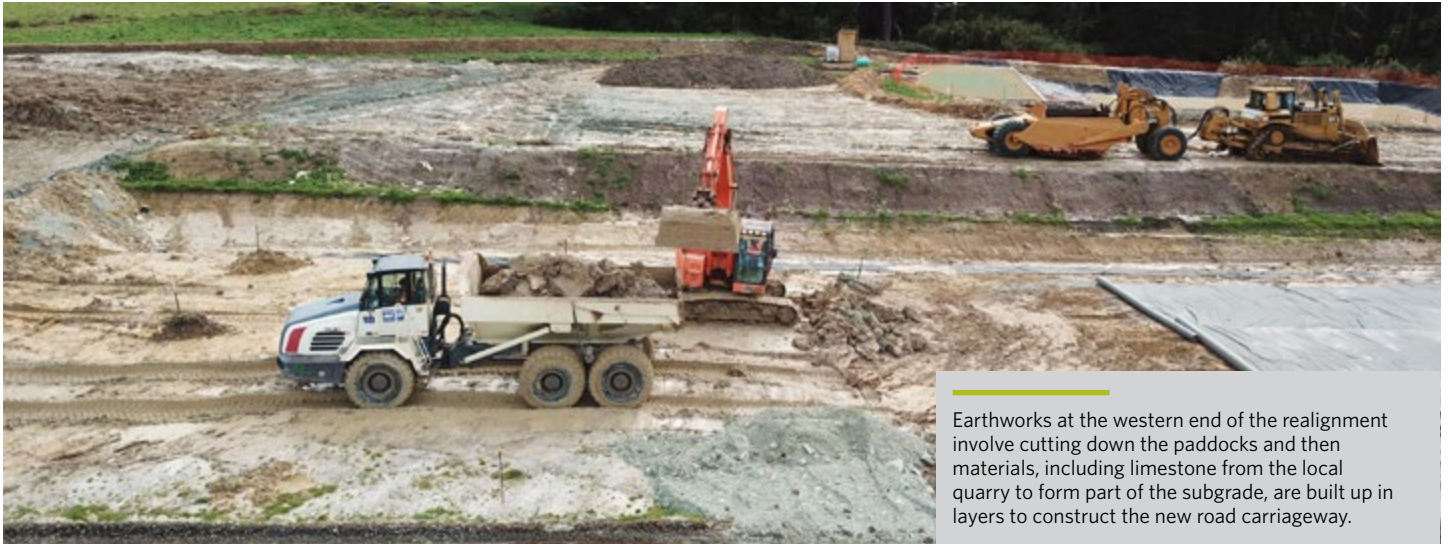
Earthworks at the western end of the realignment involve cutting down the paddocks and then materials, including limestone from the local quarry to form part of the subgrade, are built up in layers to construct the new road carriageway.

Earthworks at the western end of the SH realignment is continuing and the 33Kv area-wide power supply lines have been relocated to make way for the new intersection leading to Matakohe township which will be constructed closer to the end of the project.

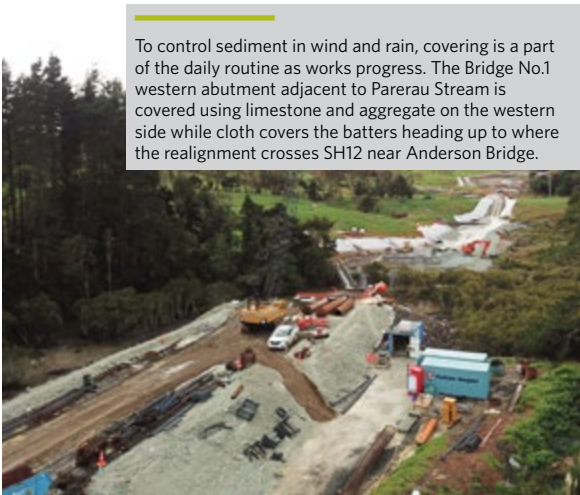
To control sediment in wind and rain, covering is a part of the daily routine as works progress. The Bridge No.1 western abutment adjacent to Parerau Stream is covered using limestone and aggregate on the western side while cloth covers the batters heading up to where the realignment crosses SH12 near Anderson Bridge.

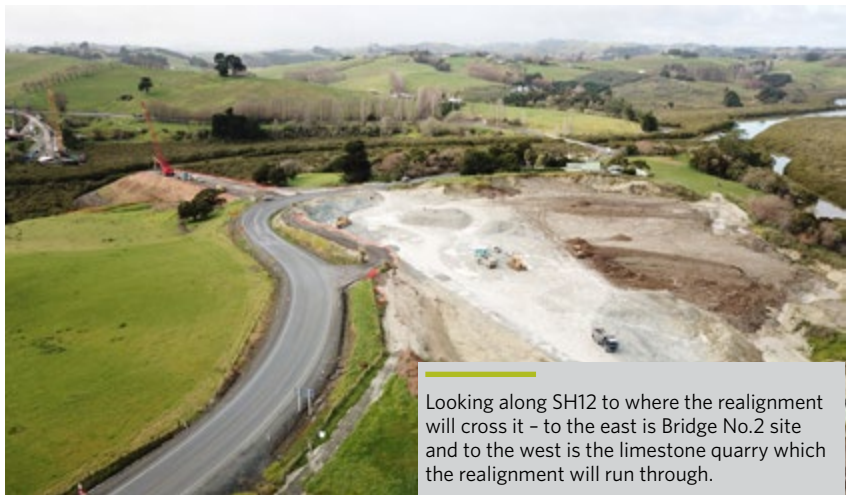
Looking along SH12 to where the realignment will cross it - to the east is Bridge No.2 site and to the west is the limestone quarry which the realignment will run through.
