SH8 Beaumont Bridge Realignment

Geotechnical Factual Report

Date: 2 April 2019

Reference: 6-CT012.00

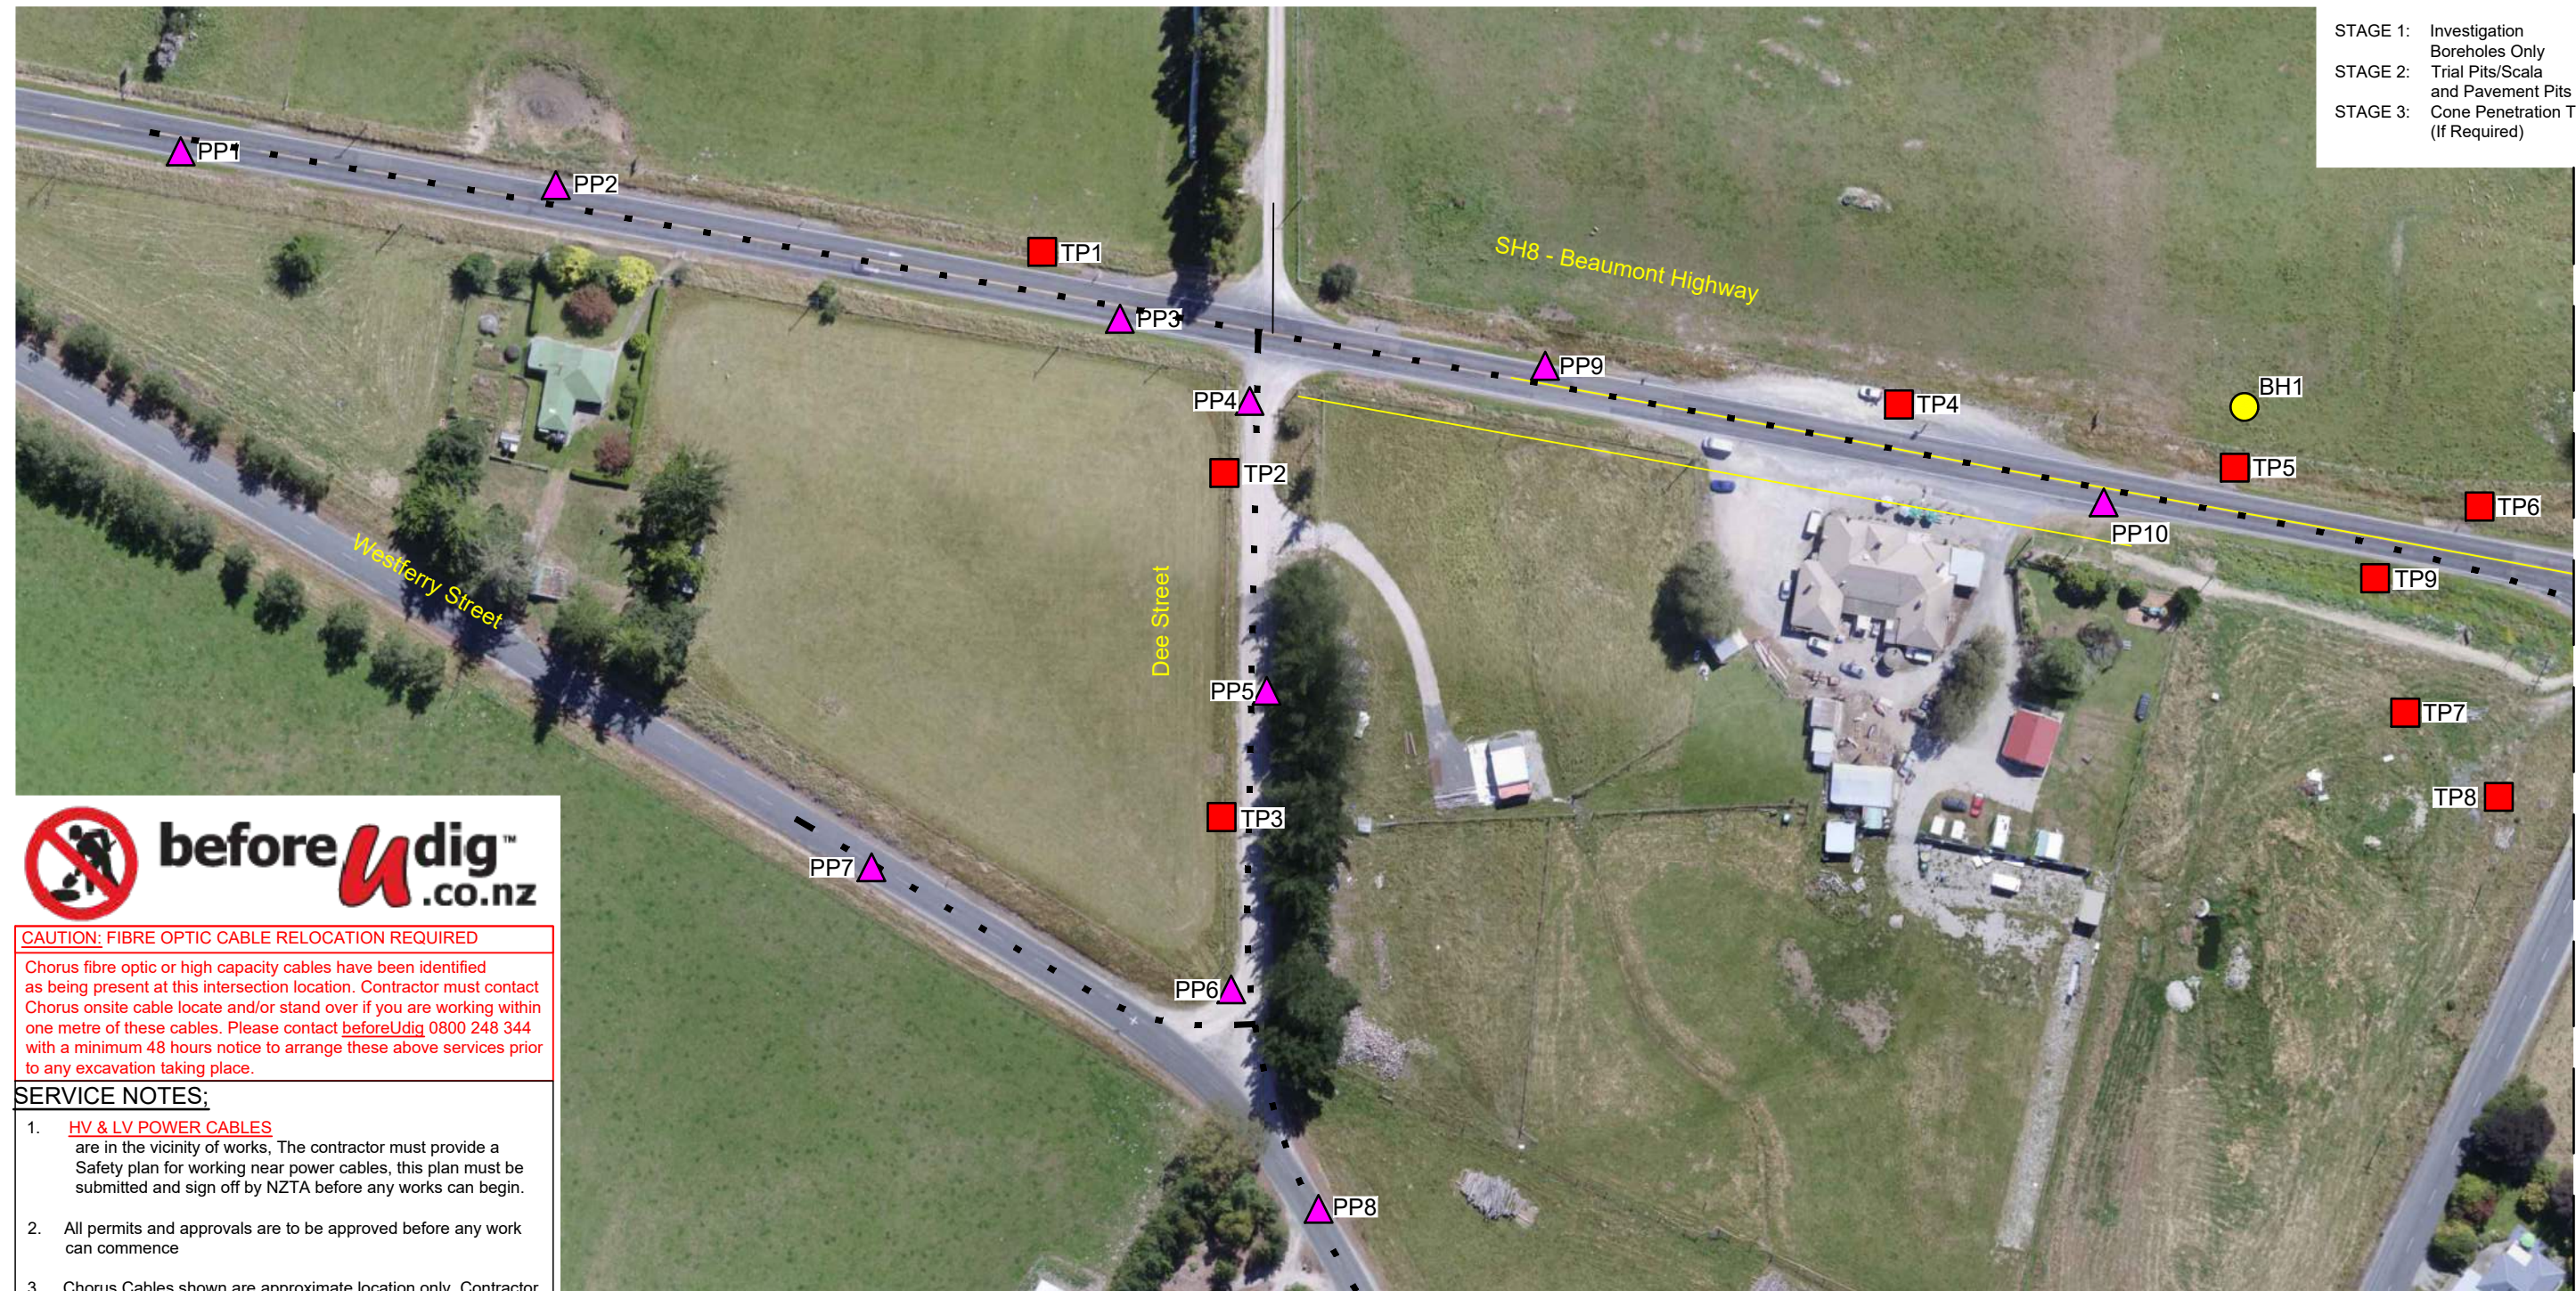
Project	NEW ZEALAND TRANSPORT AGENCY BEAUMONT, OTAGO SH8 BEAUMONT BRIDGE REPLACEMENT		
Sheet	GEOTECHNICAL TESTING LOCATIONS OVERALL LAYOUT PLAN		
Project No.	6-CT012.00	Sheet No.	C201
Revision		Revision	B

KEY	
● (BH) Boreholes	
■ (TP) Trial Pit / Scala	
▲ (PP) Pavement Pit / Scala

STAGE 1: Investigation
Boreholes Only
STAGE 2: Trial Pits/Scala
and Pavement Pits
STAGE 3: Cone Penetration Test
(If Required)

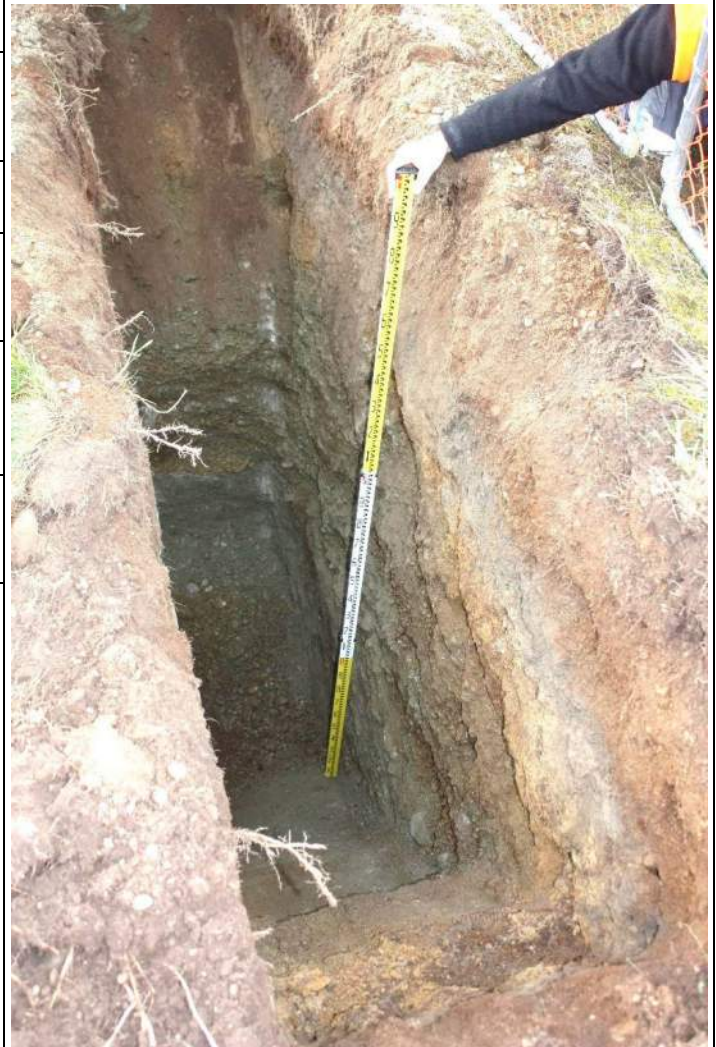
Depth (mm)	Description
0 - 150	Topsoil & vegetation.
150 - 420	Dark orangish brown Sandy GRAVEL with minor silt. Moist. Compact / Loose. Gravel, subrounded to rounded, maximum particle size 13.2mm; Sand, fine to coarse; Silt, plastic.
420 - 590	Grey SILT with trace of / minor sand. Moist. Soft / Firm. Sand, fine; Silt, plastic.
590 - 880	Mottled grey / yellowish / light brown SILT with minor clay and minor gravel. Moist. Soft / Firm. Gravel, subrounded to rounded, maximum particle size 13.2mm; Sand, fine to coarse; Silt, plastic.
880 - 1300	Light brown / yellow Sandy GRAVEL with minor / some silt and trace of clay. Moist. Compact / Loose. Gravel, subrounded to rounded, maximum particle size 37.5mm; Sand, fine to coarse; Silt, slight plasticity.
1300 - 3000	Greenish grey / brown Sandy GRAVEL with minor silt. Moist. Compact. Gravel, subrounded to rounded, maximum particle size 106.0mm; Sand, fine to coarse; Silt, non-plastic.

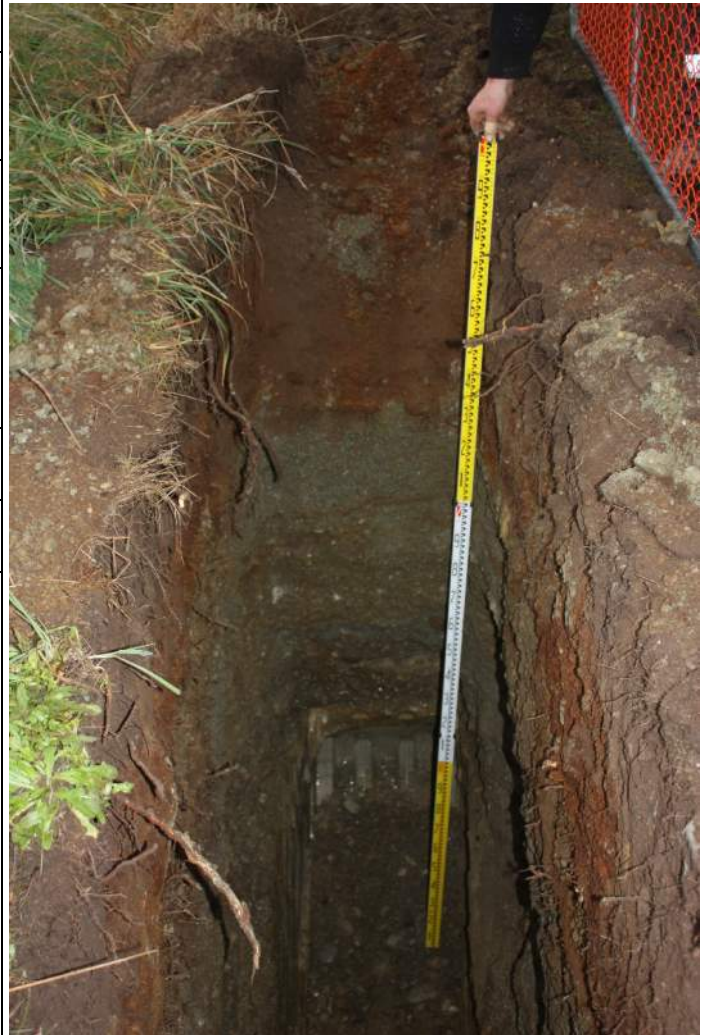
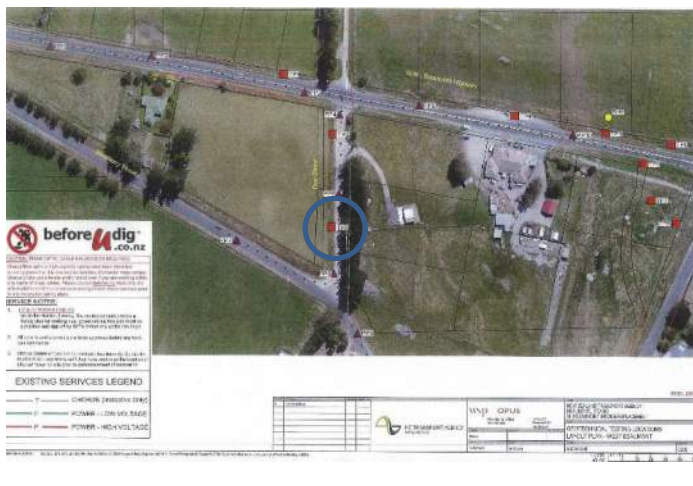
Depth (mm)	Description
0 - 230	Topsoil & vegetation (organic matter).
230 - 560	Dark orangish brown Sandy GRAVEL with some silt and trace of cobbles. Moist. Compact / Loose. Gravel, subrounded to rounded, maximum particle size 75.0mm; Sand, fine to coarse; Silt, slight plasticity.
560 - 1500	Light greyish brown Sandy GRAVEL with minor silt. Moist / Compact. Gravel / cobbles, subrounded to rounded, maximum particle size 63.0mm; Sand, fine to coarse; Silt, non-plastic.
1500 - 2050	Light greyish brown Sandy GRAVEL with minor silt and minor cobbles / boulders. Wet. Compact. Gravel / cobbles / boulders, angular to subangular, maximum particle size 400.0mm; Sand, fine to coarse; Silt, non-plastic. Free water @ 1850mm to 2050mm perched on underlying clayey silt.
2050 - 3000	Light greenish / yellowish grey Clayey SILT. Moist. Soft / Firm. Bedded. Silt / Clay, plastic.

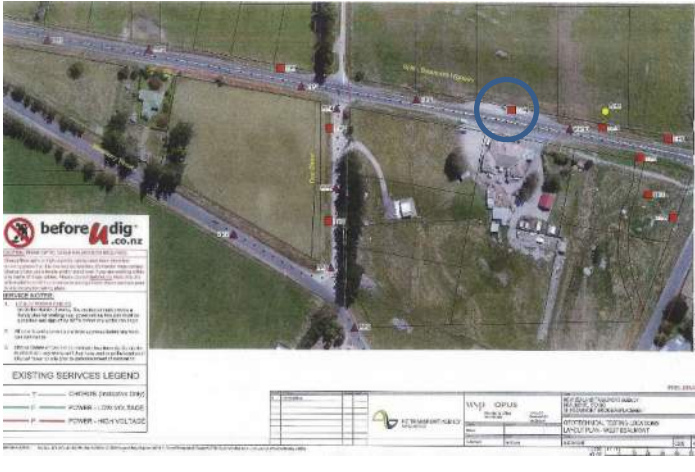
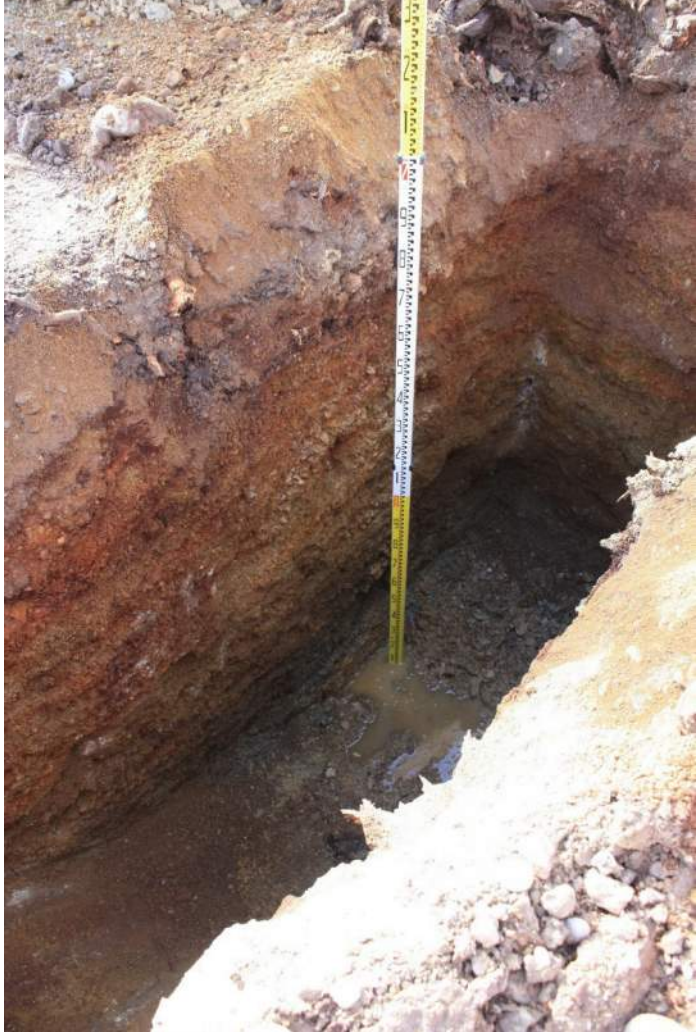
Test Pit 4; Adjacent SH8 - Increasing Side (Opposite Beaumont Hotel)	
FIELD LOG DESCRIPTIONS – Not IANZ Accredited (NZ Geotechnical Society Guidelines 2005)	
Depth (mm)	Description
0 - 250	Grey Sandy GRAVEL with some silt and trace of cobbles. Moist. Compact. Gravel / cobbles, subrounded to rounded, maximum particle size 75.0mm; Sand, fine to coarse; Silt, non-plastic.
250 - 460	Dark orangish brown Sandy GRAVEL with minor silt. Moist. Loose. Gravel, subrounded to rounded, maximum particle size 19.0mm; Sand, fine to coarse; Silt, non-plastic. Tree stump, roots and organic matter present.
460 - 1850	Orangish brown Sandy GRAVEL with minor silt and trace of cobbles. Dry / Moist. Compact / Loose. Gravel / cobbles, subrounded to rounded, maximum particle size 106.0mm; Sand, fine to coarse; Silt, non-plastic. Free water /water table @ approximately 1550mm.
1850 - 2000	Bedrock – Schist.

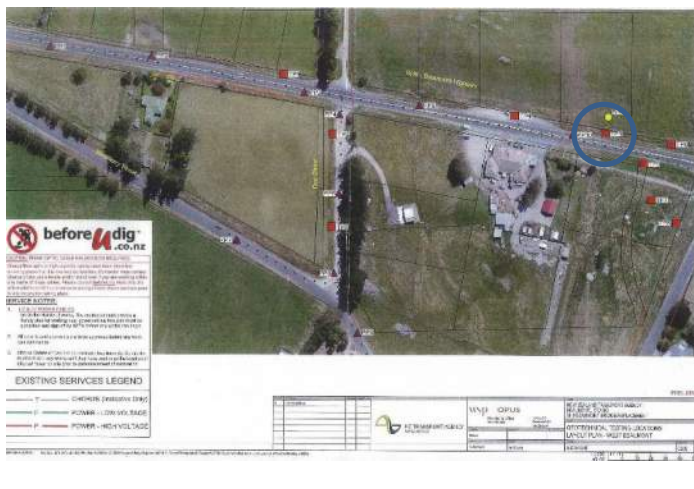
Depth (mm)	Description
0 - 100	Topsoil & vegetation (organic matter).
100 - 220	Greyish brown Silty SAND with minor gravel. Moist. Soft. Gravel, subrounded to rounded, maximum particle size 19.0mm; Sand, fine to medium; Silt, slight plasticity.
220 - 640	Grey SILT with trace of gravel and trace of / minor clay. Moist / Wet. Soft. Gravel, rounded, maximum particle size 6.70mm; Sand, fine; Silt, plastic.
640 - 1000	Greenish grey / mottled orange SILT with minor / some clay. Moist. Soft. Silt, plastic.
1000 - 1200	Dark orangish brown Sandy GRAVEL with trace of silt and trace of cobbles. Moist. Compact. Gravel / cobbles, maximum particle size 63.0mm; Sand, fine to coarse; Silt, non-plastic. Occasional weathered schist boulder to 300mm at top of layer. Water table.
1200 - 1300	Bedrock – schist.

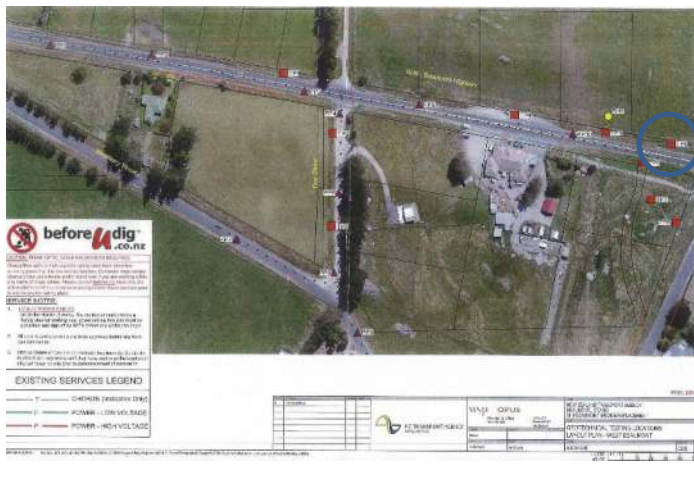
Depth (mm)	Description
0 - 200	Topsoil & vegetation (organic matter).
200 - 600	Brownish grey SILT with trace of clay. Moist / Wet. Soft. Silt, plastic.
600 - 830	Light brown SILT with trace of / minor clay and trace of gravel. Moist / Wet. Firm. Gravel, maximum particle size 6.70mm; Silt, plastic.
830 - 1050	Mottled yellowish grey / orange Silty SAND. Moist. Soft / Firm. Sand, fine; Silt, slight plasticity.
1050 - 1500	Greyish brown Sandy GRAVEL with minor silt and trace of cobbles. Moist / Wet. Loose. Gravel / cobbles, subrounded to rounded, maximum particle size 150.0mm; Sand, fine to coarse; Silt, plastic. Water table @ 1100mm.
1500 +	Bedrock.

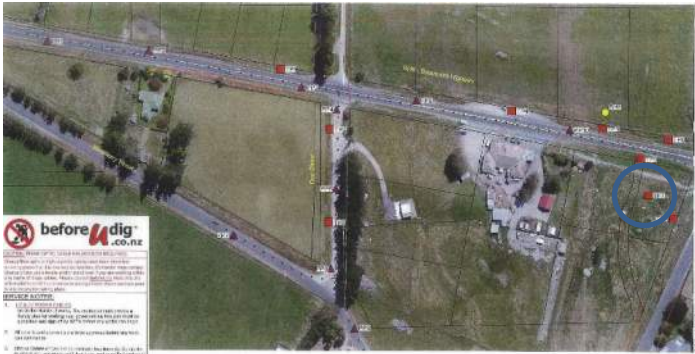
Test Pit 7; Adjacent SH8 – Decreasing Side in Paddock; Corner Section SH8 and Rongahere Road (see below)	
FIELD LOG DESCRIPTIONS - Not IANZ Accredited (NZ Geotechnical Society Guidelines 2005)	
Depth (mm)	Description
0 - 130	Topsoil & vegetation (organic matter).
130 - 400	Brownish grey Gravelly SILT with minor / some sand and trace of cobbles / boulders. Moist. Firm. Gravel / cobbles, angular to rounded, maximum particle size 500mm; Sand, fine to coarse; Silt, plastic.
400 - 1000	Green / Greenish grey / orange mottled SILT with trace of / minor clay and trace of sand. Moist. Firm / Stiff. Sand, fine. Silt / clay, plastic.
1000 - 2300	Blueish grey SILT with minor clay. Plastic. Pockets of organic material present, possible old fill area. Water present.
2300 +	Bedrock.

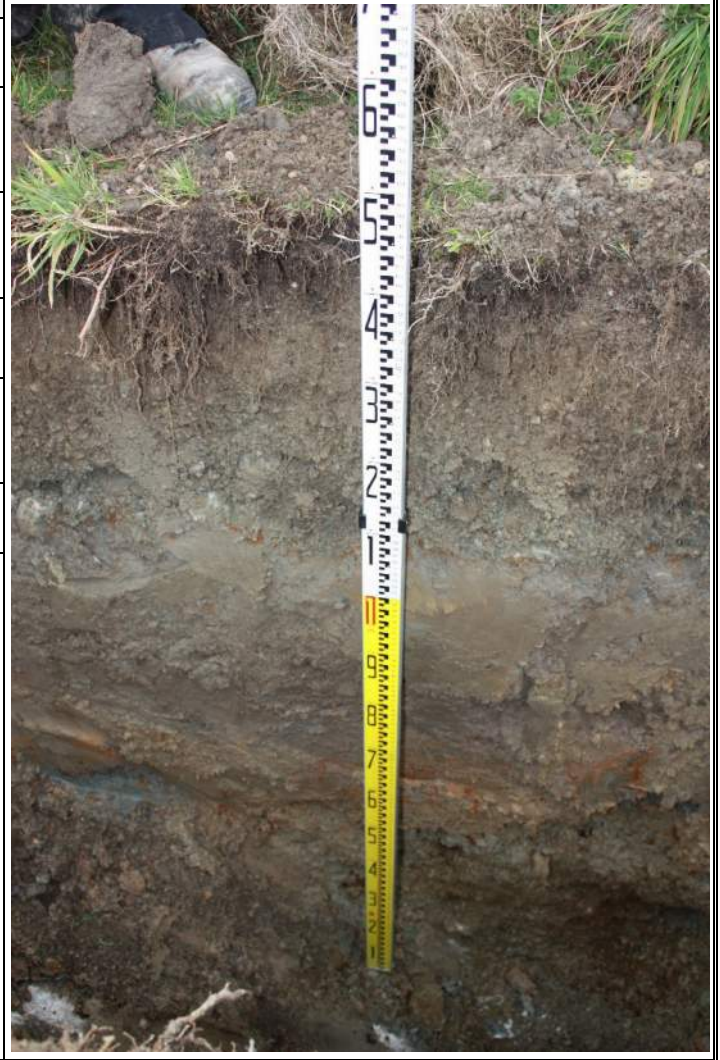
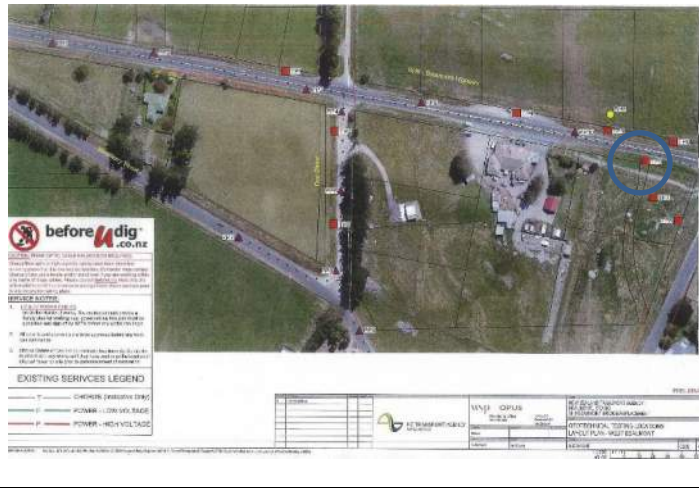
Depth (mm)	Description
0 - 200	Topsoil & vegetation (organic matter).
200 - 410	Grey Sandy GRAVEL with minor silt / clay. Wet. Compact / Loose. Gravel, subrounded to rounded, maximum particle size 19.0mm; Sand, fine to coarse; Silt, slight plasticity.
410 - 700	Grey SILT with minor sand, minor clay and trace of gravel. Gravel, subrounded to rounded, maximum particle size 13.2mm; Sand, fine to coarse; Silt, plastic.
700 - 900	Mottled orange / light greyish brown SILT with trace of sand and trace of / minor clay. Moist / Wet. Soft. Sand, fine to coarse; Silt, plastic.
900 - 1150	Greenish / brownish grey SILT with minor clay, minor sand, trace of / minor gravel. Gravel, subrounded to rounded, maximum particle size 63.0mm; Sand, fine to coarse; Silt, plastic.
1150 - 1400	Bedrock.

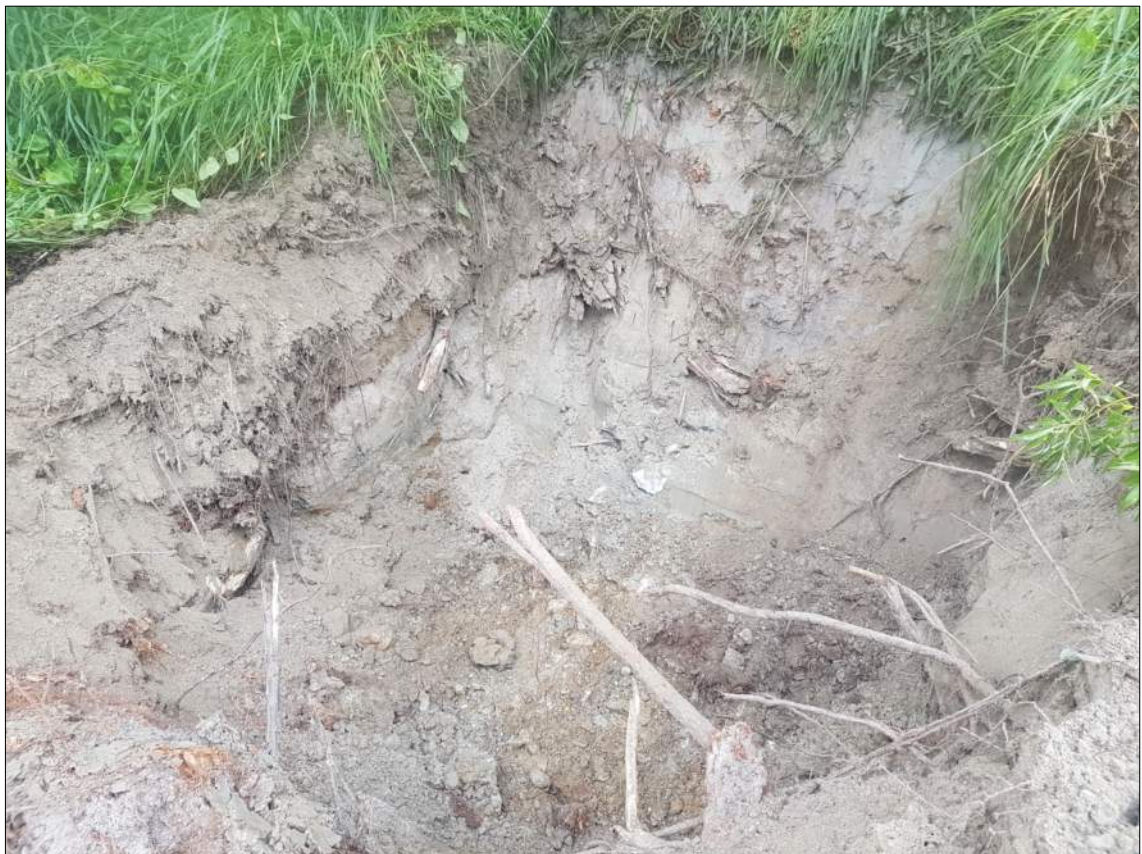
TP 13

Notes:
No ground water encountered

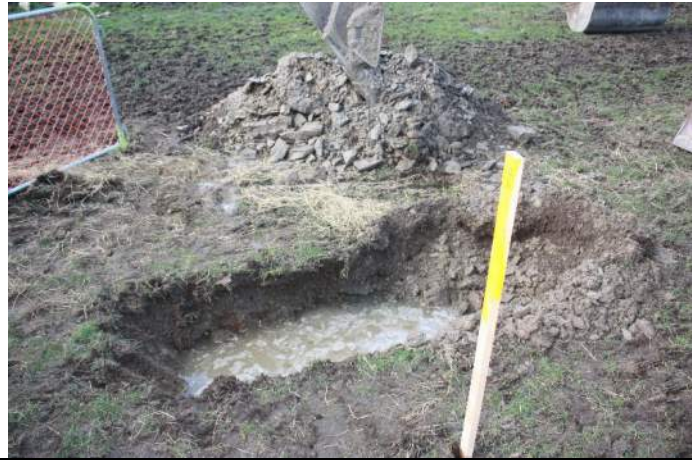
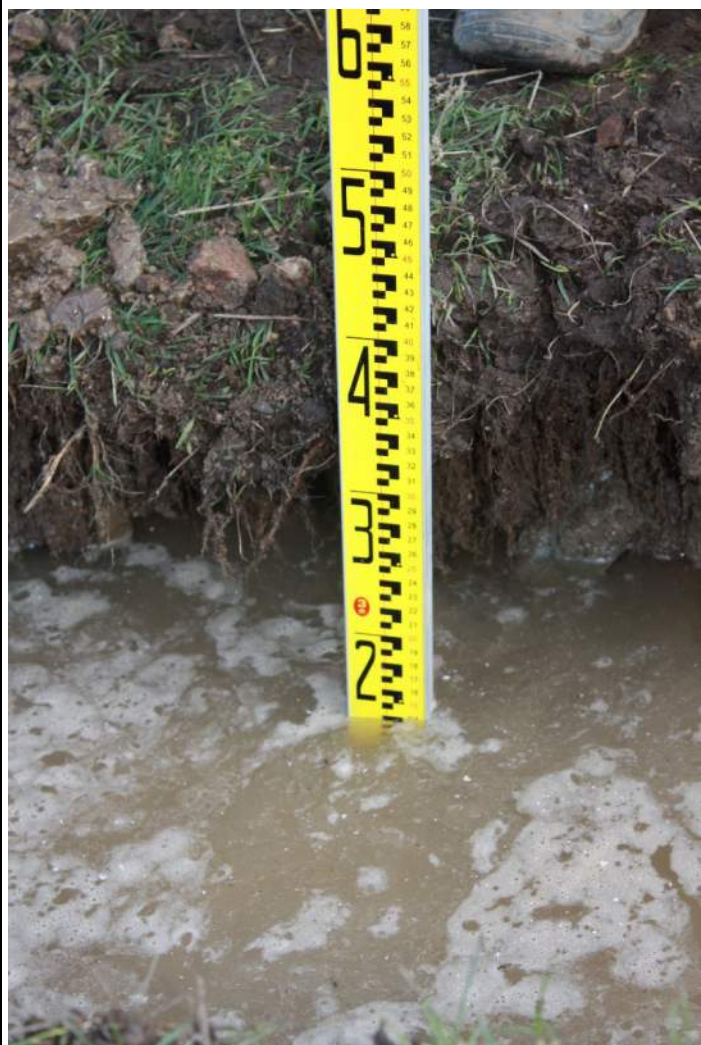
Test Pit 21; Adjacent SH8 – Increasing Side in Paddock (see below)	
FIELD LOG DESCRIPTIONS - Not IANZ Accredited (NZ Geotechnical Society Guidelines 2005)	
Depth (mm)	Description
0 - 70	Topsoil & vegetation (organic matter).
70 - 450	Grey Sandy Cobbly GRAVEL. Saturated. Loose. Gravel / cobbles, angular, maximum particle size 150.0mm; Sand, fine to coarse; Silt, plastic.

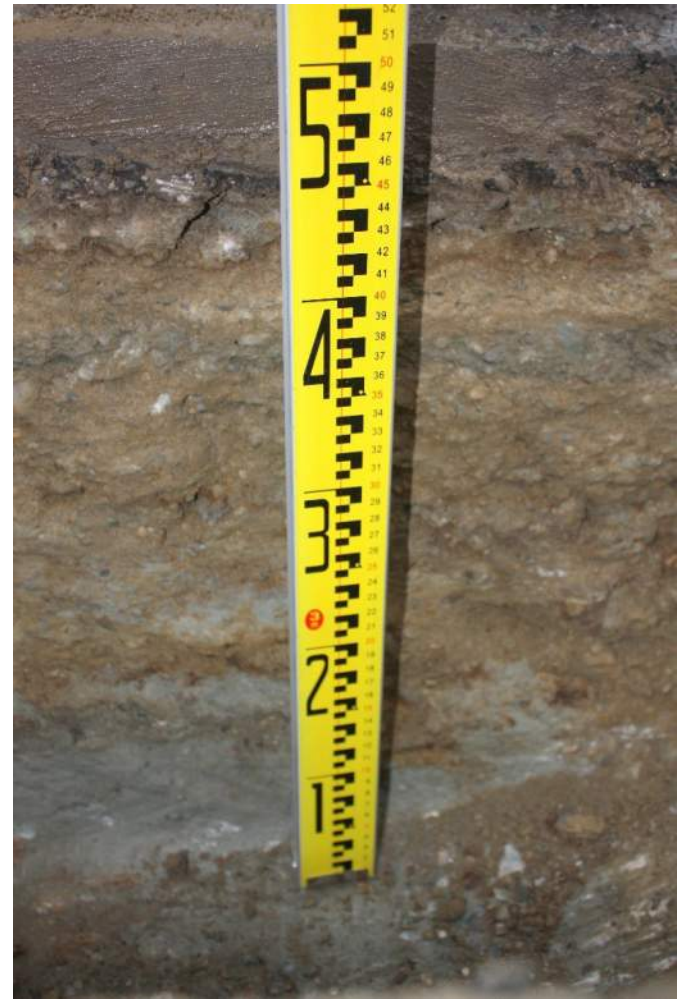
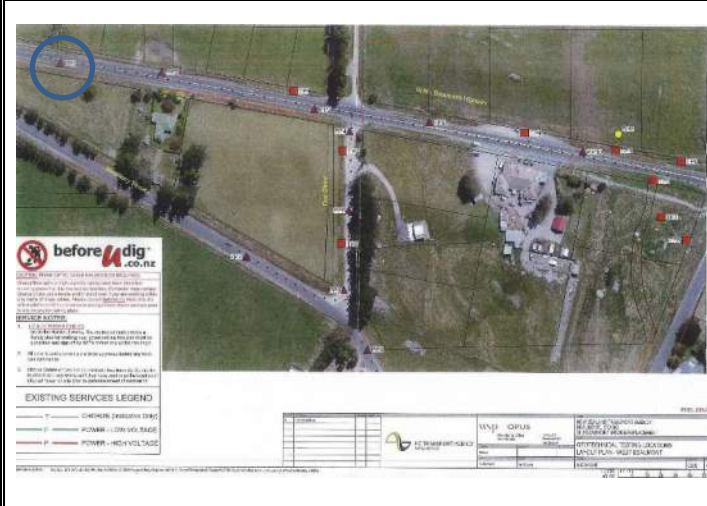
Pavement Pit 1; SH8, Decreasing Lane, O/S 2.25m to 3.40m (See below)			
FIELD LOG DESCRIPTIONS – Not IANZ Accredited (NZ Geotechnical Society Guidelines 2005)			
Depth (mm)	Description	Depth (mm)	Description
0 – 60	Chip Seal. Nearby scabbing.	260 - 390 (sampled)	Subgrade – Light orangish brown Sandy GRAVEL with trace of / minor silt. Moist. Compact. Gravel, subrounded to rounded, maximum particle size 75.0mm; Sand, fine to coarse; Silt, non-plastic.
60 - 140 (sampled)	Basecourse – Sandy GRAVEL with minor silt. Moist. Compact. Gravel, subrounded to rounded, maximum particle size 37.5mm; Sand, fine to coarse; Silt, non-plastic.	390 - 510	Subgrade – Light grey Sandy GRAVEL / Gravelly SAND with trace of / minor silt. Dry / Moist. Very Compact. Gravel, angular to subangular, maximum particle size 37.5mm; Sand, fine to medium / coarse; Silt, non-plastic.
140 - 260 (sampled)	Subbase – Brown Sandy GRAVEL with minor / some silt. Moist. Compact. Gravel, subrounded to rounded, maximum particle size 53.0mm; Sand, fine to coarse; Silt, non-plastic.

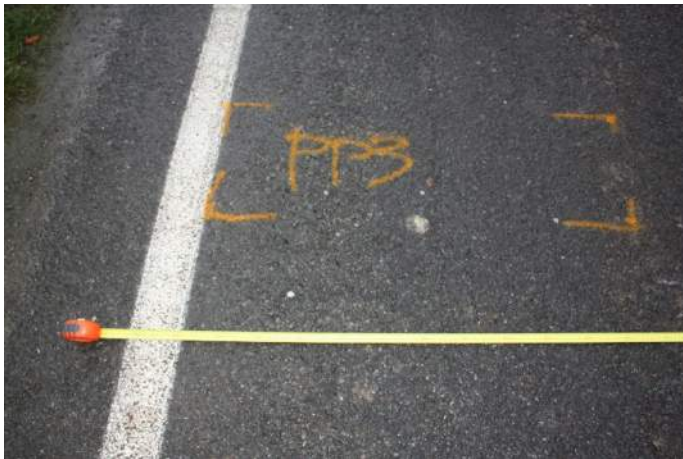
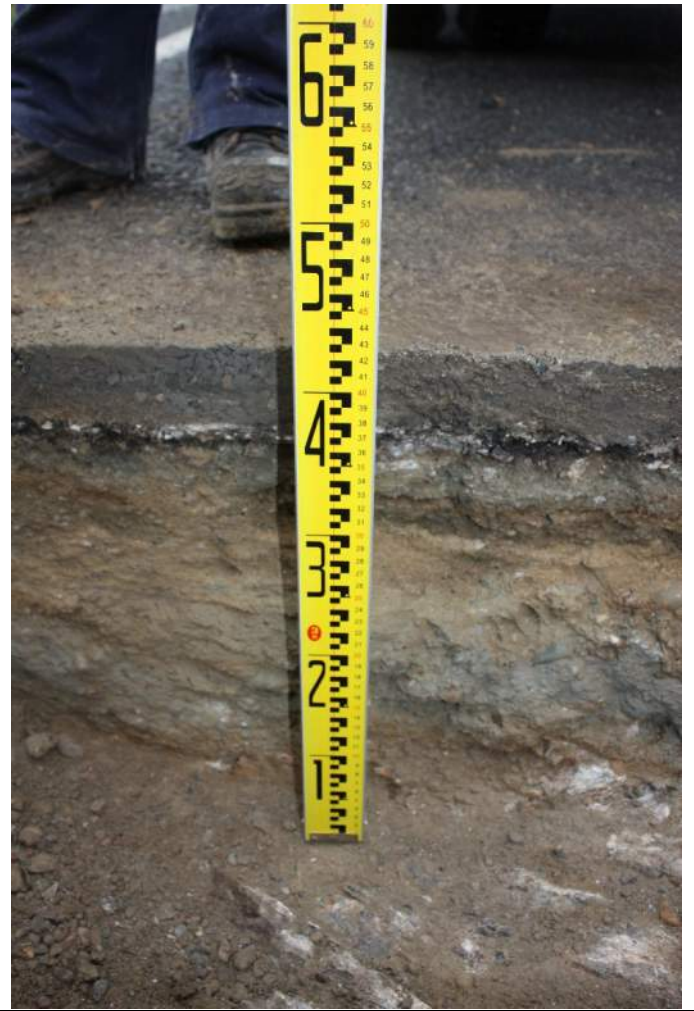
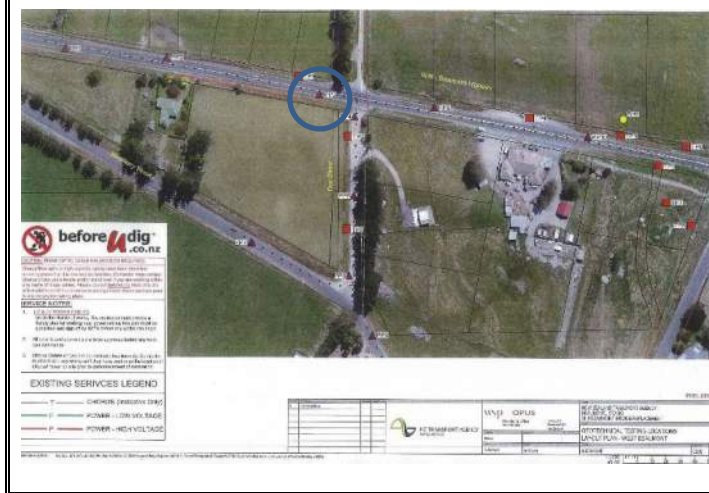
Pavement Pit 3; SH8, Decreasing Lane, O/S 2.25m to 3.40m (see below)
FIELD LOG DESCRIPTIONS – Not IANZ Accredited (NZ Geotechnical Society Guidelines 2005)

Depth (mm)	Description	Depth (mm)	Description
0 - 80	Chip Seal.	240 - 320 (sampled)	Subbase – Light greyish brown Silty Sandy GRAVEL. Moist. Compact. Gravel, subangular to rounded, maximum particle size 53.0mm; Sand, fine to coarse; Silt, non-plastic.
80 - 125 (sampled)	Cement Stabilised Basecourse – Light brown Sandy GRAVEL with minor silt. Moist. Compact. Gravel, subrounded to rounded, maximum particle size 37.5mm; Sand, fine to coarse; Silt, non-plastic.	320 - 410 (sampled)	Subgrade – Light orangish / greyish brown Sandy GRAVEL with trace of / minor silt. Moist. Very compact. Gravel, angular to rounded, maximum particle size 75.0mm; Sand, fine to coarse; Silt, non-plastic.
125 - 240 (sampled)	Basecourse – Light greyish brown Sandy GRAVEL with some silt. Moist. Compact. Gravel, subrounded to rounded, maximum particle size 37.5mm; Sand, fine to coarse; Silt, non-plastic.

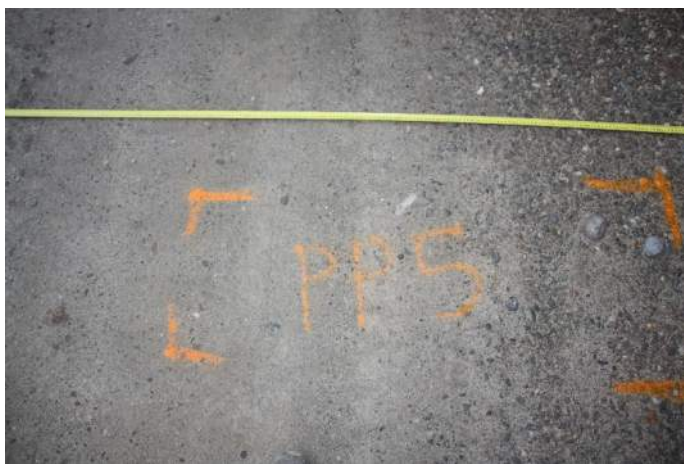
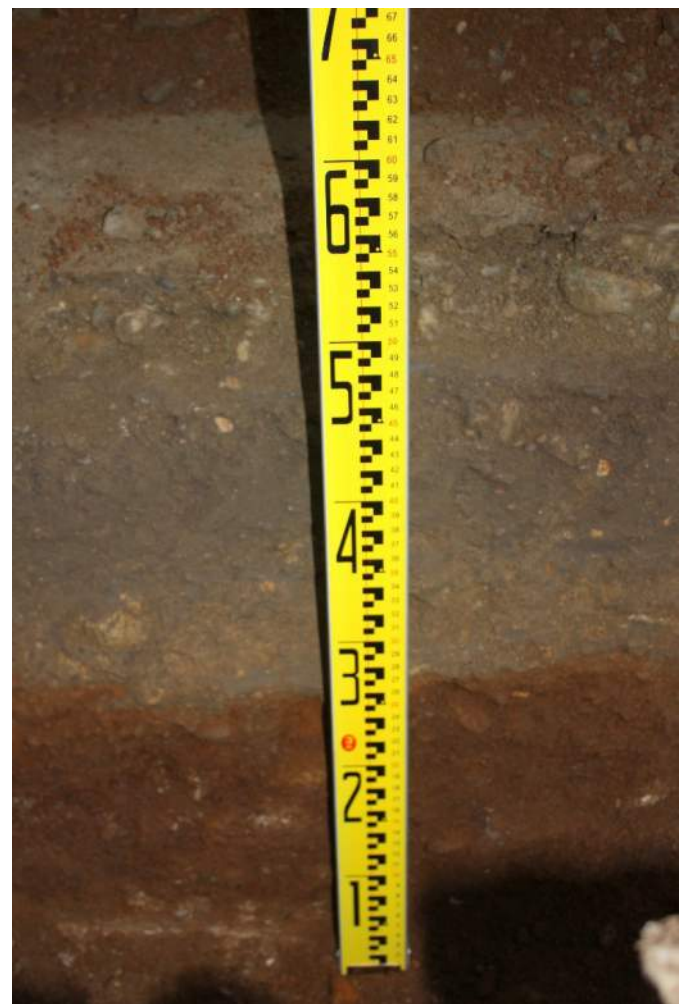
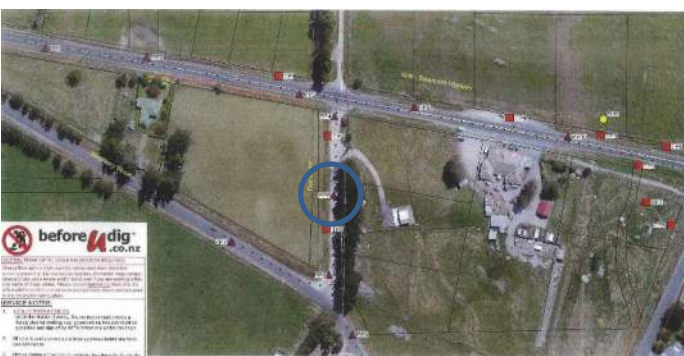
Pavement Pit 5; Dee Street, Middle (see below)			
FIELD LOG DESCRIPTIONS – Not IANZ Accredited (NZ Geotechnical Society Guidelines 2005)			
Depth (mm)	Description	Depth (mm)	Description
0 - 100 (sampled)	Maintenance Metal – Light brown Sandy GRAVEL with some silt. Moist. Compact. Gravel, subangular to rounded, maximum particle size 53.0mm; Sand, fine to coarse; Silt, non-plastic.	250 - 570	Dark orangish brown Sandy GRAVEL with some silt / clay. Moist. Compact. Gravel, subrounded to rounded, maximum particle size 63.0mm; Sand, fine to coarse; Silt, plastic.
100 - 250 (sampled)	Dark brown Sandy GRAVEL with some silt. Moist. Compact. Gravel, subrounded to rounded, maximum particle size 37.5mm; Sand, fine to coarse; Silt, slight plasticity.

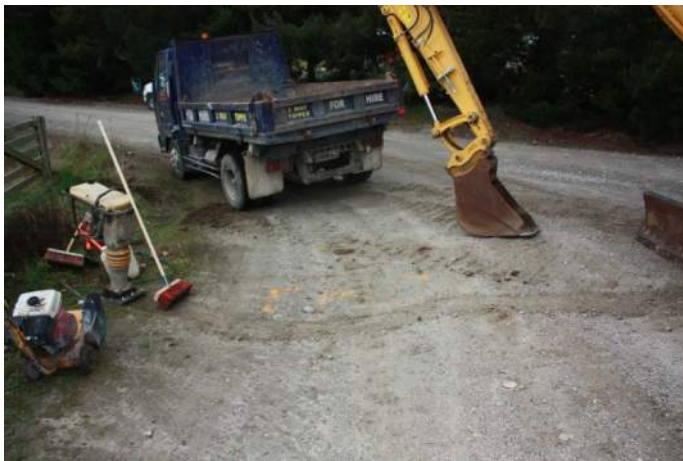
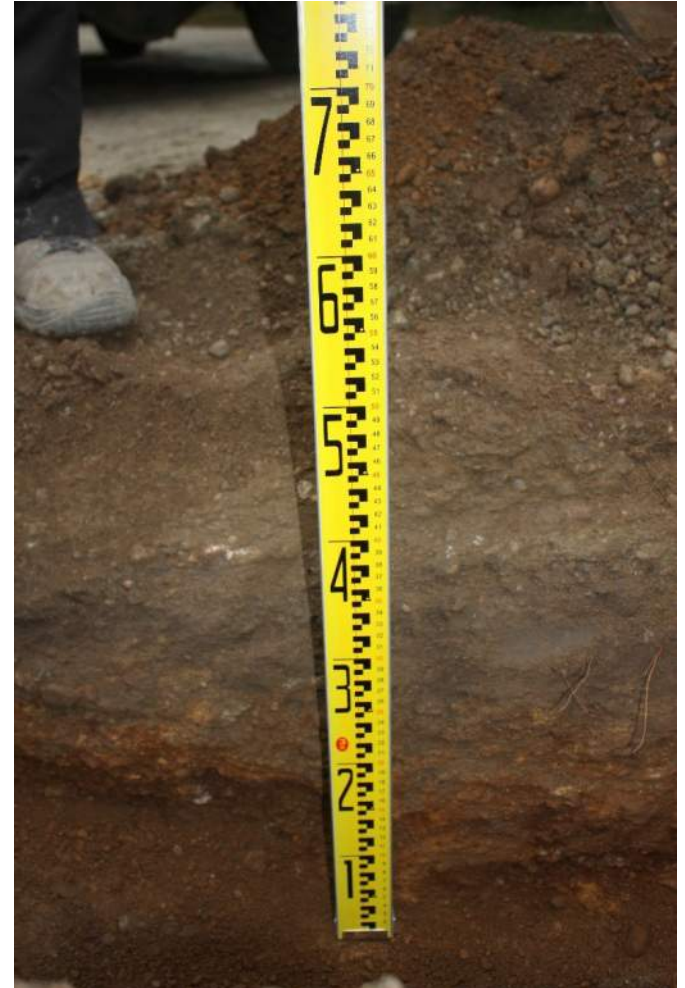
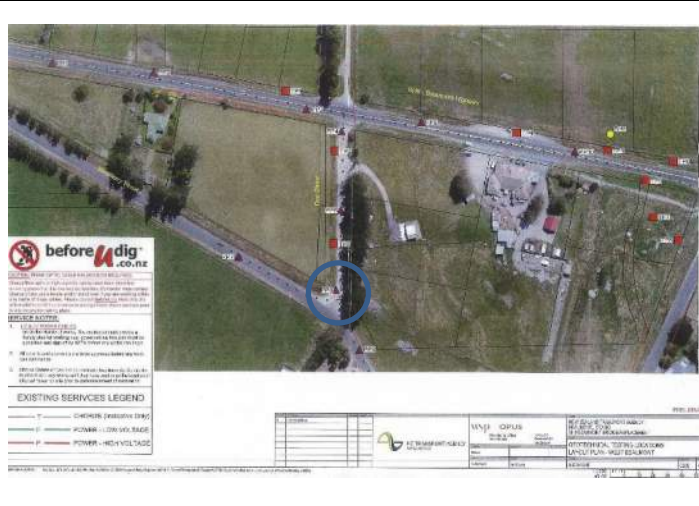
Pavement Pit 6; Dee Street, Westferry Street End (see below)			
FIELD LOG DESCRIPTIONS – Not IANZ Accredited (NZ Geotechnical Society Guidelines 2005)			
Depth (mm)	Description	Depth (mm)	Description
0 - 180 (sampled)	Maintenance Metal – Light / dark brown Sandy GRAVEL with some silt. Moist. Compact. Gravel, subrounded to rounded, maximum particle size 53.0mm; Sand, fine to coarse; Silt, slight plasticity.	400 - 560	Dark orangish brown Sandy GRAVEL with some silt. Moist. Compact. Gravel, subrounded to rounded, maximum particle size 19.0mm; Sand, fine to coarse; Silt, slight plasticity.
180 - 400 (sampled)	Dark brown Sandy GRAVEL with some silt. Moist. Compact. Gravel, subrounded to rounded, maximum particle size 26.5mm; Sand, fine to coarse; Silt, plastic.

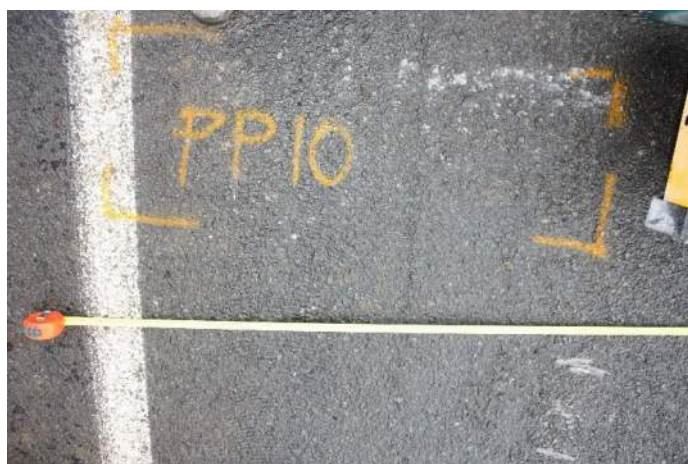
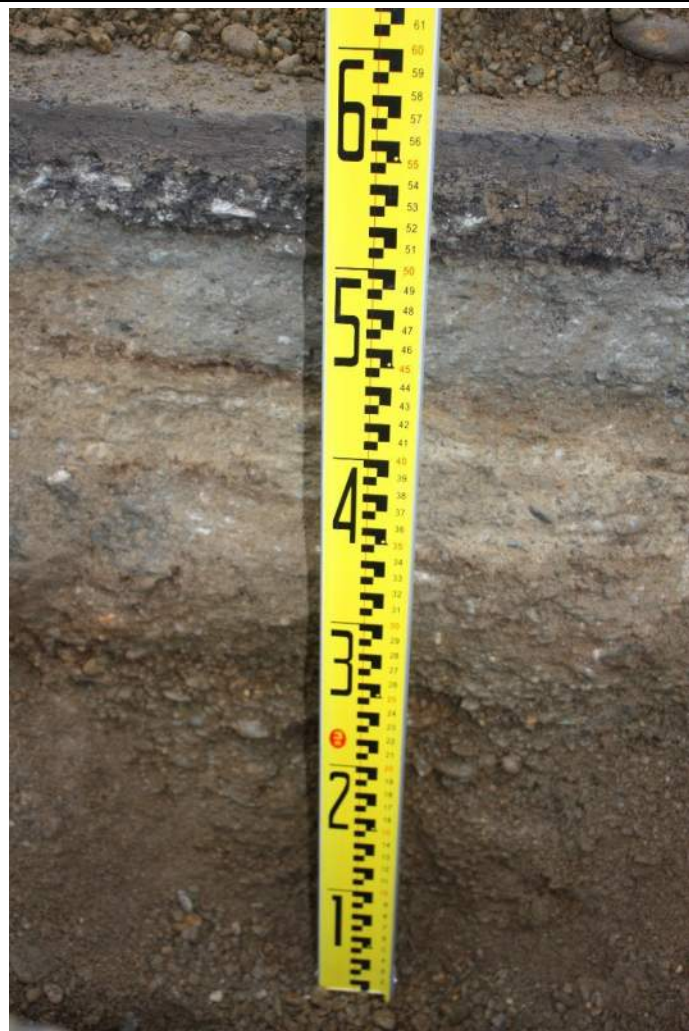
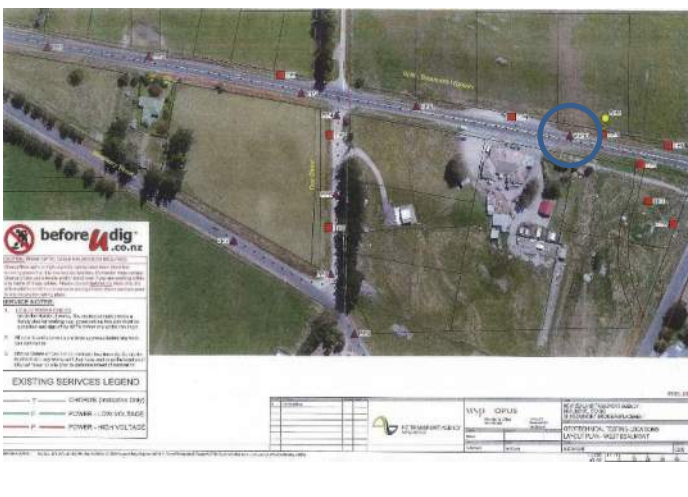
Pavement Pit 10, SH8, Increasing Lane, O/S 1.95m to 3.15m (see below)			
FIELD LOG DESCRIPTIONS – Not IANZ Accredited (NZ Geotechnical Society Guidelines 2005)			
Depth (mm)	Description	Depth (mm)	Description
0 - 50	Chip Seal.	190 - 320 (sampled)	Subgrade – Light greyish brown Sandy GRAVEL with minor silt. Moist. Compact. Gravel, subrounded to rounded, maximum particle size 63.0mm; Sand, fine to coarse; Silt, non-plastic.
50 - 130 (sampled)	Cement stabilised Basecourse - Light grey Sandy GRAVEL with some silt. Moist. Compact. Gravel, subrounded to rounded, maximum particle size 26.5mm; Sand, fine to coarse; Silt, non-plastic.	320 - 540	Subgrade – Brown Sandy GRAVEL with minor silt. Moist. Compact / Loose. Gravel, subrounded to rounded, maximum particle size 75.0mm; Sand, fine to coarse; Silt, non-plastic.
130 - 190 (sampled)	Subbase – Light brown Sandy GRAVEL with some silt. Moist. Compact. Gravel, subrounded to rounded, maximum particle size 37.5mm; Sand, fine to coarse; Silt, non-plastic.

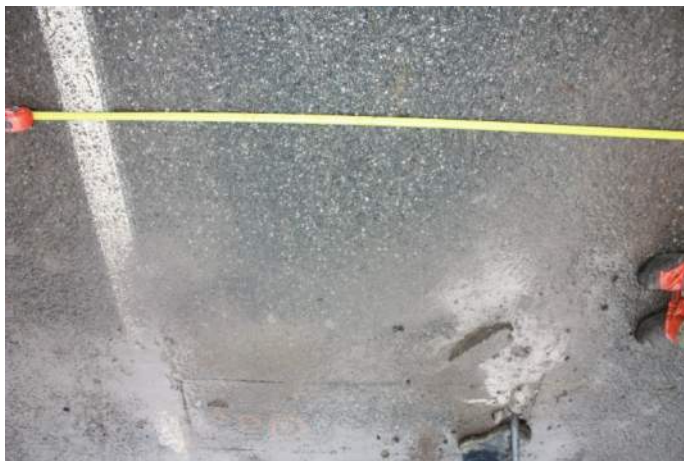
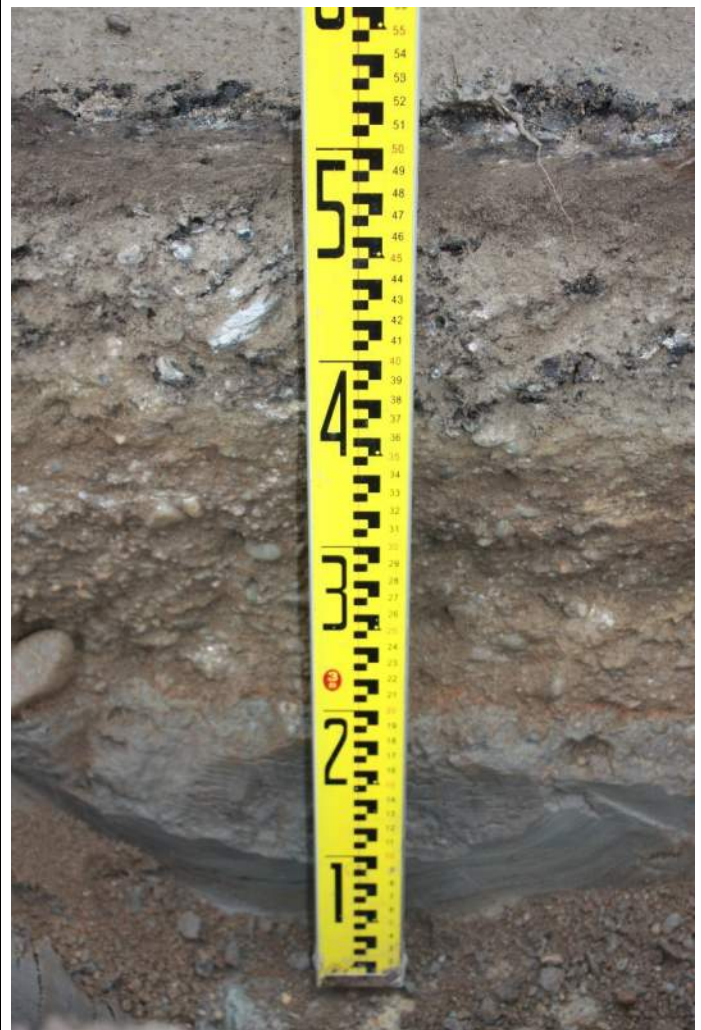
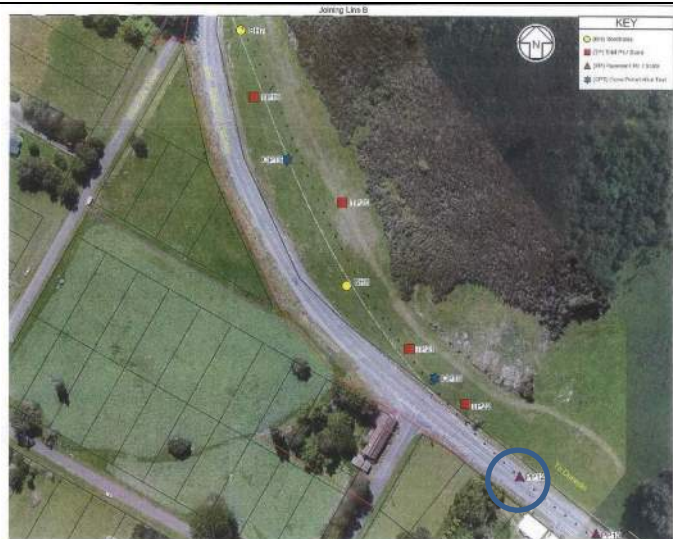
Pavement Pit 12, SH8 Increasing Lane, O/S 2.30m to 3.50m (see below)			
FIELD LOG DESCRIPTIONS – Not IANZ Accredited (NZ Geotechnical Society Guidelines 2005)			
Depth (mm)	Description	Depth (mm)	Description
0 - 70	Chip Seal.	220 - 340 (sampled)	Subbase – Light brown Sandy GRAVEL with minor / some silt. Moist. Compact. Gravel, subrounded to rounded, maximum particle size 53.0mm; Sand, fine to coarse. Silt, non-plastic.
70 - 220 (sampled)	Cement stabilised Basecourse – Light greyish brown Sandy GRAVEL with trace of silt. Dry / Moist. Compact. Gravel, subangular to rounded, maximum particle size 63.0mm; Sand, fine to coarse; Silt, non-plastic.	340 - 500 (sampled)	Subgrade – Blueish grey SILT with minor clay. Moist. Firm. Silt / clay, plastic.

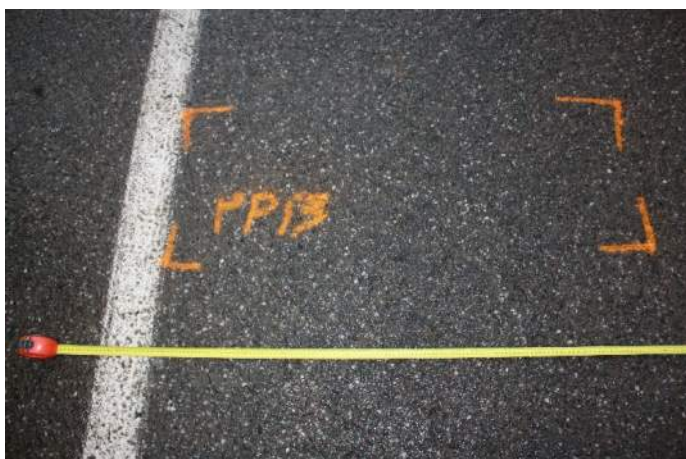
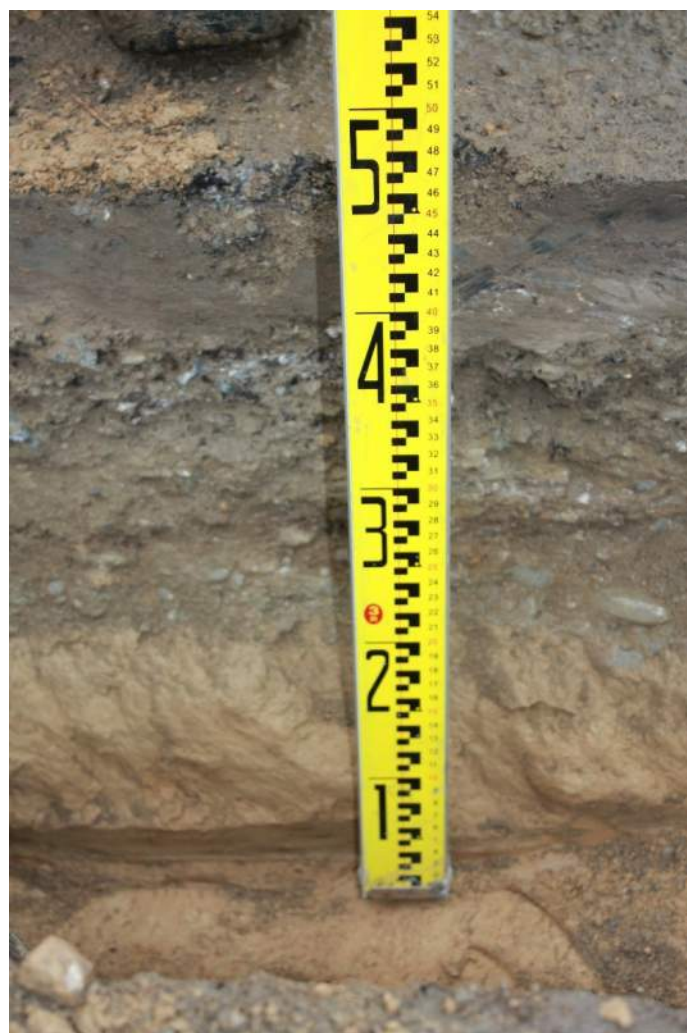
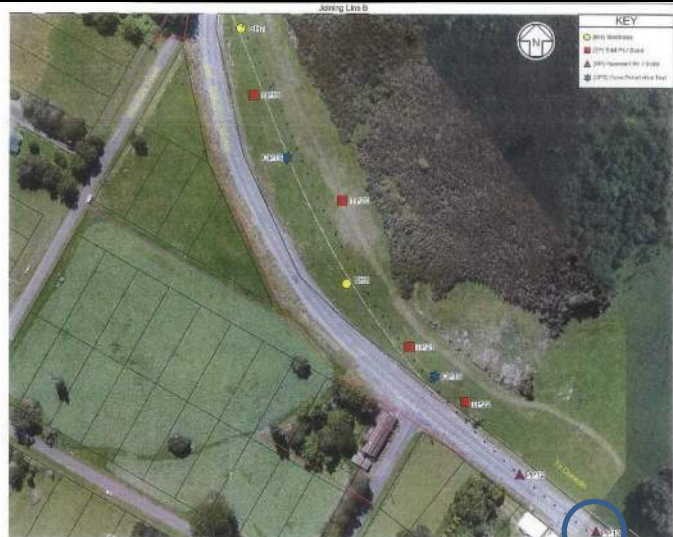
Pavement Pit 13, SH8 Increasing Lane, O/S 2.50m to 3.70m
FIELD LOG DESCRIPTIONS – Not IANZ Accredited (NZ Geotechnical Society Guidelines 2005)

Depth (mm)	Description	Depth (mm)	Description
0 - 80	Chip Seal. Trace of scabbing present.	180 - 270 (sampled)	Subbase – Light brown Sandy GRAVEL with some silt. Moist. Compact. Gravel, subrounded to rounded, maximum particle size 26.5mm; Sand, fine to coarse; Silt, non-plastic.
80 - 180 (sampled)	Basecourse (possibly stabilised) – Light greyish brown GRAVEL with some sand and trace of / minor silt. Dry / Moist. Compact. Gravel, angular to rounded, maximum particle size 53.0mm; Sand, fine to coarse; Silt, non-plastic.	270 - 440 (sampled)	Subgrade – Light orangish / yellowish brown SILT with minor clay and trace of sand. Moist. Firm. Silt / clay, plastic.
