OLD MĀNGERE BRIDGE
HERITAGE MANAGEMENT PLAN
AND SALVAGE PLAN

HERITAGE MANAGEMENT PLAN / SALVAGE PLAN

Final: 17 June 2019

Prepared by
Mātai Taonga Ltd
Historic Heritage and Archaeology Services
and
Matthews & Matthews Architects Ltd
P O Box 108 166 Symonds Street,
Auckland

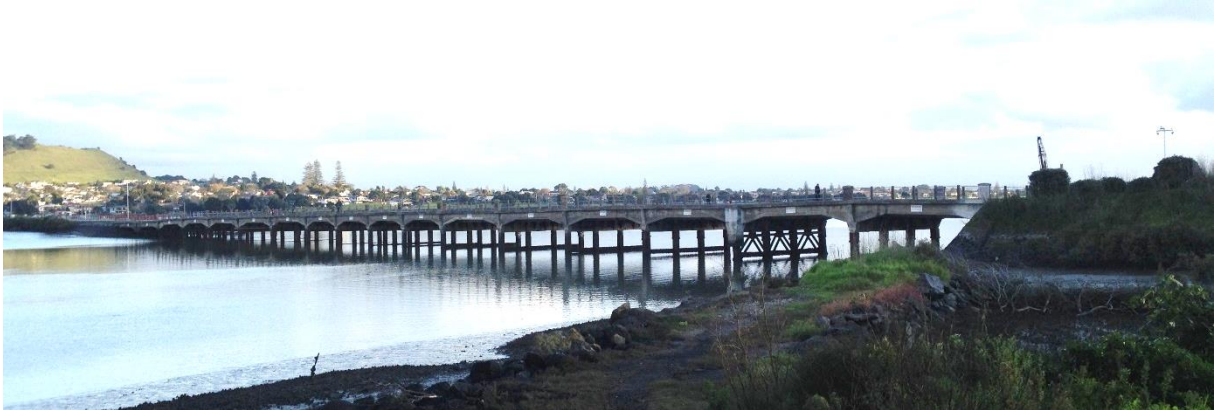
Figure 22: View of the Old Māngere Bridge Looking towards Māngere. Matthews & Matthews Architects Ltd 2014.

The OMB is a reinforced ferro-concrete multi-span bridge with an overall length of approximately 240 m. The bridge has 16 (check) spans, each span consisting of 8 parallel girders approximately 50 feet in length supported on reinforced concrete beams supported on regularly spaced rows of four piles. It has a width of 12 m. The handrails consist of three galvanised steel pipes spanning between shaped concrete piers and intermediate concrete posts. The bridge is surfaced with concrete and asphalt.

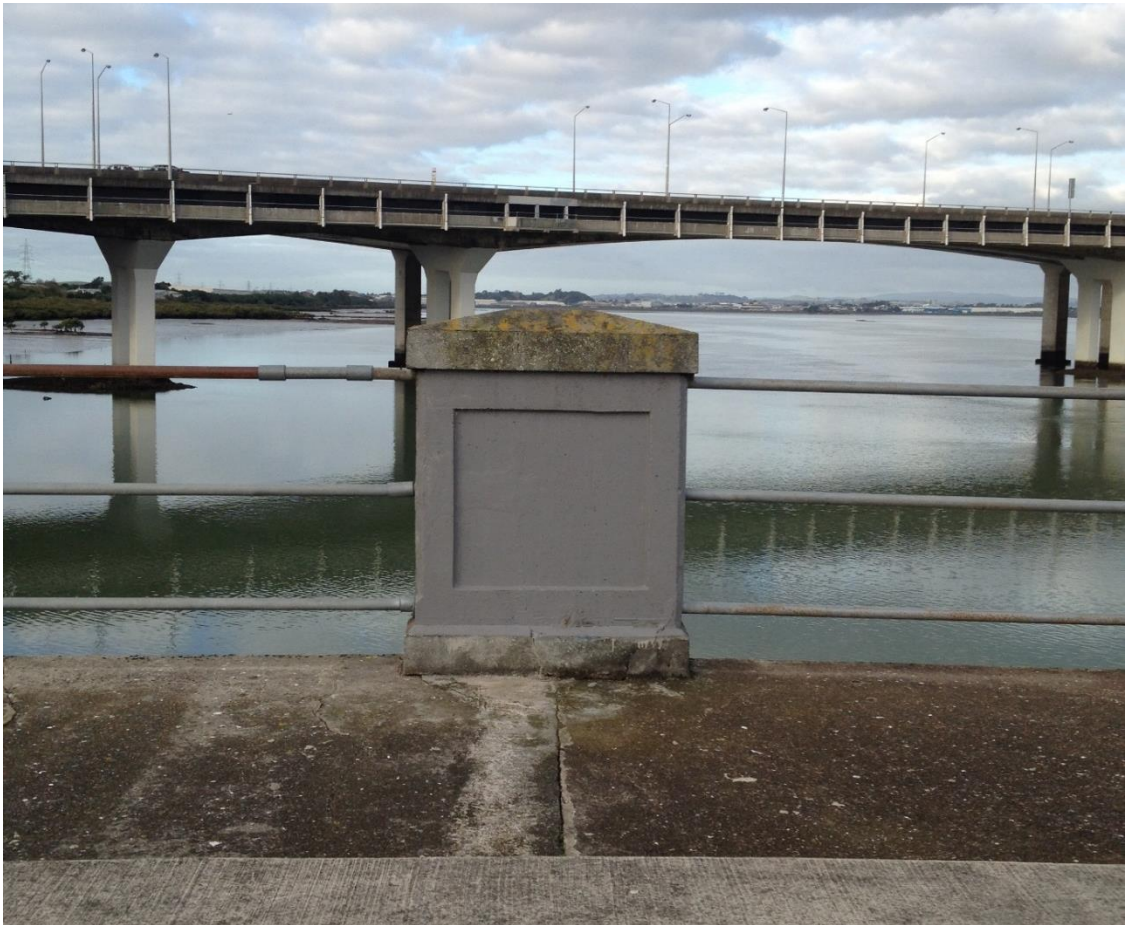
Figure 24: View of a typical concrete pier. Matthews & Matthews Architects Ltd 2014.

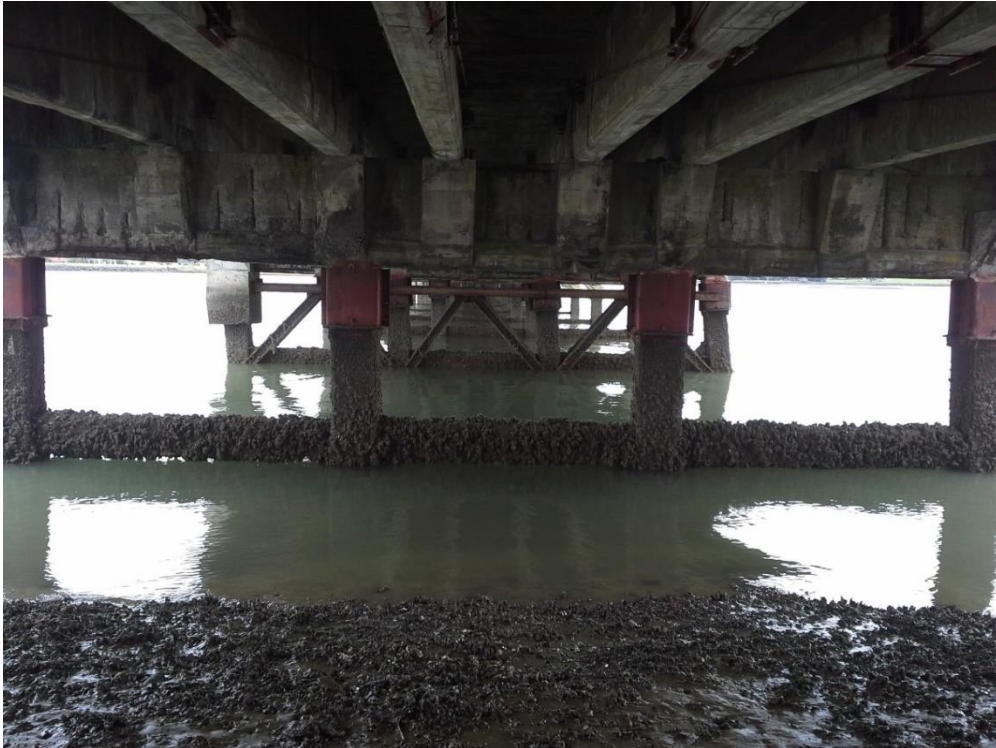
Figure 26: View to underside of the bridge showing the parallel girders spanning between the main beams, supported on four piles. Cross bracing added to strengthen the piles is visible. Dr Matthew Felgate 2017.

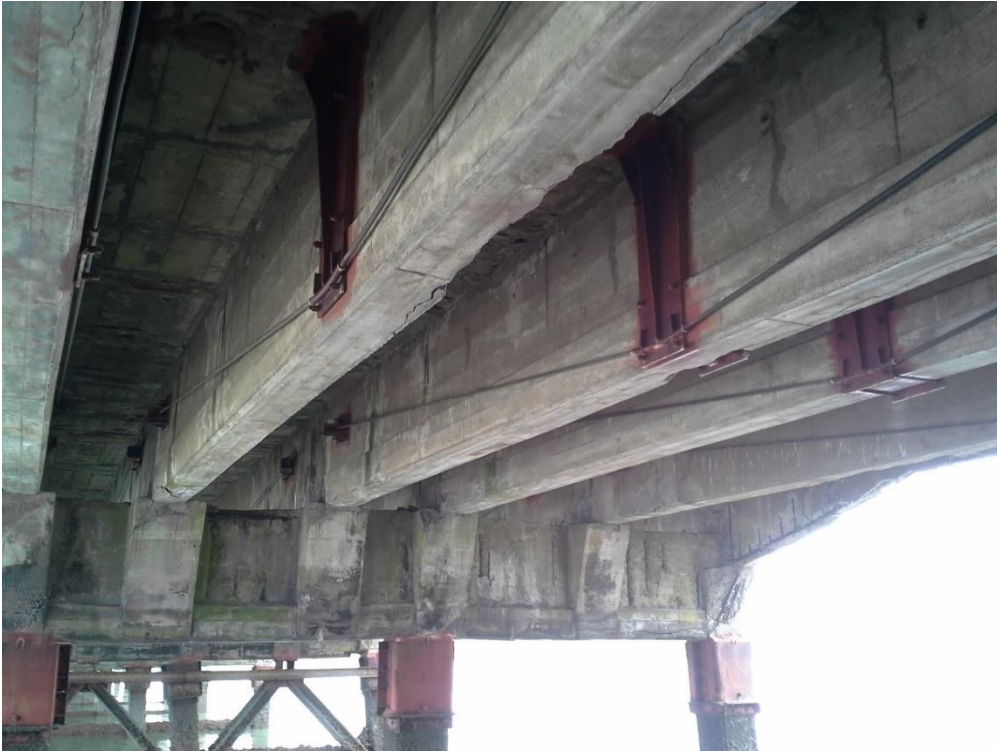
Figure 28: View to underside of the bridge showing the parallel girders spanning between the main beams. Strengthening to the girders is visible. Dr Matthew Felgate 2017.

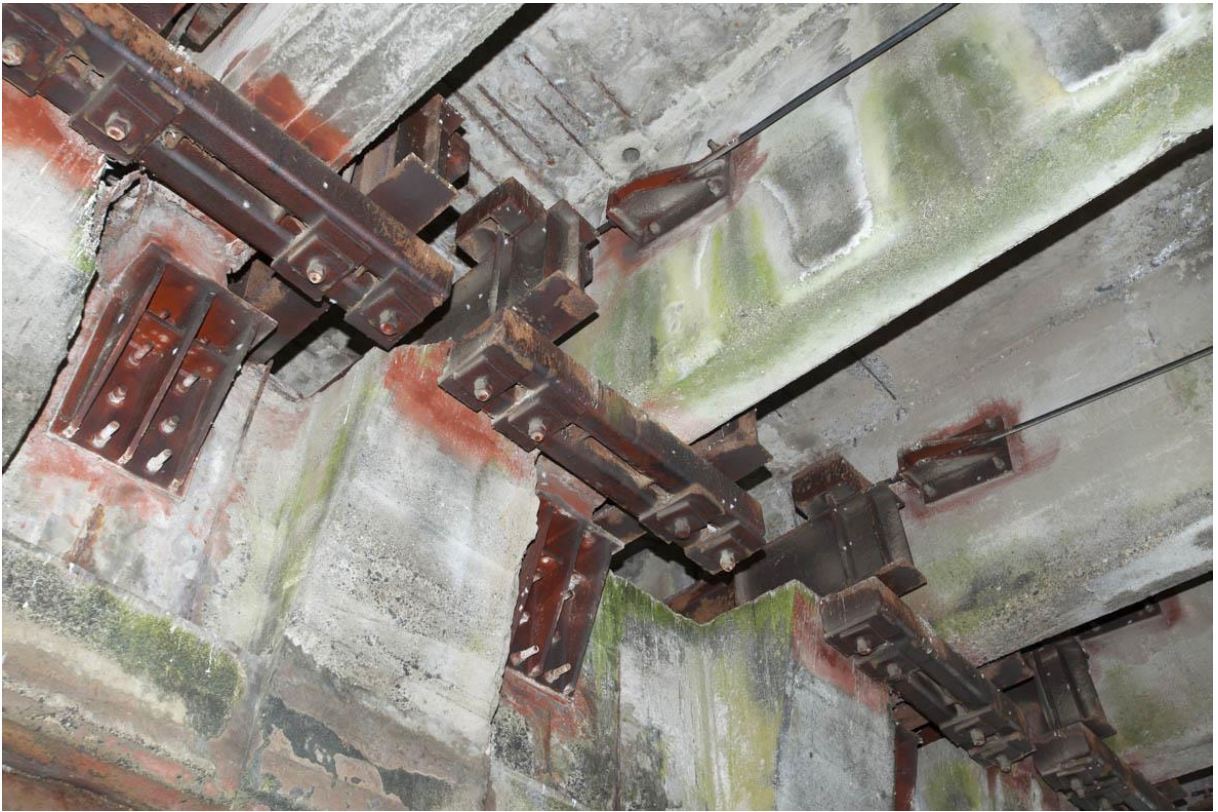
Figure 27:View of steel bracket repairs, date not confirmed. Fraser Newman Photography

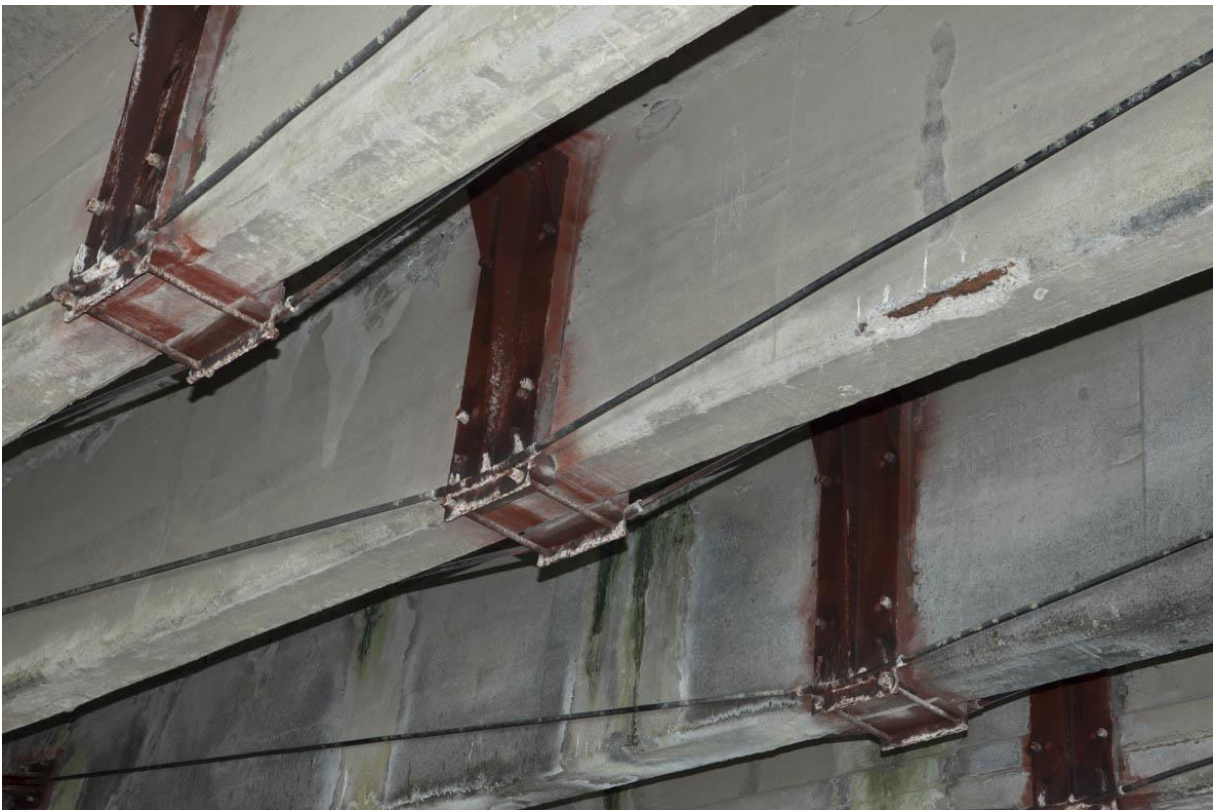
Figure 28:Bracket and tension wire repairs. Fraser Newman Photography

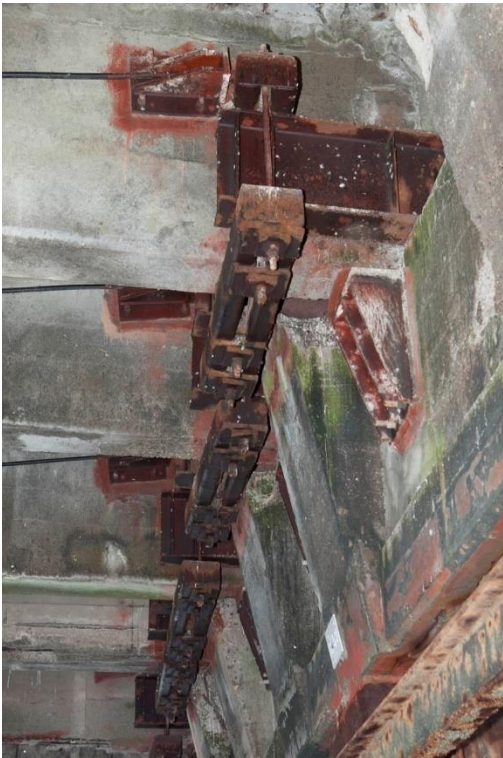
Figure 29: Repairs to support beams. Fraser Newman Photography

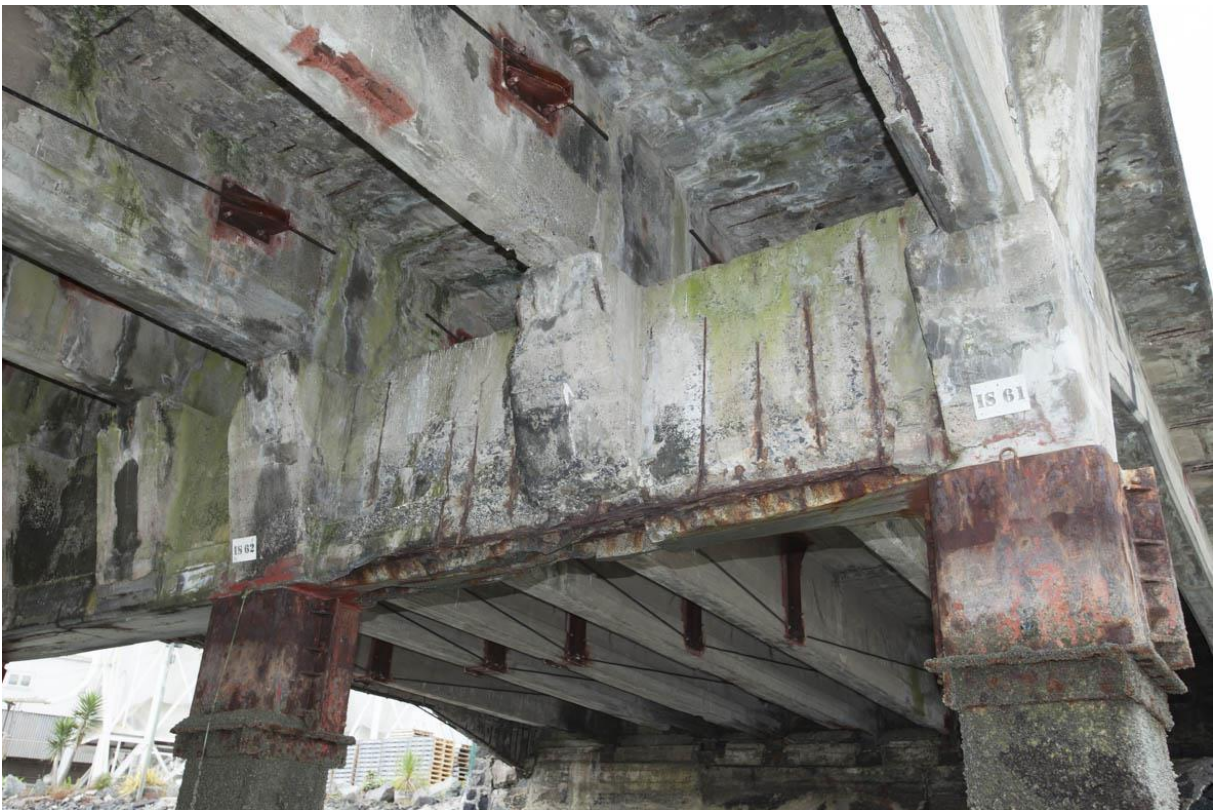
Figure 30: Repairs to column caps and beams and deterioration to beams and underside of deck. Fraser Newman Photography.

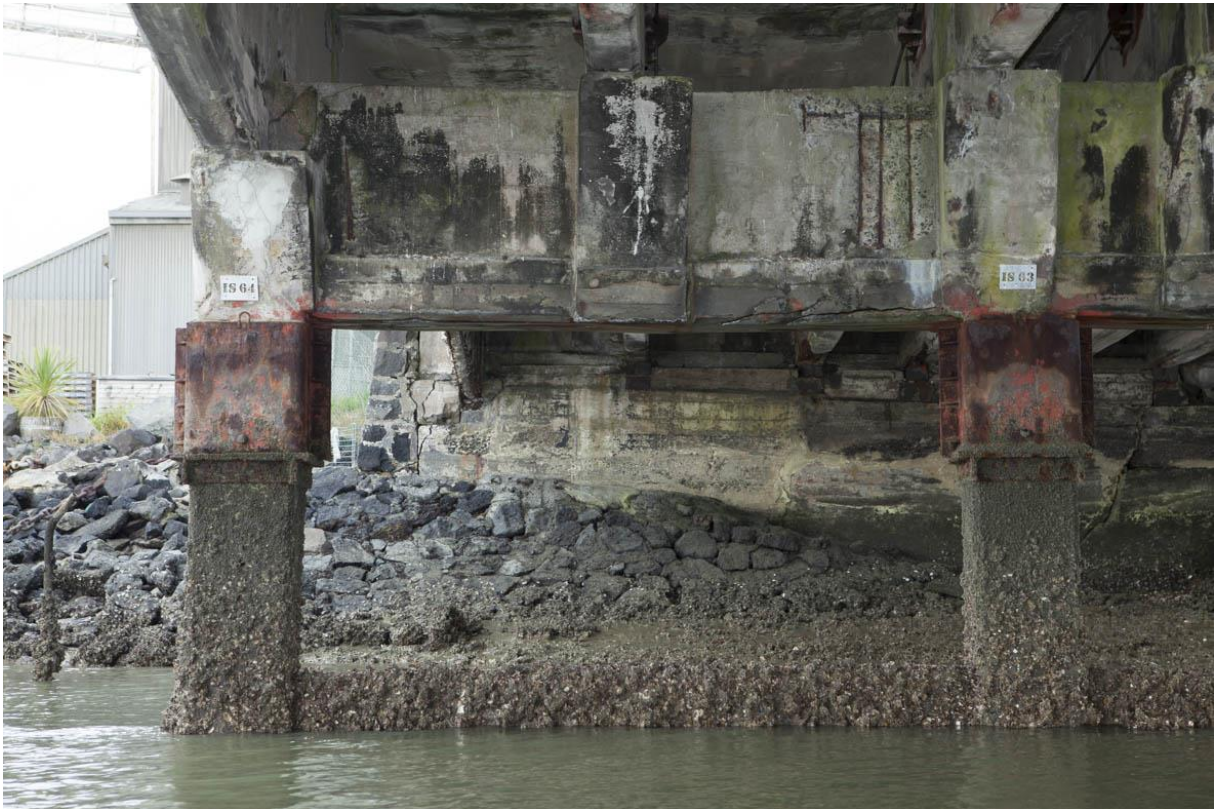
Figure 31: View to north end, showing significant deterioration and various repairs. Fraser Newman Photography.

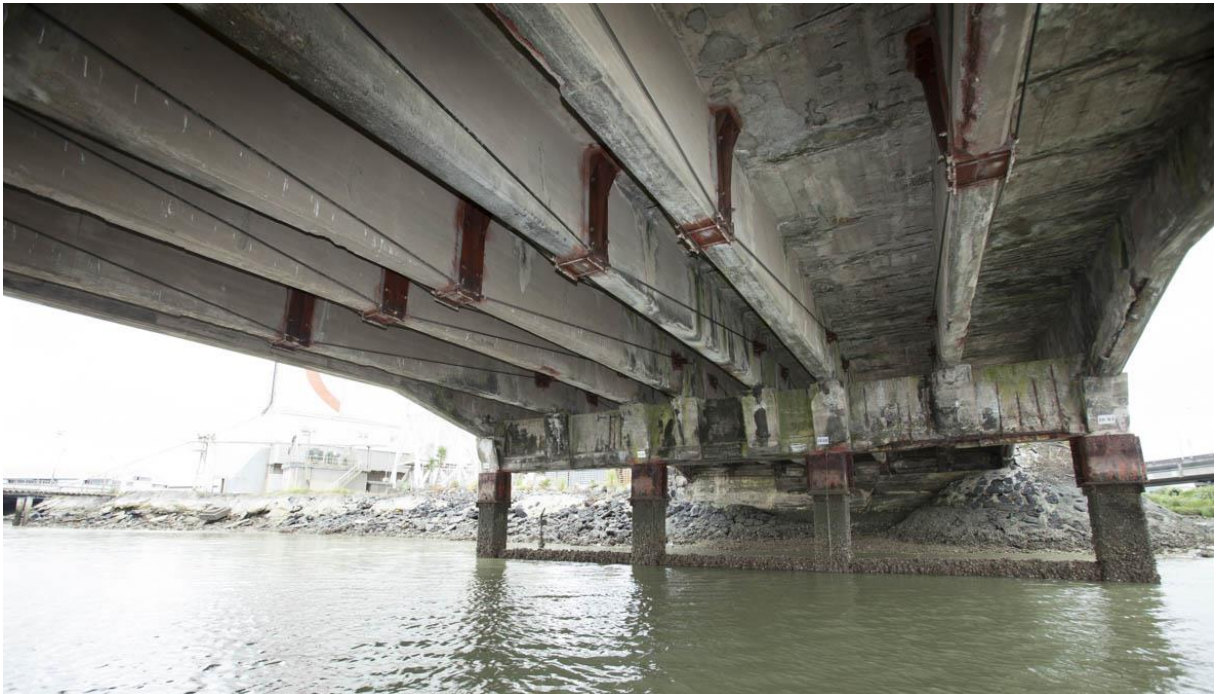
Figure 32: View towards north end showing significant deterioration to side beams. Fraser Newman Photography.

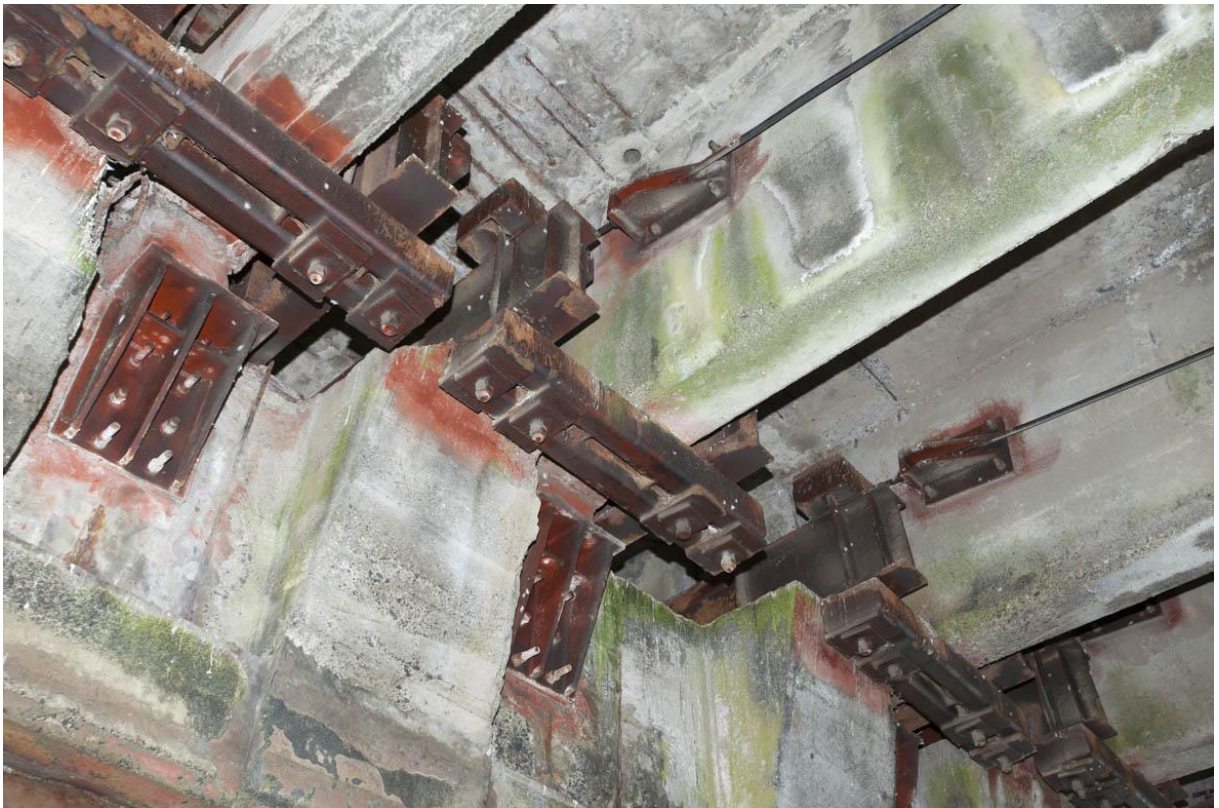
Figure 34: View of some of the repairs undertaken to the underside of the bridge. Fraser Newman Photography.

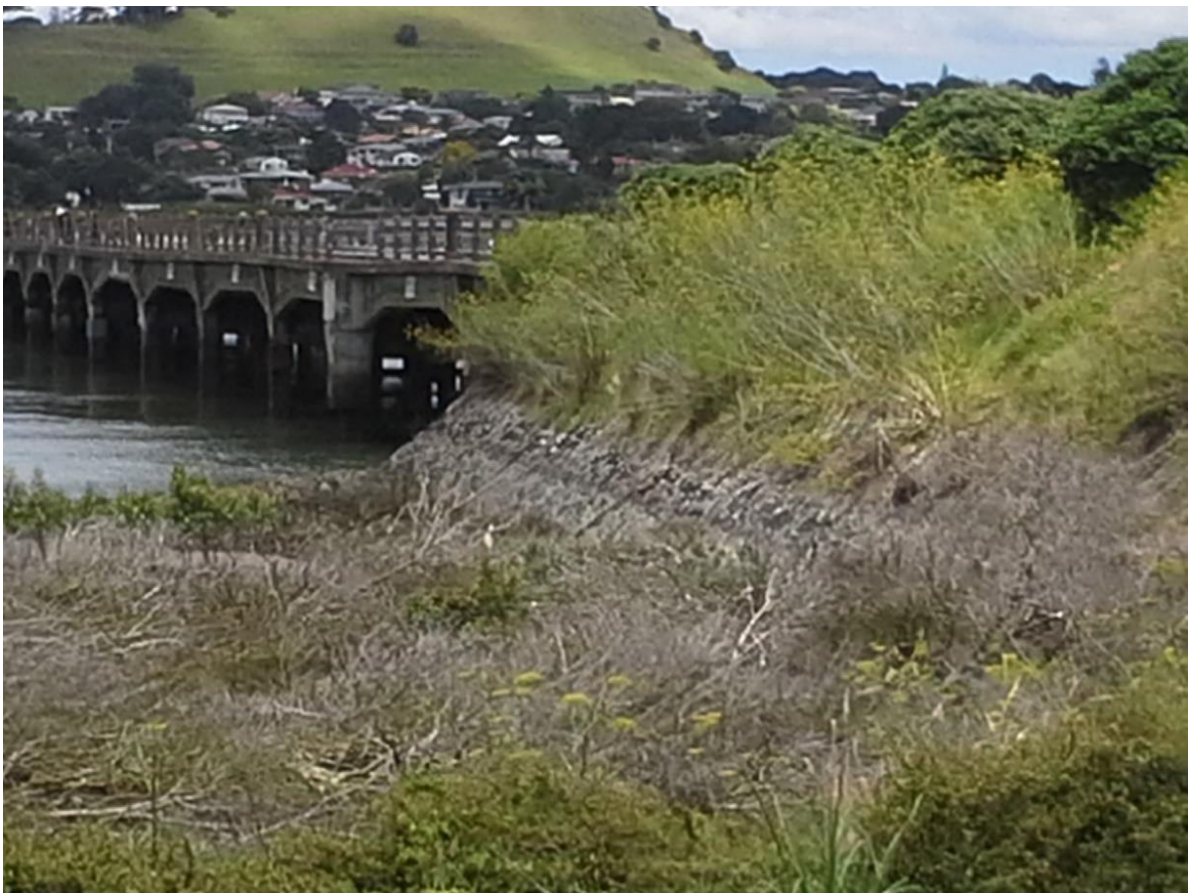
Figure 39: The east side of the northern embankment. Photo Matthew Felgate.

The east side of the northern embankment has masonry facing that matches the east side of the southern embankment, and matches the west side of the southern embankment, and the north side of the southern abutment. It may have undergone maintenance and repair but may well be primarily 1914-1915 original fabric.

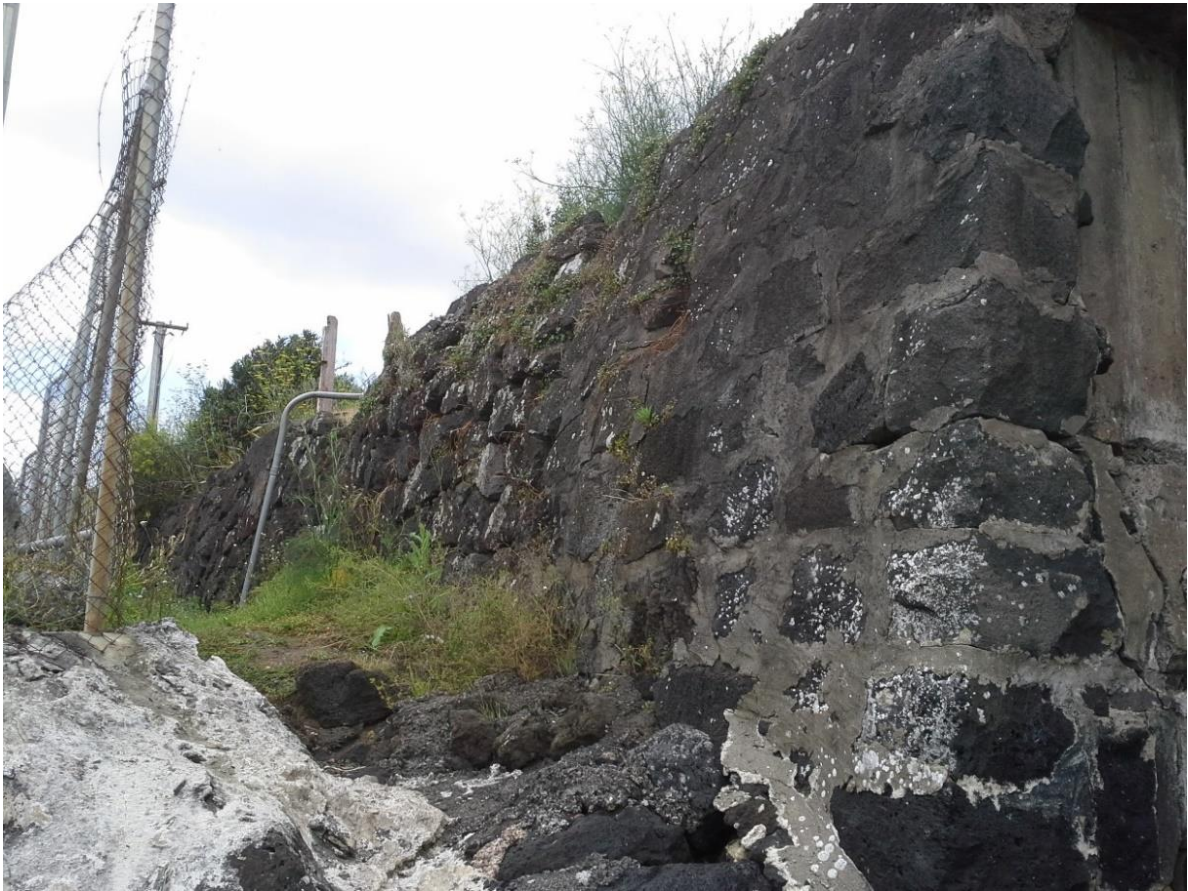
Figure 40: The western side of the northern embankment has a more vertical basalt/scoria retaining wall. Photo Matthew Felgate.

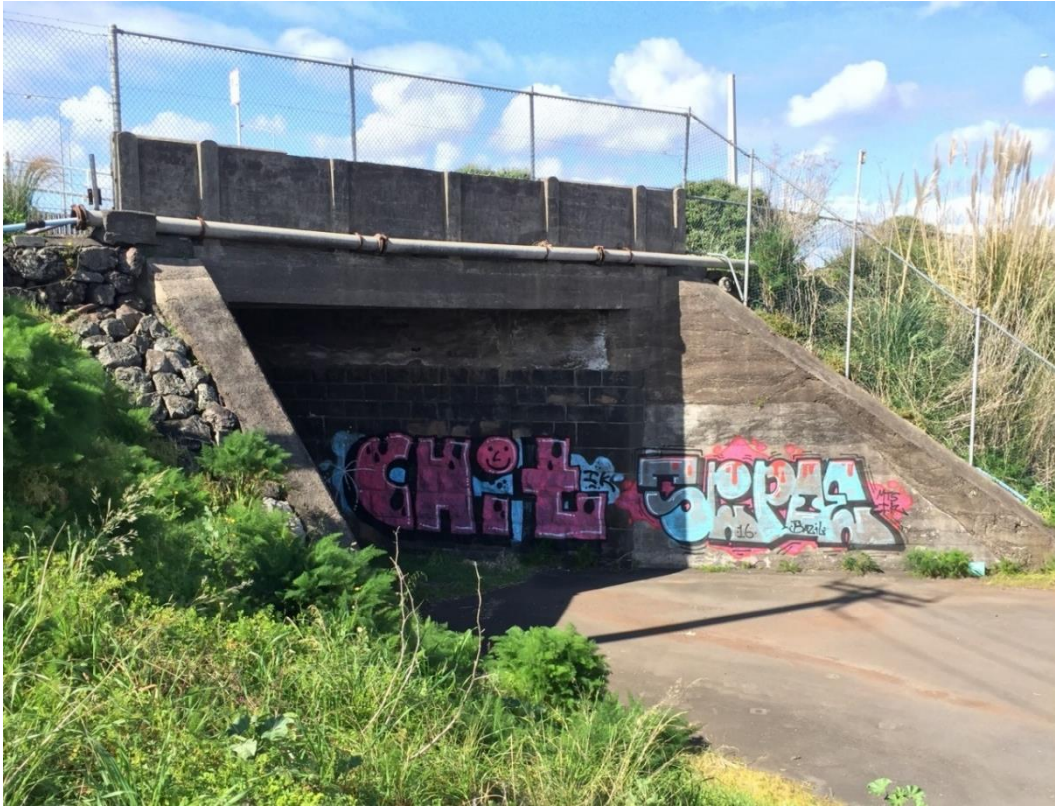
Figure 38: View of the railway overbridge. Matthews & Matthews Architects Ltd 2017.

The construction of the Māngere Bridge required widening of the railway overbridge by the railways department.¹⁴⁵ By April 1915 the reinforced concrete railway overbridge was being constructed, to replace an existing timber one. Additional space was allowed for trains to pass under the new bridge.¹⁴⁶

The extant rail overbridge structure (now retired from use as a rail bridge) is of Ferro-concrete construction with basalt facing retaining within the structure, consistent with construction circa 1915, and is in alignment with the 1915 bridge and its causeways/embankments.

The 1914 Plans and elevations for a replacement rail bridge are held at National Archives in Wellington¹⁴⁷. (Refer Figures 38 and 39).

As a consequence of the construction of the Māngere Bridge, the railway overbridge was required to be widened and was replaced at the same time.

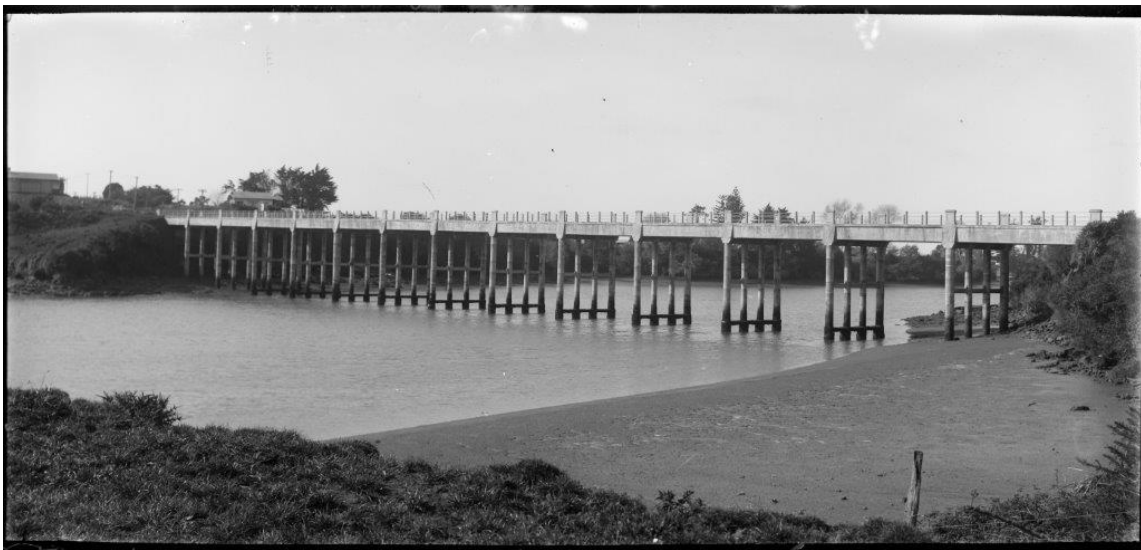
Figure 41: View towards the 1916 reinforced concrete Panmure Bridge 12 October 1927. Auckland Libraries Heritage Collections, 4-5866, photographer J D Richardson.

The new concrete bridge was formally opened on 14th August 1916 by the Prime Minister the Right Hon. William Massey. Manukau County Council were praised for having constructed four concrete bridges including at Māngere, Panmure and two at Karaka.¹⁵²

However, by 1930 serious faults in the Panmure bridge were reported when a large crack across the full width of the bridge at the southern end was discovered. The County engineer, Mr L E Utting, said the crack was caused by sinking of the first pier at the Pakuranga end. He reported that reinforcement was very badly placed with too little concrete covering and the shingle used caused very porous concrete causing the steel to rust badly.

It was pointed out that there were similar problems with other concrete bridges at Māngere, and Karaka constructed at the same time as the Tāmaki Bridge. The Council decided to immediately put a load limit of six tons and a speed limit ten miles per hour on the bridge.¹⁵³ This bridge was demolished in 1959 after the present Panmure bridge was opened.

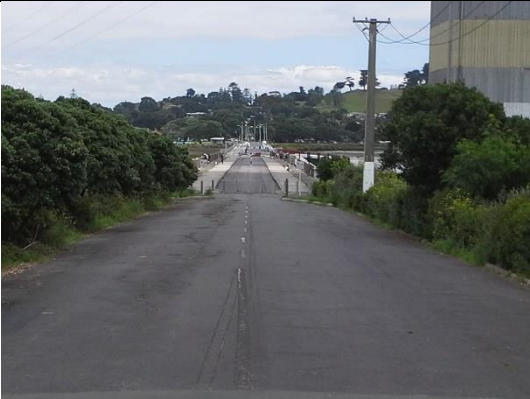
<p>The north approach road was described in 1915 as requiring a great deal of filling to raise the approach to the level of the new bridge, by 6 feet or more. Material for the</p>	Considerable

<p>filling work was taken 'from an embankment in Onehunga'.¹</p>	
<p>North Embankment Onehunga</p>

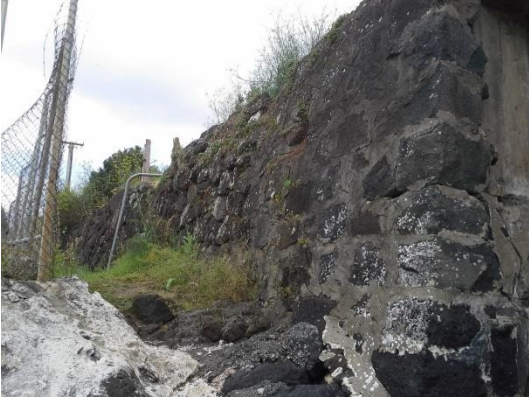
<p>West side The west side of the northern embankment has vertical or near-vertical basalt facing work. Storm damage in 1921. Comprehensive repairs were undertaken to the abutments in 1928.</p>	<p>Considerable</p>

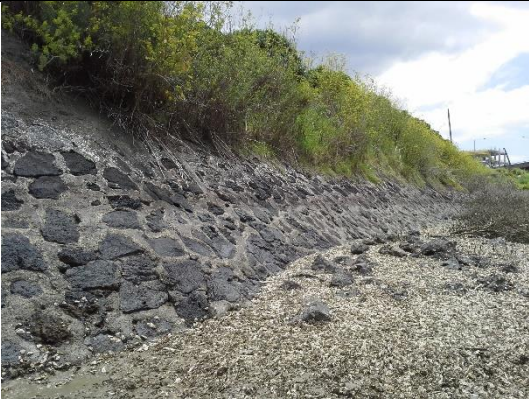
<p>East Side The east side of the northern embankment has sloped masonry facing that matches that on the southern abutment. Storm damage in 1921. Comprehensive repairs were undertaken to the abutments in 1928.</p>	<p>Considerable</p>

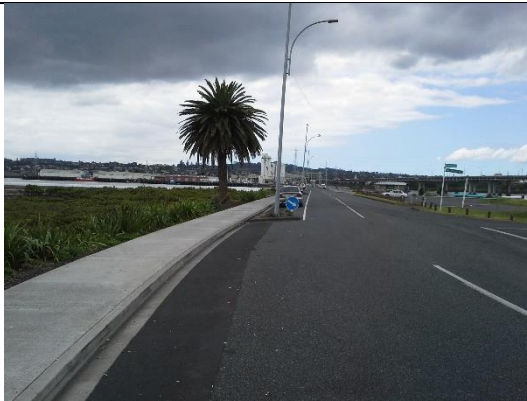
<p>The south approach road was described in 1915 as having a firm foundation of blue metal, covered with scoria and a fine coating of shells. Footpaths extended along this approach.² The road has been re-built/ resurfaced with new footpaths.</p>	<p>Considerable</p>
<p>South Embankment Māngere</p>

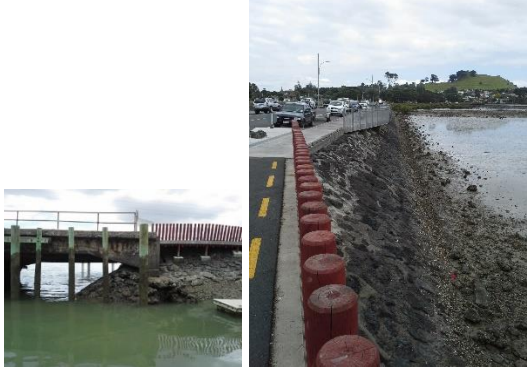
<p>West Side Sloped masonry facing. Storm damage in 1921 washed out much of the filling with the wall collapsing. Comprehensive repairs were undertaken to the abutments in 1928.</p>	<p>Considerable</p>

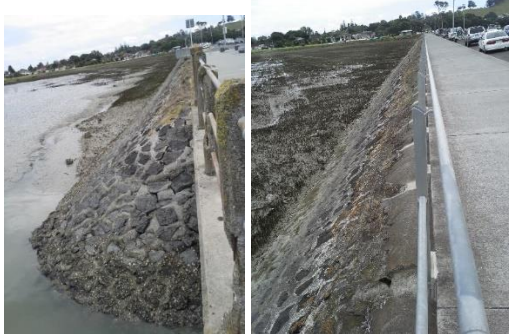
<p>East side Sloped masonry facing The east side of the Māngere embankment was described as steeper than the west in 1921 and had also suffered damage. Re-pitching the slope of the wall was considered too costly. Repairs with a heavy cement grout was proposed.³</p>	<p>Considerable</p>
	<p>Base of south abutment</p>

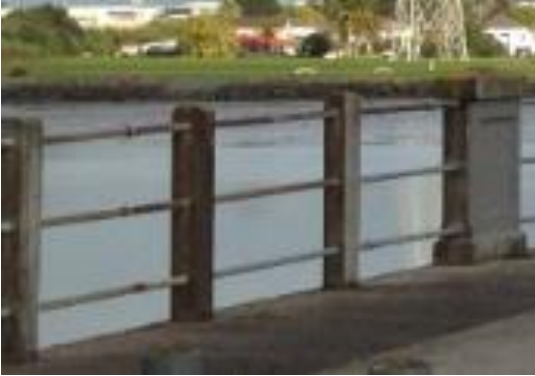
<p>Simple reinforced concrete intermediate posts. The existing posts are a simpler form than shown on the original drawings. Historic photos show they were built in this simple form. A number of the posts are now missing (in 2018)</p>	<p>Considerable</p>
<p>Balustrade rails</p>	<p>Three galvanised steel rails span between the balustrade posts. These have been periodically repaired or replaced from as early as 1939.</p>	<p>Low</p>
<p>Main haunched edge beams and longitudinal beams</p>

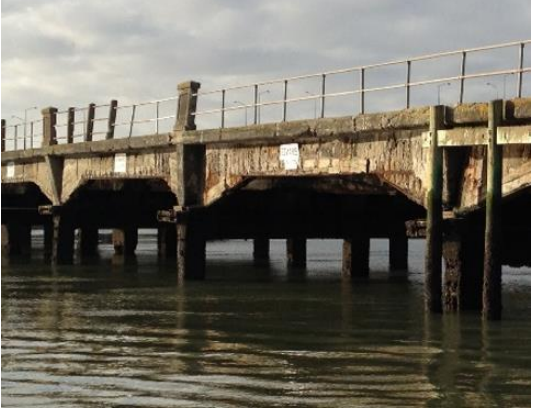
<p>Reinforced concrete structure with repairs undertaken in 1928, 1939, and to some spans in 1959.</p>	<p>Considerable</p>
<p>Cross girders</p>

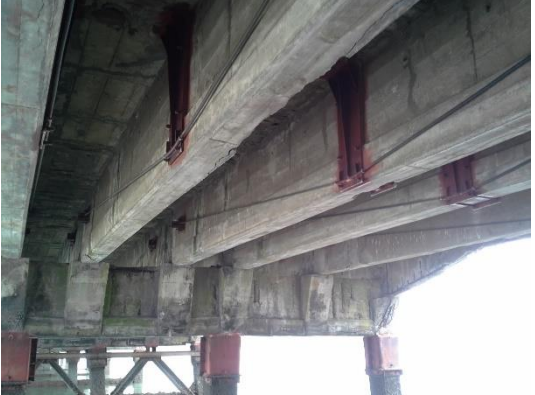
<p>Reinforced concrete girders described as being 8 feet deep and 15 inches wide.⁵ Repairs undertaken to the concrete supporting structure in 1928, 1939, and to</p>	<p>Considerable</p>

<p>some spans in 1959. Other repairs evident, date not confirmed; part of the history of the structure.</p>	
<p>Concrete piles</p>

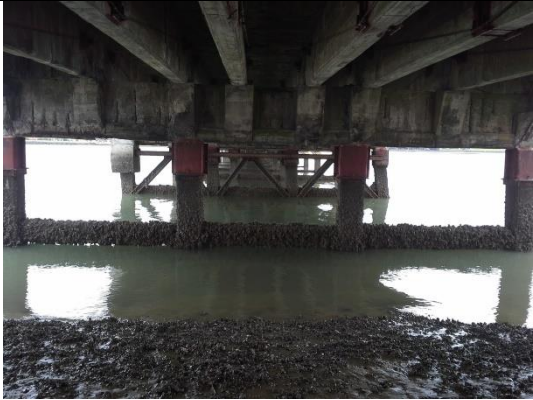
<p>Reinforced concrete piles hammer-driven into place. Various repairs to pile caps are evident, date not confirmed; part of the history of the structure.</p>

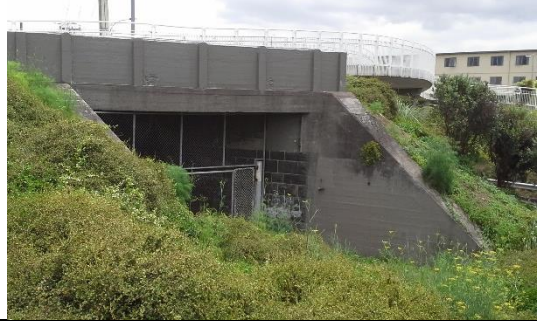
Figure 42: Cross Section through overbridge. National Archives, Wellington, BABJ A681 14406 Box 46, Record Number 3350, Overbridge at Māngere Road, 1914.

Reinforced concrete walls		considerable
Random rubble stone facing		considerable
Reinforced concrete parapet walls		considerable

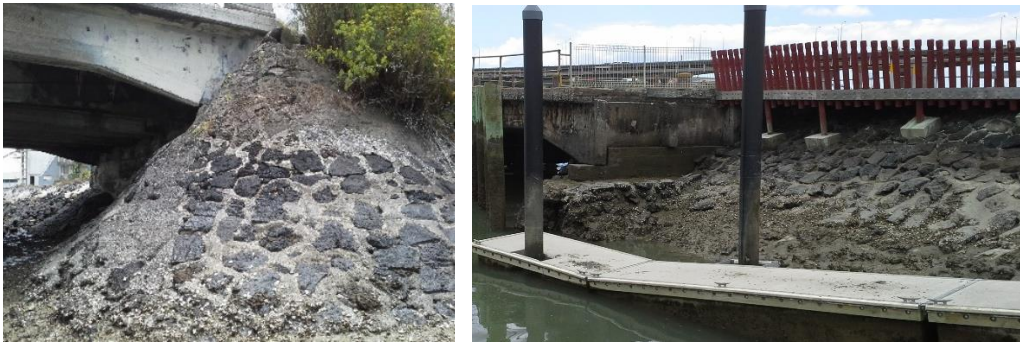
The abutments (also described as the embankments) of the old bridge are to be retained.¹⁵⁶

Views to north and south embankment. Photos Matthew Felgate.

- Policy 4 The existing form and fabric of the embankments should be retained as far as practicable, with an overall aim of minimum intervention into the historic fabric. Areas of deterioration should be repaired rather than replaced.

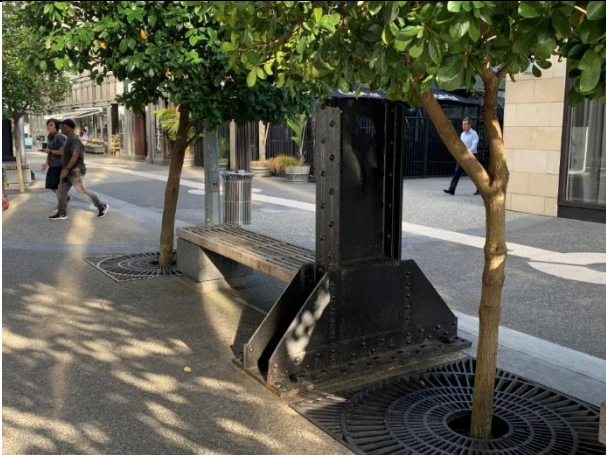
<p>Photo (J Matthews) showing historic steel artefact integrated with new seat in front of Aecom House in lane off Mahuhu Crescent, Auckland.</p>
<p>Pier, and beam connection</p>	<p>Components which explain in cross section the historic reinforced concrete structure including piles, piles to beam connection, beam and deck, as well as potentially a series of cross sections through elements such as the piles showing the reinforcing.</p> <p>The historic reinforced concrete elements could be laid out in sections as in the Cross Section and integrated as seats or to tell the story of the bridge design.</p>
<p>Cross sectional details and components</p>	<p>Components that could be mounted and set out in a similar way to the original detail drawings sheet, eg a cross section through a pile, a pile cap, a half section of a girder, a balustrade pier, balustrade post, balustrade rails.</p>
<p>General salvaged materials as mementos</p>	<p>In addition to specific elements that could be integrated in the design of new bridge, salvage of parts of the concrete structure could be considered as mementos for the community.</p>
