**ŌTAKI TO NORTH OF LEVIN PFRs**  
**Report No. 7: Levin Signals**

Prepared for NZ Transport Agency  
February 2013

## Report 7: Levin Signals

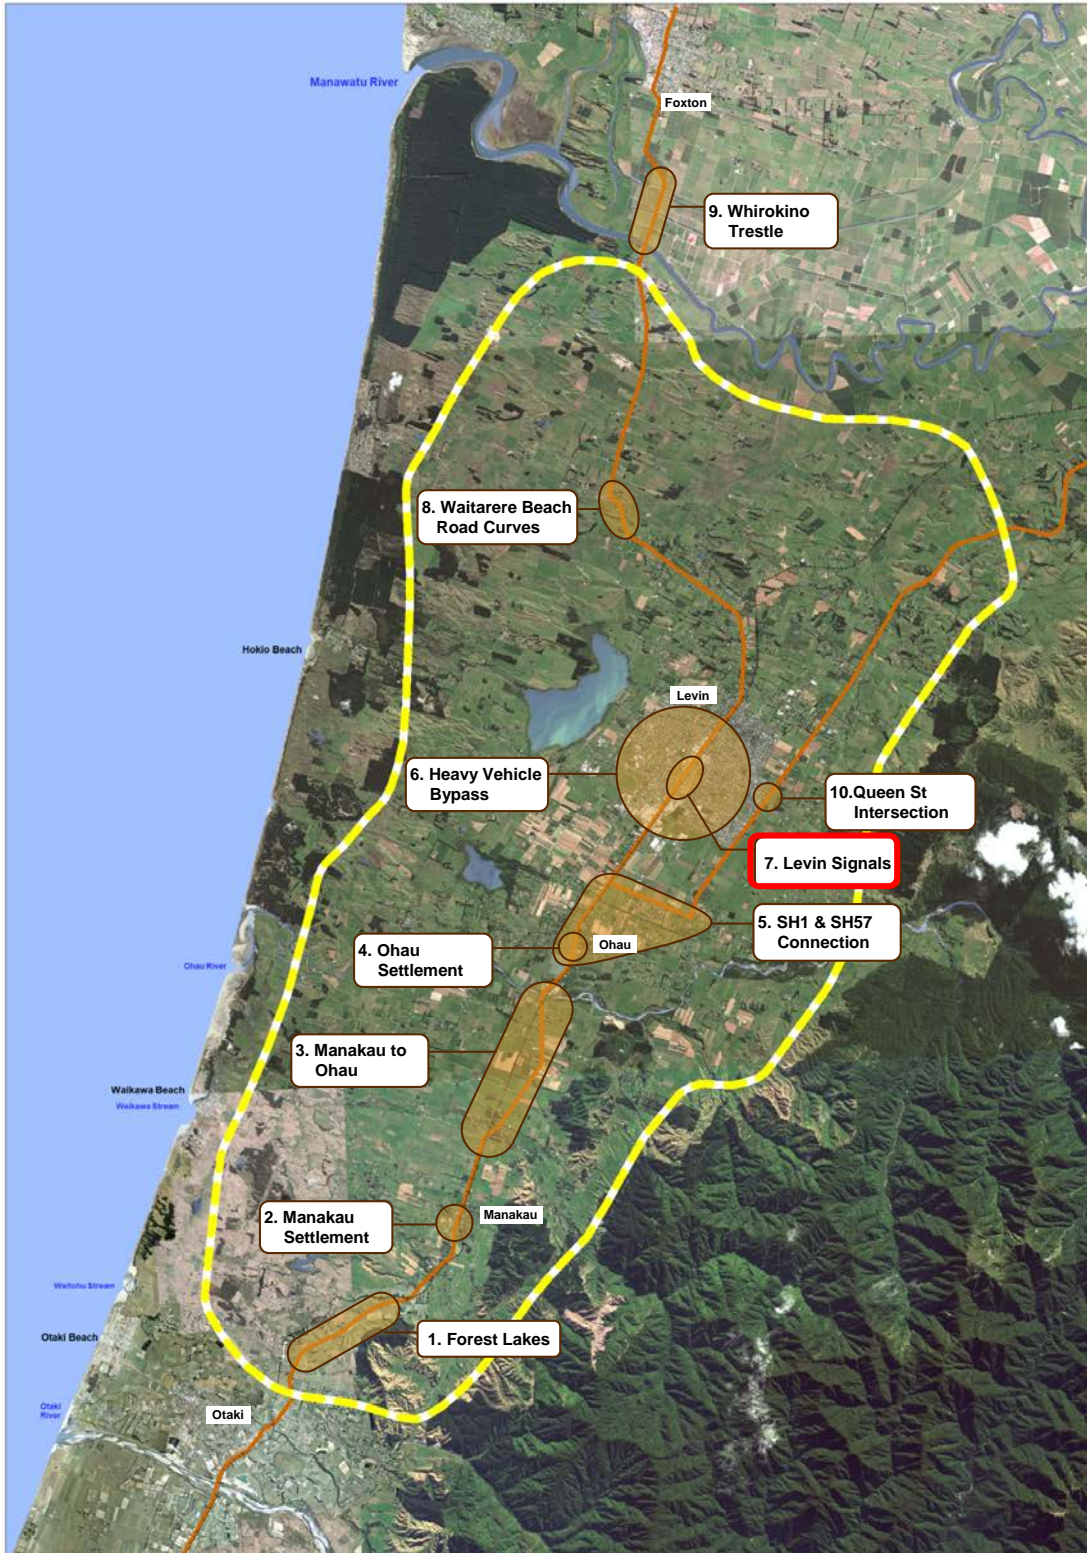
**Figure 2-1: Projects Currently Being Investigated**

The projects that are currently being investigated to meet the short to medium term objectives of the Ōtaki to north of Levin RoNS project are presented in the figure below.

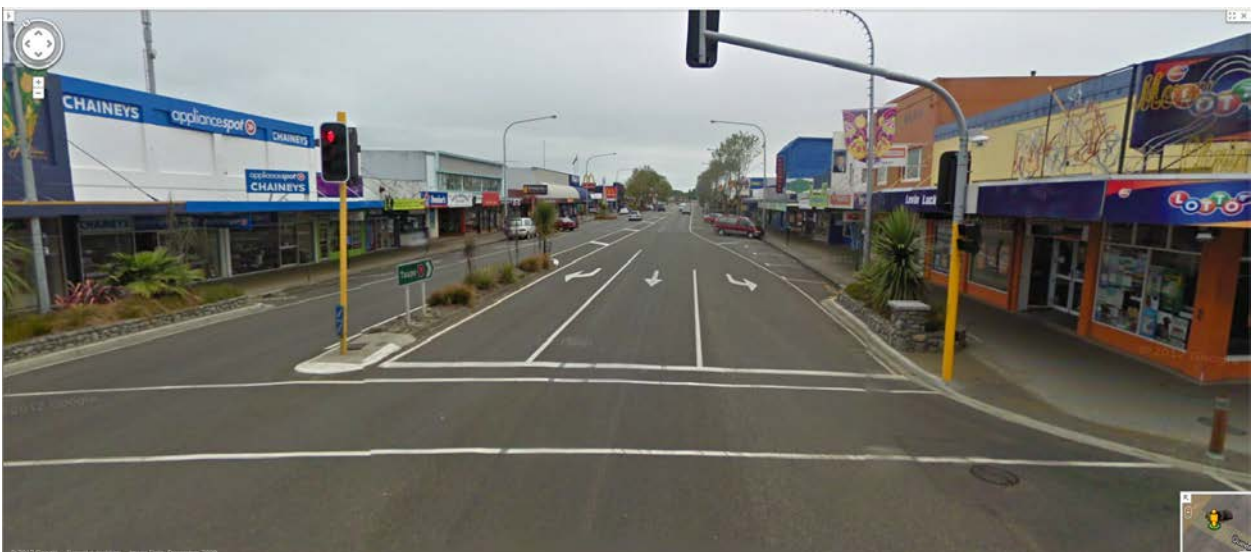
View north along Oxford Street (note lack of separation of the ped. crossings by the single bollard)

It is noted that half of the pedestrian crossings at the two intersections do not comply with current requirements that there be at least a one metre separation at the kerb between them.

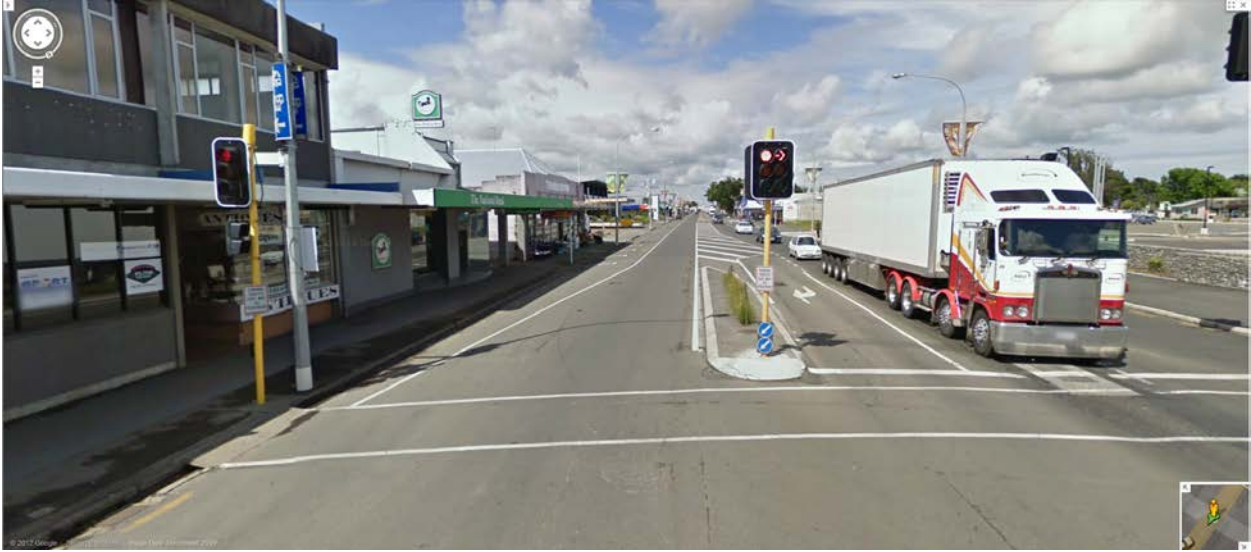
View south along Oxford Street (the n/b through lane appears to be too narrow)

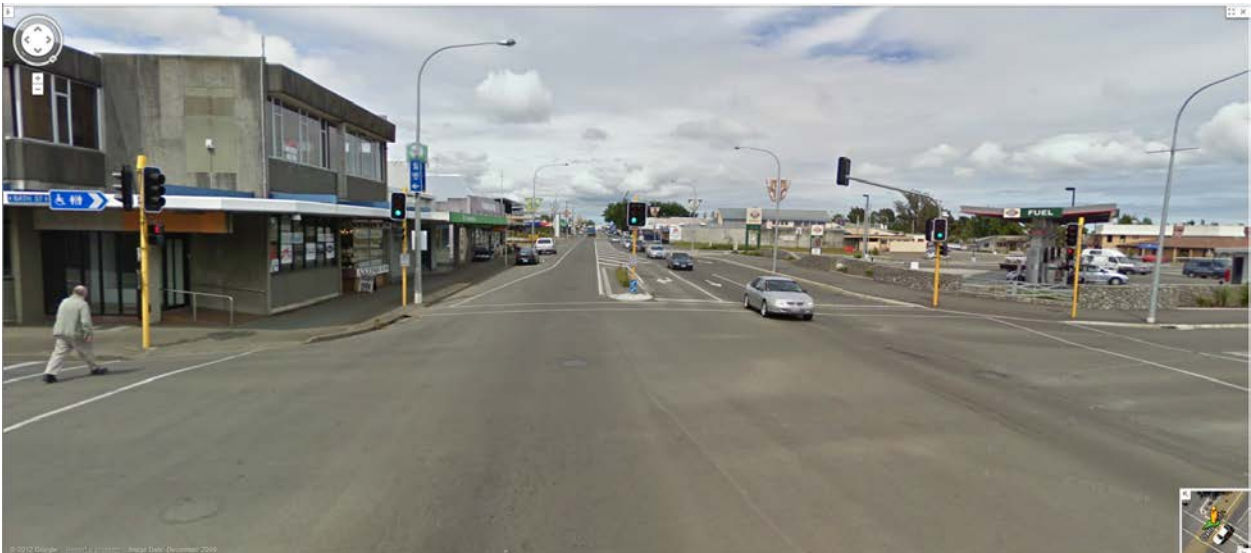
View south along Oxford Street (note the wide left turn lane that was widened in 2009)

It is recommended that a low cost safety improvement is made at the Bath Street signals by way of providing a splitter island and left slip turn on the New World corner that was widened in 2009. This could be implemented as part of the Minor Improvements Programme.

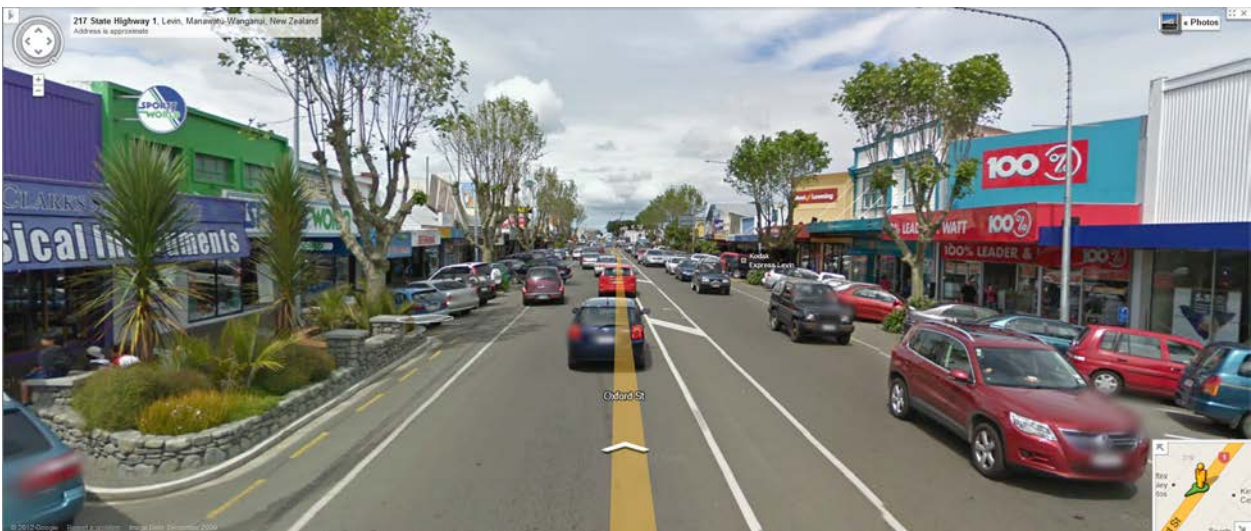
View south along Oxford Street between Queen and Bath Streets  
(note the parked car reversing out and the waiting car which the red car has passed while using the flush median)

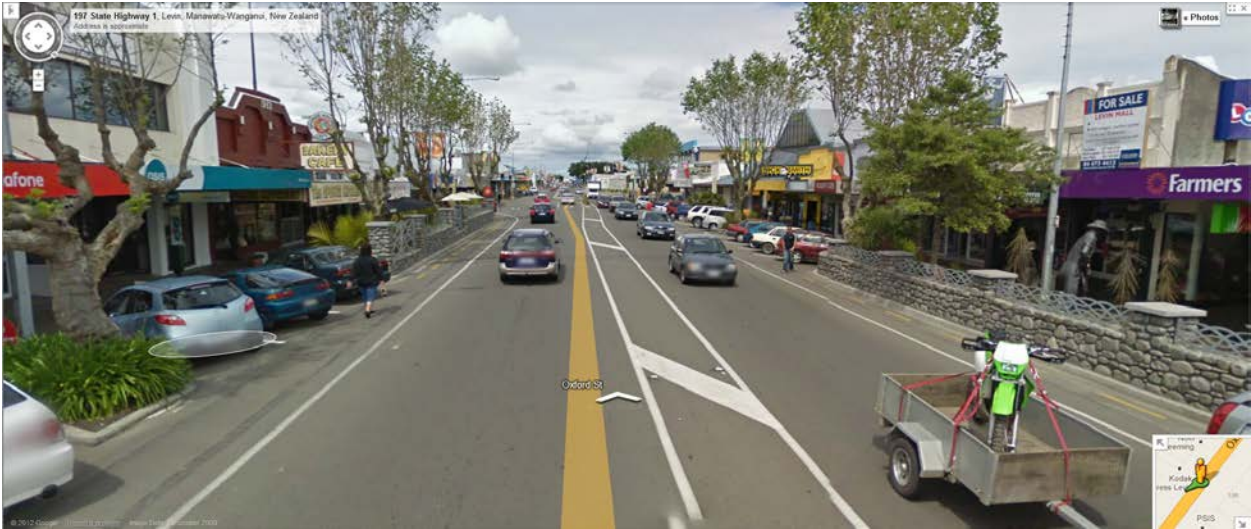
View south along Oxford Street between Queen and Bath Streets  
(note the two pedestrians walking along the road, the bicycle lying on the road and the double parked car)

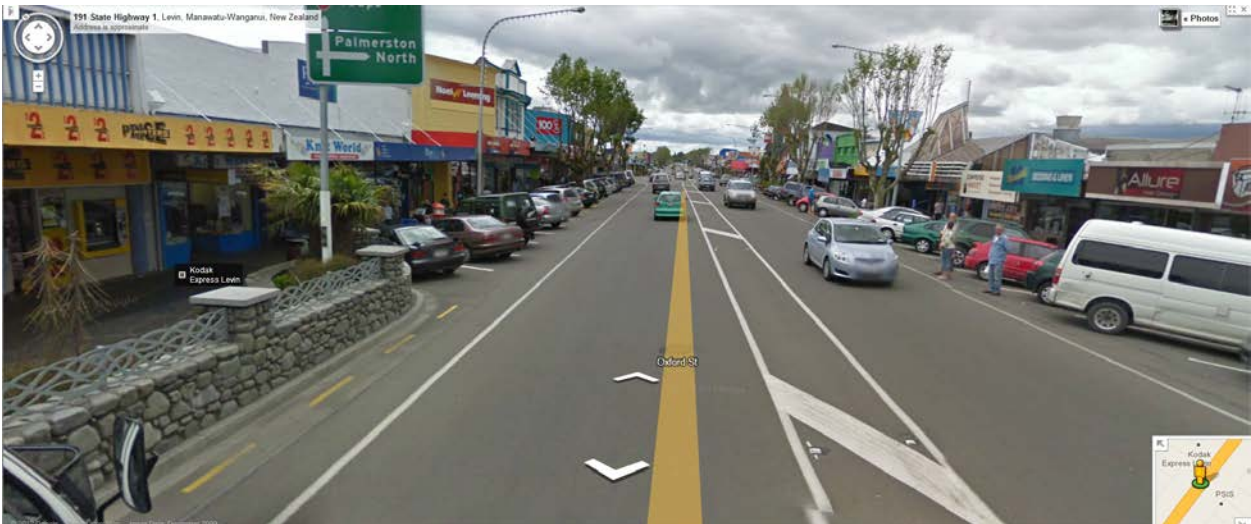
View north along Oxford Street between Bath and Queen Streets  
(note the pedestrians waiting to cross and the double parked delivery truck)

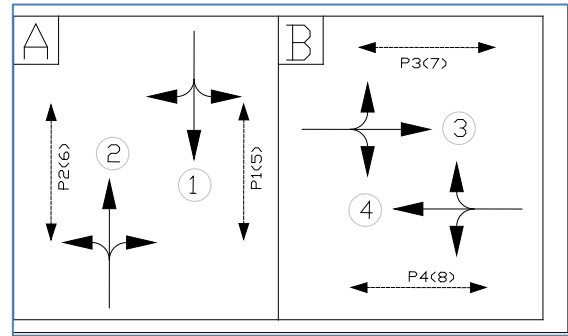
Queen Street (#5602, 2 phase)

Ped No	Table No	Ped Operates in Phases	Callaway Phase	SG No	Delay Time	Cross	Clear 1	Clear 2	Ped Protection Y/N
1	P1	A	B	5		6	14	4.0	Y
2	P1	A	B	6		6	12	4.0	Y
3	P1	B	A	7		6	12	4.0	Y
4	P1	B	A	8		6	13	4.0	Y

PHASE	LS	LS SG	MG	MAX	YEL	RED	SRED
A	3	1,2	5	90	4.0	2.0	0.0
B	3	3,4	5	40	4.0	2.0	0.0

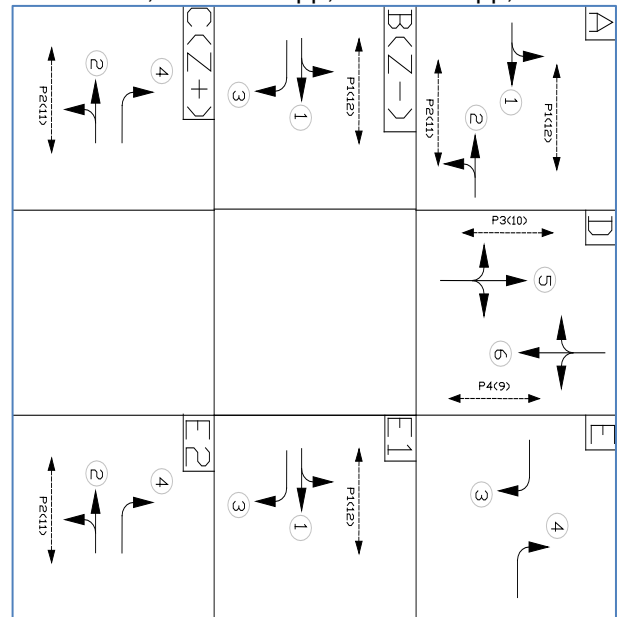
Bath Street (#5601, 3 phase)

A=Oxford; B/E1 = N app; C/E2 = S app; D=Bath

Ped No	Table No	Ped Operates in Phases	Callaway Phase	SG No	Delay Time	Cross	Clear 1	Clear 2	Ped Protection Y/N
1	DO	ABE1	D	12		6	8	3.5	Y
2	DO	ACE2	D	11		6	14	3.5	Y
3	P1	D	A	10		6	12	3.5	Y
4	P1	D	A	9		6	17	3.5	Y

PHASE	LS	LS SG	MG	MAX	YEL	RED	SRED
A	5	1,2,3,4	5	40	4.0	1.5	0.0
B(Z+)	5	1	5	15	4.0	1.5	0.0
C(Z+)	5	2	5	15	4.0	1.5	0.0
D	5	5,6	5	30	4.0	1.5	2.5
E		1,2	5	20	4.0	1.5	0.0

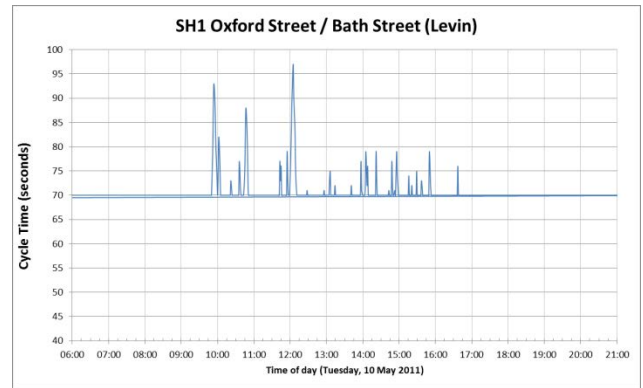
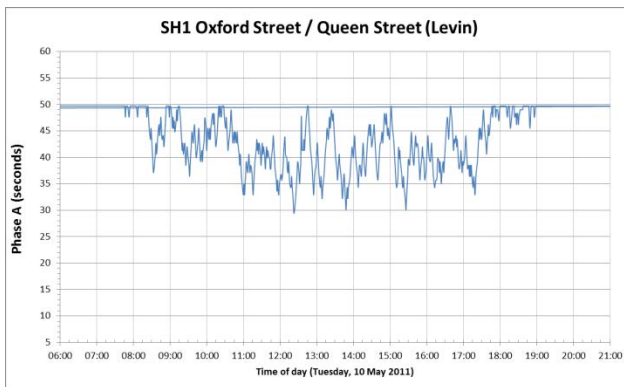
Tuesday 10 May 2011

A phase is SH1 Oxford St, B / B (D) phase Queen / Bath St, C (E) phase SH1 Oxford right turns

For the Queen Street two phase intersection, when specifying a 70 second cycle time the resulting SIDRA derived phase times were consistent with those observed (refer Appendix D). It was noted however that selecting optimum cycle time resulted in a 54 second cycle.

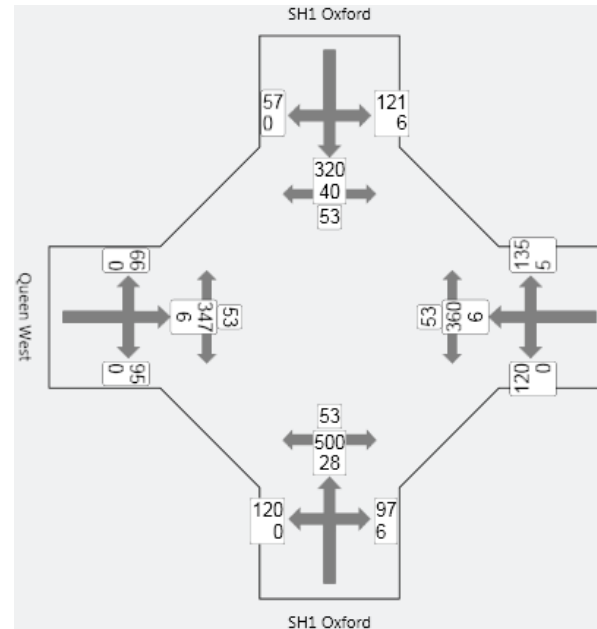
SIDRA LV & HV flows (peds default 50/hr / 0.95)

Thu 12 May 2011 (input nearest 5 vph, PFF 1%)

Mid Block Queen n/b; s/b: 717+34; 535+40

Mid-Block Bath n/b; s/b: 691+40; 551+33

**Queen St: 2011 PM, user specified 70 s cycle [38 s Oxford, 32 s Bath]**
