Otaki Traffic and Transportation Report

Date: November 2009
Reference: 5c1501.00
Status: Draft

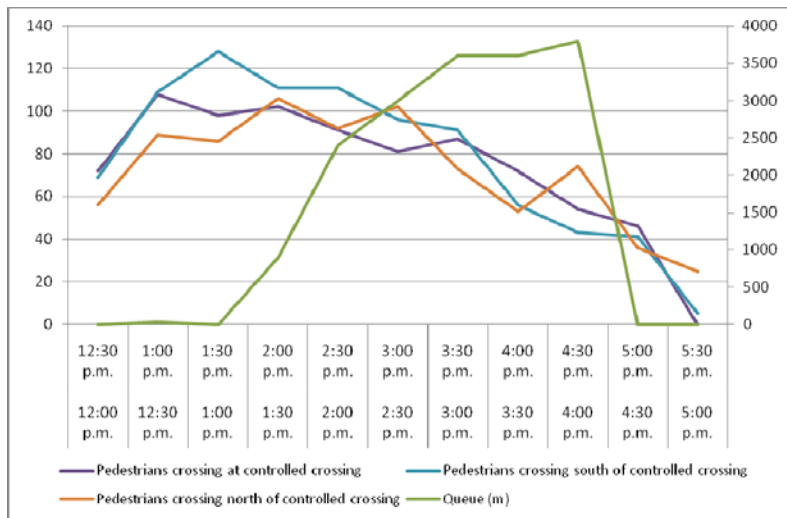
Figure 3 - Queue versus pedestrians crossing (Labour Day 2009)

A plot of queue versus pedestrians (refer Figure 3) shows that the highest pedestrian crossing demand is directly related to the start of the queue forming. The pedestrian demand starts to drop before the queue reaches its peak (refer figure 2, Appendix J).

There appears to be a clear relationship between the high demand for pedestrian and turning movements at Arthur Street and the start of the queue.

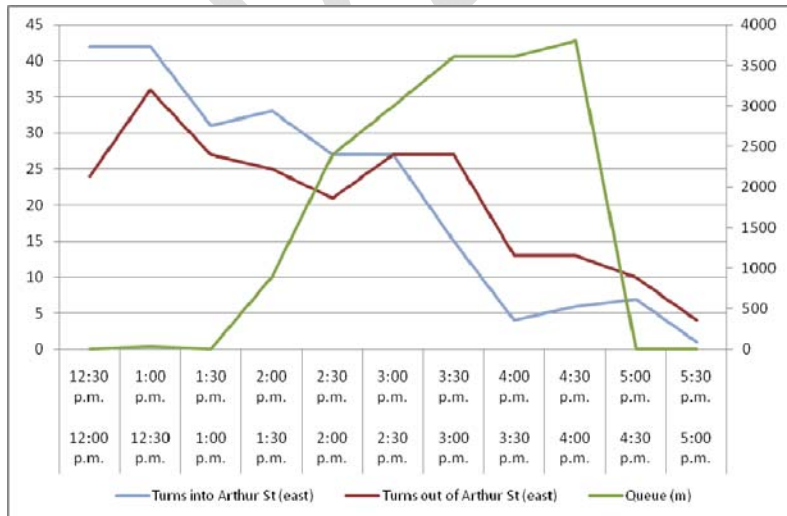
Figure 4 - Queue versus Arthur Street turns (Labour Day 2009)

A plot of queue versus turning movements at Arthur Street (refer Figure 4) shows that the turning demand is directly related to the start of the queue forming. The turning demand starts to drop before the queue reaches its peak (refer figure 3, Appendix J).

The turning demand at Arthur Street is directly related to the start of the queue forming. However, the turning demand starts to drop before the queue reaches its peak. Once a queue forms, a bottleneck is created and the queue tends to grow. A small reduction in the number of turning vehicles is not sufficient to cause the queue to dissipate. Only with significant changes to the environmental conditions in the area does the queue dissipate.

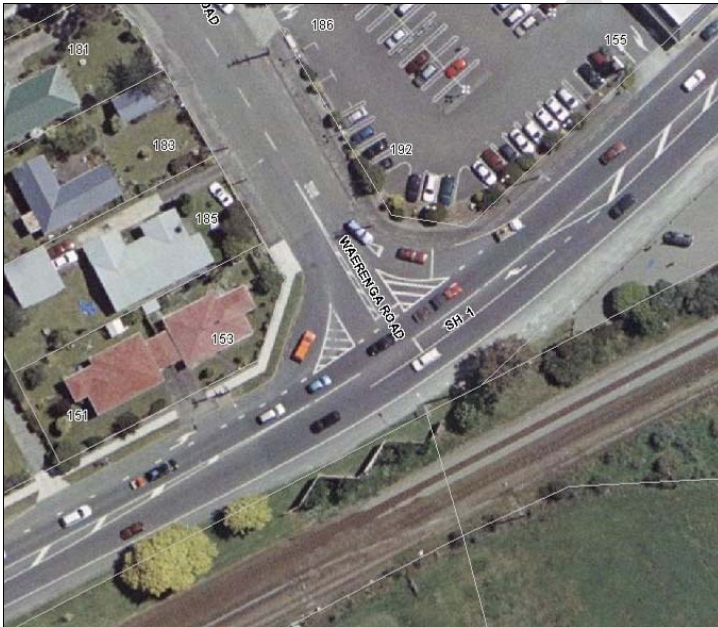
Figure 6 - Existing Layout for Waerenga Road and SH1 Intersection

As previously discussed in Section 4.1, in the five year period from 2004 to 2008 there has only been one crash related to the operation of the intersection. The lanes are well marked and there are adequate sightlines for drivers completing all turning manoeuvres at this intersection, as shown in Figure 5 below. No improvements to this intersection are required; however KCDC has said they would like to enhance the intersection to improve access for the local community and existing parking areas to the west. See Section 14.6 for possible further improvements to the intersection. These changes would allow drivers making a right turn from Waerenga Road to complete the manoeuvre in two stages and provide an increased merge taper length which is compliant with current New Zealand Standards.

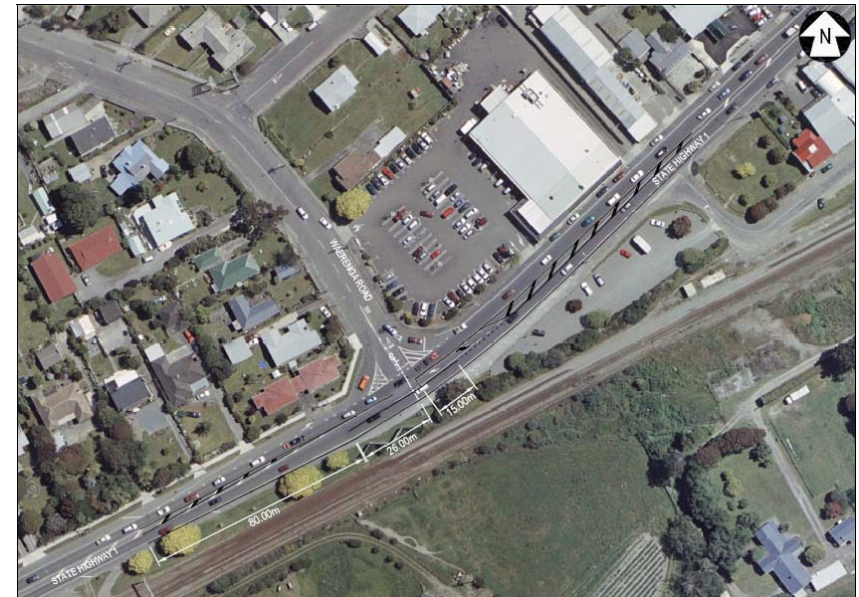
Figure 8: State Highway 1 / Waerenga Road Safety Improvements

- This would involve a right turn bay for traffic exiting Waerenga Road in a southbound direction and increase the viability of this intersection for those wishing to park on the local road network or avoid the SH1 / Mill Road roundabout. The improvement works are shown in Figure 8 below and in Appendix P.

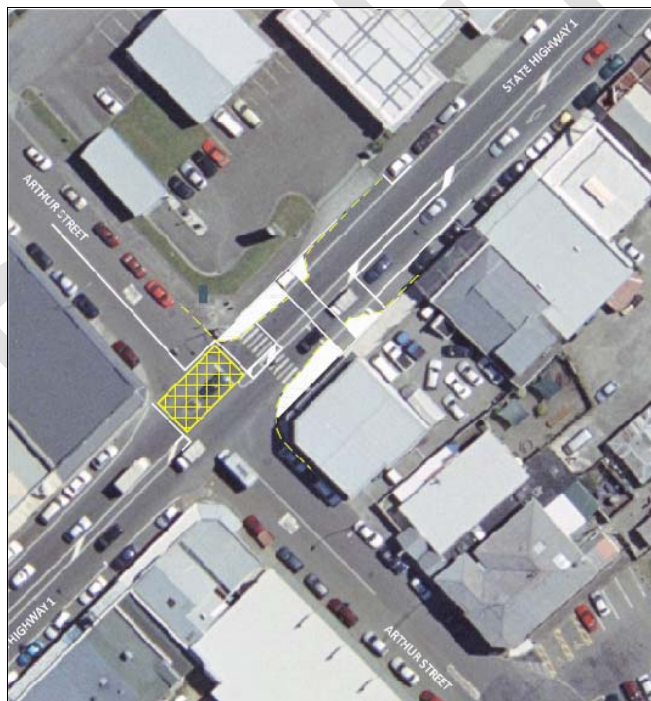
Figure 9 Signalised Pedestrian Crossing

To assist with the movement of traffic to and from Arthur Street and safety associated with the proposed crossing, the indicative location of the signal has been shifted approximately 10m north of the existing crossing and yellow box markings (or "keep clear") have been identified across the northbound lane at Arthur Street.

This site is ideally suited to the use of a signalised Puffin crossing (Puffin – refer DTLR Traffic Advisory Leaflet 1/01, 1/02). The use of Puffin crossings in NZ is currently not permitted, however they are being trailed in Lower Hutt⁵, with initial research proving to be extremely successful in encouraging pedestrians compliance. The next phase of this trail is planned to look at benefits to traffic (already proven overseas). Ultimately this location is ideally suited to a Puffin crossing due to the significant variability in traffic and pedestrian activity and the need to avoid lost time associated with false pedestrian calls on the strategic highway network.

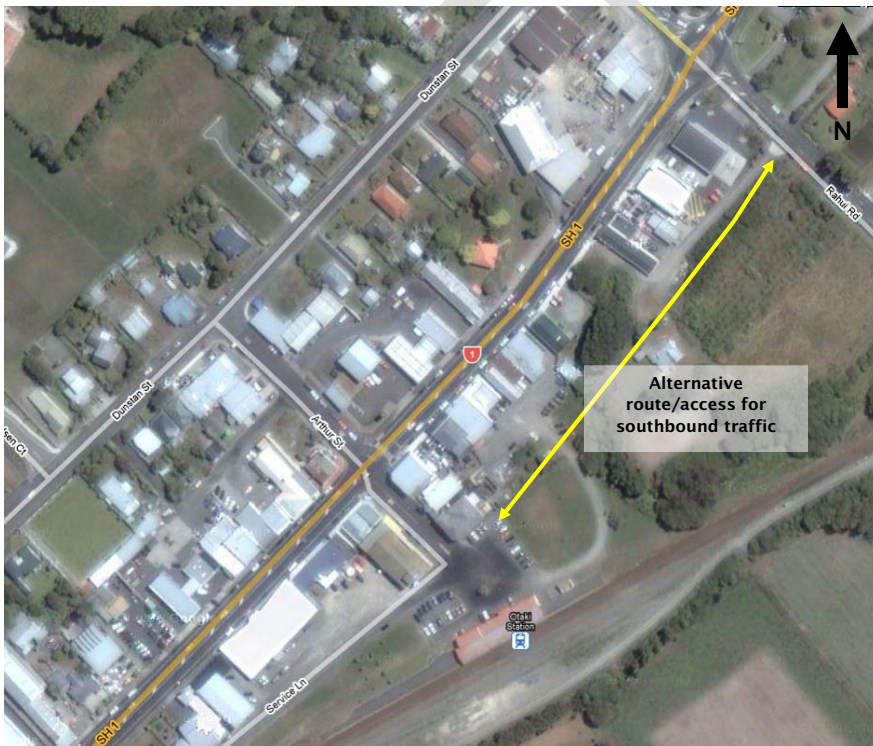
Figure 12 - Option B4 (Source: Opus Google Earth Pro Licence 2009)

development plans to the north east of the highway and incorporate an access link to the parking adjacent to the Railway Station (as illustrated in Figure 12). This option may need to be completed in conjunction with clearway concepts outlined in Option A2 or B3 to encourage use and address the through flow problems on SH1. The success of this option would depend on whether enough vehicles used the parking, thus reducing the impact of the vehicle movements.

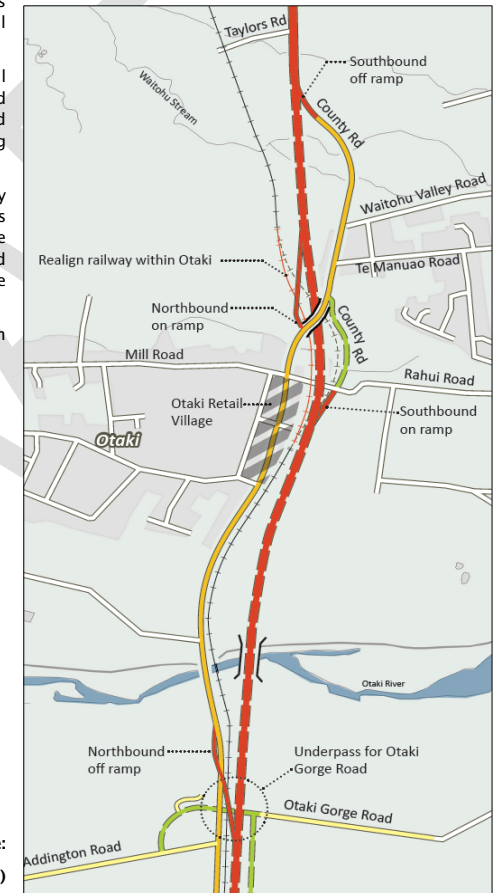
Figure 13 - Otaki Bypass Scheme (Reference: Kapiti SH1 Strategy Study Technical Report)

The proposed alignment of the Otaki Bypass is shown in Figure 13.

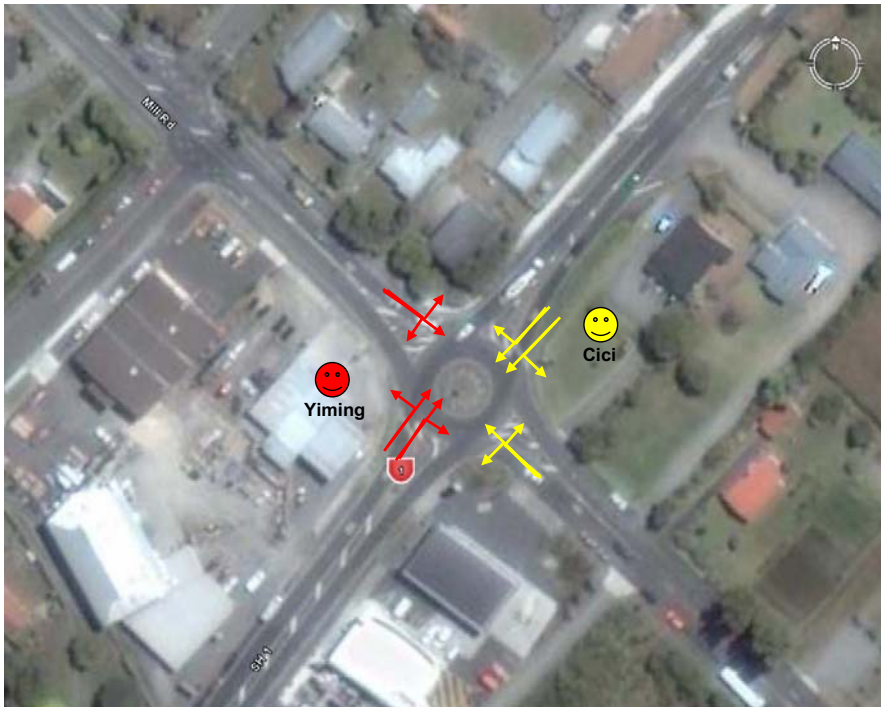
• Count no. of car head to each direction for Every 5 mins

Name	Site Position	Counts
Cici.Z	SH1 / Mill Rd	<ol style="list-style-type: none"> 1.Left Turn Traffic from SH1(NB) to Mill Rd 2.Straight ahead Traffic on SH1 (NB) 3.Right turn Traffic from SH1(NB) to Rahui Rd 4.All movements from Mill Rd to SH1 and Rahui Rd
Yiming.X	SH1 / Rahui Rd	<ol style="list-style-type: none"> 1.Left Turn Traffic from SH1(SB) to Rahui Rd 2.Straight ahead Traffic on SH1 (SB) 3.Right turn Traffic from SH1(SB) to Mill Rd 4.All movements from Rahui Rd to SH1 and Mill Rd

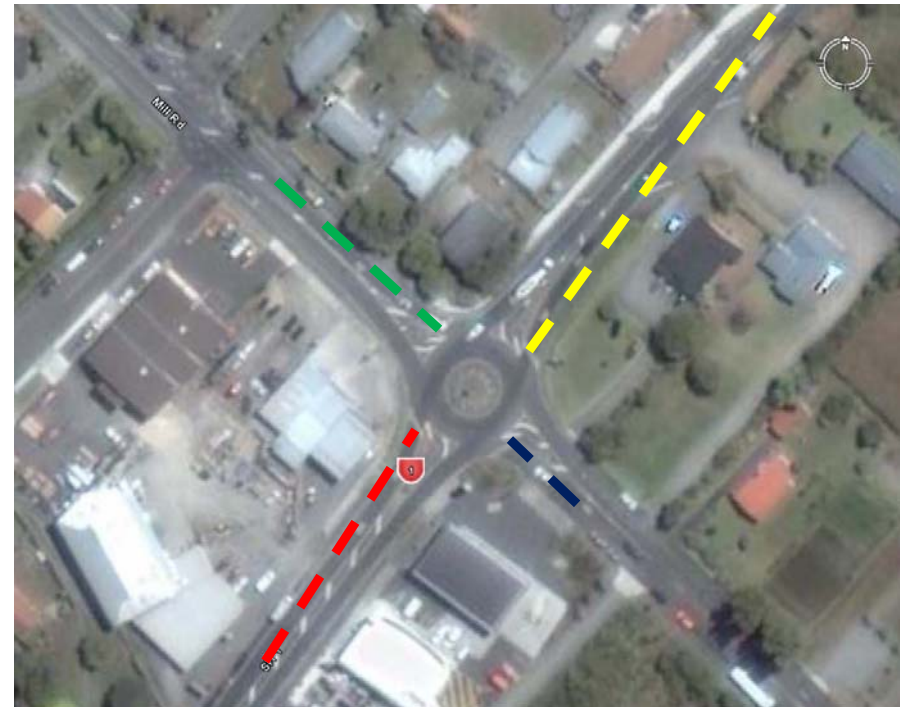
1. SH1 (NB) Approaching
2. Mill Rd Approaching
3. SH1 (SB) Approaching
4. Rahui Rd Approaching

Count the no. of cars in the queue for each leg every 5 minutes.

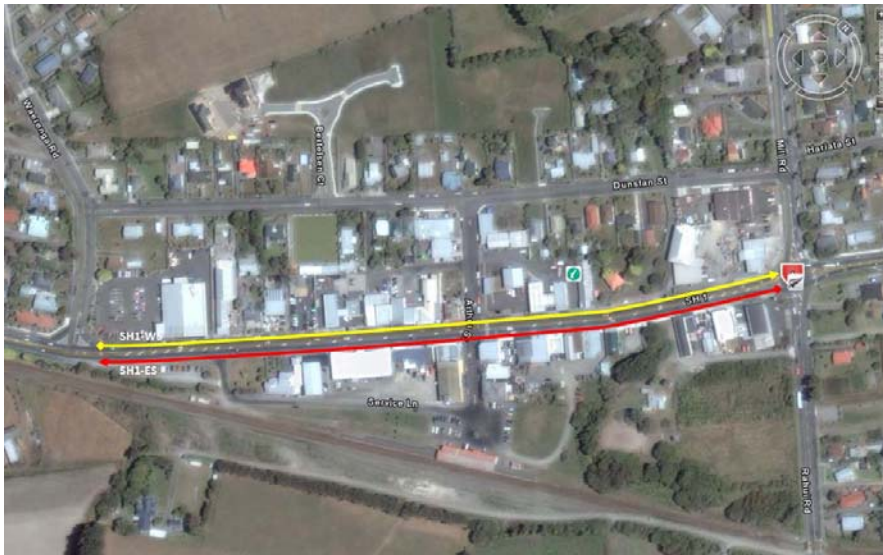
For SH1 between Waerenga Rd and Mill Rd, the surveyor will record the parking types (either no parking, parallel or angle) for each side of the road plus some comments. If a Car is parked, the first 4-digits of its number plate are recorded.

- The survey is to run every half hour.

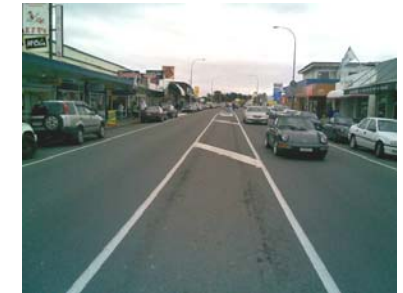
The parking facilities on SH1 between Waerenga Rd and Mill Rd were surveyed. The highway is marked with an edge line to indicate the parking areas; however, no formal parking bays are marked. There are no time restrictions.

There is room for approximately 96 vehicles: 56 on the east side of SH1 and 40 on the west side of SH1.

SH1: Looking south towards Waerenga Rd.

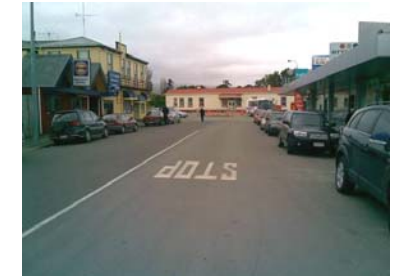
Arthur St is a local road that crosses SH1. It extends from the Otaki Railway Station in the east to Dunstan St in the west.

There are no marked edgelines or parking bays along Arthur St. However there is ample space for parallel parking. On Arthur St there is room for approximately 15 vehicles east of SH1 and 18 vehicles west of SH1. There are no time restrictions on parking on Arthur St.

Arthur St: Looking east towards the railway station.

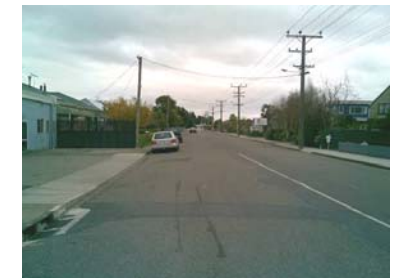
Dunstan St is parallel to SH1 and extends from Waerenga Rd in the south to Mill Rd in the north. There are no edgeline or parking space markings along the route. There are no time restrictions on parking on Dunstan St. The parking on this street was observed, but not surveyed.

Dunstan St: Looking south from Arthur St.

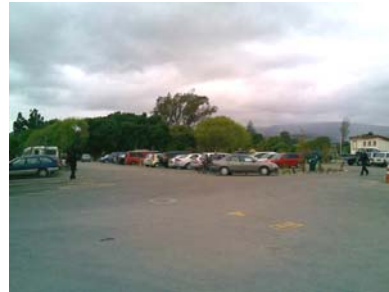
Carpark A (adjacent to the Otaki Railway Station)

Car Park A is adjacent to the Otaki Railway station. It has 75 angled parking spaces, including two bays for mobility impaired users. Parking plans provided by KCDC indicate that this area has been expanded to 157 car parks including 4 bays for mobility impaired users and a motorcycle parking area.

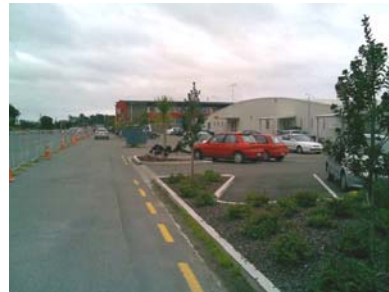
Carpark B (adjacent to a café and other shops)

Car Park B has 56 marked spaces designed for use by the patrons of the adjacent shops and café. The parking lot has 2 spaces for mobility impaired users and the remaining spaces are a combination of parallel and angled parking bays.

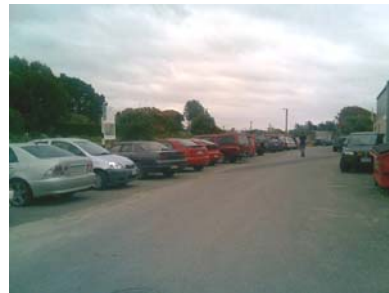
Carpark C (south end of the service lane)

Car Park C is located along the sides of the south end of the Service Lane. Up to 25 vehicles can be parked in this area with a combination of angle and parallel parking bays. There are no disabled parking spaces provided in Car Park C.

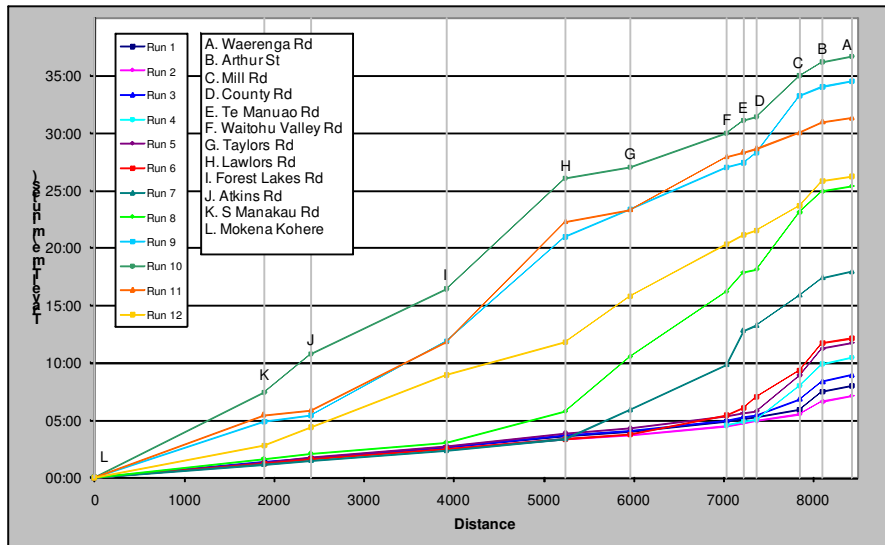
Figure 3 - Southbound Monday Travel Time on SH1 (2008)

One of the key points to note in figure 3 is that in the first few runs the speed is relatively constant between the beginning of the route and the roundabout at Mill Road. Once vehicles pass through the roundabout, vehicle speeds drop significantly between the roundabout and Arthur Street. Based on site observations and the journey time data this appears to be due to the congestions caused by the parking movements, pedestrian activity and the environmental issues. After the first few runs this congestion is not as apparent in figure 3 because the congestion between Mill Road and Arthur Street causes vehicles to queue back through the roundabout. This results in vehicles encountering the queue progressively earlier along the route after each run.

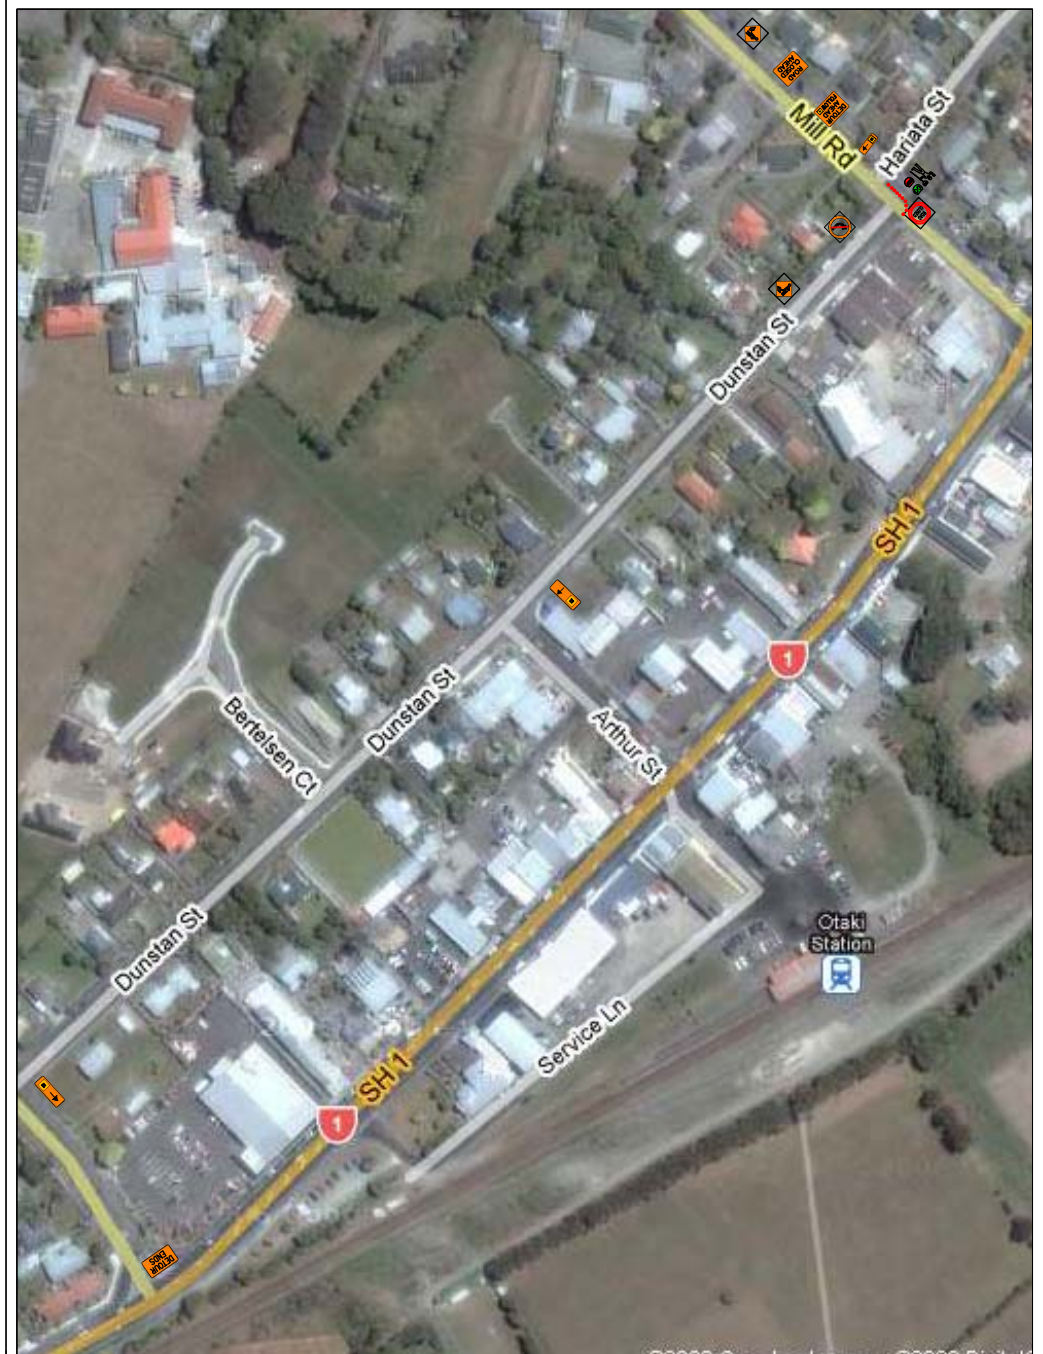
MANAGEMENT OF
TRAFFIC THROUGH OTAKI
ROB

STAGE 2

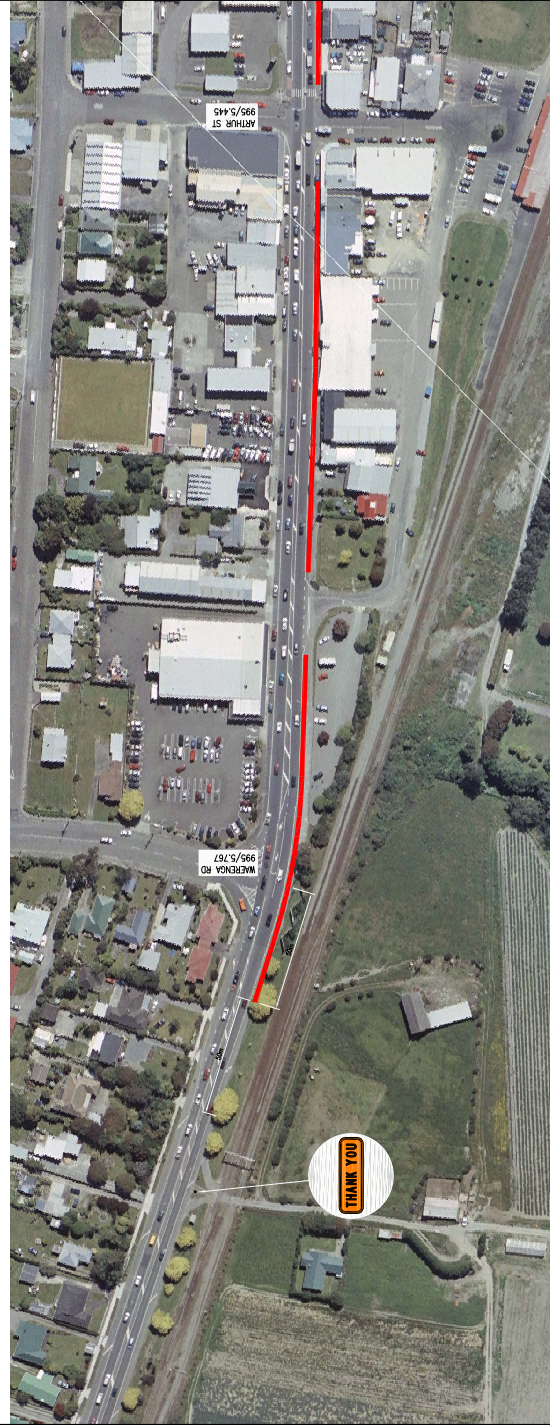
TYPICAL LAYOUT
SCALE 1:200 (M)

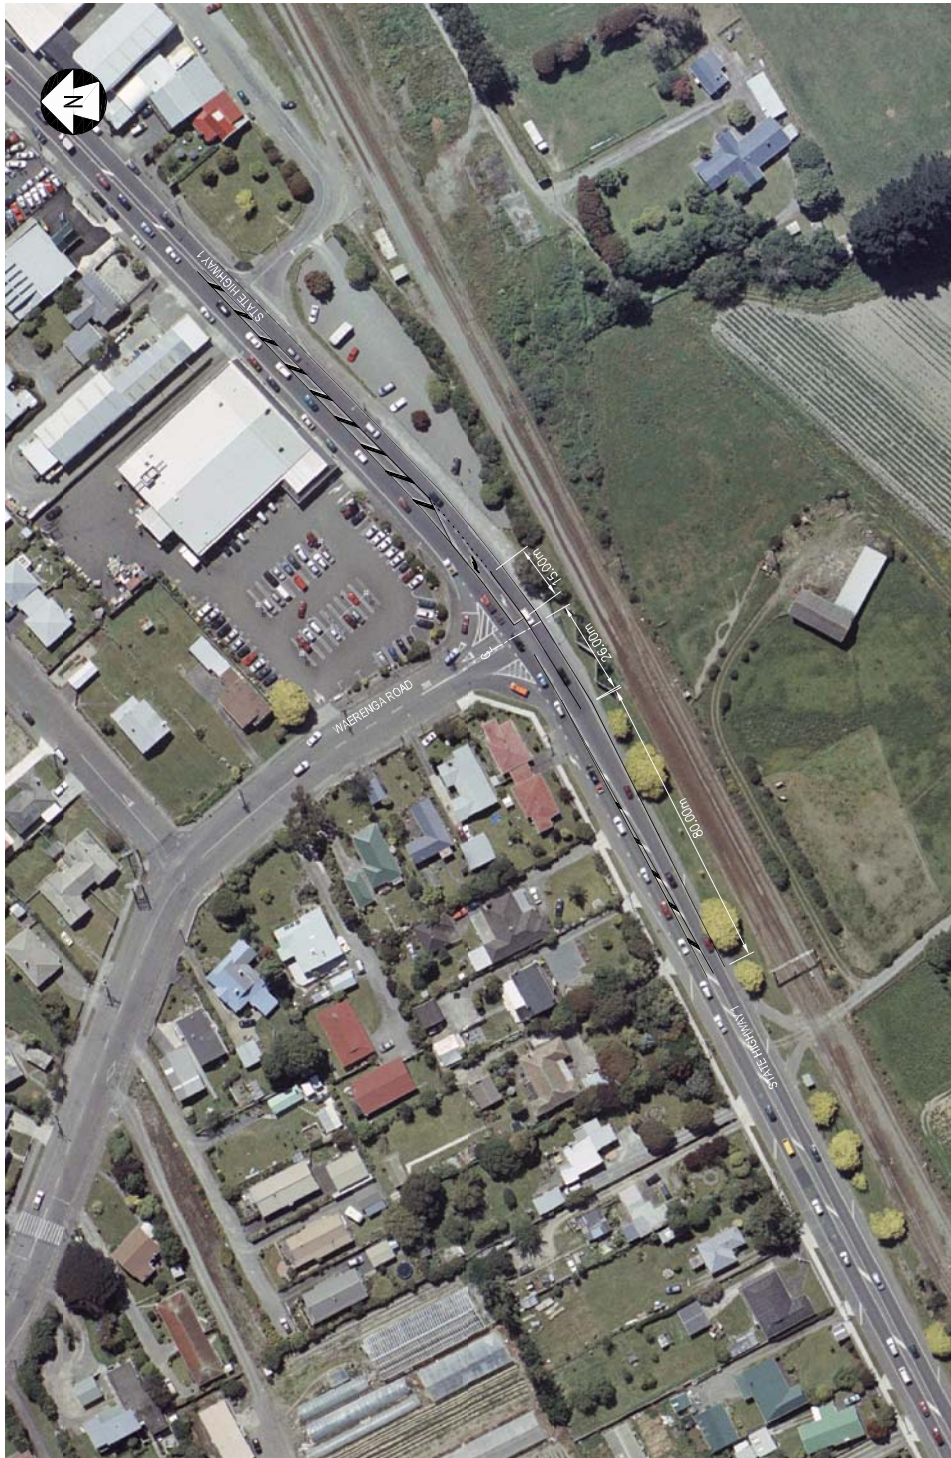
SCALE 1:500 (A1) 1:1000 (A3)
PROPOSED INTERSECTION IMPROVEMENTS
12 NOVEMBER 2009

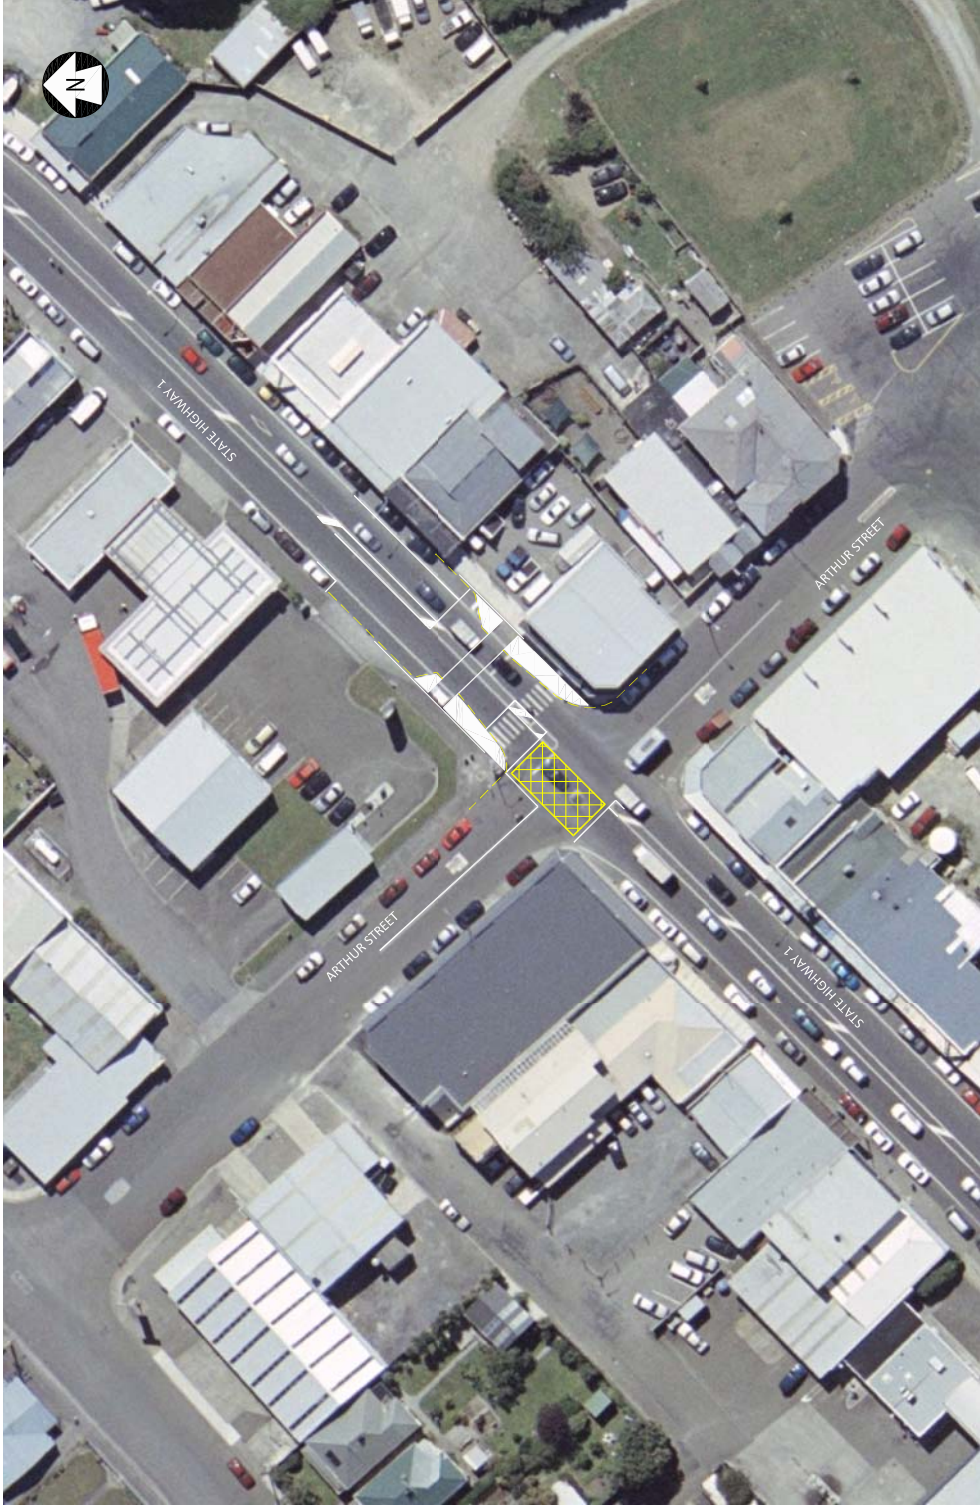
SCALE 1:250 (A1) 1:500 (A3)
PROPOSED SIGNALISED PEDESTRIAN CROSSING
12 NOVEMBER 2009
