Site Specific Environmental Management Plan

– Peka Peka to Ōtaki Project

BR04: Rahui Road Underpass (Bridge 4)

FCCL-EV-MPN-0034

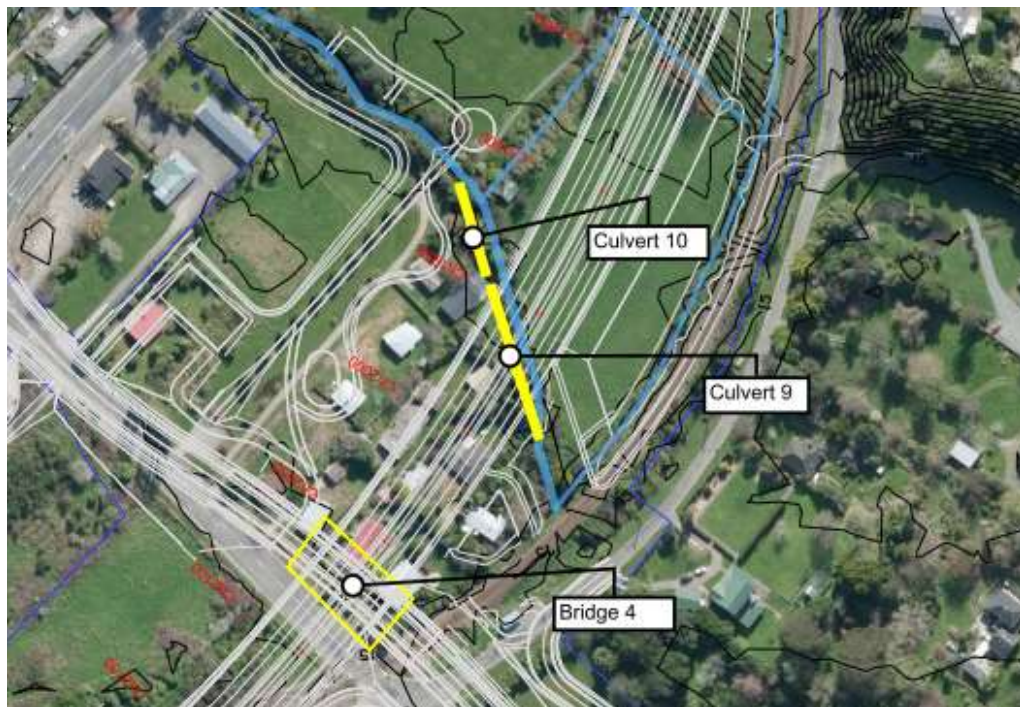
Figure 2: Location of Culvert's 9 and 10 north of Bridge 4

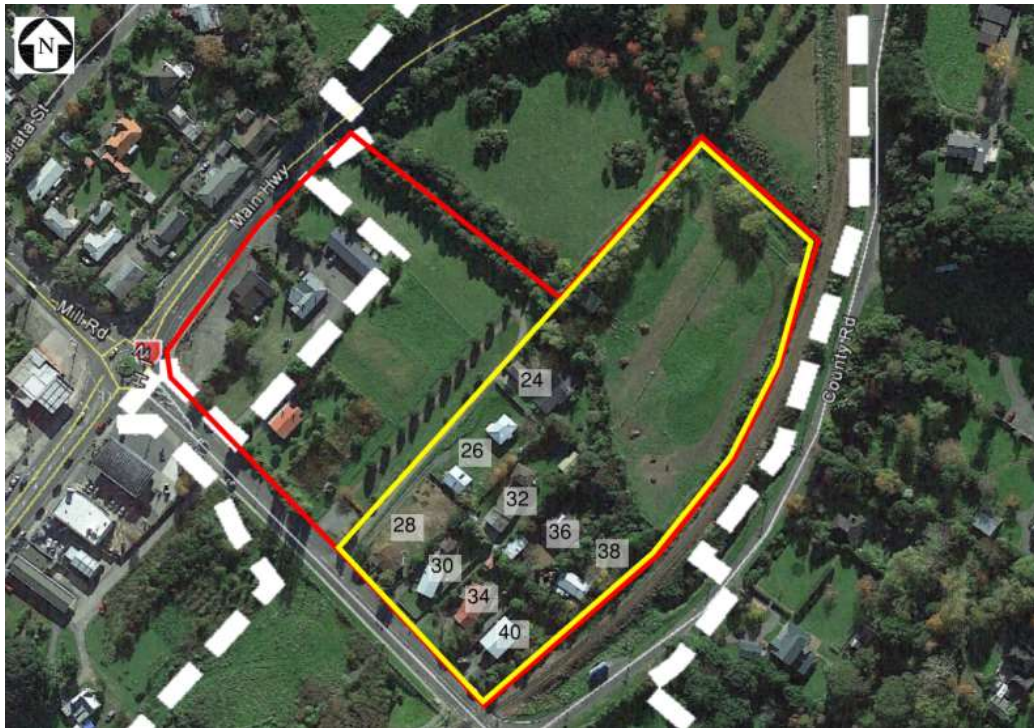
Figure 3: Historic market garden outlined in red with the area of potential works outlined in yellow (the area outside of the yellow boundary will not be impacted by these works).

As part of the AEE for the Project, a Phase One Contaminated Land Assessment was prepared by URS. This report identified land parcels within the Project boundary that had the potential to be contaminated and required further investigation. The location of works proposed in this SSEMP encroaches on one of these identified sites at 24-40 Rahui Road (referred to as the Rahui Road Northern Market Garden Site), which has been confirmed as being a site where activities listed on the Hazardous Activities and Industries List (HAIL) has occurred (namely persistent pesticide use and asbestos in soils). The definition of ‘Site’ in reference to contaminated land is the general HAIL location identified in figure 3 below.

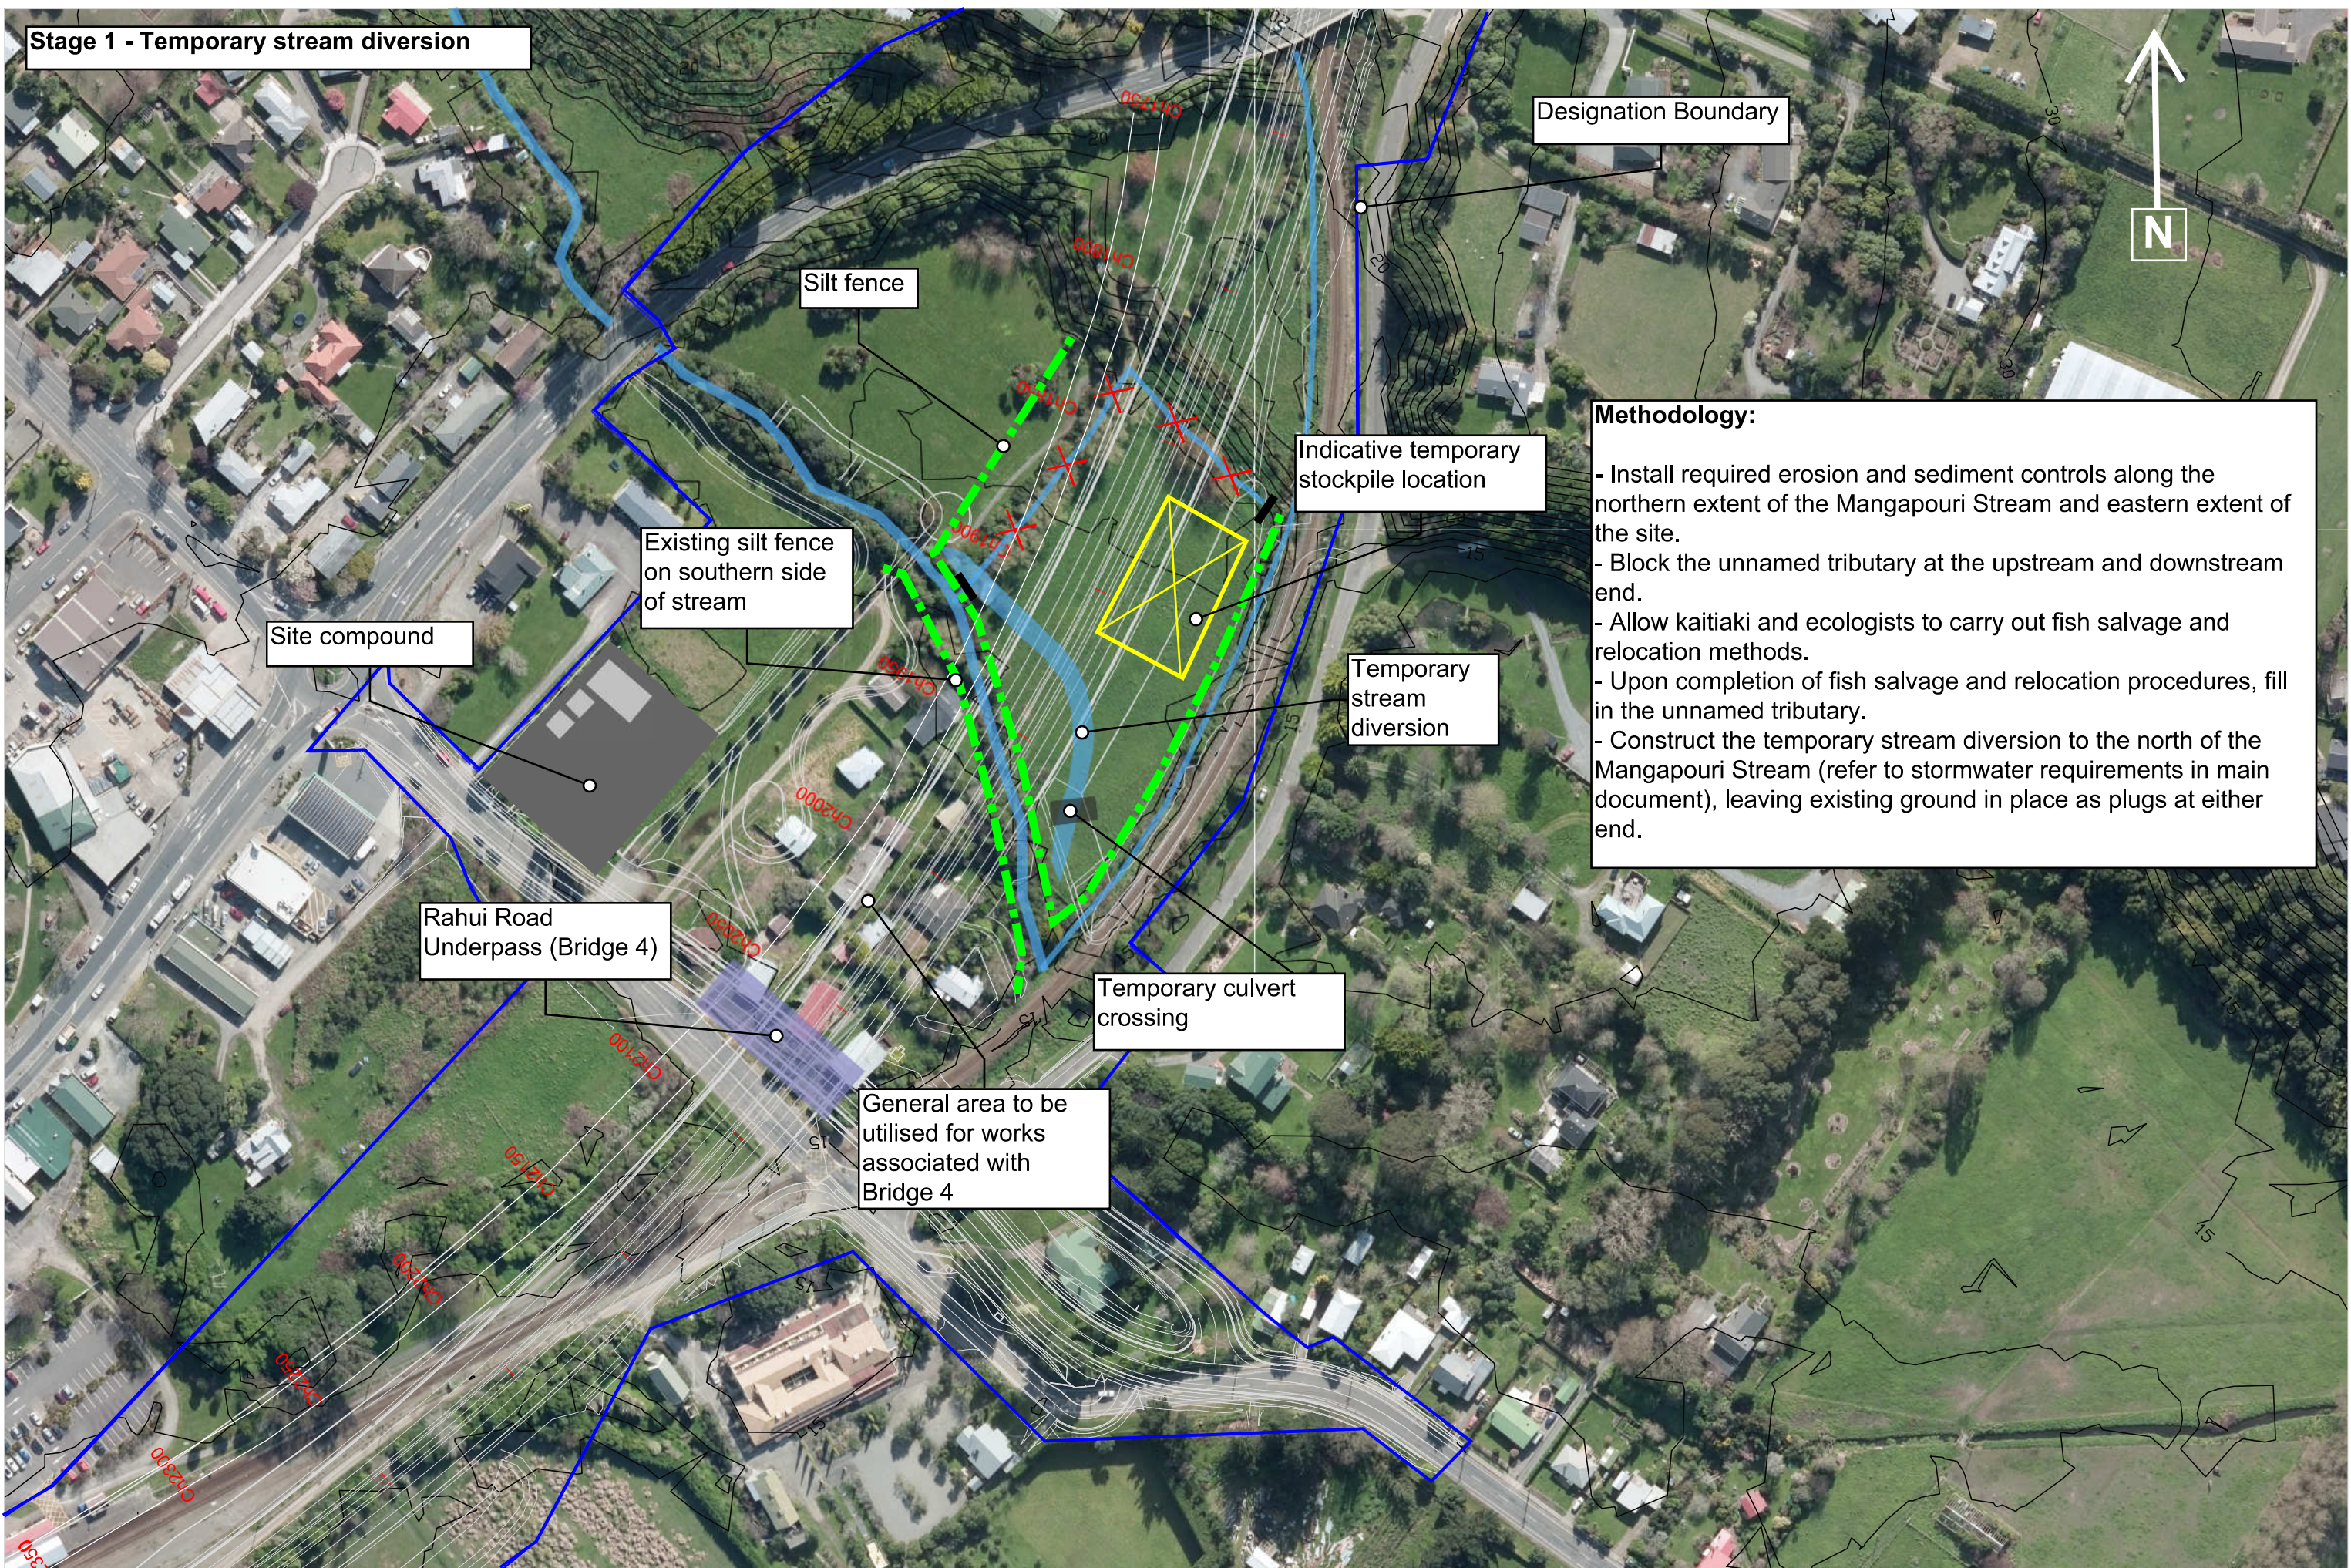
Stage 1 - Temporary stream diversion

- Install required erosion and sediment controls along the northern extent of the Mangapouri Stream and eastern extent of the site.
- Block the unnamed tributary at the upstream and downstream end.
- Allow kaitiaki and ecologists to carry out fish salvage and relocation methods.
- Upon completion of fish salvage and relocation procedures, fill in the unnamed tributary.
- Construct the temporary stream diversion to the north of the Mangapouri Stream (refer to stormwater requirements in main document), leaving existing ground in place as plugs at either end.

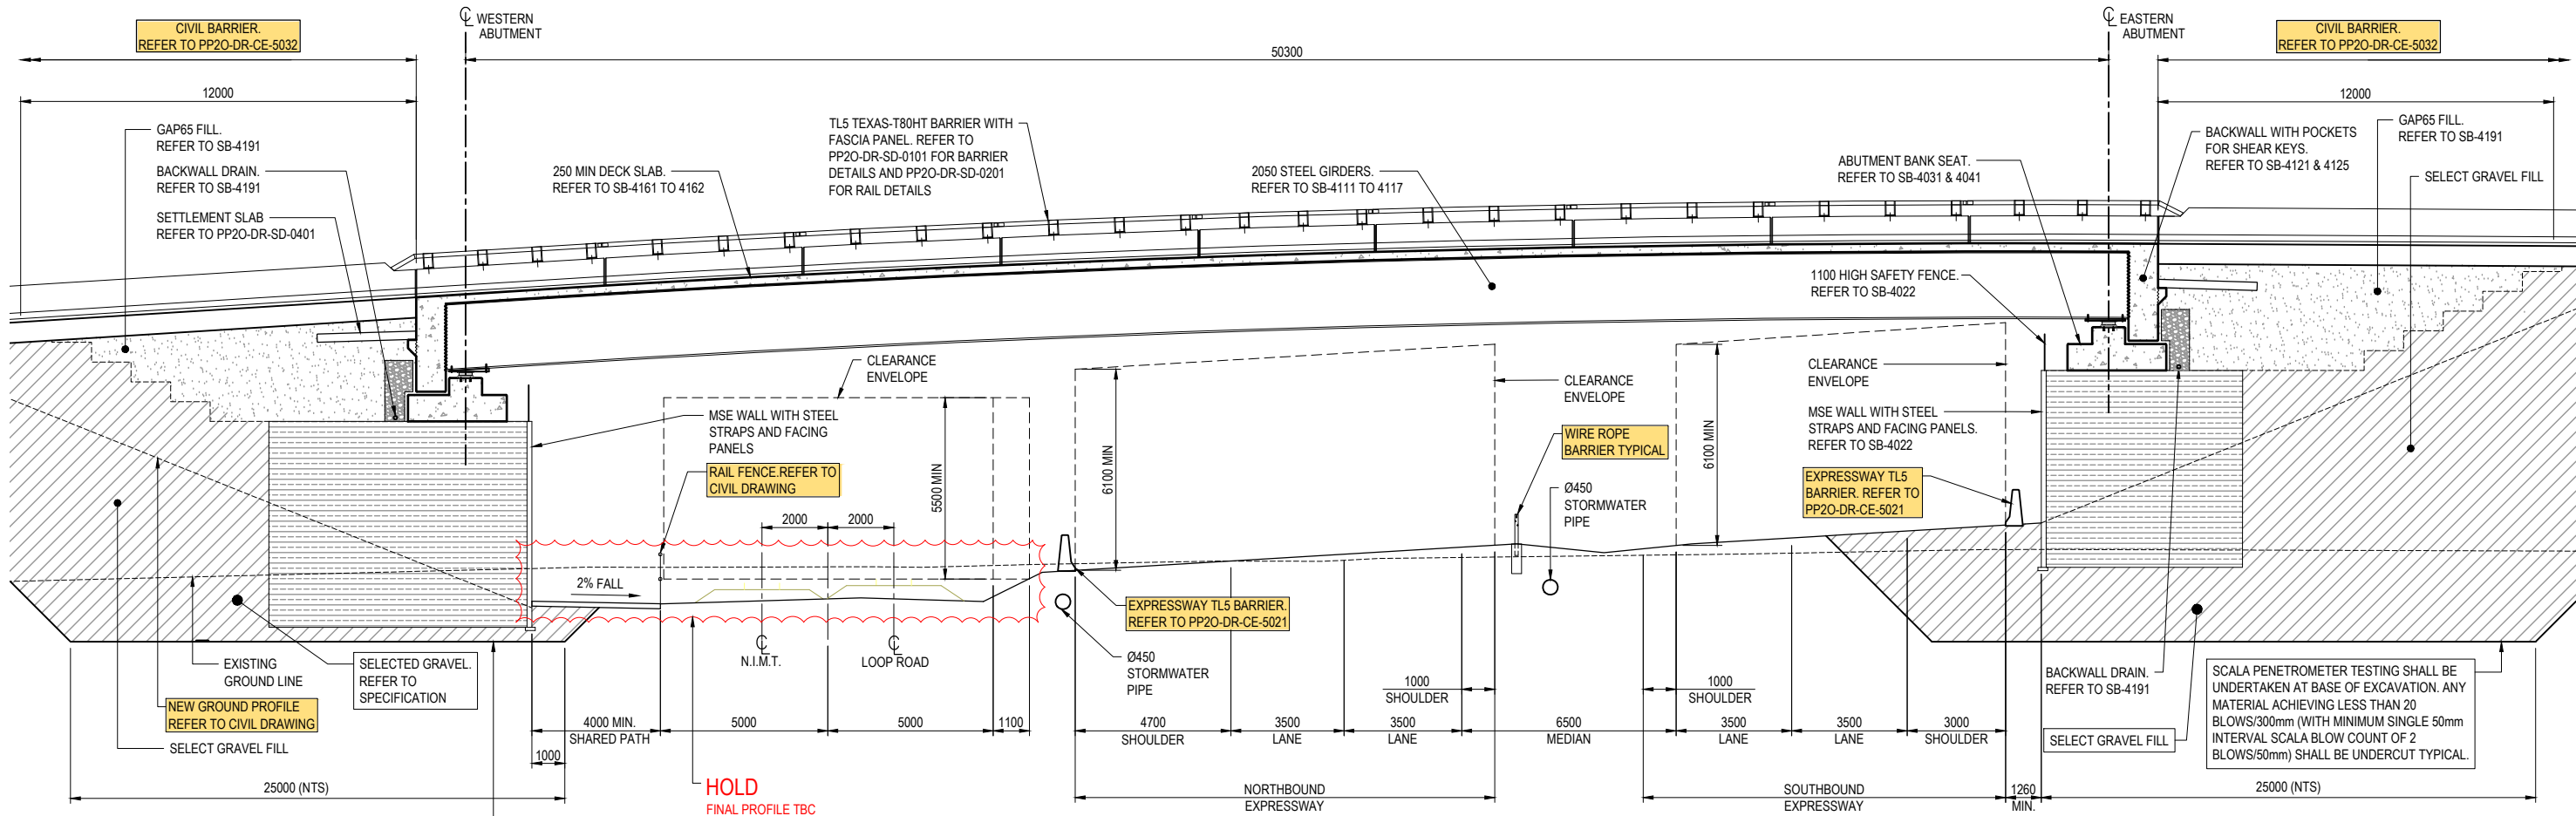
SCALA PENETROMETER TESTING SHALL BE UNDERTAKEN AT BASE OF EXCAVATION. ANY MATERIAL ACHIEVING LESS THAN 4 BLOWS/100mm SHALL BE UNDERCUT AND REPLACE WITH COMPACTED SELECT GRAVEL FILL.

SCALA PENETROMETER TESTING SHALL BE UNDERTAKEN AT BASE OF EXCAVATION. ANY MATERIAL ACHIEVING LESS THAN 20 BLOWS/300mm (WITH MINIMUM SINGLE 50mm INTERVAL SCALA BLOW COUNT OF 2 BLOWS/50mm) SHALL BE UNDERCUT TYPICAL.

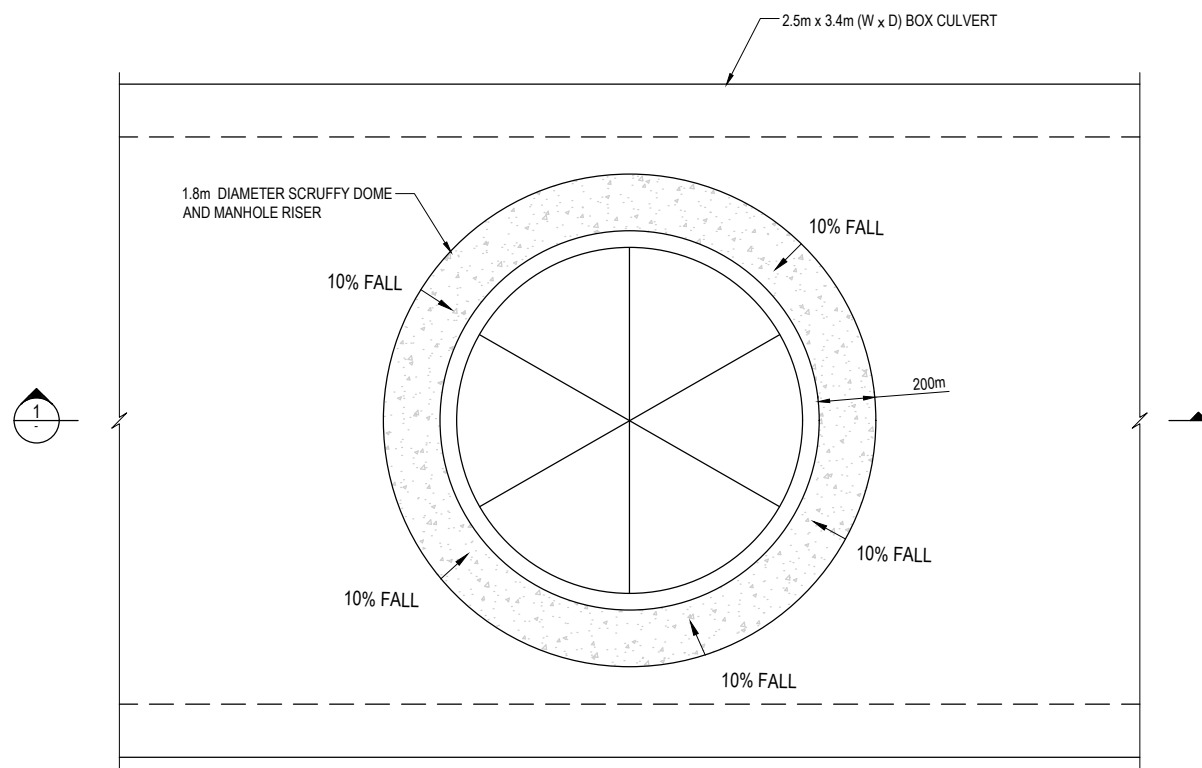
A DETAIL CULVERT 9 AND 10 SCRUFFY DOME FOR LIGHT ENTRY
1023 1:20

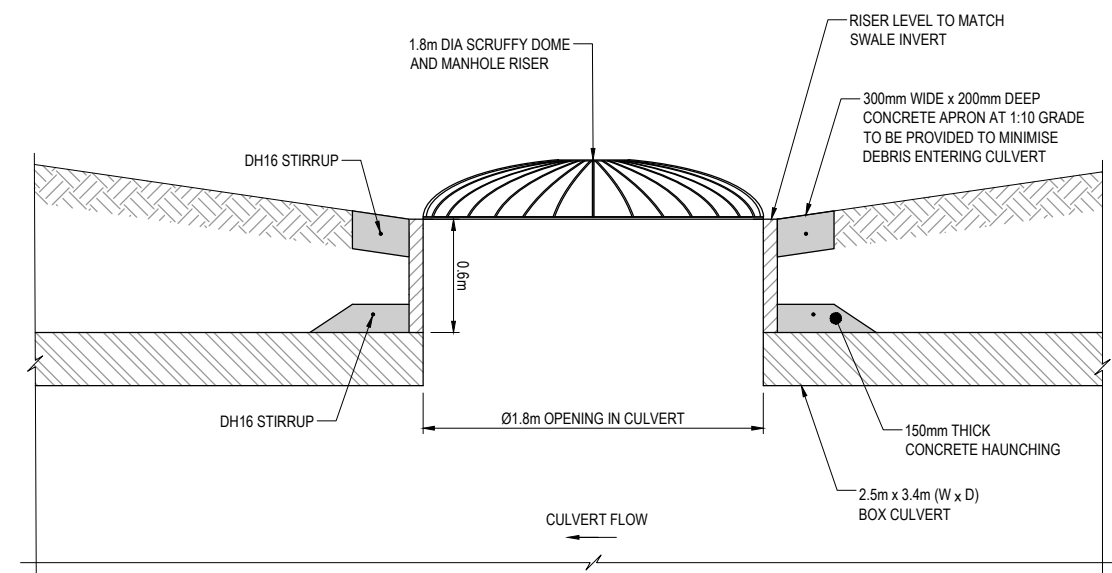
1 SECTION CULVERT 9 AND 10 SCRUFFY DOME FOR LIGHT ENTRY
1:20

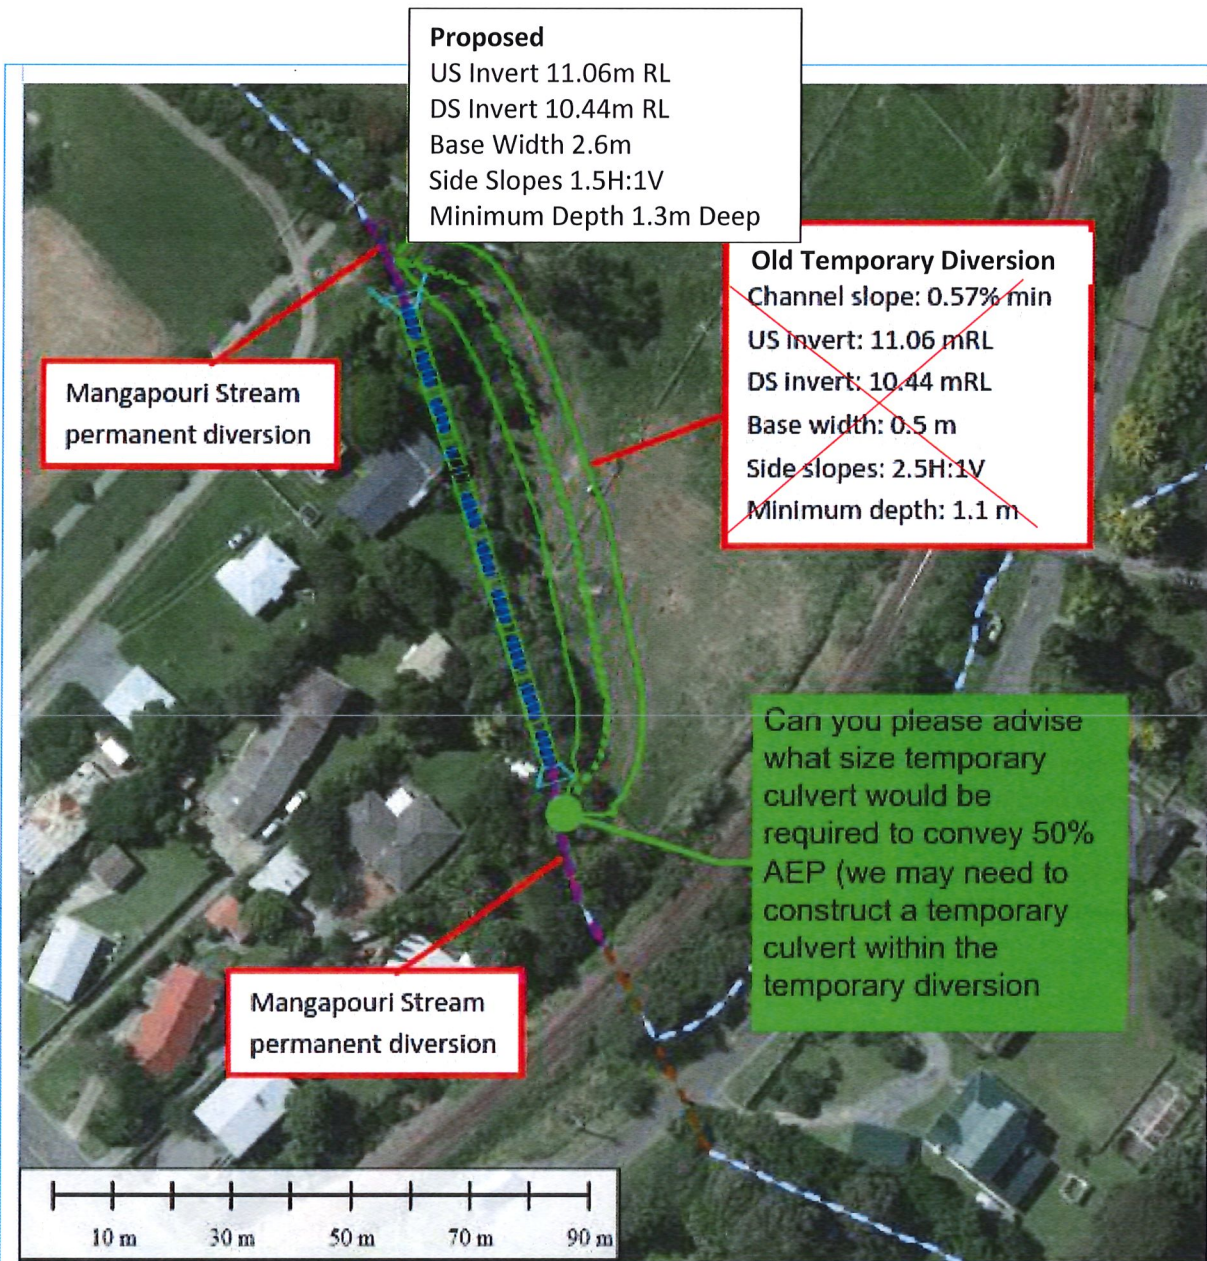
Comments
<p>A diversion channel is required for the construction of the permanent expressway culvert on the Mangapouri stream. A temporary cross of the diversion channel will also be required.</p> <p>The arrangement shown in Figure 1 was initially proposed, with the channel sized for a 2 year ARI flood discharge.</p> <p>A crossing would necessitate a culvert, which will result in additional energy losses, and hence higher water levels backing up behind the culvert, therefore a larger channel will also be required.</p> <p>We propose the following arrangement of culvert and channel sized for a 2 year ARI flood discharge of 7.7m³/s:</p> <p>A twin 1200mm diameter culvert to with a 1.3m deep, 2.6m wide channel with 1:1.5 side slopes. This allows for 200mm culvert embedment for fish passage too.</p>

Figure 1: Initially proposed arrangement without culvert crossing.

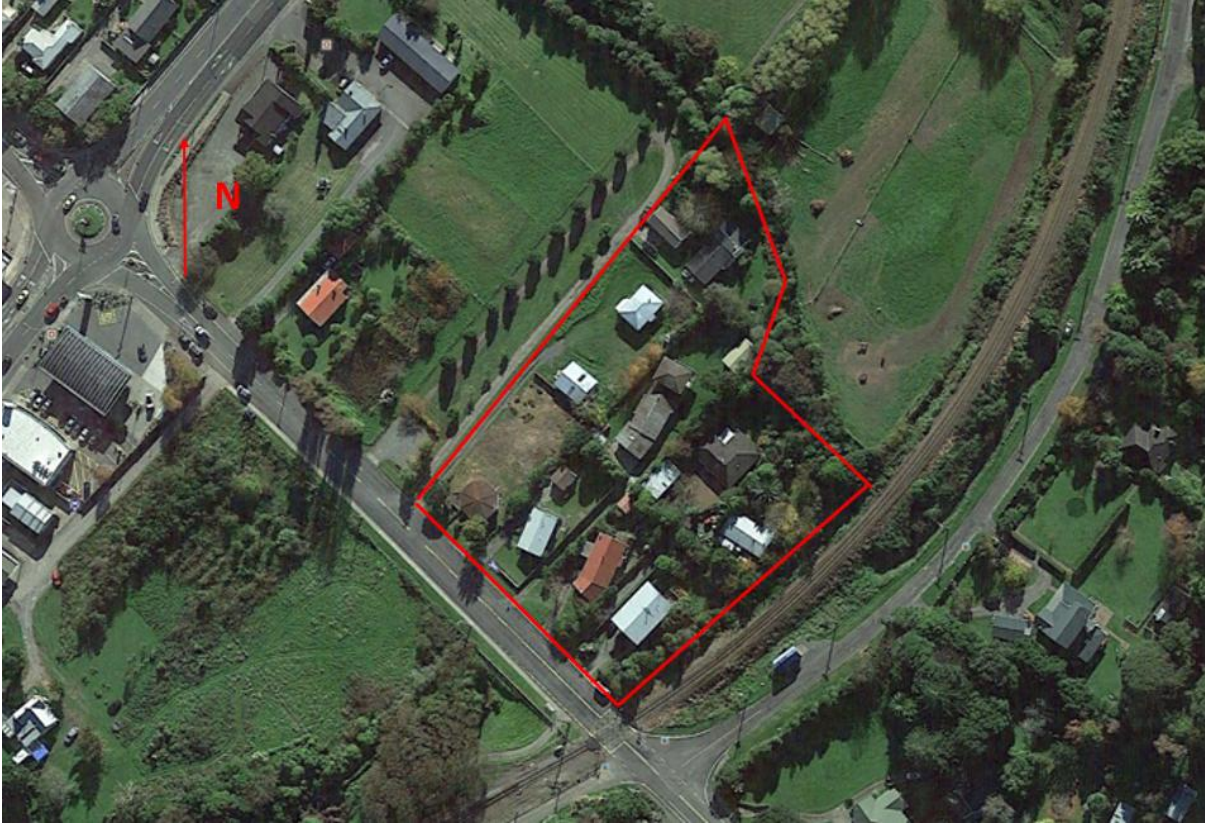
Figure 2 - Rahui Rd site area and layout prior to removal of the buildings (Source: Google Earth Pro 2017)

The realignment of the Kiwirail designation runs along the rail corridor, extending about 1,100 m to the north east and about 700 metres to the south west of the Ōtaki railway station as shown on Figure 2.

A contaminated land specialist completed a site walkover inspection of the Kiwirail designation on 21 September 2017 and at the Rahui Rd site on 27 September 2017. Relevant observations made at the time of the inspections are summarised below. Key site features are shown on Figure 2 and selected photographs are included in Appendix B (Site Photographs).

The Rahui Road section of the property currently contains vacant residential buildings and the remains of previously demolished buildings. The buildings are constructed of wood, brick, metal, corrugated plastic, aluminium composite material and fibrolite with concrete slabbing. There is a driveway running along the western boundary of the site. A stream runs along the north eastern boundary flowing in a north westerly direction towards the coast. The site is predominantly covered with topsoil and vegetation. Closer inspection of the soil revealed fragments of metal, ceramic and rock. Multiple stockpiles were present. The ground is generally flat lying.

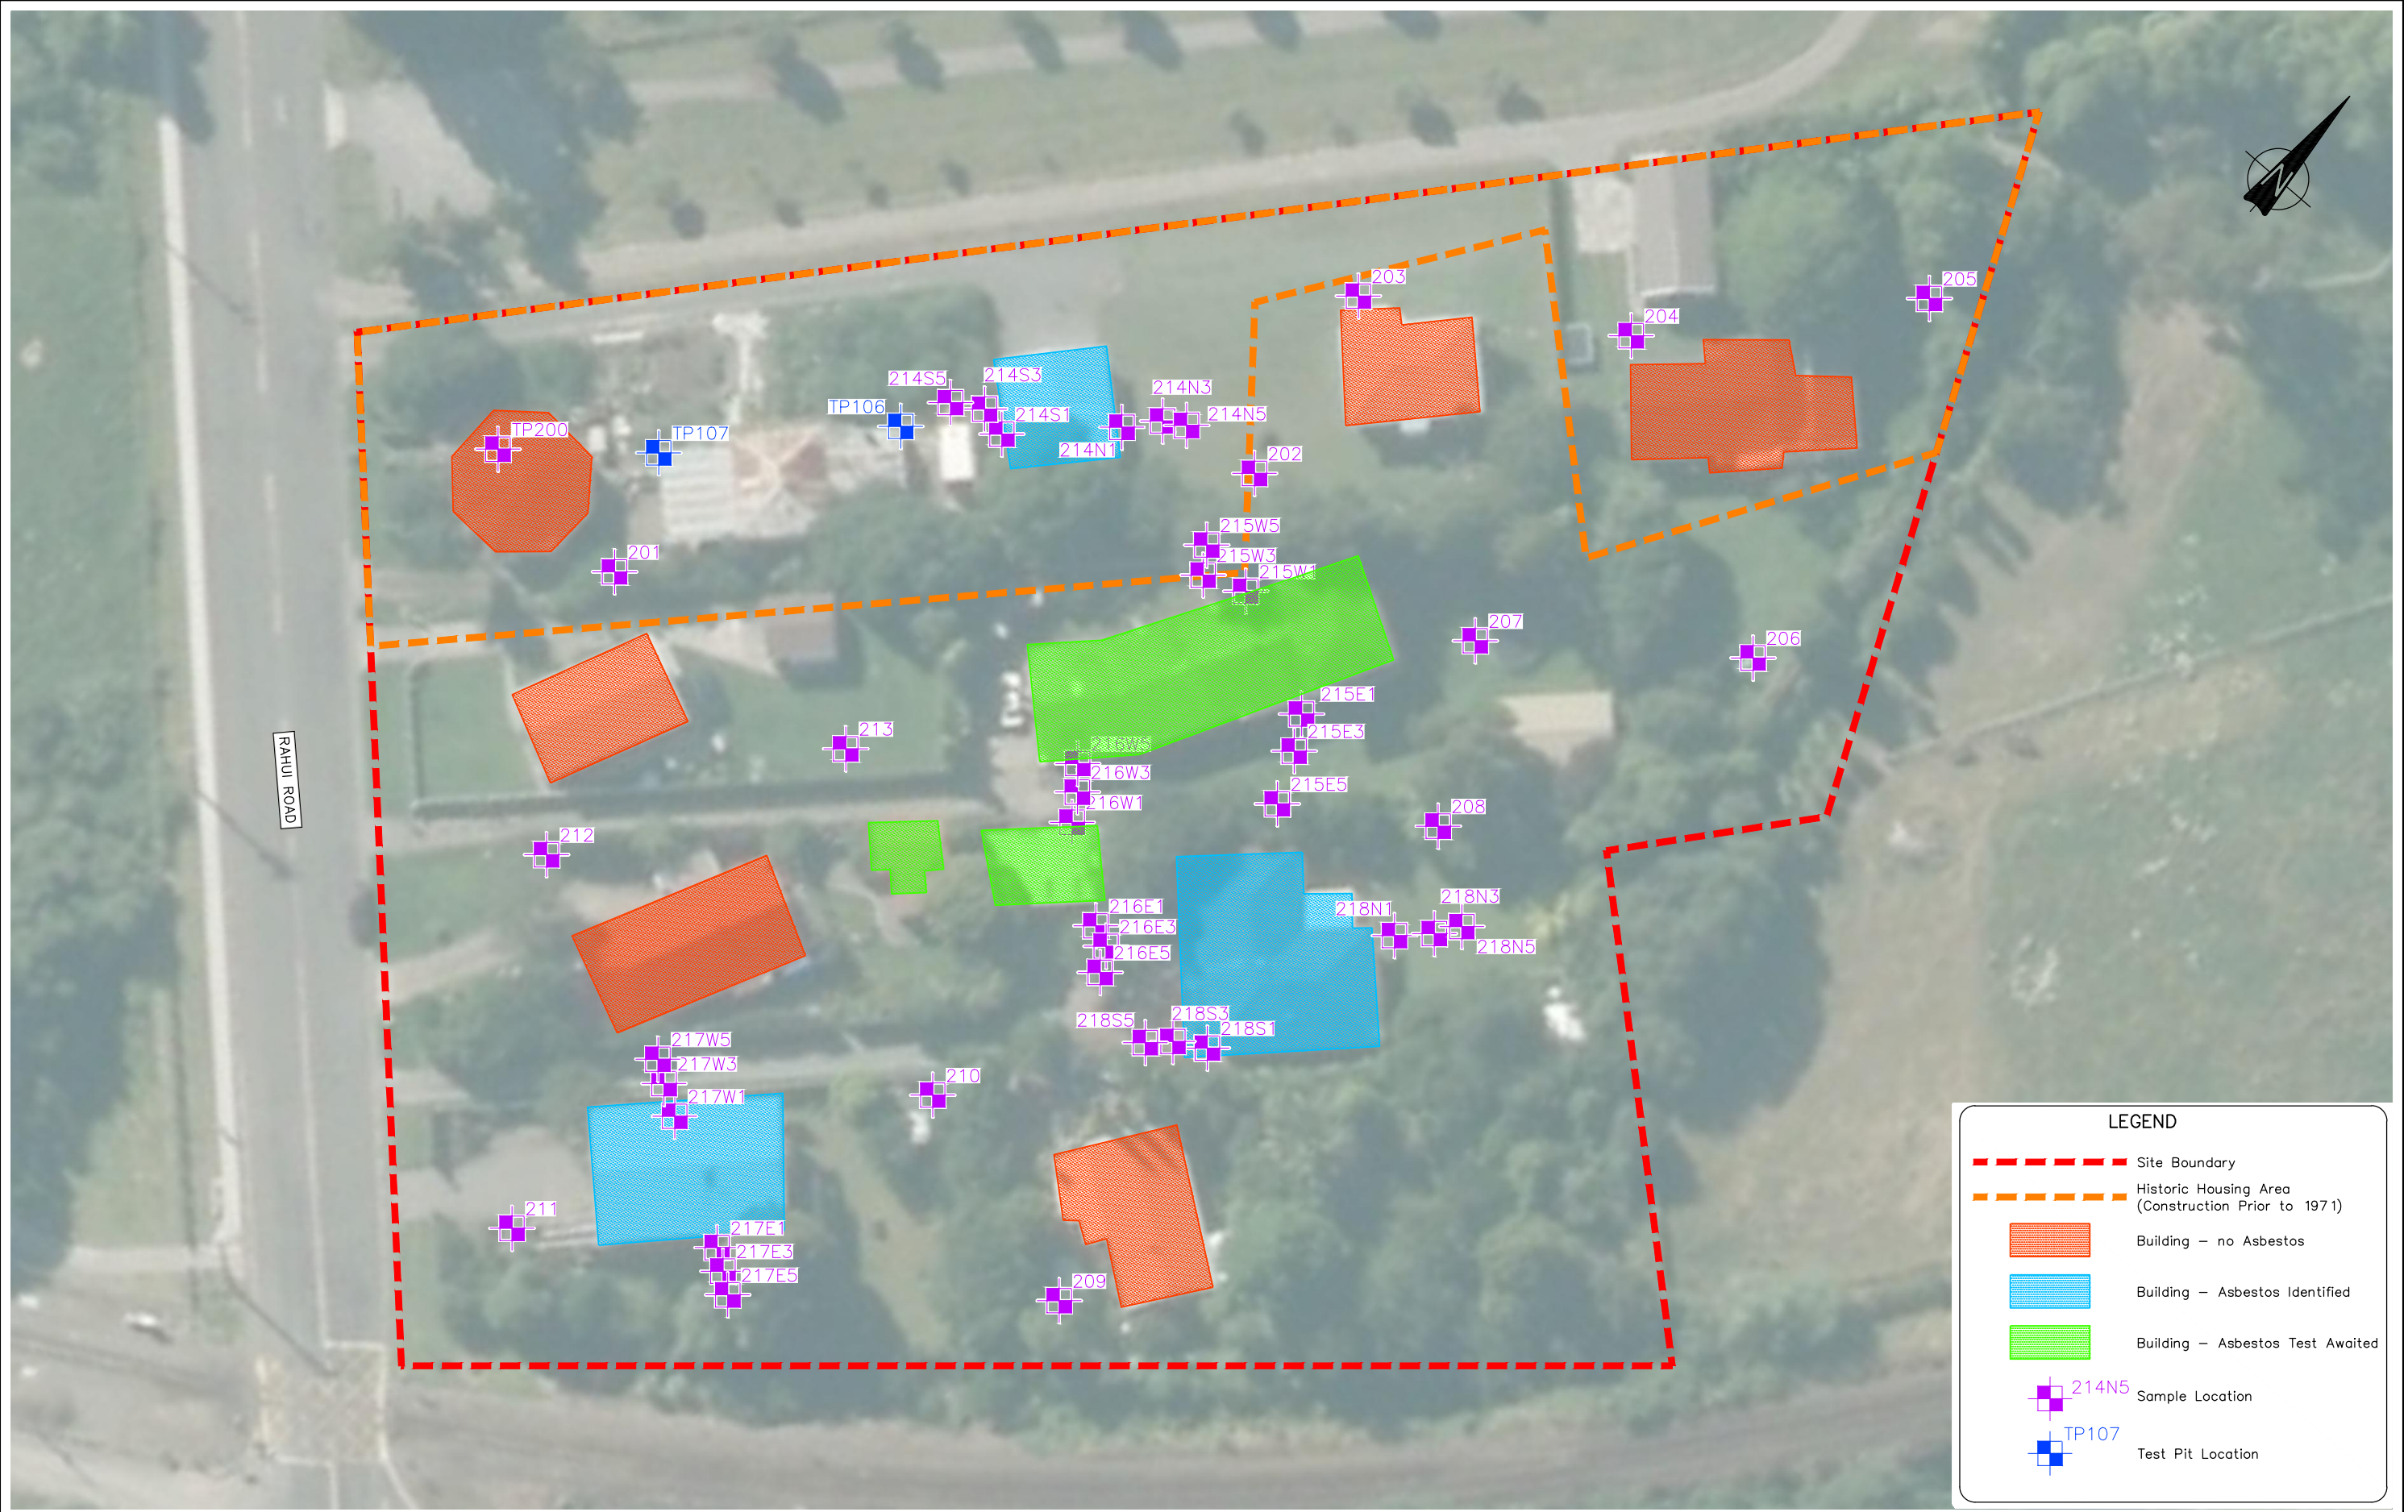
FIG. No.	Figure 4	REV.	0
----------	----------	------	---

- Site Boundary
- Historic Housing Area (Construction Prior to 1971)
- Building – no Asbestos
- Building – Asbestos Identified
- Building – Asbestos Test Awaited
- 214N5 Sample Location
- TP107 Test Pit Location

The site history indicates that this area was used for pastoral purposes up until at least the 1940s with some dwellings and sheds within the western third of the site (marked as "Historic Housing Area" on Figure 4 in Appendix A). By the early 1960s, the southern and eastern sections were converted to a market garden. By 2001, the site was converted wholly to residential land use, with nine dwellings and associated sheds and garages having been constructed. The site remained largely unchanged between 2001 and 2017.

Recent surveys identified asbestos within the fabric of some of the buildings on site. These buildings are indicated on Figure 4, based on data provided by Fletcher Construction Co. Ltd (enclosed in Appendix C).

2 machine dug test pits and 26 hand dug pits were excavated across the site, to target locations where buildings contained asbestos, as well as forming a general spread of sampling locations across the site. Sampling locations are shown on Figure 4.

Of the twenty-one soil samples and seven fragments of boarding tested, five of the samples tested positive for asbestos: two boarding fragments and three soil samples. The soil samples and one of the boarding fragments were within the eastern third of the site and the other boarding fragment was close to this area. On this basis, asbestos in soil is indicated to be limited to the eastern third of the site (labelled as the "Historic Housing Area" on Figure 4).

- Rahui Road (western area, as shown as the “Historic Housing Area” on Figure 4);
 - Location - Asbestos has been identified across this area at the surface and within the fill.

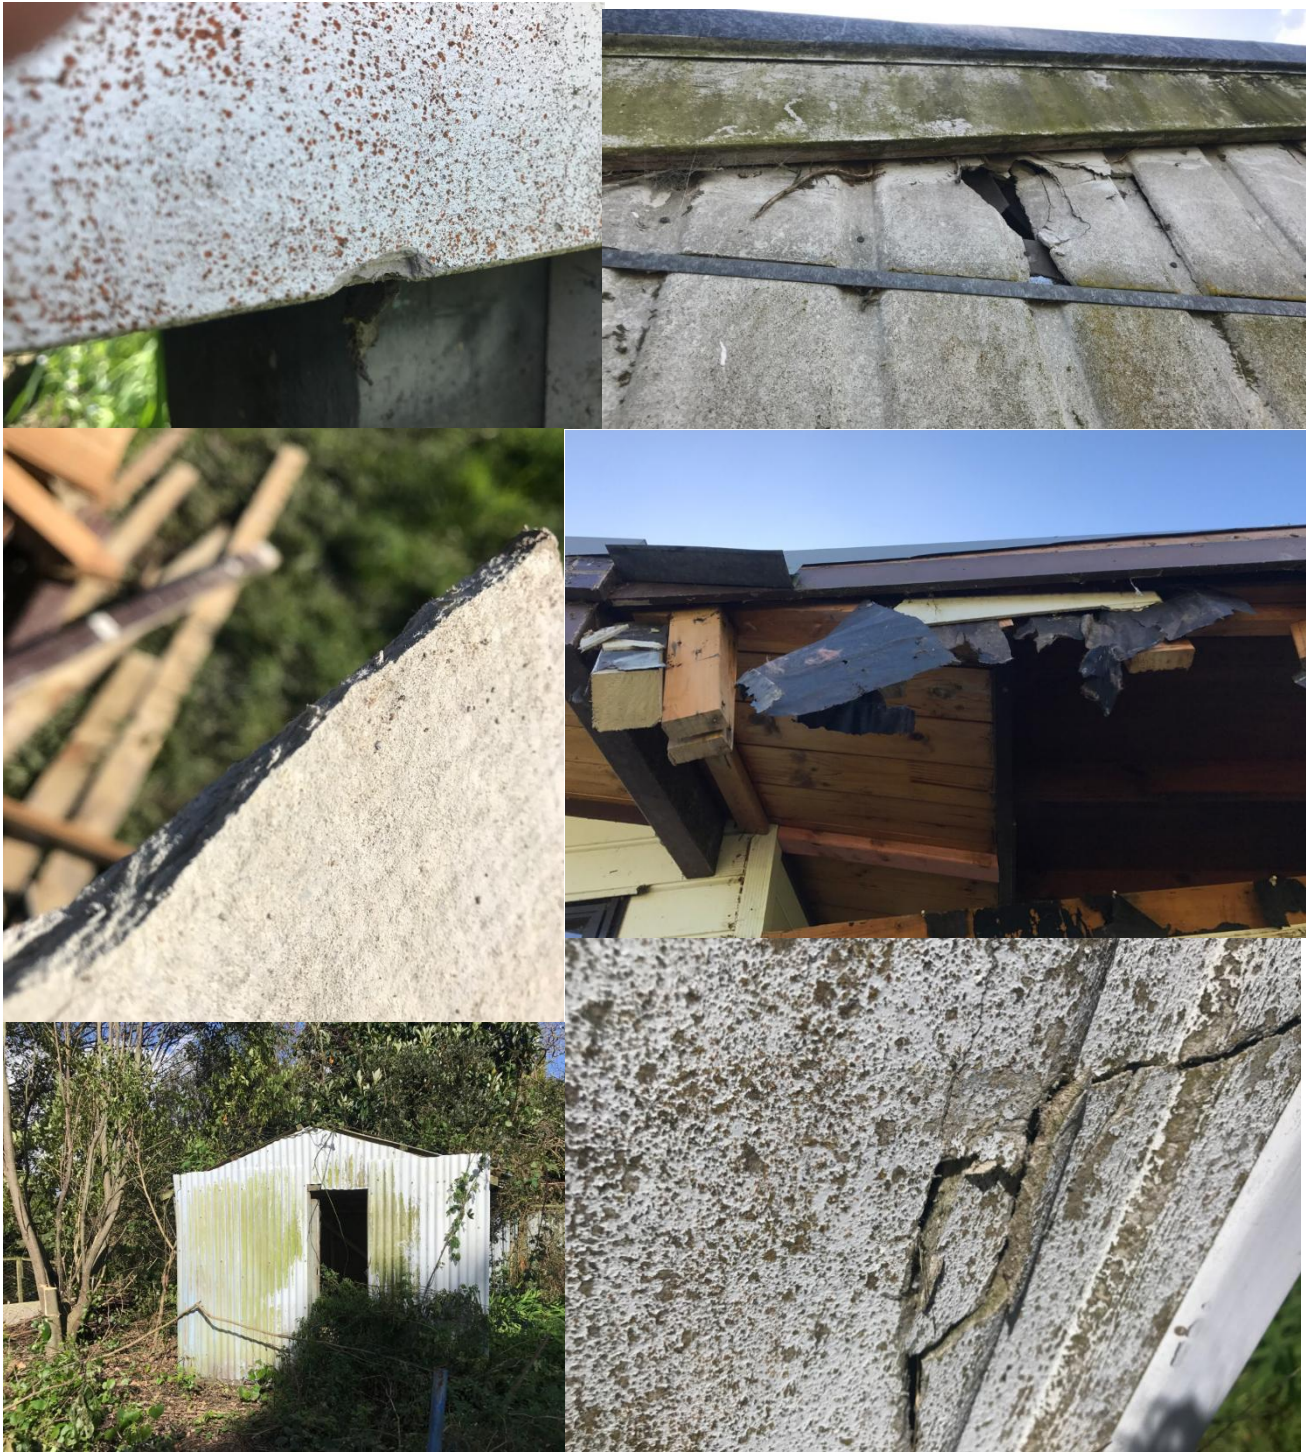
The buildings are constructed of wood, brick, metal, corrugated plastic, aluminium composite material and fibrolite with concrete slabbing (photos taken: September 2017)

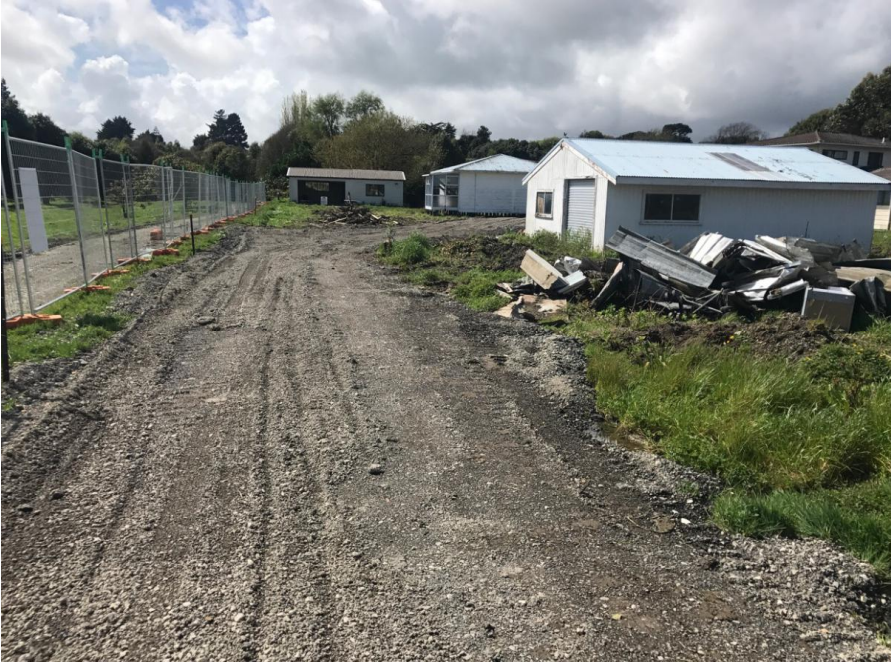
Vacant residential buildings with surrounding topsoil and vegetation (photos taken: November 2017)

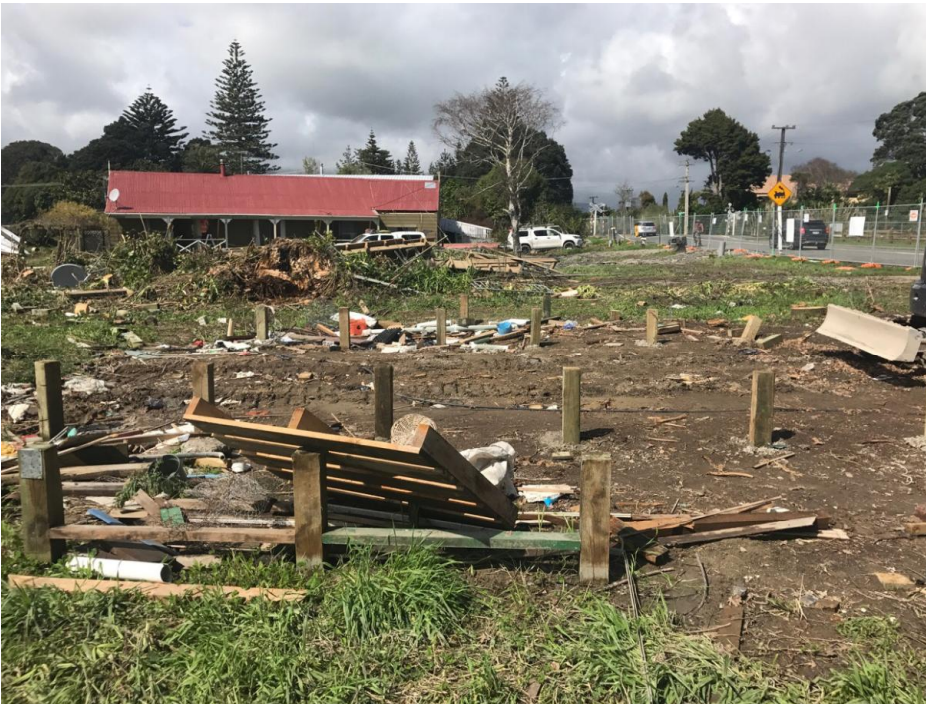
Vacant residential building and stockpiled remains of previously demolished buildings, taken from the western corner, facing south east (photo taken: September 2017)

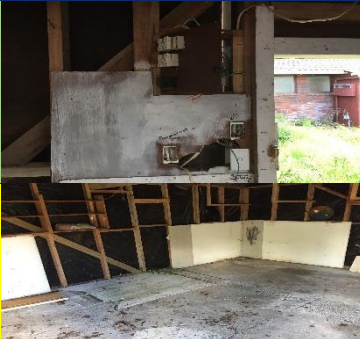
Date of Identification	Specific Location	Type of Asbestos	Condition of Asbestos	Is it Friable or Non-Friable?	Laboratory Analysis findings	Action Required
7 th November 2017.	Internal: Garage-Electrical Fuse Board 012	Suspect ACM Board	Good Condition	Non-Friable	No Asbestos Detected

7 th November 2017.	Internal: Garage-South End (Wall Panels) Refer to 010	Suspect ACM Board	Partly Damaged	Non-Friable	Chrysotile (White)	
7 th November 2017.						
7 th November 2017.
