**Peka Peka to Otaki
Specialist Report – Heritage and
Archaeology**

Specialist Report – Heritage and Archaeology

Date:
Reference: 355537.36
Status: Draft

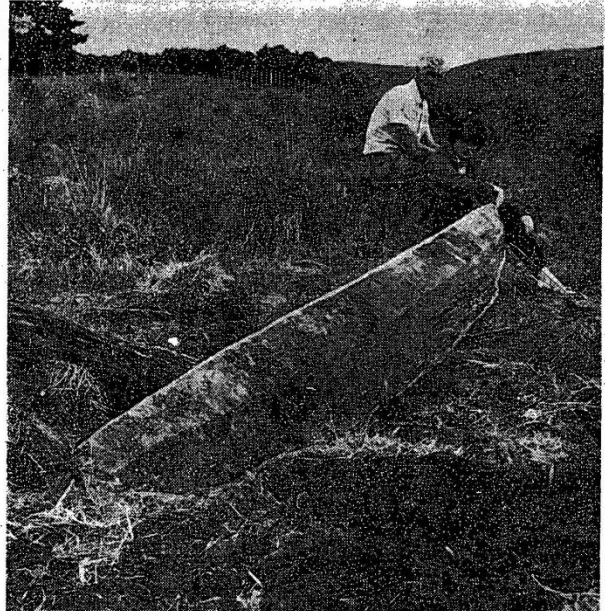
MR. H. DURHAM and his daughter Jenny rest alongside their "find" on their sheep station, "Te Hapua," at Te Horo.

One end of the canoe was projecting just above the surface where it had become decayed, but the hull was otherwise in an excellent state of preservation.

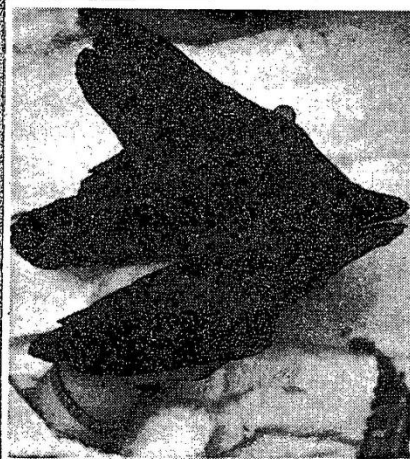
LARGE wood chips found beside the canoe.

Large wood chips were found at the side of the canoe

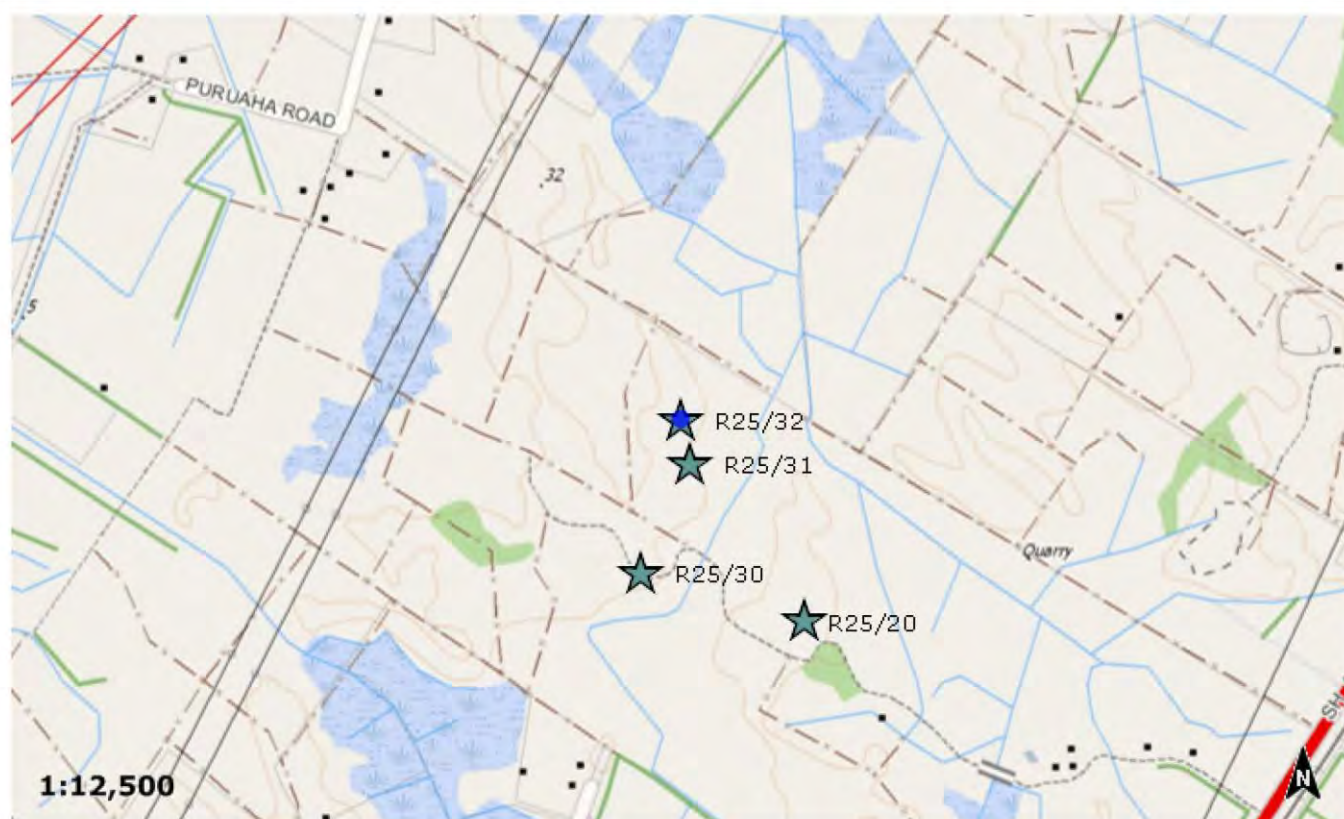
Finding aids to the location of the site

On leading dune ridge running north from Paul Faith Lane. On high knob of dune crest.

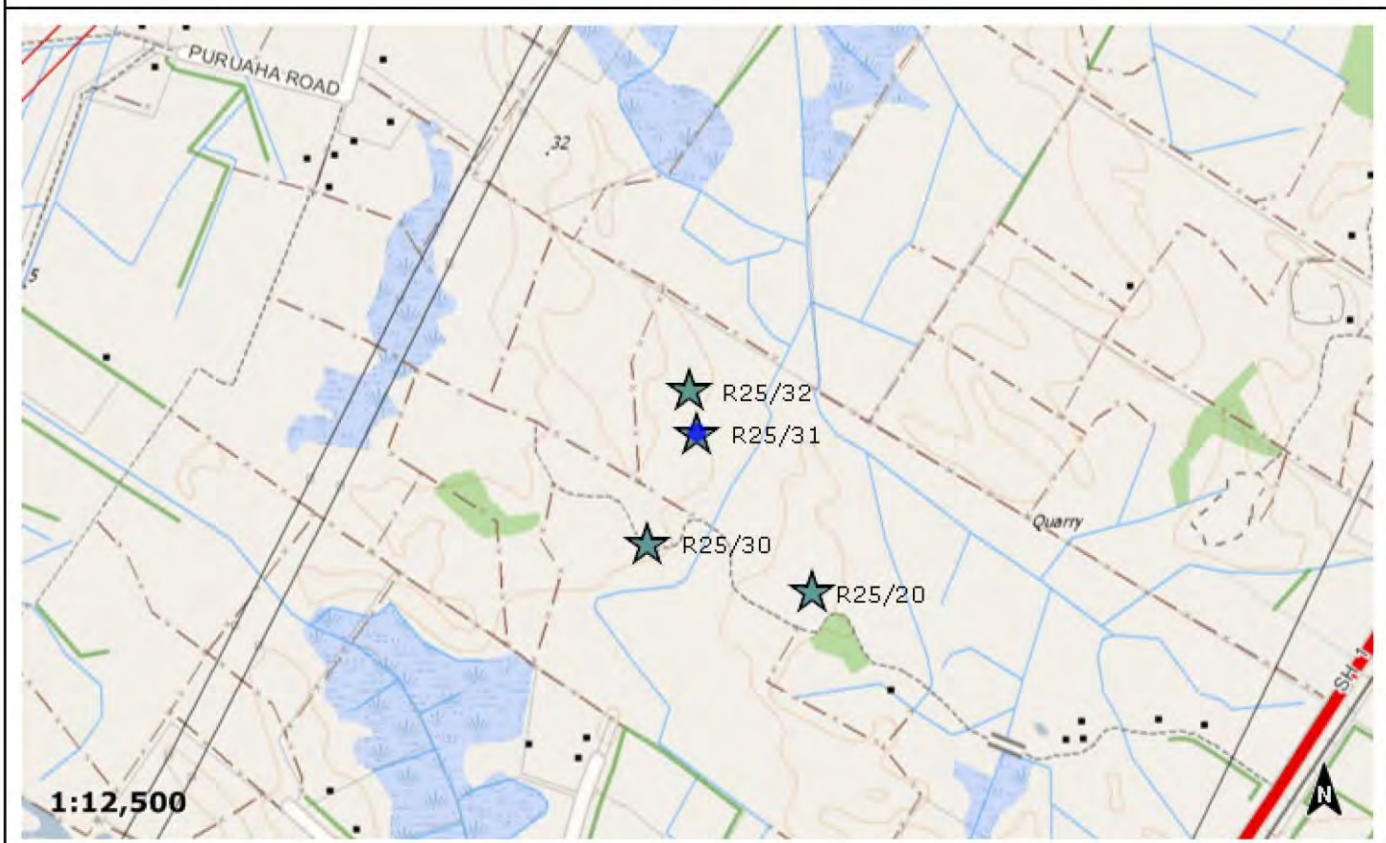
Finding aids to the location of the site
 On leading ridge running north from Paul Faith Lane. On eastern side of ridge; on end of small spur on edge of dune ridge, overlooking wetland below.

Brief description
 Two terraces.
