1 Mangamuka Gorge slip repairs

Uncovering what lies beneath

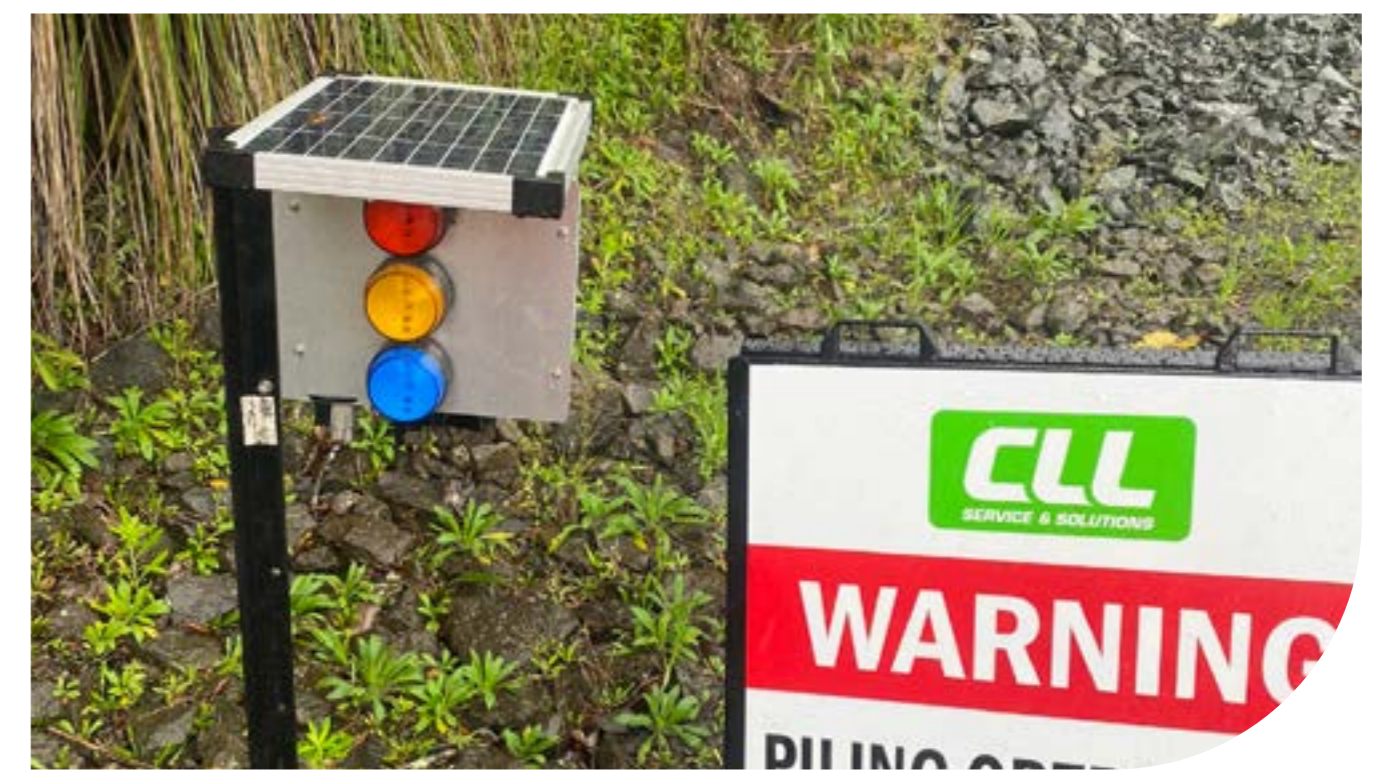
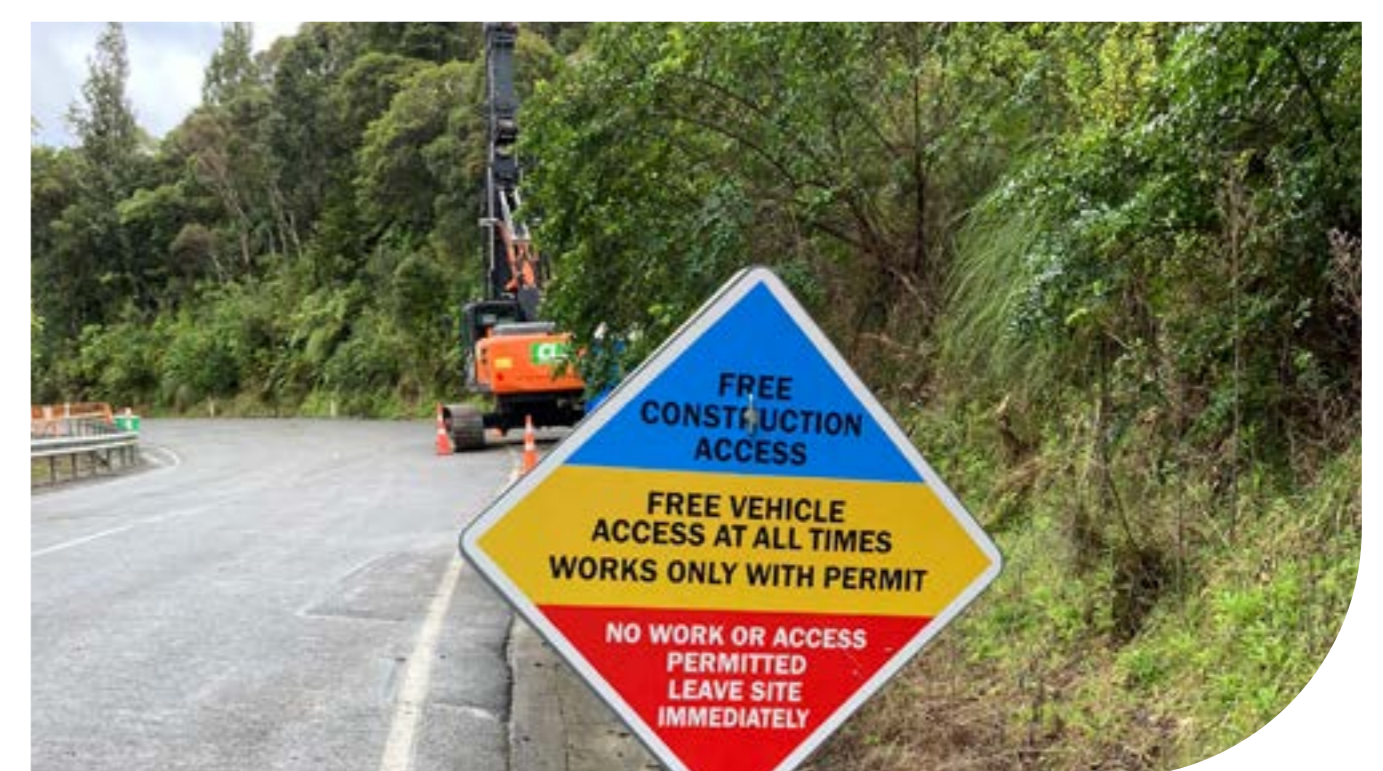
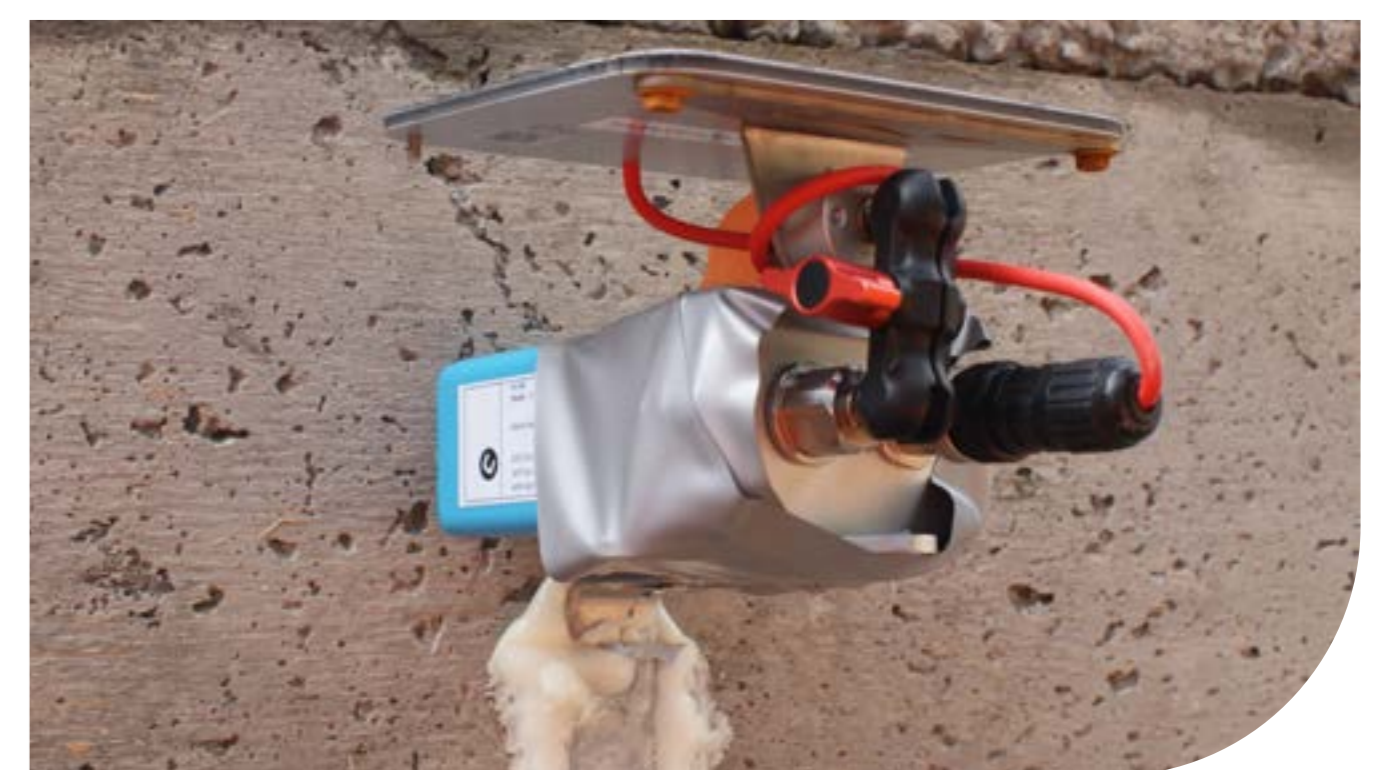
We have a complex network of sensors onsite that are working non-stop to keep the construction site safe. These gadgets are constantly checking ground movement, helping geotechnical engineers know what's happening keeping the teams on site safe as they do the hard mahi fixing the slips.

The sensors monitor ground movement, check how wet the soil is, and measure how much rain has fallen. Every day, these sensors send data to a special plan that figures out how risky the ground movement is. This plan is called a Trigger Action Response Plan, or TARP. The TARP level is shown throughout the site with lights placed at slip entry points.

If it rains a lot (50mm or more in a day), or if the ground gets wet because it's been raining for a long time, the TARP level goes up automatically. If a sensor notices that the ground has moved sustainably since the last reading, alarms will go off and the crews are moved away from the site until it safe to return.

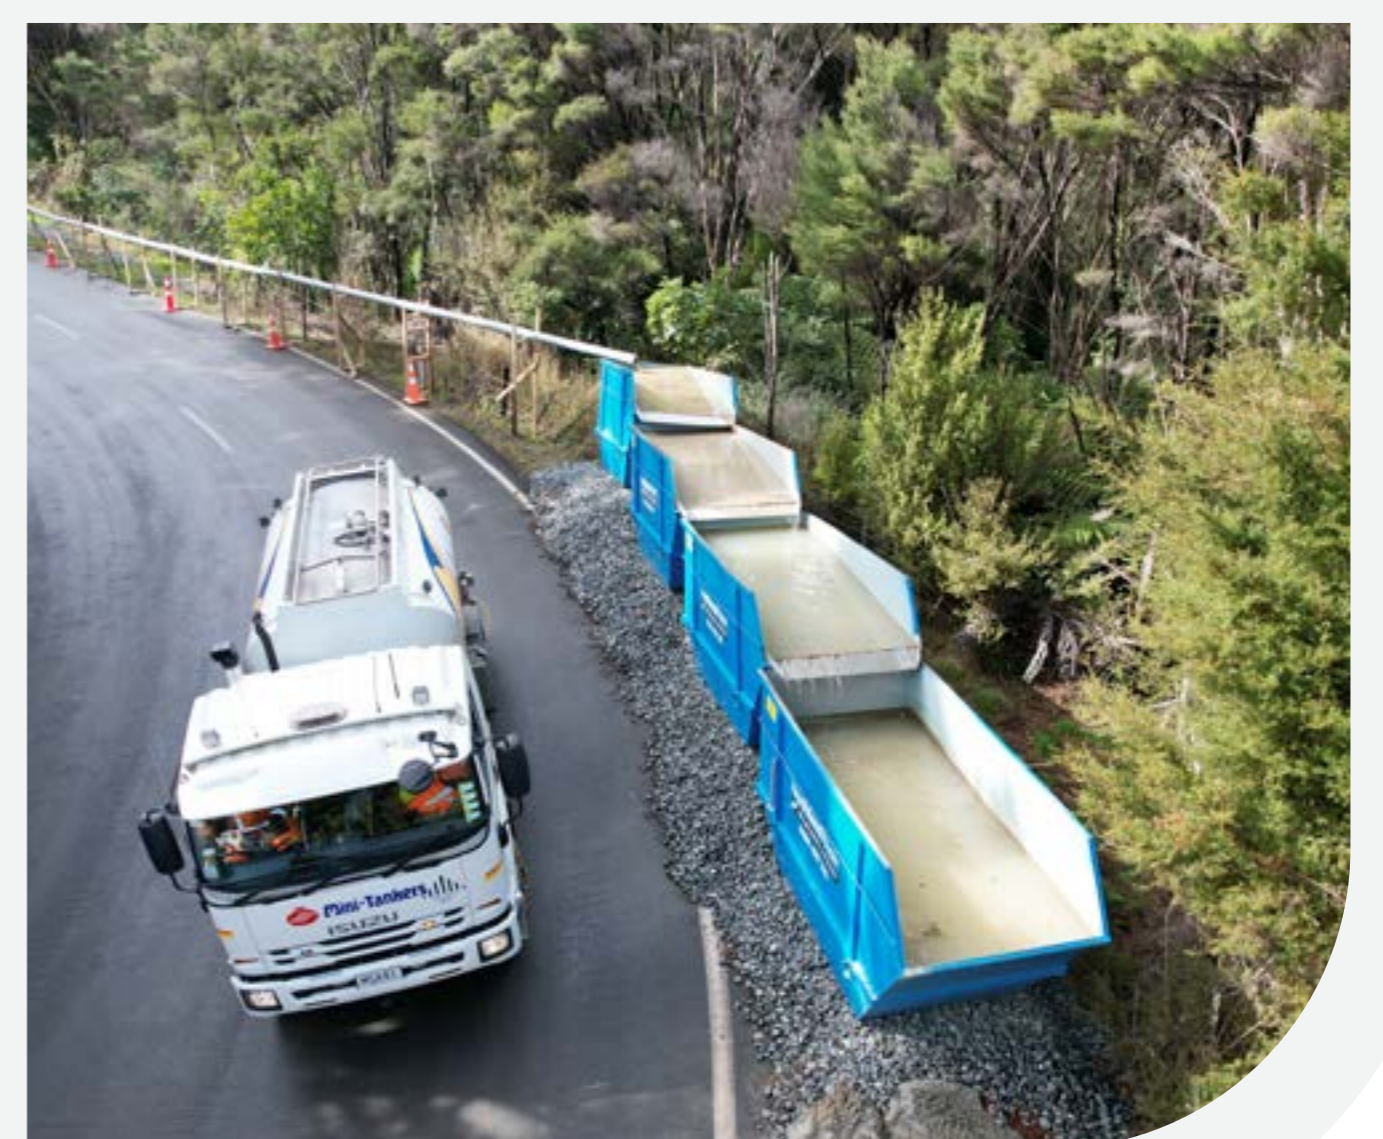
Water runoff is diverted into a series of clean industrial bins where dirt and other contaminants are allowed to settle, before overflowing into another bin. The remaining contaminants are also able to settle before being pumped out and removed offsite for further settlement and safe disposal.

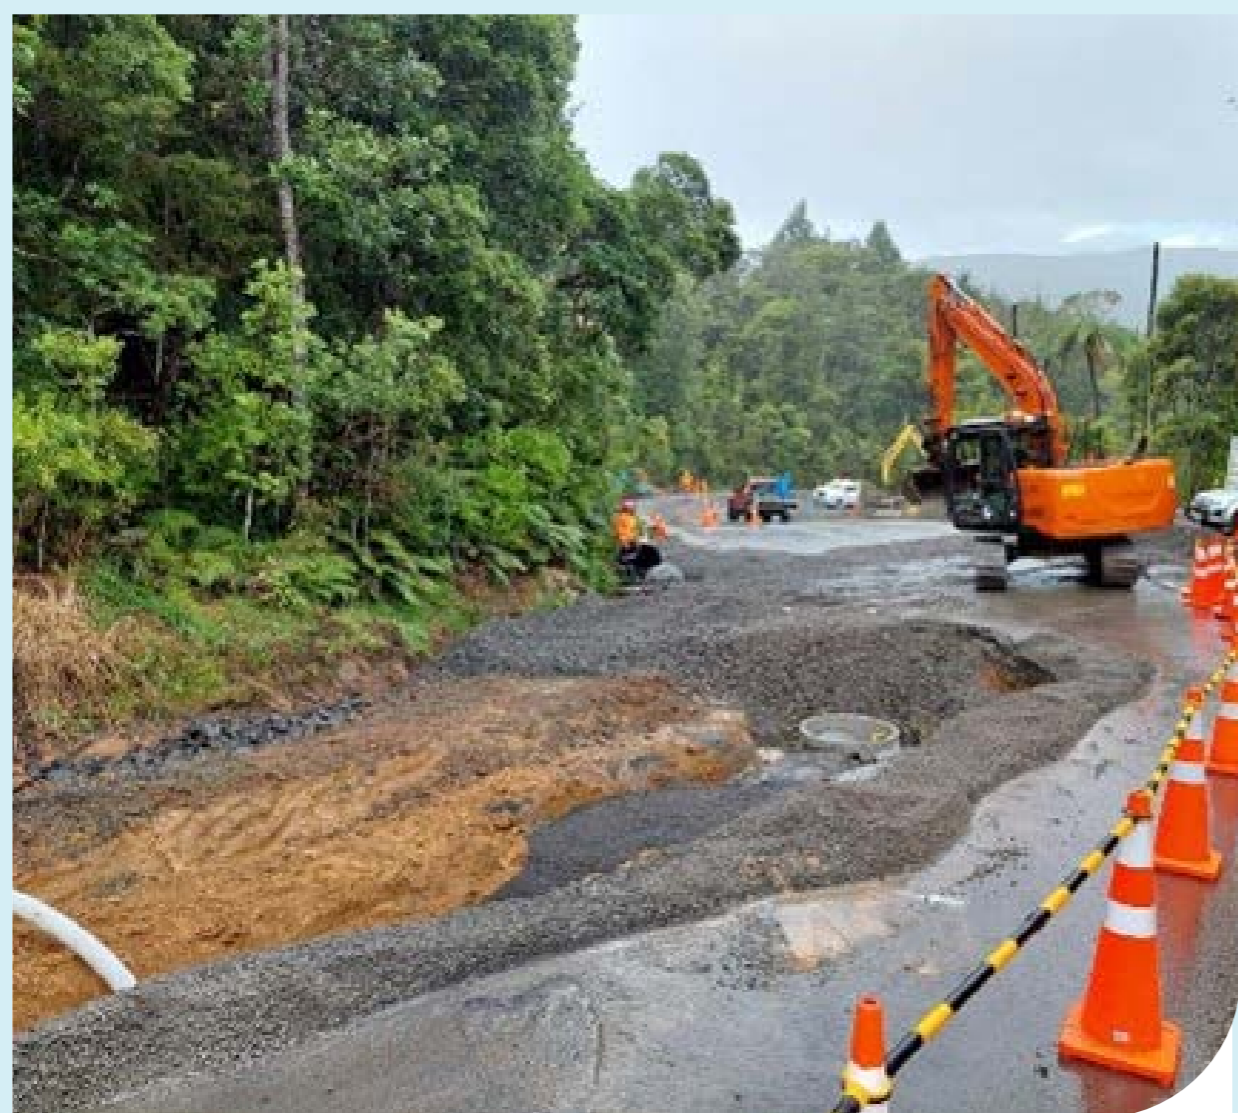
Effective stormwater and sediment management plays a major role in protecting the environment through construction. We're installing silt fencing, rainwater capture drains and sediment tanks to ensure any stormwater runoff is collected, diverted, and treated before it reaches the local waterways.
