1 Mangamuka Gorge slip repairs

Current Slip Repair Updates

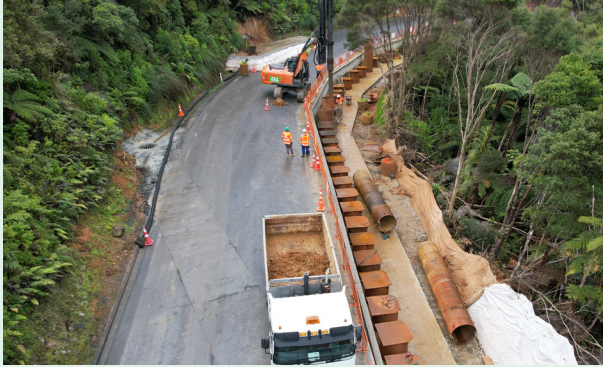
Slips A1 and A2

Enabling works - Complete.

Permanent works - 40x 6m pile casings have been installed in preparation for the return of the main piling rig from Slip A5. Once in place, the piling rig uses the casing as a guide to drill down to solid rock. It will then be filled with re-enforced concrete which forms the pile

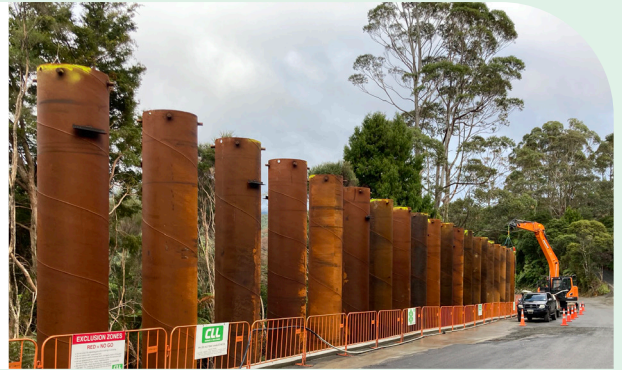
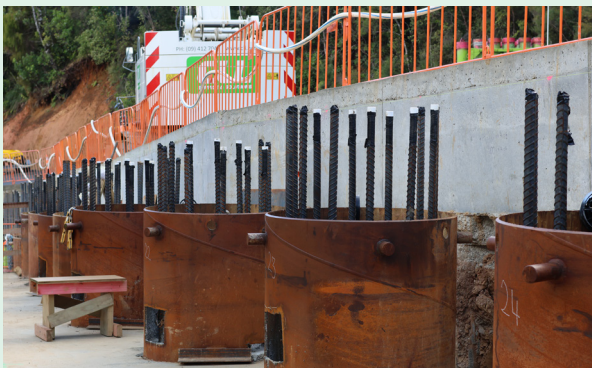
Slip A5

Slip A3

Permanent works - Pile casings are currently being spliced. Splicing of casings in piling operations refers to the process of joining together two or more sections of cylindrical casing that forms the external sleeve of the pile.

Enabling works - Complete.

Permanent works - Teams on site are currently finishing installing 25x 1050mm diameter piles and are scheduled for completion in late September.

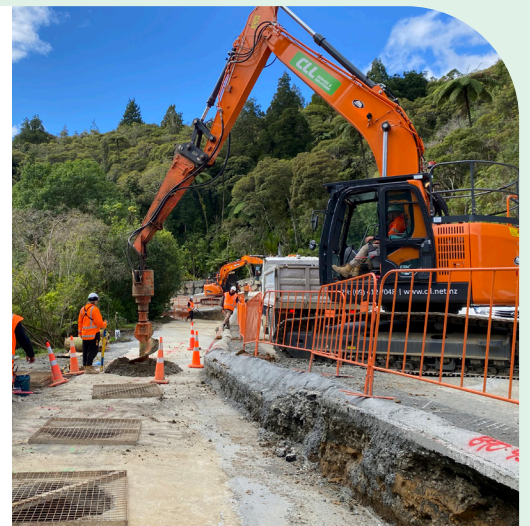
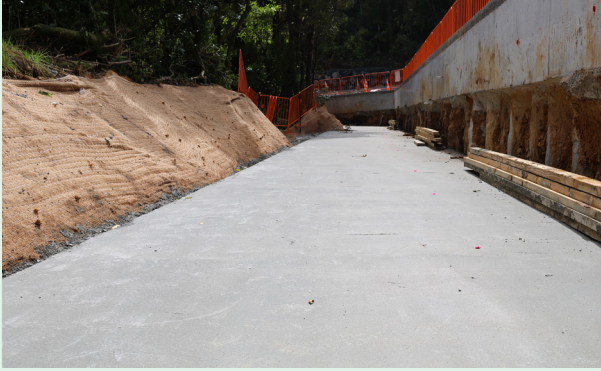
Slip A6

Enabling works - The team are currently installing the enabling piles which consist of a series of 800mm diameter piles, encompassing both reinforced (hard) and non-reinforced (soft) piles. This proactive approach aims to ensure that, once heavy machinery are established on the slip, the ground remains sufficiently stable and any potential for further movement is minimised.

In addition, the teams have installed two slot drain pads, addressed rock spalls, completed drainage installations, and established enabling work platforms.

Slip A9

Enabling works - The team is nearing completion with the capping beam complete and stormwater management controls are being re-installed.

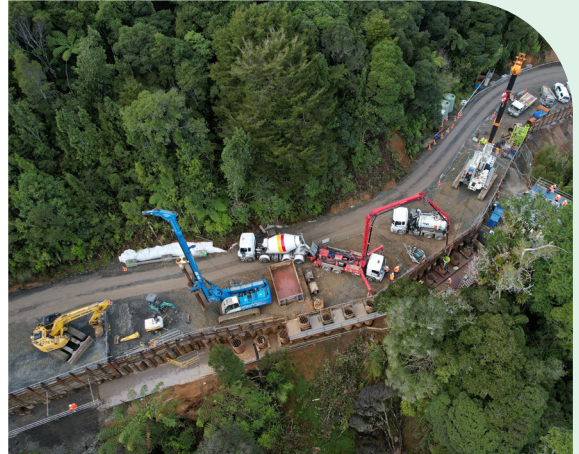
Slips A12 and A13

Enabling works - Teams are continuing with lagging, which is building the retaining wall behind the piles, as well as work platforms in preparation for the staged mobilisation across Slips A12 and A13.

Permanent works - Installation of 39x1050mm diameter piles on A12 are underway and are progressing on schedule. Due to the access requirements and overall fragility of this section, work will proceed onto A13 once the work on A12 is complete.

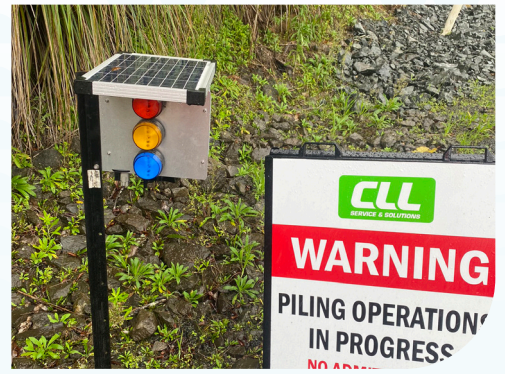
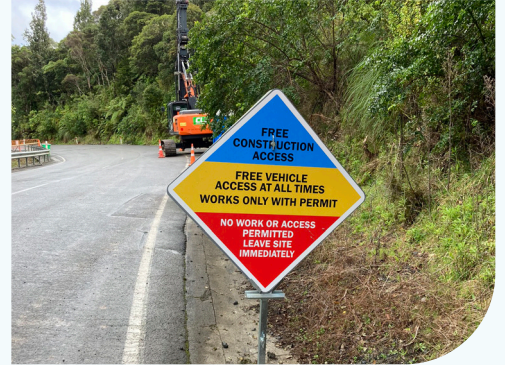
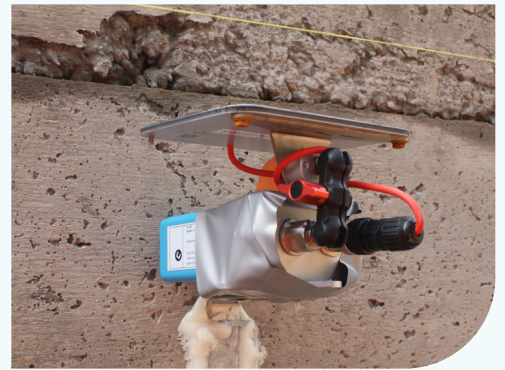
Safety Around a Moving Whenua

We have a complex network of sensors onsite that are working non-stop to keep the construction site safe. These gadgets are constantly checking ground movement, helping geotechnical engineers know what's happening keeping the teams on site safe as they do the hard mahi fixing the slips.

The sensors monitor ground movement, check how wet the soil is, and measure how much rain has fallen. Every day, these sensors send data to a special plan that figures out how risky the ground movement is. This plan is called a Trigger Action Response Plan, or TARP. The TARP level is shown throughout the site with lights placed at slip entry points.

If it rains a lot (50mm or more in a day), or if the ground gets wet because it's been raining for a long time, the TARP level goes up automatically. If a sensor notices that the ground has moved sustainably since the last reading, alarms will go off and the crews are moved away from the site until it safe to return.

Sending data out from the gorge is tough because there's no cellphone coverage and power is limited. But the sensor system that keeps our teams safe uses advanced wireless technology to make this possible.

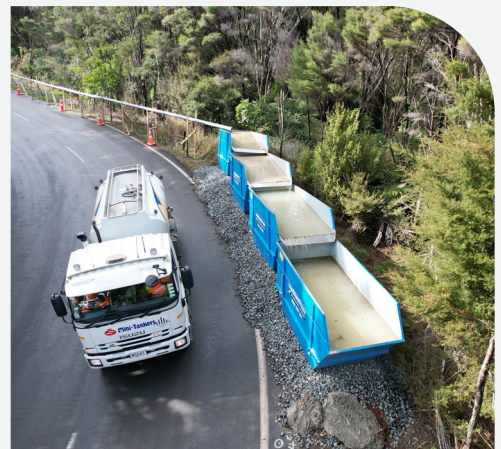
Stormwater Management

Water runoff is diverted into a series of clean industrial bins where dirt and other contaminants are allowed to settle, before overflowing into another bin. The remaining contaminants are also able to settle before being pumped out and removed offsite for further settlement and safe disposal.
