HISTORIC HERITAGE ASSESSMENT OF ARCHAEOLOGICAL EFFECTS

SH1/SH29 INTERSECTION UPGRADE

Waka Kotahi NZ Transport Agency

PREPARED BY
SIÂN KEITH

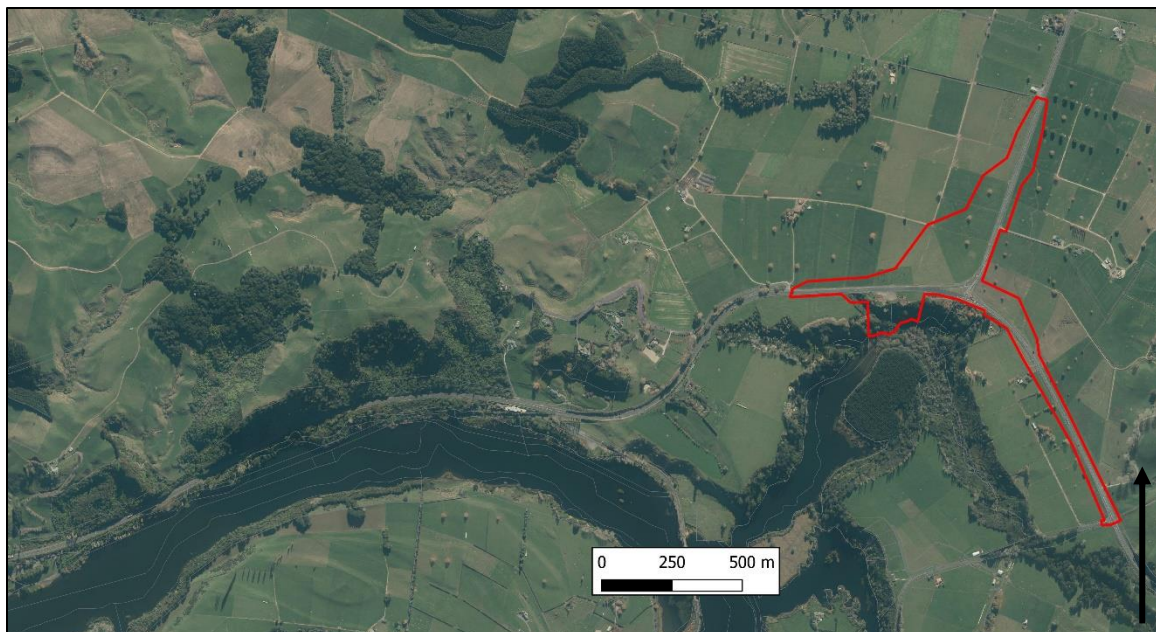
Figure 2: Aerial image showing extent of Project Footprint.

The Project is located in the northwest corner off the current SH1 / SH29 junction at Piarere (Figure 1 and Figure 2). It is on the true right side of the Waikato River / Lake Karapiro. The Waikato River is the major geographical feature of the landscape. It was an important source of fresh water and transport for both Māori and early European settlers.

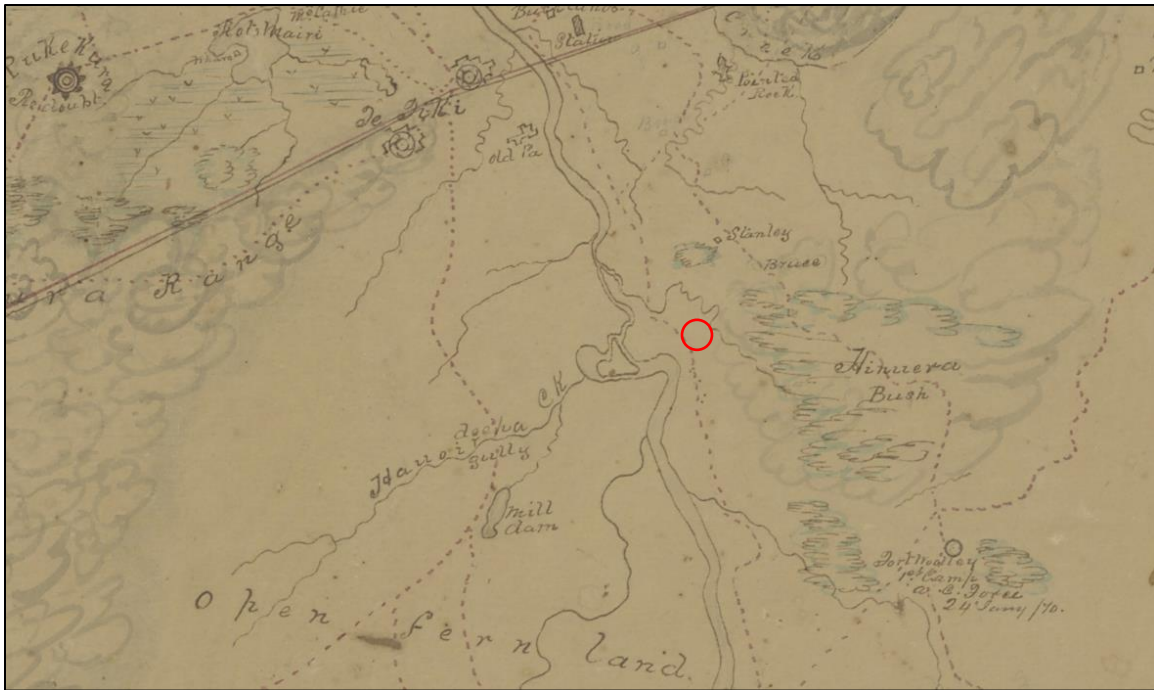
Figure 4: Captain Newell's Sketch Map of the Waikato c. 1878. Approximate study area highlighted with red circle.⁴

Captain Newell's sketch map dated to c. 1878 portrays all of the sites and settlements familiar to him at that time. The extract showing the general study area reproduced in Figure 4 depicts SH1 and settlements in the wider landscape, but nothing is shown within the approximate area of the project.

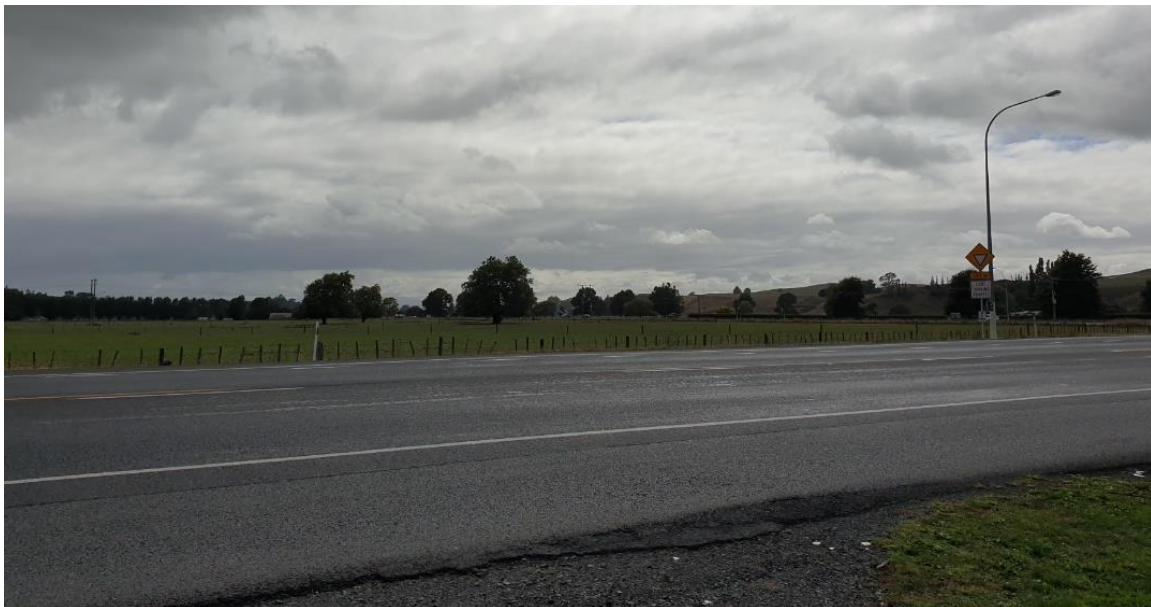
Figure 11: Image looking north-east towards the location of the proposed roundabout (9.03.2021).

The land to the eastern side of SH29 (SA1701/33 and SA646/95) was surveyed by the author in January 2021, part of which is within the Project Footprint, as part of an assessment of alternative locations for the roundabout. At the time this report was prepared, it had not been possible to access the privately owned land within the Project Footprint on the western side of SH29 (contained in Record of Title SA69C/317). A visual survey of that land from the roadside boundary has been undertaken (Figure 11).

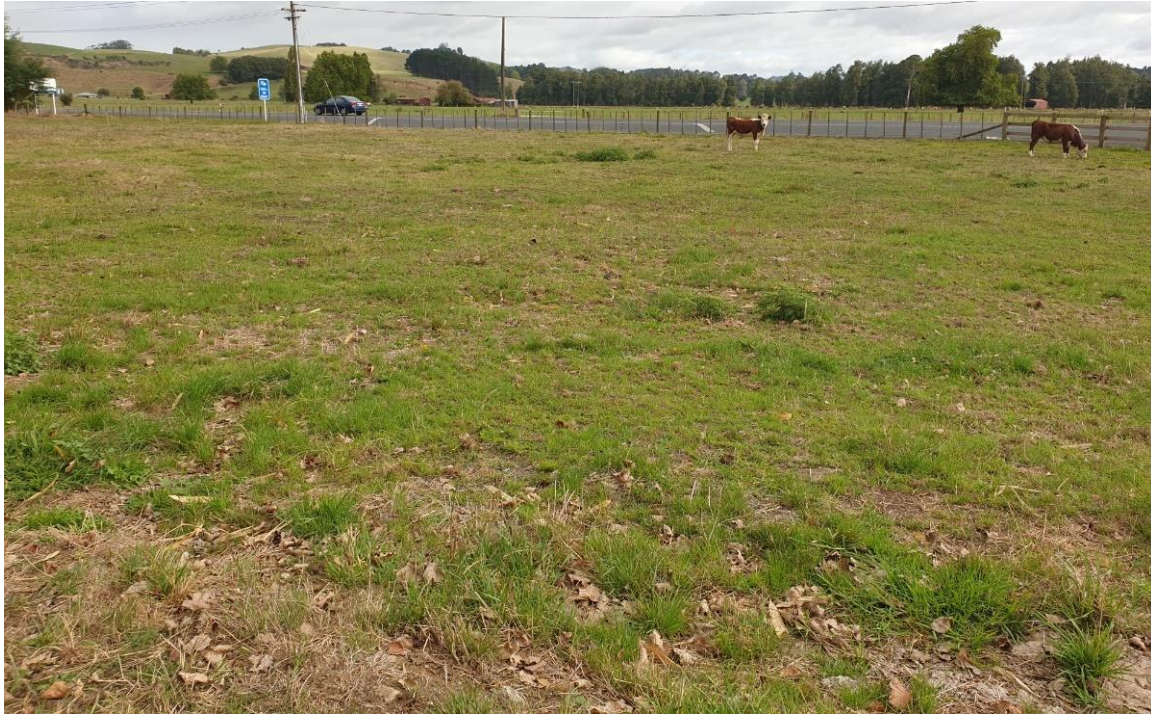
Figure 12: Image looking north across the western stormwater outlet location.

The western side (SA32A/615 and SO 53269) is a grazed paddock between SH1 and a steep falling gully (Figure 12). It has been significantly modified over the last 50 years or so. The current occupier described the previous buildings located on the site and the work he has undertaken to remove debris and recontour the paddock. The gully to the south is heavily vegetated and inaccessible. As a result, it is highly unlikely that archaeological material will be present in this location.
