Waka Kotahi New Zealand Transport Agency

STATE HIGHWAY 1 AND STATE HIGHWAY 29 INTERSECTION UPGRADE PRELIMINARY SITE INVESTIGATION

18 June 2021

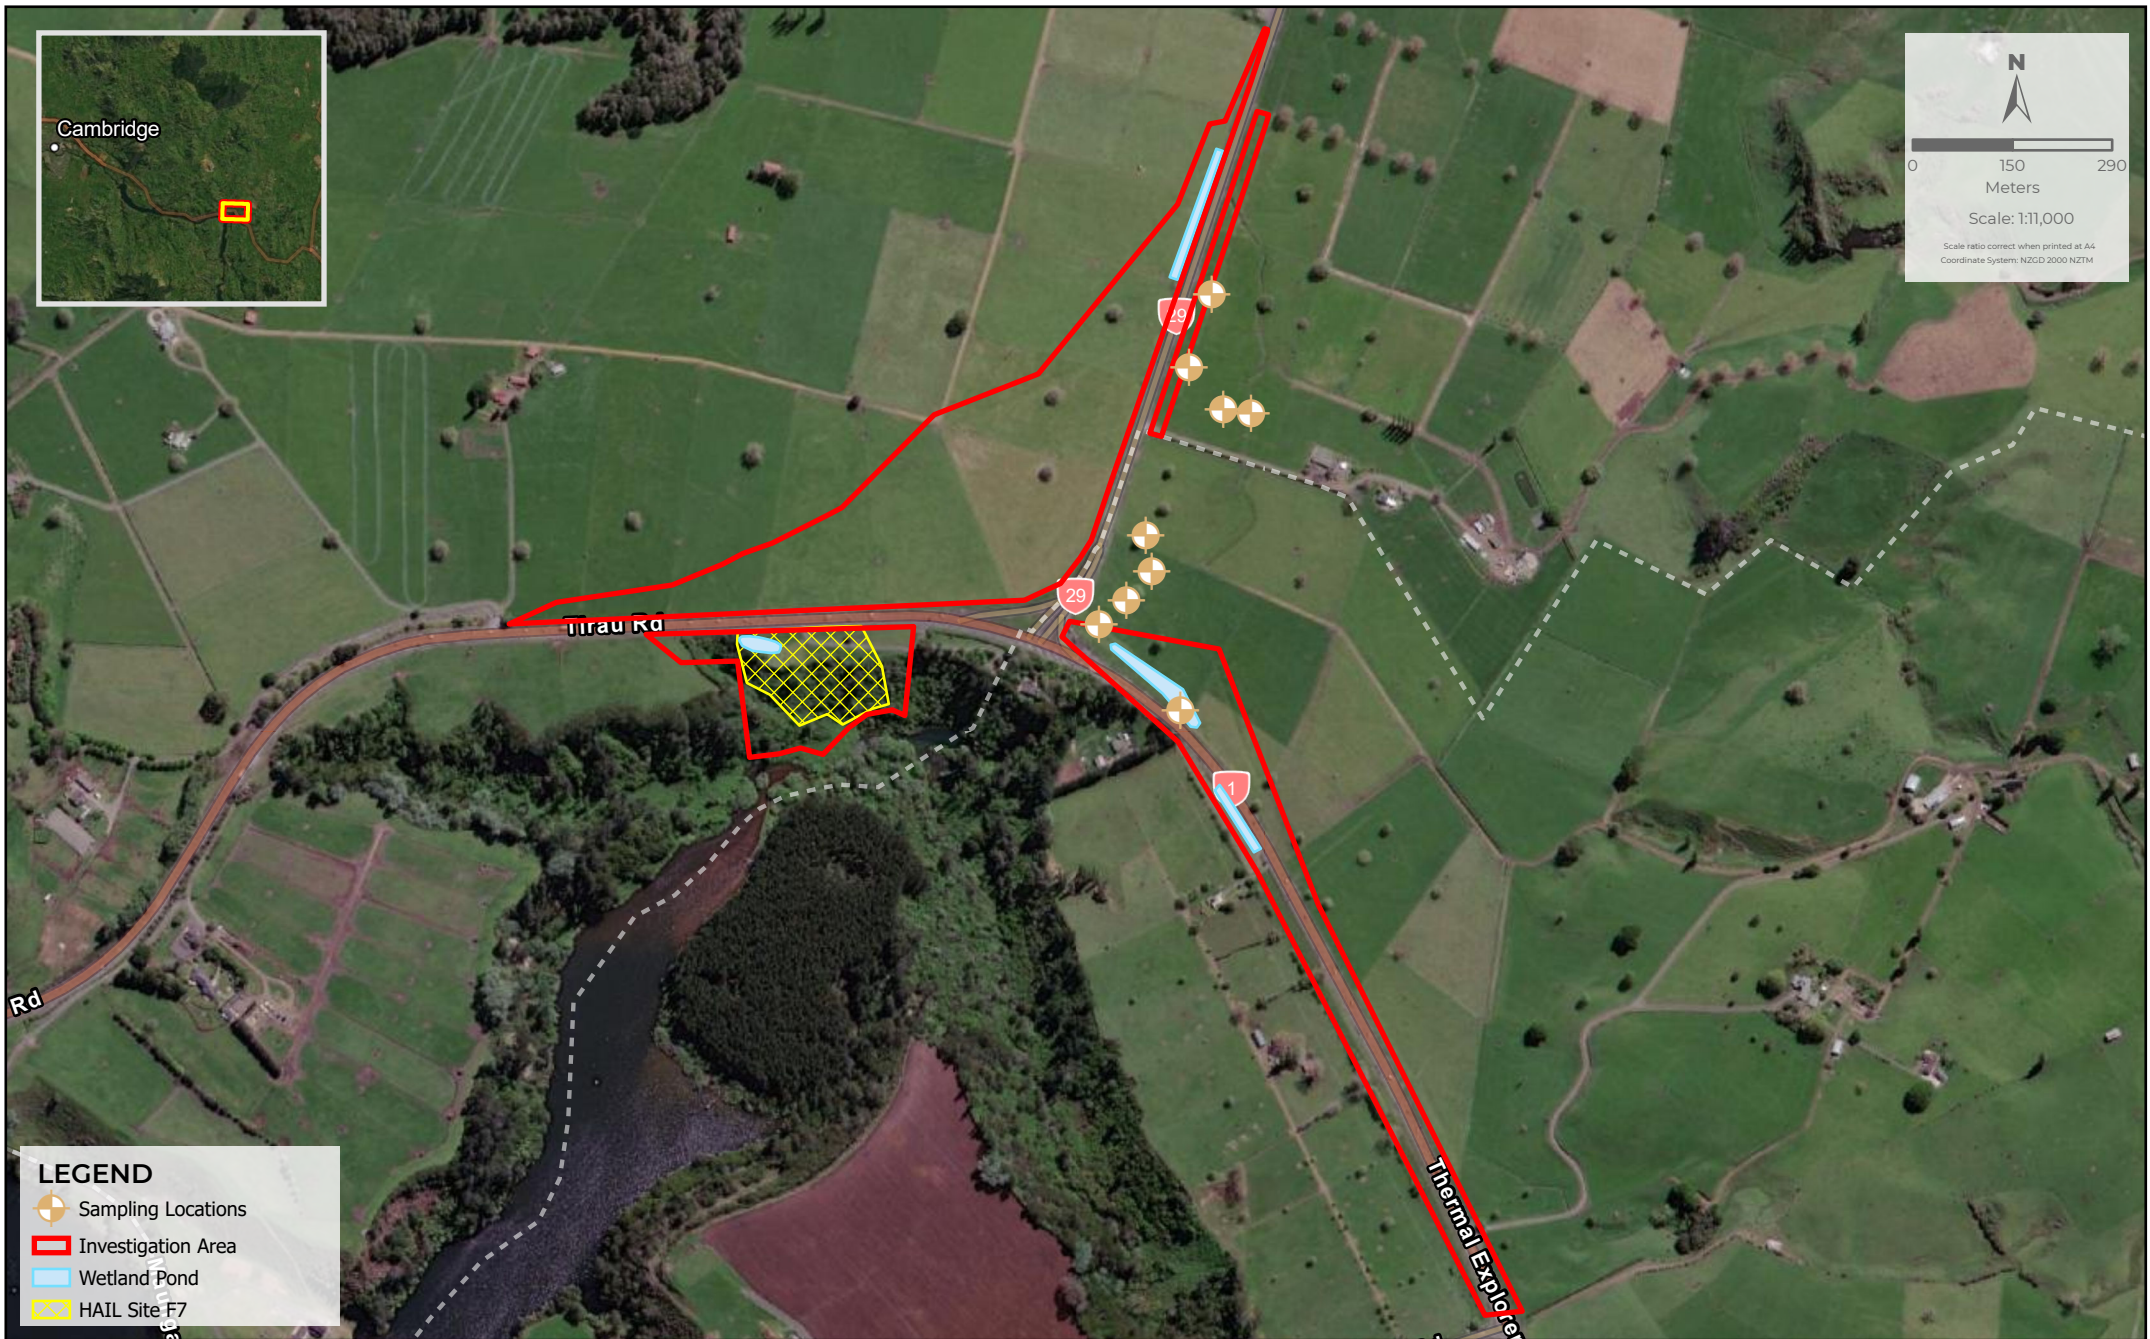
Figure 2 - Investigation Area and Sampling Locations

The CLS collected the nine samples to an approximate depth of 0.1 m below ground level (bgl). All samples were collected by hand using a stainless-steel trowel and gloved hands. Nitrile gloves were replaced between collection of each sample. All non-dedicated sampling equipment was washed and decontaminated using a phosphate-free soap between each sample location. Soil sample locations are presented in Appendix A: Figure 2.

- Sampling Locations
- Investigation Area
- Wetland Pond
- HAIL Site F7

All of the samples analysed contained concentrations of metals that complied with the NESCS SCS for the protection of human health in a Commercial/Industrial land use scenario.

All samples contained concentrations of cadmium and zinc above the WRC Natural regional background values, whilst the lead concentrations were above regional background concentrations in five samples.

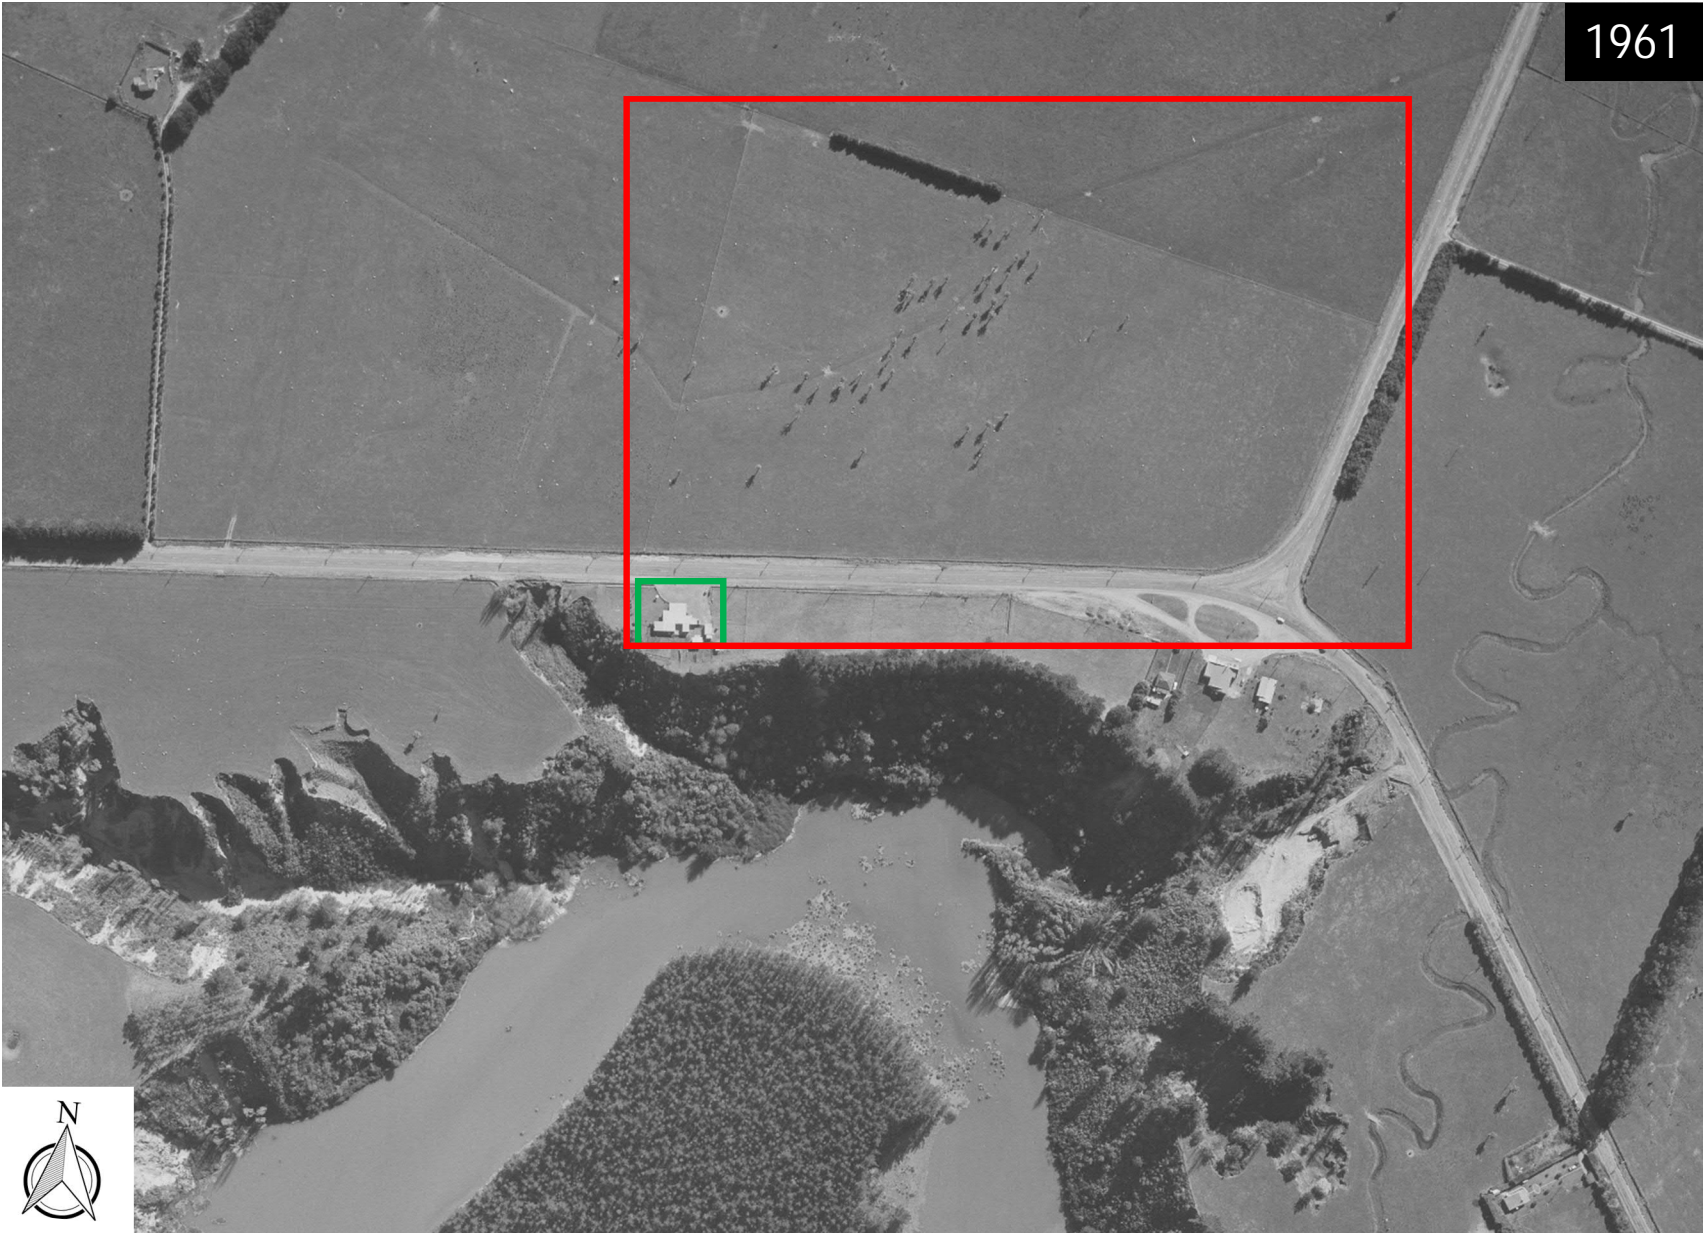
1961

Former Service Station Location

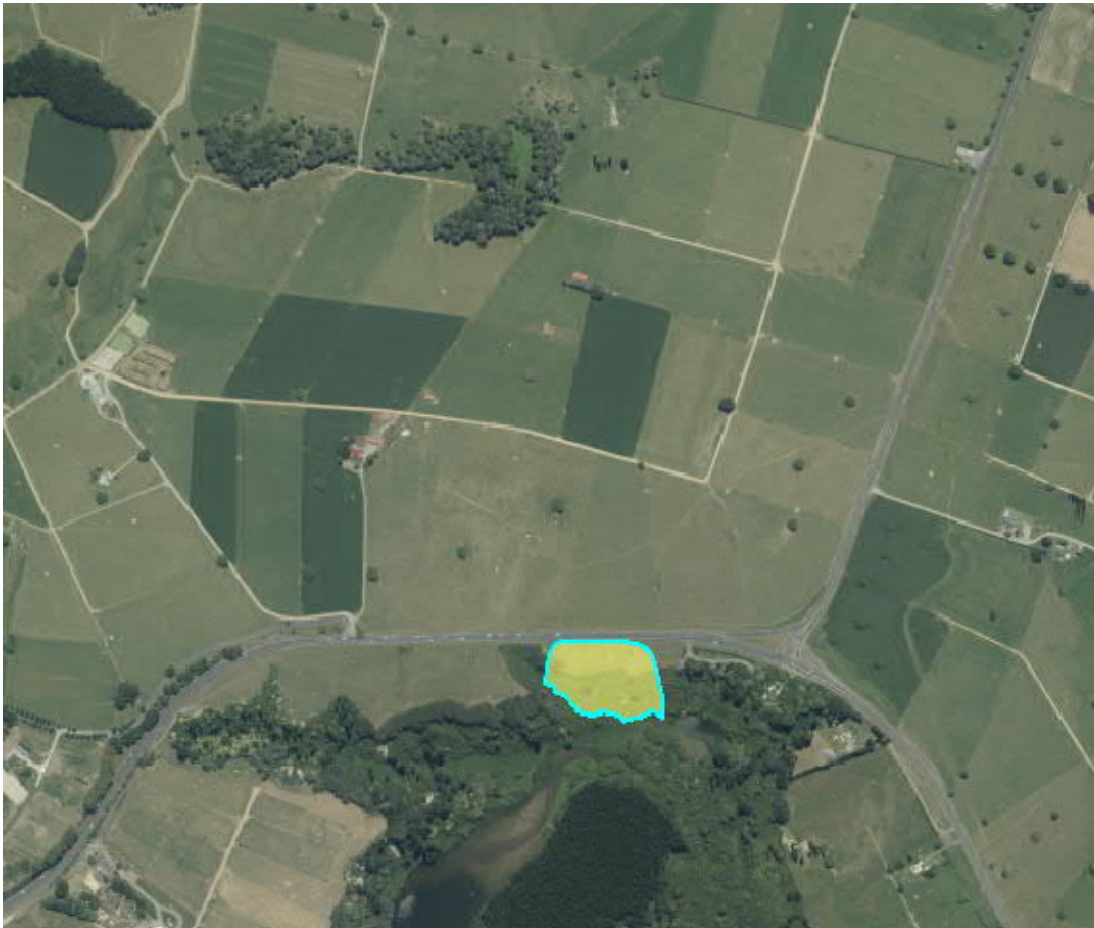
- I can confirm that this property does appear on the Land Use Information Register, as indicated by the area shaded yellow on the map below.

The area shaded yellow above (LUI01796) appears on the Land Use Information Register with a classification of 'Unverified HAIL' due to (past OR past and current) land use for HAIL activity 'F7. Service Stations' associated with Piarere Service Station Ltd.
