Prepared for  
NZ TRANSPORT AGENCY

# PSW 198 – SH3 Manawatu Gorge Alternative Route Assessment Final Report

NOVEMBER 2012

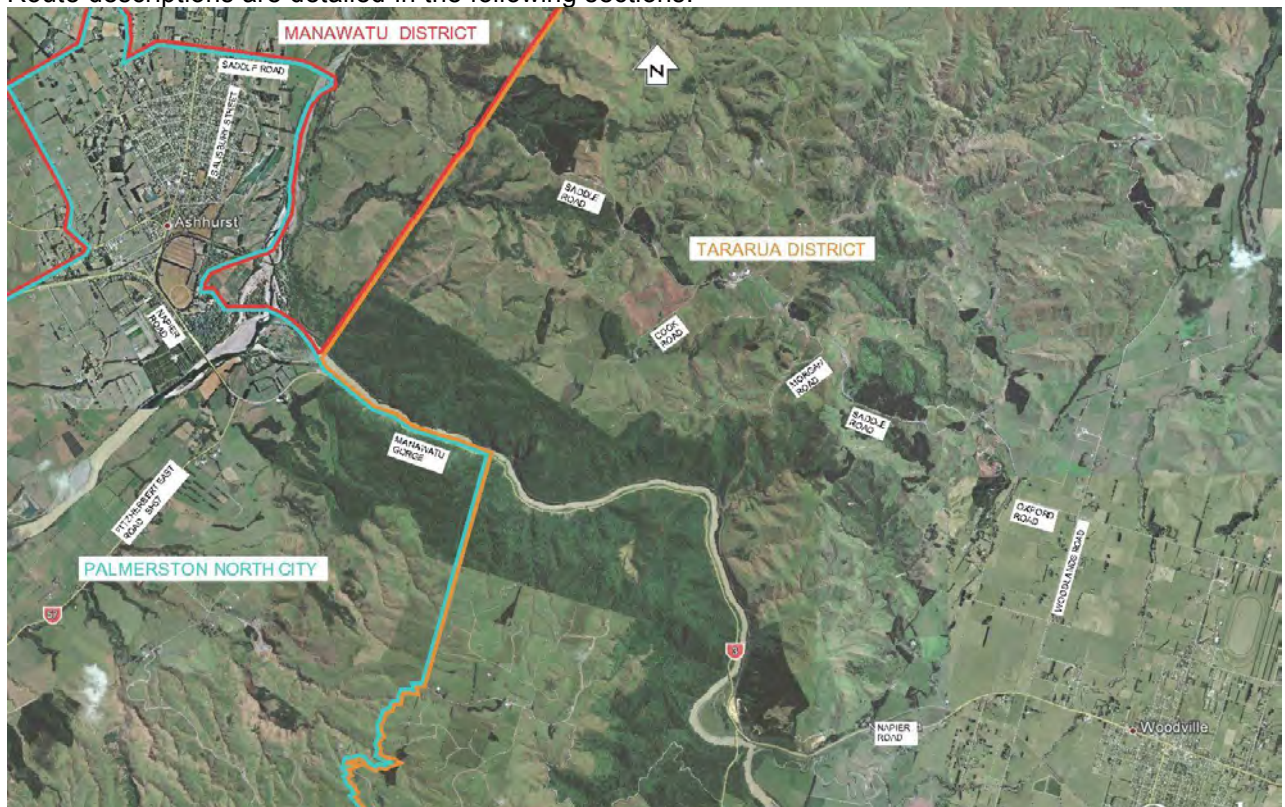
**Figure 1-1 : Territorial Authority Boundaries.**

(For a larger scale see Appendix A, Sheet D019)

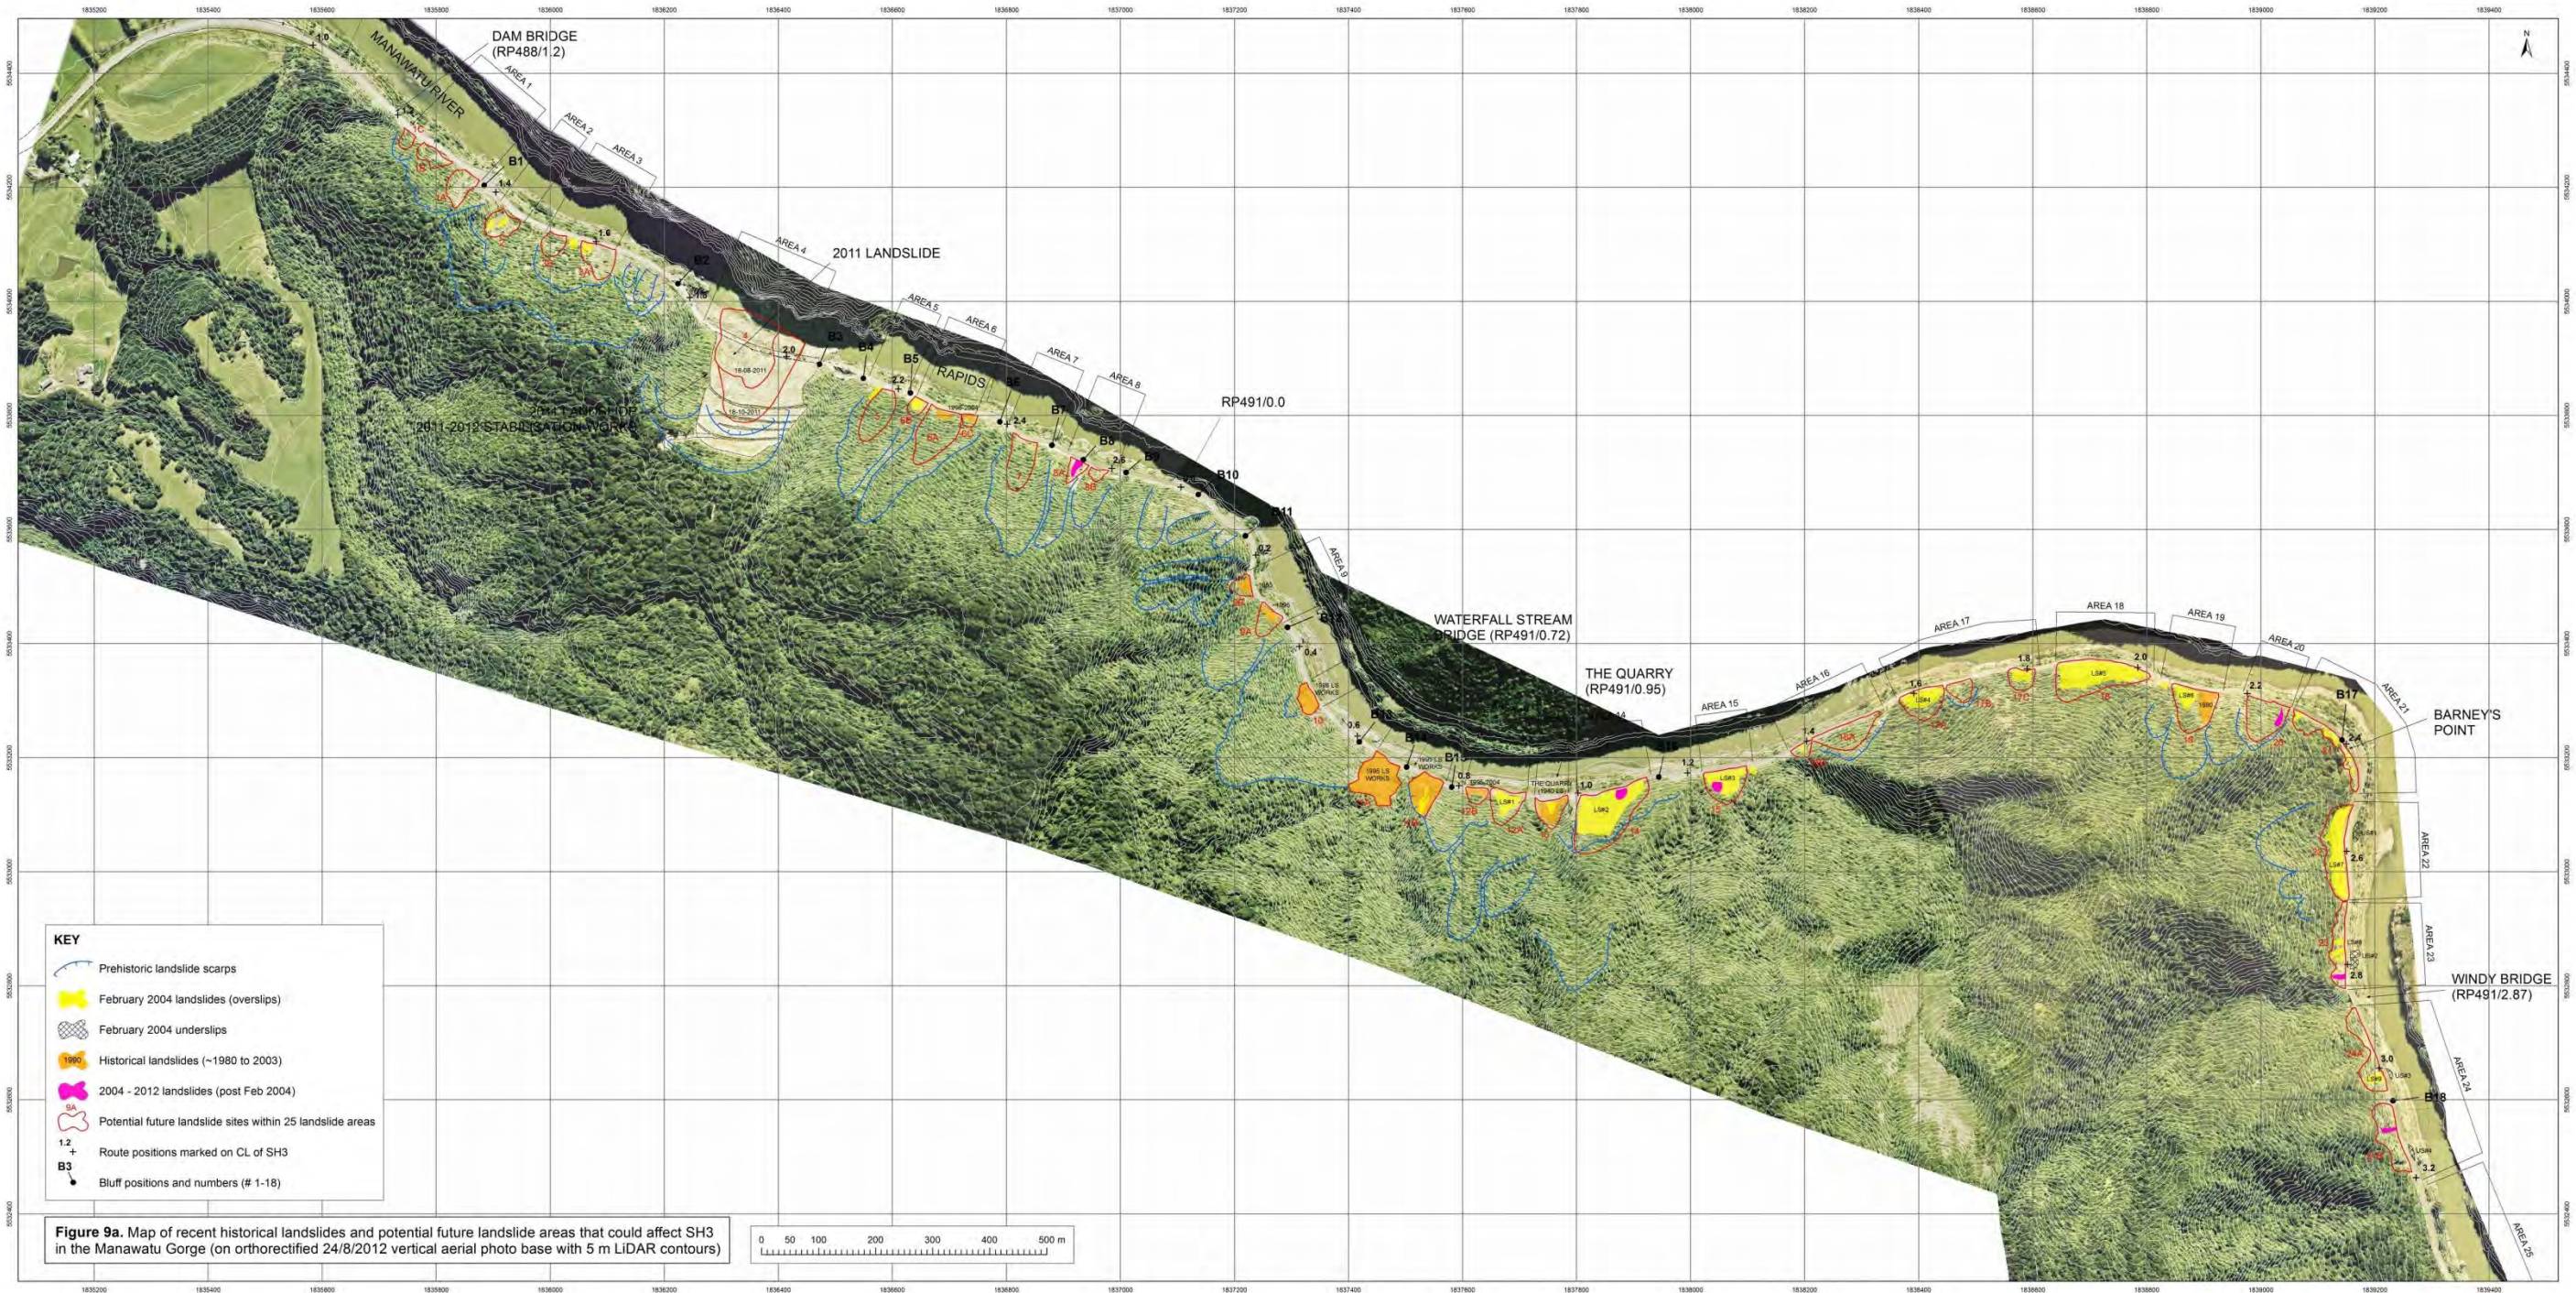
**Figure 9a.** Map of recent historical landslides and potential future landslide areas that could affect SH3 in the Manawatu Gorge (plotted on base of vertical aerial photos taken on 24 August 2012, with 5 m LiDAR contours).

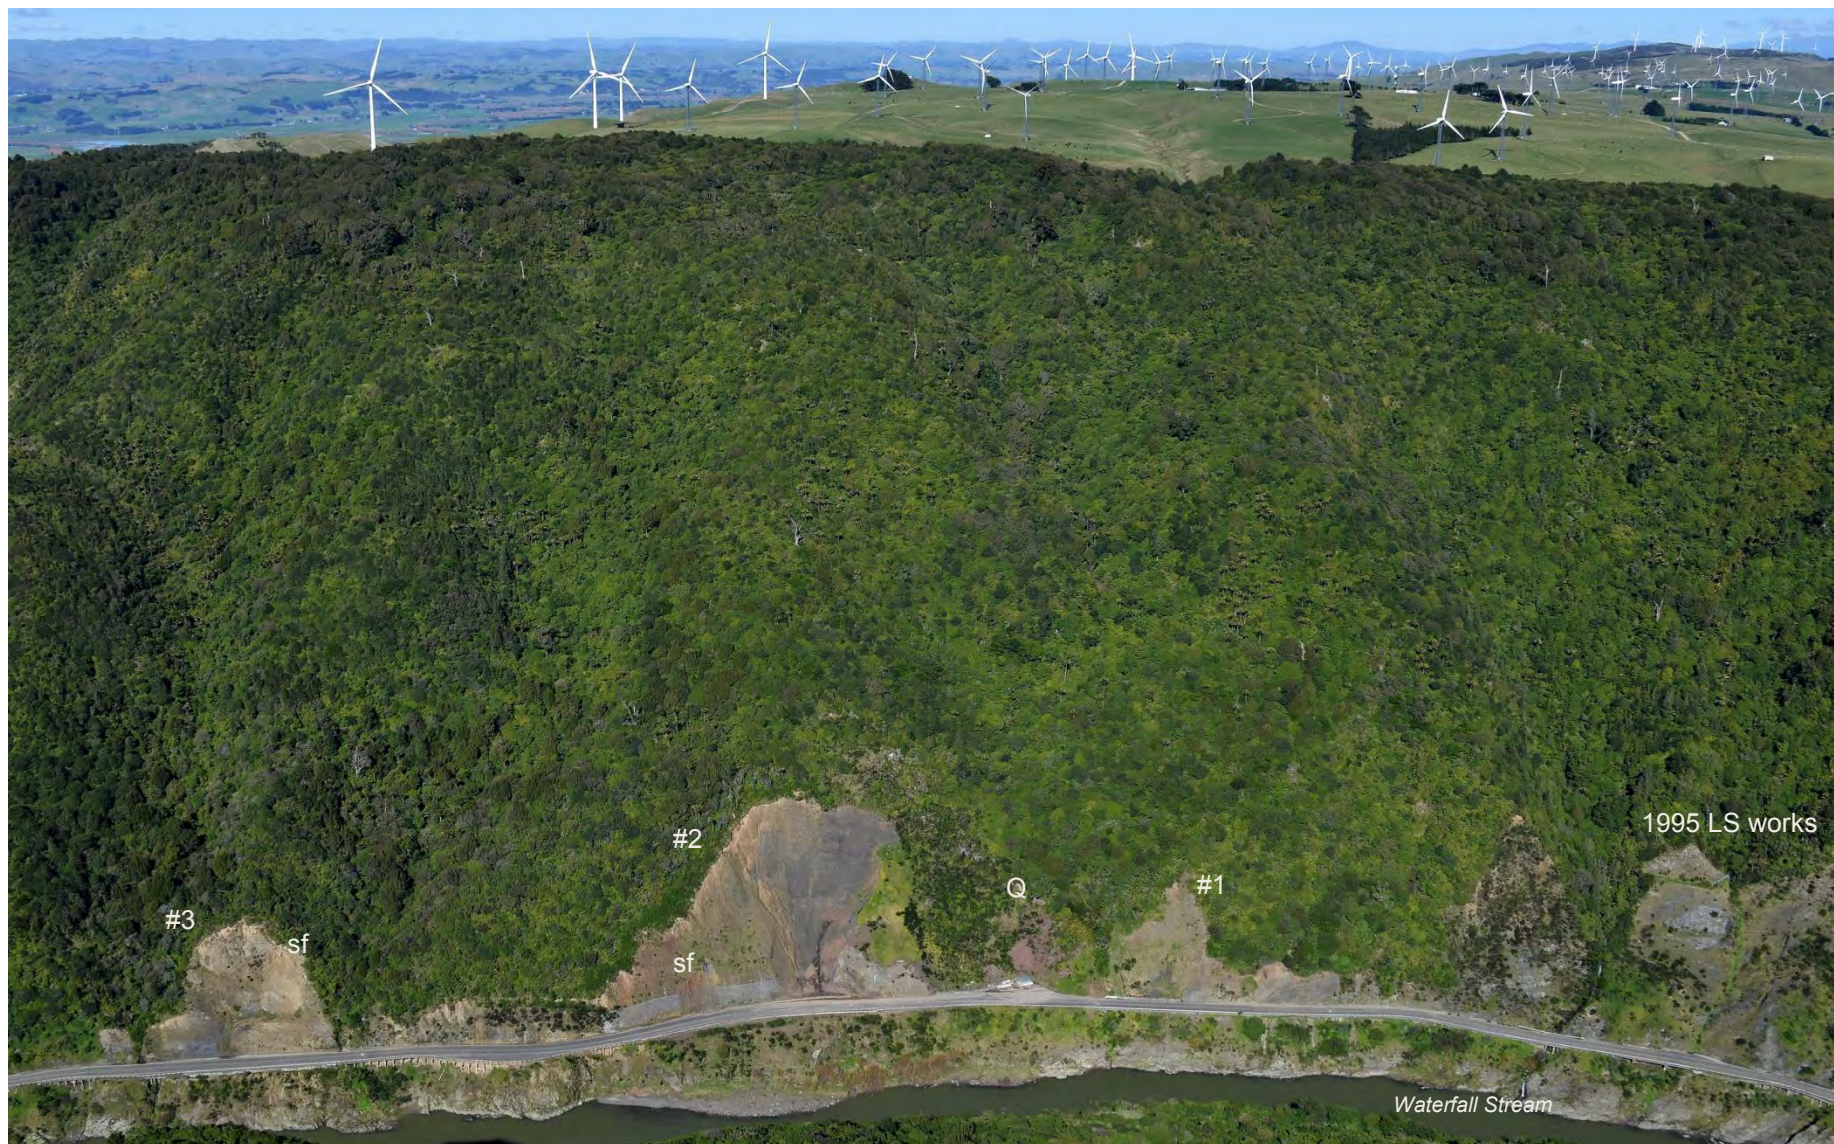
**Figure 10.** Oblique aerial photo of the central section of the Manawatu Gorge from ~RP491/0.60–1.30 showing the area of the 1995 landslide works, the „Quarry“ where small landslides occurred in 1940 and the 1960s, and three of the largest landslides (#1, #2, and #3) which occurred during the February 2004 rainstorm. The largest failure (#2) closed SH3 for over two months. Small failures (*sf*) have occurred on the scars of landslides #2 and #3 in the last 12 months.

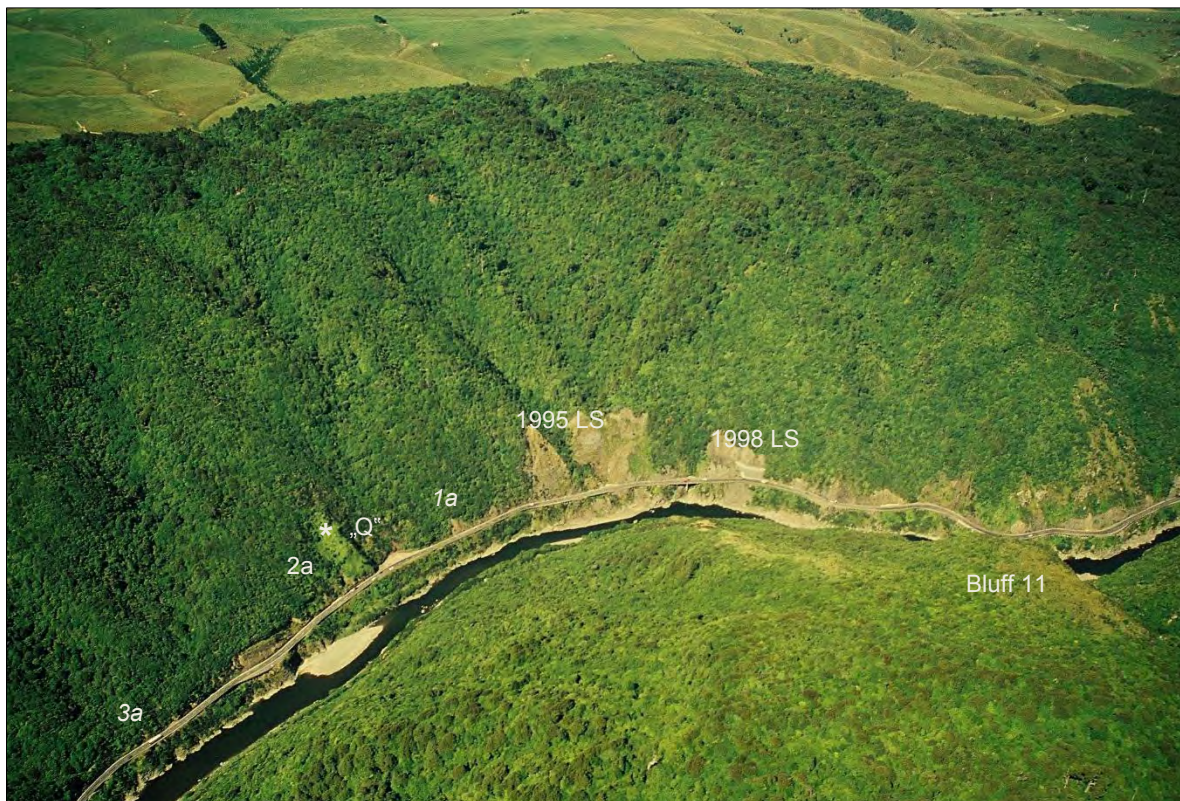
**Figure 11.** January 2000 photo of the 1995-1998 landslide works and „Quarry” in the Manawatu Gorge showing the areas (1a, 2a, 3a) where landslides #1, #2, and #3 occurred in February 2004. A shallow debris slide occurred at the landslide #2 site during the 1960s (note the young vegetation\*).

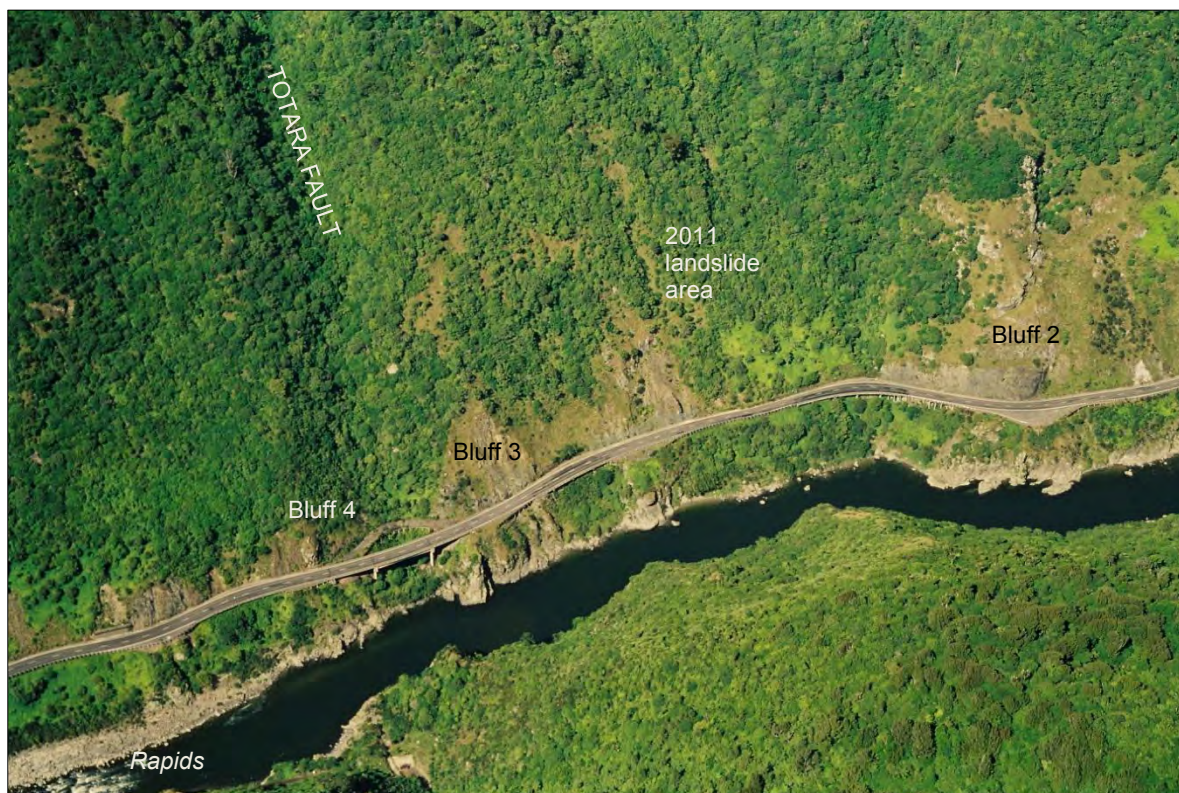
**Figure 12.** January 2000 photo of the 2011 landslide area, which developed on a slope underlain by thick colluvium deposits between bluffs of strong sandstone (B2, B3) in the Manawatu Gorge. The lower part of 2011 landslide area is sparsely vegetated because of shallow failures 1930-1940 and 1968-69 (compare with Figures 8 and 23).

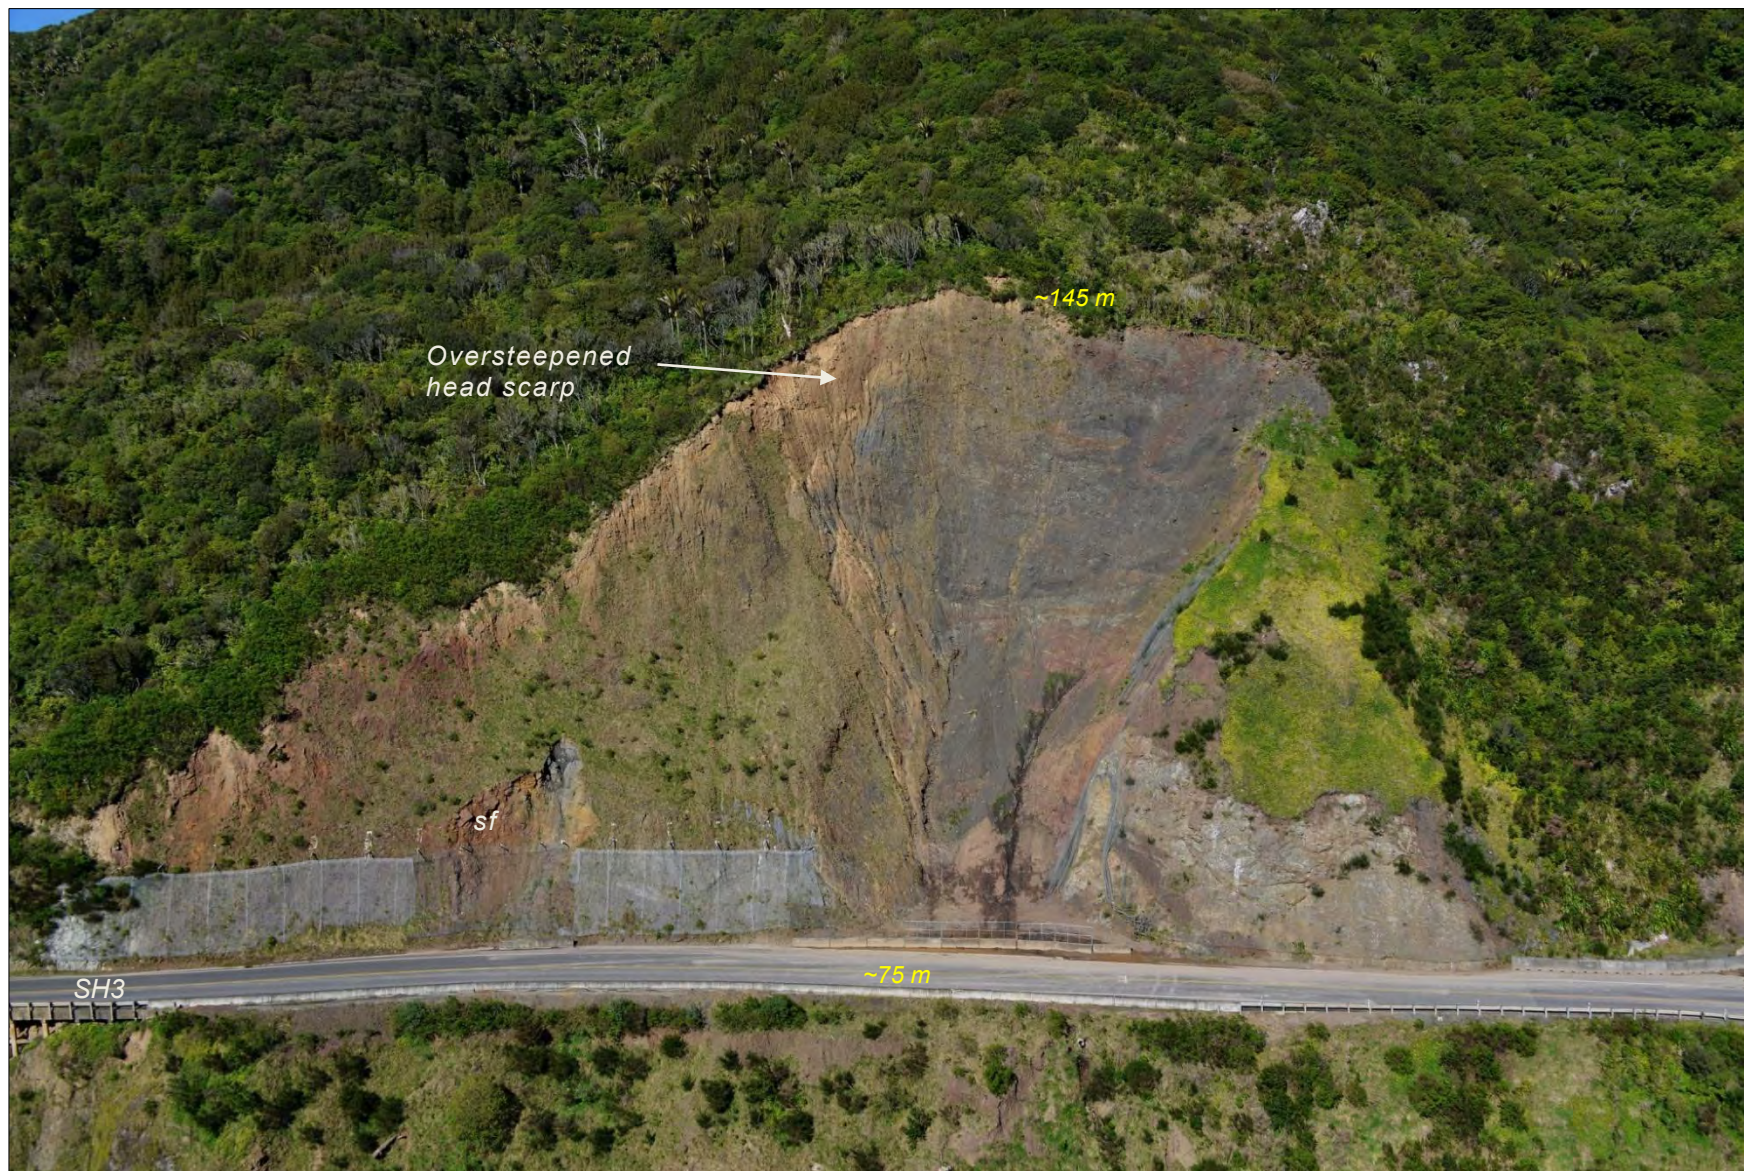
**Figure 17.** Closer view of the 2004 landslide #2, the largest potential landslide site (Area 14). A small failure (*sf*) on the lower slip face in July/August 2012 removed part of the rock fall mesh. Bedrock at this site is weak, closely jointed, weathered red argillite overlain by thick colluvial deposits. The steep ( $45\text{--}60^\circ$ ) head scarp now extends  $\sim 70$  m above SH3 and is likely to retreat further upslope in the future. Open tension cracks are present  $\sim 20$  m above the head scarp.

The 2004 landslide, overslip 2 in Area 14, is currently believed to present the greatest potential landslide risk to SH3 in the Manawatu Gorge. A large failure similar to the 2011 landslide could occur especially during heavy rainfall or strong earthquake shaking.

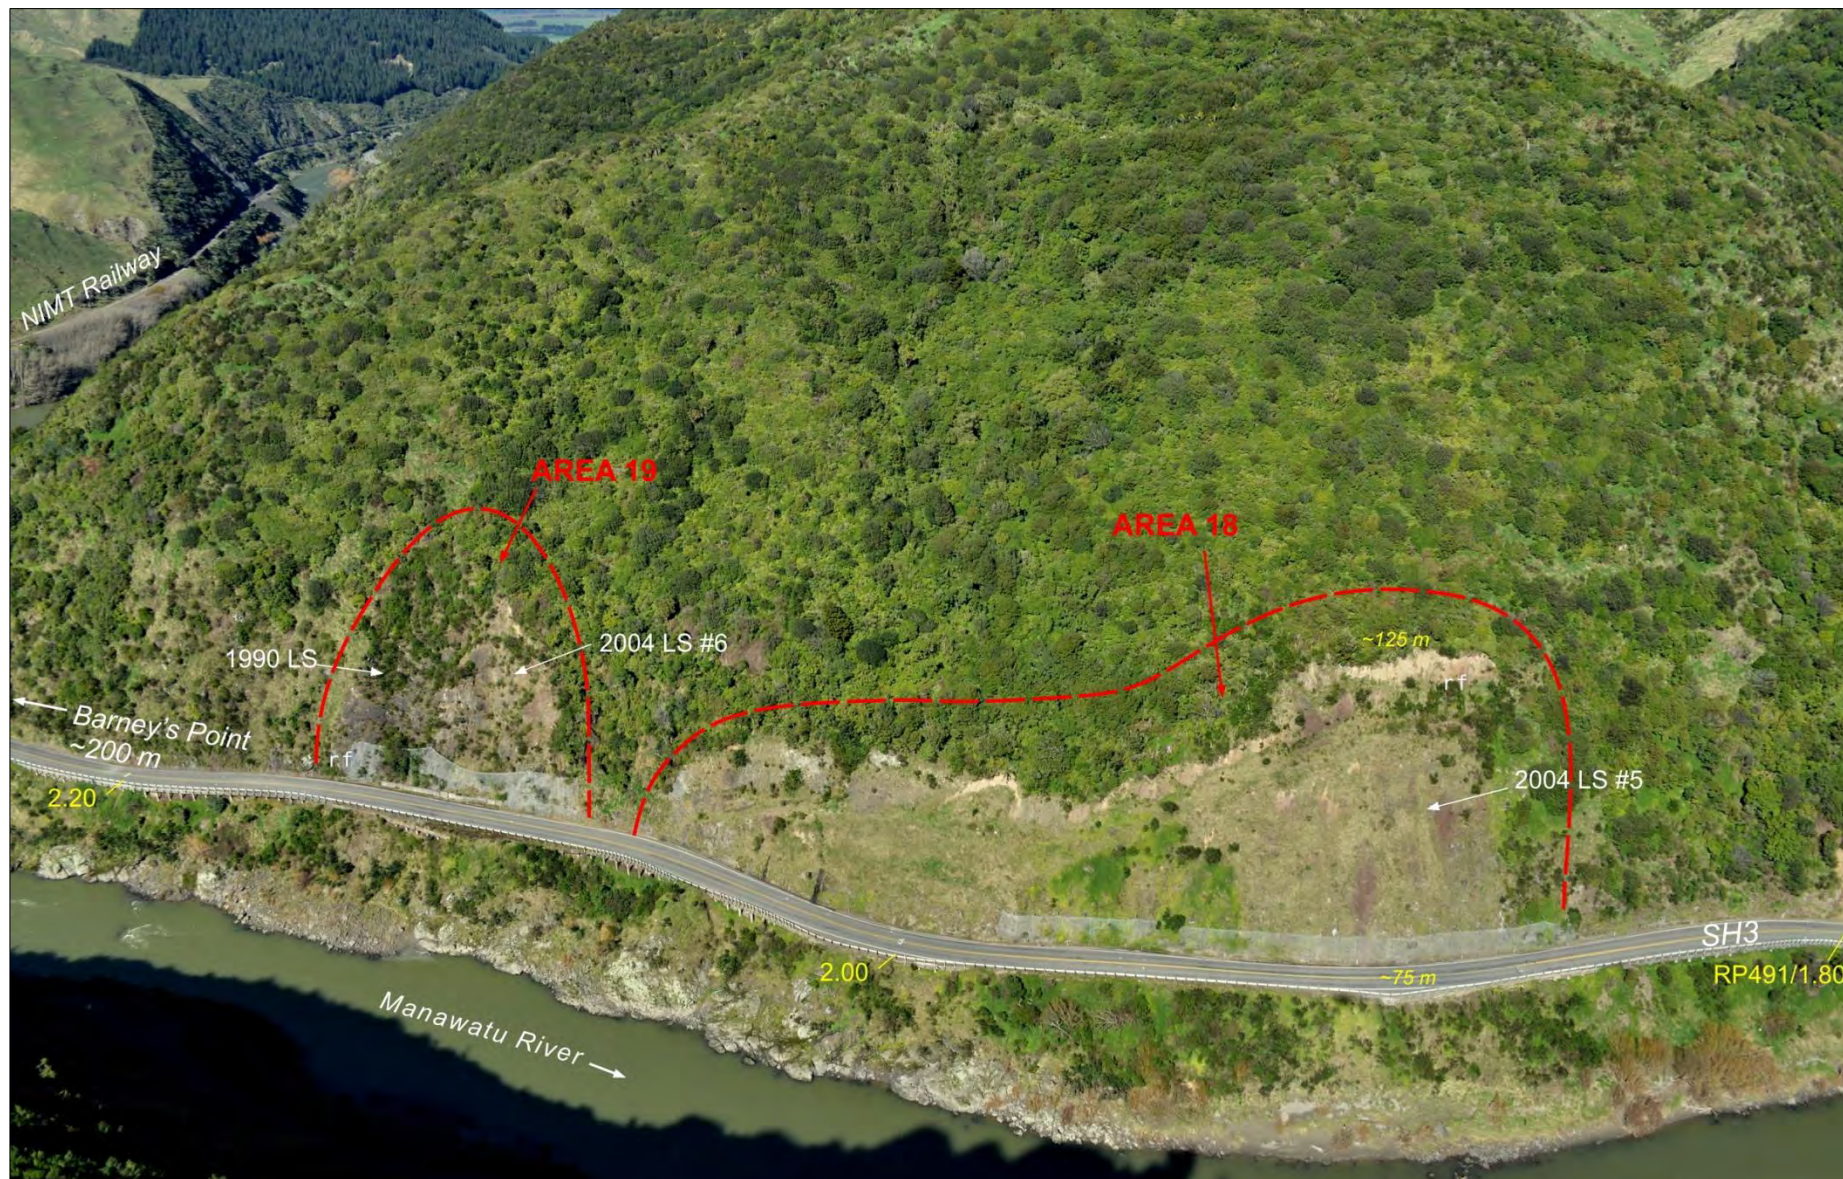
**Figure 18.** Aerial view of potential landslide Areas 18 and 19 and the sites of landslides which closed SH3 in 1990 and 2004 (#5 and #6) between RP491/1.80 and 491/2.20, about 200 m downstream of Barney's Point. The small recent failure (*rf*) on the head scarp of the 2004 landslide #5 suggests that Area 18 is perhaps more vulnerable to future failures than Area 19. The potential for failures at these sites is slightly less than those in the centre of the gorge.

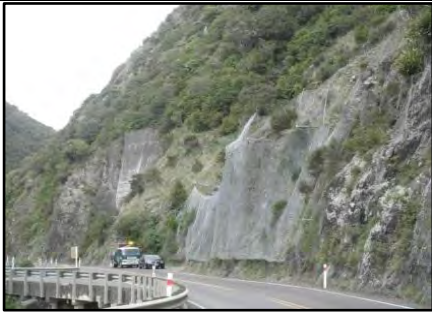
488/2.61	Large engineered, tied back anchored wall adjacent to Bluff 9.  Local rock fall potential from Bluff. May require further investigation for rock bolting and meshing (?)

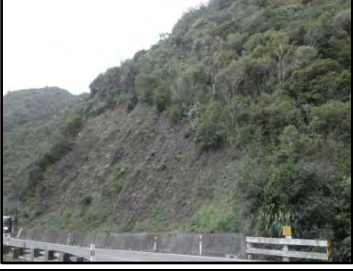
499/0.41	Sandstone at Bluff 12. Open moderate spaced jointed rock mass. Some sheared interbedded argillite bands. May require rock bolting. Local and EIL potential stability issues.	
499/0.50	1998 Gabion wall stabilisation works (Area 10). Gabion wall requires detailed structure/geotechnical assessment. Appears on first inspection to be cracking from frontal heave. Scarp behind dates to ~1998.	
499/0.60	Bluff 13	
499/0.70	Waterfall Stream bridge and creek. Area of mass landsliding 1995. Meshing and rock fence (Area 11B) in poor condition. Some moderate potential above Waterfall Stream ~25 m above highway. Large g/wacke boulders under mesh. Small 2004 slip.

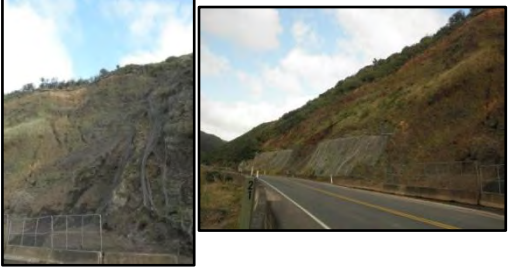
499/1.20	Area 15. Site of 2004 LS #3. Slip scarp continues to grow via joint-joint controlled rock fall in weathered dilated siltstone and sandstone. Bench only just wide enough for debris "catching". High potential for additional growth/regression. Highway requires better protection system.

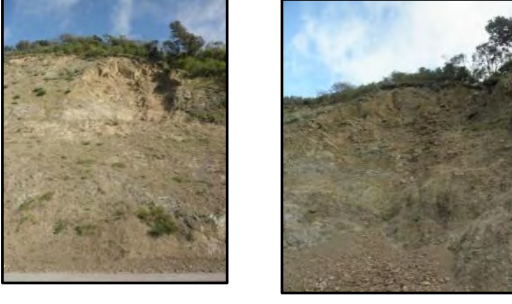
499/1.80	2004 Slip. Argillites. Toe "controlled" by concrete road barriers. Catch fence in poor state. Area of multiple failures. SDST bedding difficult to determine. Joint-joint controlled rock fall failure on sandstone bluff. Large pieces at risk of further failure from 10m above highway. High potential for further EIL growth/regression.

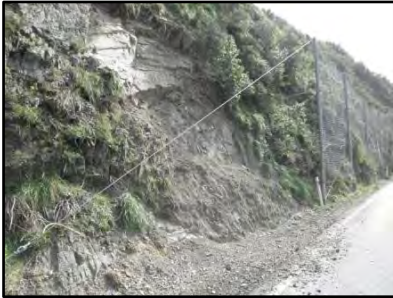
491/3.2-3.3	10m High former scarp, now grassed over, adjacent to debris deposit in cut bank. Debris deposits show some rounded cobbles and large coarse boulders in sandy coarse flow deposit.
