# **Te Ahu a Turanga; Manawatū Tararua Highway** Notices of Requirement for Designations Volume Three: Technical assessments

## 4. LANDSCAPE, NATURAL CHARACTER & VISUAL

**TE AHU A TURANGA; MANAWATŪ TARARUA HIGHWAY PROJECT**  
**TECHNICAL ASSESSMENT #4**  
**LANDSCAPE, NATURAL CHARACTER AND VISUAL EFFECTS**

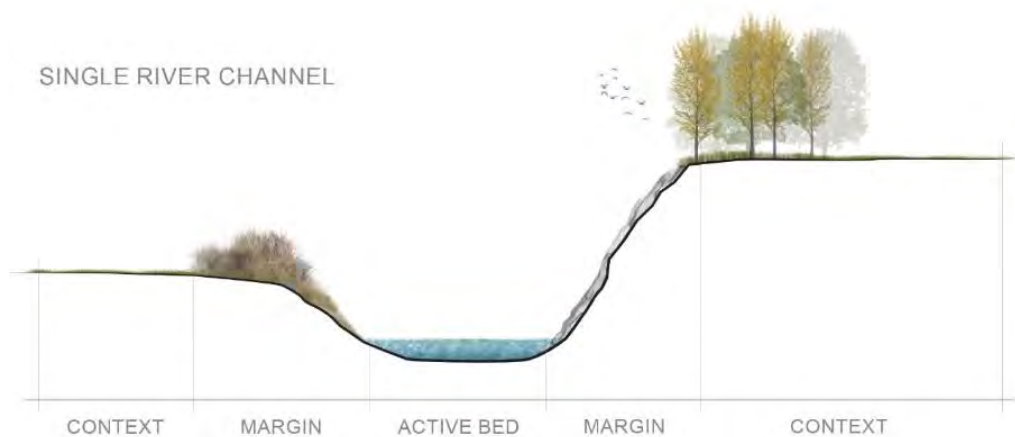
## *Active Bed*

For single stream incised rivers, the active bed comprises the actual river channel. For wider riverbeds and those with a braided character, the active river bed includes wetted areas/channels and may include dry margins, islands, banks, abandoned channels and bars of a braid plain that form part of the river's natural migration across the riverbed, as well as flood channels and side channels.

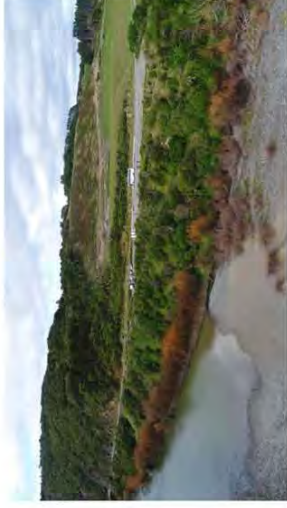
Carpark and location of the proposed south bridge abutment. The new bridge would link in to the terrace above the carpark.

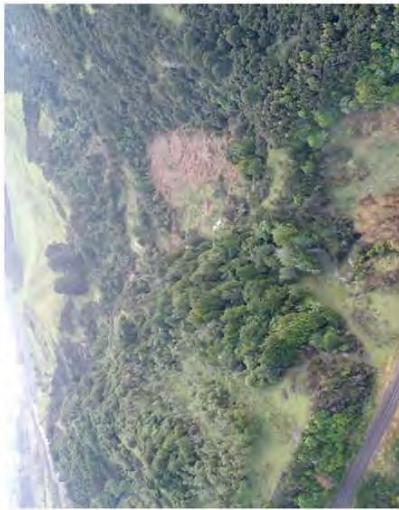
New bridge location on north bank, old growth forest, raupo swamp, and kamuka forest.

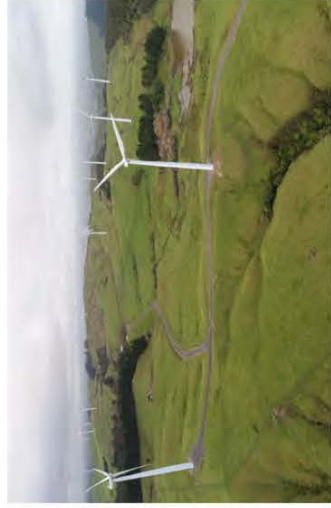
The wind farm infrastructure has altered the rural character of this area through the introduction of turbines and access roads.

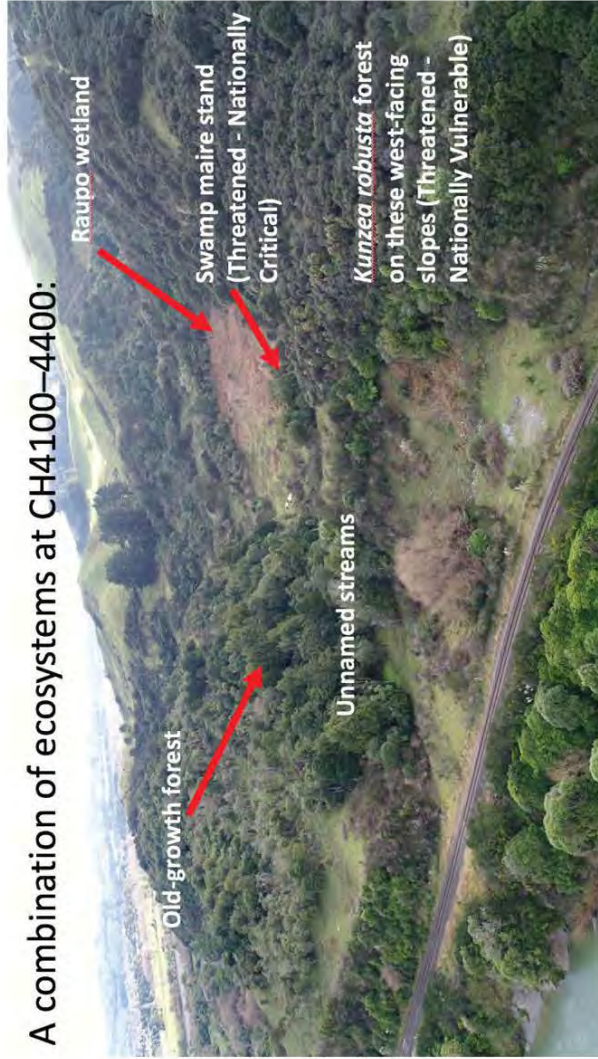
A combination of ecosystems at CH4100-4400:

QEII west Stream lower catchment - Old growth forest, stream and Raupo wetland
