applications for resource consents in relation to Te Ahu a Turanga; Manawatū Tararua Highway IN THE MATTER OF

BY **NEW ZEALAND TRANSPORT AGENCY**

TE AHU A TURANGA: TECHNICAL ASSESSMENT I

NATURAL CHARACTER

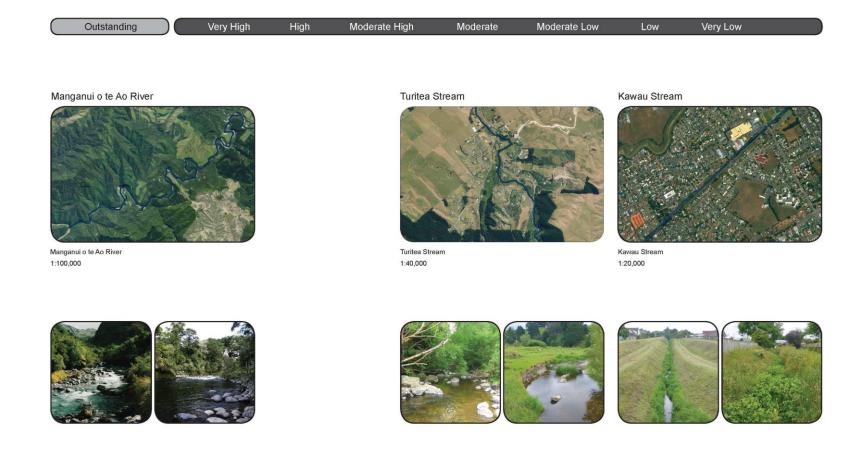
Figure I.3: Calibration Diagram

Natural Character

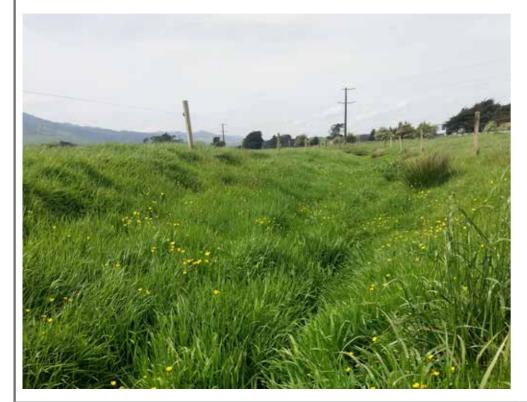
Stream 1A Looking upstream

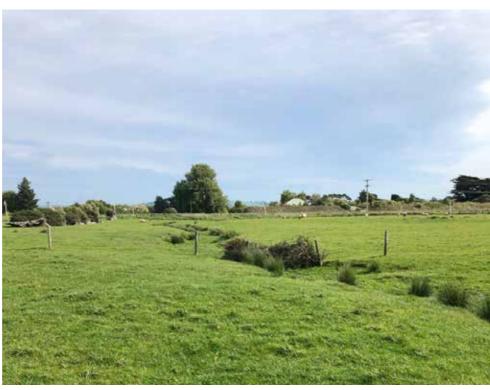
Stream 1B Looking downstream

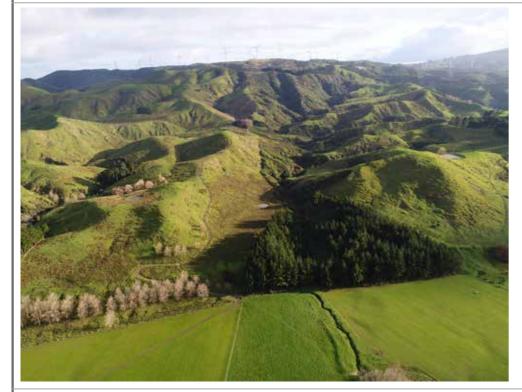
Catchment 2, veiw west, Mangamanaia Stream

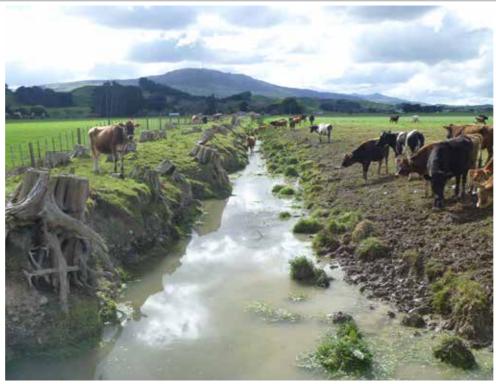
Stream 2B Looking upstream

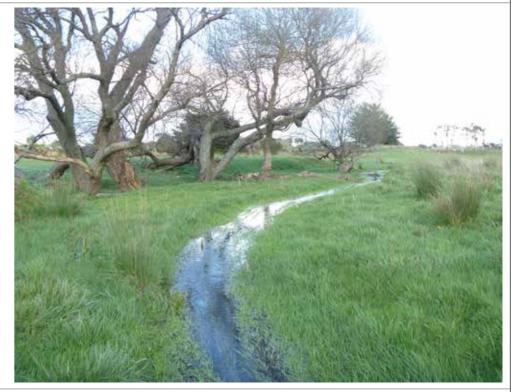
Stream 2C Looking upstream

- 170. The area where the Project crosses stream 2C has been assessed as a crossing point given its high SEV rating and that there is secondary broadleaf forest and scrubland in the headwaters (Refer **Appendix I.4**). In this location, a section of stream in the steep hill country is located under the Alignment and will be replaced by a diversion.

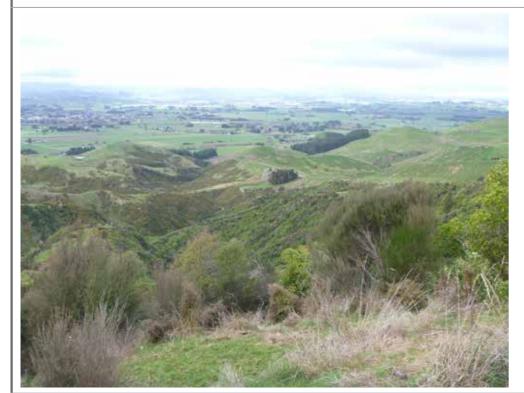
Catchment 2C Looking South-East (downstream) from top of catchment

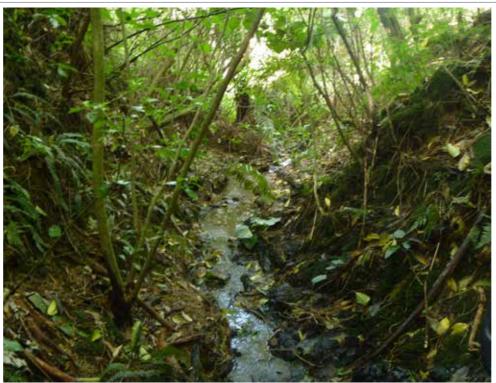
Stream 2C Mid-reach

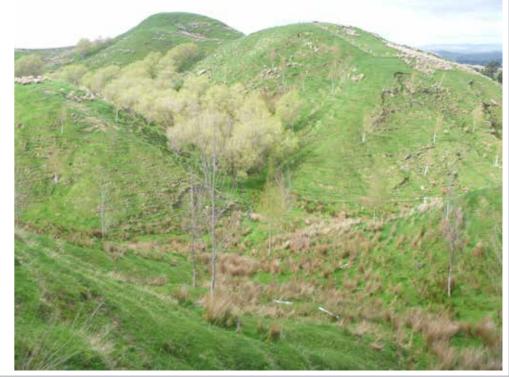
Catchment 2E Looking West to East across catchment with Eastern Tributary (Stream E2, lined with willows) in background

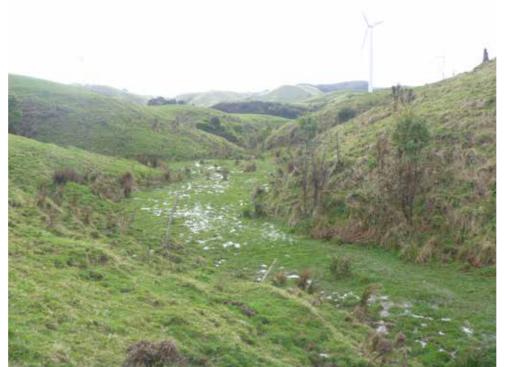
Catchment 4D Mid-catchment looking downstream

- 185. Crossing point 4D at the upper end of the catchment constitutes a small proportion of the stream length in the overall catchment, most of which will remain unchanged. However, the proposed spoil site will occupy much of stream 4D with the loss of the stream to be replaced by a diversion channel on the fill resulting in a reduction of naturalness for all but the water quality attribute. In addition, stream length will be lost under the footprint of the road and replaced by culverts and diversions. While the diversions will be able to provide limited in-stream habitat, the physical form of the natural stream will be replaced with a more engineered form. This crossing point will decrease from moderate low to low, which is the same as the overall rating for the catchment.

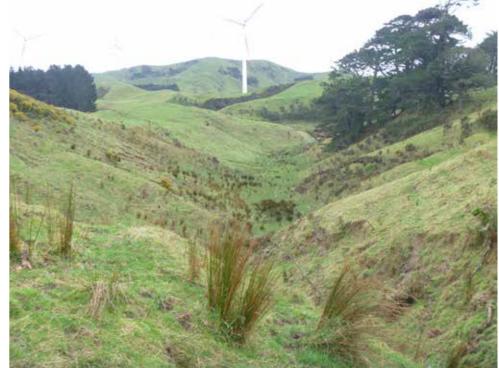
Catchment 4F Looking downstream from top of catchment

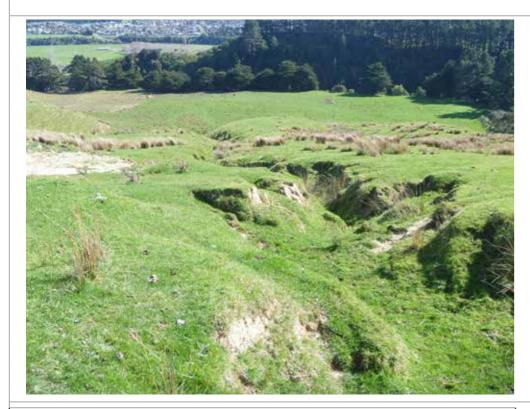
Gullies at the top of the catchment looking down toward the stream
