## Beaumont Bridge Replacement: Assessment of Ecological Effects

# Beaumont Bridge Replacement: Assessment of Ecological Effects

Prepared for: WSP Opus

By:                   Ryder Environmental Limited  
                          Urtica Ecology

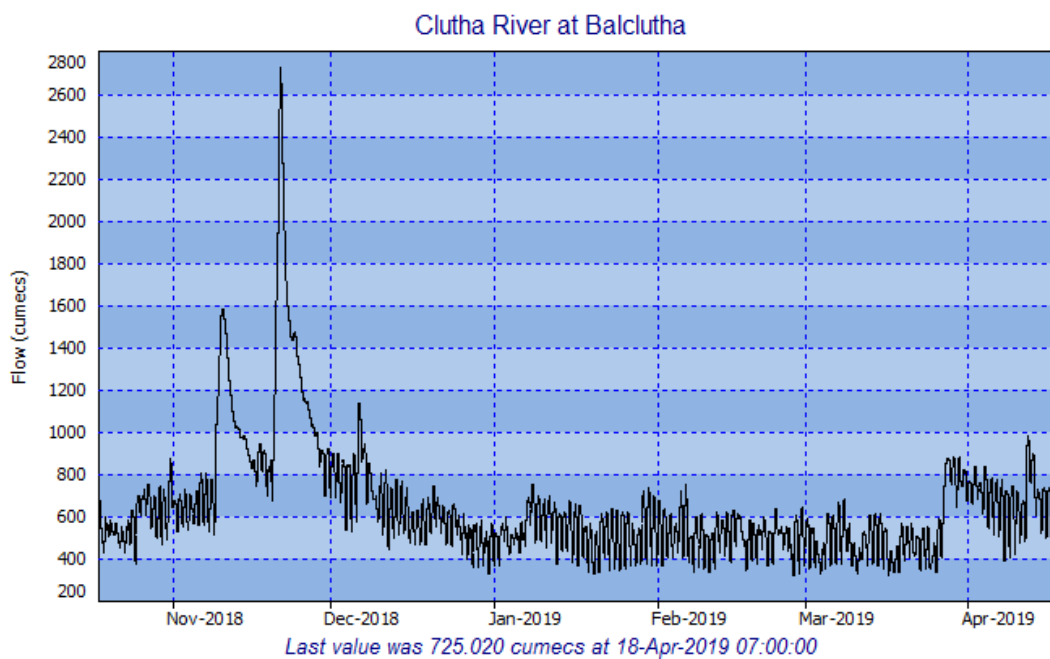
Figure 2 Hydrograph from the lower Clutha River at Balclutha hydrological site showing flood events and frequent daily flow fluctuations over the November 2018 to April 2019 period resulting from hydroelectric power generation at Roxburgh Power Station. Figure from the ORC website<sup>1</sup>.

The Clutha River/Mata-Au is New Zealand’s largest river by flow, with a mean flow of 614 m<sup>3</sup>/s and a 7-day mean annual low flow of 309 m<sup>3</sup>/s (Duncan & Woods 2013). The lower Clutha/Mata-Au is subject to significant flow fluctuations as a result of flood events and hydro-electric power generation at Roxburgh Power Station (e.g., Figure 2).

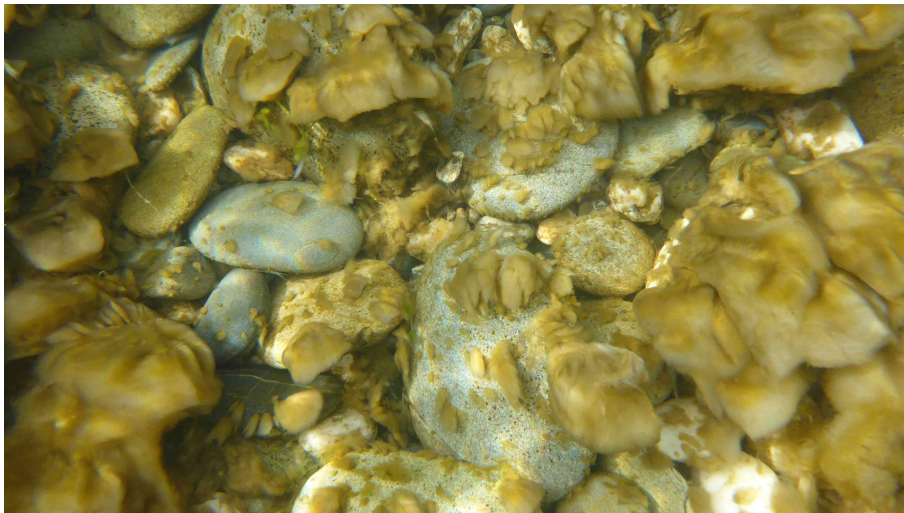
Figure 4 Photograph of the bed substrate and representative algae cover at the Beaumont sampling site in April 2014 by Ludgate & Ryder (2014).

There is limited information on the periphyton community of the lower Clutha River/Mata-Au given its very large size and the practical and safety challenges this creates for assessing its periphyton communities. Ludgate & Ryder (2014) undertook surveys in 10 riffle/beach sites in the lower Clutha/Mata-Au, when flows were lowered by Contact Energy to facilitate the surveys. They recorded that the invasive stalked diatom *Didymosphenia geminata* (didymo) “covered large areas of the river bed at most sites, with only the Roxburgh, Rongahere Road and Manuka Island sites generally clean of didymo”. A photograph of Didymo at the Beaumont monitoring site is shown in Figure 4.

Underwater video footage collected by Underwater Solutions Ltd. in August 2018 showed that bedrock outcrops had cover of didymo and bryophytes (aquatic mosses), while gravels generally had little or sparse periphyton cover.

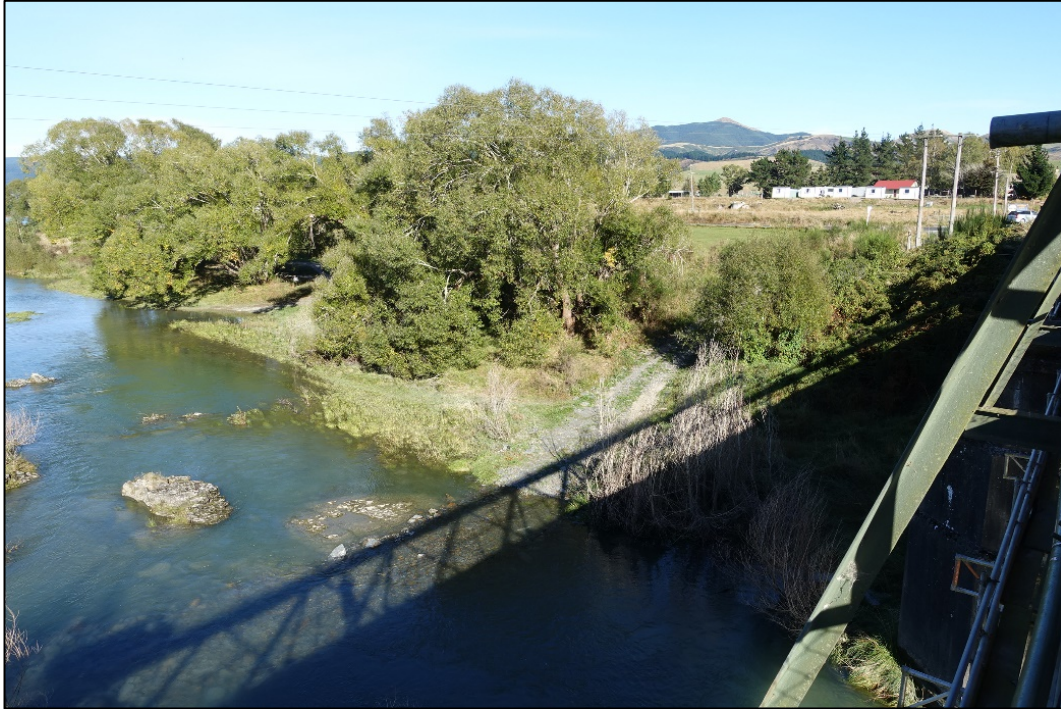
Figure 6 Riparian area (west of Clutha River/Mata-Au) showing an overview of the area south of Beaumont Bridge towards the existing boat ramp.

East of Rongahere Road, between the Beaumont Bridge and the boat ramp, vegetation was highly modified and consisted of a scrubland/grassland dominated by Scotch broom (*Cytisus scoparius\**), blackberry (*Rubus fruticosus\**), bracken (*Pteridium esculentum*), convolvulus (*Convolvulus arvensis\**), gorse (*Ulex europaeus\**), various rank grasses (exotic species) and some small crack willow (*Salix fragilis\**). A little further south, a tall (c. 14m) crack willow treeland occurs over a range of exotic grasses and herbs, primarily cocksfoot (*Dactylis glomerata\**) and tall fescue (*Schedonorus arundinaceus\**).

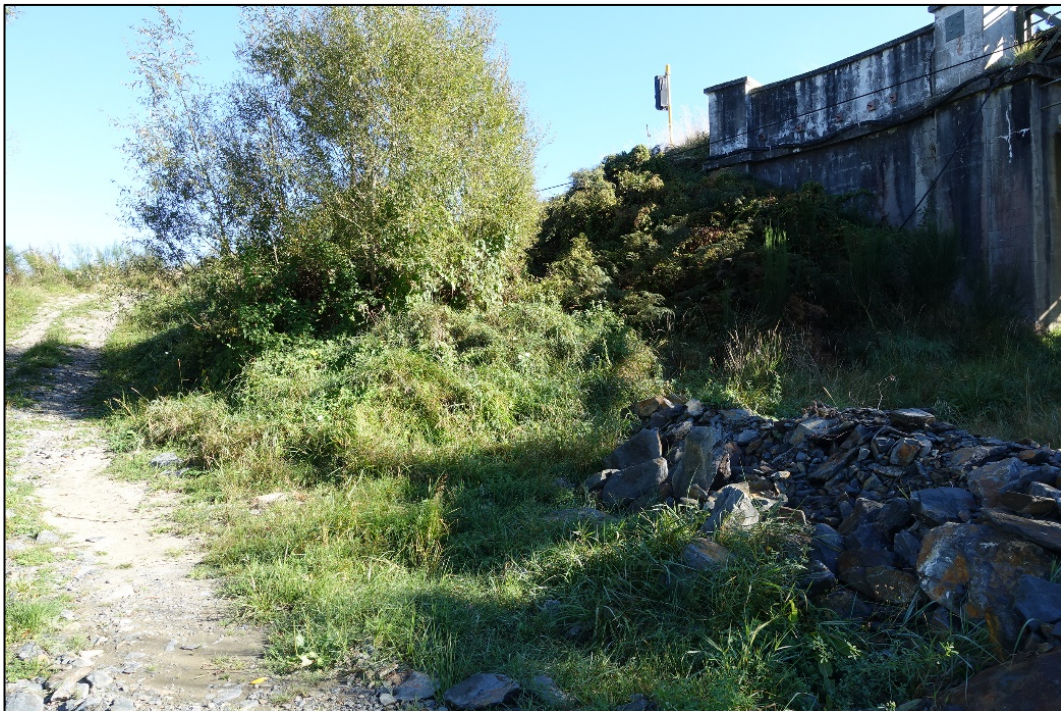
Figure 7 Riparian area (west of Clutha River/Mata-Au) showing a close-up view of vegetation immediately south of the existing Beaumont Bridge.

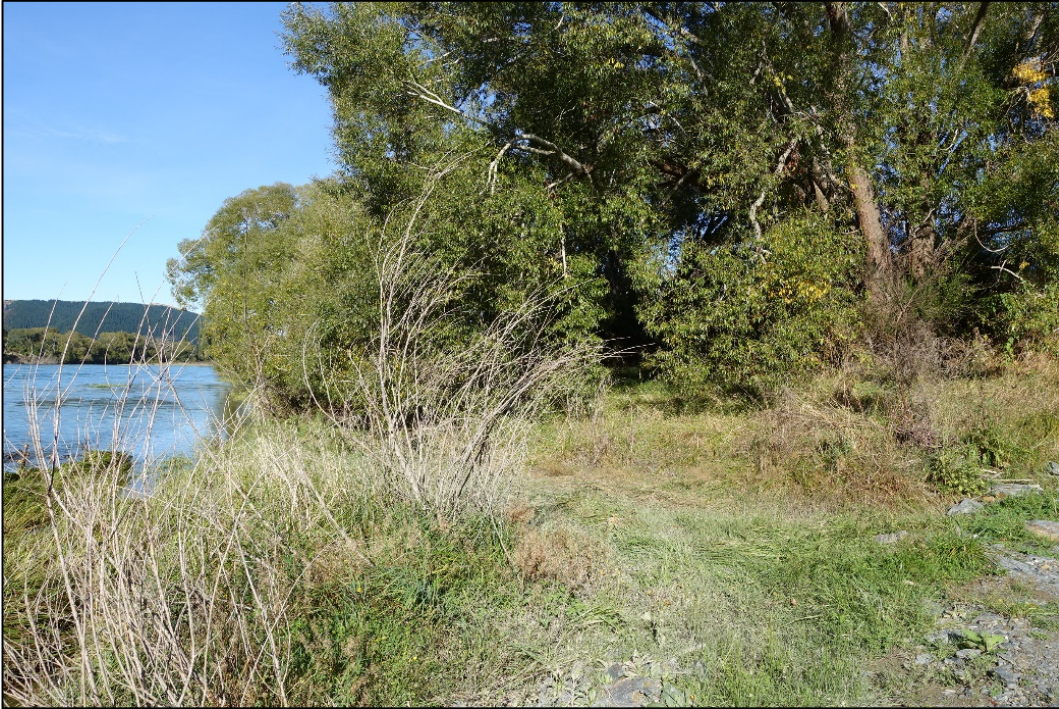
*Figure 8 Riparian area (west of Clutha River) c. 20m below existing Beaumont Bridge. Taller crack willow and rank grass dominated the vegetation at this location.*

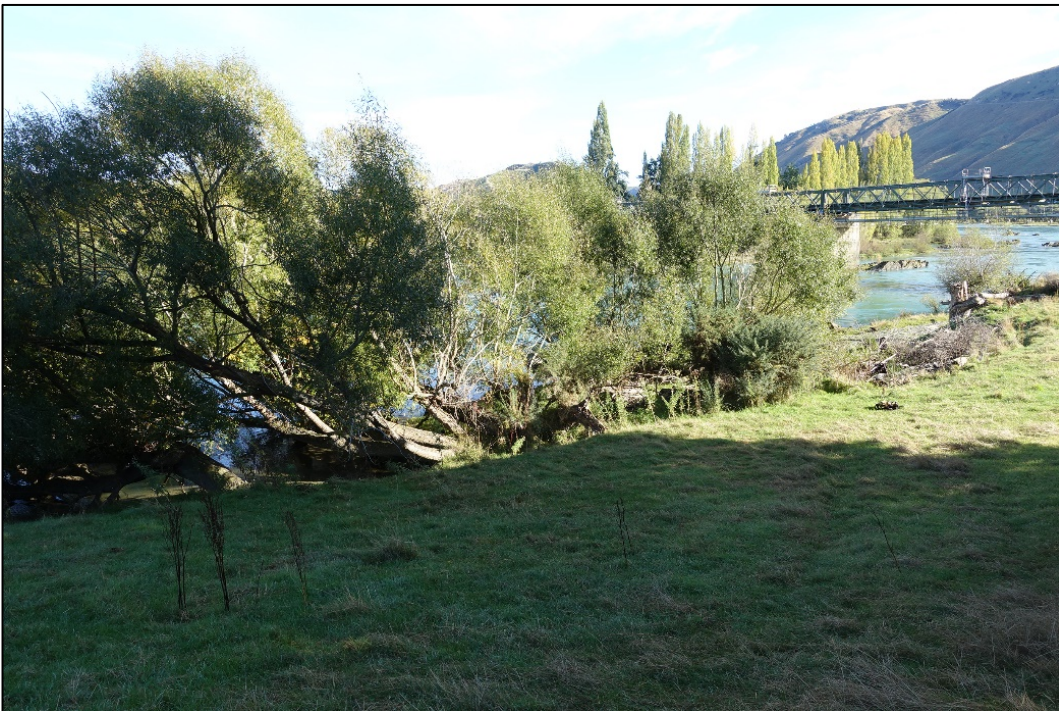
*Figure 9 Riparian area (east of Clutha River/Mata-Au) showing crack willow dominant with pasture grassland..*

Crack willow (c. 8m tall) dominated the riparian zone east of the river. Pasture grasses, with scattered exotic weeds such as Californian thistle (*Cirsium arvensis\**), foxglove (*Digitalis purpurea\**) and blackberry dominated the understory ground cover. A few small clumps of gorse and Scotch broom provided some protection for indigenous plants from grazing stock, allowing a few small native species to persist including pohuehue (*Muehlenbeckia australis*), pennyworts (*Hydrocotyle* spp.), bitter cress (*Cardamine debilis*), shield fern (*Polystichum vestitum*) and little hard fern (*Blechnum penna-marina*). Scattered rushes (*Juncus* spp.) within exotic pasture-grasses, occupied wet low-lying areas nearest to the river..

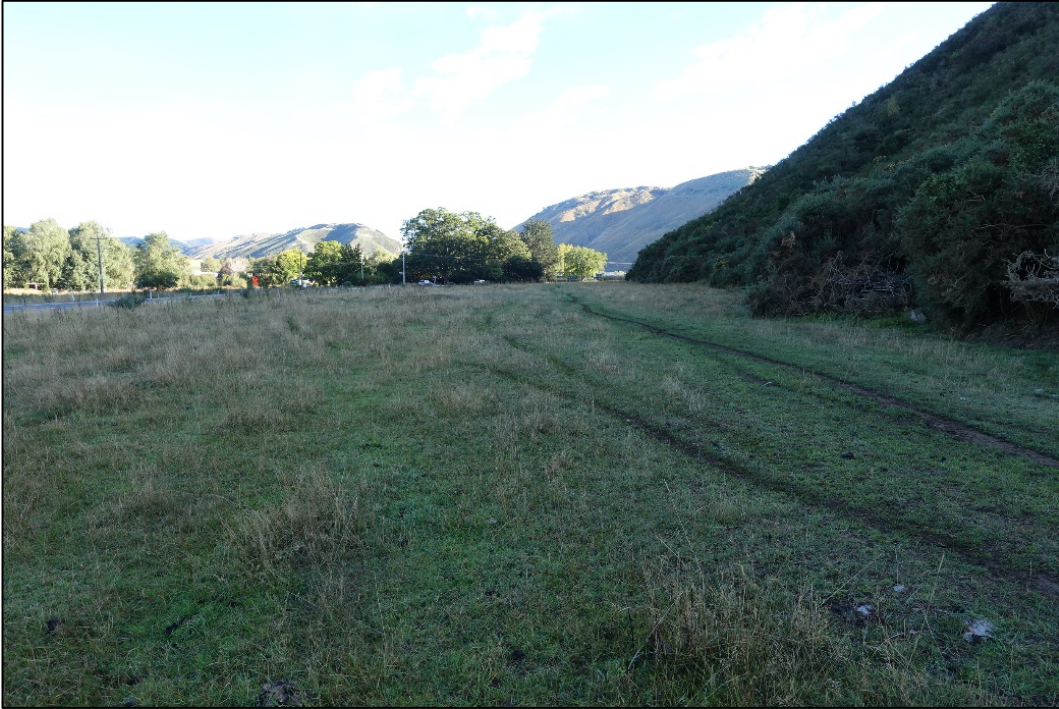
*Figure 10 Pasture Grassland (east of Clutha River/Mata-Au). View looking north-west towards Beaumont Bridge. The adjacent hill-slope primarily supported Scotch broom, gorse and other scattered exotic trees.*

Developed pasture land occurred on the eastern side of the river, north of SH8, in a line

roughly between Stonewall Street and Weardale Street; and through the small square paddock south of the bridge and west of SH8. On the western side of the river, areas affected by the proposed realignment are primarily on the northern side of SH8; the vegetation over these areas was primarily introduced pasture grasses dominated by brown top (*Agrostis capillaris*\*), crested dogtail (*Cynosorus cristatus*\*), barley (*Hordeum vulgare*\*), perennial ryegrass (*Lolium perenne*\*) and *Phleum pratense*\*, with occasional mouse-ear chickweed (*Cerastium fontanum*\*), thistles (*Cirsium*\* spp.), woolly mullein (*Verbascum thapsis*\*) and other exotic herbs.

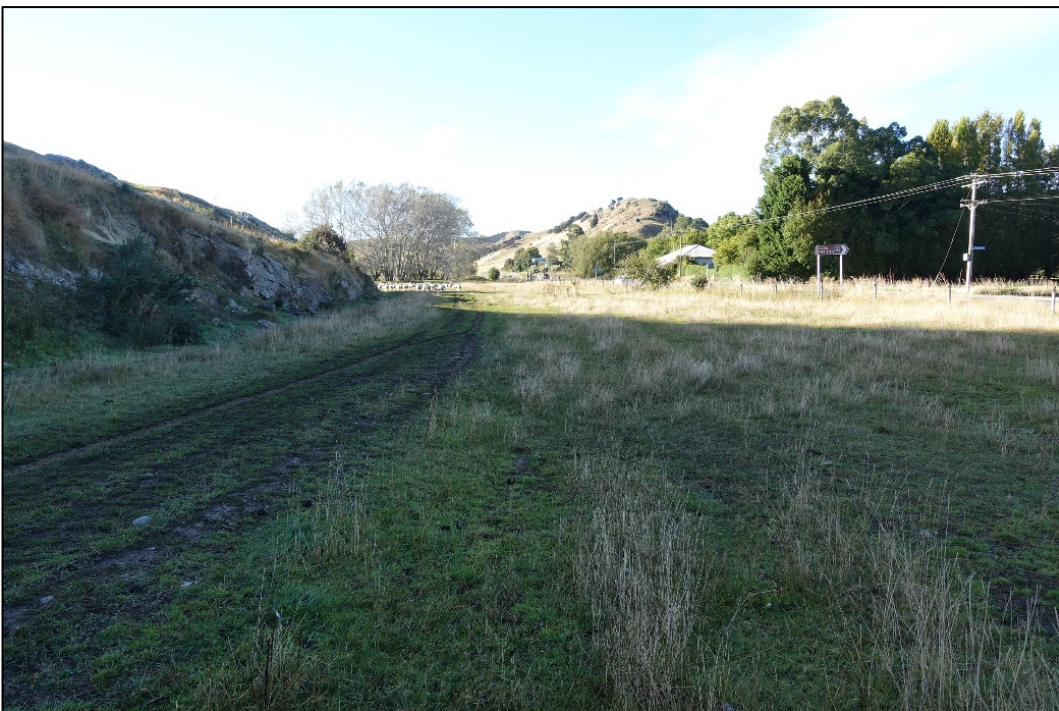
*Figure 11 Pasture Grassland (east of Clutha River/Mata-Au) looking south-east towards Low Burn..*

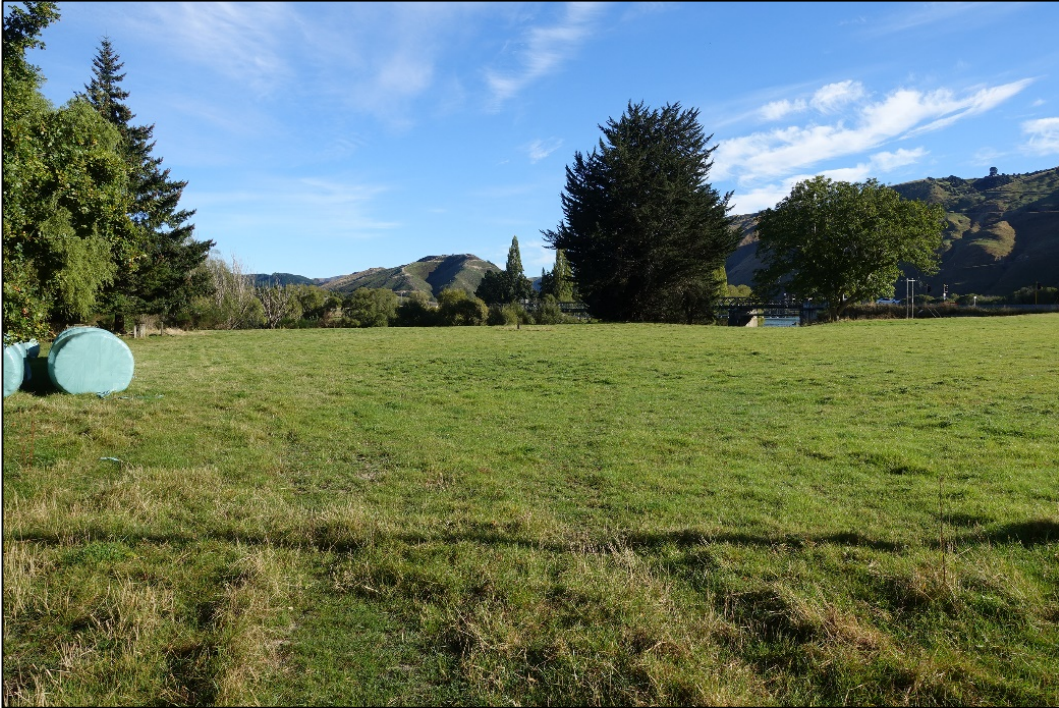
*Figure 12 Pasture Grassland (east of Clutha River/Mata-Au). View across a small paddock towards the Clutha River showing a large macrocarpa tree (centre) adjacent to a small totara (not visible), both of which will likely be removed for the realignment.*

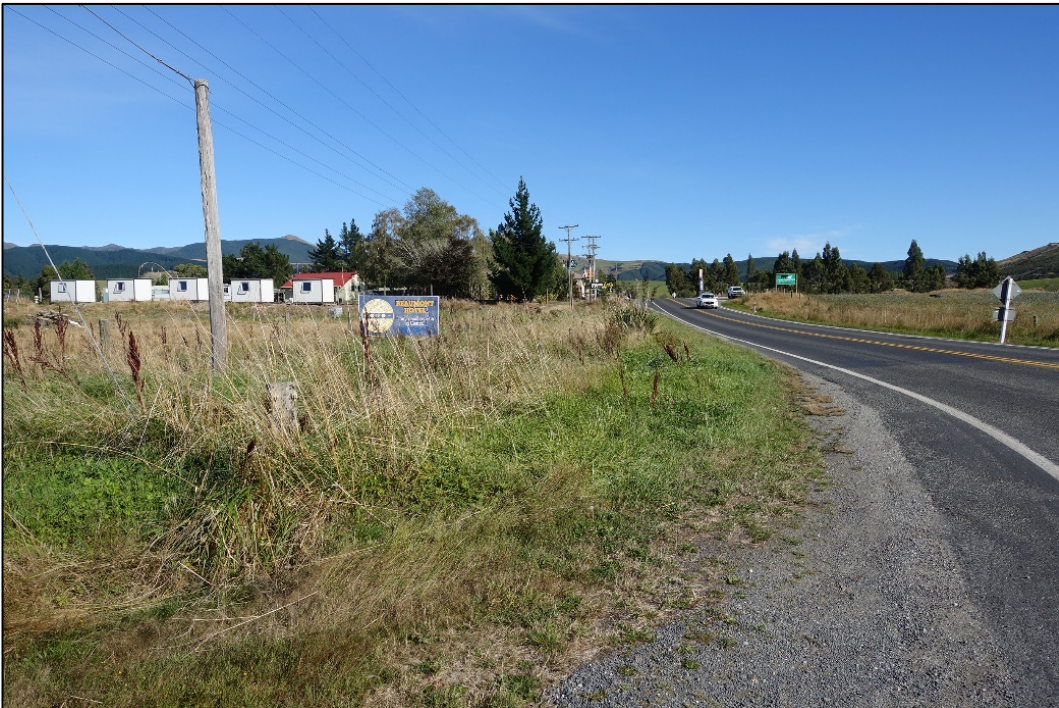
*Figure 13 Roadside vegetation (west of river). View west towards Beaumont Hotel.*

The largest areas of roadside vegetation within the footprint are along SH8 west of the river. The vegetation here was dominated by exotic grasses and herbs, including cocksfoot\*, tall fescue\*, brown top\*, and sweet vernal (*Anthoxanthus odoratum*\*). Herbs included clover (*Trifolium repens*\*), convolvulus\*, creeping buttercup (*Ranunculus repens*\*), yarrow (*Achillea millefolium*\*), birdsfoot trefoil (*Lotus pedunculatus*\*), plantains (*Plantago* spp.\*) and broad-leaved dock (*Rumex obtusifolius*\*). Occasional pampas (*Cortaderia* sp.\*), flax (*Phormium tenax*), crack willow saplings, broom, and khasia berry (*Cotoneaster simsonii*\*) were also found here.

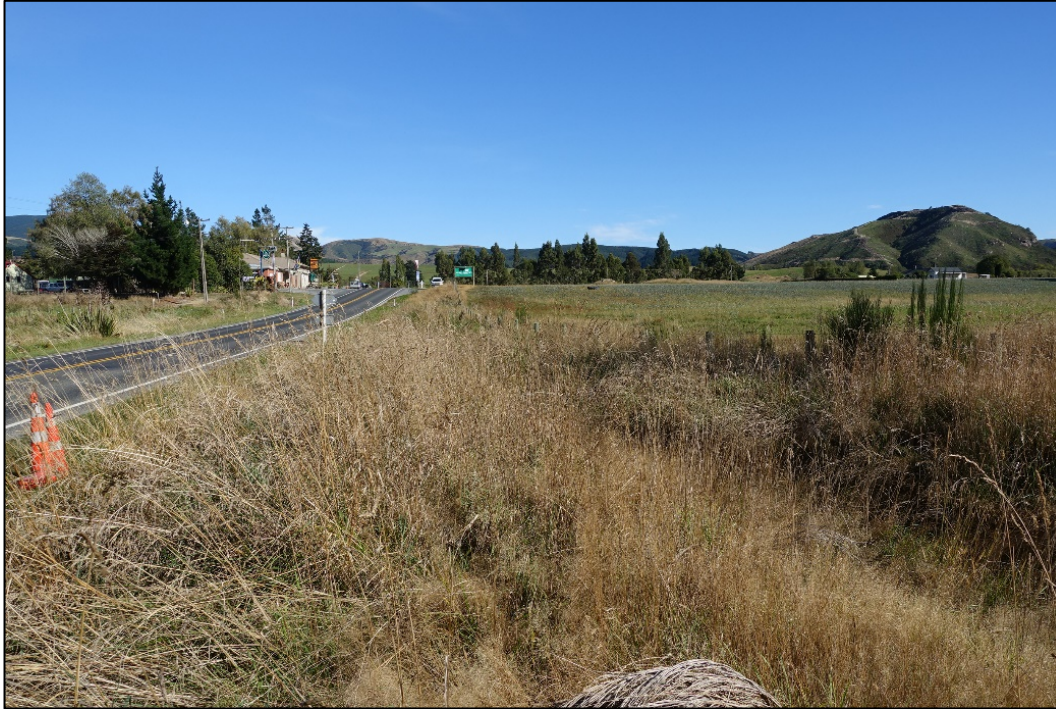
*Figure 14 Roadside and pasture grassland (west of Clutha River/Mata-Au). View west towards Beaumont Hotel.*
