# New Beaumont Bridge

Preliminary Site Investigation

Date: March 2019  
Reference: 6-CT012.00  
Status: FINAL

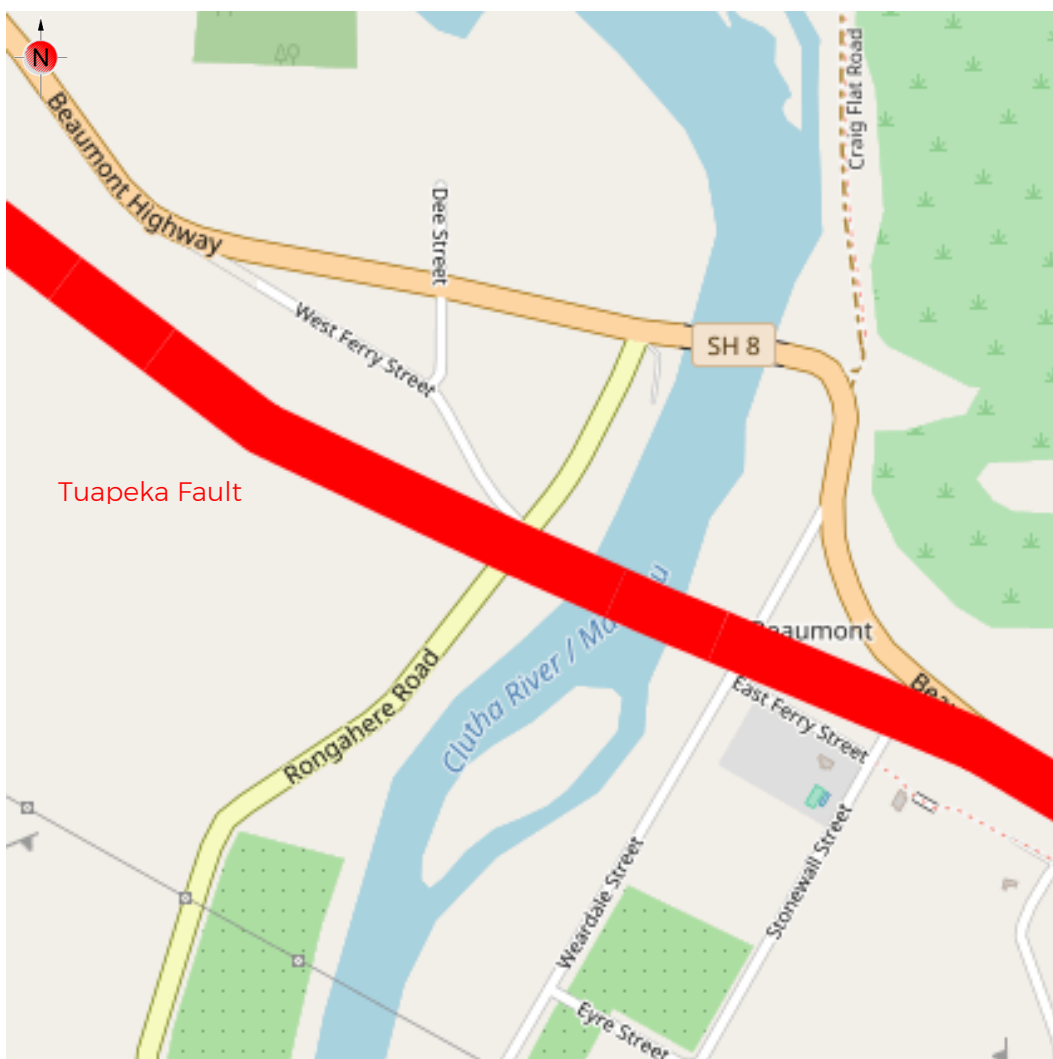
Figure 3: Extract from GNS Active Faults Database

A review of the GNS Active Faults Database indicates that the nearest active fault, the normal Tuapeka Fault, lies approximately 40m southwest of the site, as shown in Figure 3. No other information is known about this fault.

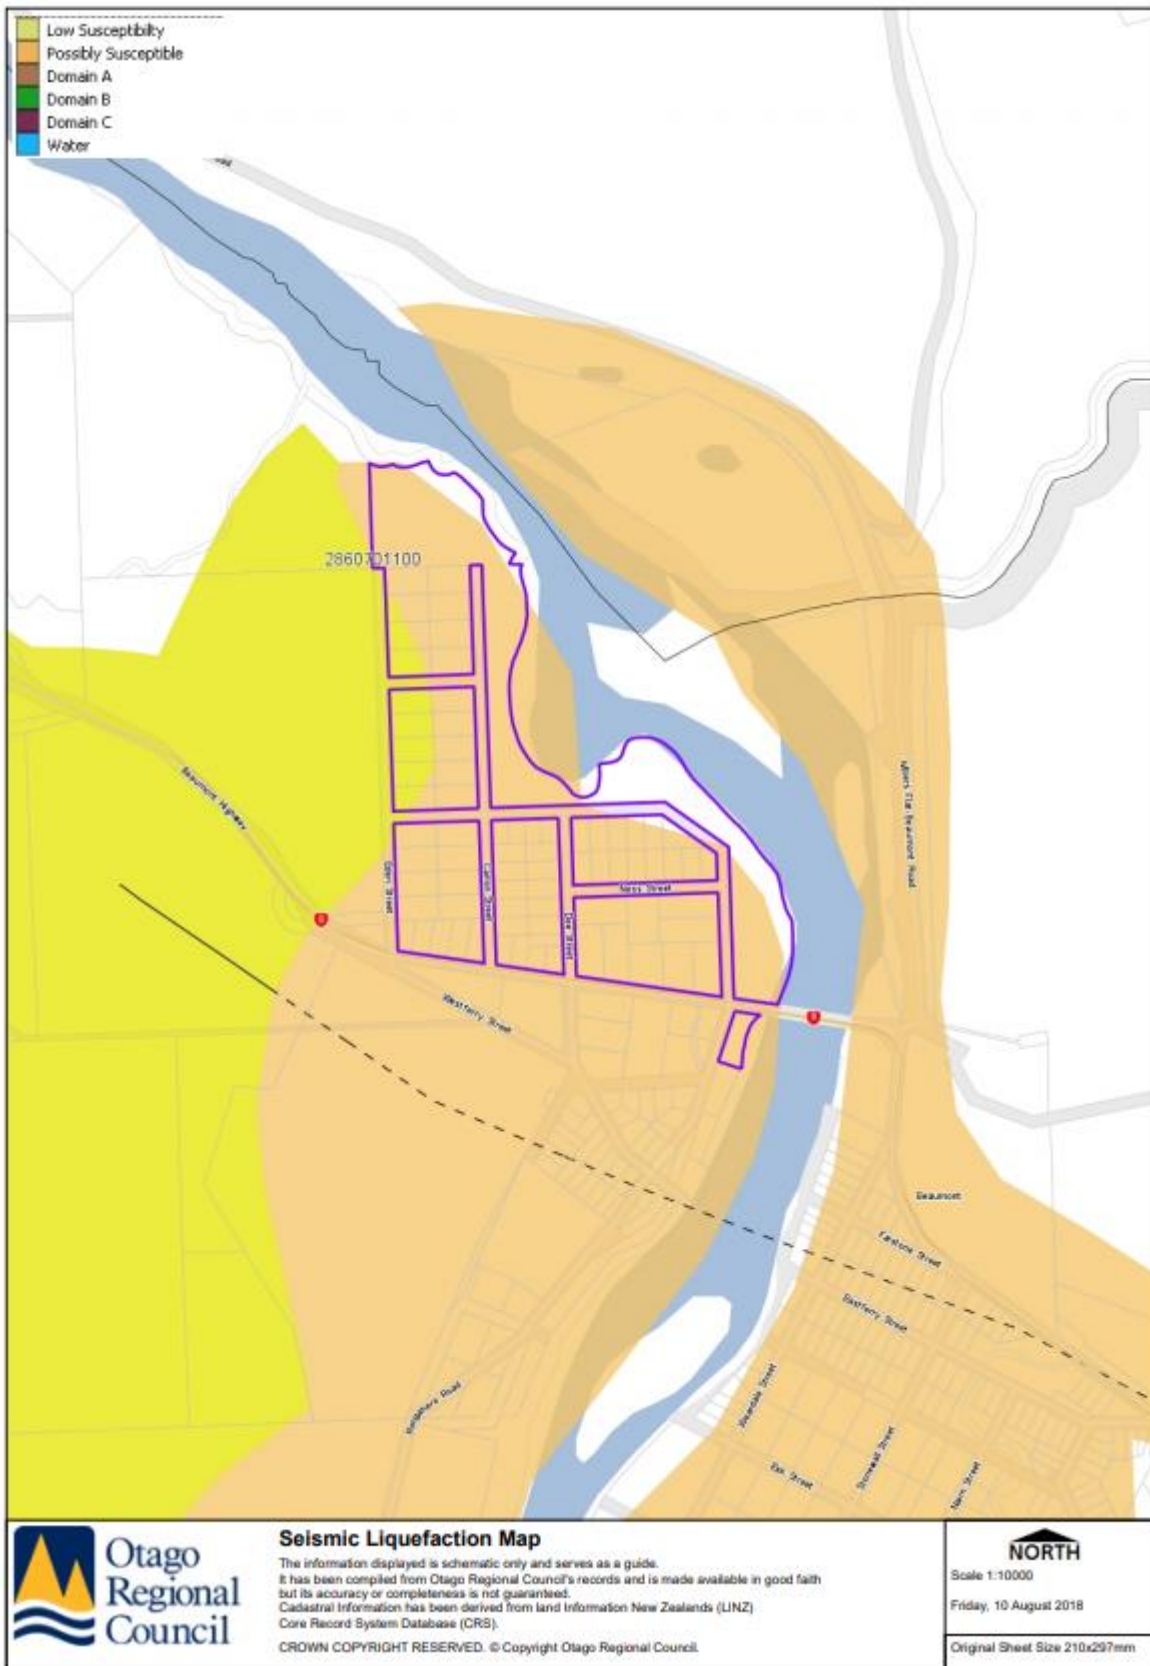
Figure 4: Seismic Liquefaction Map; West Bank Natural Hazards Database Report

Of the 10 hazards that the report looks at the highest risk to the site appears to be that of liquefaction. The seismic liquefaction map; for the west bank Figure 5, and the east bank Figure 6 shows that the parts of the site that are underlain by late Pleistocene River Deposits are possibly susceptible to liquefaction.

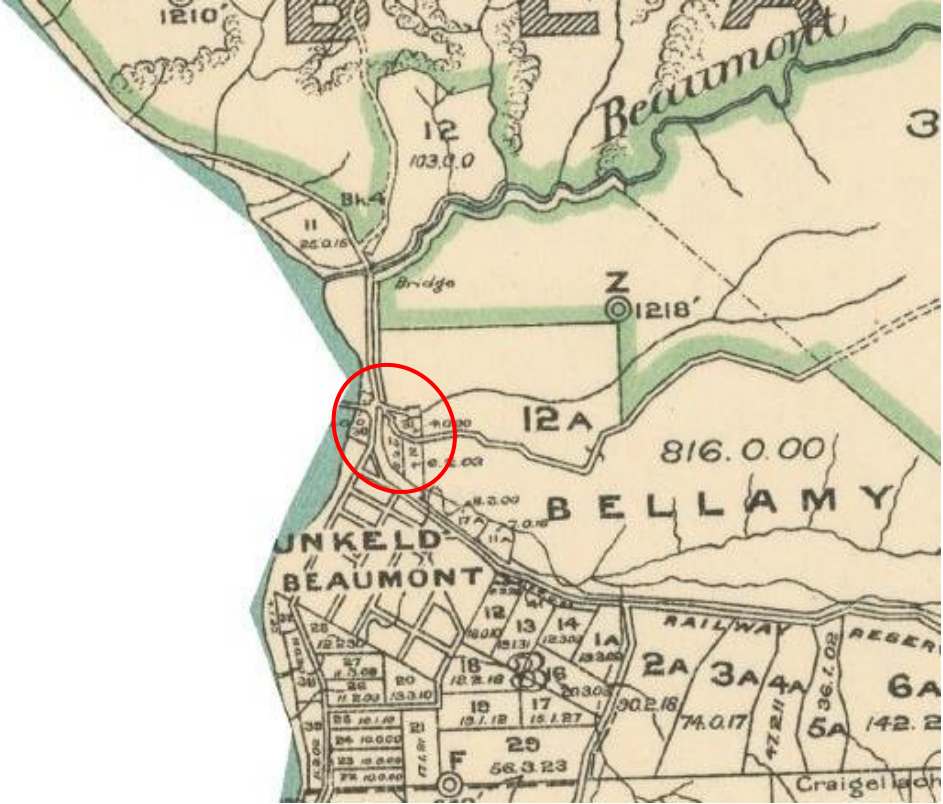
<p>Only the eastern part of the site can be seen on this map. However, the road bridge is evident and it can be noted that a railway is running across the western most part of the site.</p>

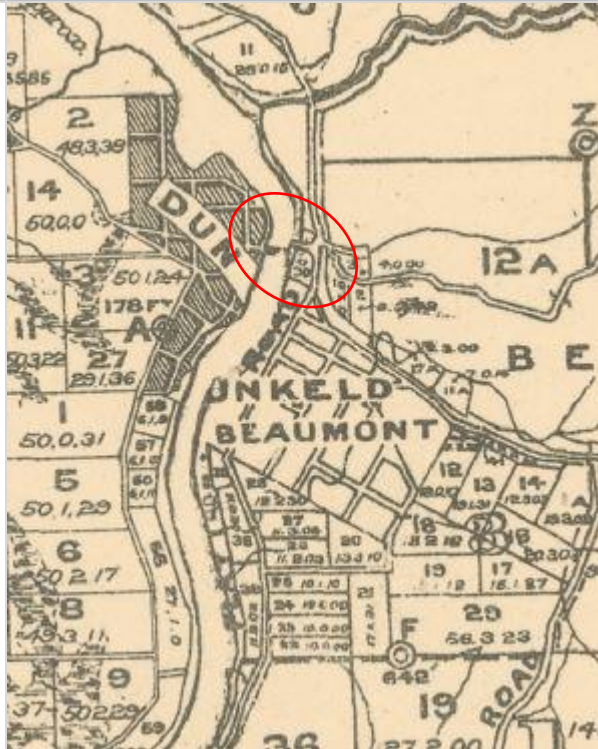
1949  
Maps Past

The whole of the site can be seen, the western back of the river appears to be built up.

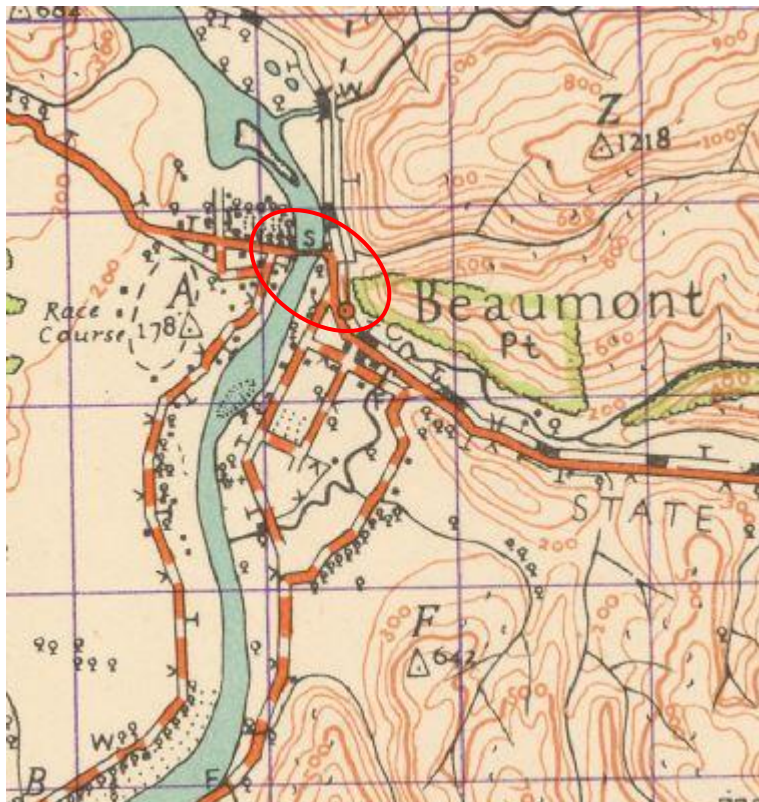
1959  
Maps Past

The Railway can still be seen running north south through the site. An orchard can be seen to the northwest of the site.

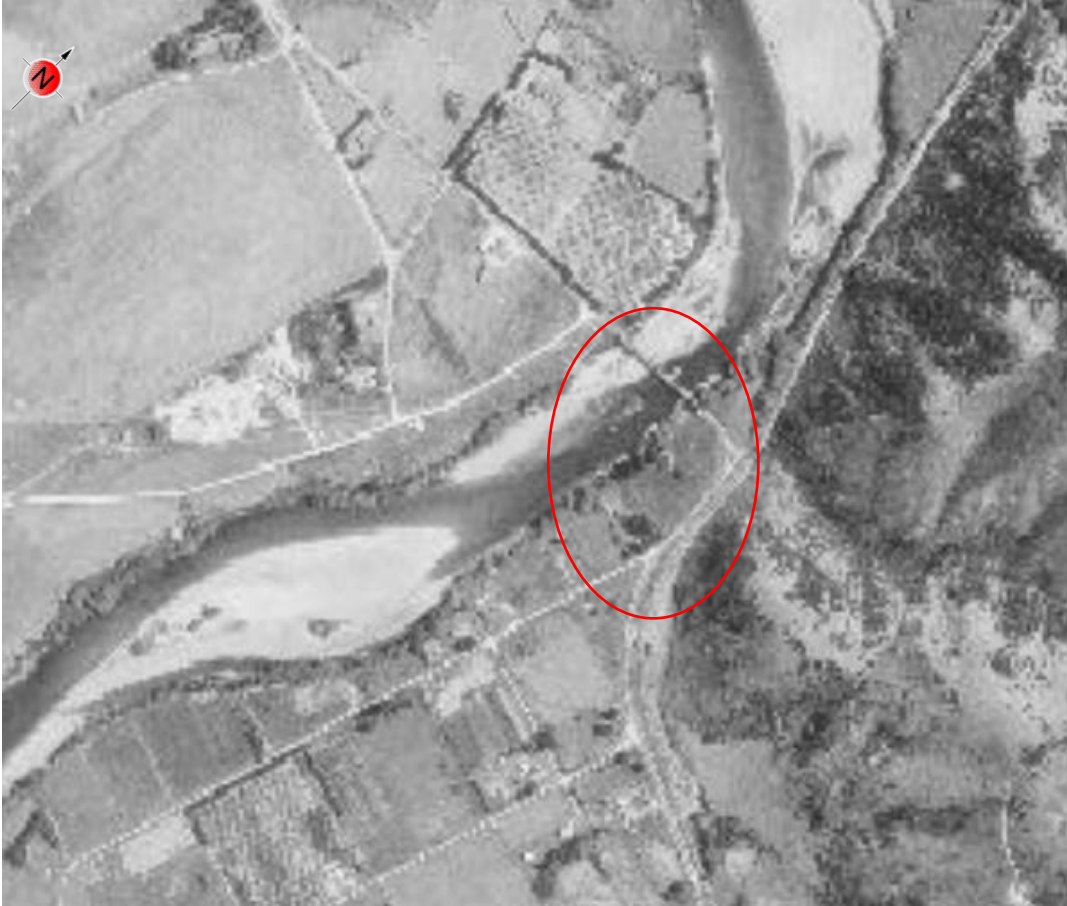
<p>A track can be seen extending towards the river in the western part of the site. There are no apparent changes to the surrounding area.</p>
<p>1979 Maps Past</p>

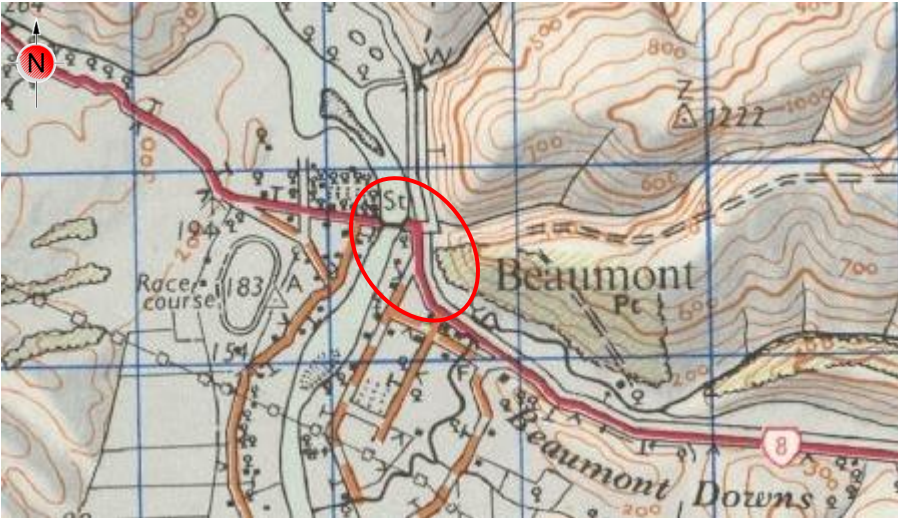
<p>The railway is no longer apparent in the east of the site or in the surrounding area.</p>

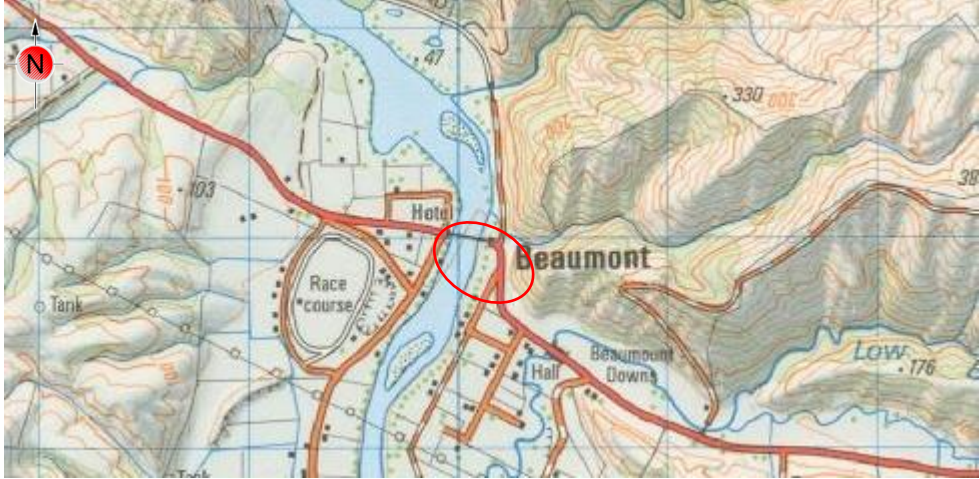
<p>There are no apparent changes to the site. The orchard is no longer apparent to the northwest of the site.</p>

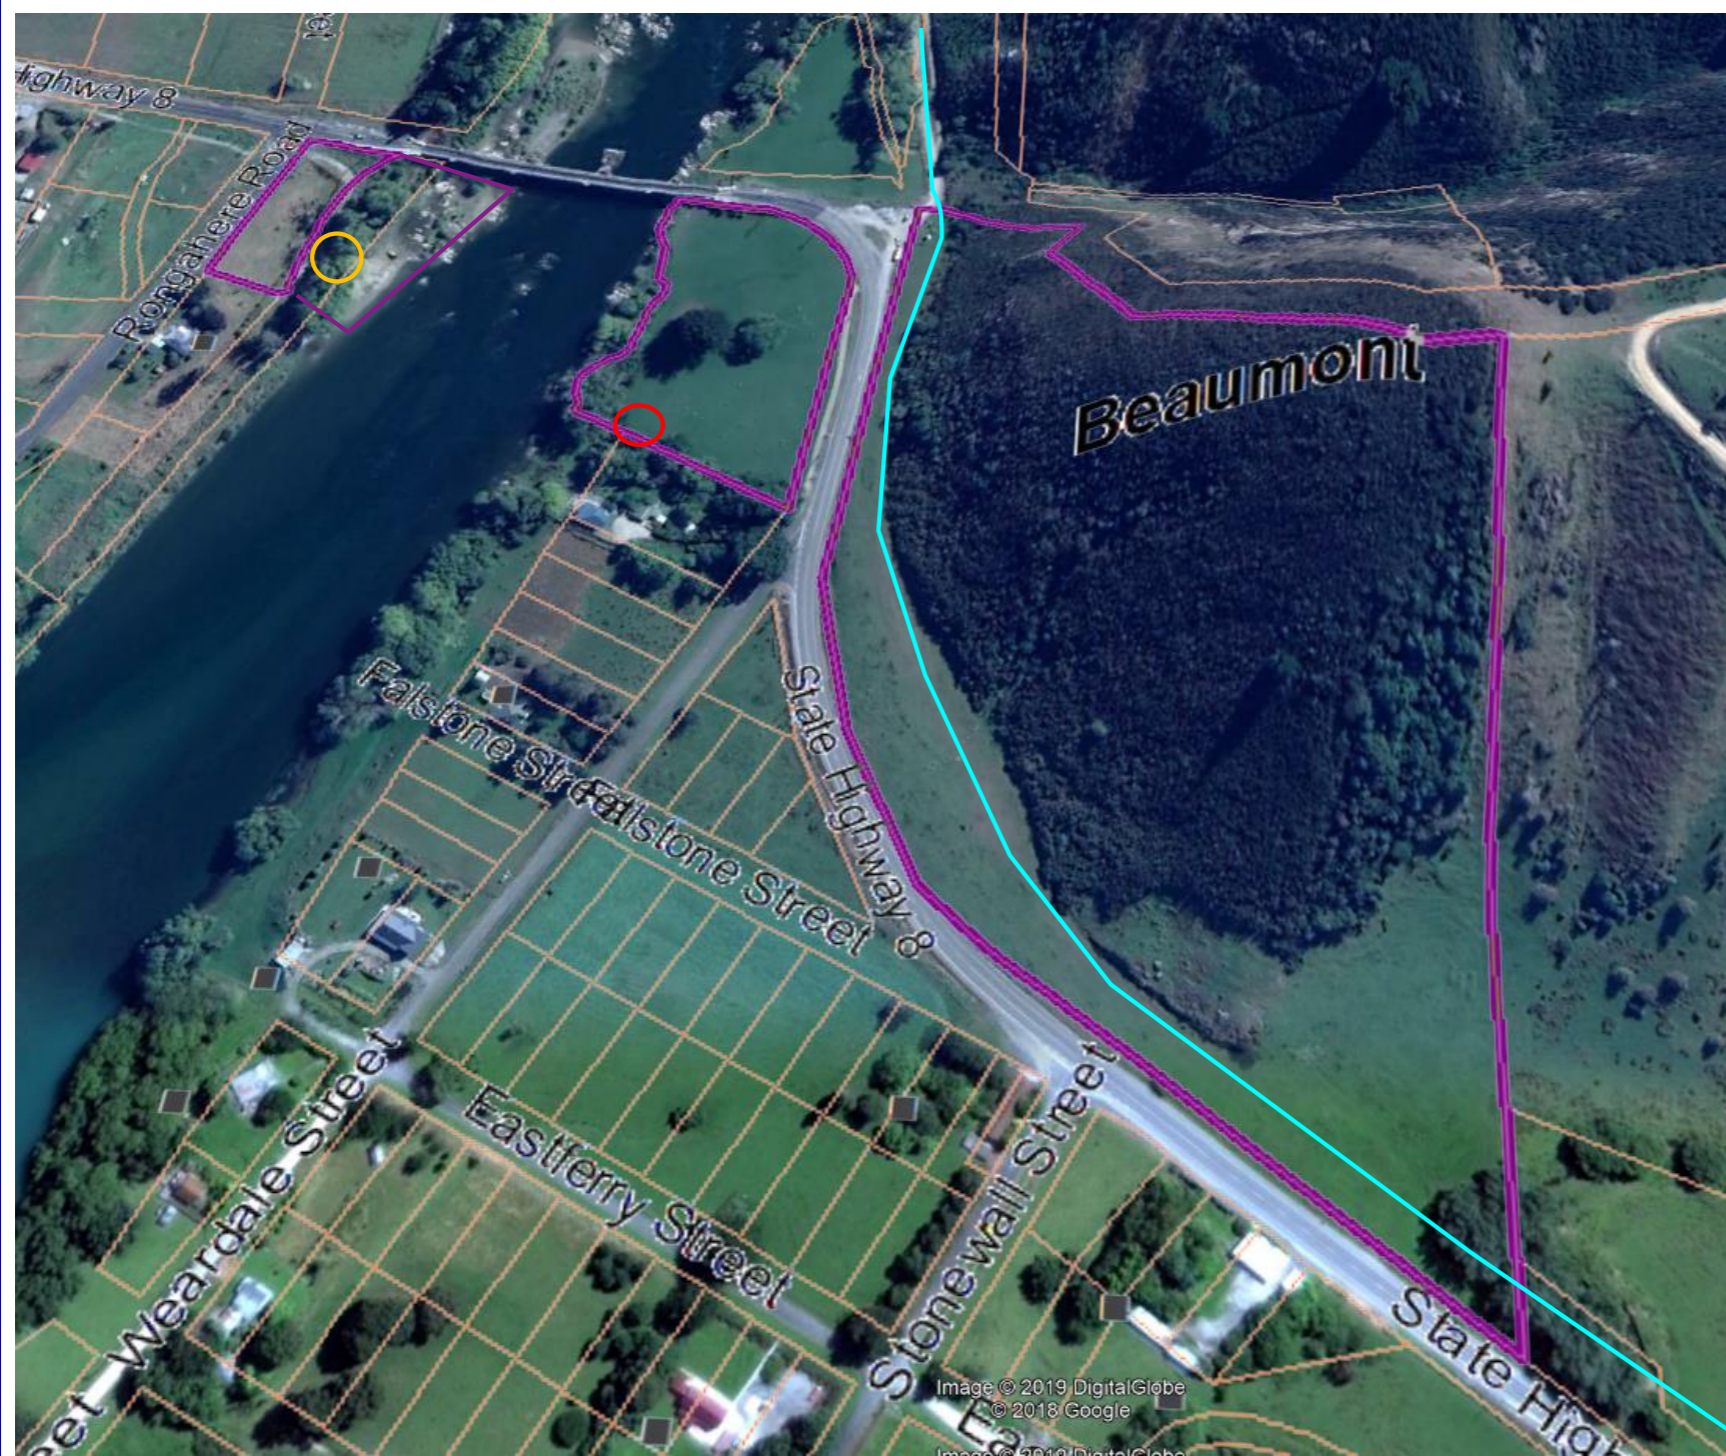
# Appendix D: Site Layout Plan

- Approximate site boundary
- Possible Sheep dip
- car parking area
- Railway line
