Technical Report No 16

# Christchurch Southern Motorway Stage 2 and Main South Road Four Laning

## Contaminated Land Assessment

November 2012

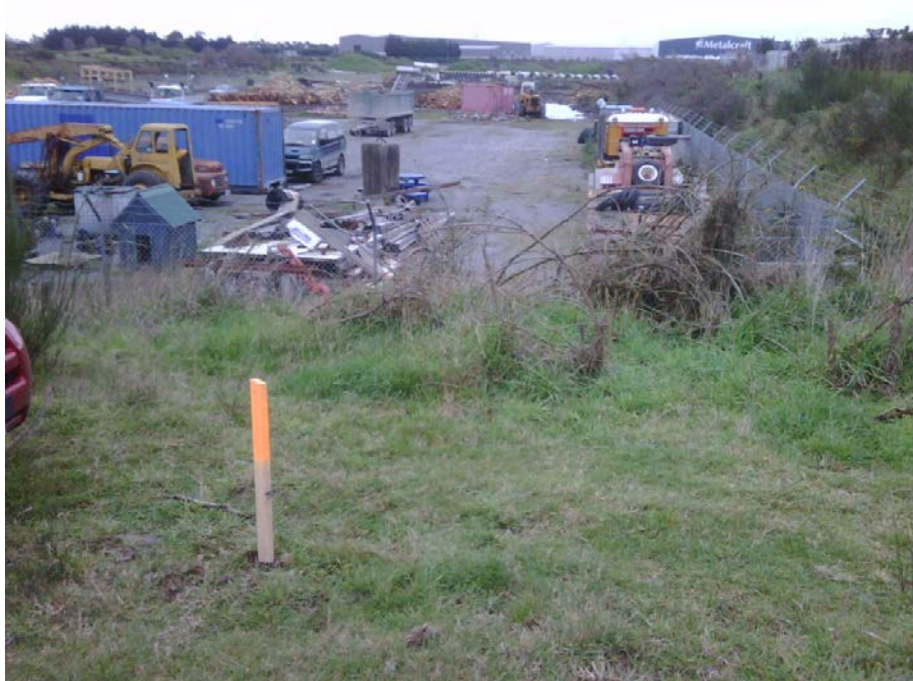
Outside of the compound area, a number of mounds of soil, concrete pipes, drums, large oil tanks and construction waste were observed, during the site visit. One of the large oil tanks was noted to have been opened and was leaking a tar-like substance directly onto the ground. Some photographs of the former quarry are presented in Figures 2 – 5.

**Figure 2 Photograph of Compound Area Looking West (30 June 2011)**

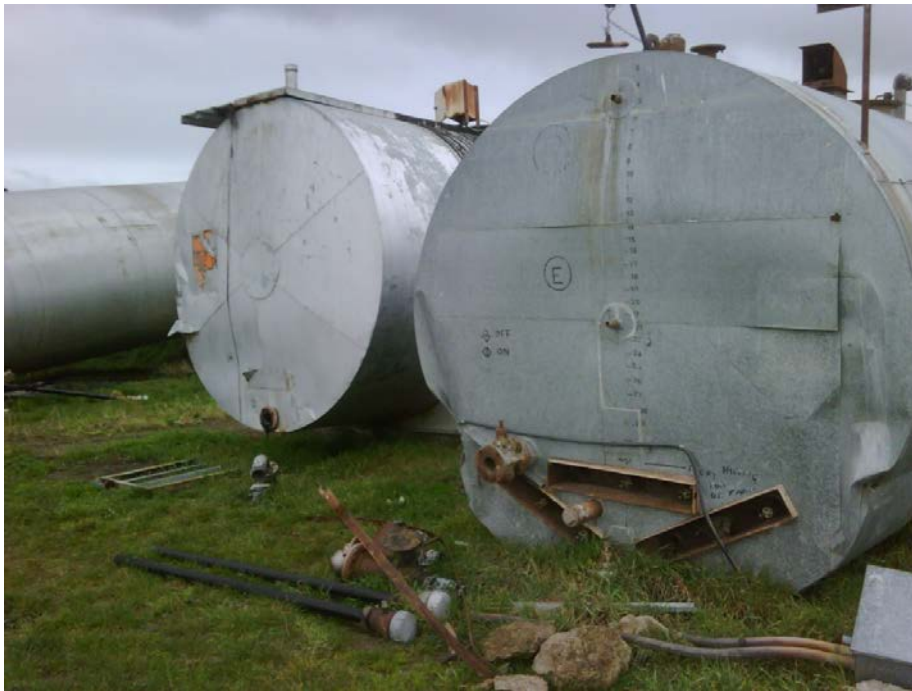
Figure 3 Photograph of Abandoned Tanks (30 June 2011)

Three large disused stationary tanks were located in the western half of the site near Q4. One of the tanks was noted to be leaking a tar-like substance from the outlet pipe, whilst another had its ends removed and a tar-like substance had been spilt directly on the ground surface (Figure 9). A soil sample, Q4, collected adjacent to the tanks contained low concentrations of heavy metals similar to the soil background concentrations and low concentration of PAH. None of the contaminant soil concentrations at this location exceed the Rural Residential SCSs<sub>(health)</sub> of the Soil NES.

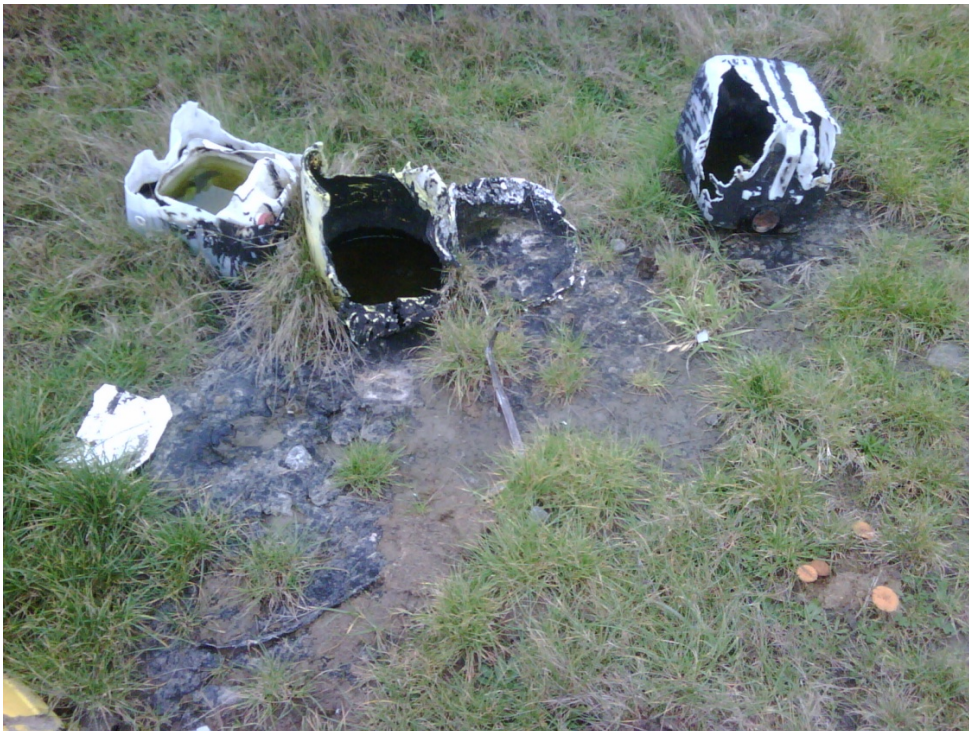
Figure 4 Photograph of Discarded Containers (30 June 2011)

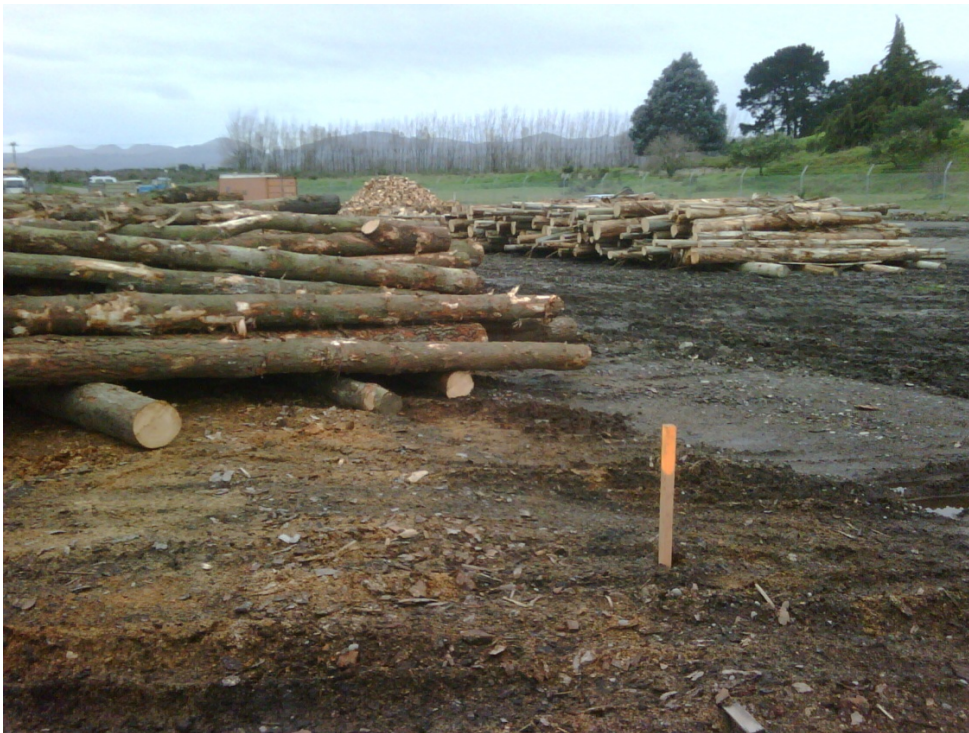
Figure 5 Photograph of Timber Storage in Compound (30 June 2011)

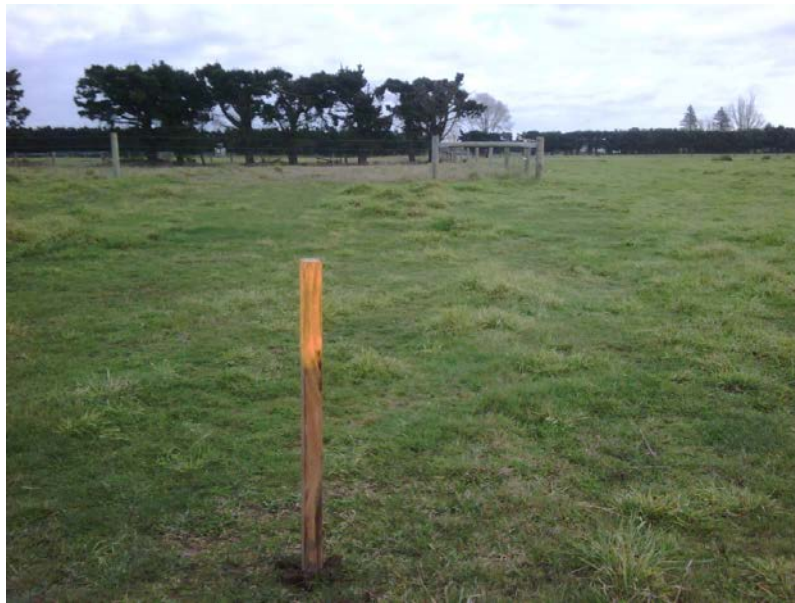
Soil samples from the near-surface were obtained at regular intervals along the proposed CSM2 and MSRFL routes. A total of ten (10) samples were collected within the alignment of CSM2 and five (5) samples were collected within the MSRFL alignment. Most of the samples were collected in paddocks used for cropping or light stock grazing as these land uses are considered typical for the alignment. A photograph of a typical sampling location is shown in Figure 7. No indicators of contamination were noted at the sampling locations or in the samples collected.

**Figure 7 Photograph of Typical Greenfield Soil Sampling Location**

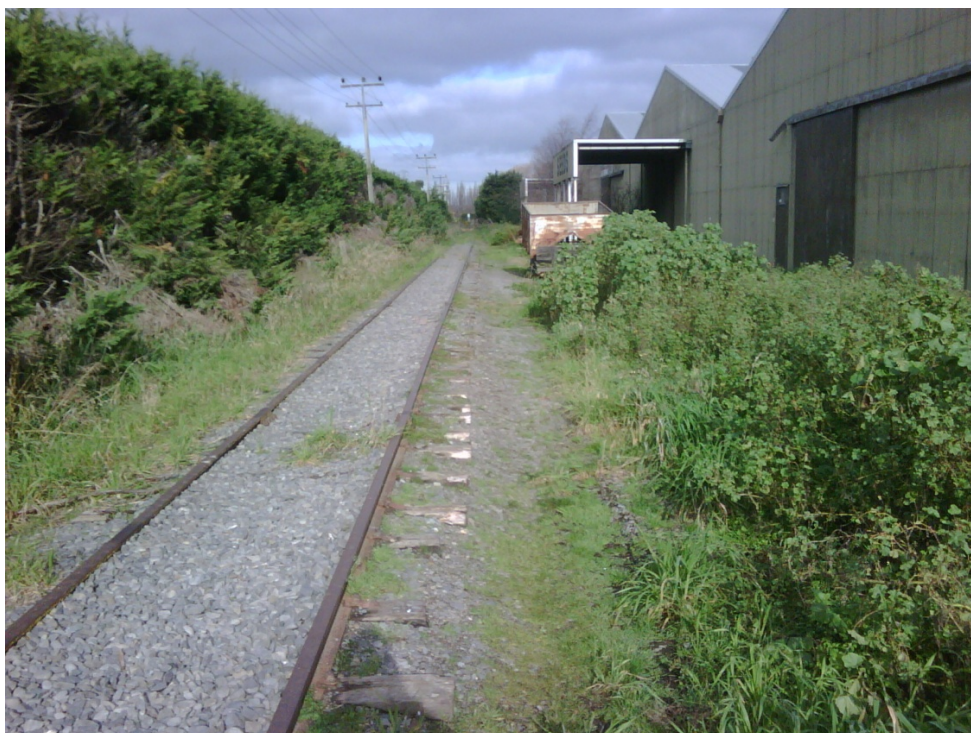
A total of five samples were collected along the alignment of the former Southbridge Branch Railway Line. It is understood that the line is still used occasionally for manoeuvring goods wagons associated with the line towards Hornby. A photograph of the former Southbridge Branch railway line is presented in Figure 8.

**Figure 8 Photograph of former Southbridge Branch Railway Line looking South (1 July 2011)**

The route of the CSM2 will intersect the Southbridge Branch railway line which runs in a roughly north-south direction from Hornby towards Prebbleton. It is proposed to realign the railway siding to curve eastwards on the northern side of the proposed motorway. The railway line was in generally good repair with wooden sleepers and coarse gravel (ballast) between the rails. The immediate verges were grass covered and overgrown.

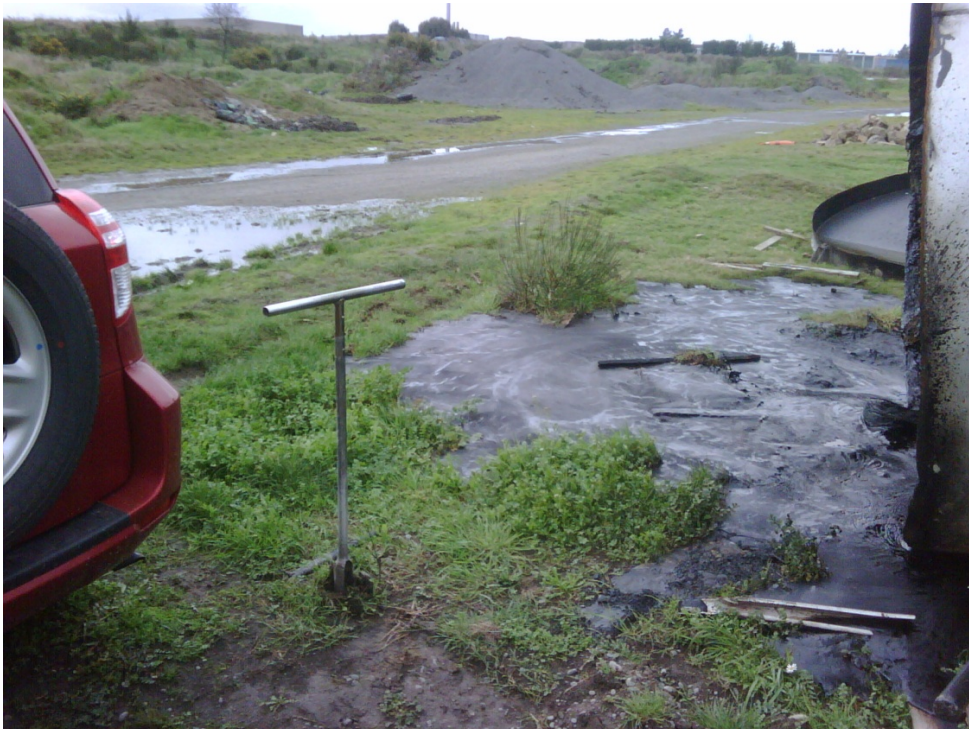
**Figure 9 Tar-substance spilt from tank (30 June 2011)**

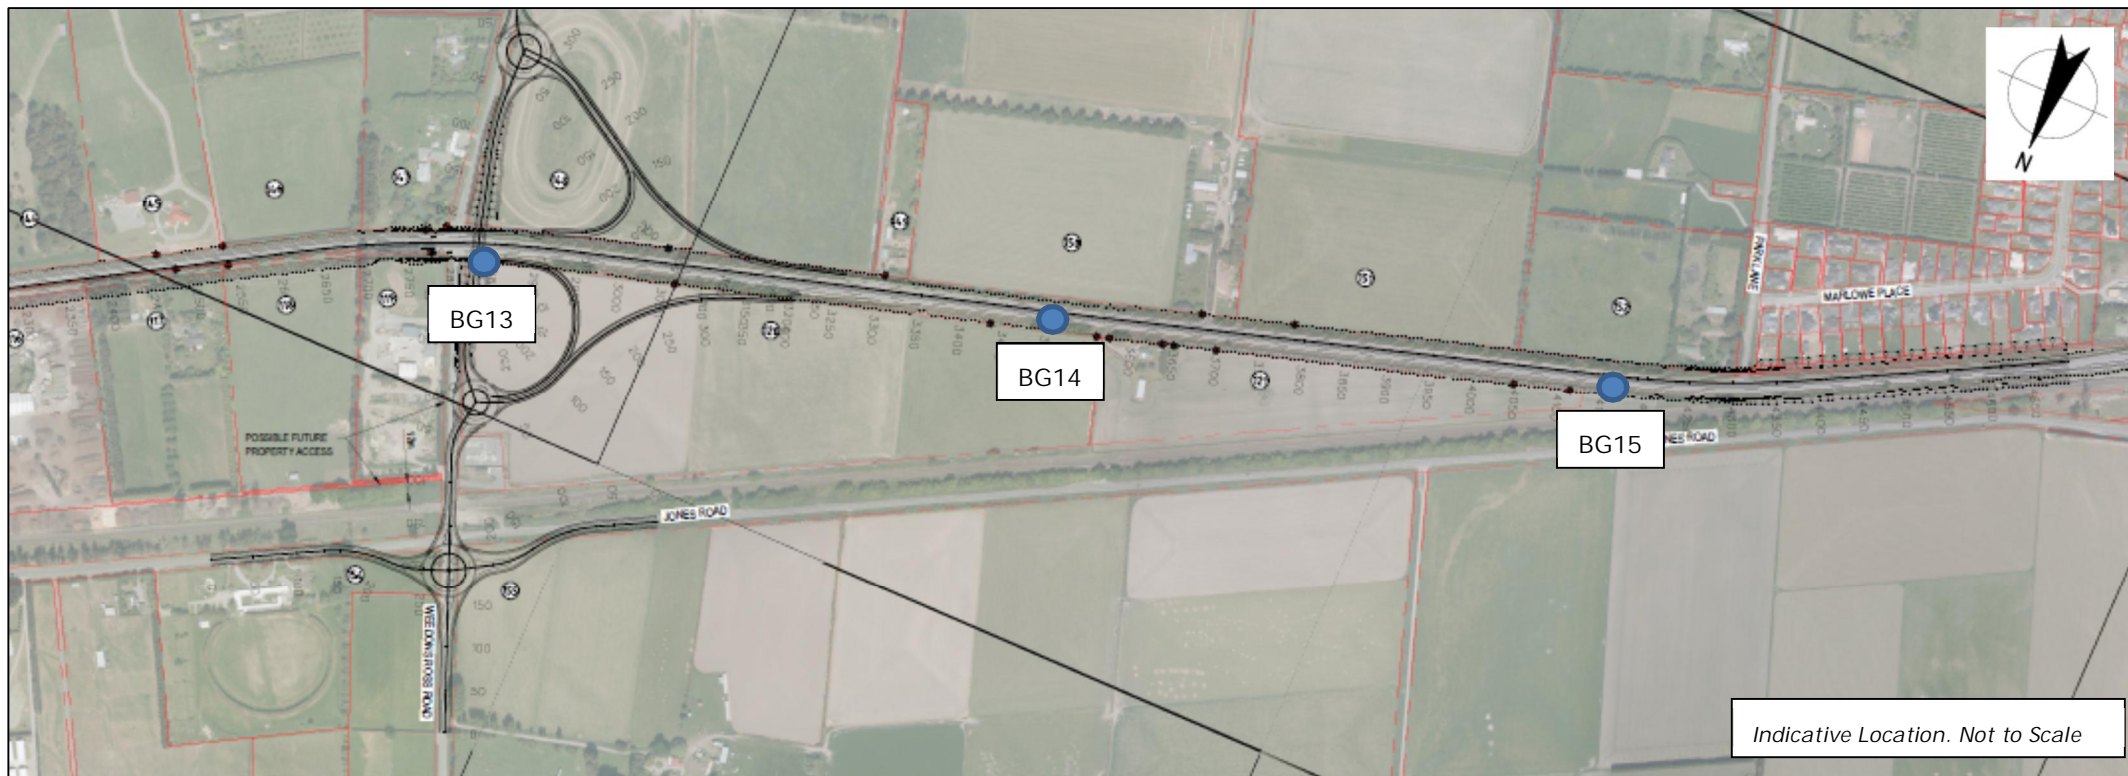
Figure A2

Investigation Locations (MSRFL)
