# One month since Gabrielle

## State of the network

### Then, now and into the future

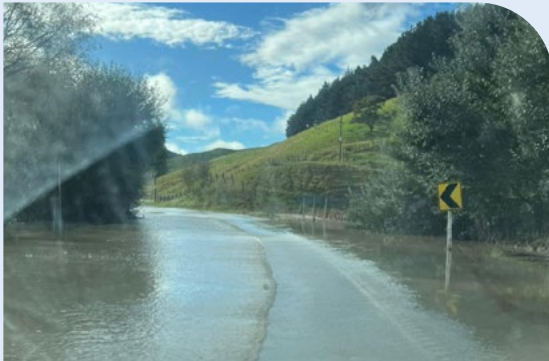
**The damage:** This route was cut off due to flooding in Te Karaka, and multiple slips on Otoko Hill (south of Matawai).

Flooding in Te Karaka on 14 February

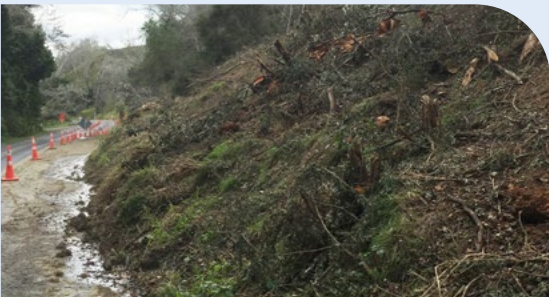
A slow moving slip on Otoko Hill - There is enough room here to build a temporary lane around the slip, creating two lanes and allowing contractors to clear and stabilise the site

**Where we're at now:** Our focus now is on stabilising the road and removing the risk of road closure. There are still two major slip sites that need work — from cutting and benching (stabilising), to de-watering, and looking to cutting the toe of the slip back to contain it with barriers.

These are planned works which require a rolling road closure from 22–23 March. The road will be closed from 6:30am to 4:45pm with a 45 minute opening every 2 hours. However, it's short-term pain for long-term gain and the route will be more resilient as a result.

We are also installing a weather station at one slip site so we can monitor rain, wind and other triggers for movement.

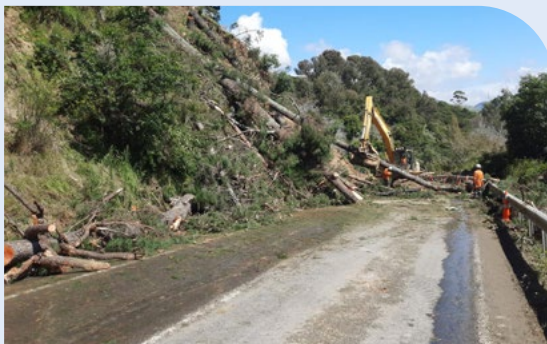
Removing trees from high-risk areas to help stabilise the slip faces

We have removed over 40 trees from slip sites to reduce risk of further damage.

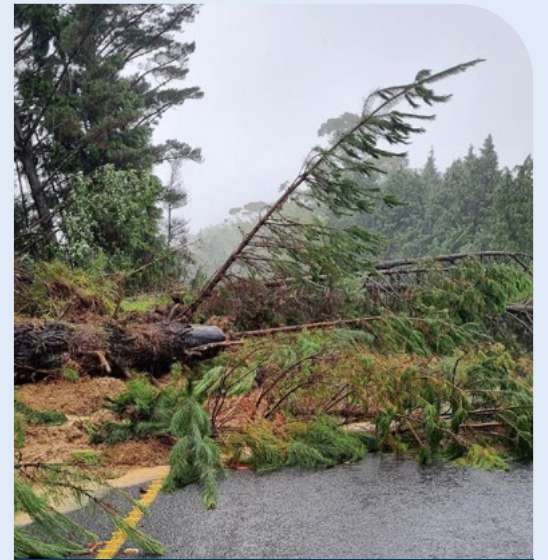
**The damage:** A major slip came down at Moumoukai, just north of Morere, covering both lanes and further north a blocked culvert caused a small lake to accumulate next to the road. The extra water in the area caused subsidence on the road and continuous movement.

A large slip covered both lanes just north of Morere

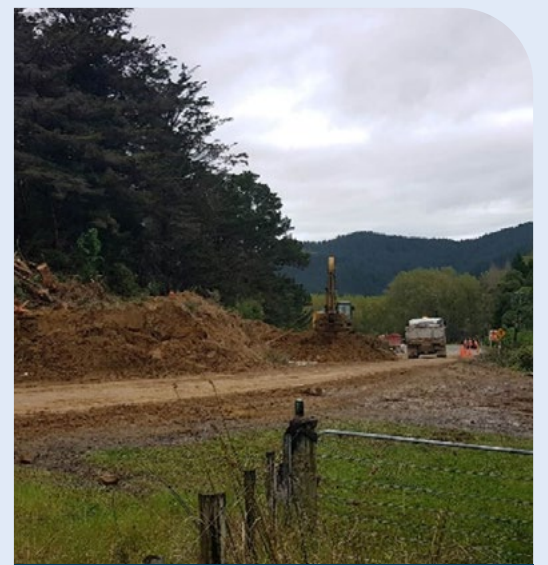
Contractors clearing the slip at Moumoukai

**Our immediate response:** Contractors from both Gisborne and Wairoa worked to clear the road as quickly as possible, and four days after the cyclone, we were able to open the road during daylight hours.

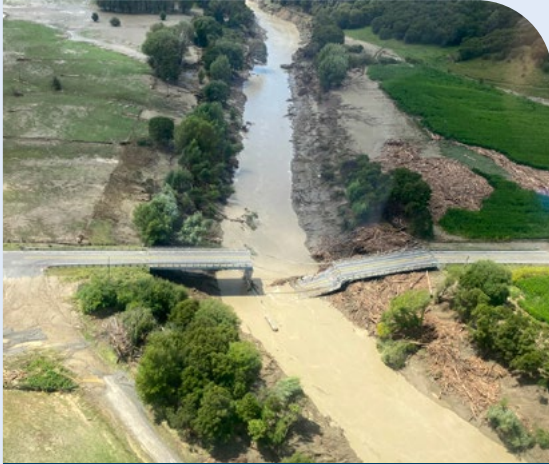
**The damage:** Multiple sites were severely affected. Hikuwai #1 Bridge was washed away, and Mangahauini Gorge suffered major damage - multiple drop-outs as well as a large landslide that created a dam. The landslide material filled up the riverbed and redirected the water to run over the road.

Hikuwai #1 Bridge was severed after Cyclone Gabrielle

**Where we're at now:** Work has begun this week preparing for the installation of a Bailey bridge for Hikuwai #1. Construction will start next week, and the bridge is expected to open in May.

A community-led initiative is also underway to create a temporary diversion road across private land to open a vital temporary route due to the loss of the Hikuwai #1 Bridge. This road will allow commercial enterprises to recommence operations, as Bailey bridges have some limitations for regular heavy freight movements. We are working with Ngāti Porou and landowners around access for the public, and with Kuru Contracting to contribute some funding towards construction costs. This will draw from the \$250m of Crown funding allocated to emergency works (announced on 20 February). We will also continue to offer advice on safety measures and engineering standards to ensure the road is constructed to the correct standard.

We anticipate this secondary road could be used for two to three years, while a replacement bridge is constructed over the Hikuwai River.

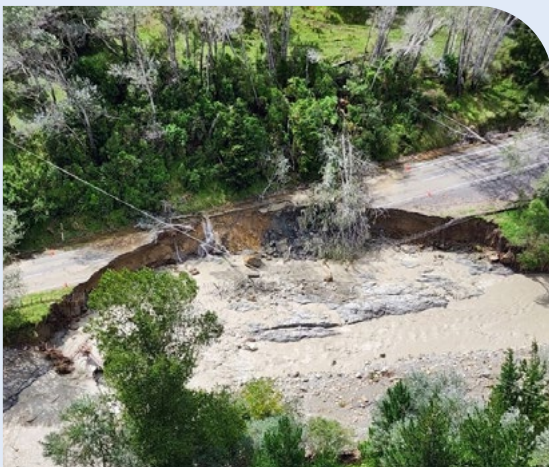
One of three major drop-outs in the Mangahauini Gorge

Great progress has been made in the Mangahauini Gorge, with drop-outs repaired, and a temporary bypass to connect the broken section of SH35 through the gorge should be complete by April (weather dependent).

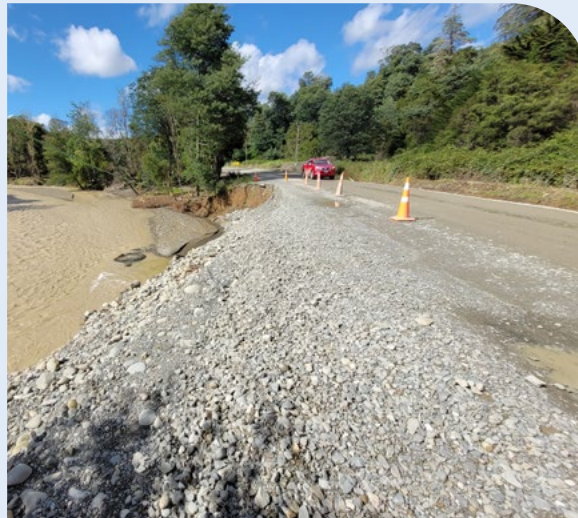
Just north of Te Puia Springs, there was a large washout where the river eroded the road.

The washout at Makarika, north of Te Puia Springs, was temporarily repaired quickly by Blackbees

The washout north of Te Puia Springs was quickly repaired by Blackbees in order to gain critical access to Te Puia Hospital. Further work will be required here to create a permanent fix.

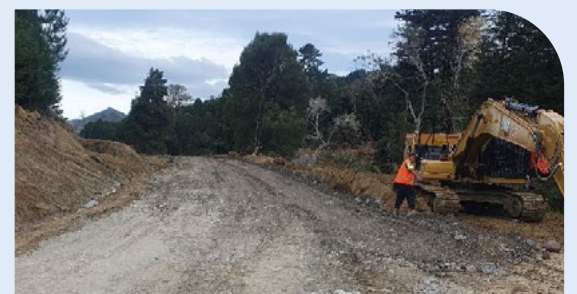
Progress on the temporary bypass in the Mangahauini Gorge - taken 13 March
