Project Number: 5-C4006.00

P2M Walking & Cycling Link

Detailed Design Road Safety Audit

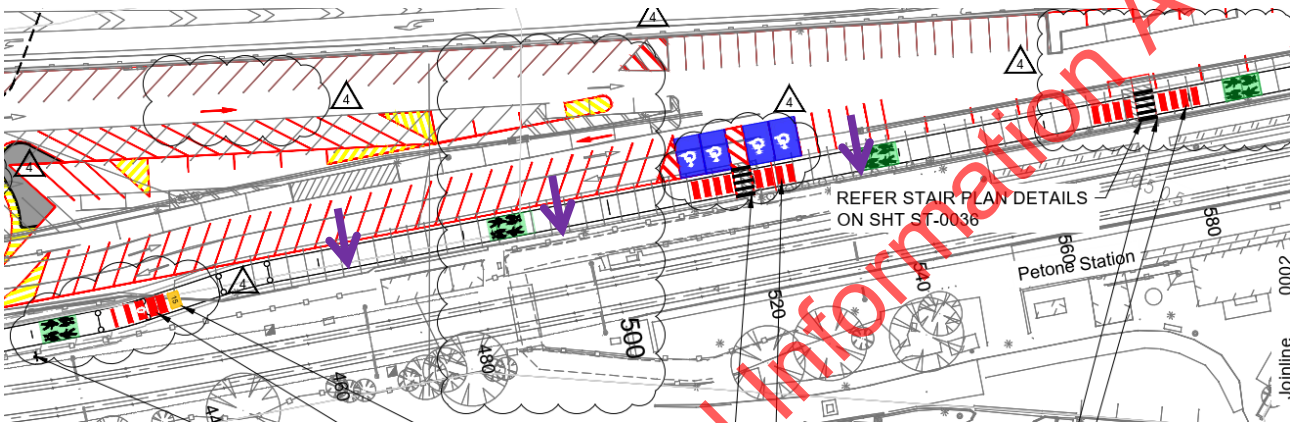
Where the shared path travels at the same level as and adjacent to parking spaces within Petone Station, large vehicles (e.g. vans) are likely to obscure intervisibility between cyclists travelling along the path and pedestrians crossing the path, between the park and ride and the Petone Station platform.

Pedestrians may appear out from between parked vehicles directly onto the path, leaving northbound cyclists in particular very little time to react to brake or avoid a collision.

- 1 Ideally reconfigure the park and ride to ensure there is a (1.0-1.5m) gap between the front of vehicles and the shared path to improve intervisibility between pedestrians and cyclists.

- 2 If the above recommendation is not possible, install a painted buffer on the edge of the path where the vehicles abut so northbound cyclists ride closer to the centre of the path, out of the area where pedestrians may suddenly appear from between parked vehicles. A similar treatment is used where on-street parking is adjacent to a bi-directional facility in locations in Wellington City (Hutt Road – white dashed line, Oriental Parade – exposed aggregate separator strip).

- 3 Mark the warning block and slow symbol on the path in both directions prior to where cyclists would enter the section of path where these conflicts may occur, and where there are pedestrian desire lines, e.g. outside the stairs and where there are wider gaps between parking spaces abutting the shared path.

- 4 Where there are pedestrian desire lines because there is a gap between vehicles or a feature such as stairs up to the platform, mark zebra crossing bars (or other similar treatments) both across the shared path and in the parking aisle to direct pedestrians to these locations. The zebra crossings on the shared path should be proportional to the recently updated zebra bar widths and have limit lines to mimic the TCD crossing markings as closely as possible.

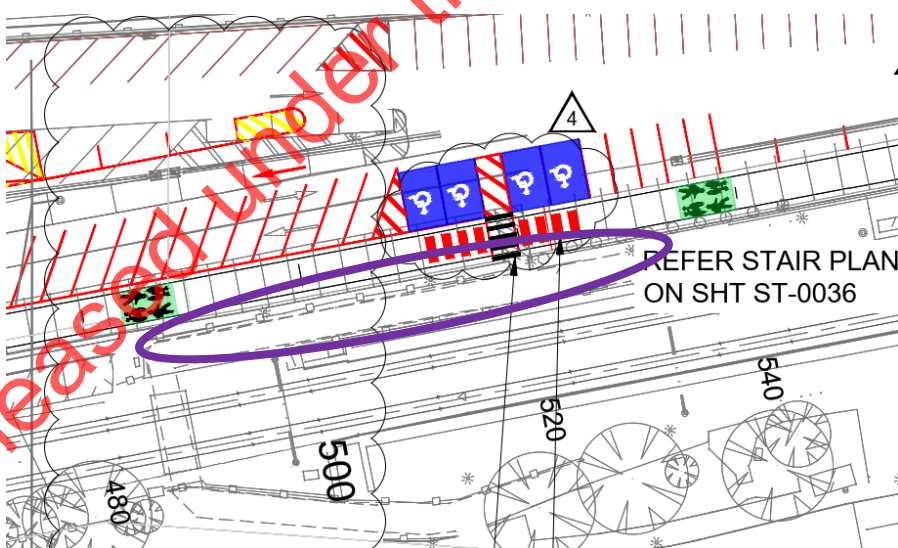
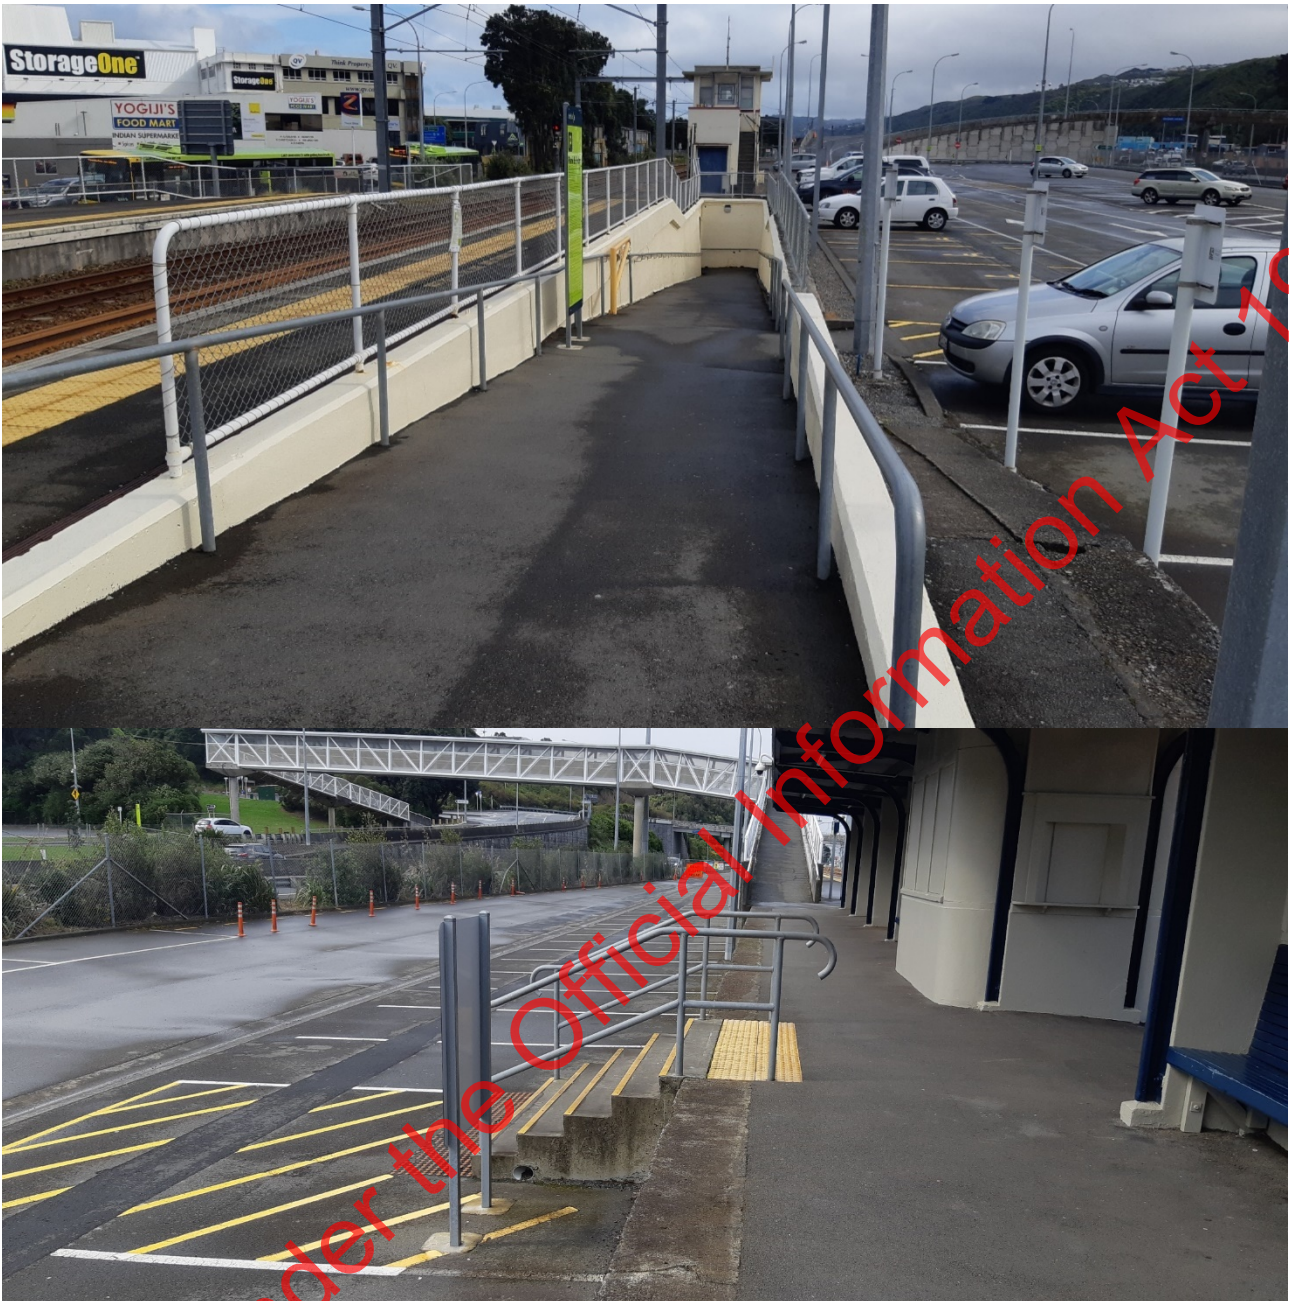
There are several locations in the project where there is a risk of fall, but where the existing fall restraints are insufficient to prevent cyclists, pedestrians or small children falling. These locations are:

- The balustrade beside the existing pedestrian underpass for Petone Station which will be directly adjacent to the shared path is not high enough for cyclists to prevent them falling off the shared path onto the underpass ramps.
- The balustrades on the steps connecting to the Petone Station platform from the park and ride do not have adequate measures to prevent small children falling through.

1. Ensure all fall restraints adjacent to the shared path and other areas with increased cycle demand are 1.4m high.
2. Ensure all fall restraints are designed in accordance with the NZ building code with regard to gaps appropriate for small children.

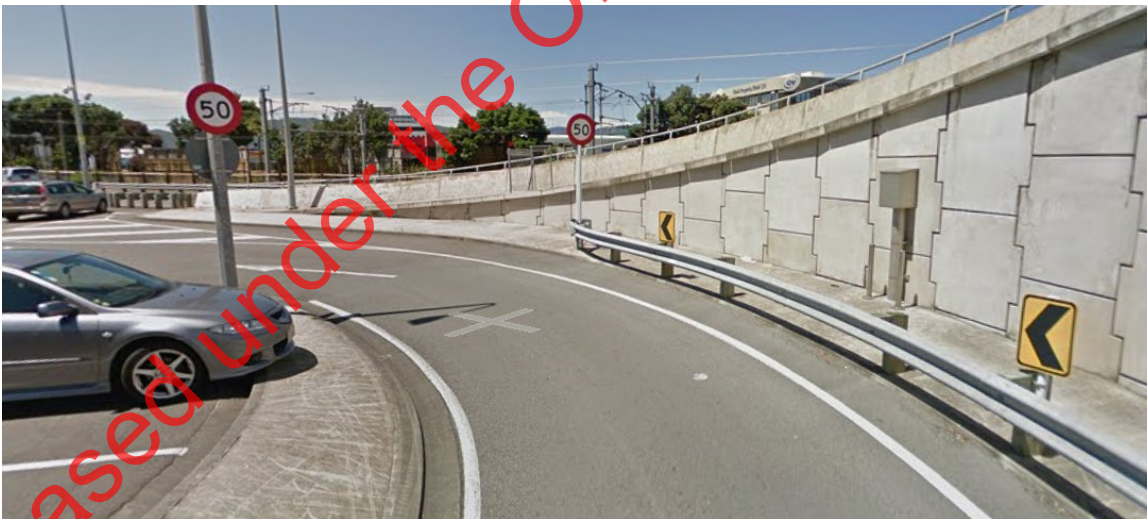
The posted speed limit for vehicles in the park and ride facility is presently 50km/h. While most drivers would be unable to travel around the park and ride at this speed, it is well above the 30km/h survivable speed (based on Safe System Guidance) for cyclists and pedestrians.

- 1 Reduce speed limit in park and ride to 30km/h or less.
- 2 Install speed management measures such as speed humps in the park and ride to reduce speeds prior to conflict points, or where there are long straight sections of parking aisle where driver speeds could be higher.

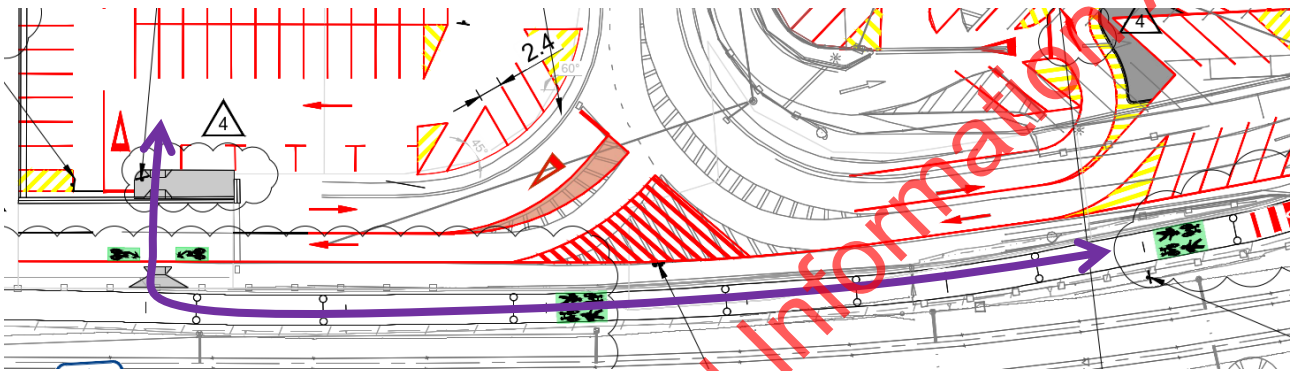
Where the path passes nearby the overflow parking south of the MacKenzie Ave overbridge, it is likely pedestrians will cross the road and walk north along the shared path to the Station Platform and underpass, or vice versa when travelling in the other direction. Although during peak hours pedestrians doing this movement will likely be travelling the opposite direction along the path to cyclists, there is still a possibility of collisions.

- 1 Install keep left and “share with care” (or similar) reminders along the path in areas where there are likely to be numerous pedestrians walking along the path.

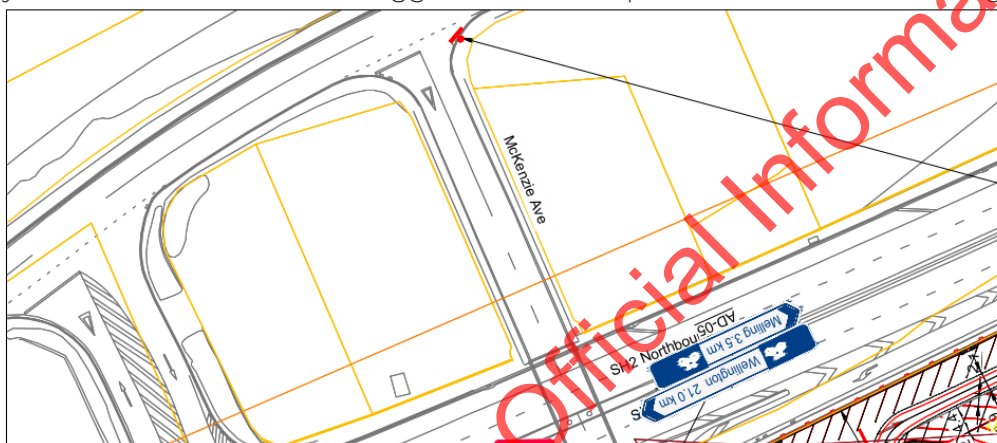
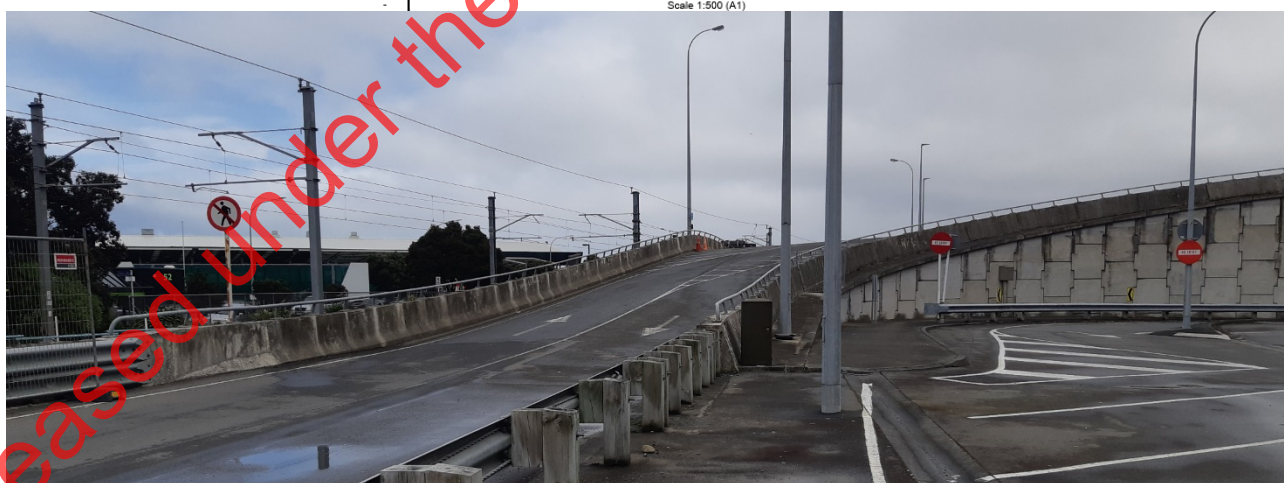
1 | DETAIL (McKenzie Ave Overbridge)

Pedestrians are presently not allowed on the MacKenzie Ave overbridge, which is appropriate given that there is no footpath and steep vertical geometry with poor visibility. However; the proposed wayfinding signs on either side of MacKenzie Ave overbridge include instructions for cyclists but do not include a suggested route for pedestrians to avoid walking over the overbridge.

- 1 Install wayfinding signs for pedestrians (via appropriate routes) near the overbridge.

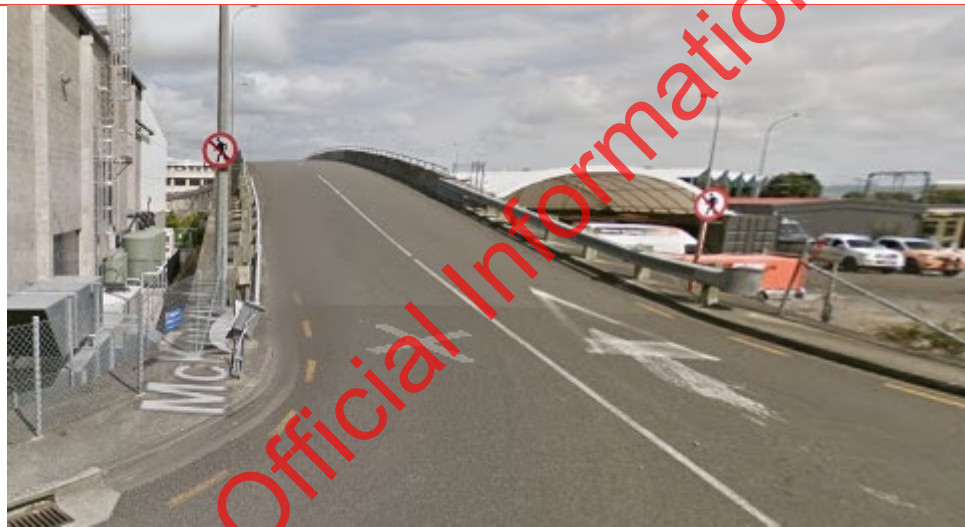
Designer Response:	McKenzie Avenue has no footpaths and is unsuitable as a pedestrian route. This route is unlikely to be used by pedestrians and signage to the pedestrian overbridge is a decision for Waka Kotahi.
Safety Engineer:	Agree with SAT, noting that many walkers/runners exit the Korokoro Walkway nearby. Suggest wording of the proposed cycleway sign be changed from 'Shared Path' to 'Te Ara Tupua' (as 'Shared Path' reads like an invitation to pedestrians) and a new sign be added at this point. '<-- Pedestrian overbridge to Railway Station 300m' with a pedestrian symbol at the top.
Client Decision:	GR: There are already pedestrian no-go signs in place so not exactly an invitation. So instead of 2 new signs preferably the wayfinding information can be conveyed in one sign E.g. 'Te Ara Tupua' with a pedestrian symbol with arrow in direction of pedestrian overbridge 300m, and cyclist symbol with arrow in direction of McKenzie overbridge

Action Taken:	[
Existing signage

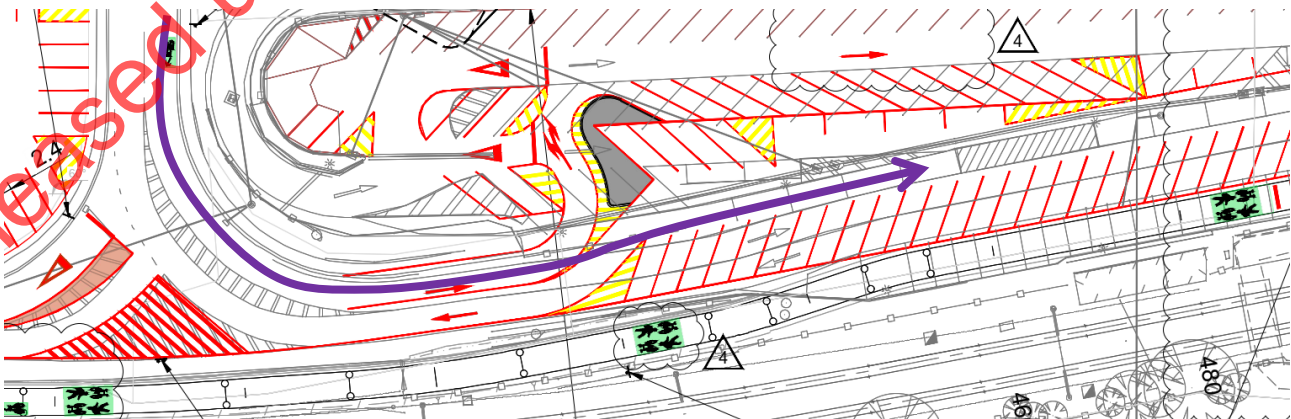
For cyclists heading northbound onto the path from MacKenzie Ave, the recommended route (shown through the markings on the plans) would take cyclists in the wrong direction before they can enter the path. This is likely to lead to cyclists riding the wrong way along the parking aisle, which increases the risk of drivers exiting angle parking spaces reversing into cyclists, as drivers would not expect to see or look for cyclists performing this movement.

- 1 If possible, install a drop-kerb from MacKenzie Ave to the path to prevent this movement through the carpark.

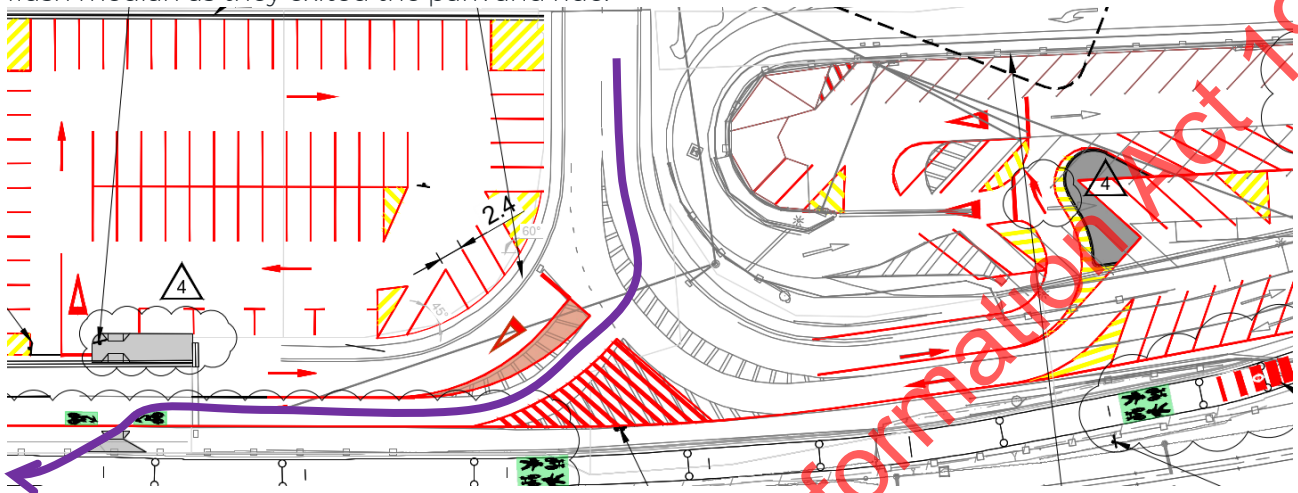
The flush median is in an area with poor forwards visibility due to the vertical geometry of the MacKenzie Ave overbridge and will be used by cyclists to wait while performing turning manoeuvres to the path. While on site, several vehicles were observed cutting the corner over the flush median as they exited the park and ride.

- 1 Install a turning treatment on the median for cyclists to ensure drivers are aware that cyclists use this area and are physically prevented from cutting the corner. Several good designs are presently installed on Evans Bay Parade in Wellington with green coloured surfacing on the flush median and safe hit posts preventing vehicle cutting into the flush median area.

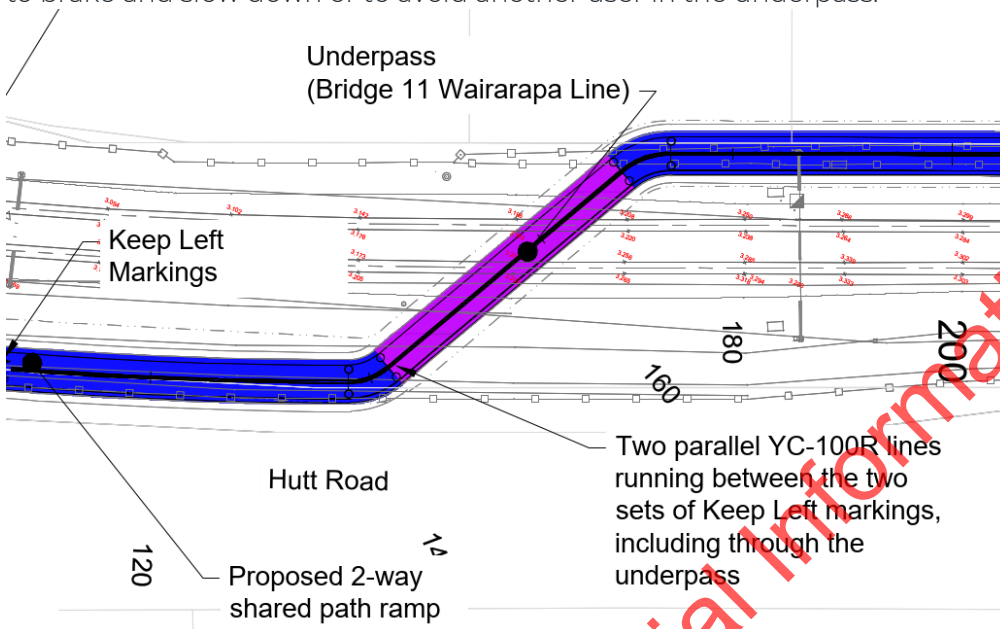
The horizontal and vertical geometry of the new underpass restricts forwards visibility. The SAT are concerned a cyclist travelling at speed down the underpass ramps would not have enough time to brake and slow down or to avoid another user in the underpass.

- 1 Install convex mirrors on the outside of the curves to allow approaching pedestrians and cyclists to see into the underpass from the ramps; or
- 2 Install a radar or other detection system with electronic warning signs to warn of approaching users from the opposite direction on both approaches to the underpass.

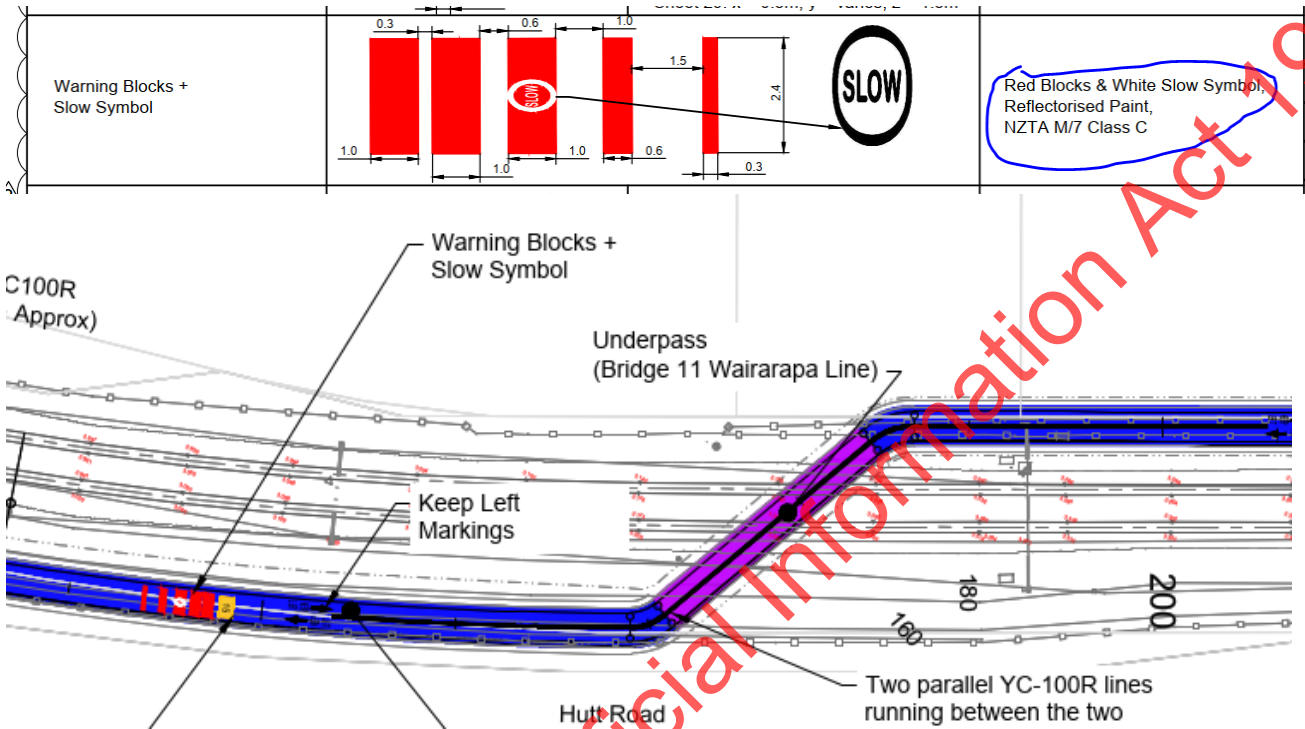
marked on the ramps into the underpass, where cyclists travelling down the ramps towards the underpass will brake to reduce speeds prior to the curve into the underpass.

Reflectorised paint does not have good skid resistance, and large blocks of reflectorised paint should be avoided in areas where there are high braking demands to avoid loss of control under braking.

- 1 Materials for red warning blocks should all be calcined bauxite or otherwise in accordance with the P33 coloured surfacing specification

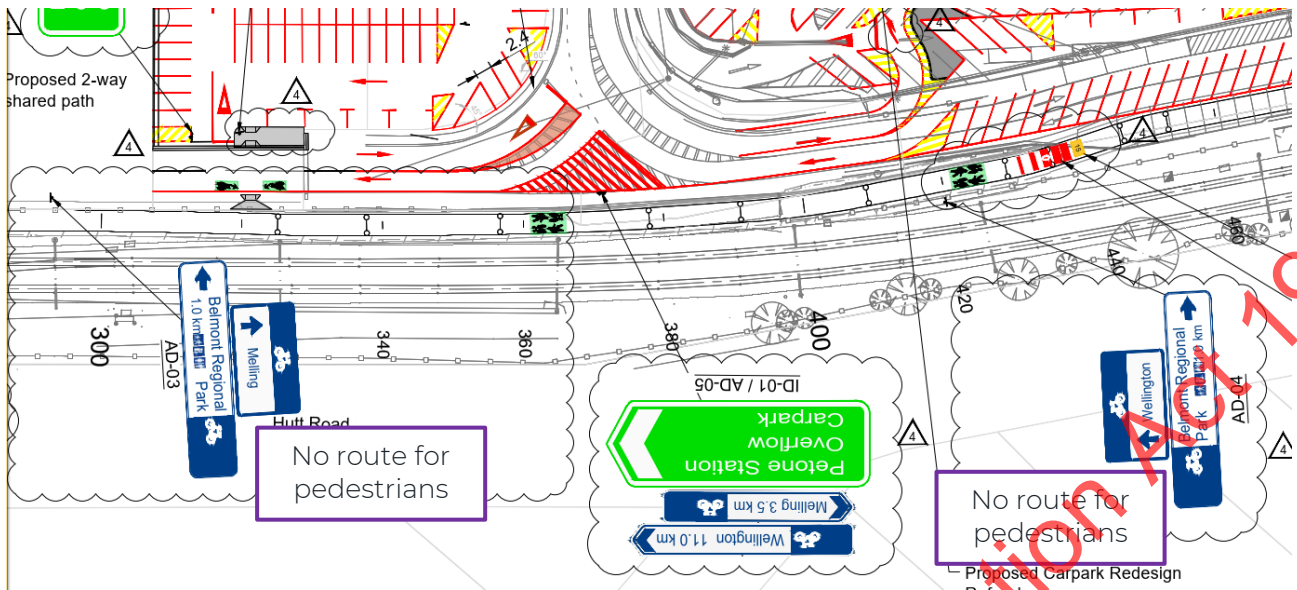
In addition, there are several areas where the wayfinding signs do not provide consistent information for both pedestrians and cyclists, in terms of following the advance direction, intersection direction and confirmation direction methodology, which may result in less familiar users not turning off in the correct location to go where they intend.

- 1 Amend wayfinding signs to inform northbound pedestrians of the existing footpath and underpass route to Petone Station at the southern terminus of the project.
- 2 Install wayfinding signs for the pedestrian route to Belmont Regional Park.
- 3 Review destinations along the route with the preferred route through the project area separately for pedestrians and cyclists to ensure advance direction, intersection direction and confirmation direction signs are installed in appropriate places.

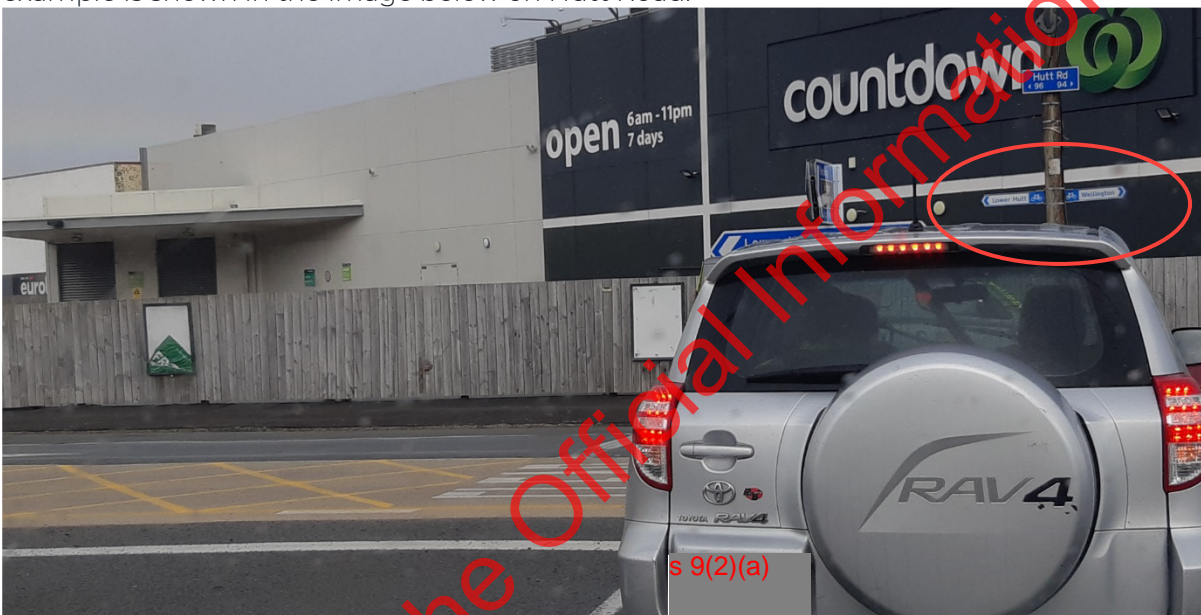
There are multiple wayfinding signs for pedestrians and cyclists in the vicinity of the project which direct users to the existing path, which would no longer be the preferred route following construction. The removal of these signs is not shown in the drawings, and there are safety in design issues associated with the ongoing maintenance of irrelevant signs that aren't removed, as well as poor information provided to potential path users which would inconvenience them. One example is shown in the image below on Hutt Road.

- 1 Review existing wayfinding signs in the area and remove if no longer relevant given the new route.
