# TRANSMISSION GULLY

REBUTTAL EVIDENCE OF **GAVIN CRAIG LISTER**

**APPENDIX A** UPDATED PHOTOMONTAGES OF VIEWPOINT 1

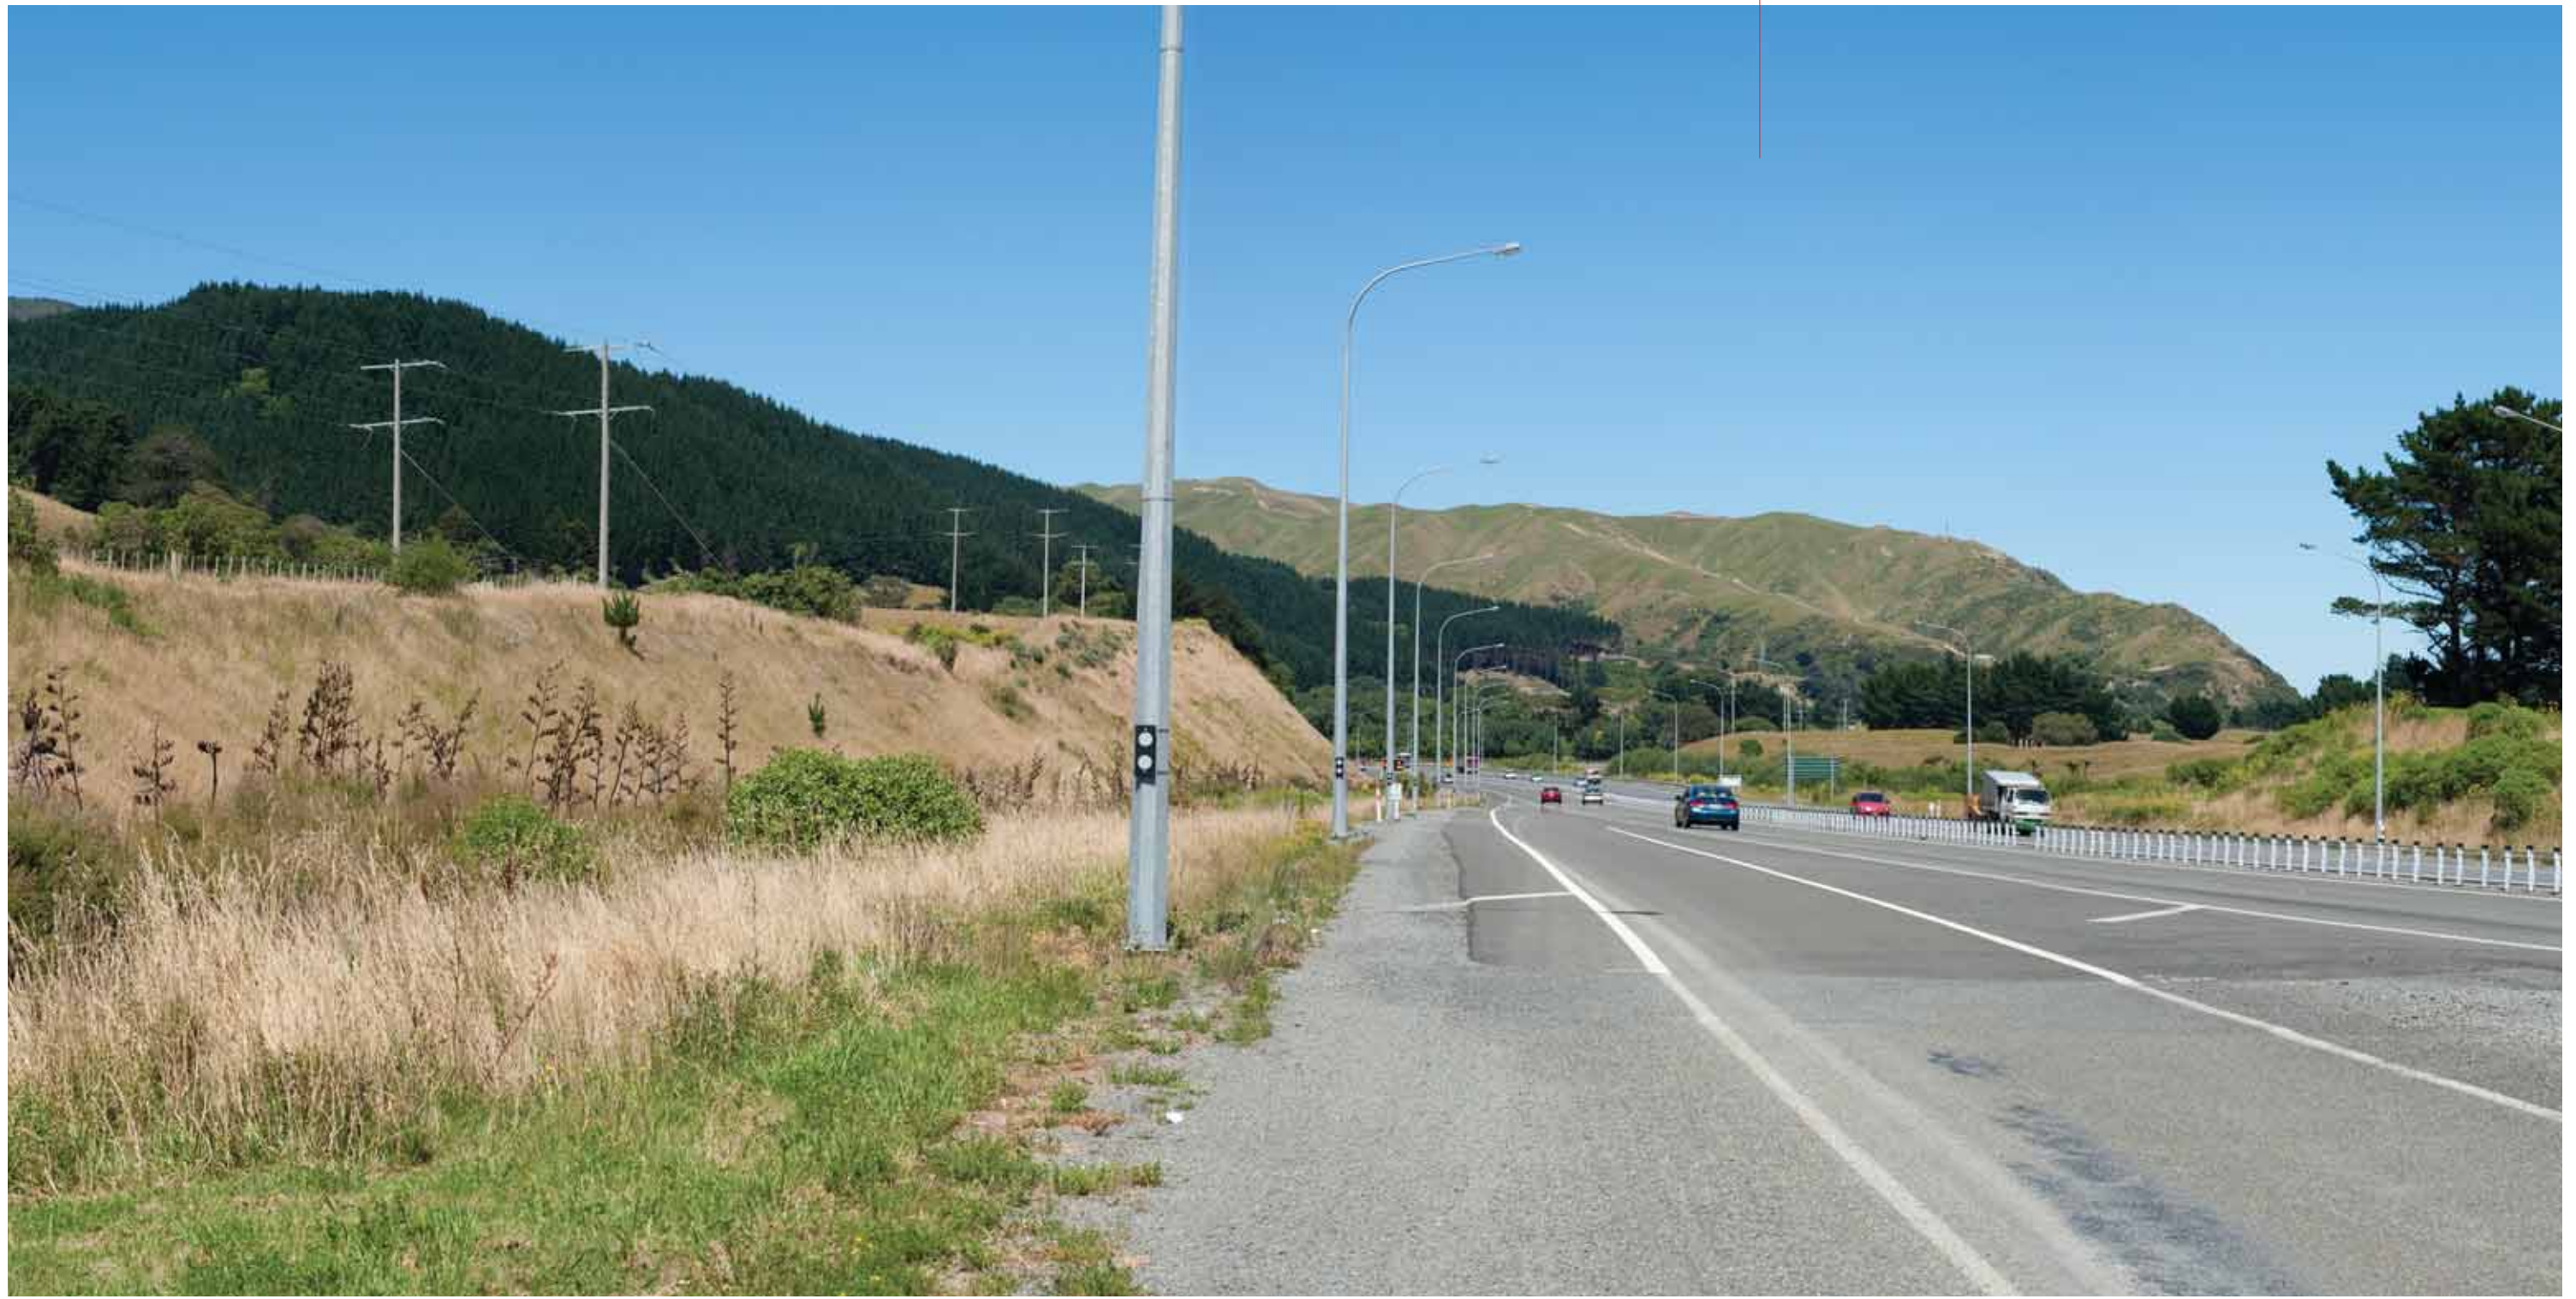
**Viewpoint 1**

Looking south from south bound on ramp at MacKays Crossing

**Existing Landscape**

Original Photo | Lisa Rimmer | 50mm DSLR Nikon D700 | 1218hrs 17th JAN 2012 | E 1766790 N 5462420 (NZTM)  
Reading distance for correct scale: 400mm | Computer model elevation: 22m  
Photomontages should be used as a guide to field observations.

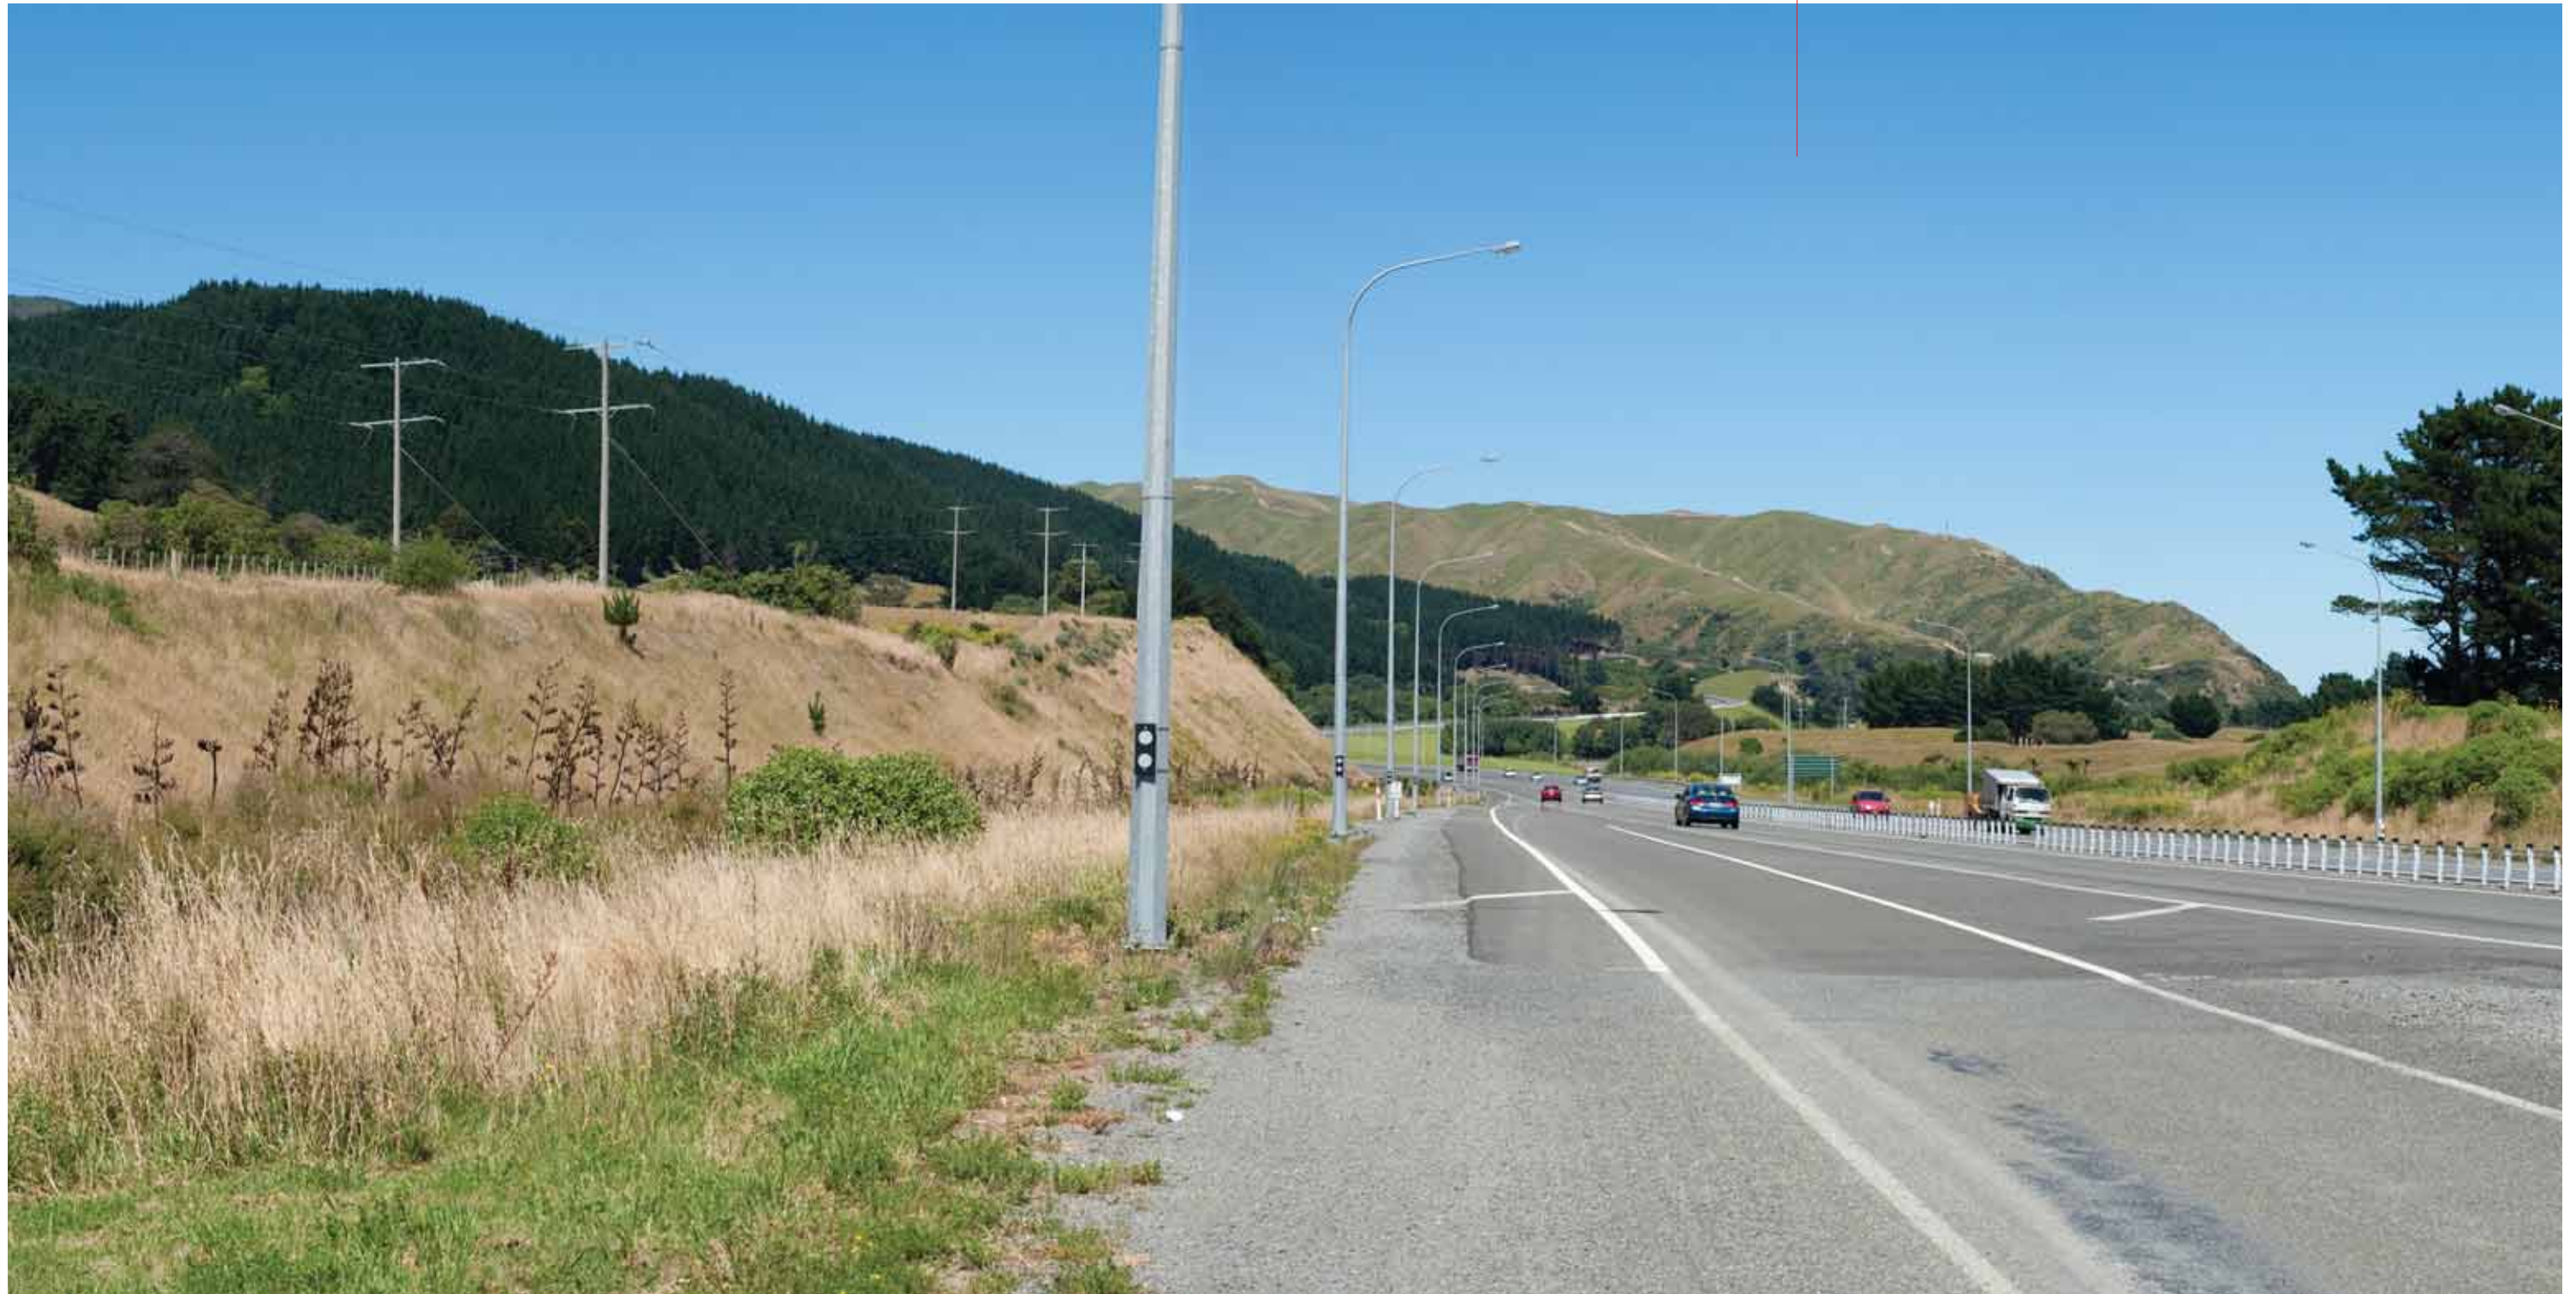
### Viewpoint 1

Looking south from south bound on ramp at MacKays Crossing

### Proposed Road - without Mitigation

**Original Photo** | Lisa Rimmer | 50mm DSLR Nikon D700 | 1218hrs 17th JAN 2012 | E 1766790 N 5462420 (NZTM)  
**Photomontage** | Grace He | Photoshop CS4 & 3ds Max Design | Reading distance for correct scale: 400mm | Computer model elevation: 22m  
**Distance** | 10m from Proposed Road  
 Photomontages should be used as a guide to field observations.

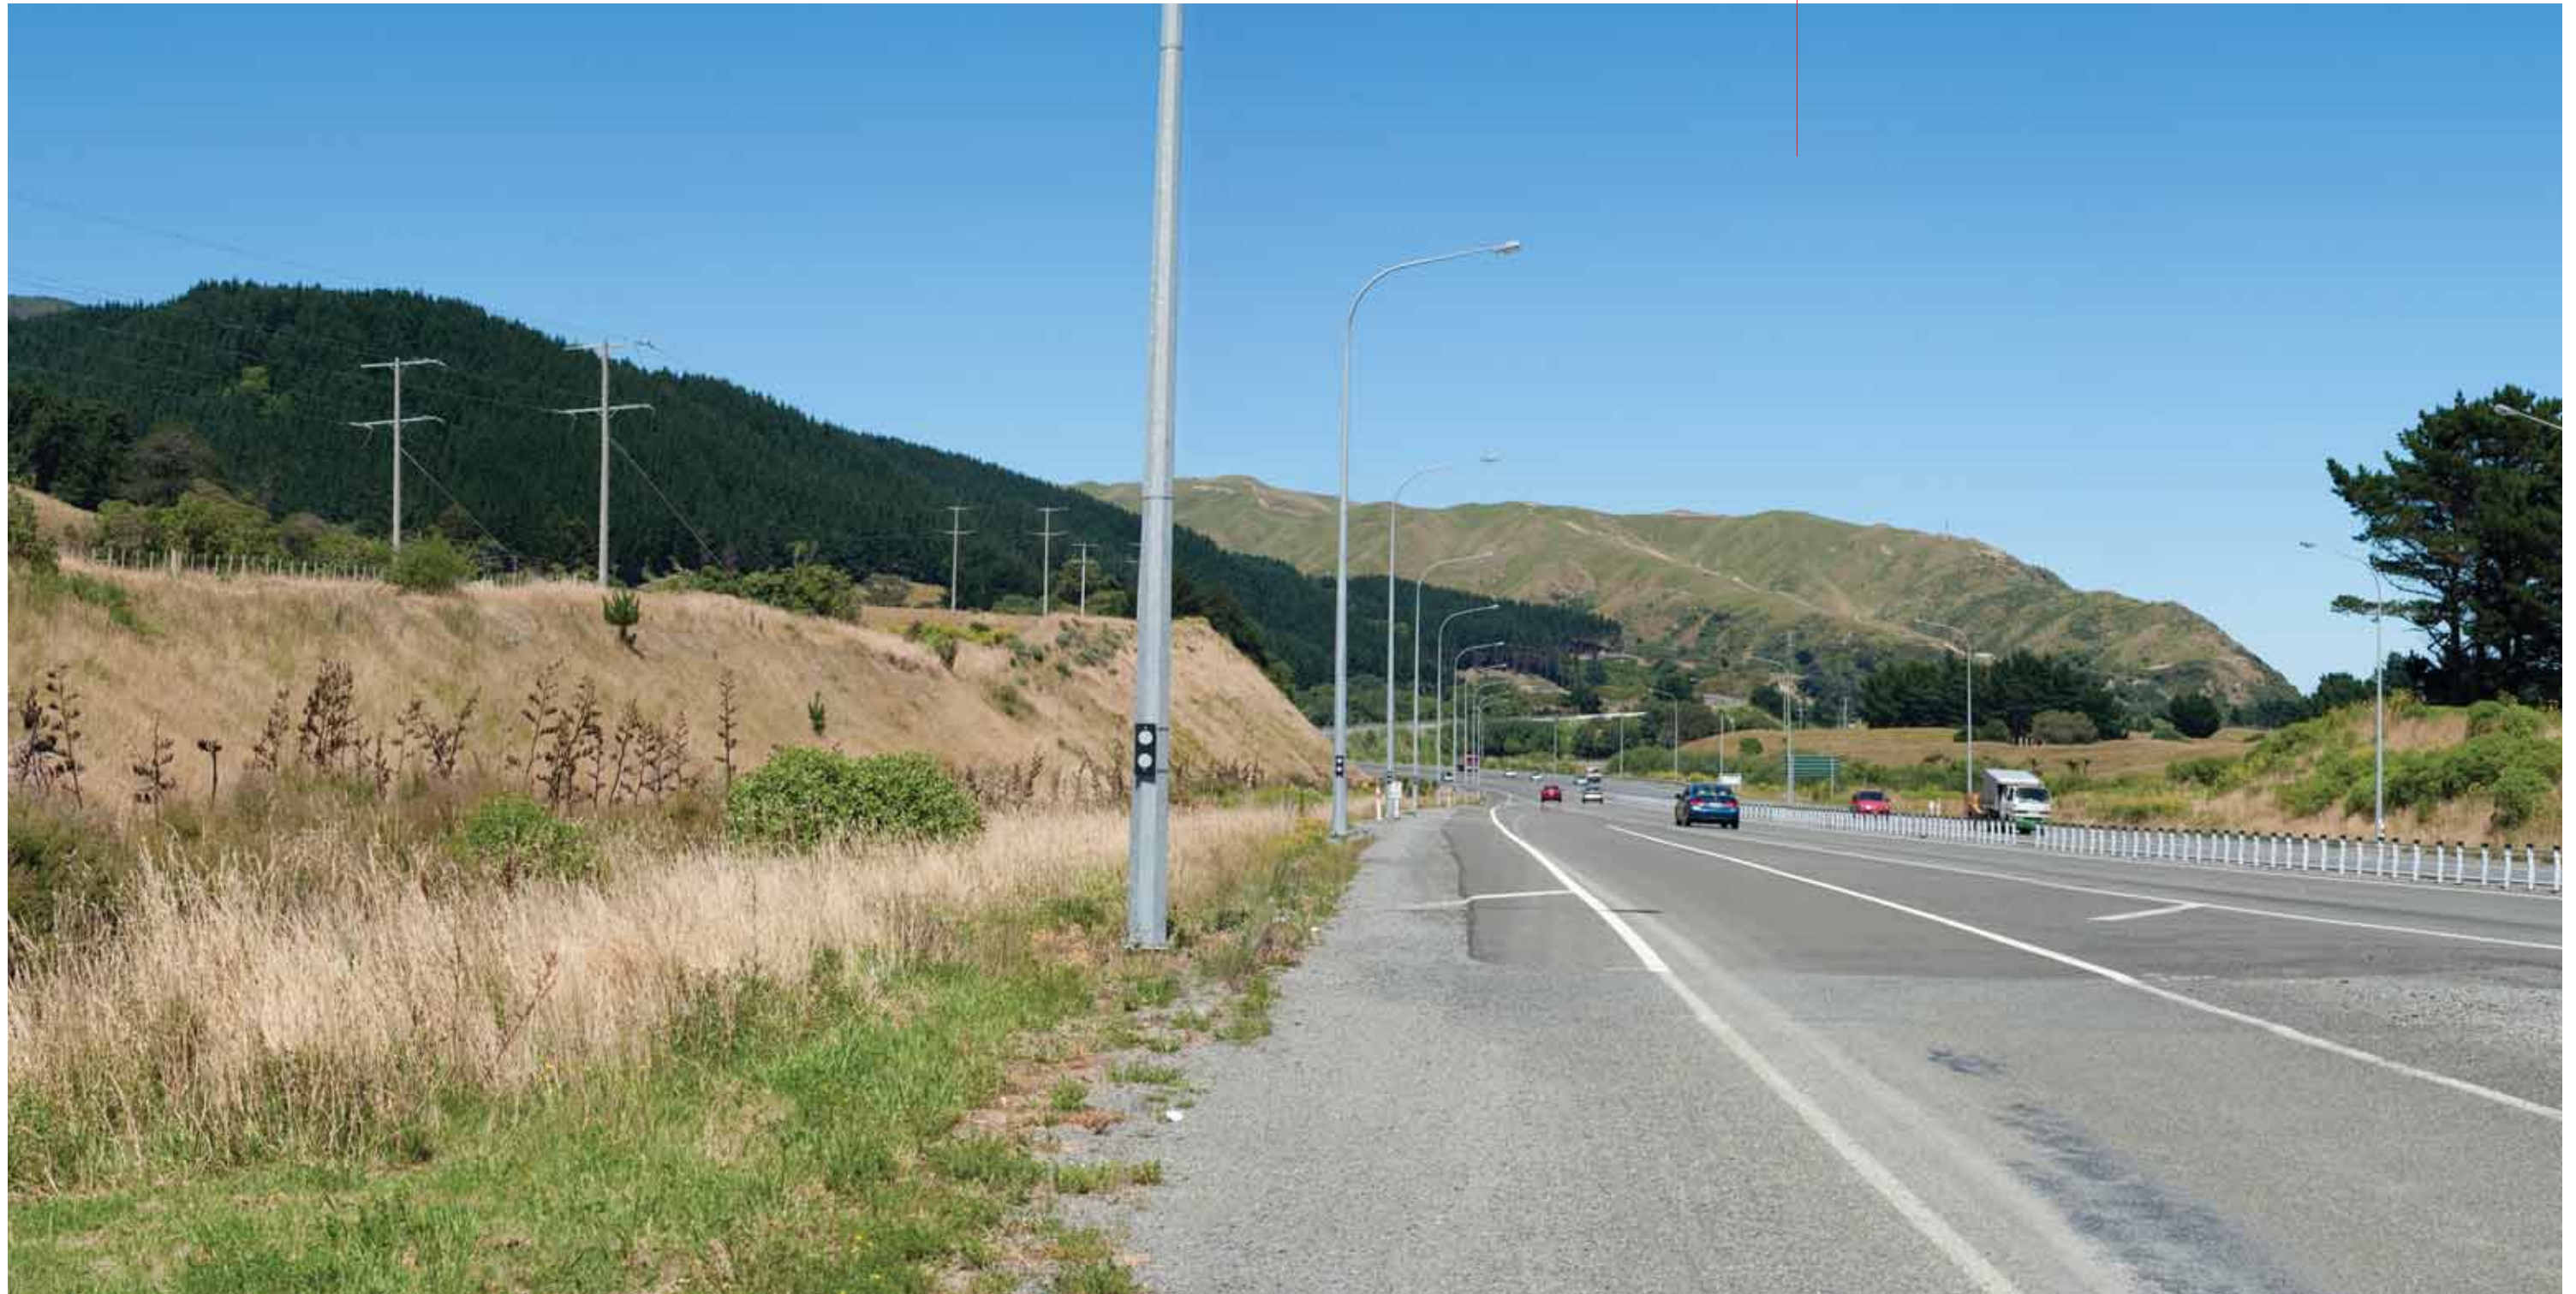
### Viewpoint 1

Looking south from south bound on ramp at MacKays Crossing

### Proposed Road - with Mitigation

**Original Photo** | Lisa Rimmer | 50mm DSLR Nikon D700 | 1218hrs 17th JAN 2012 | E 1766790 N 5462420 (NZTM)

**Photomontage** | Grace He | Photoshop CS4 & 3ds Max Design | Reading distance for correct scale: 400mm | Computer model elevation: 22m

**Distance** | 10m from Proposed Road

Landscape mitigation planting shown at approximately 10 years growth. Note: Photomontage illustrates revegetation of cut and fill batters. It does not illustrate the retirement and enrichment planting of the hillsides within Te Puka valley.
