TRANSMISSION GULLY PROJECT

TECHNICAL REPORT 19 BUILT HERITAGE

Ian Bowman
Architect and conservator

July 2011

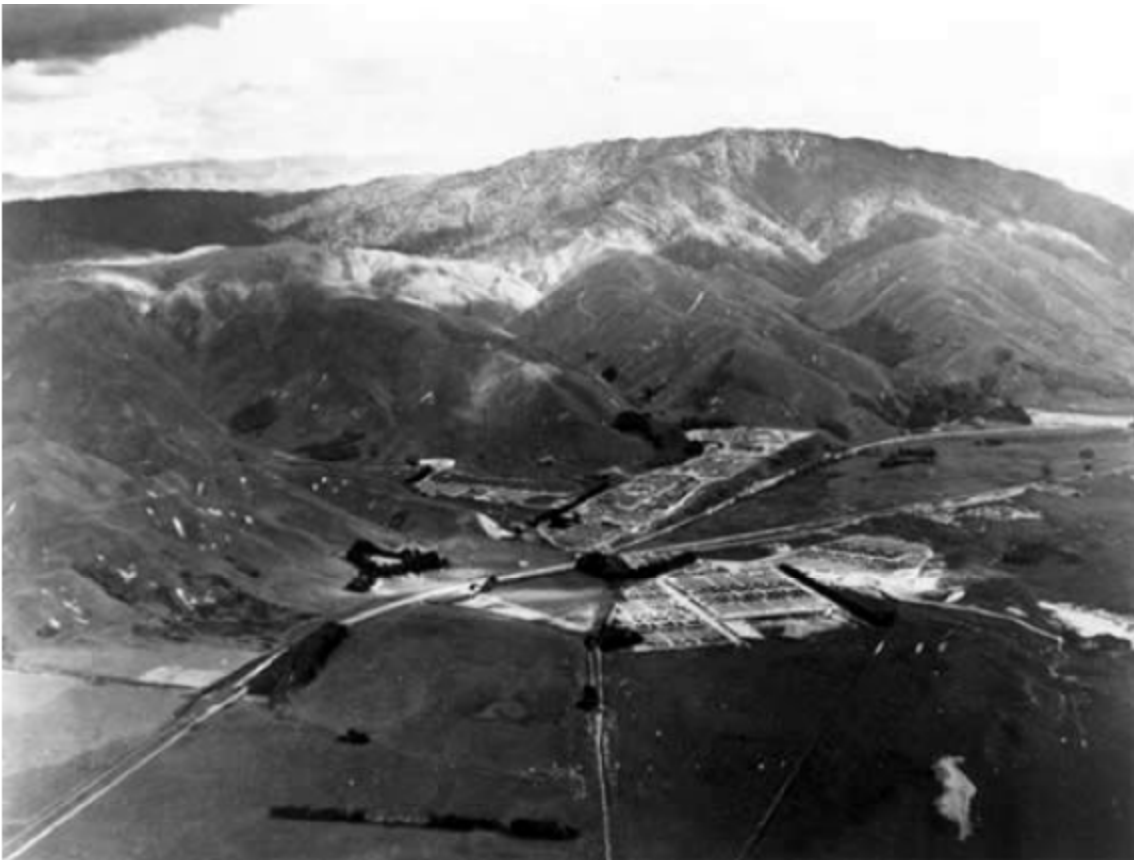
Camps McKay and Russell on either side of the highway at Paekakariki. Alexander Turnbull Library, National Publicity Studios Collection Reference: F 100013 1/2

In the south, the major area of American settlement was on the Kapiti coast, the lovely area between the west coast beaches and the Tararua mountains. At Paekakariki there were two large settlements, Camp Russell (now Queen Elizabeth Park) and, on the other side of the highway, Camp McKay. Close by were further camps at Pauatahanui, Judgeford Valley and Titahi Bay. In all, more than 21,000 men were able to be accommodated in the area.¹

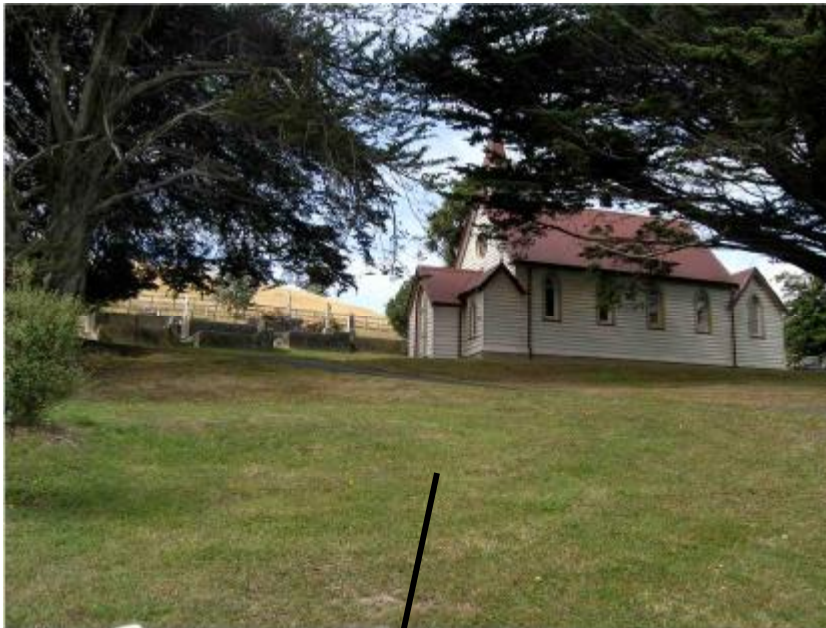
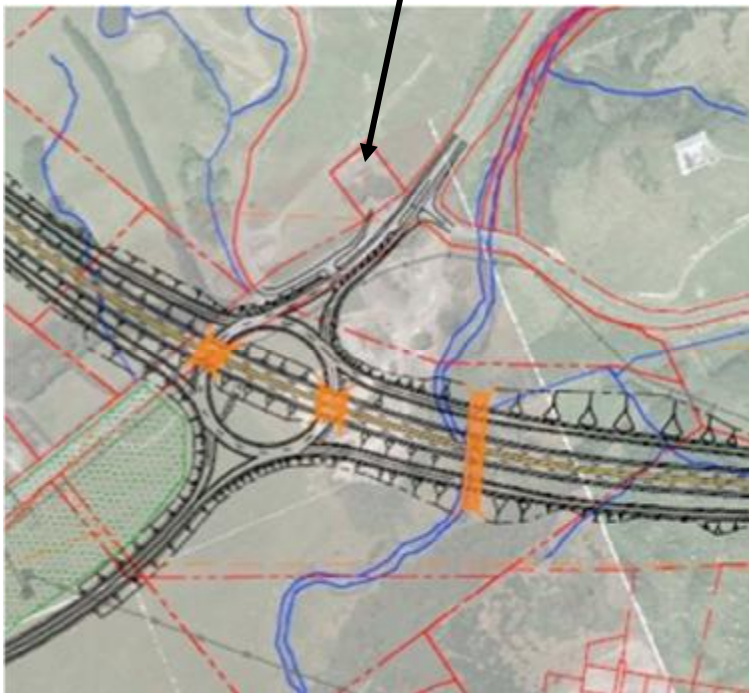
Map	Name	Location	NZHPT Class	Issue/feature
JA02	St Joseph’s Catholic Church	State Highway 58 Pauatahanui	I	Consists of church and graveyard which are well maintained and has been virtually unaltered since 1878. First Catholic Church in Porirua Basin and oldest catholic church building still in use in Wellington.

St Joseph's is the oldest Catholic Church building still in use in Wellington and was the first Catholic Church building in the Porirua basin. Prior to its construction, Catholic services in what was known as the Pahatanui [sic] Small Farms District, were held in a private residence by Father Petijean SM. In August 1876, Henry Abbott, Roderick Mulhern, and Patrick Murphy donated money to acquire land for a new church from local landowner, Thomas Hollis Stace.

St Joseph's is noted for the use of 'poor man's stained glass', a form of printed, coloured transparent paper, imitating the forms and colours of glass. Adjacent to the church is a graveyard where a number of early settlers to the Pauatahanui area are buried.
