Waterview Tunnel Joint Operation
1405 Great North Road
Waterview
Auckland 1026
New Zealand

Stormwater Monitoring - Annual Report 2018

Attachment A: Sample Locations

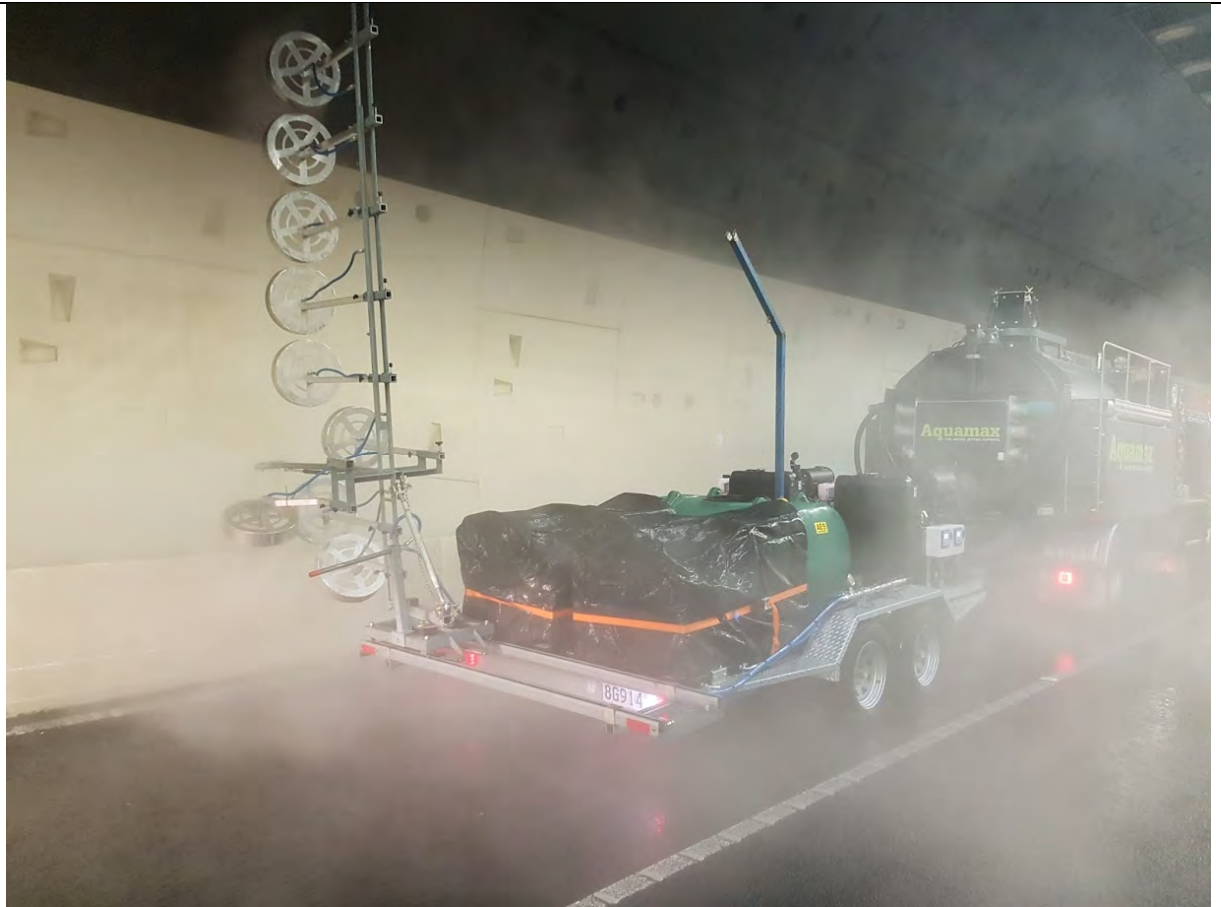
The high pressure wash uses 120 litres of water per minute. This gives approximately over the 5000 m of tunnel wall washed around 30,000 litres of water per night.

Typical Tunnel Washing Setup

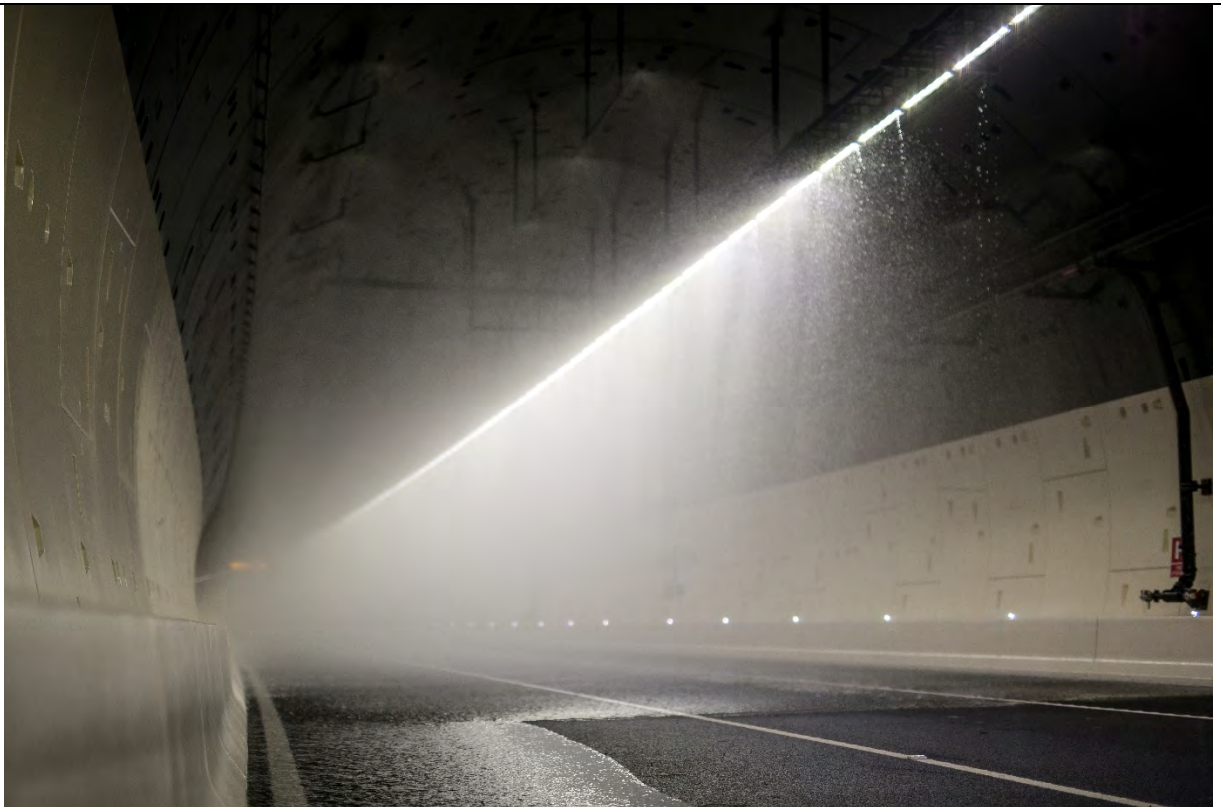
The Tunnel Deluge test commenced shortly after the Tunnel washing started and started at the NBT entrance to the exit. The deluge proceeded zone by zone and took only a couple hours.

Typical Deluge Setup

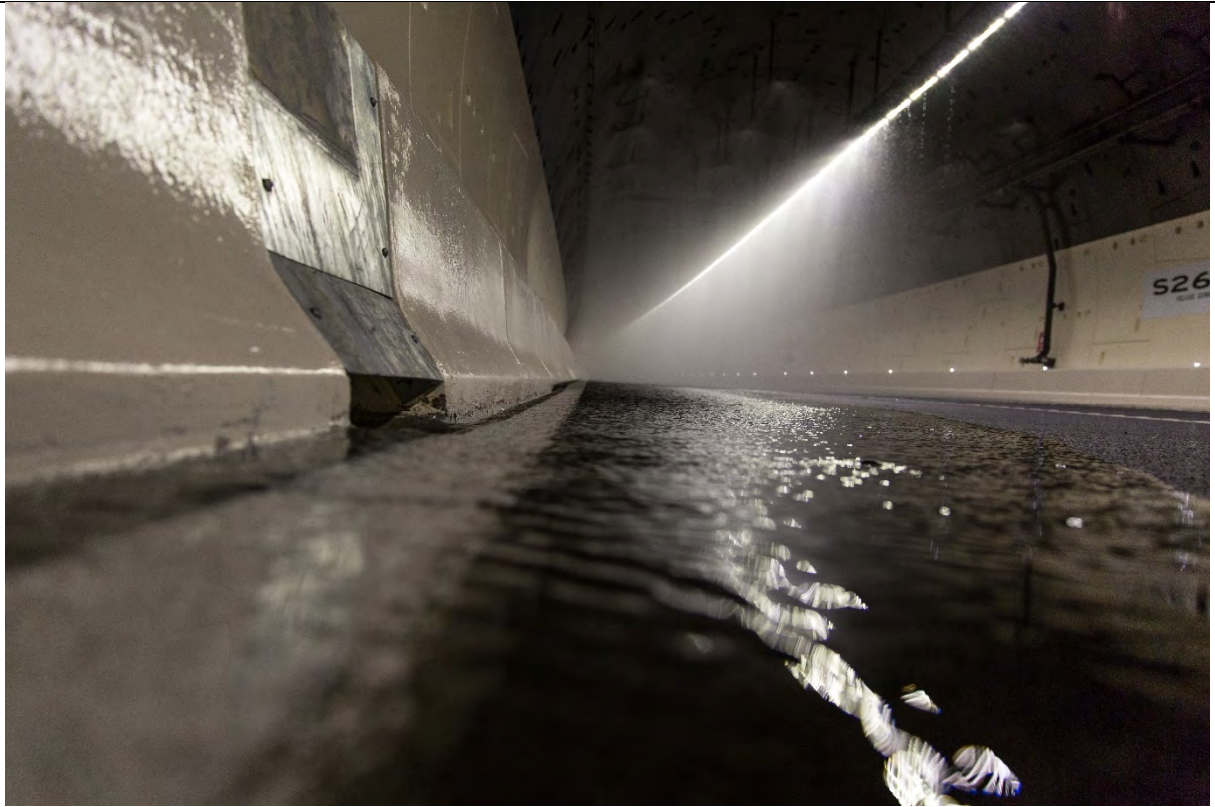
Typical Deluge run off into drain

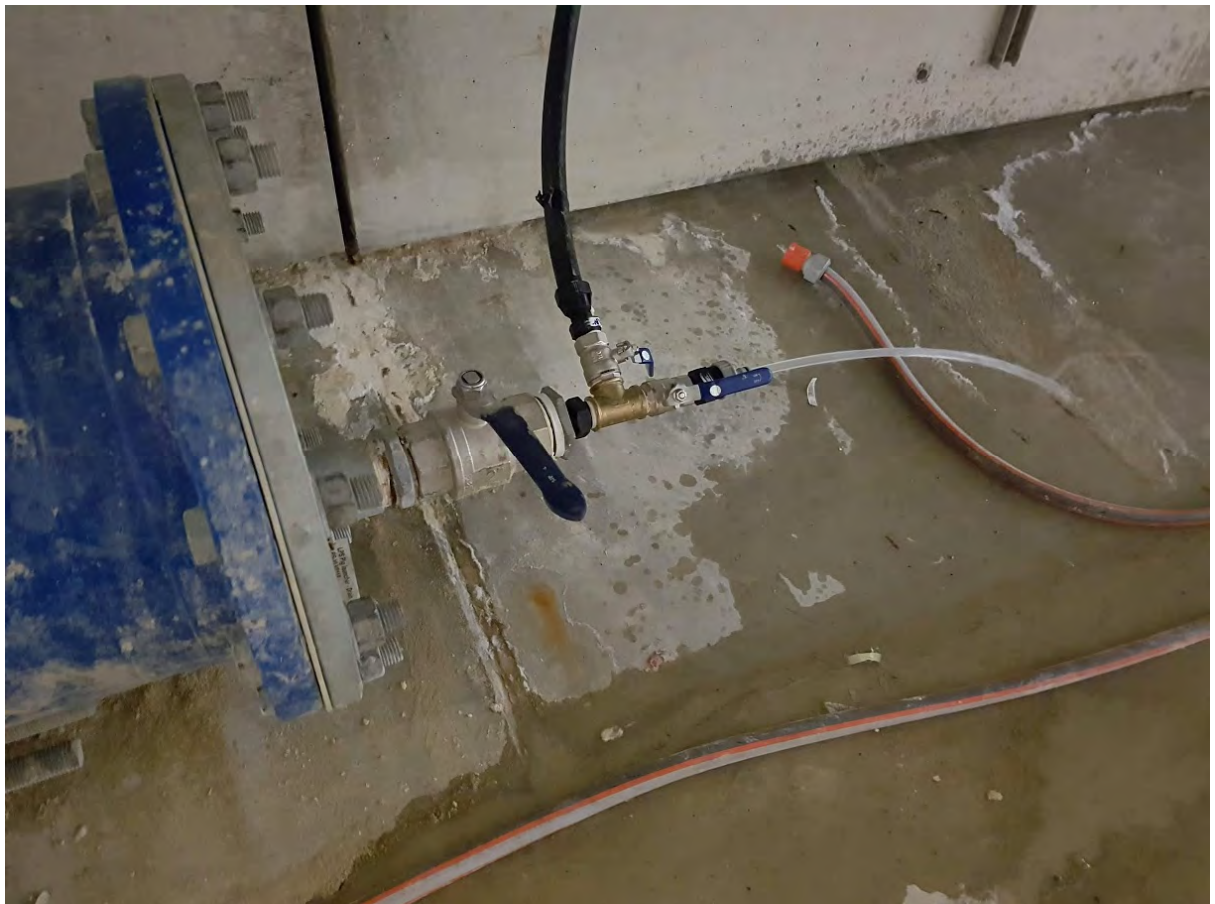
Sample was taken from the discharge pipe in the North Bound Culvert at XP14. The sample delivery line was flushed to ensure a presentative sample was taken.

Sample point at North Bound Culvert XP14

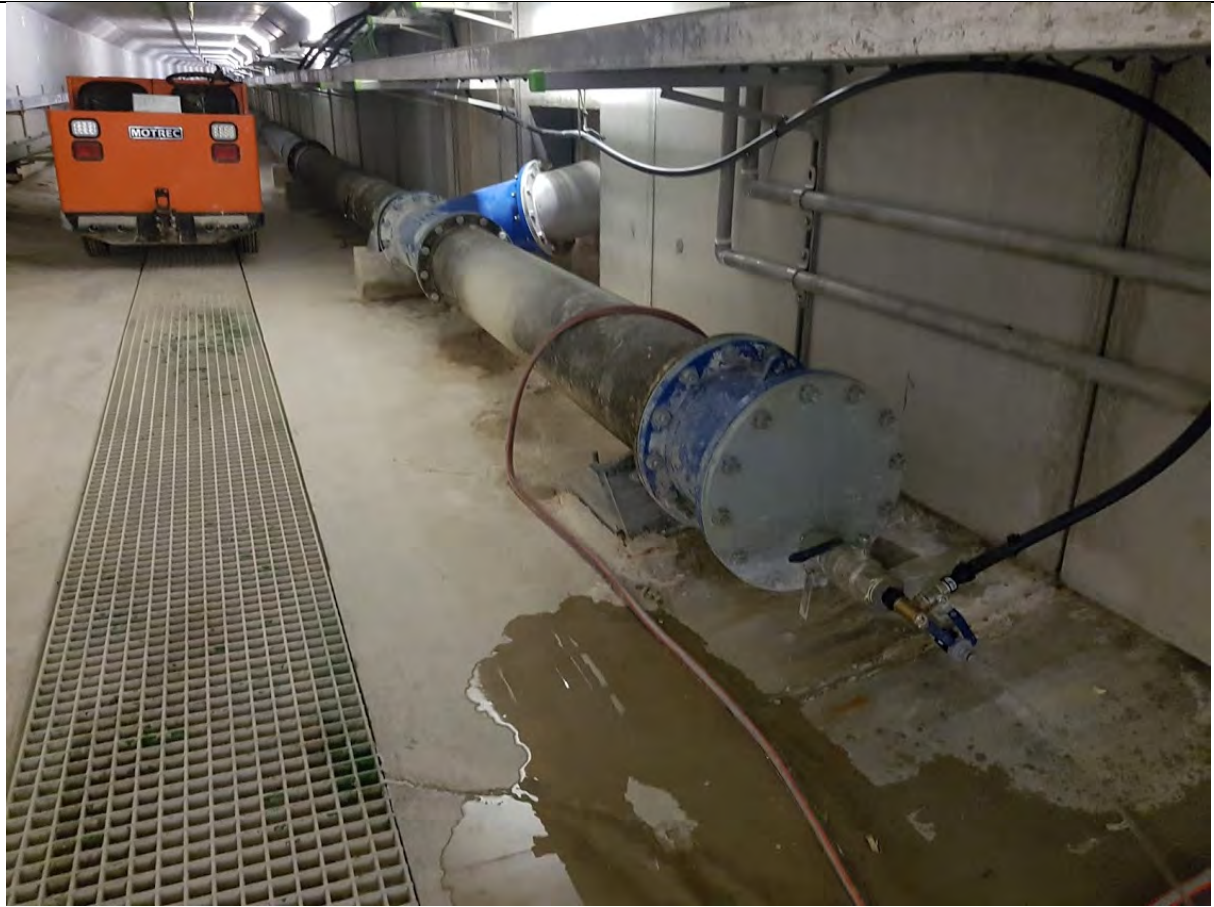
Pipe Work and Sample point at North Bound Culvert XP14

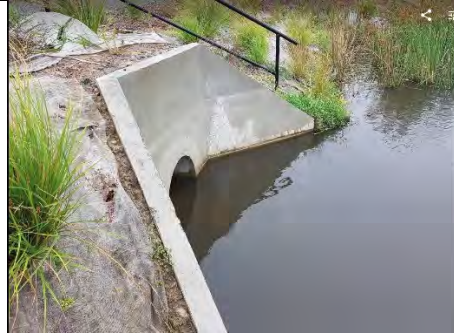
Pond level slightly raised, low flow from inlet. No erosion or damage was seen.

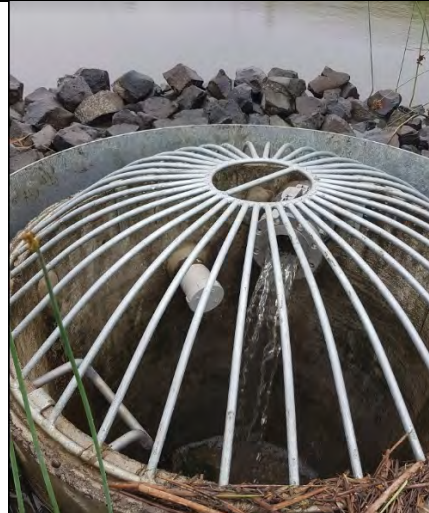
Waterview Reserve Wetland Outlet

Pond level slightly raised, low flow from outlet, not high enough to discharge over the culvert weir. No erosion or damage was seen.

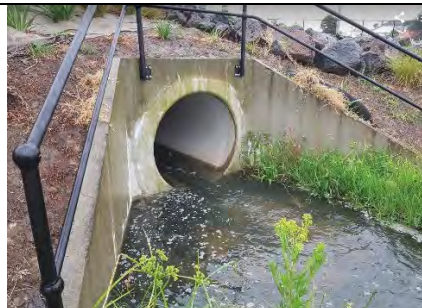
Valonia Wetland Inlet

Pond level raised, medium flow from inlet. Solids like leaves seen in the flow. No erosion or damage was seen.

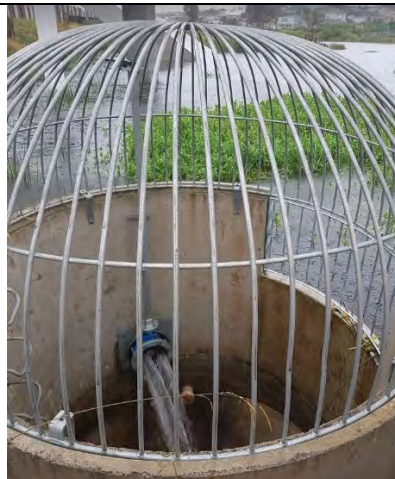
Valonia Wetland Outlet

Pond level raised, medium flow from outlet, not high enough to discharge over the culvert weir. No erosion or damage was seen.

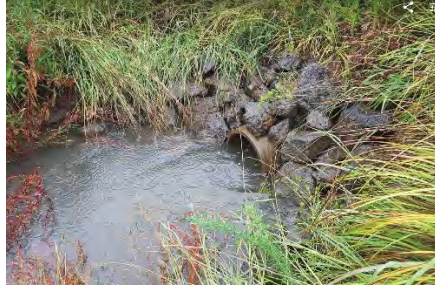
Alan Wood Wetland Inlet

Pond level raised, medium flow from inlet. No erosion or damage was seen.

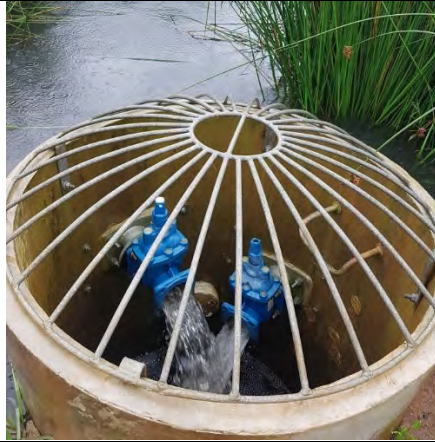
Alan Wood Wetland Outlet

Pond level raised, medium flow from outlet, both valves, not high enough to discharge over the culvert weir. No erosion or damage was seen.

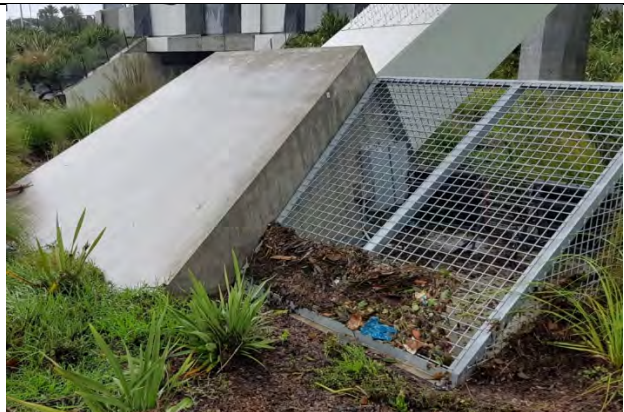
Barrymore – Kukuwai Park / Te
Whitanga Footbridge Footing

Debris around footing

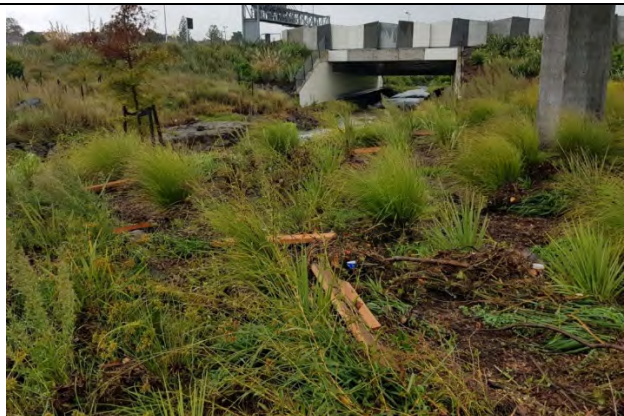
Barrymore – Kukuwai Park / Te
Whitanga Footbridge Footing

Debris from Oakley Creek Te Auaunga
/ Richardson Road Pedestrian
underpass construction site.

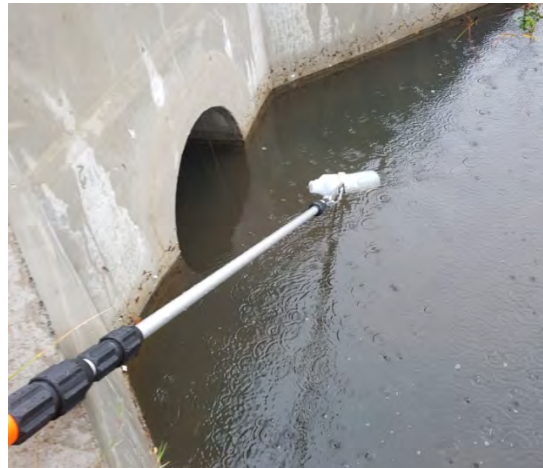
Waterview Reserve Wetland Inlet

Pond level slightly raised, low flow from inlet as rain event had passed with only rain squalls occasionally. Had Tunnel Operator at ATOC turn the North Sump Pump to Waterview Wetland on to achieve a sample.

No erosion or damage was seen.

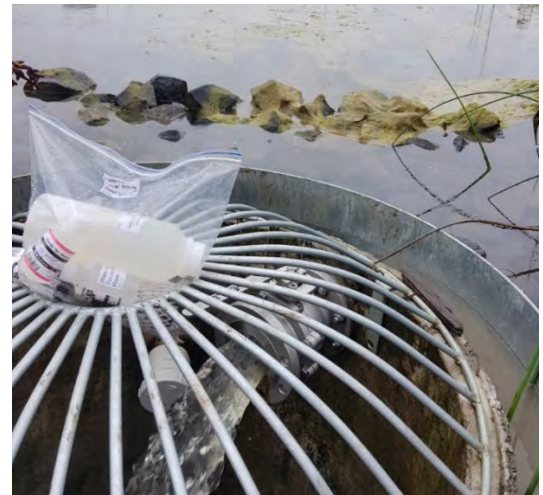
Waterview Reserve Wetland Outlet

Pond level slightly raised, medium flow from outlet, not high enough to discharge over the culvert weir. No erosion or damage was seen.

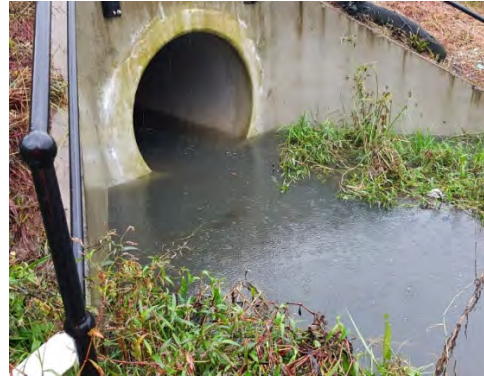
Valonia Wetland Inlet

Pond level raised, low flow from inlet as rain event had passed with only rain squalls occasionally. No erosion or damage was seen.

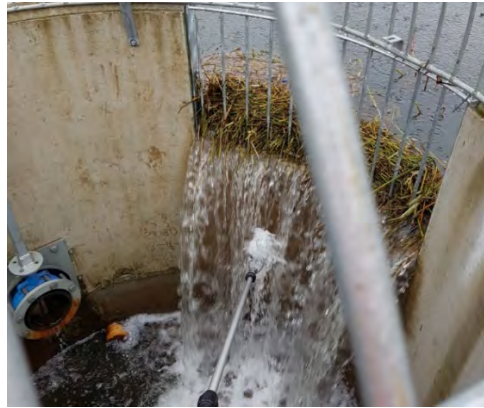
Valonia Wetland Outlet

Pond level slightly raised, medium flow from outlet, high enough to discharge over the culvert weir. No erosion or damage was seen. Note the plant debris on the weir protection grate. Could do with a gap to allow passage of this material. Cleared the debris after sample taken.

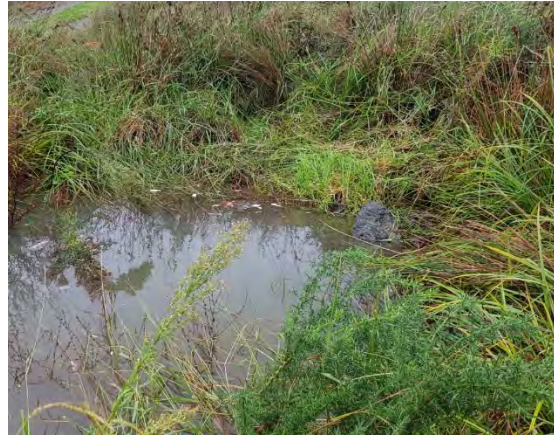
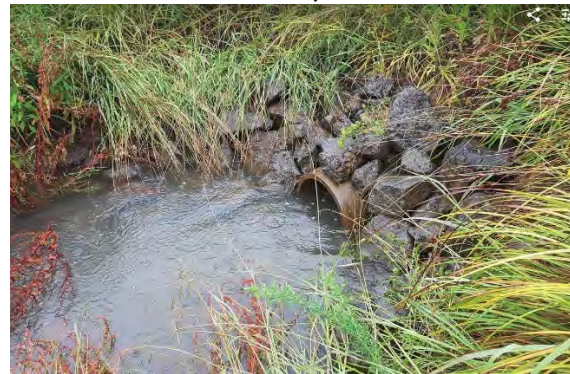
Alan Wood Wetland Inlet

One can see that the outlet pipe is completely overgrown and need to be cleared (AMA have been sent a MEX order to tidy up parts of the pond).

Last sample on 14th April it was thought that the outlet pipe was completely overgrown. This is revised as the wetland water level at the time was high and covering the inlet.

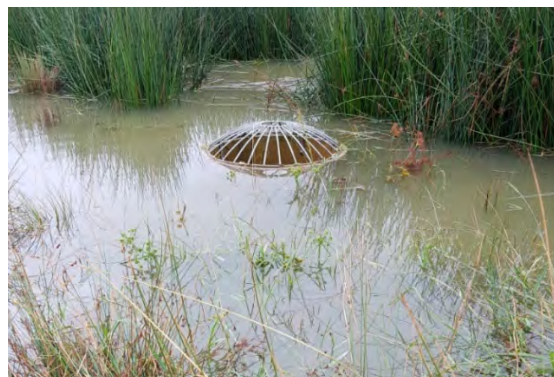
Alan Wood Wetland Outlet

Pond level raised, medium flow from outlet, both valves, almost high enough to discharge over the culvert weir. No erosion or damage was seen. Water was discoloured.

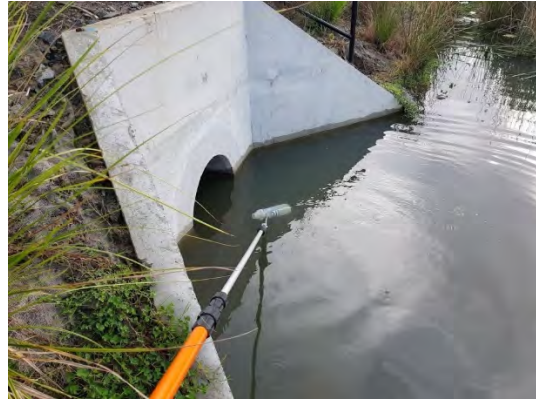
Pond level slightly raised, good flow from inlet, rain event had passed with only rain squalls occasionally. North Sump Pump to Waterview Wetland was operating.

No erosion or damage was seen.

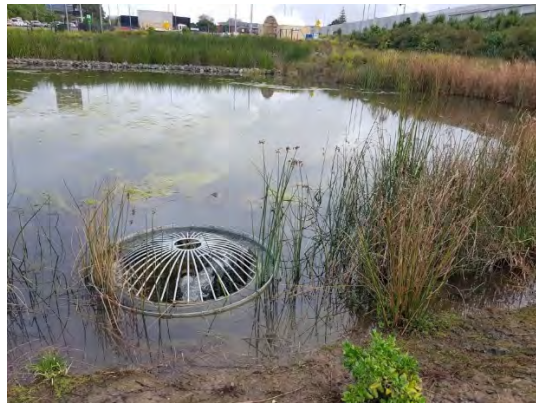
Waterview Reserve Wetland Outlet

Pond level slightly raised, medium flow from outlet, just high enough to discharge over the culvert weir. No erosion or damage was seen.

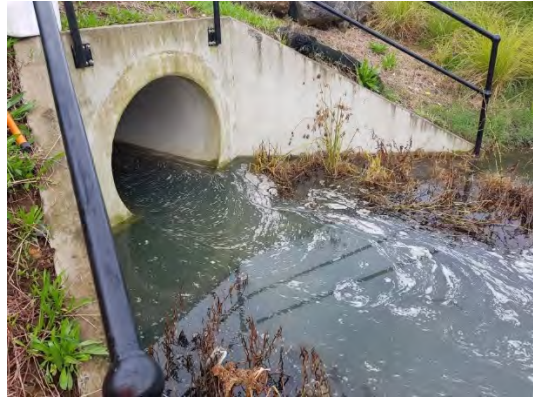
Valonia Wetland Inlet

Pond level raised, low flow from inlet as rain event had passed with only rain squalls occasionally. Scum on surface but no oil visible. A lot of rubbish had been flushed into the Wetland. No erosion or damage was seen.

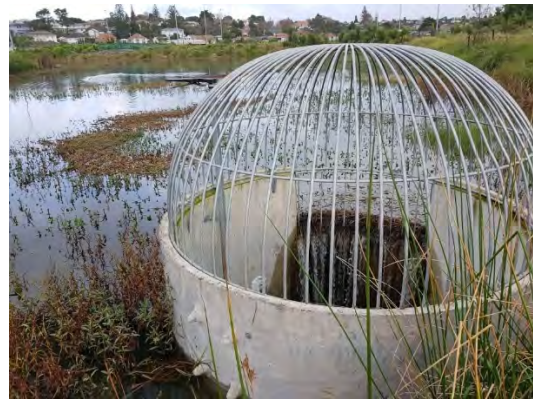
Valonia Wetland Outlet

Pond level slightly raised, medium flow from outlet, high enough to discharge over the culvert weir. No erosion or damage was seen. Note the plant debris on the weir protection grate. Could do with a gap to allow passage of this material. Cleared the debris after sample taken.

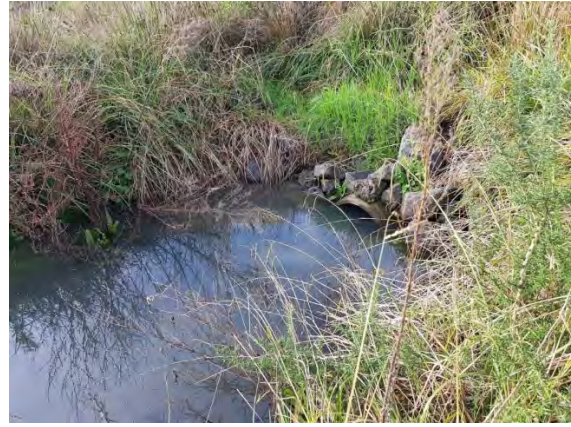
23rd May 2018

No erosion or damage was seen.

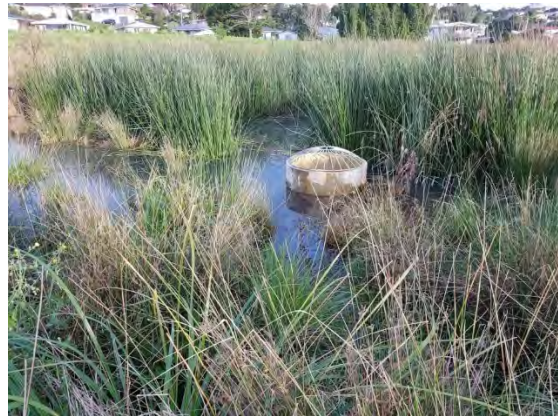
Alan Wood Wetland Outlet

Pond level raised, medium flow from outlet, both valves, almost high enough to discharge over the culvert weir. No erosion or damage was seen. Water was clear.

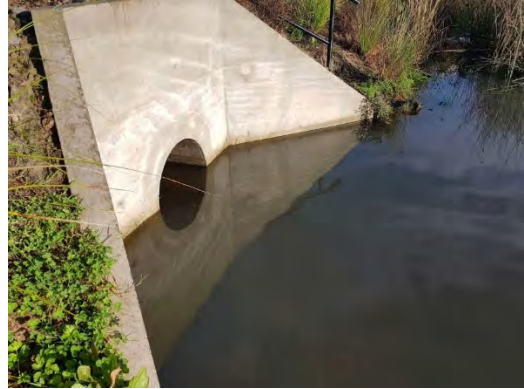
Pond level slightly raised, good flow from inlet, rain event had passed. Water was very clear. No erosion or damage was seen.

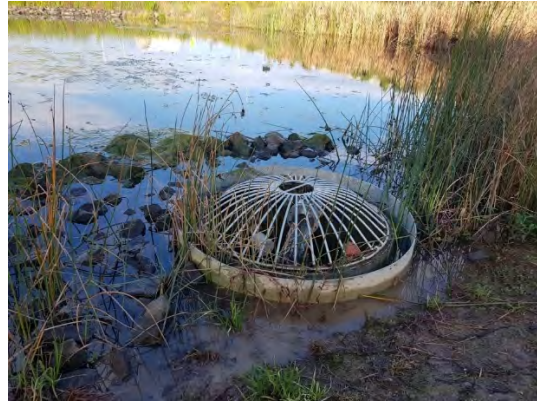
Waterview Reserve Wetland Outlet

Pond level slightly raised, low to medium flow from outlet, Water was clear. No erosion or damage was seen.

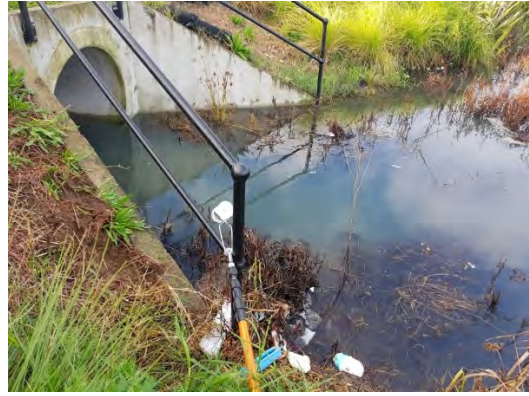
Valonia Wetland Inlet

Pond level raised, low flow from inlet as rain event had passed. A lot of rubbish was present. No erosion or damage was seen.

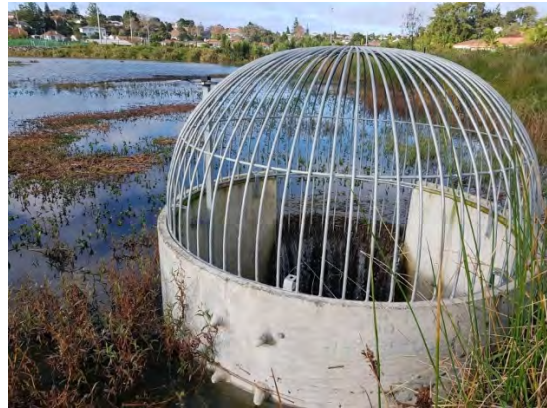
Valonia Wetland Outlet

Pond level slightly raised, medium flow from outlet, high enough to discharge over the culvert weir. No erosion or damage was seen. The weir protection grate is to be modified.

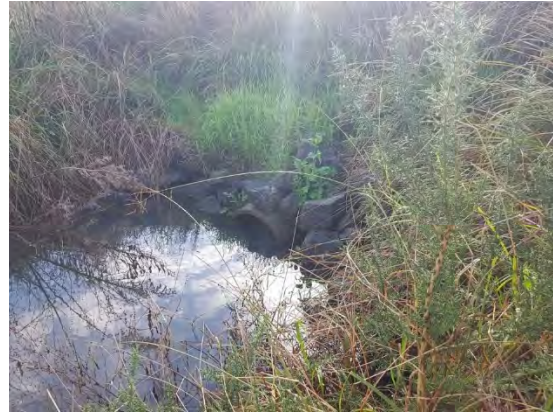
Pond level raised, low flow from inlet as rainfall event had passed.

No erosion or damage was seen.

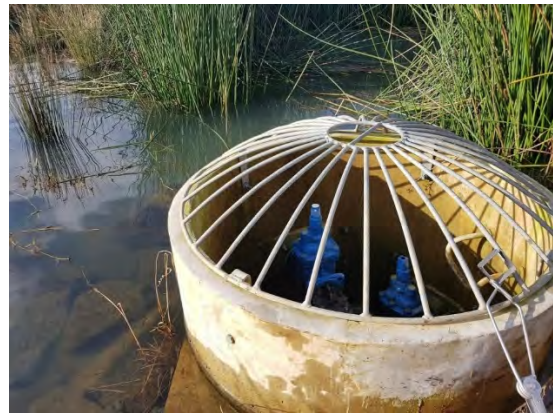
Alan Wood Wetland Outlet

Pond level raised, low flow from outlet, both valves. No erosion or damage was seen. Water was clear.
