# **Pavement moisture measurement to indicate risk to pavement life March 2017**

Arnold, G, P Fon Sing, T Saarenketo and T Saarenpaa (2017) Pavement moisture measurement to indicate risk to pavement life. *NZ Transport Agency research report 611*. 160pp.

**Keywords:** drainage, ground penetrating radar, laser scanner, moisture, monitoring, water content

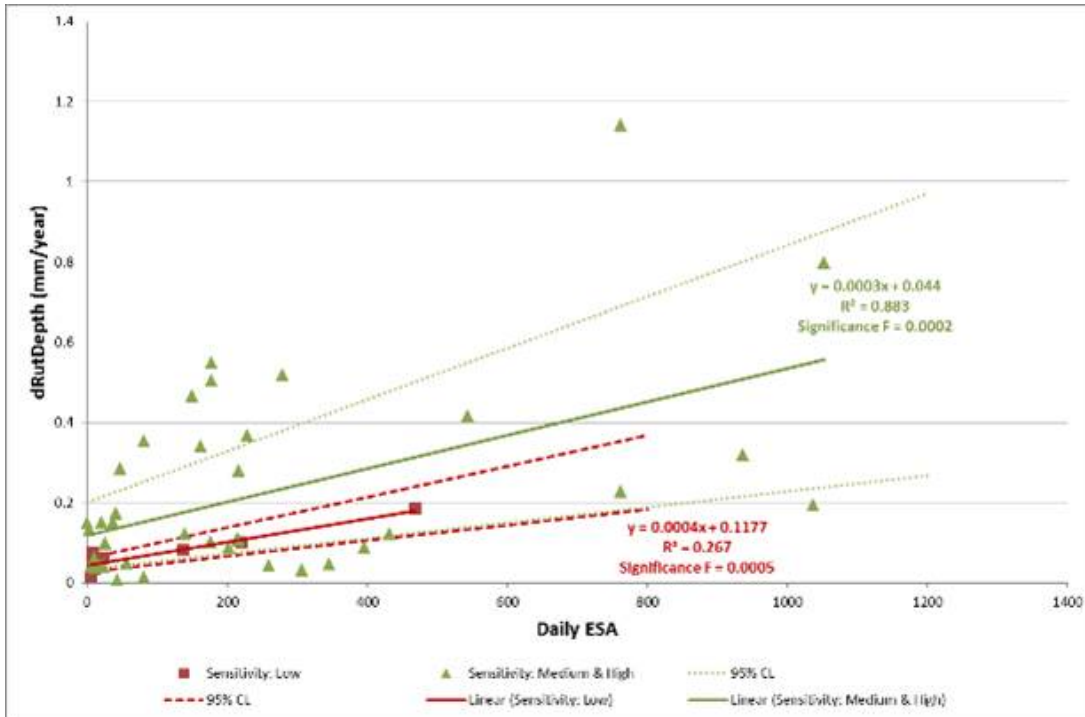
**Figure 1.1 Rut progression as a function of traffic loading and environment (Henning et al 2014)**

Studies by Henning et al (2014) on the long-term pavement performance (LTPP) sites found poor drainage was the number one factor affecting the rate of rutting and roughness deterioration. Two trends were observed: one for sites having adequate drainage and the other for sites having inadequate drainage. There was a slight absolute difference between the deterioration rates of the two drainage states with sites with inadequate drainage having approximately 2.5 times the deterioration rate compared with those sites with adequate drainage (figure 1.1). For example, at 400 ESA per day the rut rates are 0.65 and 0.25 for inadequate and adequate drainage respectively.

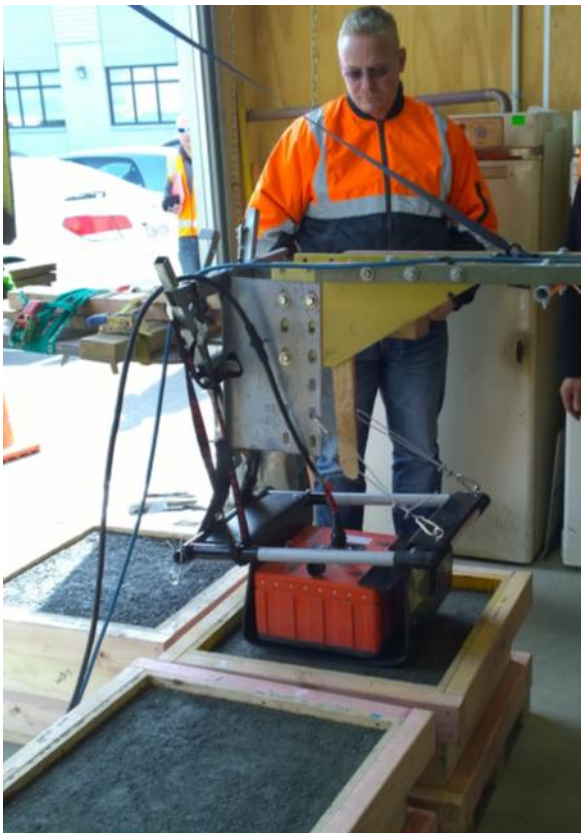
**Figure 2.2 Performing 'box tests' in Downer laboratory in Auckland. In this case measurements are carried out using 400 MHz ground coupled antenna**

- 1 Before starting GPR testing a sample for grading analysis and initial water content was taken to be analysed in the laboratory.
- 2 First GPR measurements were made with two different antennas and with the percometer surface probe and box weighed. Then two litres of water were added to the material surface.
- 3 After 1.5 hours the GPR and percometer measurements were repeated and box was weighed.
- 4 This process was repeated until water saturation was apparent.

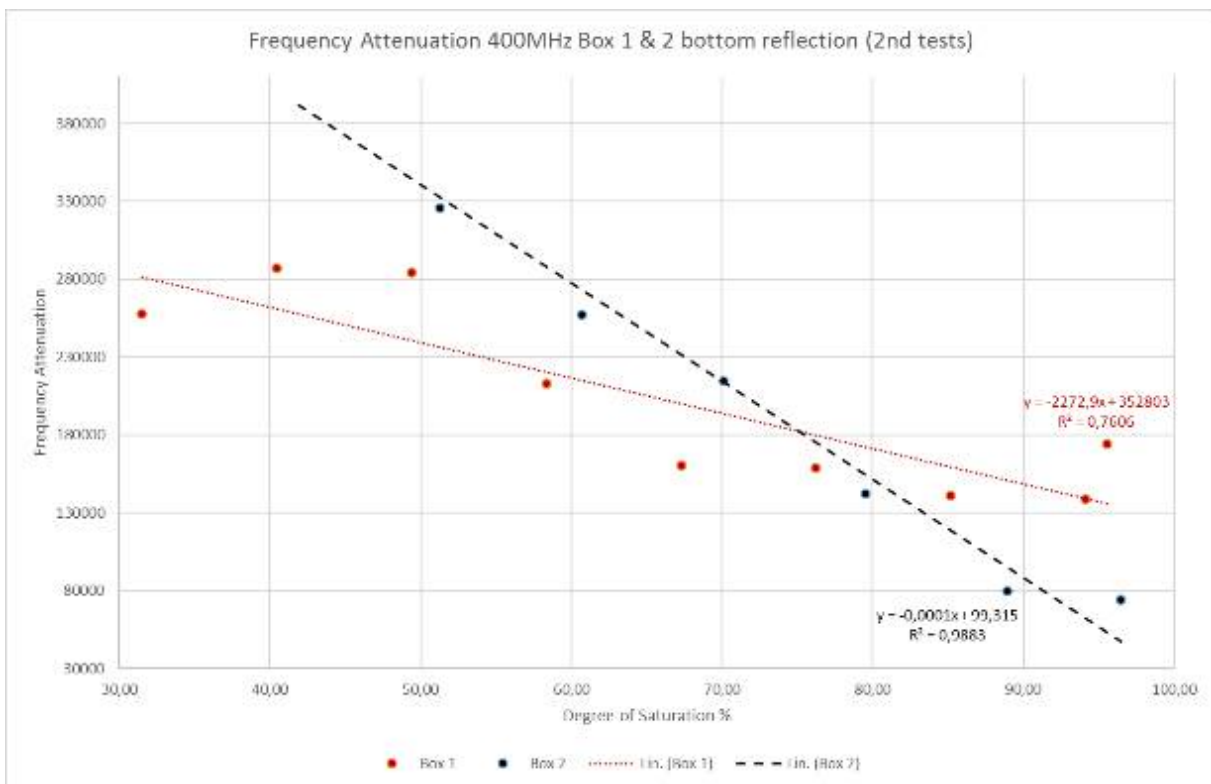
**Figure 2.6** Correlation between frequency attenuation and saturation degree of Winstone aggregate (box 1) and Poplar Lane Quarry basecourse aggregate (box 2)

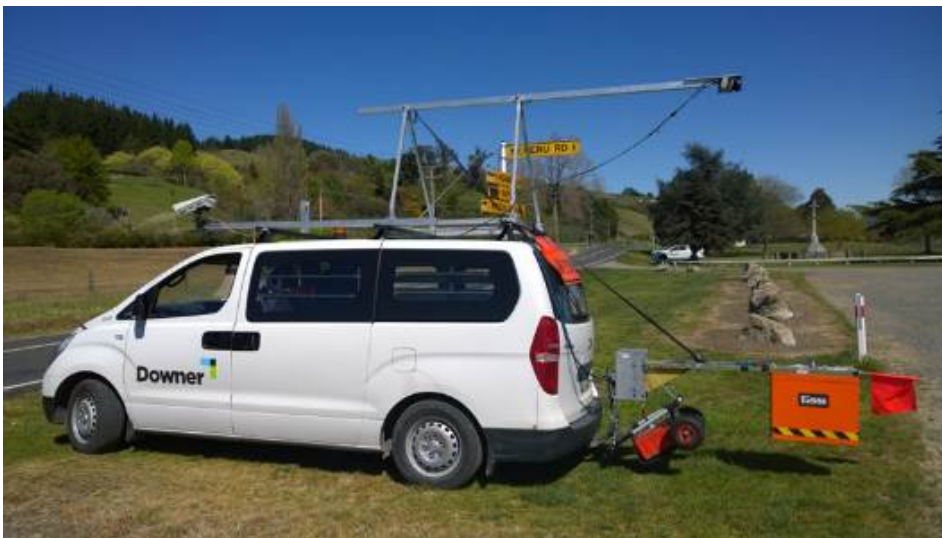
**Figure 2.7** The survey van equipped with video camera (top front), laser scanner (high up), GPR ground coupled antenna (red box with wheels, elevated) and air coupled antenna (orange box far rear)

The data collection in New Zealand started in early October 2015 with setting up Roadscanners ground penetrating equipment, GPS, video and laser scanner to a Downer vehicle (figure 2.7). The GPR unit was GSSI SIR-30 equipped with 2 GHz air coupled and 400 MHz ground coupled antenna mounted in the rear. The GPR data was collected with 10 scans per metre and 1,024 samples per scan. The air coupled antenna had 25ns time window, while the ground coupled was set to use 100ns time window. The video was in the front of the van collecting the data from the road surface and surroundings. The laser scanner was in the rear of the vehicle, elevated to 3m in height to be able to scan the road surface as well as the surroundings (ditches and side slopes).

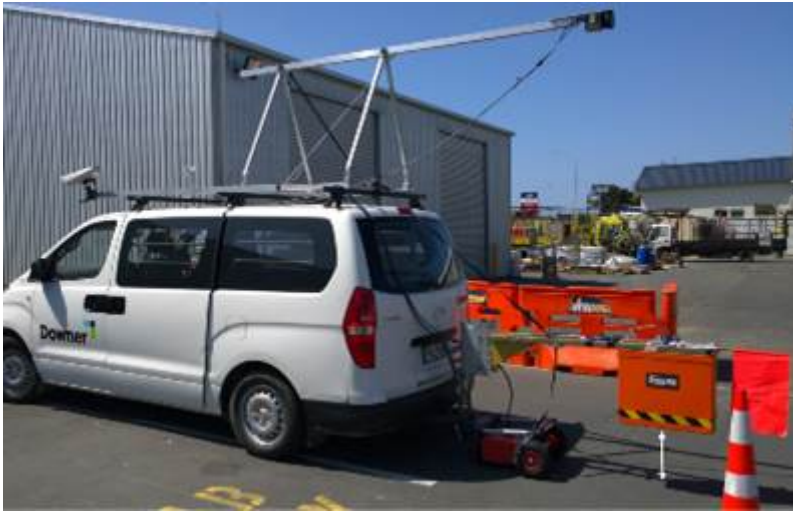
**Figure 2.9** Antenna elevation analysis for roughness surveys (exact distance from antenna to pavement surface is measured continuously)

In addition, horn antenna elevation information could be used to describe the roughness of the road. This was done by measuring the distance from the horn antenna to the pavement surface, which varied greatly on rough pavement surfaces (figure 2.9).

Extra information that can be collected from air coupled horn antenna data is antenna elevation measurement for roughness detection, a parameter that has been also called the 'poor man's international roughness index'. Figure 2.9 describes the basic principle of the measurement technique and results of this data can be seen in different figures in this report.

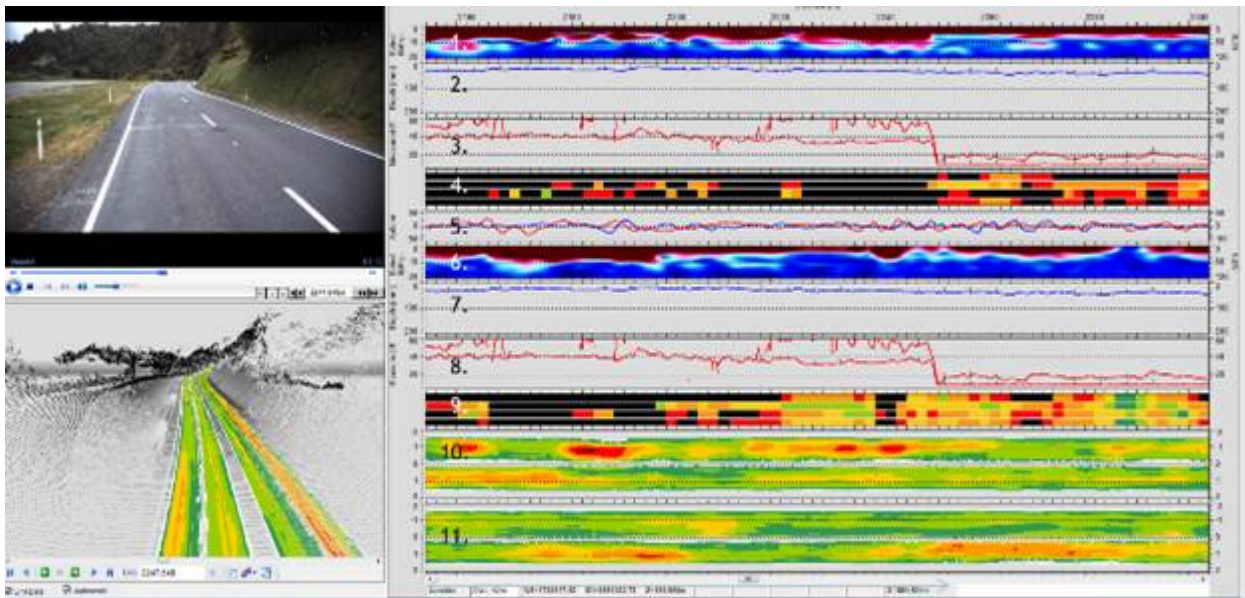
**Figure 2.10** Example of steel slag made from magnetite sand on dielectric value of pavement surface on SH3 Mount Messenger

Figure 2.10 shows fields 1 and 6 present 400MHz GPR moisture profiles (left and right lanes), fields 2 and 7 present bituminous pavement thickness and fields 3 and 4 present dielectric values from pavement surface (lower line) and basecourse surface (higher line). Fields 4 and 9 present MDI data. Field 5 presents antenna elevation data and fields 10 and 11 present rut depth maps from left and right lanes.

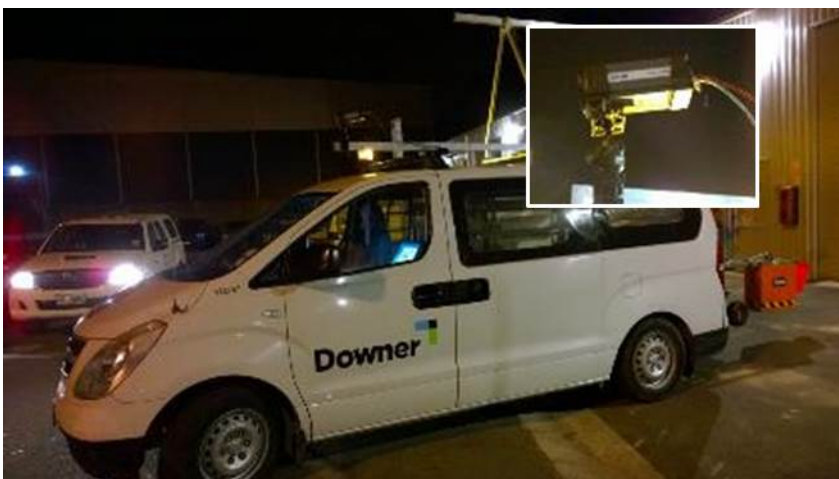
**Figure 2.16 Installation of thermal camera in the survey vehicle**

A thermal camera was mounted on Downer's survey van using a similar clamp as for the video camera (figure 2.16). There was no video camera while capturing infrared data because it was night time.

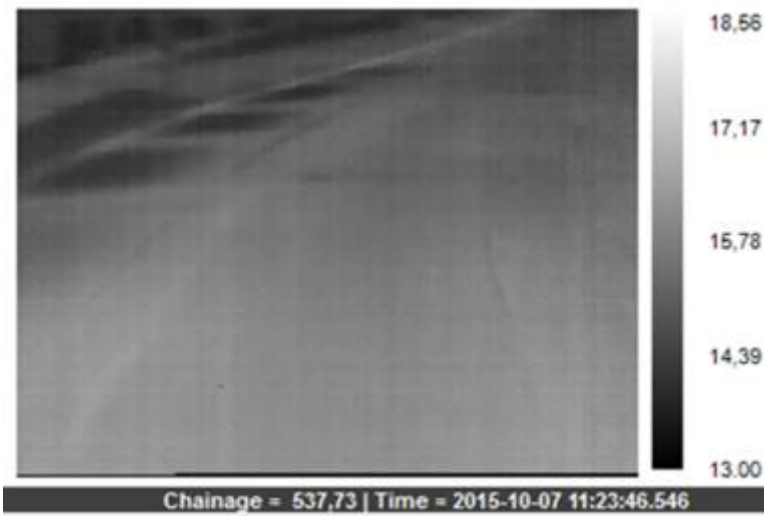
**Figure 2.17** Thermal camera data from Lyttleton Avenue (D1, L2). Cool anomalous areas, compared with the surroundings, are caused by car parked during the day

Collected infrared data was analysed and linked to the Road Doctor software for further analysis. The thermal camera survey could not detect wet areas on the roads surveyed. Most likely the difference in temperature between day and night was not great enough to get similar results as those seen in Finland. Error sources like shadows from the trees and parked cars can be seen even hours after the sun has gone down (figure 2.17).

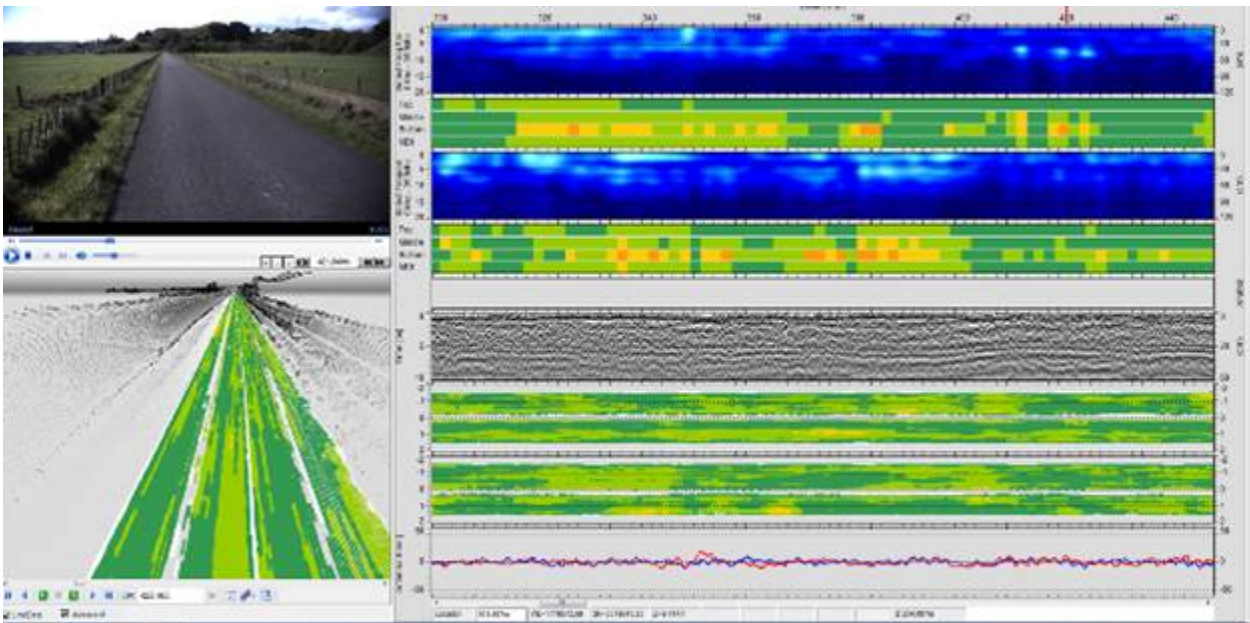
**Figure 3.5** Example of a good quality road section with no moisture- related problems (blue areas indicate dry and the LIDAR point cloud is mostly green indicating nil rutting)

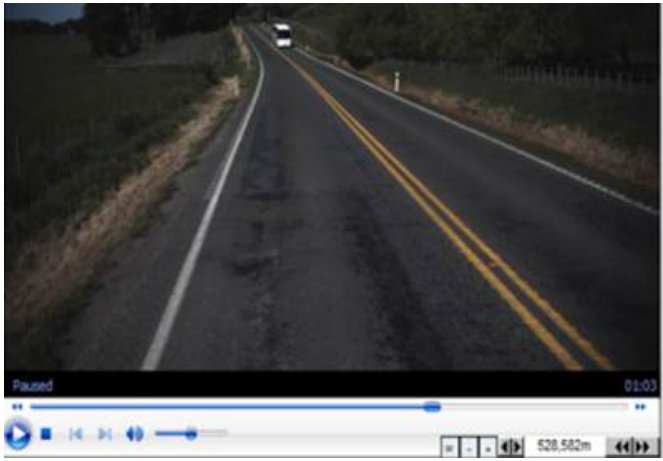
<p>Video</p>

<p>The video can be expanded to full screen and the picture assists in giving more information to support or otherwise a drainage problem and the type of treatment. Chipseal flushing shown here supports high levels of saturation within the pavement layers.</p>

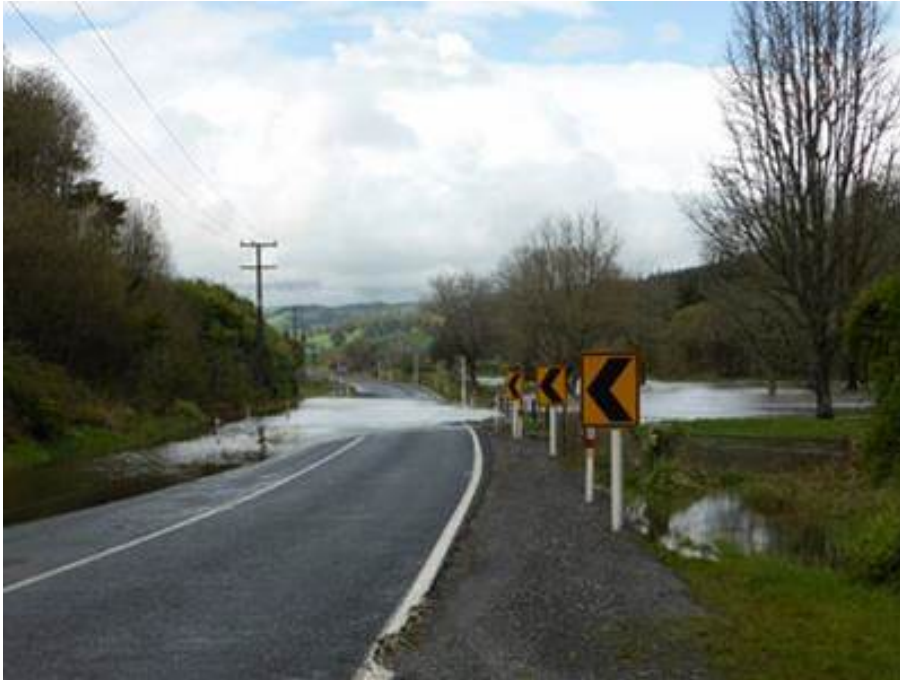
**Figure A.1 Heavy rainfall and an inadequate drainage system can cause flooding and erosion around and under the road pavement. Water infiltrating the pavement structures also reduces the stiffness and bearing capacity of the road and exposes the pavement to permanent deformation**

If water flows uncontrollably on the road surface or if the drainage system has inadequate capacity, it causes flooding and erosion (figure A.1). The places of high erosion risk are culverts. Clogged or too small culverts steer the water towards the road and saturate it until it is destroyed.

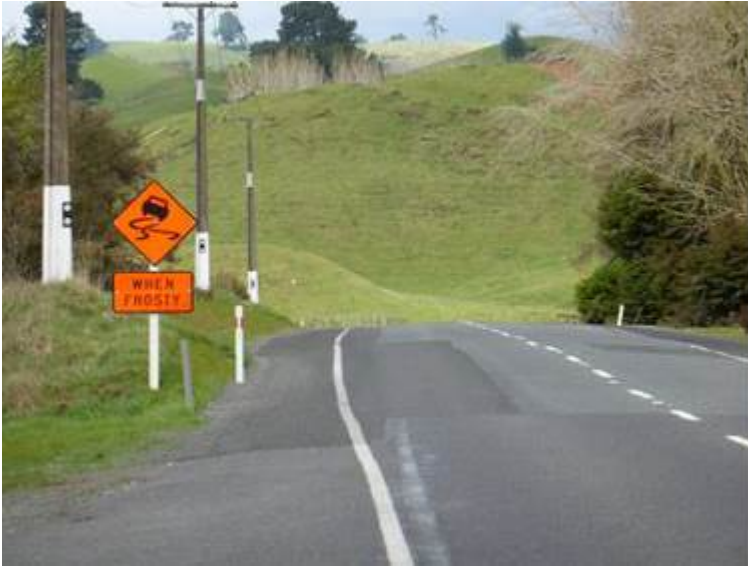
**Figure A.2** Drainage problems can quite often be related to road cut sections where structures are also thinner and ditches are missing. In such sections water usually infiltrates under the pavement and only a few cold days can cause frost heaves and permanent deformation

Drainage condition is one of the most critical issues, especially in cold-climate countries, since it can cause frost heaves and permanent deformation during the thawing period. Frost heaves generate unevenness and cracks in the road surface that also decrease traffic safety (figures A.2 and A.3). Frost heave is due to water freezing within the soil and pavement layers, causing them to expand in size until they become bumps in the surface. When this frozen water defrosts the combination of the expansion or the aggregate becoming less dense and the extra water causes significant weakness and ruts.

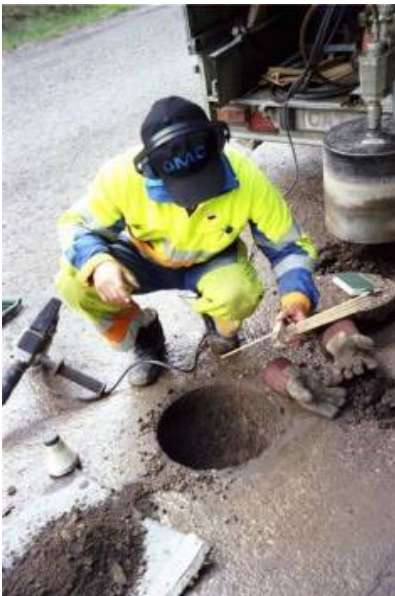
**Figure A.13 Sampling of unbound basecourse sample, which is then stored normally in plastic bags**

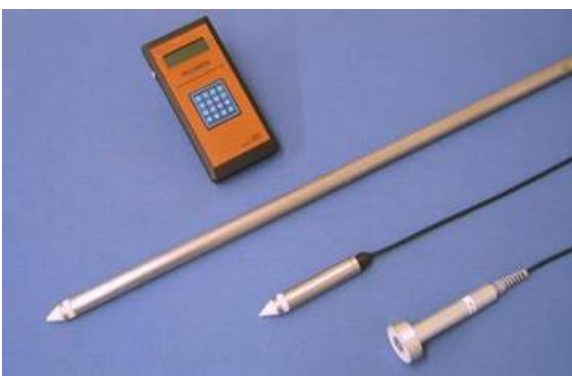
**Figure A.14 Typical percometer sensors: the long tube probe is used for soil measurements, the short tube probe is installed inside the road structure and a surface probe is used to measure dielectric values and electrical conductivity from the material surface**

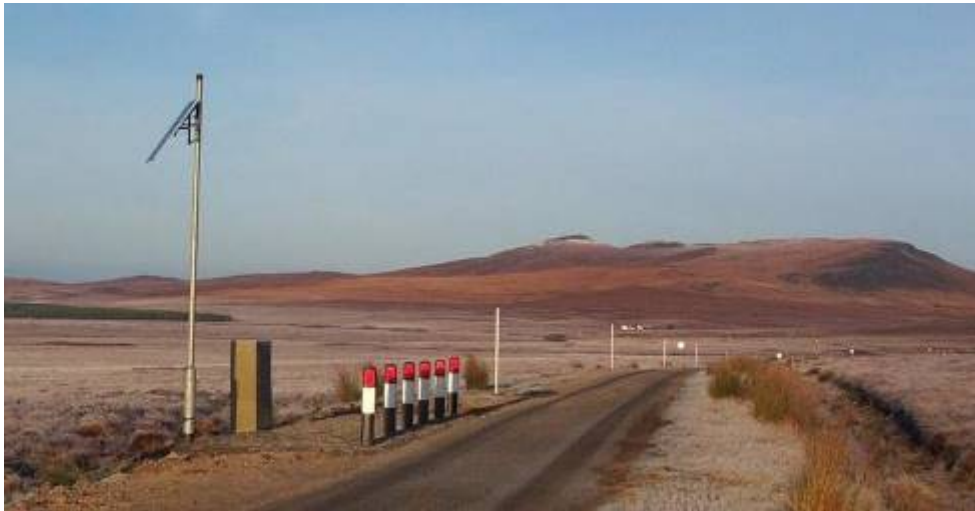
Figure A.15 Percostation installed in road B871 in Scotland

Percostations are used for monitoring seasonal changes and moisture content throughout the year and the results are used, for instance, in deciding the proper time to apply load restrictions and when they can be removed. The percostation differs from the percometer in that it presents the option of measuring the dielectric value, electrical conductivity and temperature through a maximum of eight channels. The measurements are normally repeated at two-hour intervals and the results are saved in the station's memory where they can be read via a wireless modem. Normally the percostation uses solar panels to supply power (figure A.15).

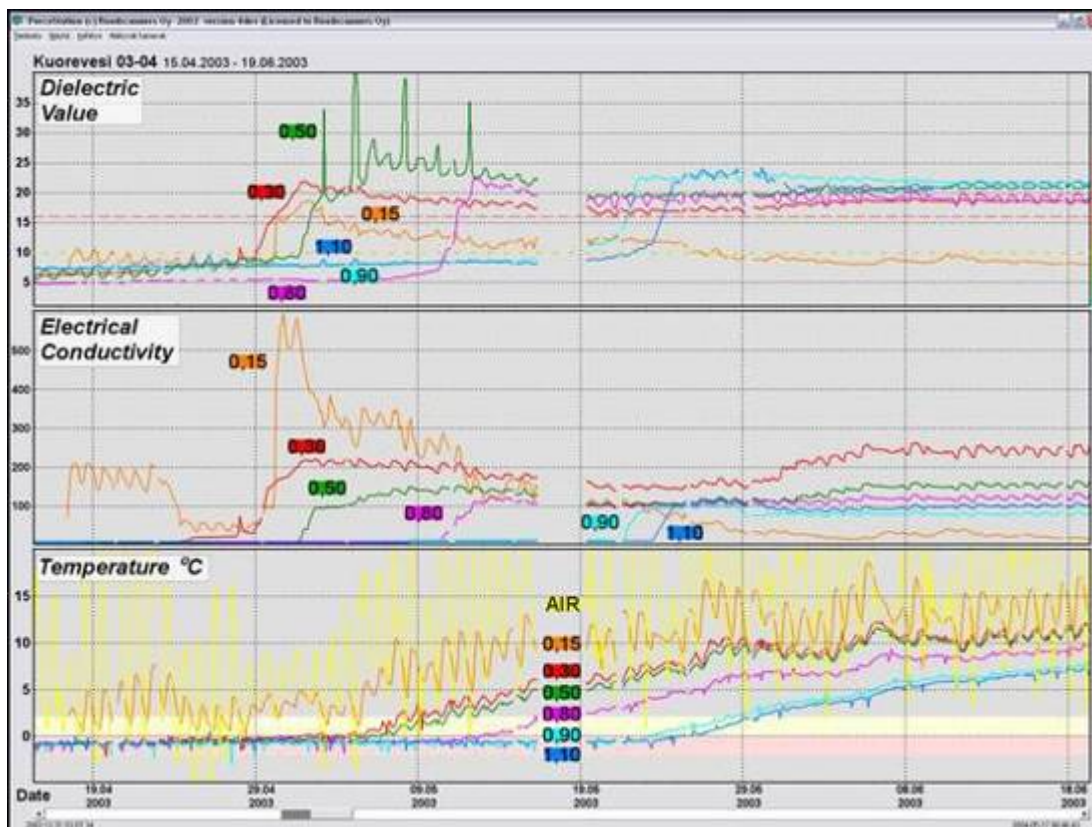
Figure A.16 Percystation monitoring results from spring thaw in 2003. The top field presents dielectric value, the middle field presents electrical conductivity monitoring results and the bottom field presents temperature results.

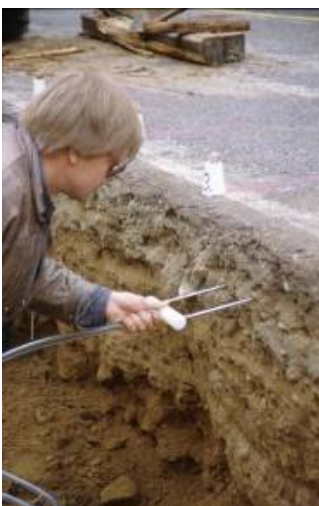
**Figure A.17 Installation of a typical TDR probe in road structure (Hänninen 1997)**

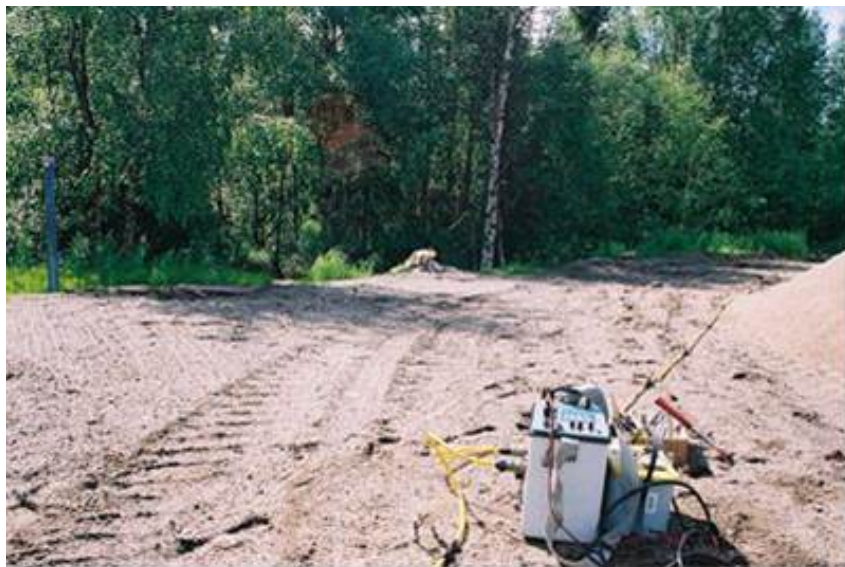
**Figure A.27** Example of static multi- electrode array with IRIS Syscal unit

For resistivity imaging there are two types of systems available: static and dynamic systems. The more common static system enables measurement of multi-electrode array, in which the electrodes are connected to a multi-electrode cable and planted into the ground during the survey (figure A.27). Static measurement is relatively slow and demands a large number of electrodes to get dense data coverage.

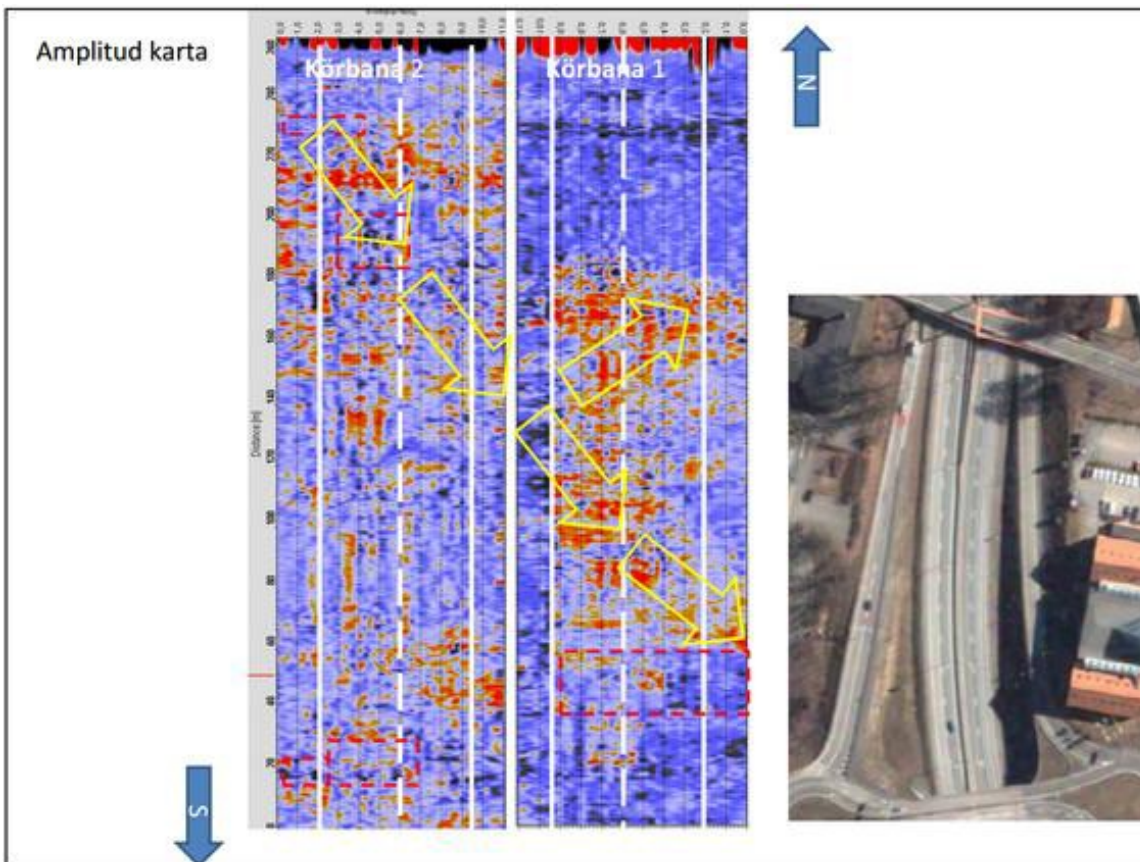
**Figure A.51 Amplitude map from a major road in Sweden. The red colour represents stronger reflections, which has been interpreted here to indicate high moisture. Yellow arrows show the estimated water flow in the road structure. The surrounding terrain supports the idea of the suggested water flow.**

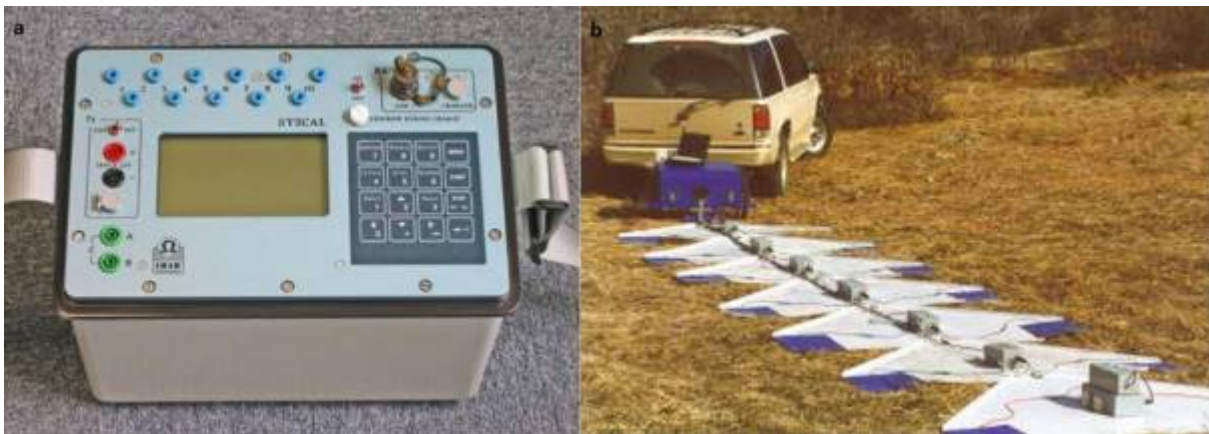
**Figure A.57** (a) Electrical resistivity meter, (b) capacitive coupled carpets pulled on the surface behind a towing vehicle (source: IRIS Instruments)

The productivity depends on the configuration and the equipment used for the survey. Normally two technicians, with the PA-CEP technique, can survey 10–20km/day at a speed of 3km/h using eight electrode arrays (Møller et al 2006). Figure A.57 presents a photo of electrical resistivity meter (a) and six capacitive coupled carpets pulled on the surface behind a towing vehicle (b).

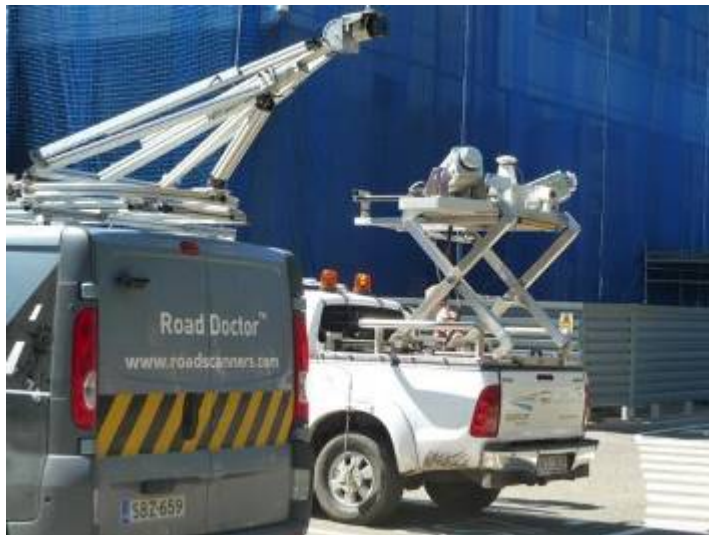
**Figure A.61 2D (left) and 3D laser scanning systems (right) for road surveys**

A laser scanner is composed of three parts: a laser canon, a scanner and a detector. The laser canon produces the laser beam, the scanner circulates the beam and the detector measures the reflected signal and defines the distance to the target. The distance measurement is based on the travel time of light, or phase shift, or a combination of both. Laser scanner systems can be classified into two types of system: 3D laser scanners, which are used for mobile mapping and 2D laser, which is designed to be used in basic pavement engineering projects (figure A.61). A 3D laser scanner system normally uses two powerful and accurate laser scanners which map the road and its surroundings up to 200m both sides of the road. The price range for these systems varies from US\$0.5–1 million. A 2D laser scanner system normally has one laser scanner that measures a cross section of the road and its surroundings about 20m both sides of the road. The price for a 2D laser scanning system is less than US\$100,000. There are numerous laser scanner systems on the market and some of the most popular used in road surveys are: Carl Zeiss, Optech, Riegl, Sick, TopCon and Trimble.

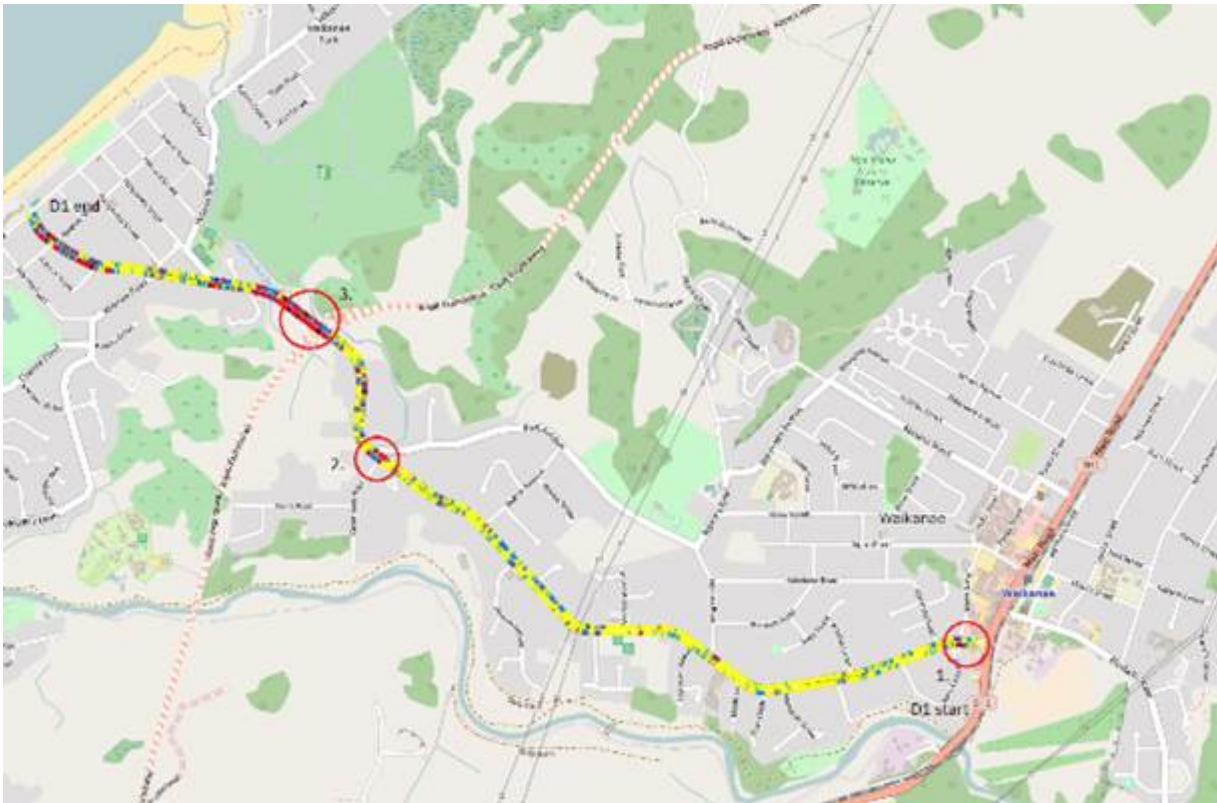
**Figure B.2** Locations of high moisture on Te Moana Road

Spot number 3 (figure B.2) was examined further using the Road Doctor viewer software with a screen shot shown in figure B.3. As can be seen at this location (RP 3220 to RP 3300) there are high levels of saturation in the top pavement layer indicated as a black shade in figure B.3. Reviewing the video photo of the site it can be seen that the shoulders pond water which could be the reason for the high moisture content.

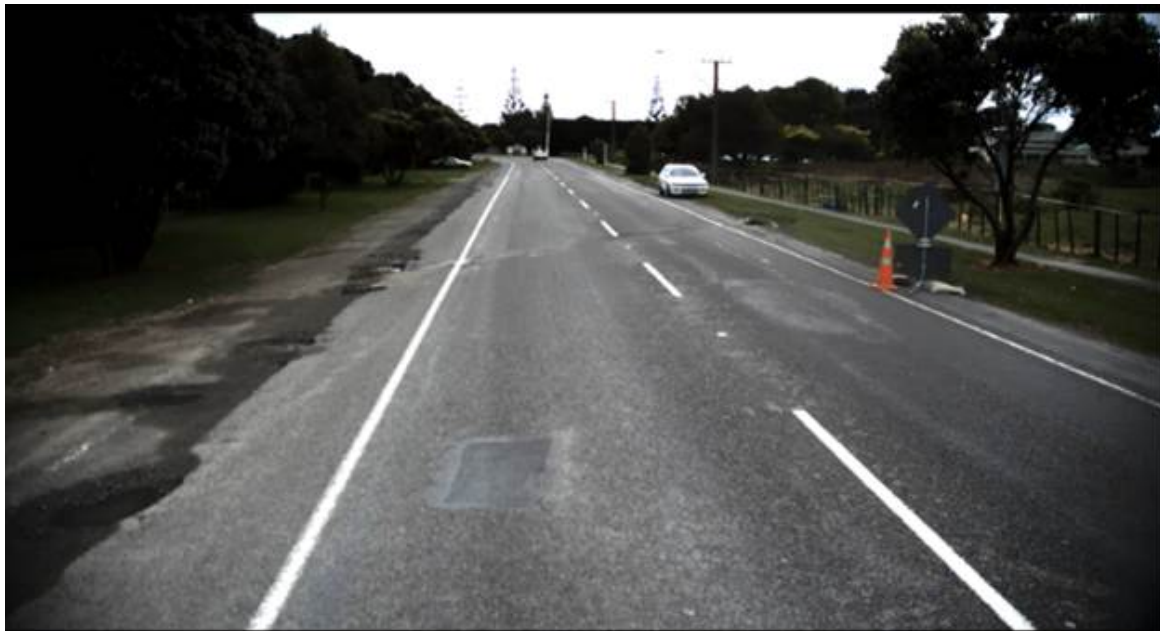
Figure B2.3 Moisture survey results on Te Moana Road spot # 3 (RP approx 3,220m) – black shade indicates highest level of saturation or MDI

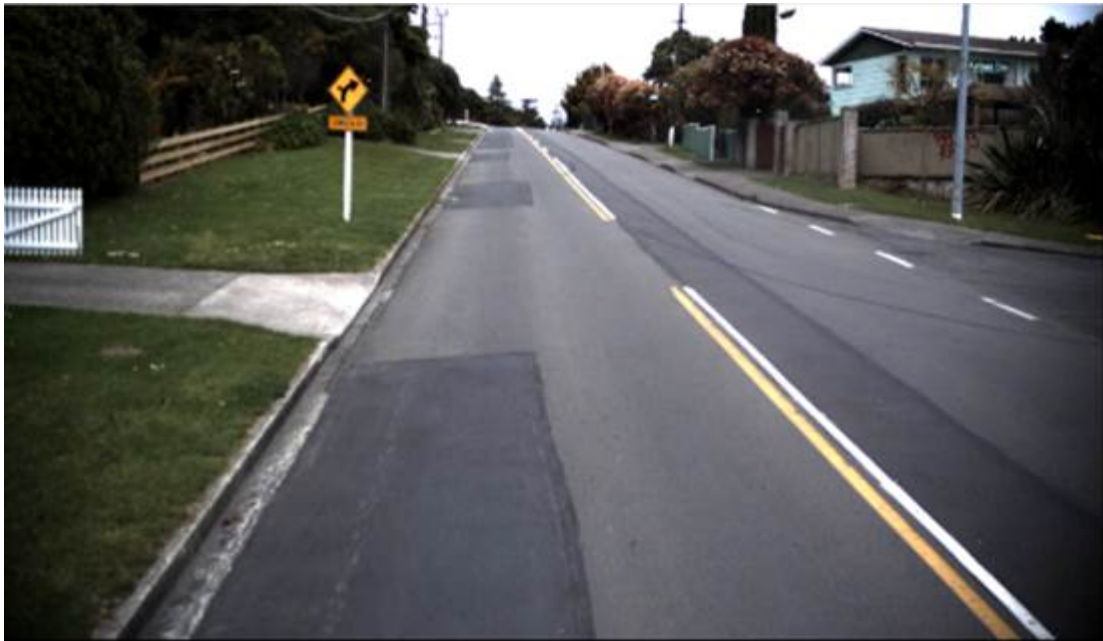
Figure B.5 Moisture survey results on Ruapehu Street spot # 3 (RP approx 688m) - black shade indicates highest level of saturation or MDI

Spot number 3 (figure B.4) was examined further using the Road Doctor viewer software with a screen shot shown in figure B.5. As can be seen at this location (RP 3220 to RP 3300) there are high levels of saturation in the top pavement layer indicated as a black shade in figure B.5. Reviewing the video photo of the site has many patches possibly replacing pipes which could be an indication of high moisture in the pavement layers.

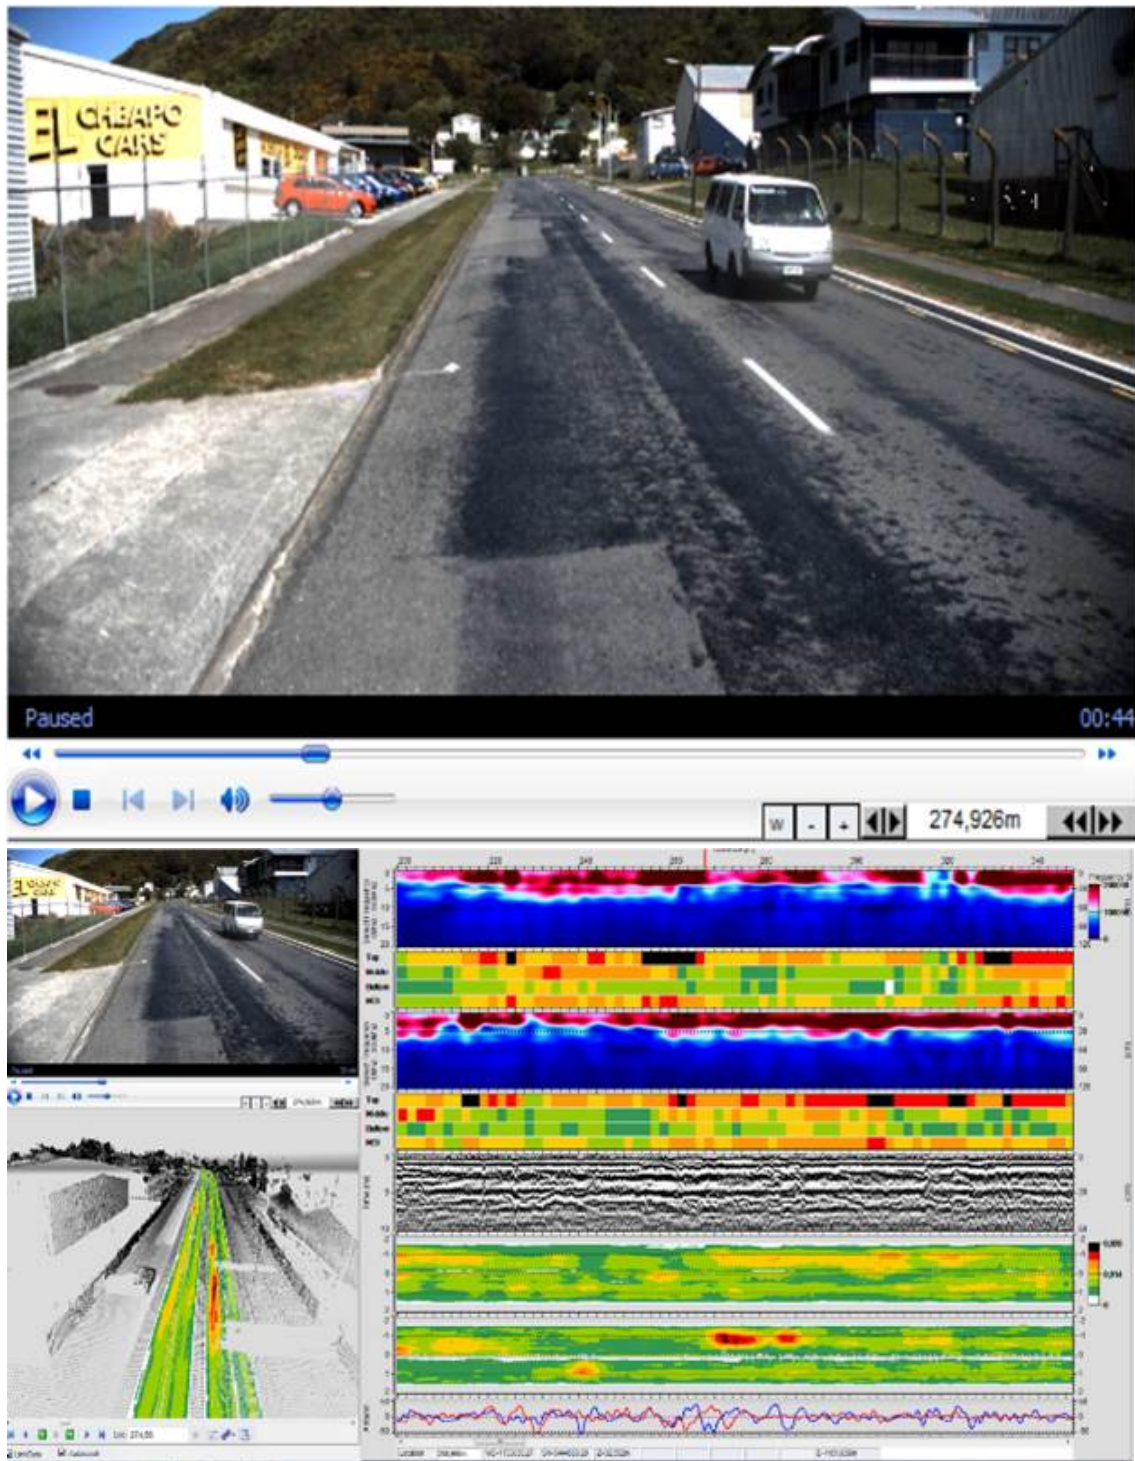
Figure B.10 High moisture locations at point 2 (274m) on Raiha Street in Porirua

Figure B.10 shows a location on Raiha Street where high moisture was recorded (black bars shown in top layer being the top 250mm of the pavement). From the photograph there is flushing in the wheel track and the LIDAR survey does show some rutted areas which further supports an area of high flushing.

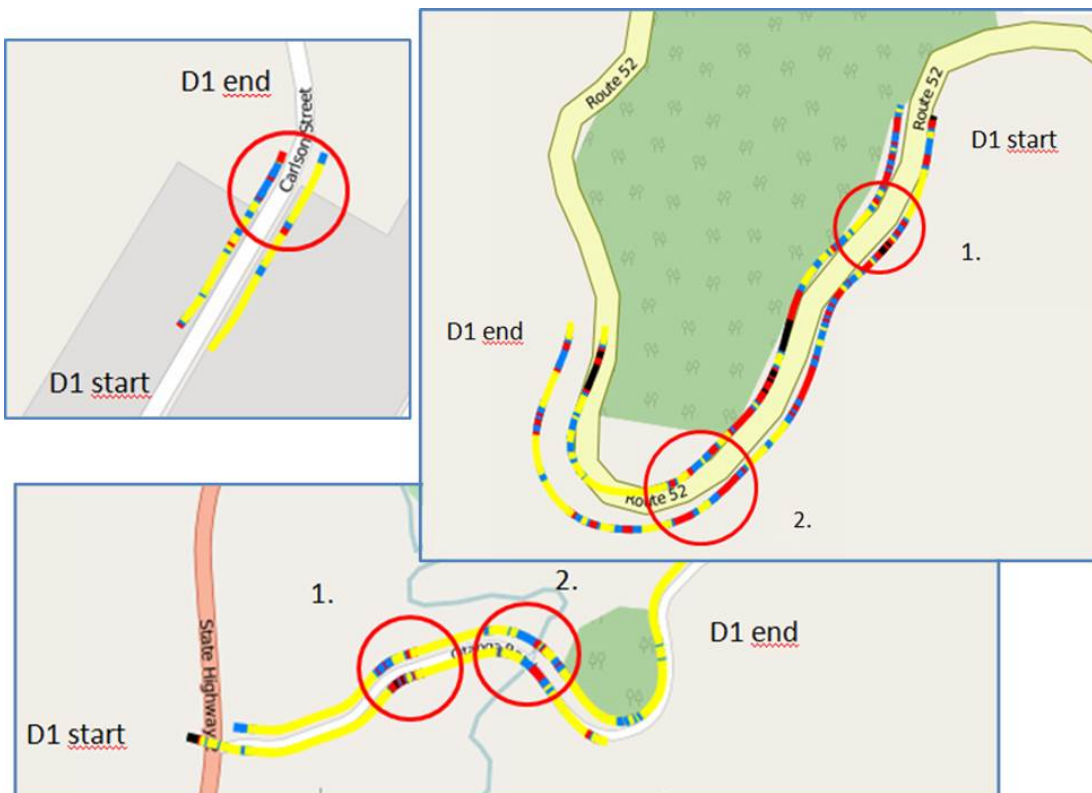
Figure B.18 High moisture locations surveyed in Tararua (Carlson Street, Route 52 and bottom shown is Otonga Rd)

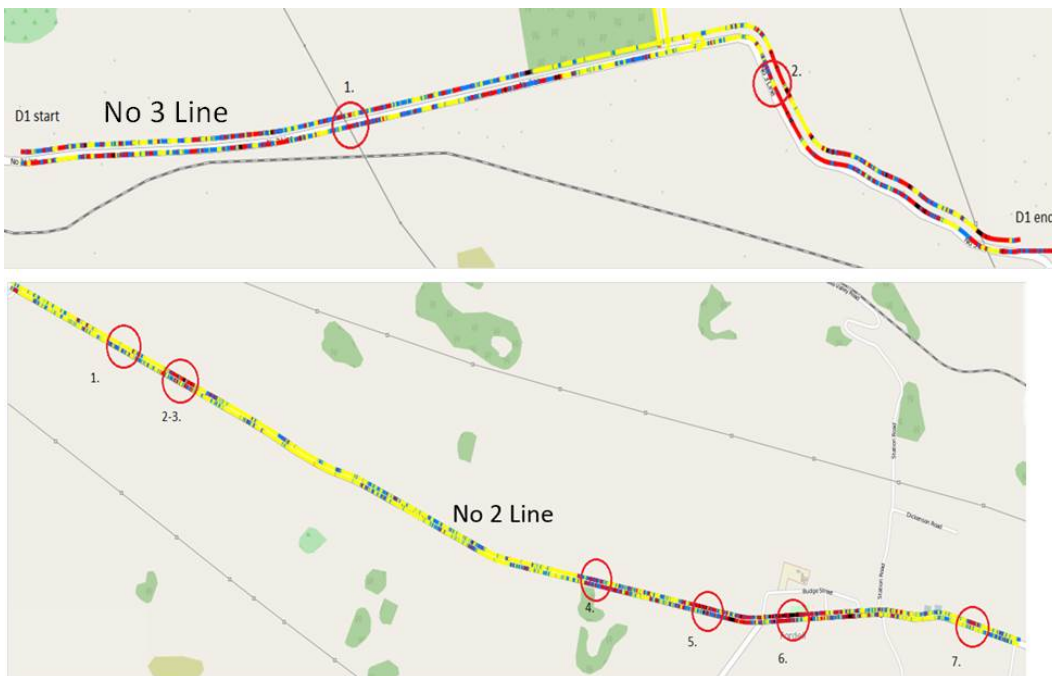
Figure B.23 Sites where high moisture was measured in the Whanganui district

Figures B.20 to B.24 show MDI maps of where the moisture surveys were undertaken in Whanganui.

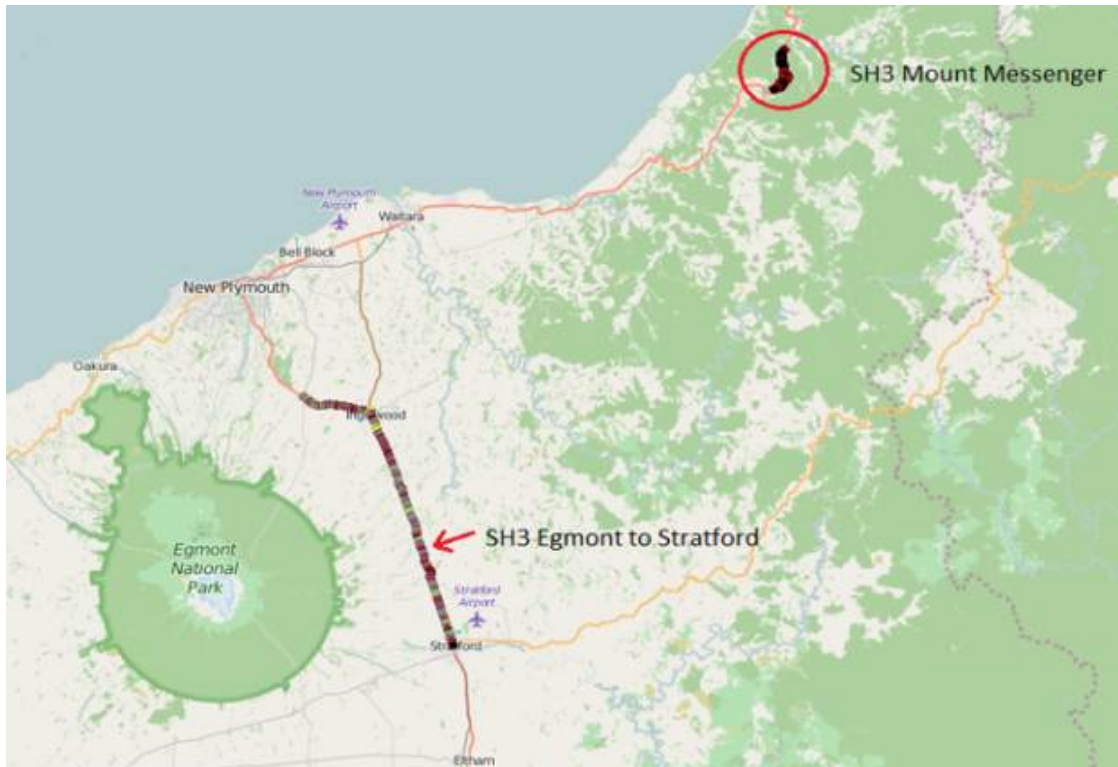
Figure B.26 Locations in Taranaki surveyed for moisture

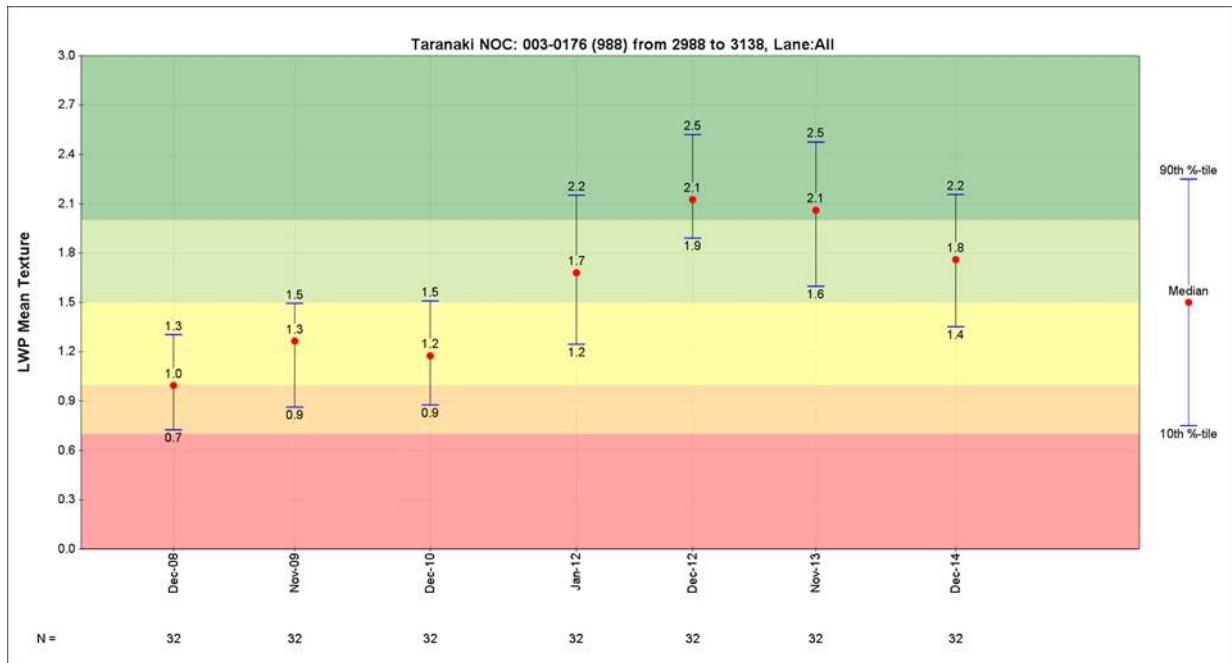
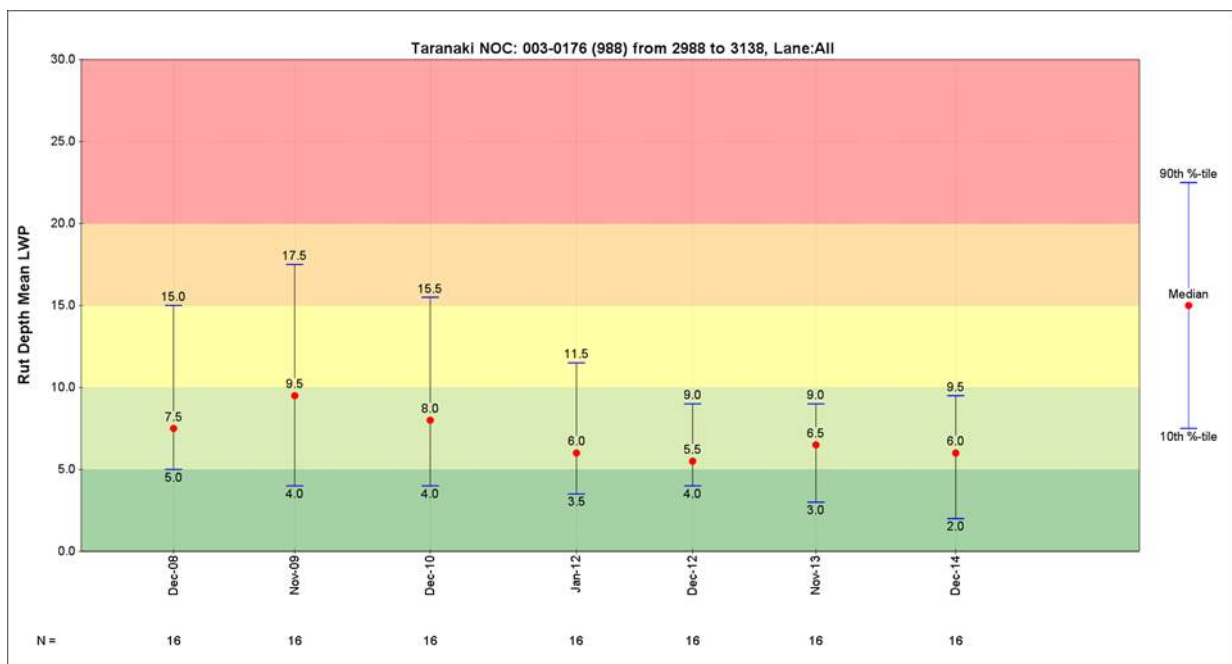
Figure B.31 SH3 Mount Messenger 1,400-1,550m: rutting and texture measurements from 2008 to 2014

Texture deterioration

Rutting deterioration
