# **Pavement moisture measurement to indicate risk to pavement life March 2017**

Arnold, G, P Fon Sing, T Saarenketo and T Saarenpaa (2017) Pavement moisture measurement to indicate risk to pavement life. *NZ Transport Agency research report 611*. 160pp.

**Keywords:** drainage, ground penetrating radar, laser scanner, moisture, monitoring, water content

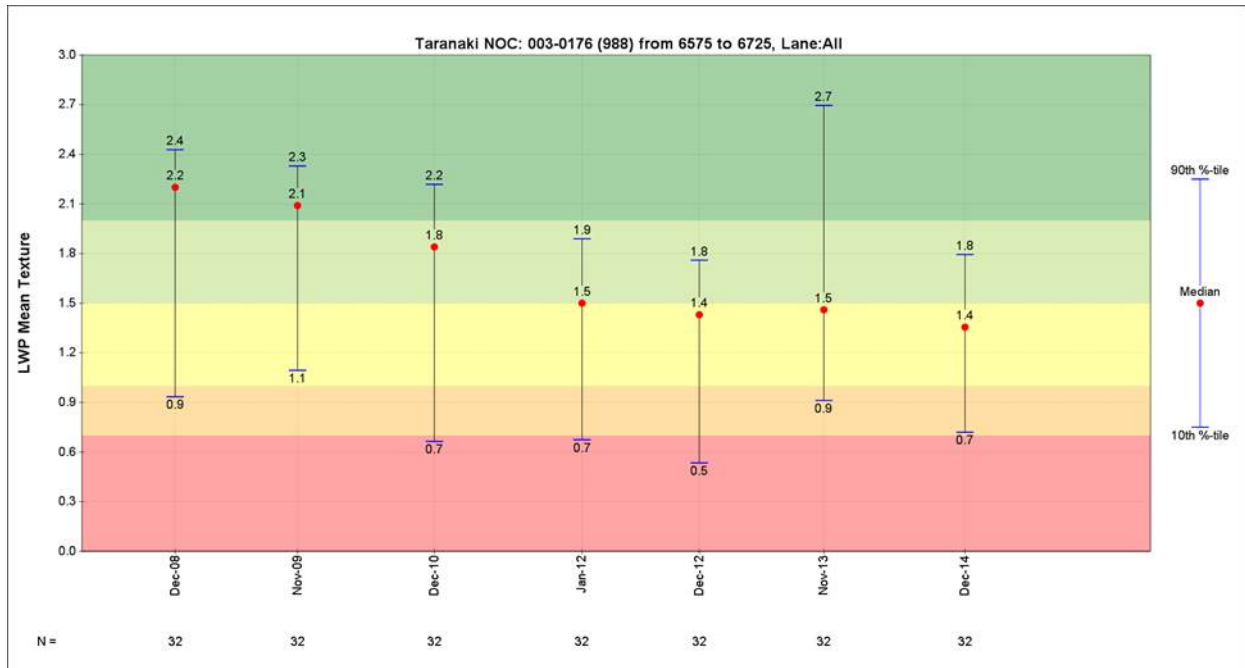
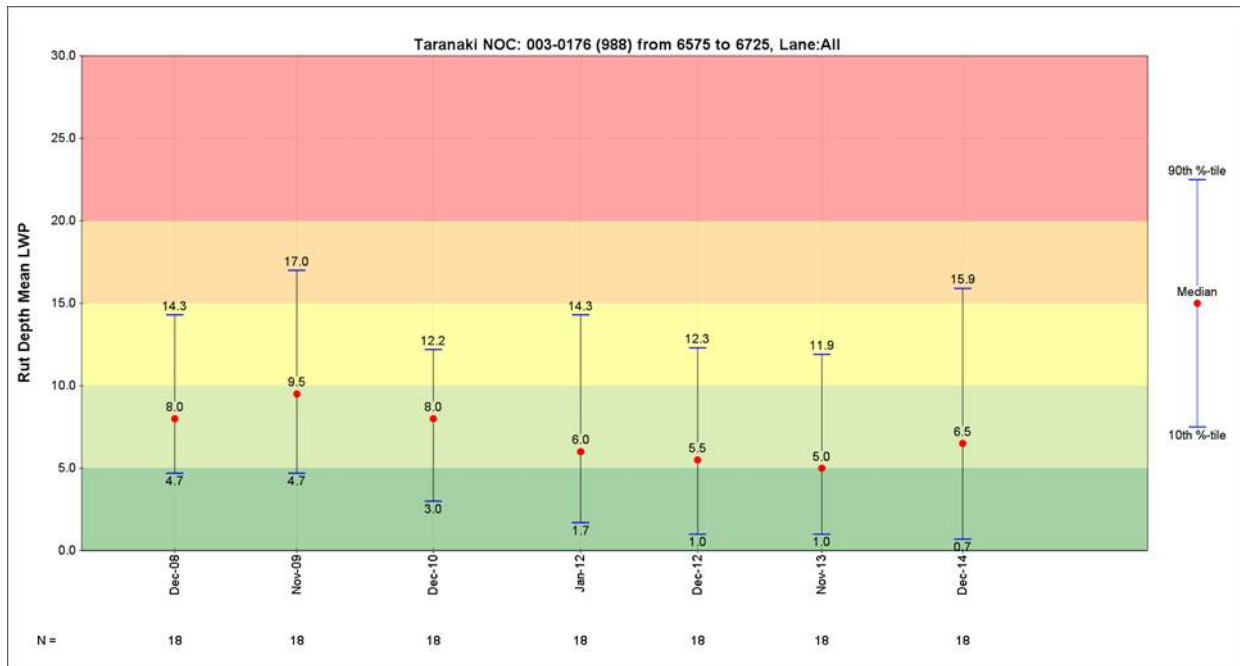
Figure B.33 SH3 Mount Messenger 5,000-5,150m: rutting and texture measurements from 2008 to 2014

Texture deterioration

Rutting deterioration
