# Maintaining the effectiveness of audio tactile profiled roadmarkings for their full life cycle May 2017

T Lester, V Dravitzki and J Burton Opus International Consultants, Opus Research ISBN 978-1-98-851225-9 (electronic) ISSN 1173-3764 (electronic)

Lester, T, V Dravitzki and J Burton (2017) Maintaining the effectiveness of audio tactile profiled roadmarkings for their full life cycle. *NZ Transport Agency research report 615*. 59pp.

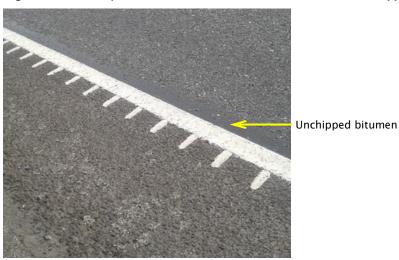
Figure 2.2 Example of an in-lane reseal with a line of excess 'unchipped' bitumen

Figure 2.2 shows another example of in-lane reseal. The longitudinal seam of the in-lane reseal is approximately parallel to the edgeline, which is considered good, but this seam is marked by a line of bitumen with no chips on it. This is attributed to the execution of the in-lane reseal operation. The unchipped line of bitumen may have reduced skid resistance with potential effects, particularly for cyclists. The unchipped line of bitumen is also visually obvious in some conditions and could affect drivers' lane positioning and effectively narrow the traffic lane. The good practice example in figure 2.1 is considered to have no visual impact on the lane width.

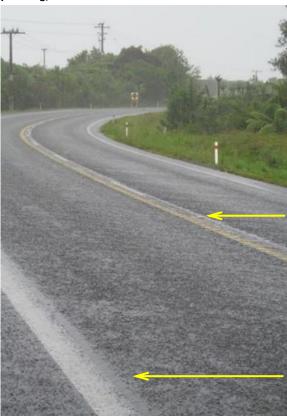
Figure 2.3 Example of an in-lane reseal seen in heavy rain and with lighting conditions highlighting water ponding/accumulation  $^4$

From the existing examples observed, the longitudinal seam does not seem to create a strong lip. This may be in part because the nature of chipseal is that the reseal edge depends on the scatter of chip and interaction with the underlying chipseal layer. There was no experience of drainage problems at the longitudinal seam, even at sites with multiple in-lane reseals. Figure 2.3 shows a photo of an in-lane reseal

during heavy rain. Although there is appearance of some slight ponding/accumulation of water along the seam, it does not seem to create a major adverse effect or risk. The ponding/accumulation is not universally visible at sites of in-lane reseals but the location of the photo was specifically chosen to illustrate the effect.

Seam

Seam, no strong lip but some unchipped bitumen

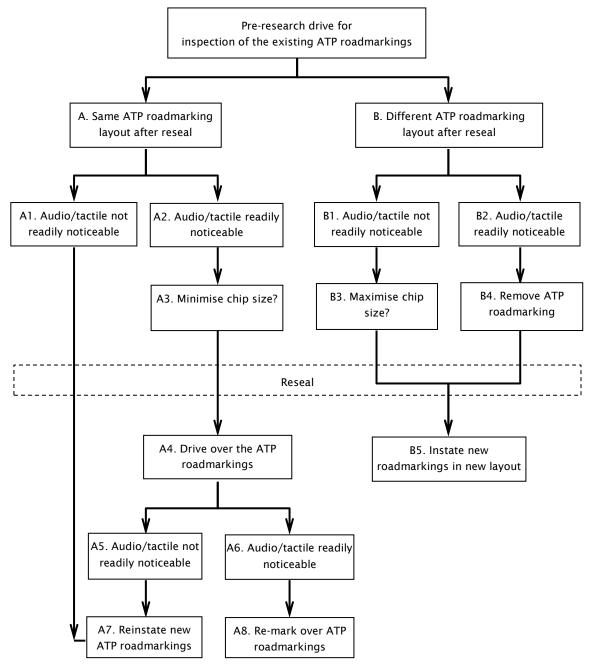
Figure 2.4 Suggested 'seal over' practice for determining retention/reinstatement of ATP roadmarkings

The alternate retention technique is resealing the full carriageway width, from road edge to road edge, including over the ATP roadmarkings. The general process follows the flowchart shown in figure 2.4. Note, this is not necessarily a recommendation, only a summary of the process currently in practice.<sup>5</sup>

The first step in the process is to drive over the existing ATP roadmarkings at the site for reseal, and decide subjectively if the ATP roadmarkings generate sufficient audio/tactile effects. (A subjective rating system is discussed in section 2.3.3.)

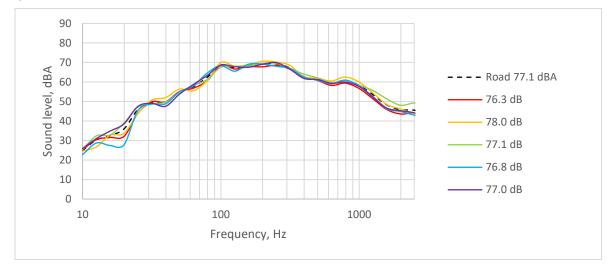
Figure 4.3 Spectral analysis of in-vehicle samples from vehicle travel on the road surface

Figure 4.3 shows spectral analysis of one-second samples from each of five accepted measurements taken during travel on the road surface (in the traffic lane) and the average calculated from the five measurements. The figure indicates the variation between measurements and the effect of averaging multiple measurements.

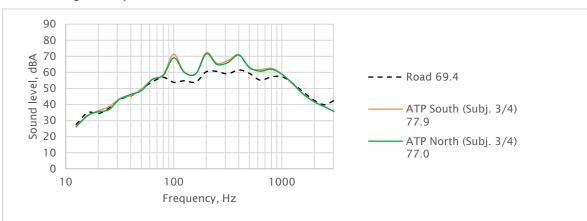
Figure 4.6 Spectral analysis of in-vehicle samples from vehicle travel on the road surface and ATP roadmarkings (example 1)

Figure 4.6 shows the average one-second spectral analyses from measurements on the road surface in the traffic lane, the ribs of the ATP roadmarkings adjacent to the edgeline for the southbound direction, and the ribs of the ATP roadmarkings adjacent to the edgeline for the northbound direction.

• In terms of magnitude, the total sound level measured from the ATP roadmarkings was 77.9 dBA and 77.0 dBA, and from the road surface in the traffic lane 69.4 dBA. The tonal peaks at 100 Hz were approximately 17 dBA and 15 dBA respectively above the road-only noise level for this frequency band. The difference in sound level and tone was easily distinguishable for the driver and passenger in the vehicle during the measurements.

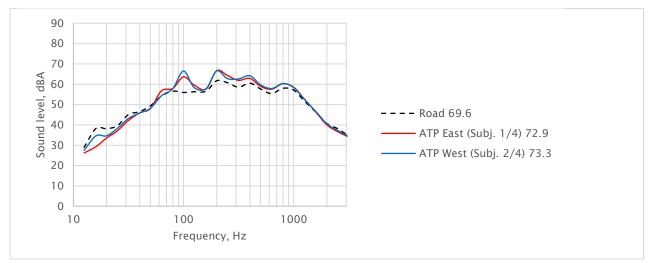
Figure 4.8 Spectral analysis of in-vehicle samples from vehicle travel on the road surface and ATP roadmarkings (example 2)

From figure 4.8 it is observed:

- The total sound level measured from the ATP roadmarking of the eastbound edgeline (ATP east) was 72.9 dBA, found to be 3.3 dBA higher than the total sound level measured from the road surface in the traffic lane and the tonal difference at 100 Hz compared with the road surface was only 8 dBA. The audio effects of this ATP roadmarking had been subjectively rated as 1/4 about one year prior to these measurements. The total subjective rating for the audio, tactile and visual effects of the ATP east was 3/10 and would be judged as not effective according to that subjective rating system's criteria.

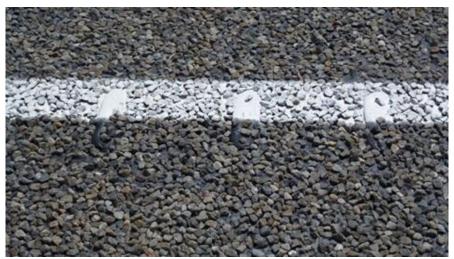
Figure 4.11 shows the road surface and ATP roadmarkings post-reseal. The ATP roadmarkings were laid only in December 2014 and were in a good condition prior to resealing with a grade 3 chip in February 2015 (about two months prior to these measurements).

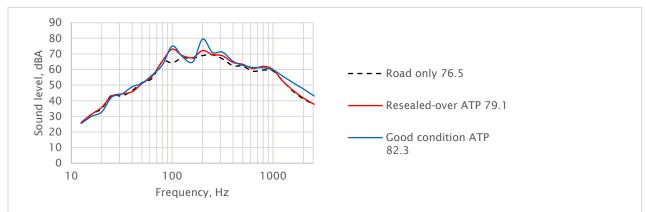
Figure 4.12 Spectral analysis of in-vehicle samples from vehicle travel on road and ATP roadmarkings (example 4)

Figure 4.12 shows the average one-second spectral analyses from measurements on the road surface in the traffic lane and the sealed over ATP roadmarking. On this site, prior to the sealing over the ATP roadmarkings, there were some previous ATP roadmarkings that had not been sealed over. Measurements were also taken from the good condition ATP roadmarkings and the average one-second spectral analysis of those measurements is also shown in figure 4.12.

Figure 4.12 shows:

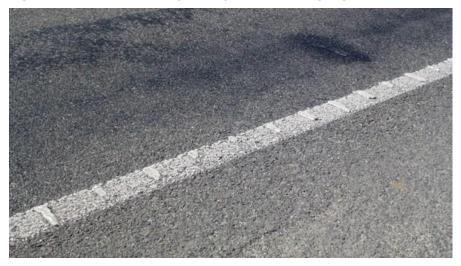
Figure 4.15 ATP roadmarkings damaged by snowploughing (example 6)

For further information on potential maintenance issues for ATP roadmarkings, measurements were undertaken on some ATP roadmarkings that had been damaged by snowploughing.<sup>20</sup> As indicated by figure 4.15, many of the individual ATP roadmarking ribs had lost some portion of their width but few ribs had been completely removed by the snowploughing.

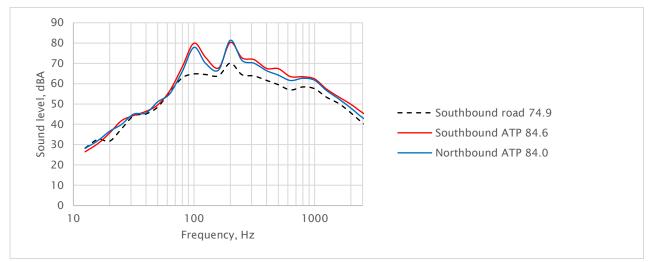
Figure 4.16 Spectral analyses of in-vehicle samples from vehicle travel on the road surface and ATP roadmarkings damaged by snowploughing (example 6)

Figure 4.16 shows the average one-second spectral analyses from measurements on the road surface in the traffic lane, the ATP roadmarking of the southbound edgeline and the ATP roadmarking of the northbound edgeline. The road surface was a grade 3/5 two-coat chipseal laid in March 2008 and the total sound level measured from the road surface in the traffic lane was 74.9 dBA. This sound level is higher than measured from other road surfaces shown in this section and aligns with observations by the driver and passenger that the road sounded and felt 'rough'. The total sound level measured from the ATP roadmarkings was 84.6 dBA and 84.0 dBA. Despite the apparent loss of rib width, total sound levels measured from the ATP roadmarkings were 9.7 dBA and 9.0 dBA greater than the total sound level measured from the road surface in the traffic lane. Figure 4.16 clearly shows tonal peaks present in the sound measured from the ATP roadmarkings that do not feature in the sound measured from the road surface. These were about 12 dBA and 15 dBA greater than for the road surface at 100 Hz, and 10 dBA greater at 200 Hz. The driver and passenger also observed the audio effects of the ATP roadmarkings were obvious. The measurements and observations indicate the reduced rib width was sufficient to stimulate the vehicle's suspension to generate audio/tactile effects.

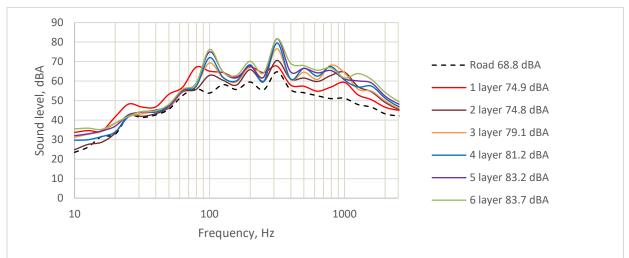
Figure 5.3 Results of in-vehicle sound measurements with 250 mm rib spacing

The results follow expectations and other literature. Figures 5.3 and 5.4 show increasing total sound level with increasing rib height. With vehicle-travel of 95 km/h (26 m/s) the vehicle traverses about 106 ribs/s with 250 mm rib spacing or 53 ribs/s with 500 mm rib spacing. Tonal peaks aligning with these frequencies are visible in the respective graphs of figures 5.3 and 5.4.

Comparing figures 5.3 and 5.4, the measurements from equal rib heights show the sound level decreases between the 250 mm rib-spacing and the 500 mm rib spacing, showing the sound level decreases as the number of traversed ribs/s decreases.

Figures 5.3 and 5.4 show the spectral analyses of the audio inputs to the simulator and the total sound levels obtained from each layer (one to six layers)) for each rib-spacing (250 mm and 500 mm). It is observed that:

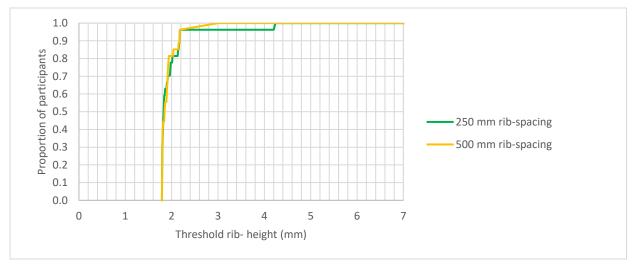
Figure 5.5 Threshold number of layers (from Group A)

From analysis of the threshold layers and rib heights, it appears there is little difference between response to the 250 mm rib-spacing audio/tactile effects and the 500 mm rib-spacing audio/tactile effects. However, the sound levels and spectral analyses should also be considered.

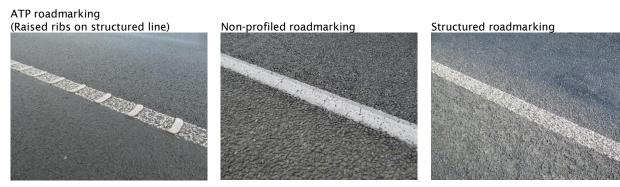
Figure A.2 Samples of the three roadmarking types measured

A local length of roadway was identified where sections of edgelines suitable for measuring included ATP roadmarkings, non-profiled paint-type roadmarkings, and structured or 'splatter-type' structured roadmarkings. Samples of the three roadmarking types are shown in the figure A.2. Note these are not 'ideal' examples but photographs representative of the edgelines measured.

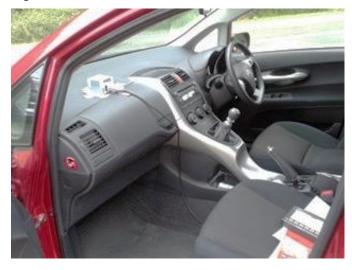
Figure B.1 Accelerometer mounted on the dashboard

During the December 2013 measurements of audio effects, tactile effects were also measured. They were logged, selected and analysed as the audio effects were (as described in chapter 4). Tactile effects were measured with a triaxial accelerometer mounted on the passenger-side dashboard, as shown in figure B.1. It is acknowledged this may be a compromised representation of the driver's experience of tactile effects. The driver has multiple points of contact with the vehicle (including the driver's seat, pedals, footwell and steering wheel) through which tactile effects may be transmitted, albeit with damping. The single accelerometer has only one point of contact and at a point not shared with the driver. This project was to measure tactile effects of ATP roadmarkings in a similar way as Dravitzki et al (2007), who measured tactile effects of ATP roadmarkings with the accelerometer mounted on the central moulding around the drive shaft near the passenger's footwell. Dravitzki et al (2007) adopted this position after trialling other mounting positions on the steering wheel and steering column. The passenger's footwell position is favoured as responsiveness to tactile effects is similar to the other positions trialled but has less impedance or potential interference to the driver. It was intended for this research project to also mount the accelerometer near the passenger's footwell. However, mouldings and materials of the hired vehicle's interior inhibited mounting of the accelerometer other than as shown in figure B.1.

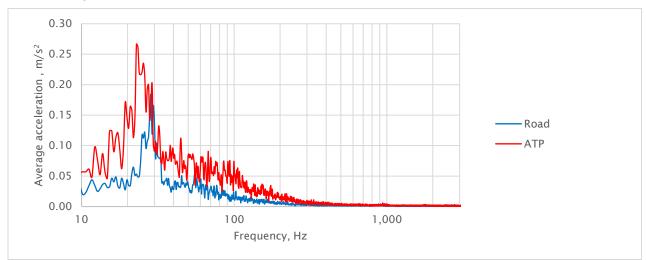
Figure B.2 Spectral analysis of one second in-vehicle samples from vehicle travel on the road surface and ATP roadmarking

During the December 2013 measurements, acceleration rates were measured in three dimensions. The vertical acceleration rates are taken as giving the clearest indication of tactile effects. Figure B.2 shows spectral analysis of the vertical acceleration obtained during travel on the ATP roadmarking and obtained during travel on the adjacent road surface. These results are from just one site found representative of the results obtained from other measurement sites.

The frequency distributions of responses shown in figure B.1 are affected by the individual vehicle's damping and resonating characteristics through the path of transmission to the accelerometer mounting position. The magnitude of total vertical acceleration is clearly larger while the vehicle is travelling on the ATP roadmarking compared with the vehicle travelling on the adjacent road surface. This matches the subjective response to the driver and passenger in the vehicle during measurements.

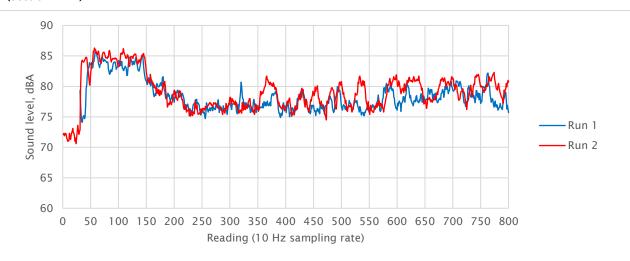
Figure C.1 Continuous record of sound level readings during measurements of reseal-over example 4 (section 4.2.4)

During the measurements reported in chapter 1, while the driver was holding the vehicle to travel along the ATP roadmarking, the driver and passenger subjectively noted variations in the strength of audio and/or tactile effects. It was sometimes unclear if this was due to inconsistent contact with the ATP roadmarking or due to variations in the ATP roadmarking itself. The method for analysis of the measurement samples then averages results from one second of the total logged measurement period, thereby removing effect (or evidence) of any longitudinal variation. However, as ATP roadmarking audio/tactile effects will be judged on a largely relative basis, longitudinal variation could be a significant consideration. Subjective ratings or impressions of the longitudinal variation could be obtained, or objective measurements could be used. Figure C.1 shows a continuous record of sound level readings during measurements of resealing over example 4 (section 4.2.4). Prior to driving on the reseal over ATP roadmarkings, within the same continuous record, a set of ATP roadmarkings in good condition was driven over. Audio of these good condition ATP roadmarkings was recorded between approximately reading 40 and reading 150. Between reading 150 and 250 is a length of transition, then readings from the length with reseal over ATP roadmarkings follow for the remainder of the record.

Figure C.1 indicates the driver can make fairly consistent and repeatable contact with the ATP roadmarking when it is in good condition. A good condition ATP roadmarking provides clear and immediate feedback to the driver to reinforce when good contact is being made.
