# Guidelines for using audio tactile profiled (ATP) roadmarkings

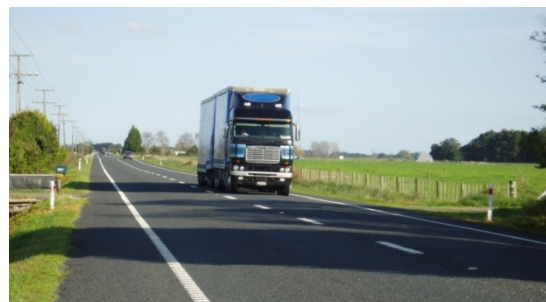
Figure 4. Sufficient shoulder width is needed to accommodate cyclists where ATP roadmarkings are used

Research suggests that drivers may only need approximately 0.3m of shoulder to respond to ATP roadmarkings (Finley et al. 2009), therefore cyclists are the main concern when considering shoulder width. Current OPUS research has found that cyclists generally need a minimum of 0.7m, but this does not consider a desirable separation between vehicles or avoiding detritus or other obstacles that may exist in the shoulder. In order to accommodate cyclists, ideally 1.5m (MOTSAM) but a

minimum shoulder width of 1m should be present before ATP roadmarkings are used. However, a balance between accommodating cyclists and providing a continuous safety countermeasure for motorists needs to be reached and ATP roadmarkings may be used with narrower shoulder widths in special circumstances. It is important that engineers and consultants carefully consider cycling use on a road before decisions are made, and documented consultation with local cycle advocacy groups is required.

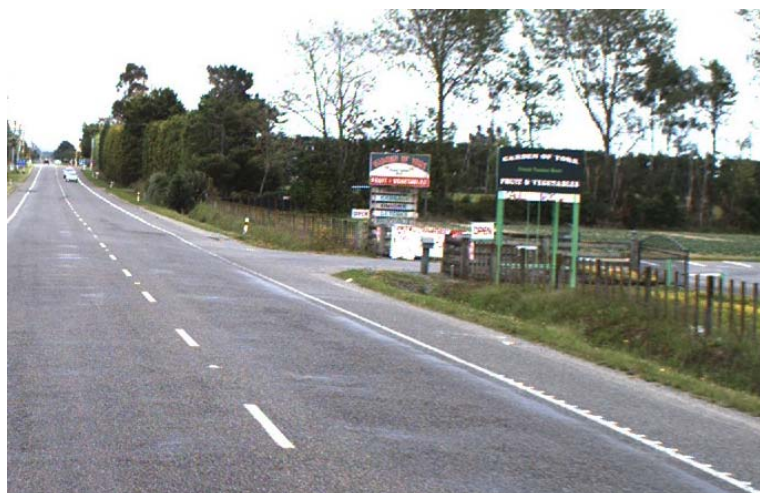
**Figure 5. ATP roadmarkings should be omitted from major accessways and intersections but continuous across minor entrances unless noise is a problem for residents**

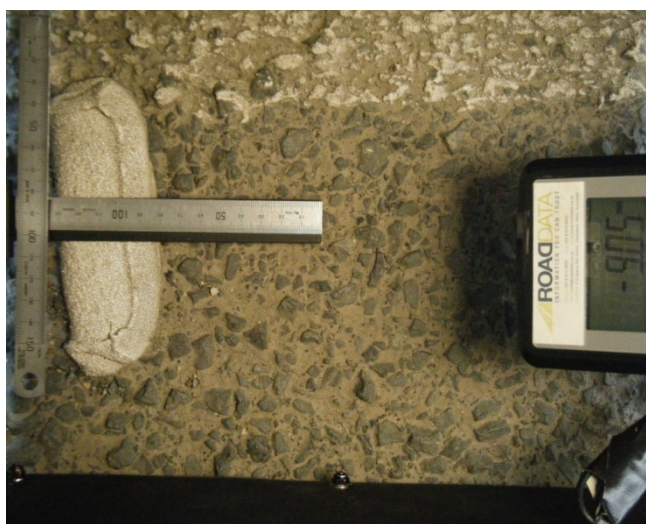
**Figure 6. New ATP ribs, with good rib height, in need of cleaning (along with the road surface in this case)**

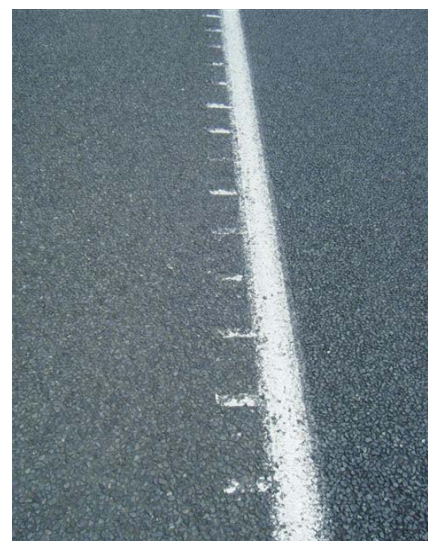
**Figure 7. ATP rib removal via grader blade**

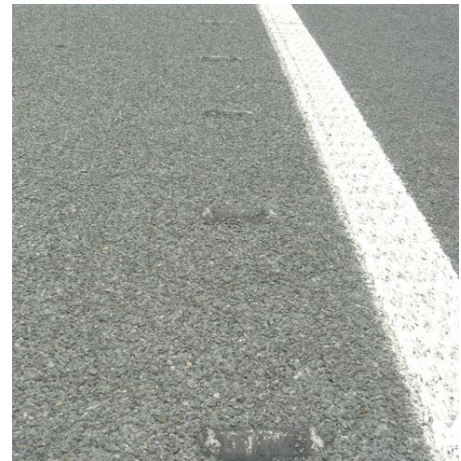
**Figure 8. A reseal using a fine grade chip over relatively new ATP ribs. Note the new line has been incorrectly placed and should be immediately adjacent to the ATP ribs**

**Note:** Figure shows that the bitumen has stuck to the existing ribs following resealing. This potentially poses a hazard to cyclists and motorcyclists as they may not detect the ribs. Until the bitumen has worn off through trafficking, a temporary 'rumble edgeline' warning sign should be placed at the beginning of the resealed section.

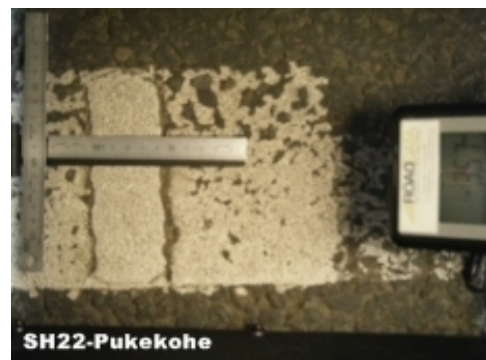
**Figure 9. Old ATP that is due for reinstatement**
