6 APPROACHES

6.1 GENERAL

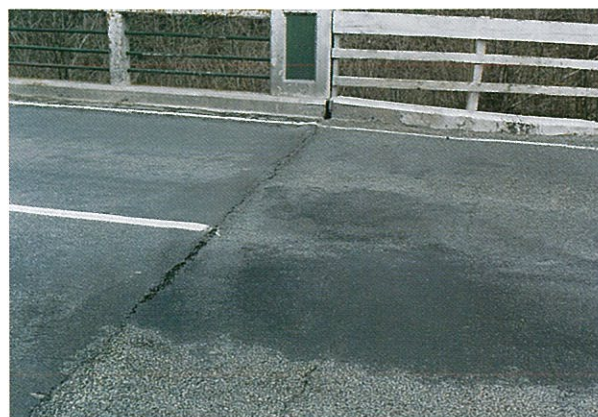
Figure 6.1: Settlement of approach caused by lack of fill containment.

Settlement usually shows up as a localised depression in the pavement adjacent to the end of the bridge. The amount of settlement necessary before problems develop can be quite small. Depressions in excess of 15-20 mm will be detected by the road user, and when greater than 25 mm will quickly become unacceptable. Apart from the road safety aspect, the effects on the bridge will be increased impact loading and fatigue, with particularly serious consequences for the deck joint nearby. The pavement will suffer the same effects, leading to further accentuation of the depression.

Settlement may be the result of:

- Plastic deformation of the ground underlying the fill itself if it has not been properly compacted or is of inappropriately graded material;
- Migration of fines from the fill if it is poorly graded with excess fines. This can occur by piping, after high water levels caused by flooding, or by water from defective drains. Seepage from the fill can be a warning sign of this problem;
- Movement of the abutment or wingwalls, which reduces support to the fill;
- Poorly shaped fill around and in front of a spill-through abutment. A horizontal berm should be formed in front of the abutment, allowing the projected fill slope to line up with the road surface immediately behind the abutment, as shown in Figure 6.4. Otherwise material will tend to move through under the abutment and cause settlement.

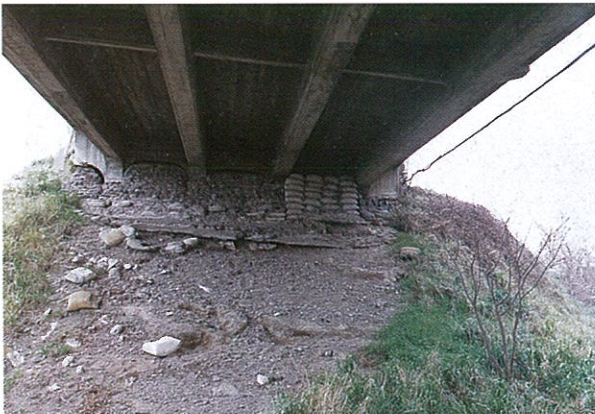
Figure 6.2: Ineffective fill containment.

If there is insufficient fill in front of a spill-through abutment, as described above, this should be corrected if there is sufficient space to do so. Otherwise, some method of retaining the fill beneath the abutment may be sufficient, such as placing rocks. If there is no settlement slab, construction of one, as required by the Transit New Zealand "Bridge Manual" (SP/M/014) will also improve the situation by preventing a depression forming immediately next to the abutment.

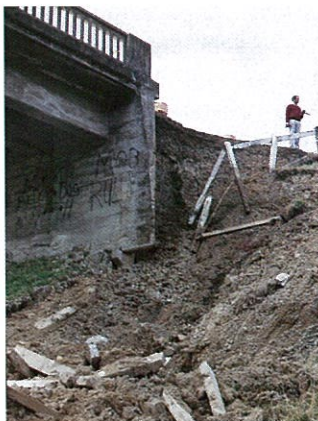
Figure 6.3: Failure caused by seepage and poor drainage.

If the cause is migration of fines, it may be sufficient to improve the drainage system by lining channels. Horizontal perforated drains drilled into the fill to remove groundwater may also be beneficial.
