History of Chipsealing in New Zealand

Chapter 1 History of Chipsealing in New Zealand

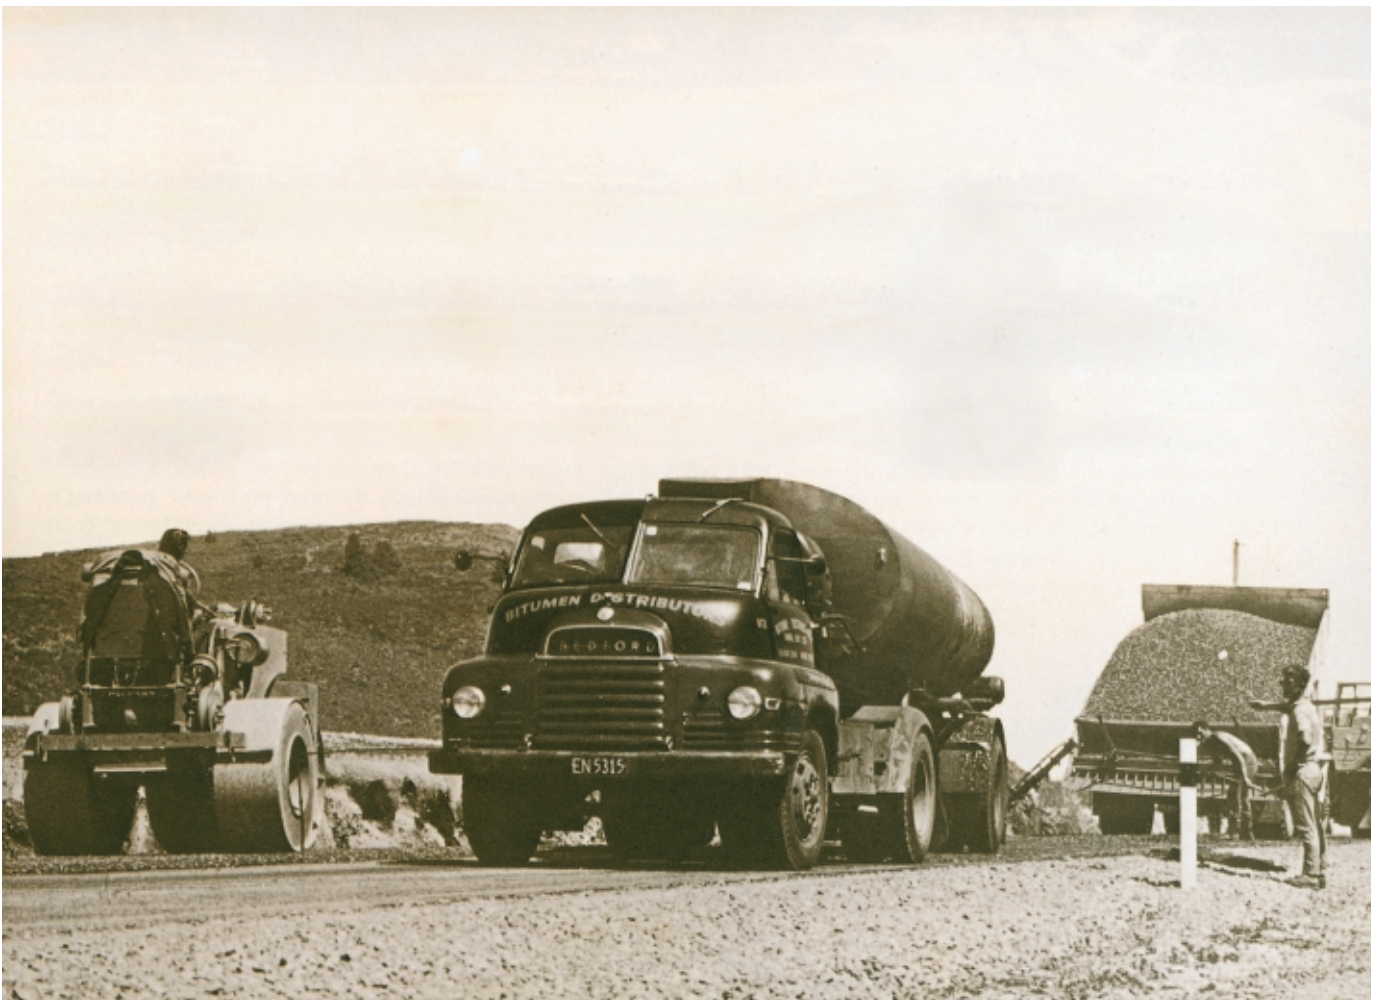
Previous page: Laying a first coat chipseal on a New Zealand state highway in the 1970s. From left is a 9-ton 3-wheeled roller, a bitumen distributor and on the right a fan-tailed chip spreader on a short wheel-based tip truck.

These chip spreaders have fan-tailed shaped rear gates and were generally used on short-wheel-based trucks to allow the tray to be raised high enough in all situations (see Frontispiece). As these trucks were operated in reverse, they were an occupational hazard for the fan-tail operators who had to perform a number of dangerous tasks, e.g. walking alongside the rear of the truck, sometimes on the driver's blind side, and running in to put in dividing plates. Operators were likely to be injured if the driver of the reversing truck could not see them.

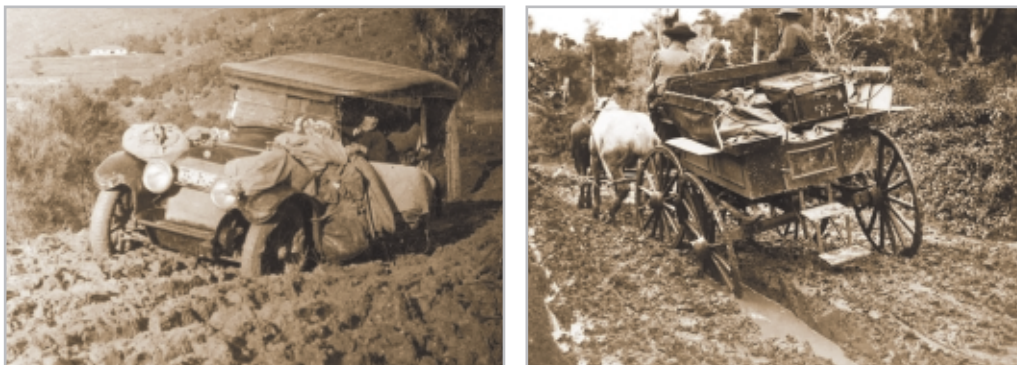
Figure 1-1 Chipsealed roads made a great improvement to travel in New Zealand, as “up to the axles in mud” was commonplace in the early days of transport. Right image shows a horse-drawn wagon bogged down on its way to Frederic Truby King’s farm at Tahakopa, South Otago (c. 1910s).

Two advances made in the latter part of the 19th century encouraged sealing roads with protective surfaces in New Zealand. One was of the increased production of coal gas for lighting and heating, and its by-product coal tar. The other was the automobile which required smoother and safer surfaces than the rutted gravel surfaces which had previously provided the needs of lighter horse-drawn traffic (Figure 1-1).

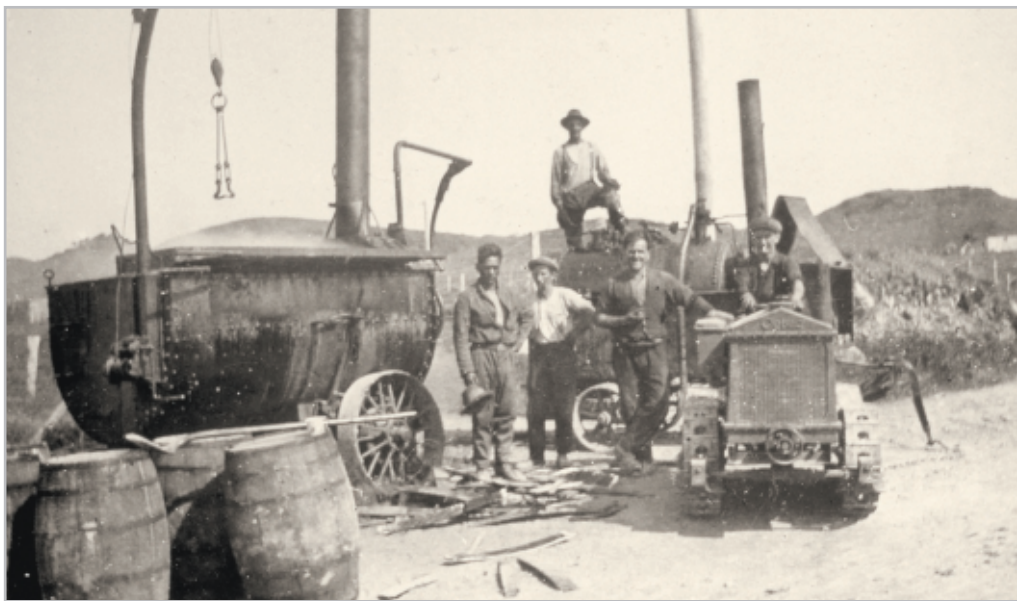
Figure 1-3 This bitumen heating kettle (left) being used in Taranaki was the way to heat bitumen in the 1920s. The fire, stoked with staves from empty bitumen barrels, was in the firebox under the kettle. The firebox gases passed around all sides of the kettle. Photo courtesy of John Matthews, Technix Group Ltd

As if the task was not hazardous enough, the bitumen was pumped by a hand-operated gear pump, and that was a very unpleasant occupation for the person standing alongside the uninsulated surfaces of the tar kettle.

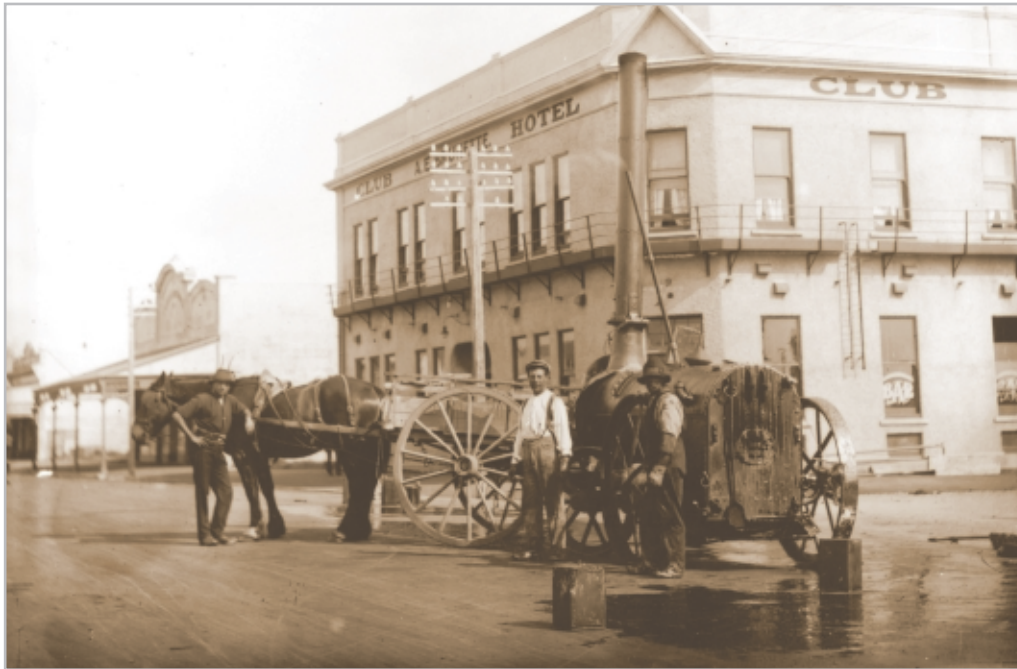
Figure I-4 Draughthorse-drawn bitumen hand sprayer ready for sealing the main street of Opunake, Taranaki, in the 1920s. Photo courtesy of Feaver Collection, Puke Ariki Museum Archives, New Plymouth

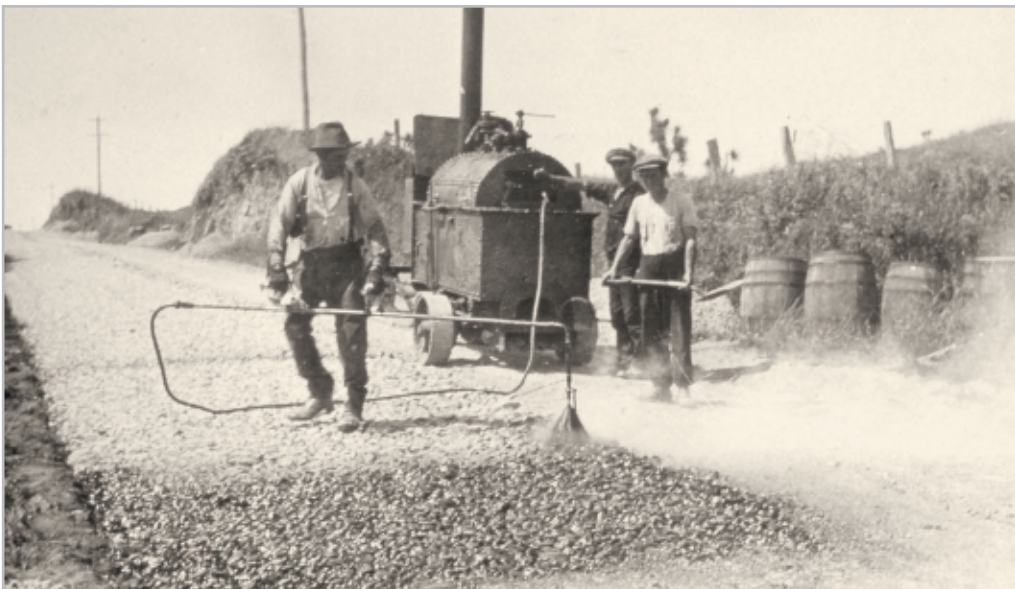
Figure 1-5 Most early chipsealing was carried out to keep down dust in the summer and mud in winter. In the 1920s this spray operator in Opunake County was using a hand sprayer with a swinging boom that kept the hose clear of the hot bitumen tank. Photo courtesy of John Matthews, Technix Group Ltd

Early chipseal methodology compared to modern methods was quite primitive and based more on experience than research. Before the introduction of spraybars, bitumen was hand sprayed (Figure 1-5), and typical equipment used for hand spraying included:

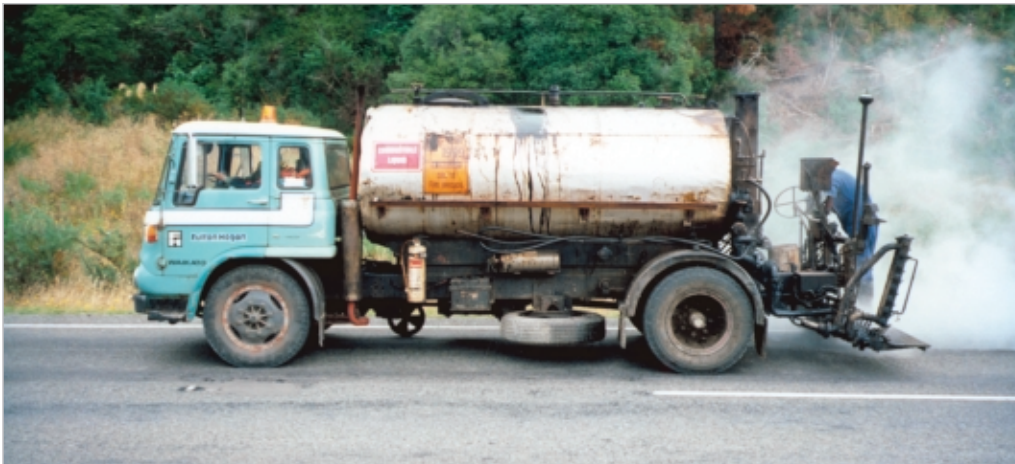
Figure 1-6 An old-style bitumen distributor (sprayer). Note the tall handle behind the distributor tank which was used to open and shut the spraybar. Photo courtesy of Laurence Harrow, Opus

Spray nozzle valves were interconnected with a gangbar-lever system to enable all the nozzles to be operated together. All these spray bars were operated manually, and the sight of someone swinging on the lever to turn taps on and off was common (Figure 1-6). The V-jet nozzle has been the most favoured for use on spraybars and, although the quality has significantly improved, they have never been able to produce a uniform spray pattern. To compensate for this, triple overlapping of the nozzle sprays (so that three fans of spray covered each section of the road) was adopted at a very early stage. This arrangement is discussed further in Chapter 10.

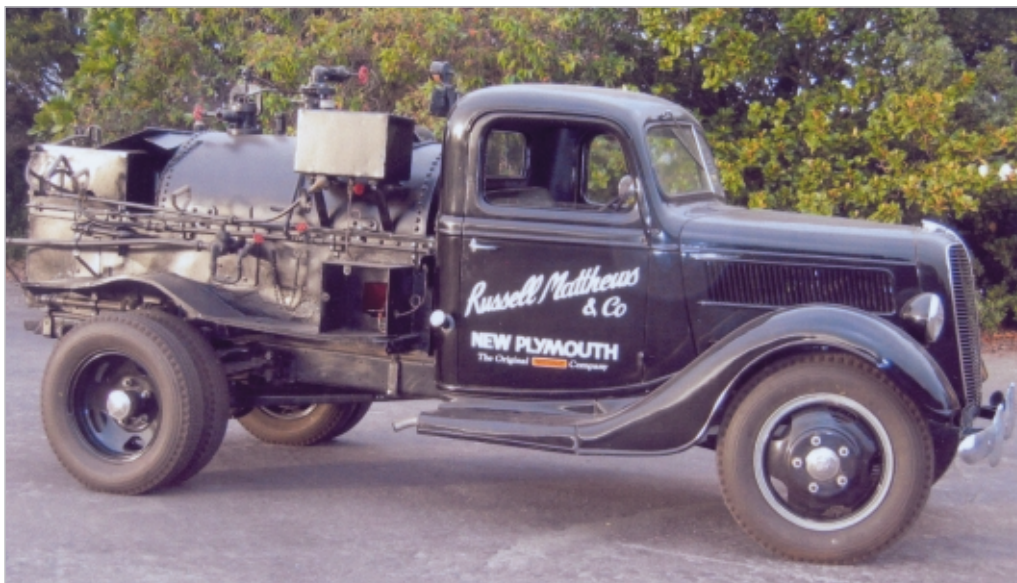
Figure 1-7 A 1940s bitumen distributor and hand sprayer, vacuum-filled and pressure discharged, on display at the property of John Matthews, Technix Group Ltd, New Plymouth.

In the early days of mechanical sprayers (Figure 1-7), another skill the driver needed was to alter spray rates by altering road speed. The gearing systems of some trucks could not cope with the slow speeds needed for high application rates, and many clutches were burnt out.
