CHAPTER
FOUR

Typical Chipseal Performance

Chapter 4 Typical Chipseal Performance

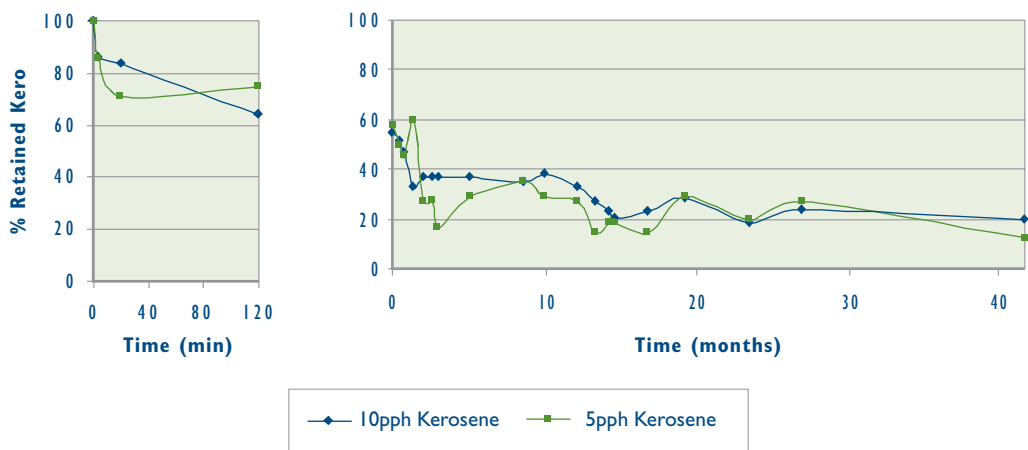
Figure 4-1 Estimate of kerosene content made by measuring weight loss from samples over a period of 5 years (Ball 1999). Approximately 20% of the added kerosene evaporated while being sprayed, and 30% within 2 hours.

One year after chipsealing, all the kerosene had evaporated from the chipseal's binder except for the last 20% which remained in the binder for the rest of the chipseal's life.

This slow down in kerosene loss over the winter is consistent with laboratory trials (Patrick 1987) which indicated that the rate of loss of kerosene, mineral turpentine and AGO was controlled by the diffusion of the diluent to the seal surface, not by its volatility. This means that the diluent needs to diffuse through the binder film to the surface before it will evaporate. Therefore the diluent lower down in the chipseal takes a longer time to diffuse to the surface and evaporate. Patrick also found the following relationship.

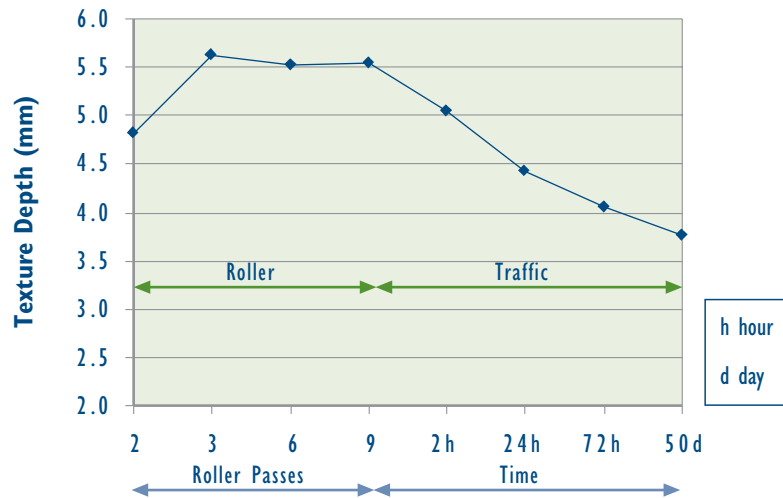
Figure 4-2 The change in texture depth (which is a measure of compaction) that occurs in the early life of a seal (adapted from NRB RRU 1989).

The change in texture depth (which is a measure of compaction of the seal) that occurs in the early life of a seal is illustrated in Figure 4-2 adapted from a 1989 NRB RRU report.

Figure 4-2 shows an apparently very slow change in texture under the roller during construction, followed by a rapid decrease in texture depth under normal traffic. This pattern was confirmed in other roller trials on single coat seals, results of which are given in Figure 4-3. In this research Hudson et al. (1986) used rollers of three different weights (8.3 tonnes, 10t, 13t).

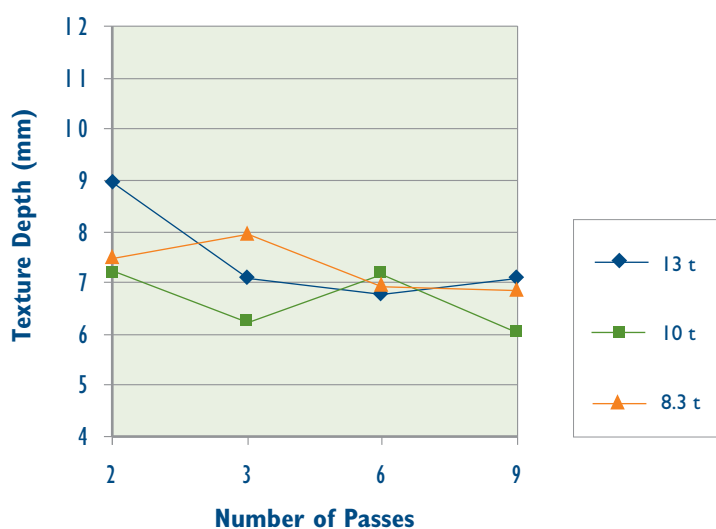
Figure 4-3 Effect of roller mass (8.3 tonnes, 10t, 13t) and number of passes on the compaction of a single coat chipseal (Hudson et al. 1986).

As shown, no significant change in texture took place between roller passes 3 to 9, or between different weights of rollers.

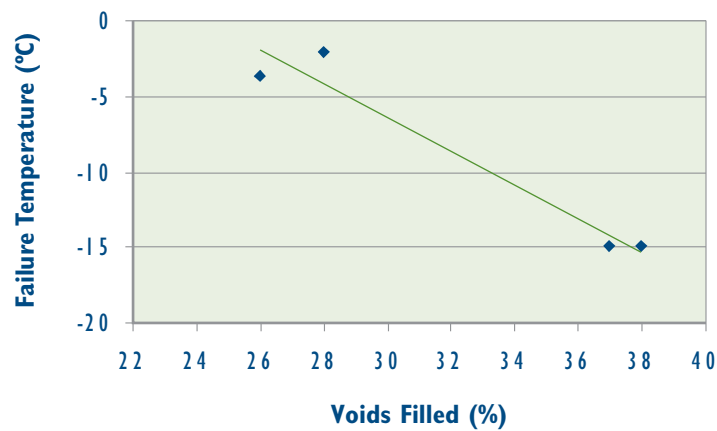
Figure 4-4 Temperatures at which failure by chip loss occurs in seals using 180/200 grade bitumen and subjected to impact as for traffic stress. The trends reflect field behaviour (from Ball et al. 1999).

The interactions between temperature, viscosity, rolling and traffic have been investigated by Ball et al. (1999). Figure 4-4 adapted from the research illustrates the results where samples of seals using 180/200 grade bitumen were manufactured in the laboratory and then subjected to impacts to simulate traffic stresses. Although the temperatures at which failure occurred are not expected to model the field conditions exactly, the trends do reflect field behaviour.

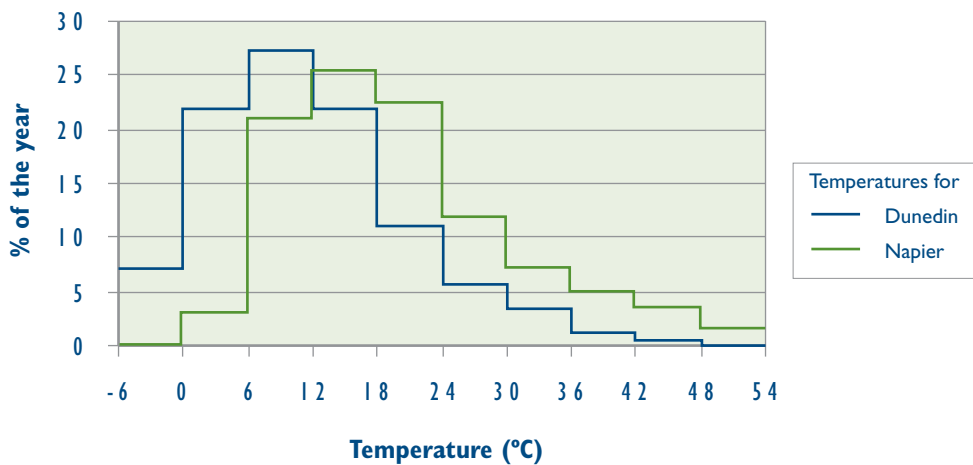
Figure 4-5 A comparison of pavement surface temperatures for Dunedin and Napier to show why chip loss is more likely to occur in Dunedin pavements.

If the low temperature properties of the binder and its durability cause it to get very hard at the prevailing pavement temperature, then chip loss caused by traffic can occur. The variation in temperature experienced in New Zealand is illustrated in Figure 4-5. It shows that pavement surfaces in Napier do not experience temperatures below 0°C, while those in Dunedin have surface temperatures below 0°C for 7% of the year. In Central Otago (one of the coldest regions of New Zealand) the surface can be below 0°C for 14% of the year.

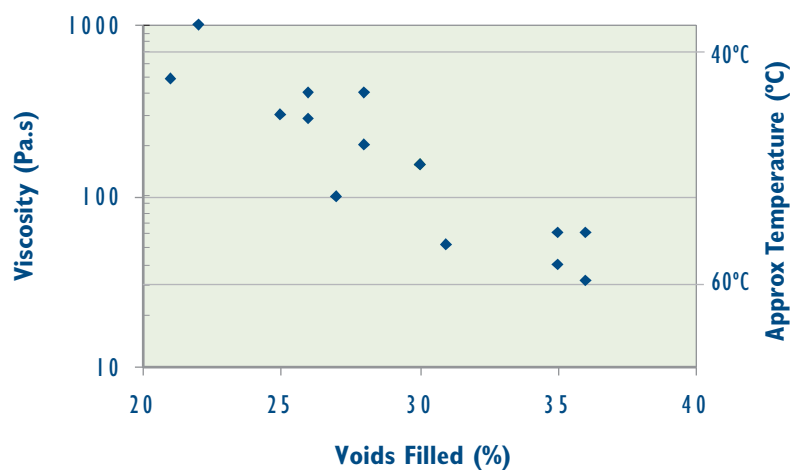
Figure 4-6 The effect of binder viscosity and % voids filled on the strengths of seals compacted in the laboratory (from Ball et al. 1999).

High pavement temperature also affects seal strength by affecting binder viscosity and chip interlock. Figure 4-6 taken from Ball et al. (1999) illustrates the effect of binder viscosity and % voids filled on the strengths of seals compacted in the laboratory. The range in viscosity is equivalent to a change in temperature from 40°C to over 60°C.

The laboratory tests performed used a similar apparatus as used for the low temperature tests, and failure was defined when the seal sheared under impact loading. Figure 4-6 shows that the seal would fail at 40°C when approximately 22% of the voids are filled, but at 60°C when over 35% of the voids are filled.

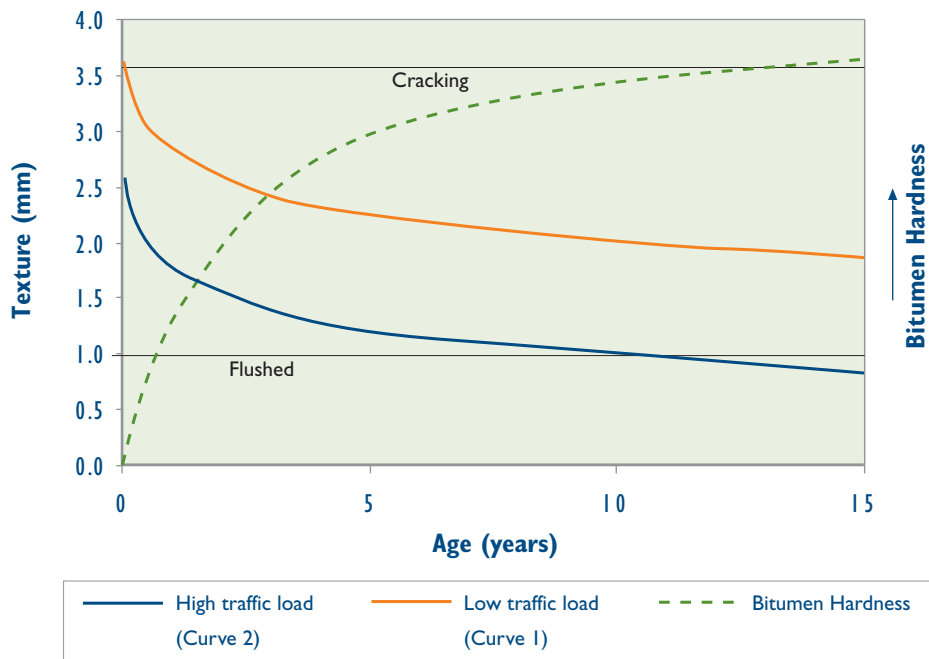
Figure 4-7 Over 15 years the ageing process related to oxidation of the bitumen causes hardening, leading to cracking or chip loss, or loss of texture by traffic compacting the chip, leading to flushing. Bitumen hardness and texture depth (mm) are shown for a low deflection, less flexible pavement, under low (curve 1) and high (curve 2) traffic loadings.

Therefore the pavement under higher traffic loading (curve 2) would fail through flushing while the pavement with lower traffic loading (curve 1) would fail through cracking. This cracking could be thermally induced as the binder would not be able to accommodate the thermal expansion and contraction cycles it undergoes every day and night.

In the above example the pavement was assumed to have low deflection so that effects of load-induced cracking or fatigue were not significant.

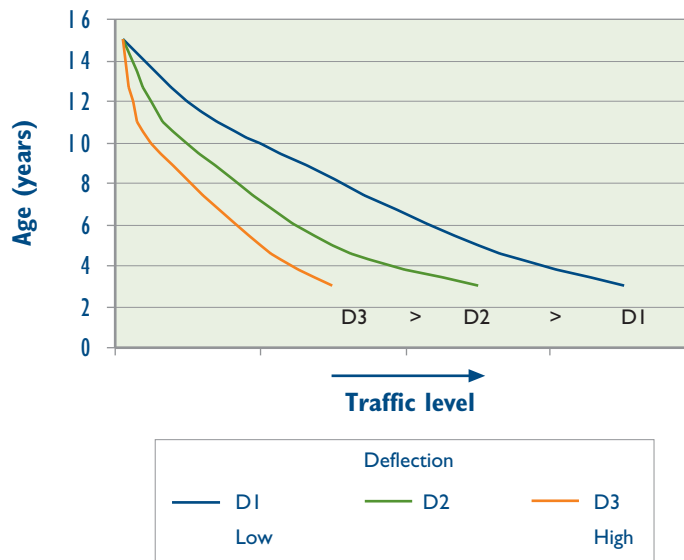
Figure 4-8 The time taken for a chipseal to crack under the effect of 3 levels of deflection: D1 (low), D2, D3 (high). (Deflections 1, 2, 3 are relative units.)

Figure 4-8 illustrates the effect of pavement deflection on the time a seal takes to crack. The three deflection levels converge under low traffic to a single point at 15 years. As the traffic increases the increased flexing of the seal will lead to fatigue cracking. The age at which this occurs is affected by the deflection of the pavement and the traffic volume. At the same traffic volume, seals on low deflection pavements will take longer to fatigue crack than those subjected to higher deflections.

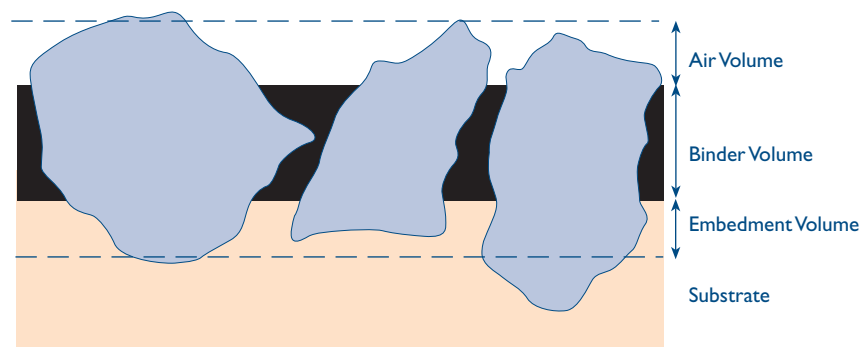
Figure 4-9 The voids concept as it applies to a single coat seal: spaces between chips are taken up by air, binder or embedment in the underlying substrate (from Potter & Church 1976).

The basic voids concept of a single coat seal is illustrated in Figure 4-9. The spaces between the sealing chips are taken up by air, binder and by embedment of the chip into the underlying substrate. Under traffic the total voids decrease through chip re-orientation and embedment, at different rates related to the traffic load.

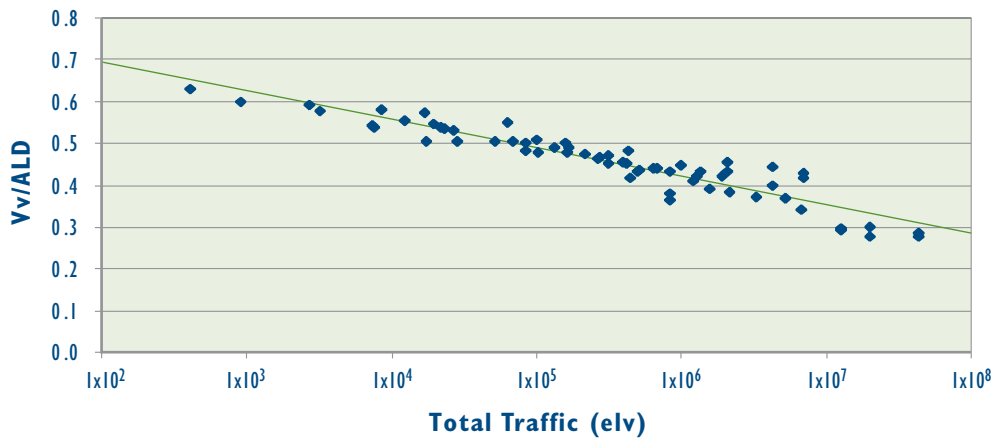
Figure 4-10 Relationships between volume of voids (Vv), chip ALD, and traffic volume (elv) for single coat seals on roads in Lower Hutt (from Patrick 1999).

A summary of the relationships found between V_v/ALD and traffic volume is given in Patrick (1999). The most comprehensive set of data that is available was obtained for single coat seals in Lower Hutt, and is shown in Figure 4-10. As the extent of chip embedment into the substrate is a function of the substrate hardness, and as soft substrate and chip embedment are regular causes of flushing, a discussion on soft substrate is included in Section 4.7.4.1. Chapter 9 also covers it as part of chipseal design.

The traffic has been converted to equivalent light vehicles (elv), a concept which was developed in South Africa to equate heavy vehicles to light vehicles. Currently in New Zealand an equivalence factor of 10 is used, i.e. one heavy vehicle is considered to be equivalent to 10 cars. Very little data are available in New Zealand to robustly determine what the factor should be.

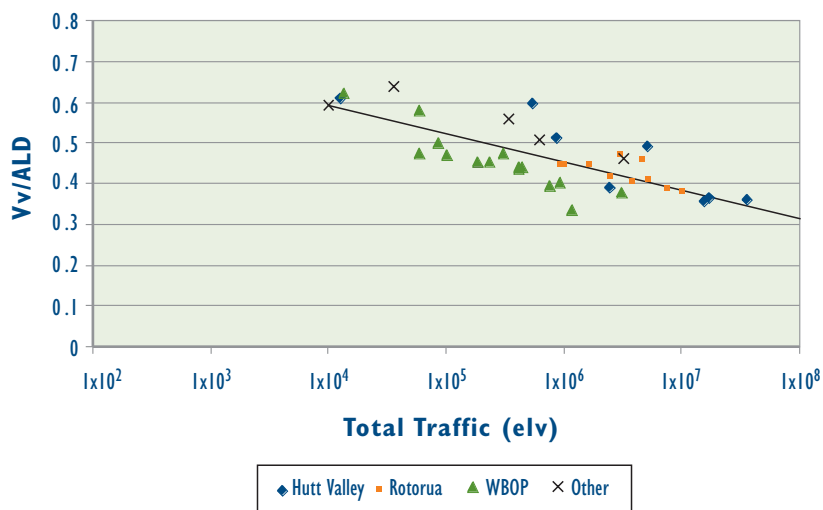
Figure 4-11 Relationships between volume of voids (Vv), chip ALD, and traffic volume (elv) for two coat seals on roads in Hutt Valley, Rotorua, Western Bay of Plenty and other areas in North Island (from Patrick 1999).

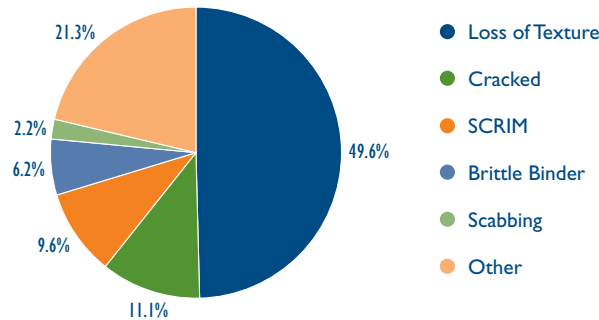
Figure 4-12 Reasons for resealing pavements on New Zealand state highways during the 2003 sealing season.

The reasons for resealing New Zealand state highways, as shown by 2003 data, are illustrated in Figure 4-12. It shows that the predominant reason for resealing for that sealing season was flushing (loss of texture) of the existing surface.

Flushing (called Loss of Texture) was found to be the predominant reason for resealing on New Zealand's state highways (Figure 4-12) but was ranked at number 3 (by New Zealand authorities) for New Zealand state highways in Oliver's research (Table 4-3).

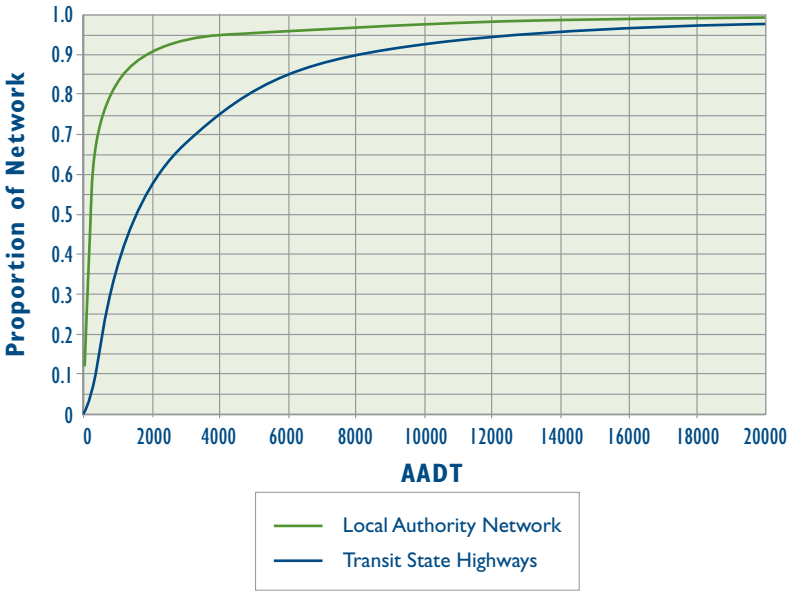
Figure 4-13 An estimate of the distribution of traffic volumes on New Zealand roads in 2000 (from National Traffic Database).

The data also help explain why the predominant reason for resealing local roads given in Oliver's (1999) report is cracking. Figure 4-13 shows that 90% of them had traffic volumes less than 2000 vpd.

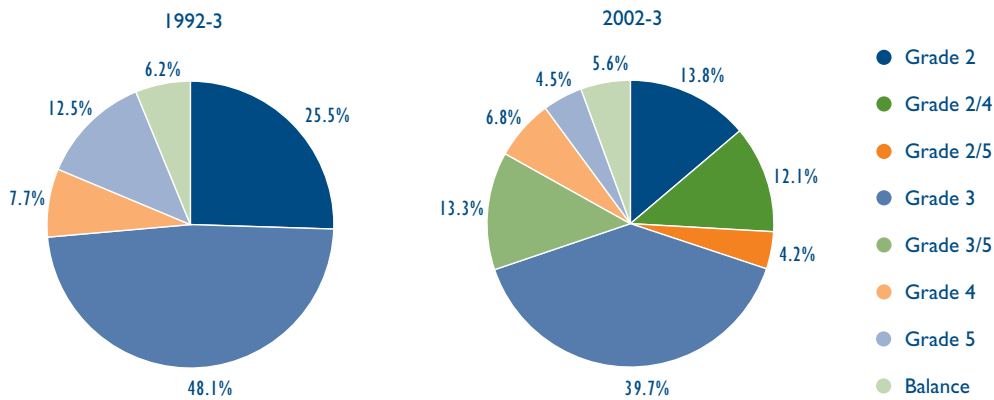
Figure 4-14 The use of multicoat seals, e.g. two coat and racked-in, has increased significantly over the last 10 years on state highways in New Zealand.

Over the last ten years the increase in the use of multicoat seals, e.g. two coat and racked-in, has been significant, as illustrated in Figure 4-14 by the state highway data.

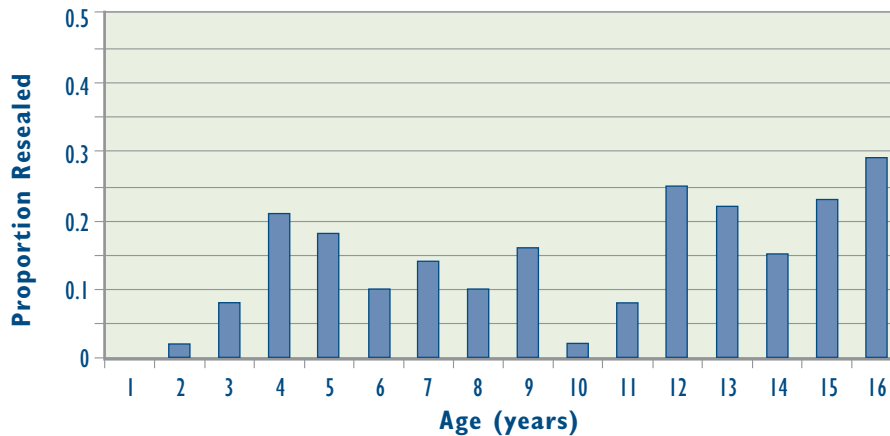
Figure 4-15 Distribution of seal lives for Grade 3 chipseals on New Zealand state highways at 2000 to 4000 vpd traffic volumes.

The above discussion of seal lives suggests that the ‘design life’ or average life of seals is relatively predictable. However in practice, the distribution of seal lives in any traffic volume band is not a normal distribution. Figure 4-15 illustrates the distribution of seal lives for a Grade 3 chip on New Zealand state highways.

Figure 4-15 shows that the distribution of failure is relatively flat and there is an almost equal probability that a seal will last 3 years as it will for 10 years. Some of the reasons for seals to not attain their expected life are:

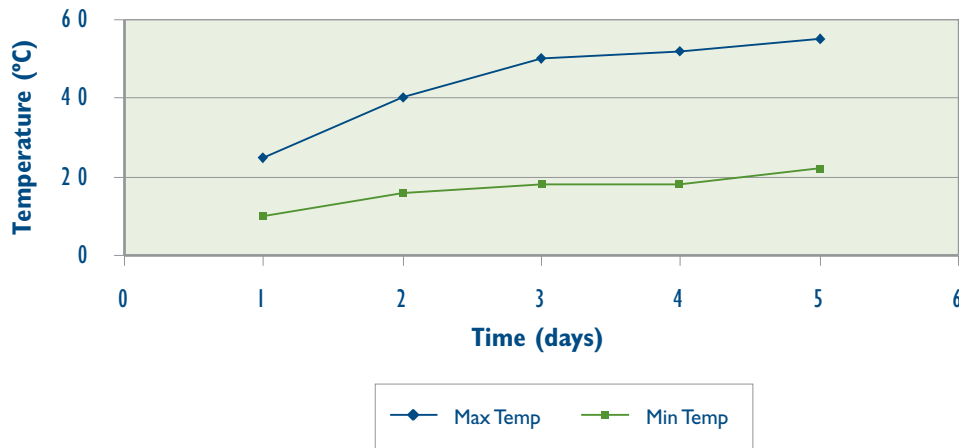
Figure 4-17 Temperature build-up over a number of sequential days in a pavement surface accelerates chip embedment.

A chipseal can appear to be in a stable condition but, as Figure 4-17 illustrates, if successive days of warm weather occur, then the pavement does not cool down overnight and the temperature builds up in the pavement. This temperature build-up can result in the acceleration of chip embedment and in flushing.

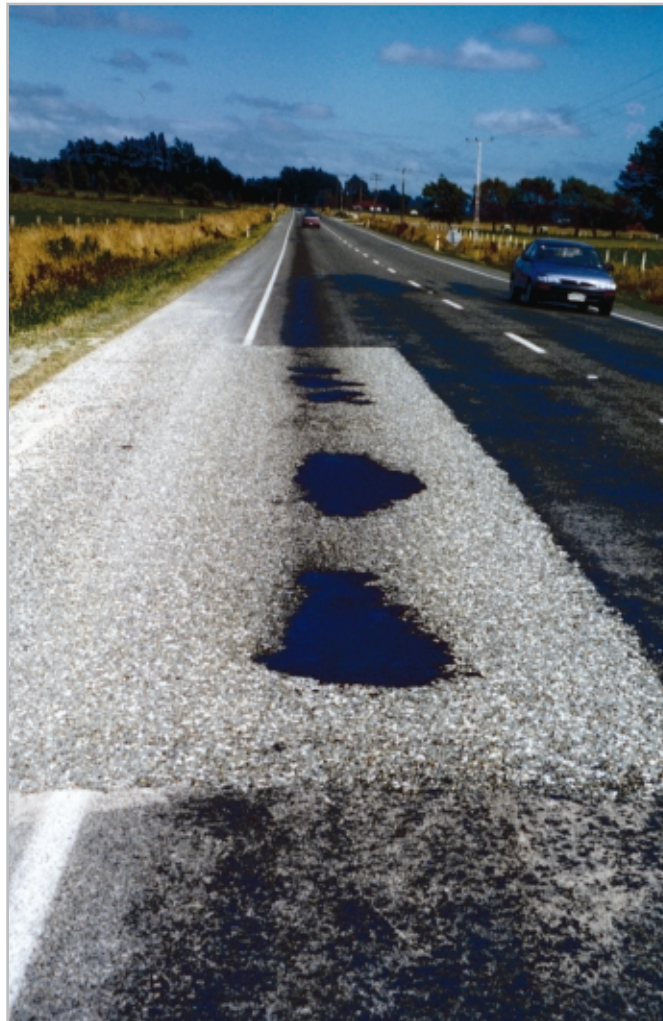
Figure 4-18 A flushed and tracked repair patch.

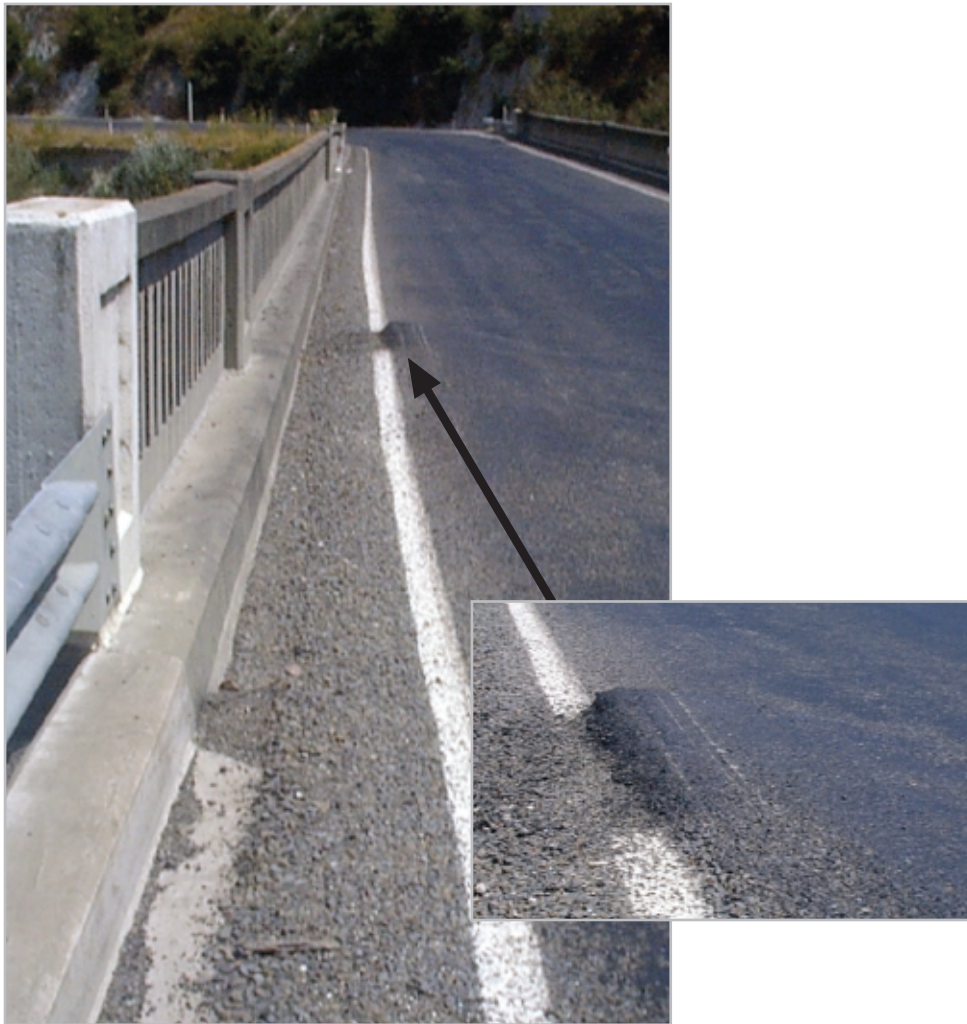
Figure 4-19 Shear failure on a bridge deck.

To illustrate this concept, Figure 4-19 shows a shallow shear failure that would usually be associated with poor performance of the basecourse layer of the pavement structure. The wider view of this shear failure shows that it has occurred in a number of seal layers above the concrete bridge deck. As the concrete bridge deck is rigid it cannot have sheared in this way, and the failure can only be attributed to the structural performance of the seal layers.

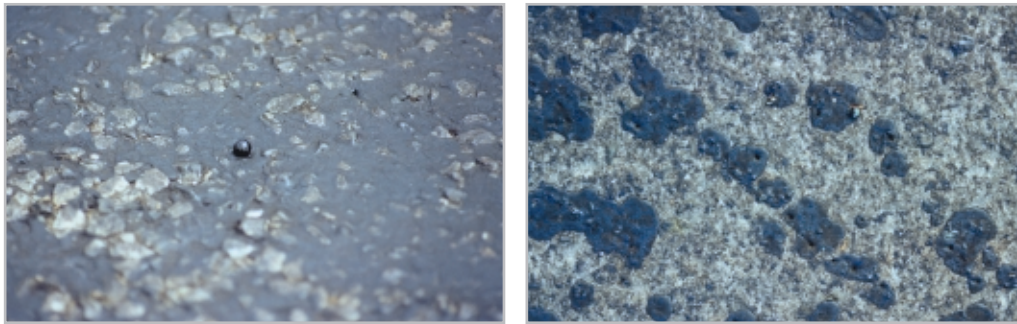
Figure 4-20 Binder rise showing vapour venting.

Although research into the phenomenon of volcanoes has demonstrated the physics, it has not been able to reproduce it in the laboratory. In the field, volcanoes show up initially as small 20¢-size ‘blobs’ of bitumen (Figure 4-20), which then tend to join together, ultimately resulting in a large area of flushing. This water vapour binder rise can normally be distinguished from flushing from other causes, such as trafficking, as it occurs in significant areas outside the wheelpaths.

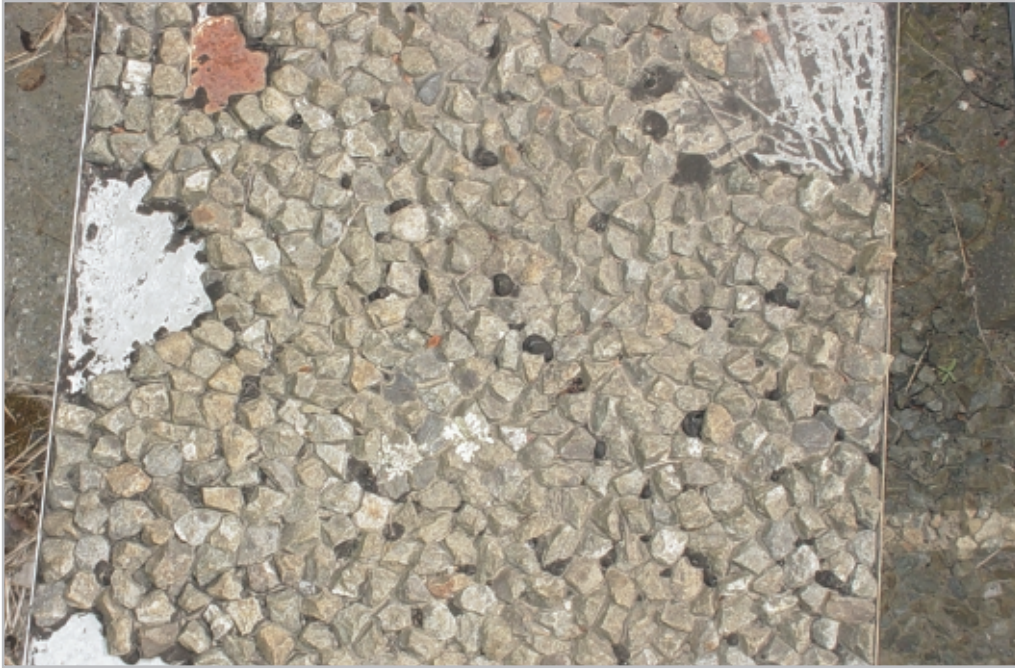
Figure 4-21 Binder rise in a chipseal constructed on a steel plate, for bitumen durability trials at Opus Central Laboratories, Lower Hutt. Samples have been taken from the bare sites.

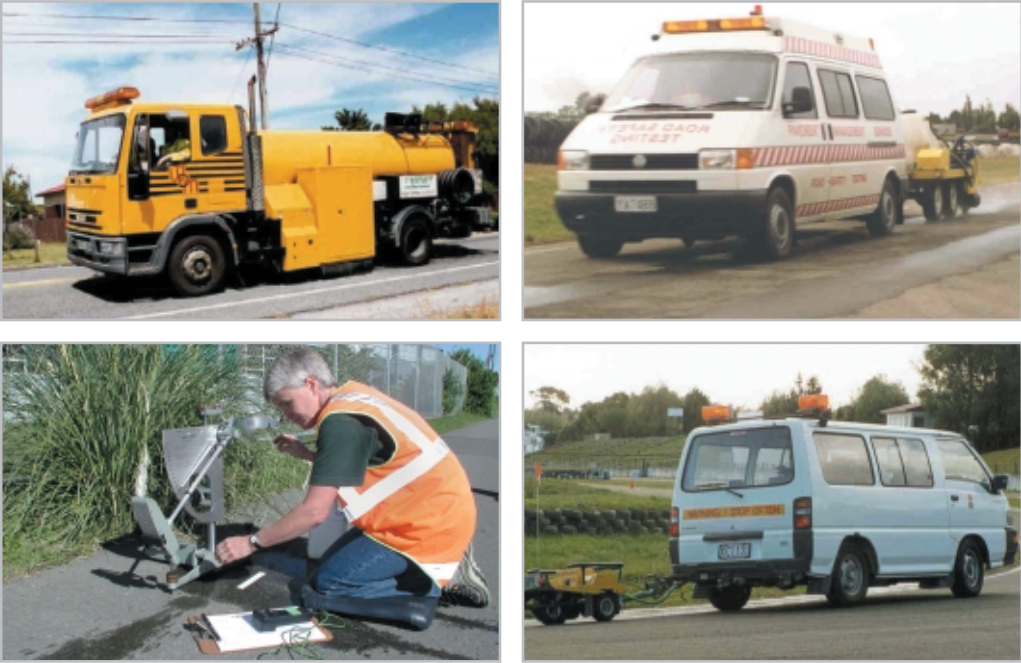
Figure 4-22 Machines used in New Zealand for measuring skid resistance. Clockwise from top left: SCRIM. Top right: RoAR. Bottom right: GripTester.

Machine. Other machines sometimes used in New Zealand are the GripTester, Norsometer RoAR (Road Analyser and Recorder) and British Pendulum Tester (BPT) (Figure 4-22).

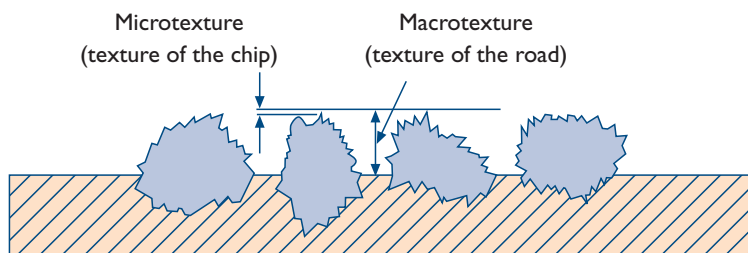
Figure 4-23 The relationship of macrotexture and microtexture of a road surface.

Microtexture is the fine texture caused by irregularities or asperities on the surfaces of each individual chip. This is shown diagrammatically in Figure 4-23.

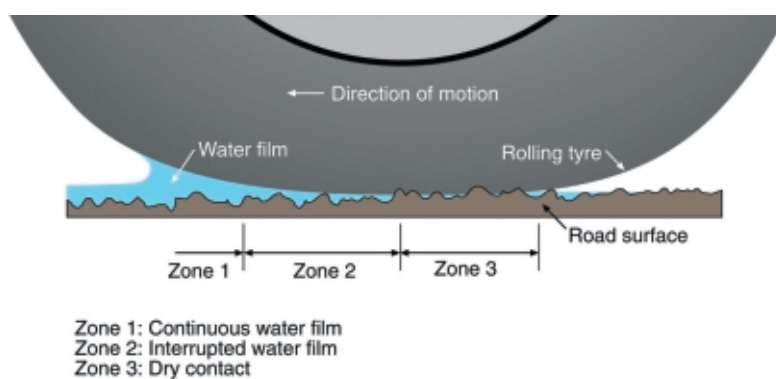
Figure 4-24 Tyre interface on a wet road.

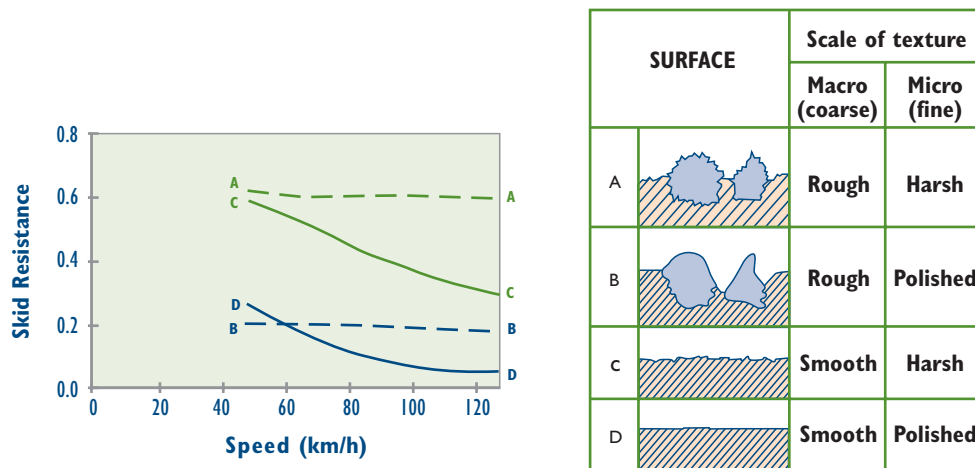
Figure 4-25 Effect of microtexture, macrotexture, and speed on skid resistance.

increase the macrotexture becomes increasingly important (Figure 4-25). If a vehicle increases its speed from 50 km/h to 130 km/h on a conventional bituminous surface with texture depth of 0.5 mm, the reduction in skid resistance is about 30%, whereas for a texture depth of 2.0 mm there is very little reduction.

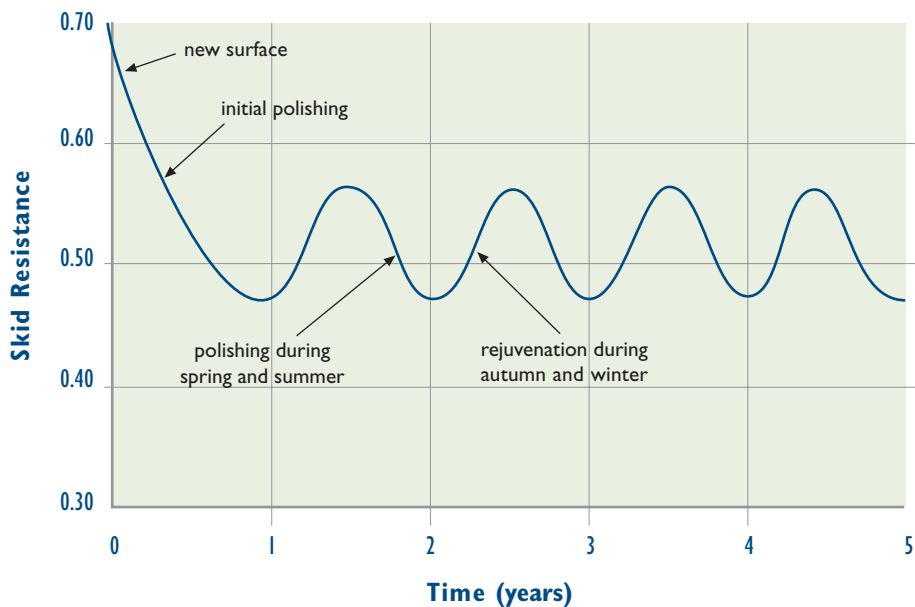
Figure 4-26 Effect of polishing on a new surface, showing initial high skid resistance followed by stabilisation at an equilibrium level.

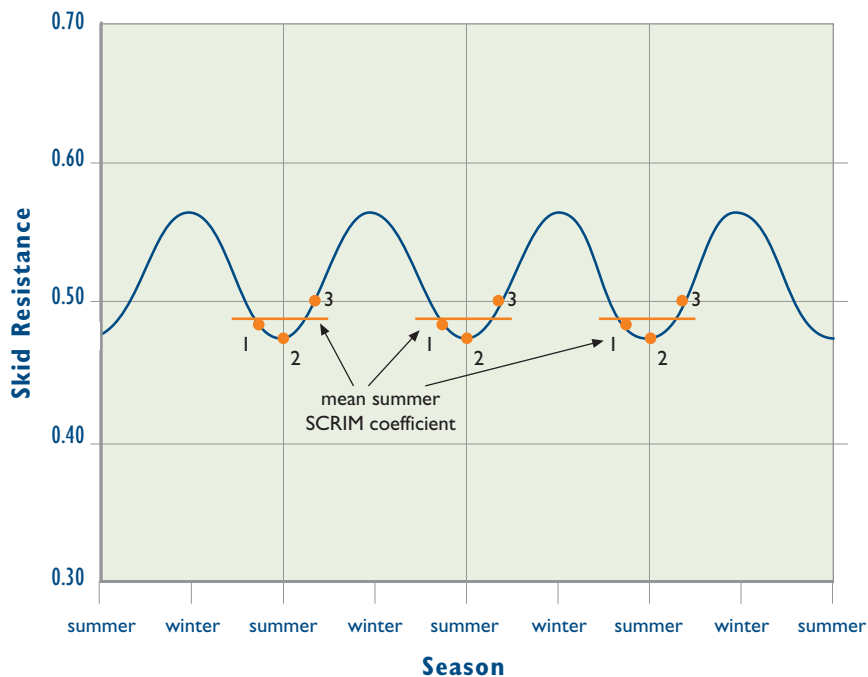
Figure 4-27 At each seasonal site, three SCRIM measurements (1, 2, 3) are made at different times during the summer. The average skid resistance for the summer for each site is calculated to obtain the Mean Summer SCRIM Coefficient (MSSC).

The sites have been selected to represent what are considered to be climatologically similar areas. These sites are tested three times each summer and the measurements used to give a Mean Summer SCRIM Coefficient (NZ MSSC) for each site. The three surveys are spread across the summer season with one survey at the start of the survey programme, one survey when the adjacent highways are being tested and one survey at the end of the survey programme. The procedure is shown diagrammatically in Figure 4-27.

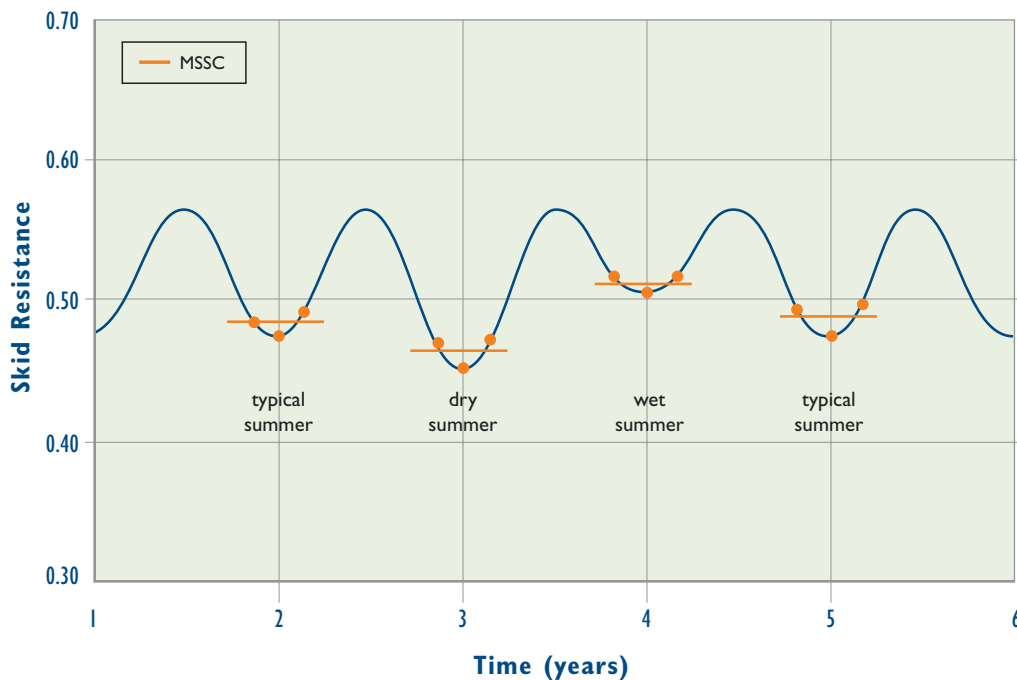
Figure 4-28 Year-on-year variations in weather patterns reduce the effectiveness of skid resistance policy in wet summers and cause over-reaction in dry summers.

However, with data available for 3 years on some seasonal control sites, the results have clearly shown that the year-on-year variations in New Zealand's weather patterns are also affecting skid resistance (Figure 4-28).

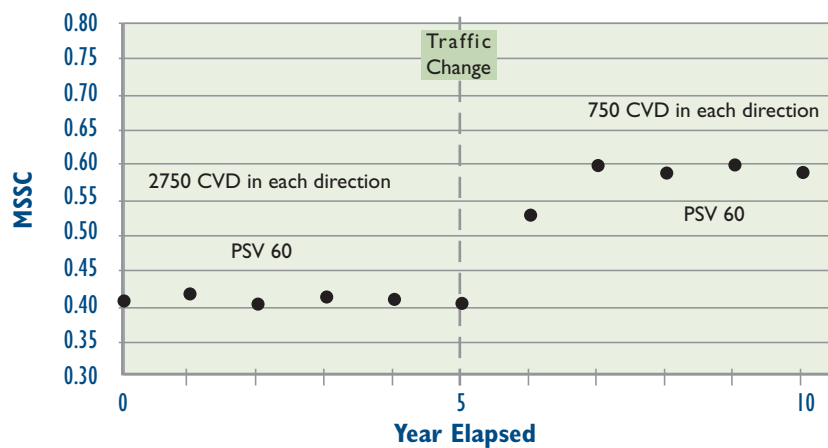
Figure 4-30 Improved skid resistance with decreased traffic volume (CVD).

The extent to which a road surface becomes polished is directly related to the traffic volumes of commercial vehicles and heavy commercial vehicles using the road. Consequently, a transverse profile of skid resistance will reveal lower levels of skid resistance in the wheelpaths and, on an otherwise uniform surface, a longitudinal profile will show that skid resistance levels are lower where additional stresses to the pavement are caused by braking or turning vehicles. On bituminous surfacings a highly significant correlation has been shown to exist between commercial vehicle traffic flow and equilibrium skid resistance. Figure 4-30 shows the increase in skid resistance of a road surface once a by-pass had been opened and the numbers of commercial vehicles per day (CVD) had reduced.
