# Effectiveness of a Speed Display Sign on reducing vehicles' speeds at road works

Anandita Pujara  
Graduate (ITS) Engineer

This research paper investigates the impact of a Driver Feedback Speed Display (DFSD) sign on drivers' speed through road works.

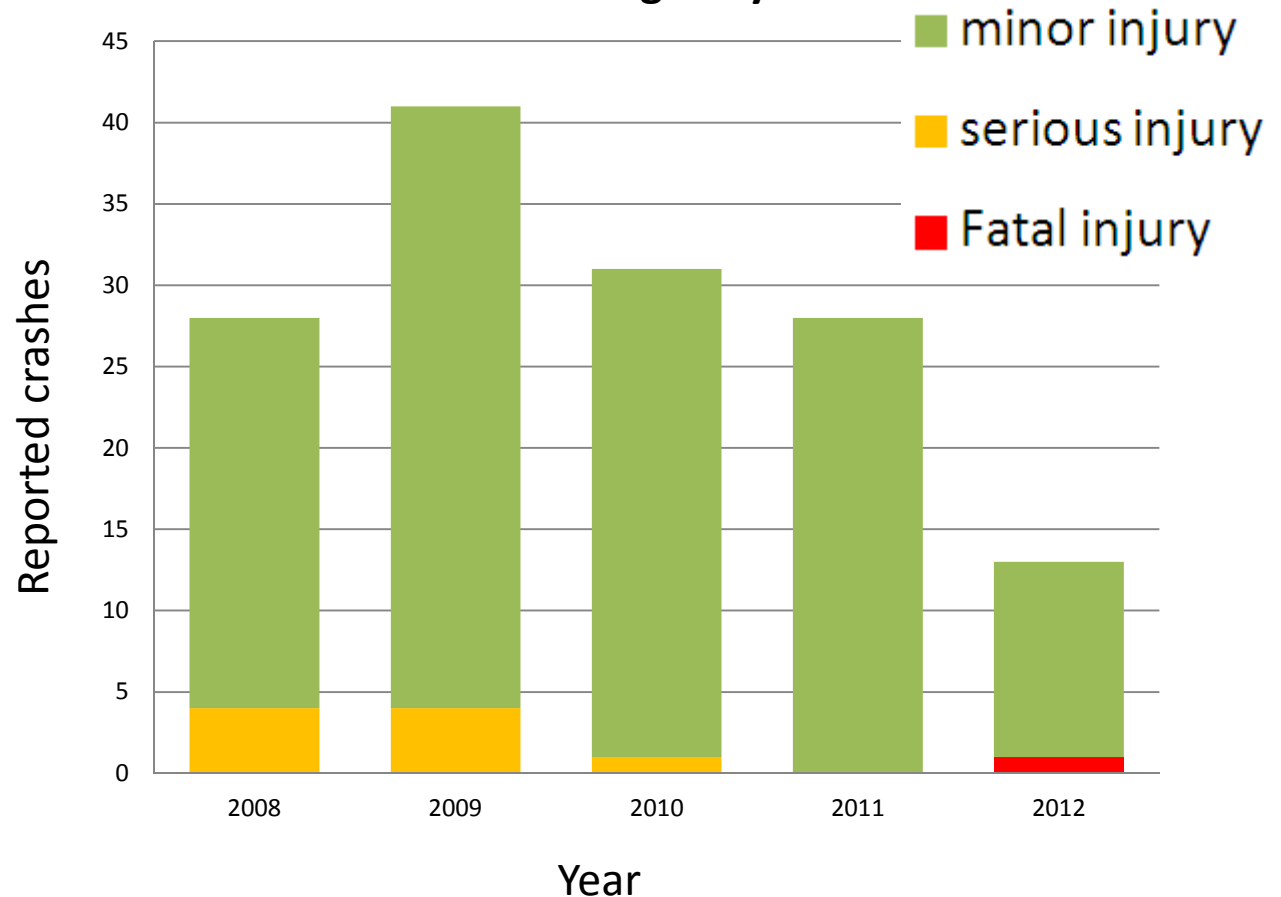
Reported Injury Crashes due to speeding drivers within Temporary Speed Limit - State Highways

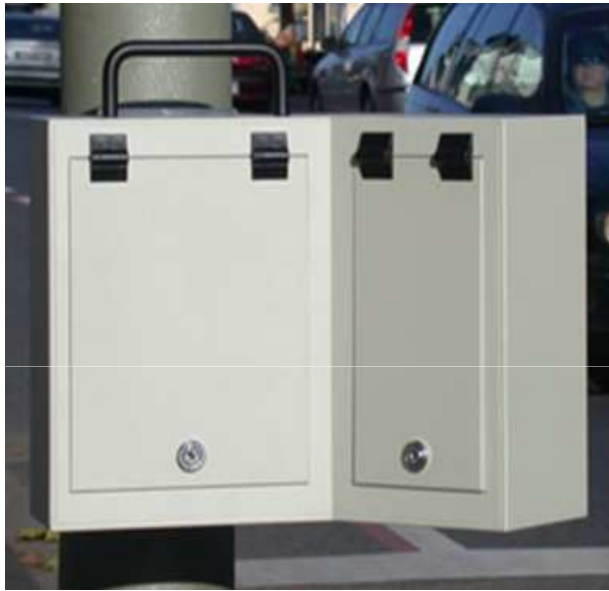
A radar unit

Product Name: Viacount II

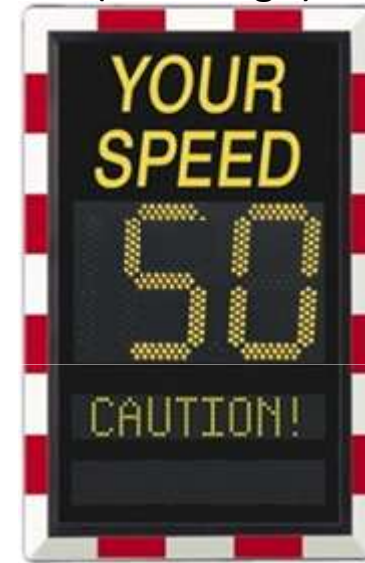
Driver Feedback Speed Display Sign  
(DFSD Sign)

Product Name: Vaisis

Supplier: ELWC Australia

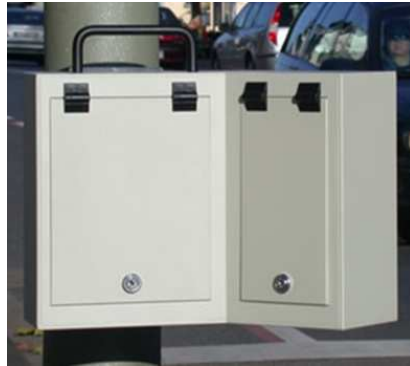
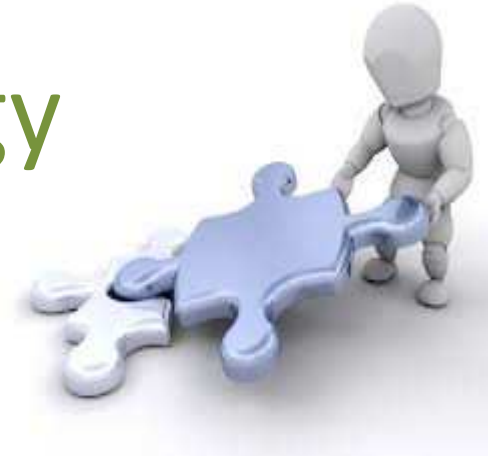
- Day 1

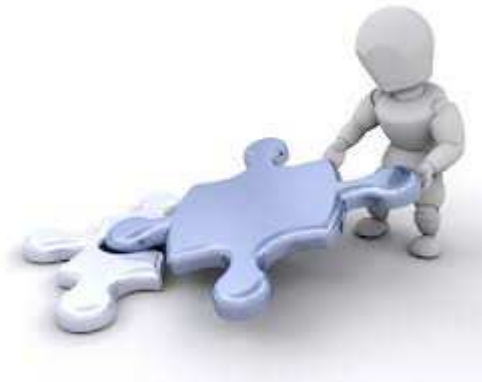
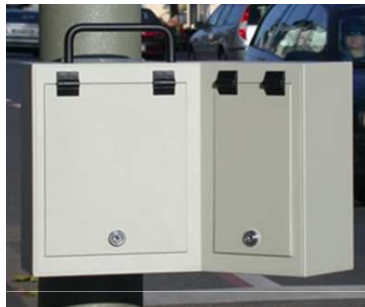
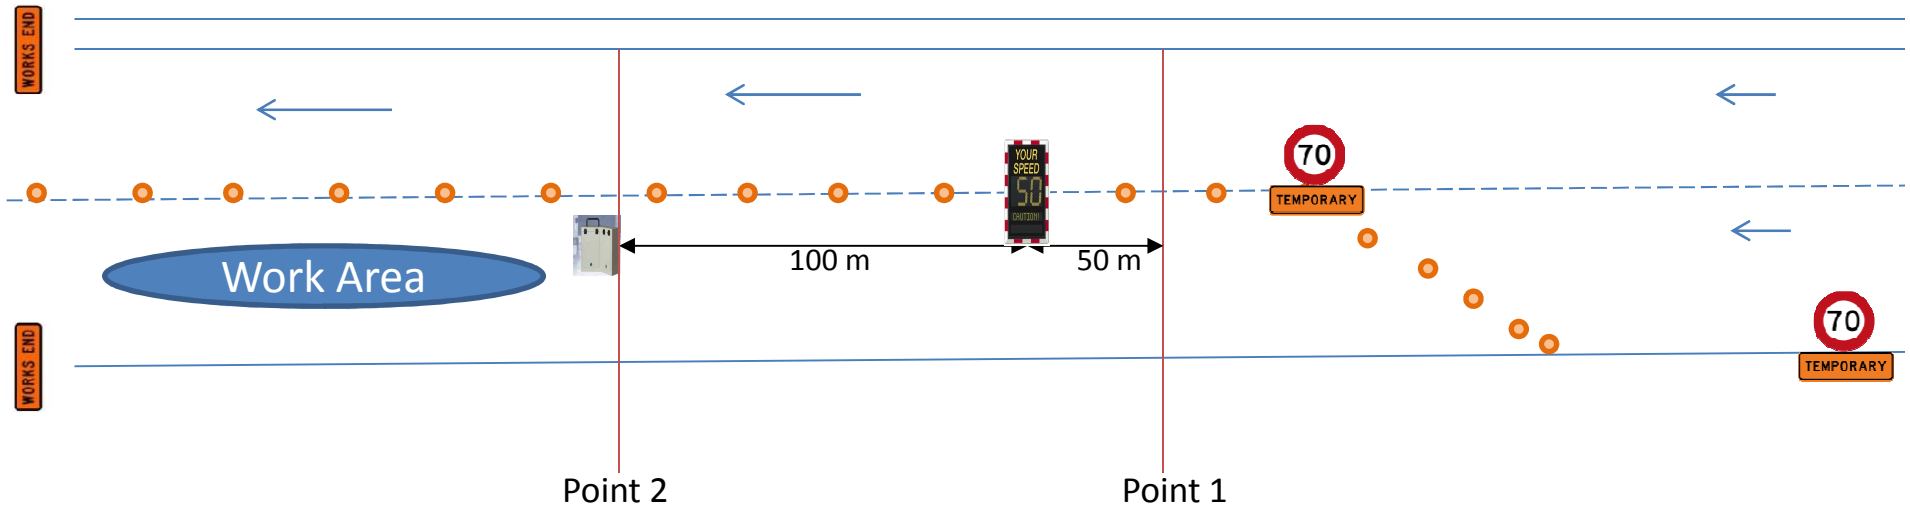
- Day 2

Point 2

Point 1

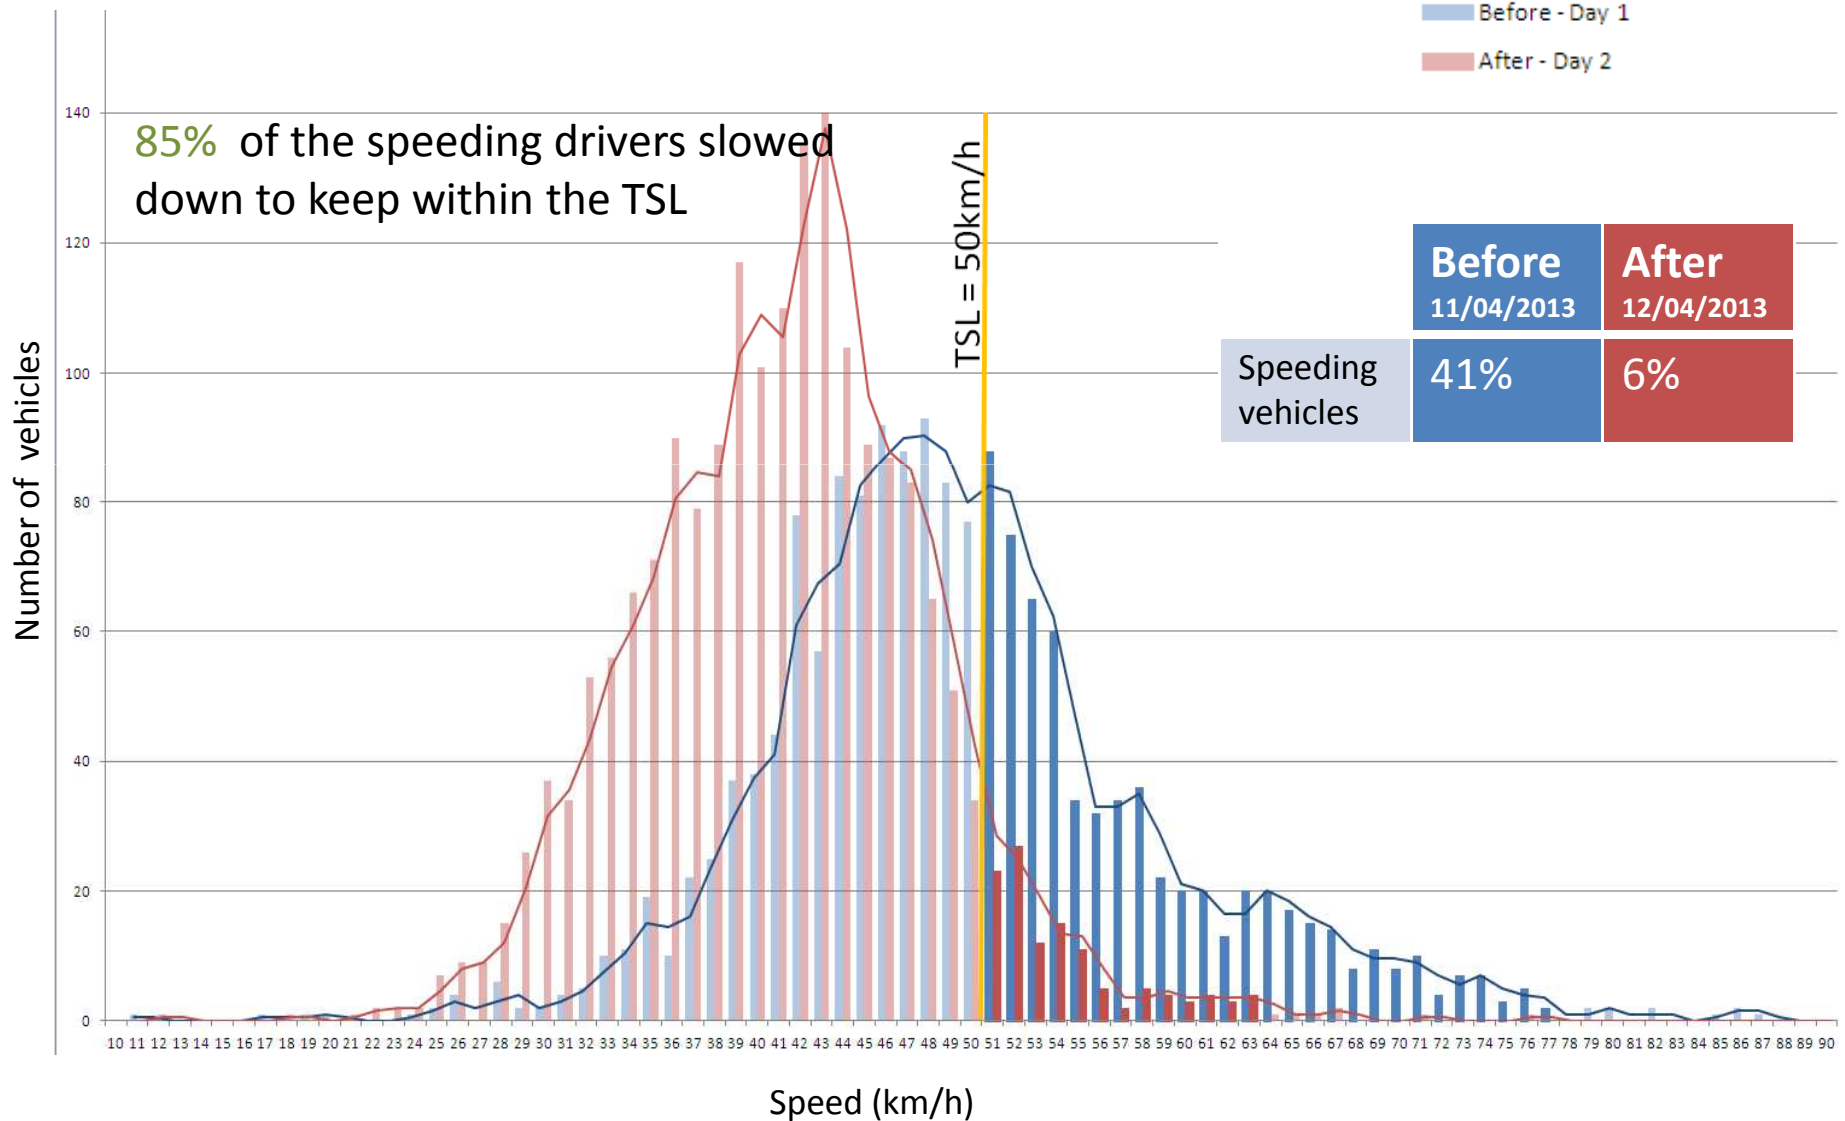
## Site 1: Te Horo – Method 1 Temporary Speed Limit (TSL) = 50km/h

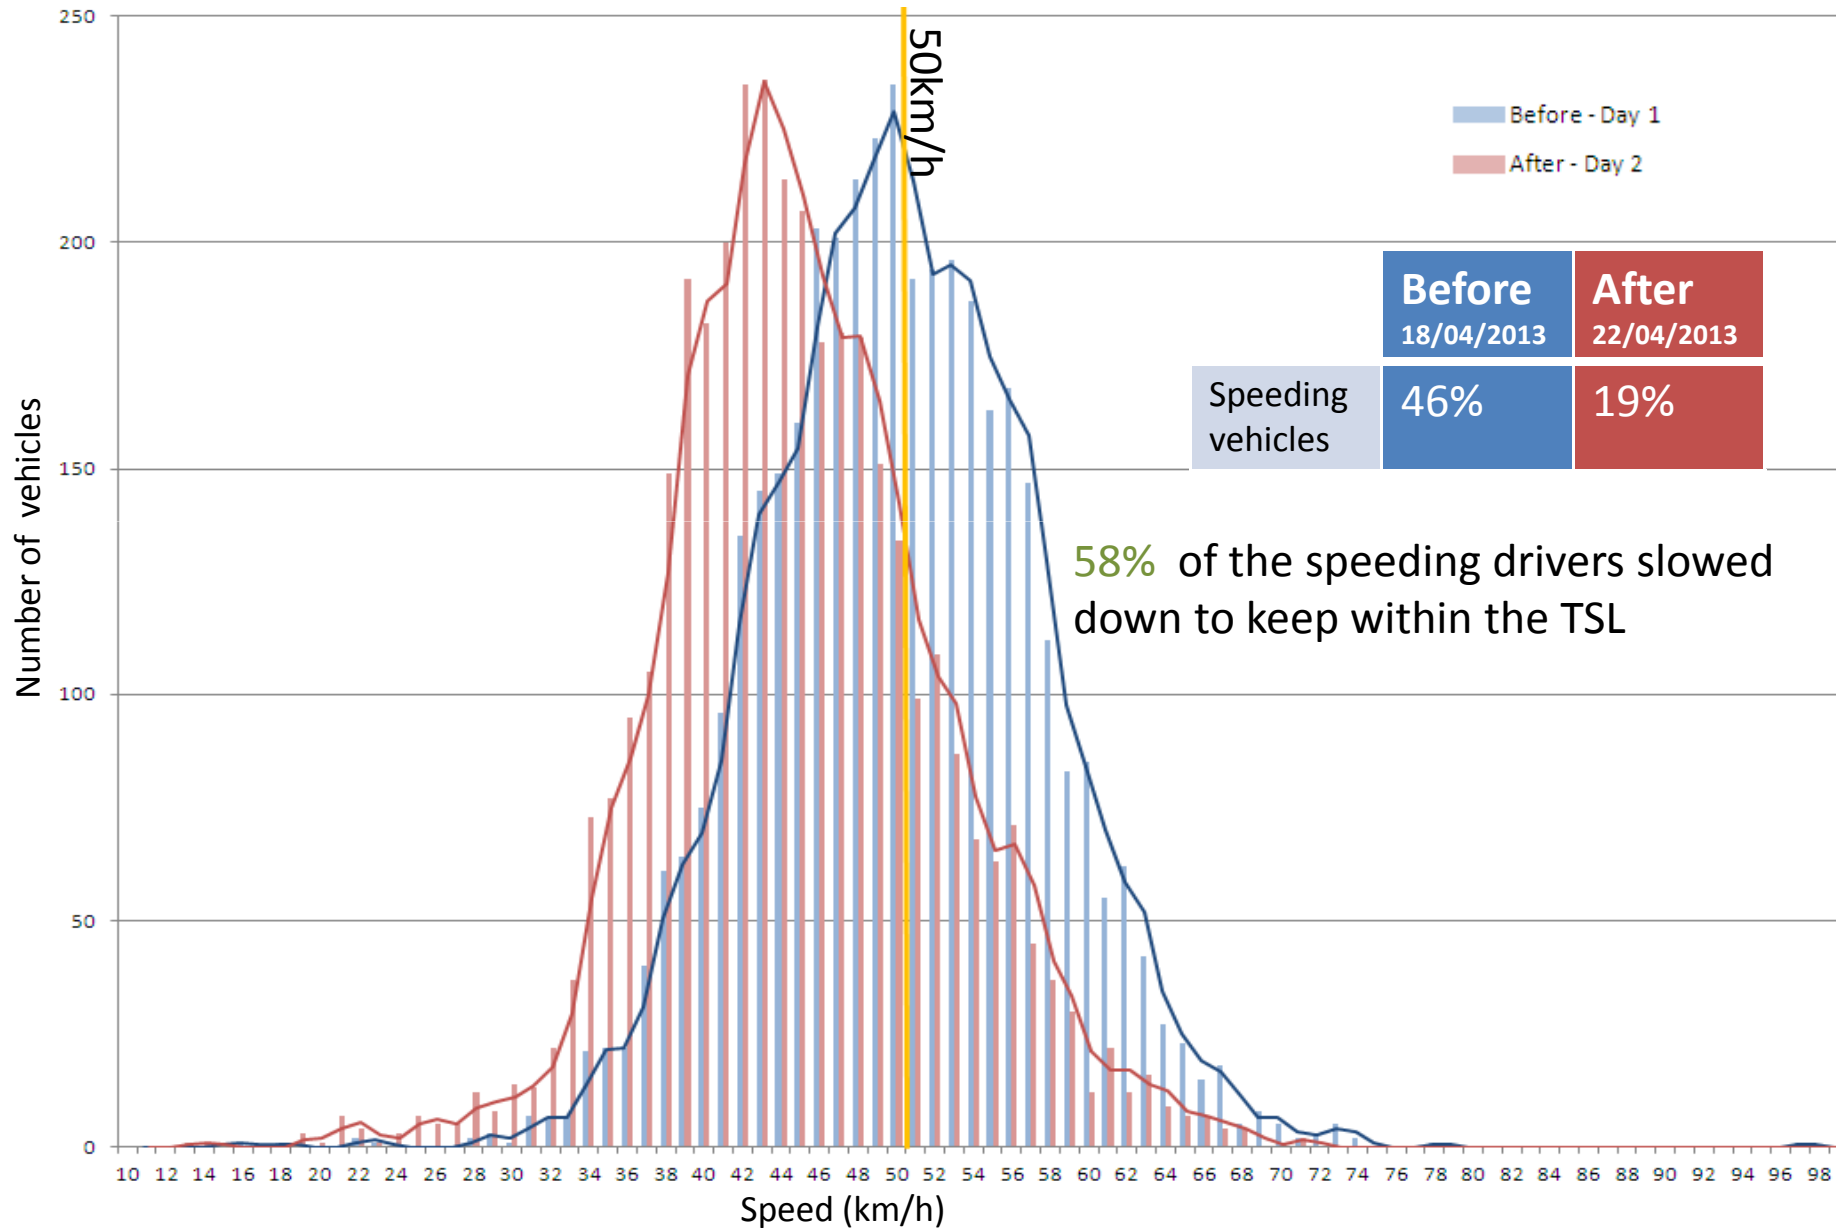
## Site 2: Ngauranga on-ramp – Method 1

Temporary Speed Limit = 50km/h

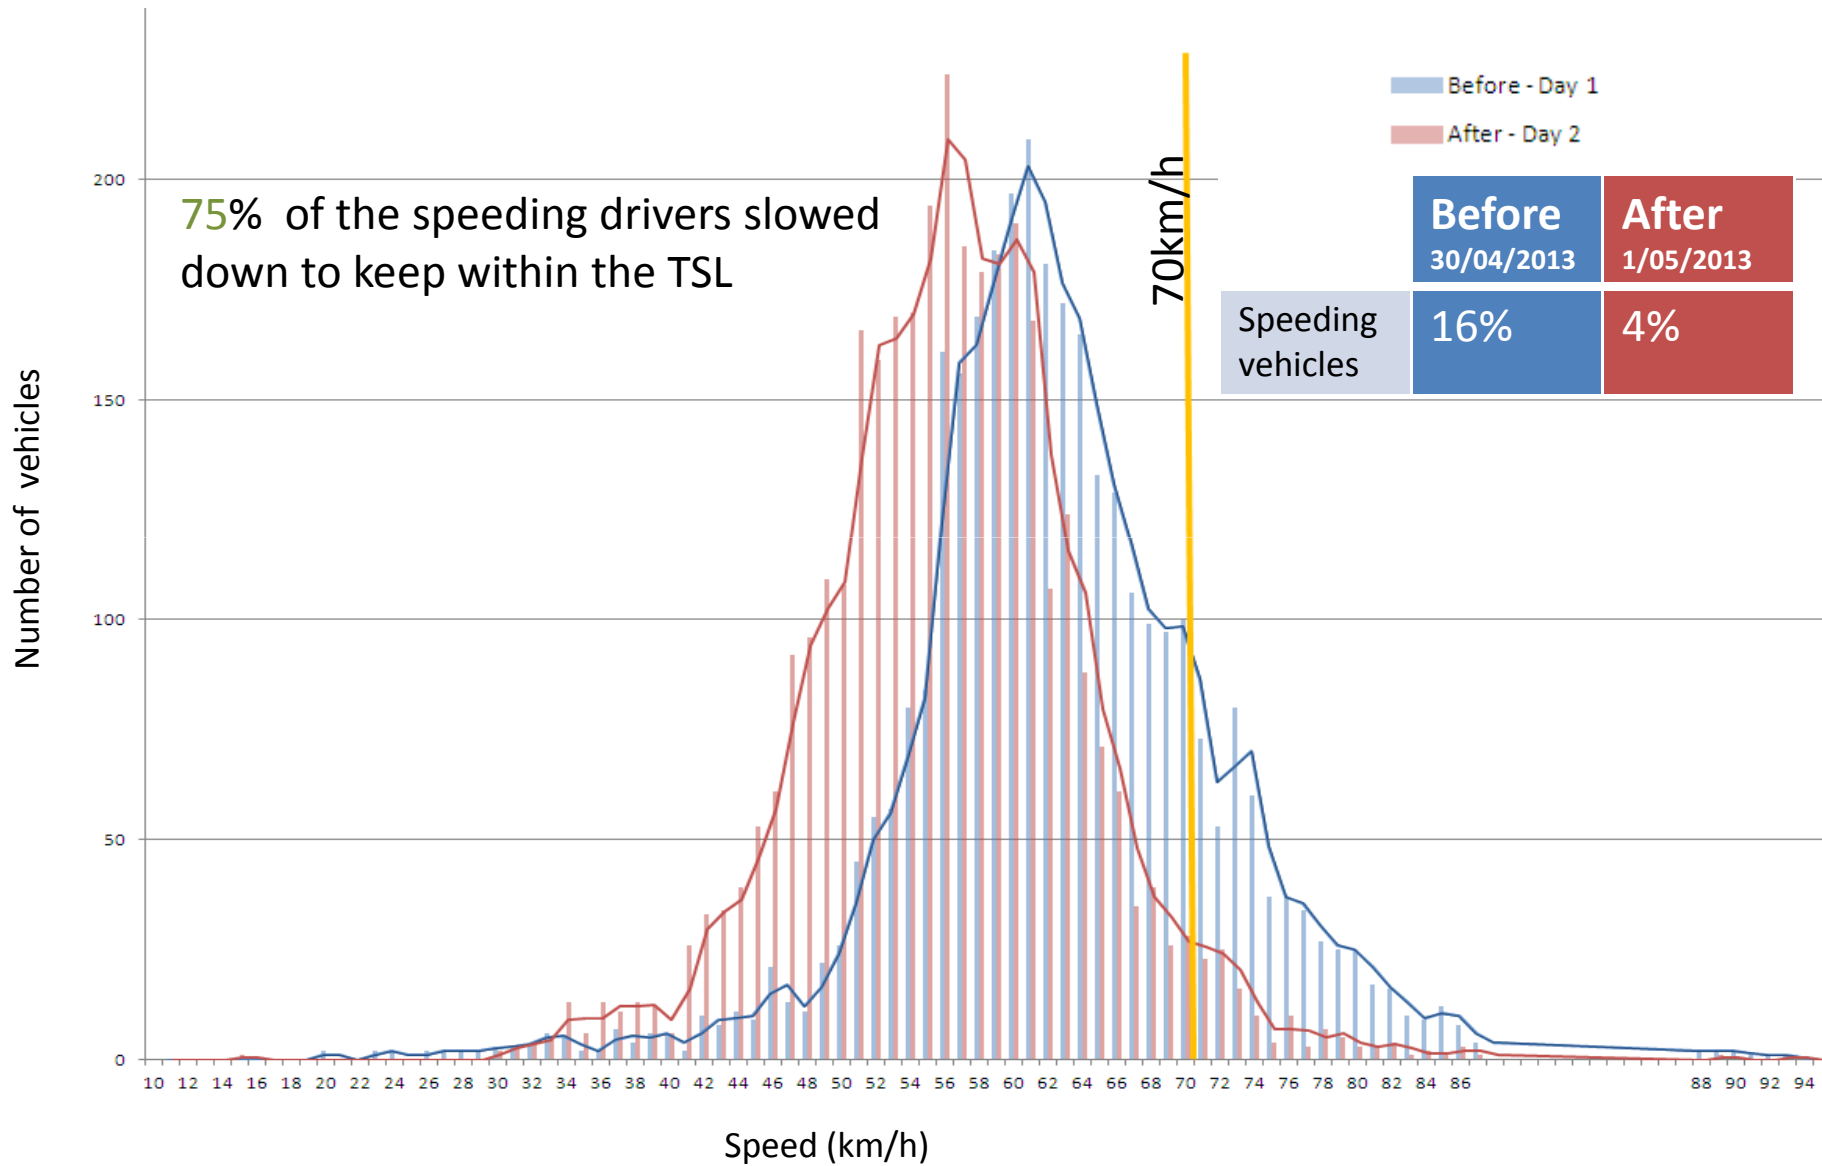
# Site 3: Dowse Drive – Method 1

Temporary Speed Limit = 70km/h

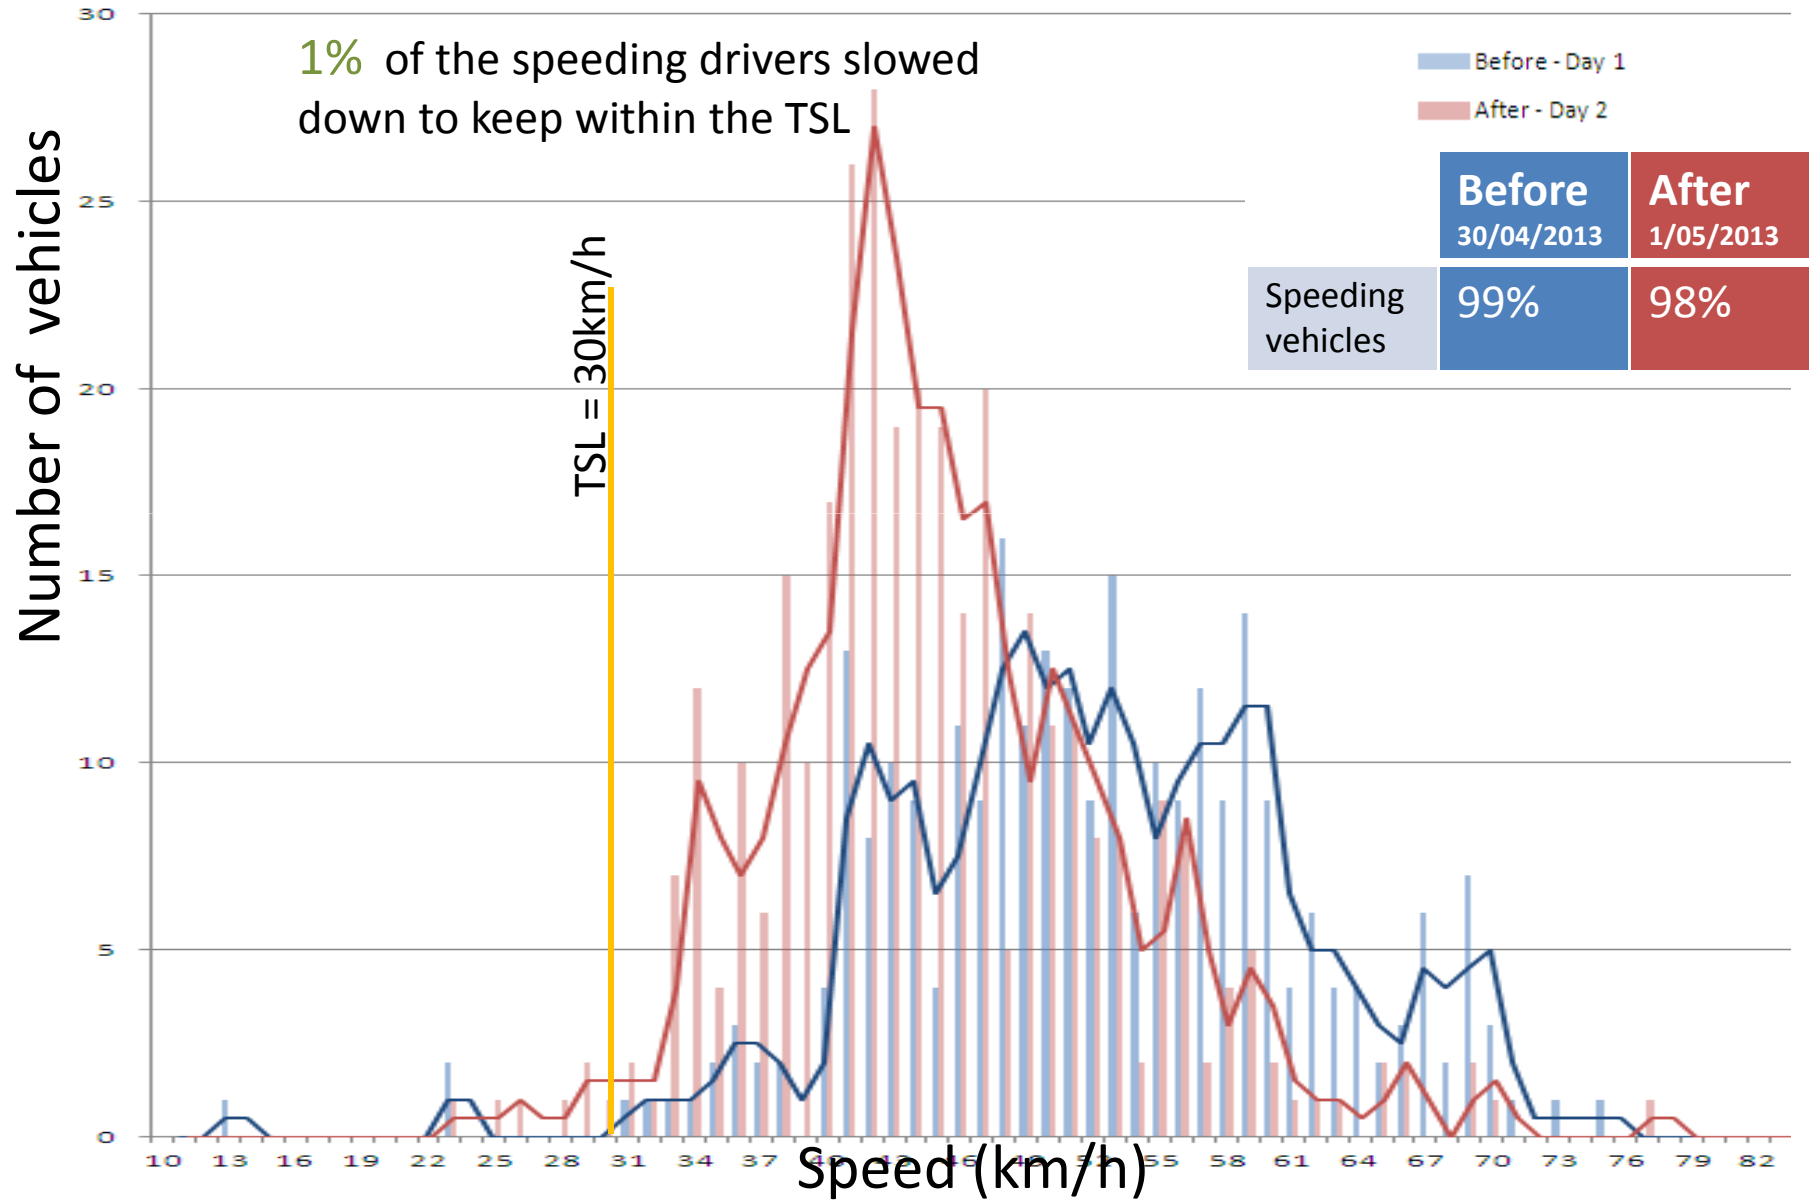
Site 4: SH2 / Willow Park Drive - Method 1  
 Temporary Speed Limit = 30km/h

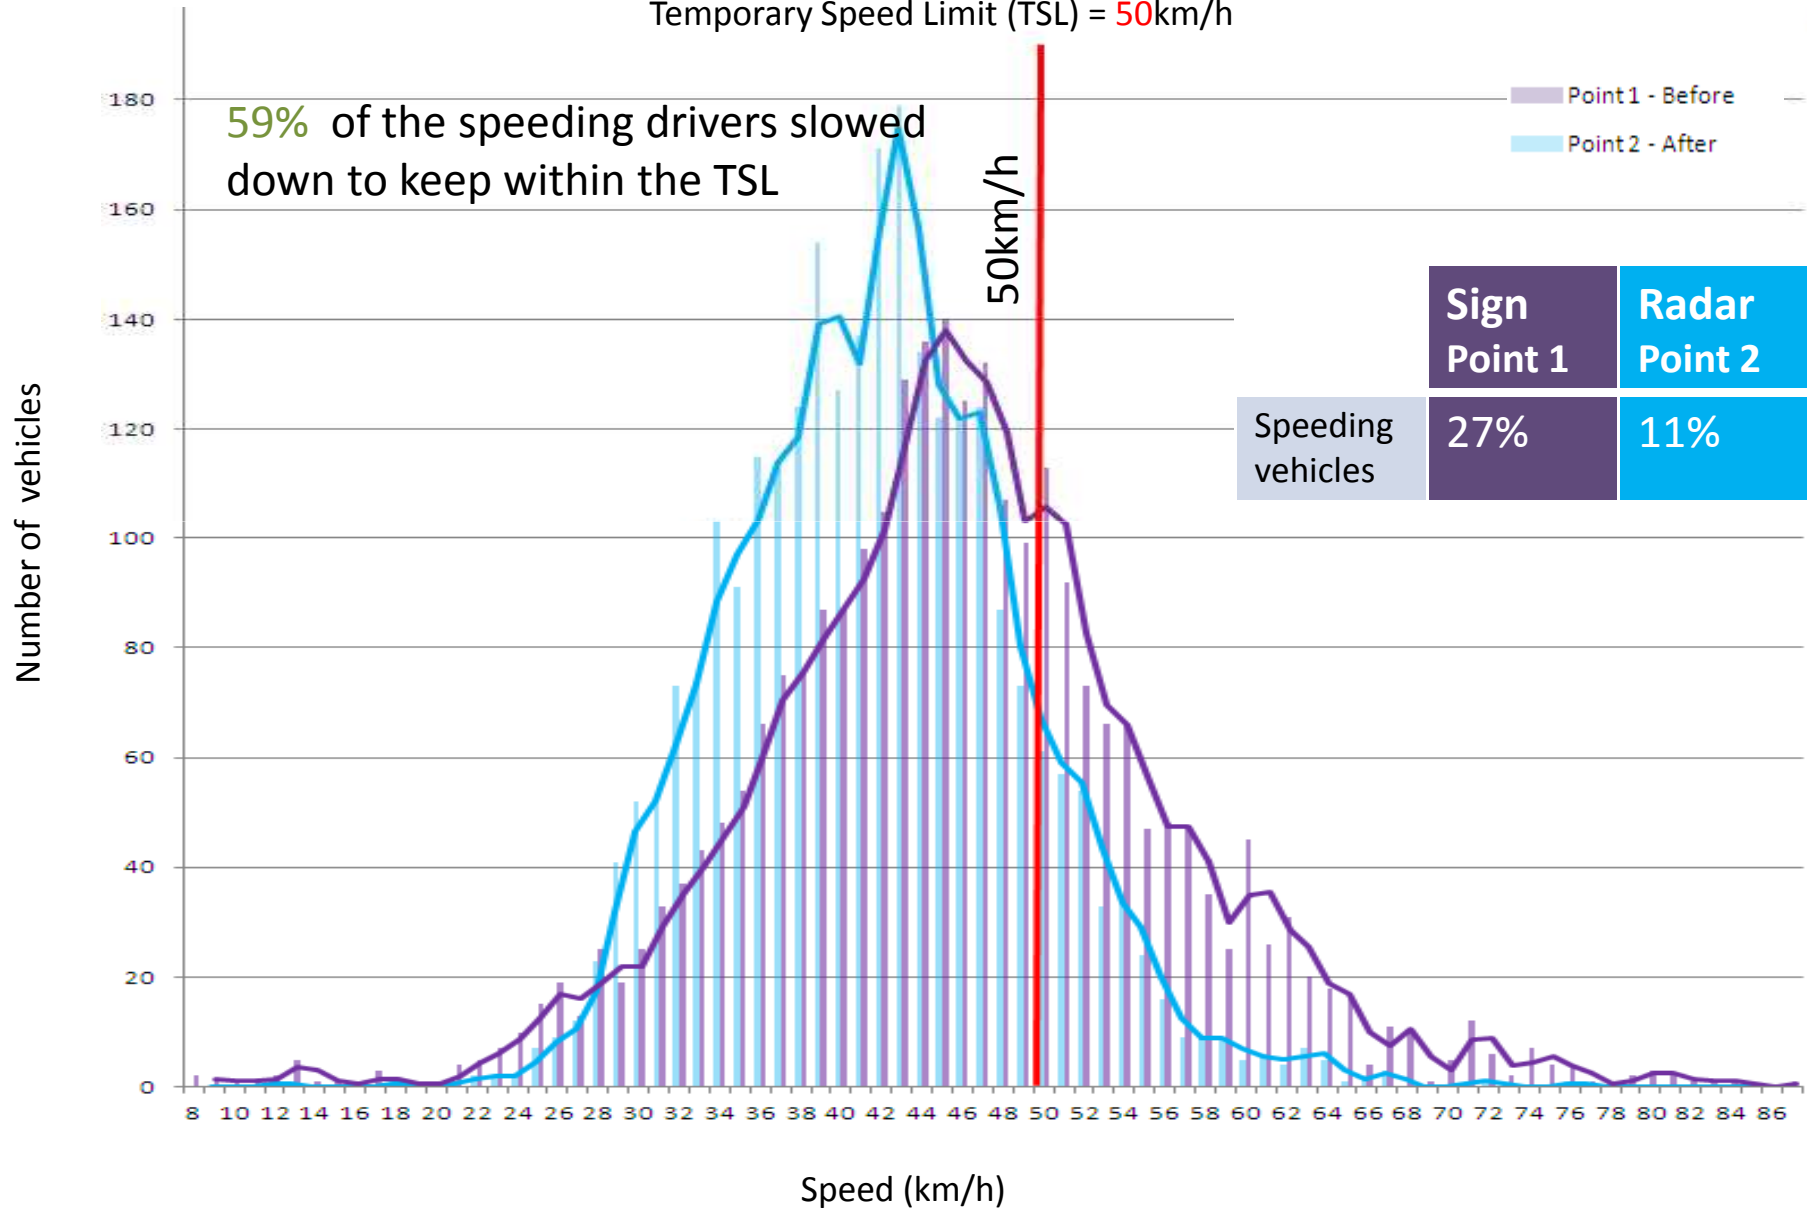
## Site 1: Te Horo – Method 2

Temporary Speed Limit (TSL) = 50km/h

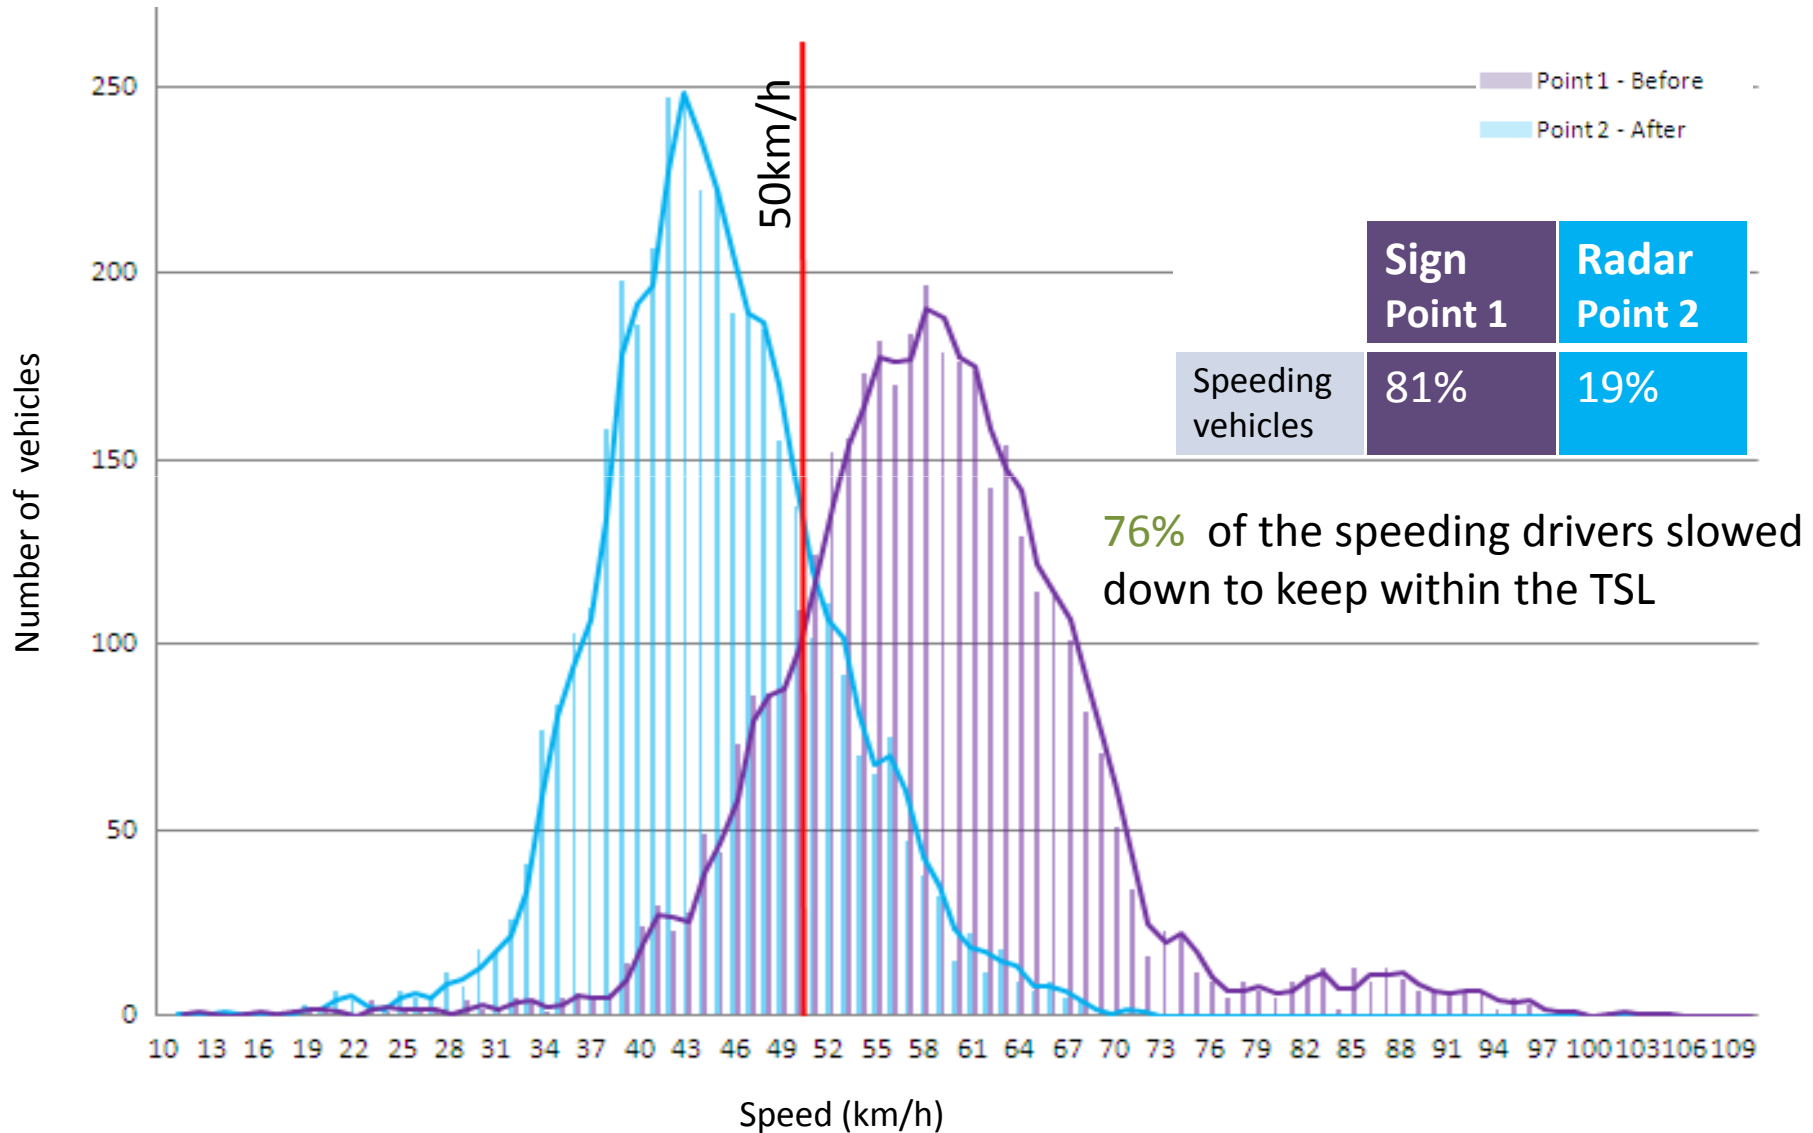
## Site 2: Ngauranga on-ramp – Method 2

Temporary Speed Limit = 50km/h

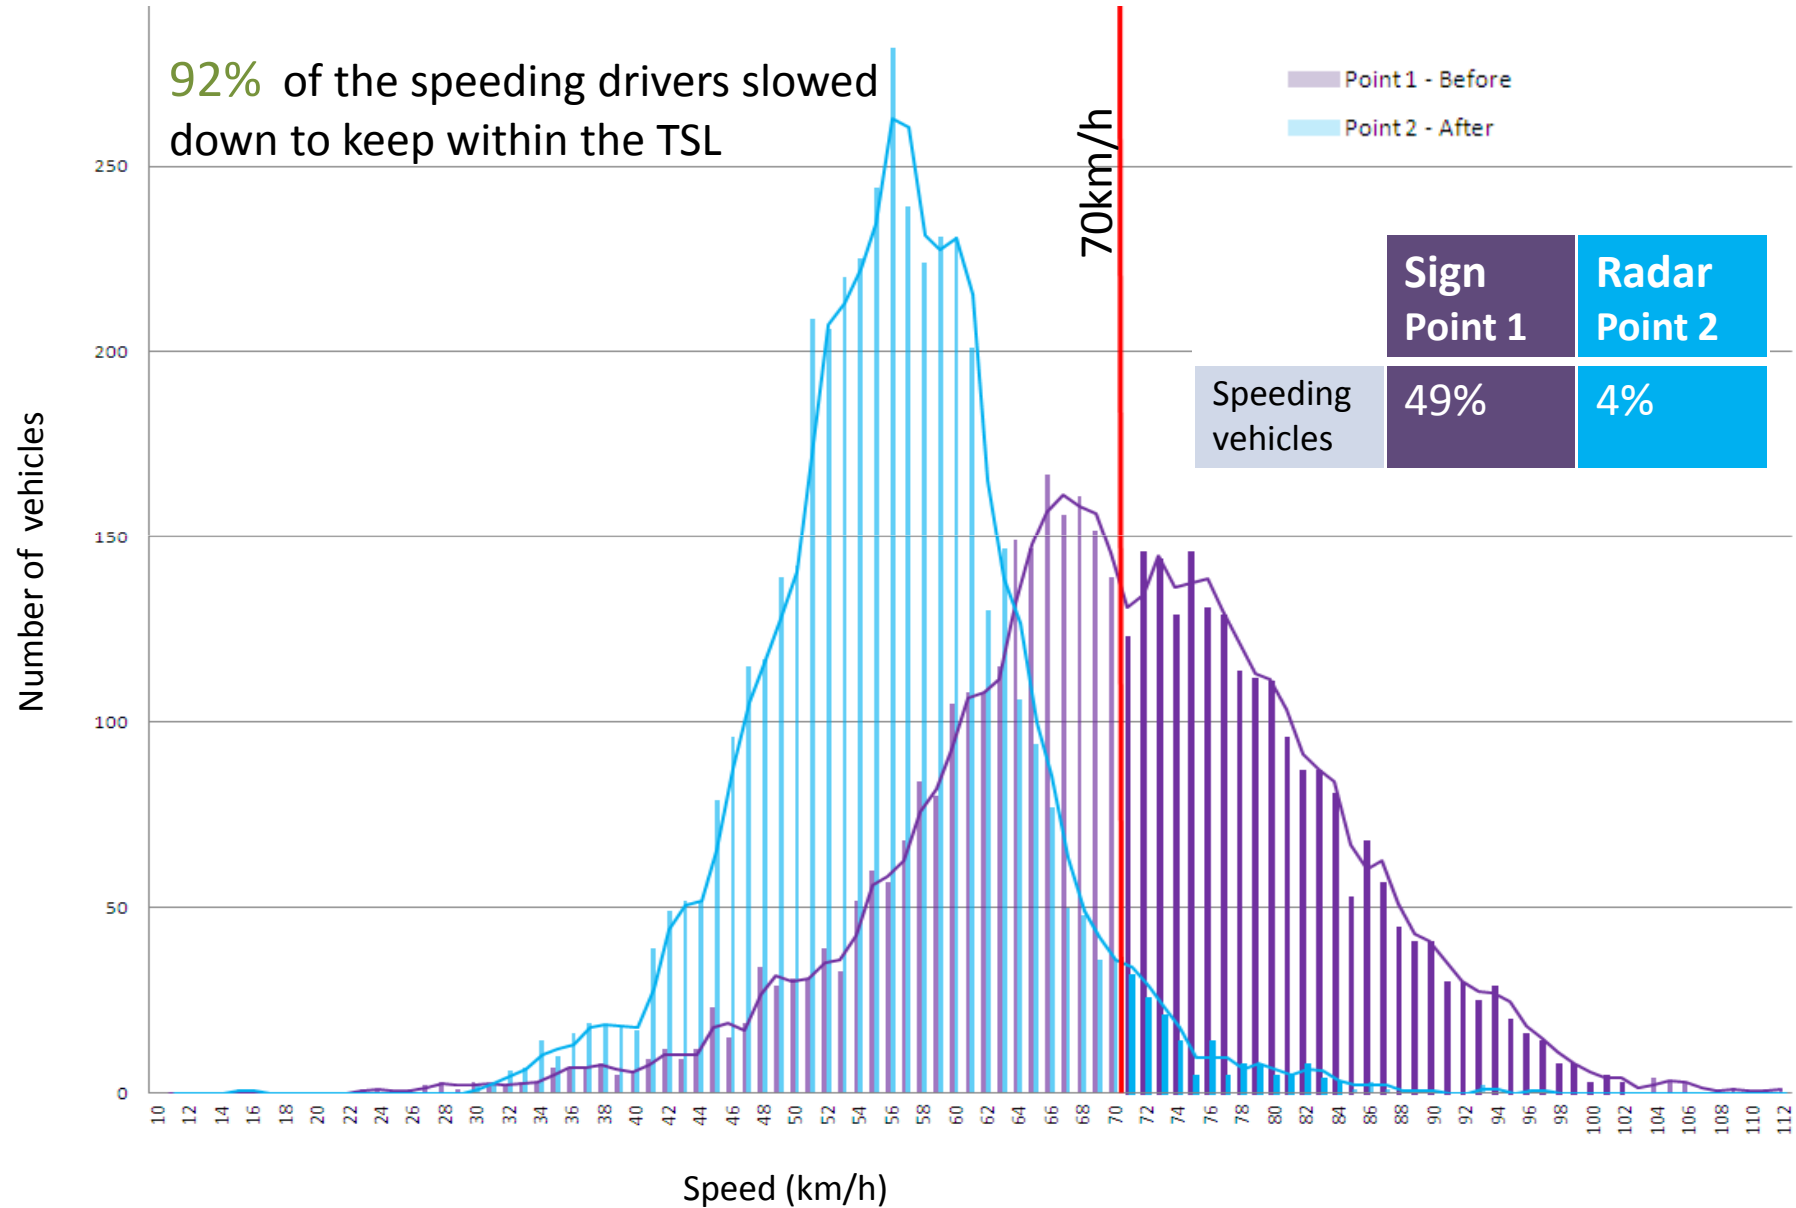
# Site 3: Dowse Drive – Method 2

Temporary Speed Limit = 70km/h

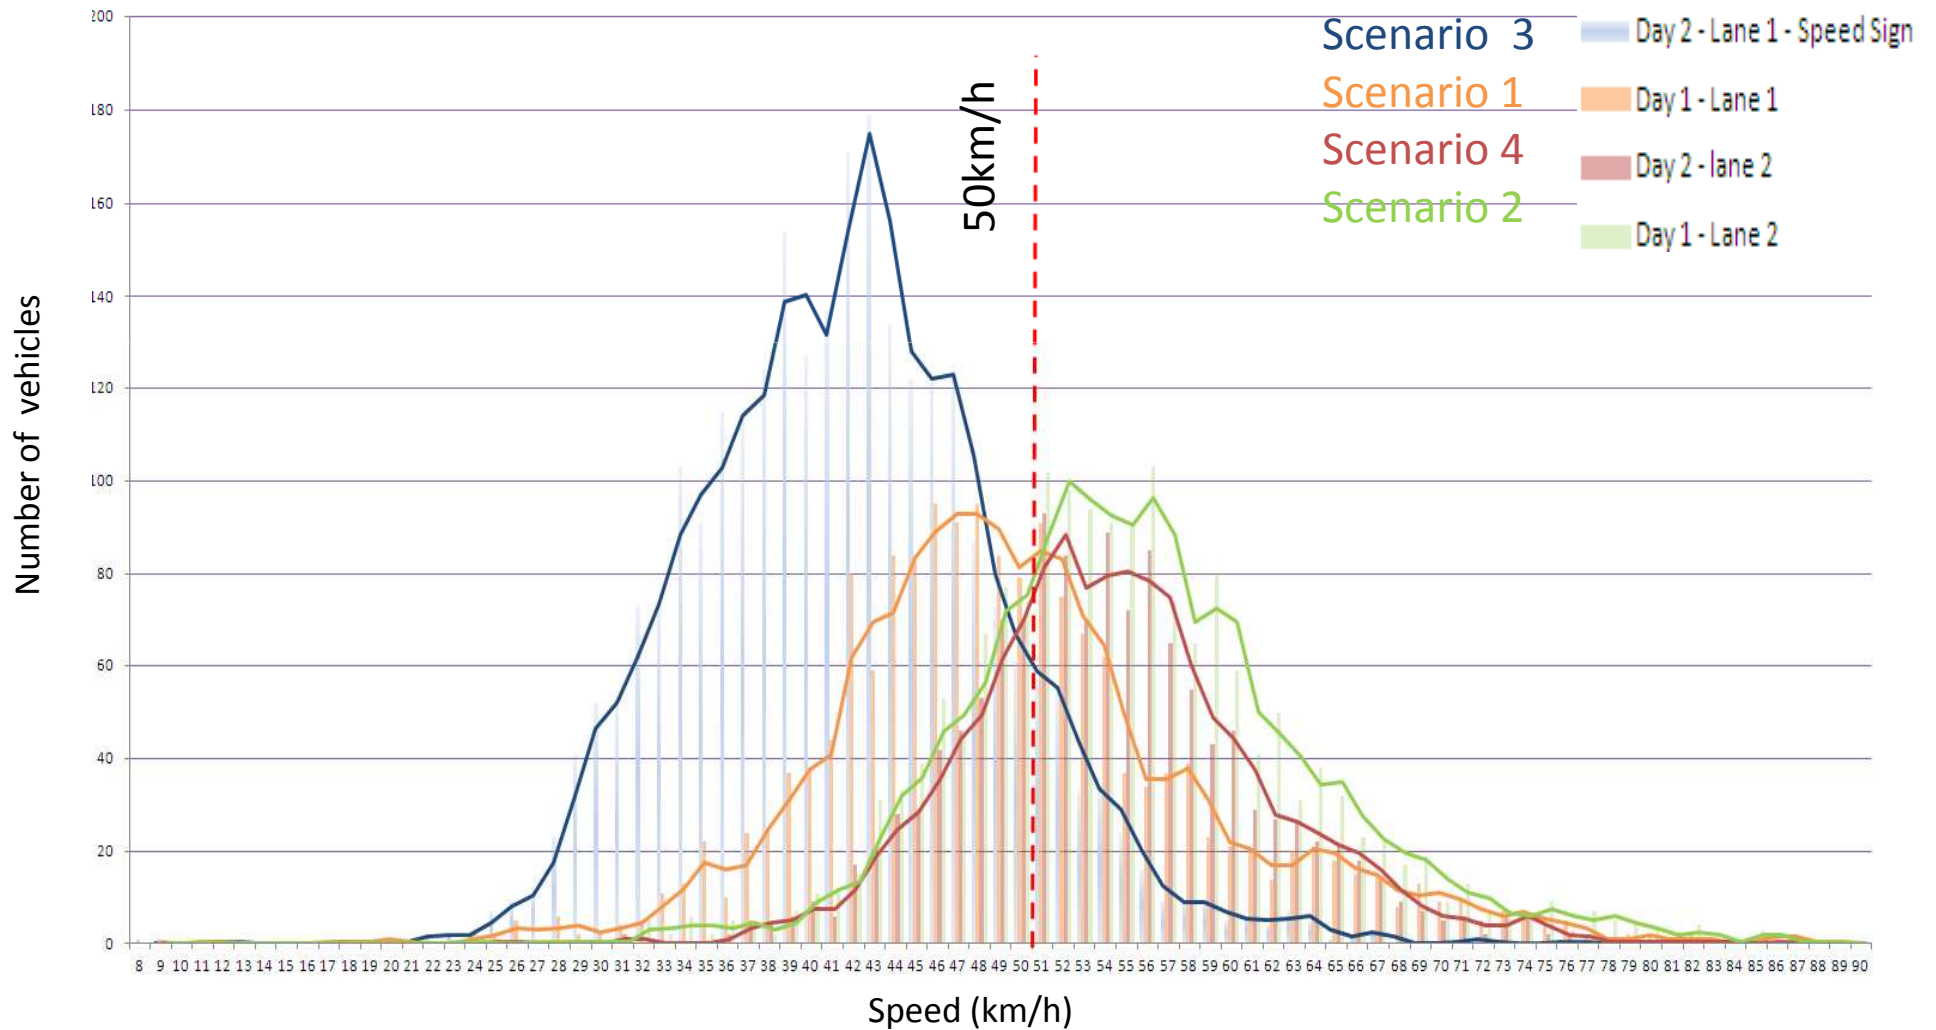
**Site 1: Te Horo – Method 3**  
Temporary Speed Limit (TSL) = 50km/h

Speeding vehicles (%)	Day 1 11/04/2013	Day 2 12/04/2013	% drop on Day 2
Lane 1	41%	11%	-74%
Lane 2	71%	69%	-3%

1. Compliance to temporary speed limit will improve with the use of speed display sign at road works site
2. The proportions of drivers exceeding the Temporary Speed Limit (TSL) were significantly reduced at three sites while the feedback sign was in operation.
3. The effectiveness of a driver feedback speed display sign varied across sites
4. Wet weather had little impact on the speed compared to the driver feedback speed sign
  - Only 3% of the drivers reduced their speed due to a wet weather
  - 74% of the drivers reduced their speed while the speed sign was in operation
