Case study of a Crash at a Manual Traffic Control Worksite using a Generic Traffic Management Plan

Author & Presenter:
Leanne McAdams

Introduction

- worksite crash
- manual traffic control worksite
- lines company was removing a power line
- generic traffic management plan

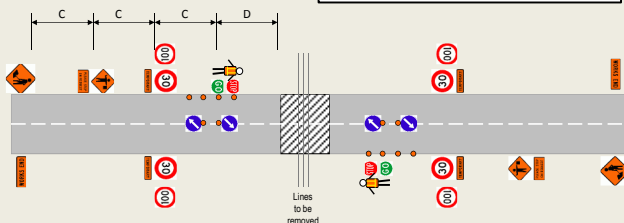
- layout of approved TMD for MTC

- MTC to stop approaching vehicles
- workman to lift lines to allow vehicles to pass underneath

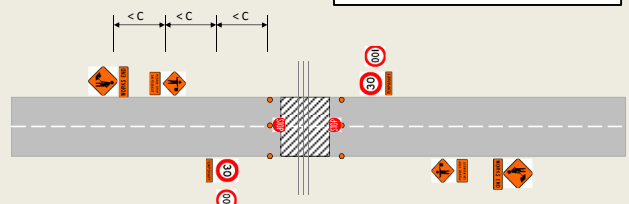
- low volume road, leniencies were made on site

- no longitudinal safety zone
- stop/go paddles placed in cones

- STMS set up & conducted the worksite as a one person operation
